NASA/TM—2015-218887

Effect of Notches on Creep-Fatigue Behavior of a P/M Nickel-Based Superalloy

*Jack Telesman, Timothy P. Gabb, Louis J. Ghosn, and John Gayda, Jr.
Glenn Research Center, Cleveland, Ohio*

November 2015

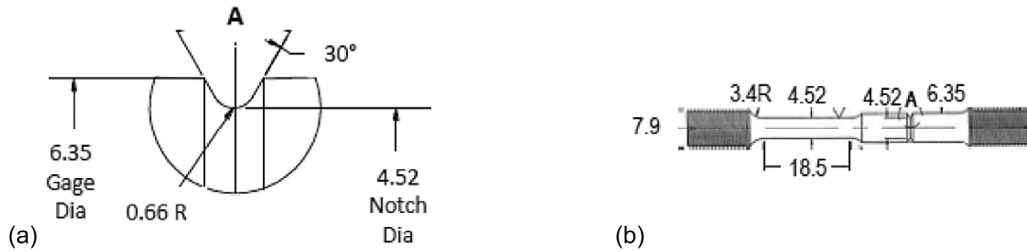
Figure 3.—Combo-bar specimen geometry. (a) Notch detail; (b) Specimen geometry.

In addition to the smooth specimens, creep rupture tests were performed on six combo-bar specimens of the geometry shown in Figure 3. All the combo-bar tests were done at 793 MPa. All six combo-bar failures occurred strictly in the uniform gage region. The lives of the combo-bar specimens were very similar to the uniform gage creep specimens as shown in Figure 22. For comparison, the much longer notch creep rupture and cyclic dwell NLCF lives are also shown in this figure.

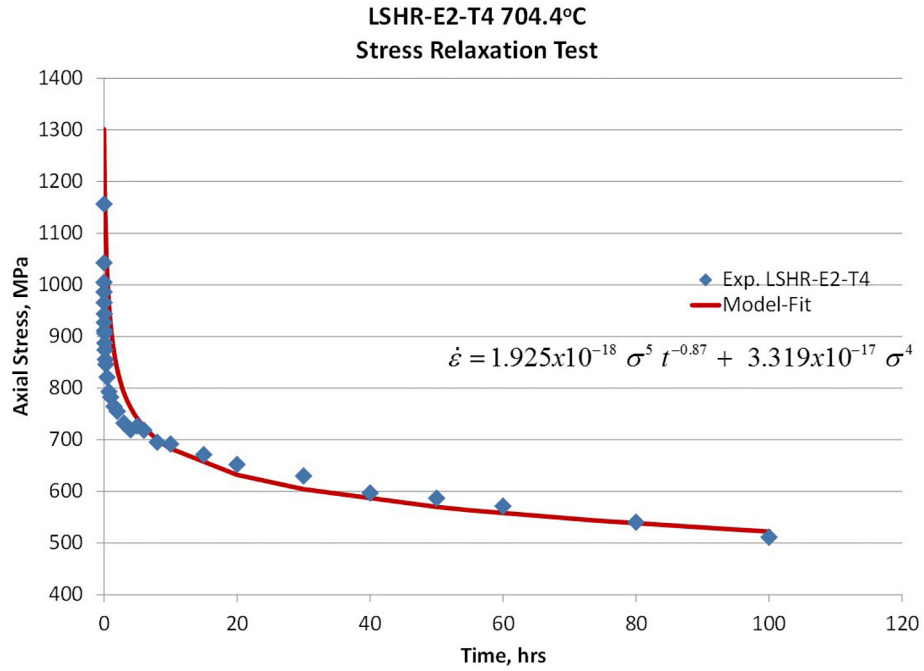
Figure 5.—Stress relaxation experiment and model fit.

An axi-symmetric visco-plastic FEM analysis was performed using the constitutive creep model previously derived (Fig. 5). The creep analyses were performed using both the von Mises and Drucker-Prager inelastic flow models embedded in ABAQUS to determine their ability to predict material behavior. The von Mises flow model is most commonly used for ductile metals. One of its theoretical assumptions is that the yield strength is independent of hydrostatic stresses. The resulting yield surface of the von Mises flow model is a circular cylinder. The Drucker-Prager yield criterion is rarely used to model metal inelastic behavior, however for high hydrostatic stresses, the model may be preferable to von Mises (Ref. 10). It differs in that in the model formulation, the effective inelastic stress is a function of the hydrostatic stress as the deviatoric stress. In terms of the yield surface, Drucker-Prager yield function results in a conical yield surface.

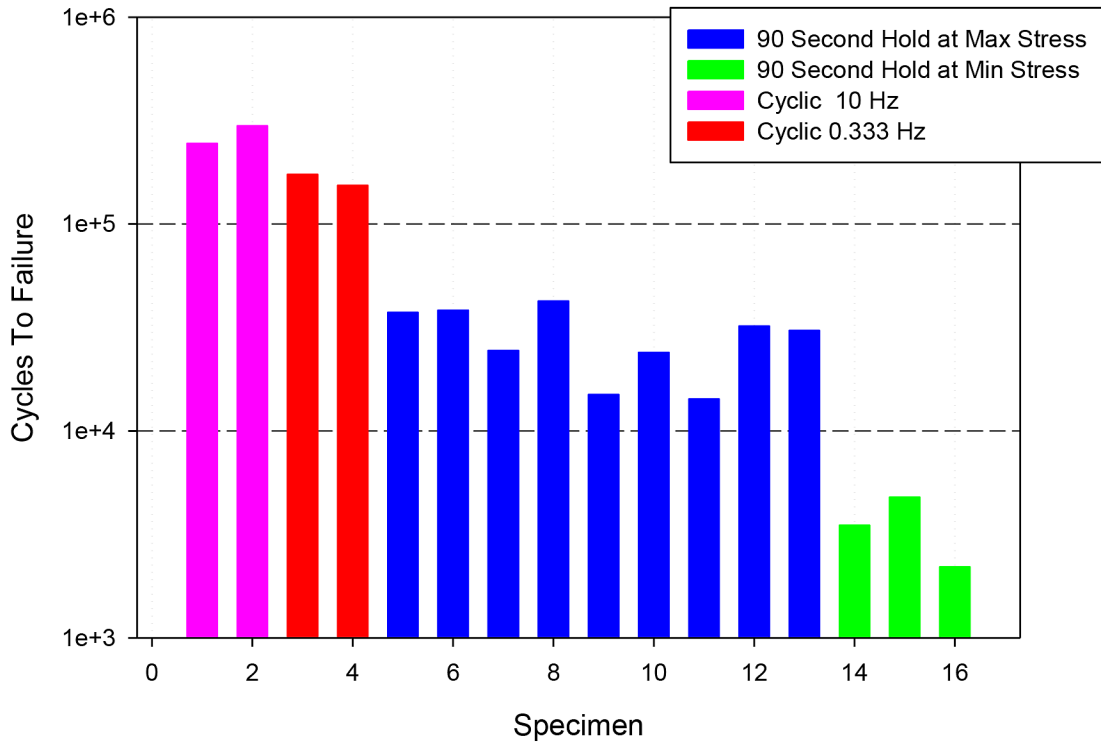
Figure 6.—Notched LCF results for cyclic and dwell tests performed in air at a maximum stress of 793 MPa.

As shown earlier, the life of the cyclic max dwell notch tests performed at the 793 MPa net section stress was considerably higher than for the min dwell tests performed at the same maximum stress (Fig. 6). It was also shown (Fig. 7(c)) that in contrast to the cyclic and the min dwell cyclic tests tested conducted at the same stress, the primary crack initiation shifted internally at a considerable distance away from the notch root. Fractography of some of the other cyclic max dwell notch tests showed similar behavior (Fig. 14(a)). The measured distances from the notch root to the internal initiation locations for the various specimens is shown in Table III. As shown, while there is a considerable scatter, most of the internal initiations occurred at distances ranging from 1 to 2.5 mm away from the notch root. A companion test performed in vacuum not only revealed a similar internal initiation mechanism (Fig. 14(b)), but also had a fatigue life similar to the other cyclic max dwell notch specimens tested in air (Fig. 14(c)). The comparable fatigue life for both air and vacuum tests is due to the environment not being a major factor in influencing the life of the specimen due to its internal initiation.

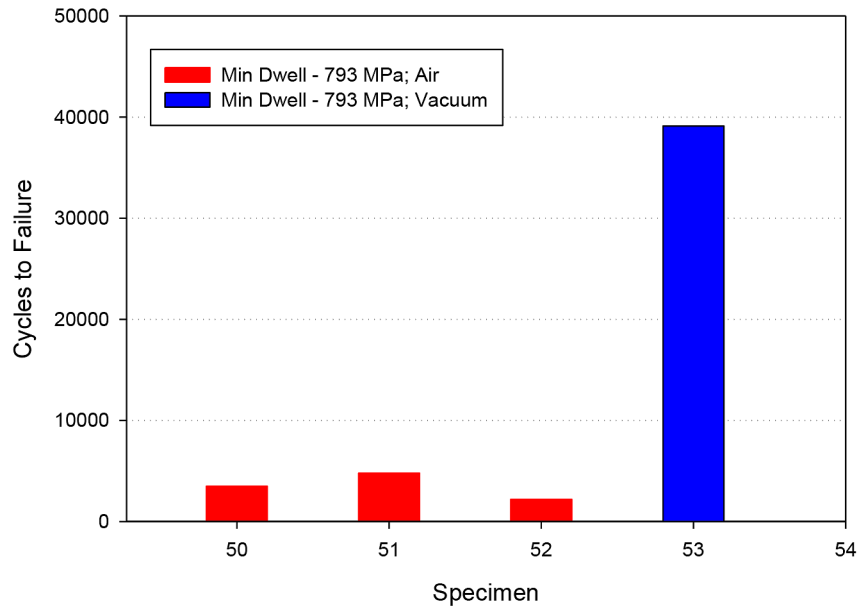
Figure 10.—Min dwell NLCF test results in air versus vacuum at a max stress of 793 MPa.

To confirm that the environment is indeed the culprit in reducing the notch dwell fatigue lives for min dwell testing, a test was conducted in a vacuum test chamber under the same loading conditions. As shown in Figure 10, the min dwell notch fatigue life of the specimen was approximately 39,000 cycles and thus an order of magnitude longer than the tests performed in air. It should be noted that the life of the vacuum specimen would likely have been even longer, since an improper bake out of a new heating element installed at approximately 28,600 cycles coated the specimen with a thin layer of a brittle ceramic phase. An array of cracks formed in this layer upon the restart of the test, with these cracks growing into the substrate and shortening the specimen's life. The specimen notch surface which was examined in the SEM at 28,600 cycles prior to the installation of the new heating element shows the notch in almost pristine condition with no apparent cracks (Fig. 11(a)). As shown, after 28,600 cycles no oxide blisters or cracks were present on the notch root surface. This is in stark contrast to the min dwell notch specimens tested in air where a multitude of cracks were present after only few thousand cycles. Thus the relationship between oxidation damage and min dwell notch fatigue life is quite evident. The same vacuum specimen examined after failure at approximately 39,000 cycles shows an array of cracks originating from the inadvertently deposited brittle coating (Fig. 11(b)). The vacuum test has not as yet been repeated due to the unavailability of the test rig.

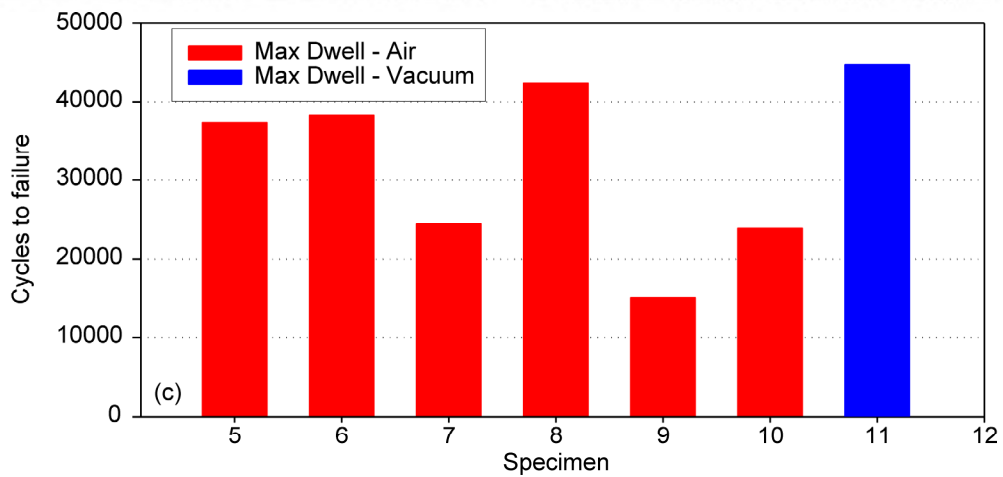
Figure 14.—Comparison of failure modes and dwell fatigue lives for air and vacuum tested cyclic max dwell NLCF specimens tested at 793 MPa. (a) Cyclic max dwell NLCF in air. (b) Cyclic max dwell NLCF in a vacuum. (c) Cyclic max dwell air versus vacuum.

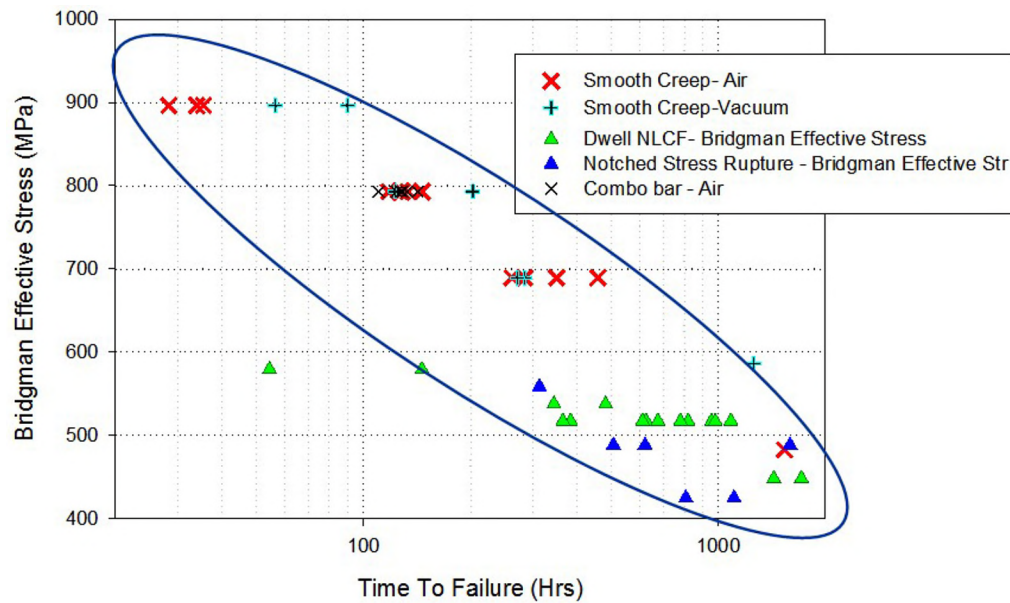
Figure 27.—Notch and uniform gage test data plotted in terms of the Bridgman effective stress. Methodology adequately accounts for visco-plastic notch strengthening.

considerably longer lives to failure in terms of the net section stresses than the uniform gage specimens. However when the same data set is plotted in terms of the Bridgman effective stress (Fig. 27), most of the data converges into a singular grouping. It should be noted that much of the scatter still present in the Bridgman effective stress plot shown in Figure 27 is due to the inherent variations in lives of specimens tested under “identical” conditions. No mechanistically derived parameter can account for that type of scatter. Thus, this methodology, which was developed many years ago, is still very useful in modeling notch-induced plastic deformation.
