External Publication No. 740 WELDED TITANIUM CASE FOR SPACEPROBE ROCKET MOTOR

A. J. Brothers, R. A. Boundy, H. E. Martens, and L. D. Jaffe

JET PROPULSION LABORATORY

A Research Facility of
National Aeronautics and Space Administration
Operated by
California Institute of Technology
Pasadena, California
September 3, 1959

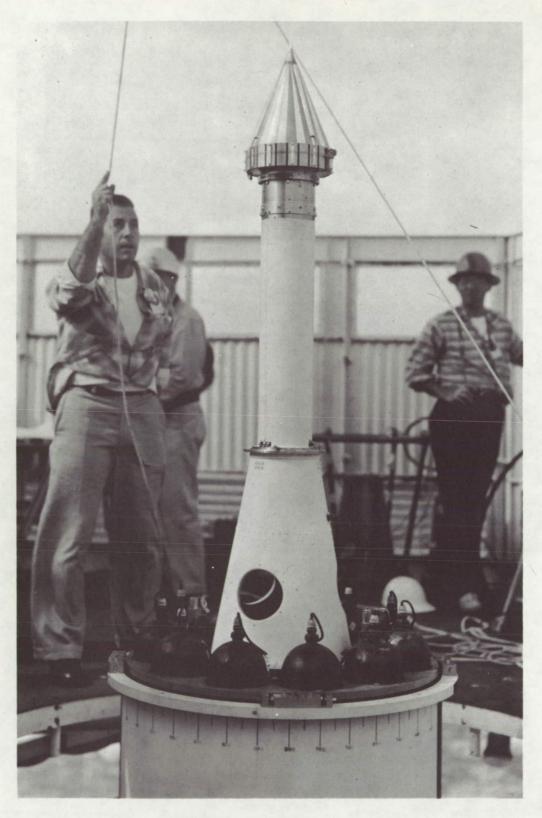
Fig. 1. Moon-Probe Vehicle, Showing <u>Pioneer IV</u> Mounted on Titanium-Cased Fourth-Stage <u>Rocket Motor</u>

The titanium-case fourth stage of Juno II is shown with the payload and on the missile in Fig. 1; the stainless-steel motor cases used in the Jupiter-C vehicle are shown in Fig. 2. The fourth-stage motor case has a diameter of 6 in., a length of approximately 38 in., and a nominal cylindrical wall thickness of 0.025 in. As shown in Fig. 1, the case serves as the structural support of the payload and is aligned to the upper stage assembly through an alignment ring. The nozzle is threaded into the end of the motor case, and is of the ceramic-coated steel design.

As shown in Fig. 1, the <u>Pioneer IV</u> payload was attached to the forward skirt of the fourth-stage motor. To conserve weight, nut plates were used to make this attachment. These nut plates were bonded to the titanium alloy with an epoxy adhesive, since soldering is not a simple procedure on titanium alloys.

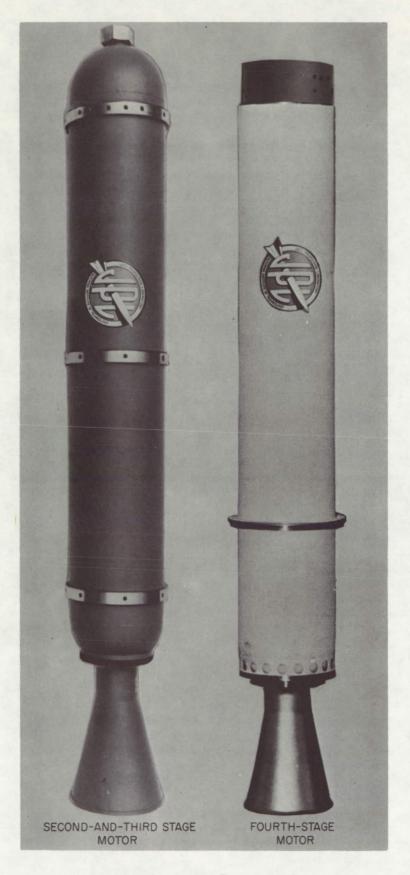
Fig. 2. Stainless-Steel <u>Jupiter-C</u> Upper-Stage Motor <u>Cases</u>

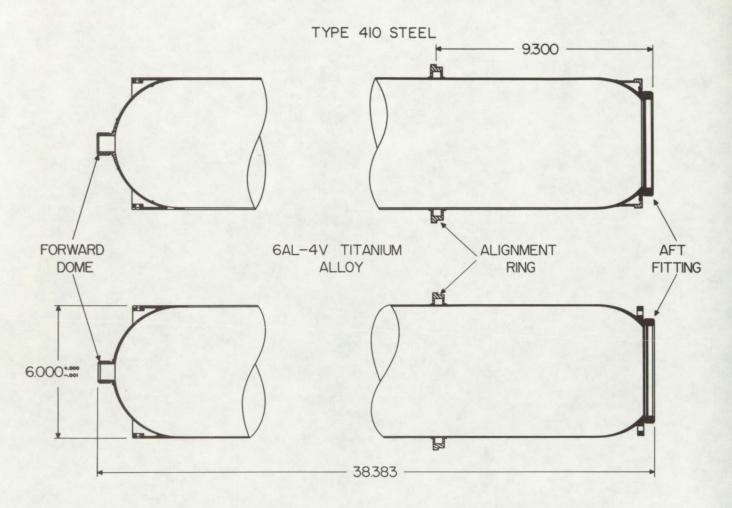
FORWARD DOME AND AFT FITTING OF TYPE 410 STEEL CASE CONSTRUCTED OF THREE PIECES WELDED TOGETHER. CORRESPONDING COMPONENTS OF 6AL-4V TITANIUM ALLOY CASE WERE MACHINED FROM 6.5 INCH DIAMETER BILLET.

Fig. 3. Comparison of 6Al--4V Titanium-Alloy and Type-410 Stainless-Steel Fourth-Stage Motor Cases

Figure 3 shows a comparison of the components used to make the stainless steel and the 6A1--4V titanium alloy cases. The forward dome and aft fitting for the stainless steel assembly were fabricated from a combination of forged, spun and machined parts. In order to facilitate the fabrication of the titanium alloy motor, these components were machined from a large-diameter billet.

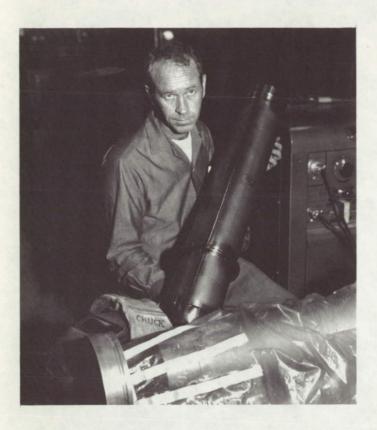
Fig. 4. Completed Weldment of Titanium-Alloy Motor Case

A completed fourth-stage rocket motor case fabricated from the titanium alloy is shown in Fig. 4. The details of the various fabrication operations are depicted in Figs. 5 through 11. Table 1 describes the welding procedures used.

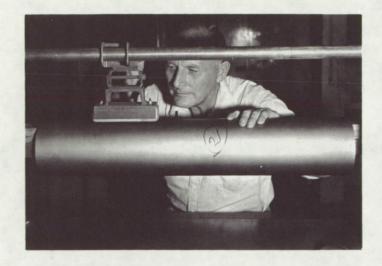
Fig. 5. Final Sizing of Titanium-Alloy Shell

Figure 5 shows a sizing jig being used to finish the 6-in.-diam rolled shell. Because of its high annealed yield strength and considerable "spring-back" the titanium alloy could not be hand formed at room temperature as was the stainless steel, but required use of the jig. By maintaining good joint fit, a high

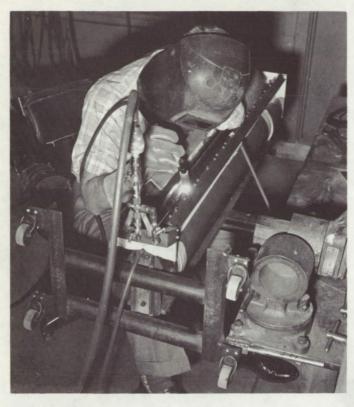
Fig. 6. Seam-Welding Titanium-Alloy Shell

degree of cleanliness, and adequate gas shielding, the longitudinal weld could be done without an enclosure, as shown in Fig. 6.

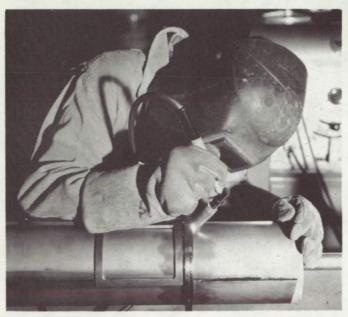
Fig. 8. Tack-Welding Alignment Ring to Shell

Figures 8 and 9 illustrate tacking and welding of the alignment ring. This weld required no filler metal, since a flange was provided on each edge of the ring for fusing to the shell. Although the final welding was carried out in the plastic chamber, the tacking was performed without an enclosure. Improper fit-up between the ring and the shell resulted in low cooling rates and shrinkage distortion, both of which caused weld contamination. To keep this contamination at a minimum, short segments of the ring were welded 180 deg apart and along opposite edges until the entire weld was complete.

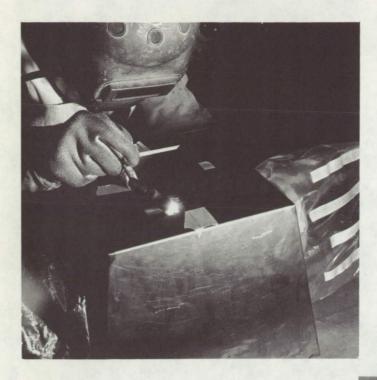
Fig. 9. Welding Alignment Ring to Shell
