(Preprint) AAS 15-083

GLOBAL PRECIPITATION MEASUREMENT MISSION LAUNCH AND COMMISSIONING

During launch and early operation of the Global Precipitation Measurement (GPM) Mission, the Guidance, Navigation, and Control (GN&C) analysis team encountered four main on-orbit anomalies. These include: (1) unexpected shock from Solar Array deployment, (2) momentum buildup from the Magnetic Torquer Bars (MTBs) phasing errors, (3) transition into Safehold due to albedo induced Course Sun Sensor (CSS) anomaly, and (4) a flight software error that could cause a Safehold transition due to a Star Tracker occultation. This paper will discuss ways GN&C engineers identified the anomalies and tracked down the root causes. Flight data and GN&C on-board models will be shown to illustrate how each of these anomalies were investigated and mitigated before causing any harm to the spacecraft. On May 29, 2014, GPM was handed over to the Mission Flight Operations Team after a successful commissioning period. Currently, GPM is operating nominally on orbit, collecting meaningful scientific data that will significantly improve our understanding of the Earth's climate and water cycle.

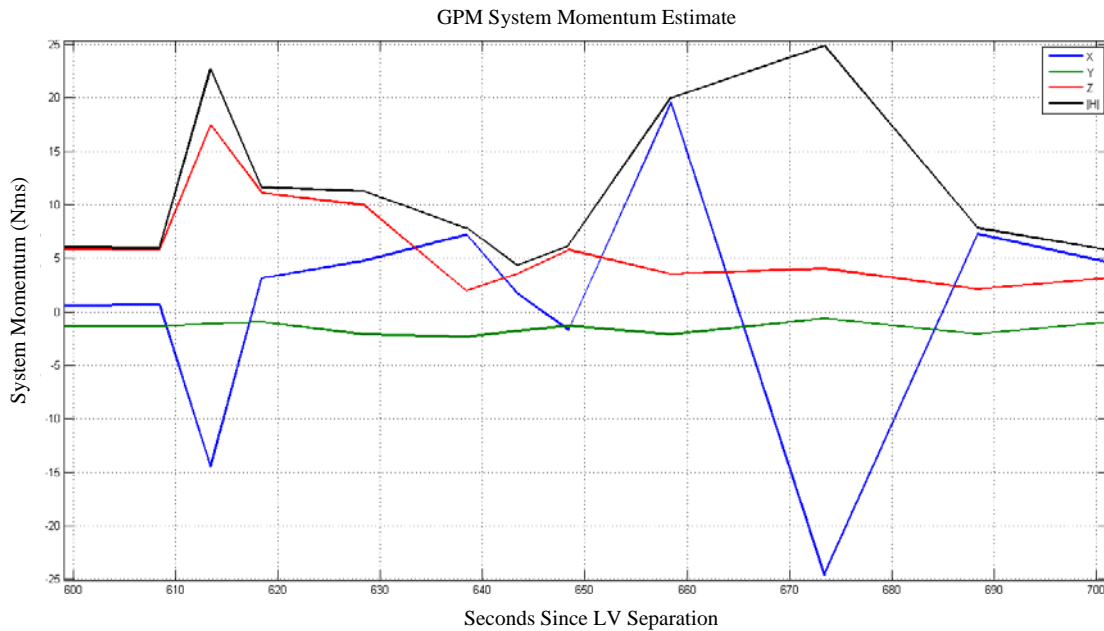
During the Launch and Early Operations sequence, real-time telemetry is limited due to the available bandwidth of the S-band link. On-board telemetry is also down-sampled to once per 10 seconds in order to conserve data storage space. This telemetry sampling made reconstruction of the events surrounding the FDC actions difficult. However, enough data was collected to show substantial change in system momentum had occurred (Figure 2). Large jumps in the estimated system momentum occurred at approximately Sep+610 seconds and Sep+655 seconds. From the event log, it was during the second of these two events that the FDC check failed. It cannot be seen from the down-sampled, on-board storage data whether there was sufficient change over three 10Hz cycles to warrant the actions, but there is enough circumstantial evidence to conclude that the system responded to the unexpected large torques on the body due to the solar array deployment.

Figure 2: System Momentum Estimate During Solar Array Deployment.

In retrospect, more analysis could have been done on the actual solar array deployment and the dynamic interaction with the GPM core body. Also, the FDC check on delta system momentum could have been disabled until after solar array deployment. Given the resources needed for the dynamic analysis, and the low risk of propulsion issues prior to propulsion system checkout, the latter would have likely been the recommended choice.

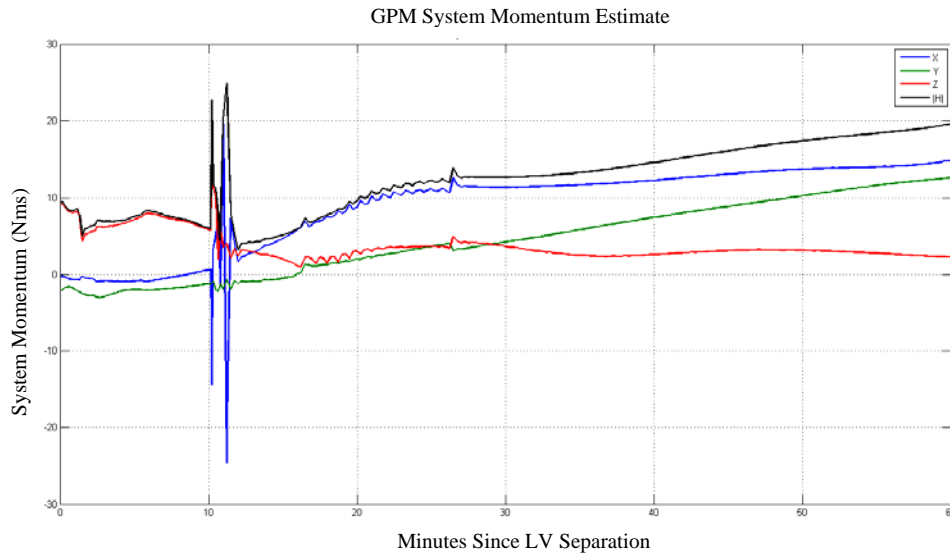
After the transients of separation from the launch vehicle, initial deployments, and Sun acquisition had settled, the GN&C engineers on console in the GPM launch support room observed that the observatory system momentum was slowly increasing (Figure 3). Although limited real-time telemetry was available and the spacecraft dynamics were not yet quiescent, the experience of the engineers on console with simulations and performance testing led to additional scrutiny of the trend. At this point, less than one full orbit's worth of data had been collected and the existence of an anomaly was not a certainty. However, the GPM Systems Engineering team was notified immediately of the concern and the decision was made to continue monitoring the data trend and consult the contingency documentation to eliminate potential sources of the issue.

Figure 3: System Momentum Trend During First Hour.

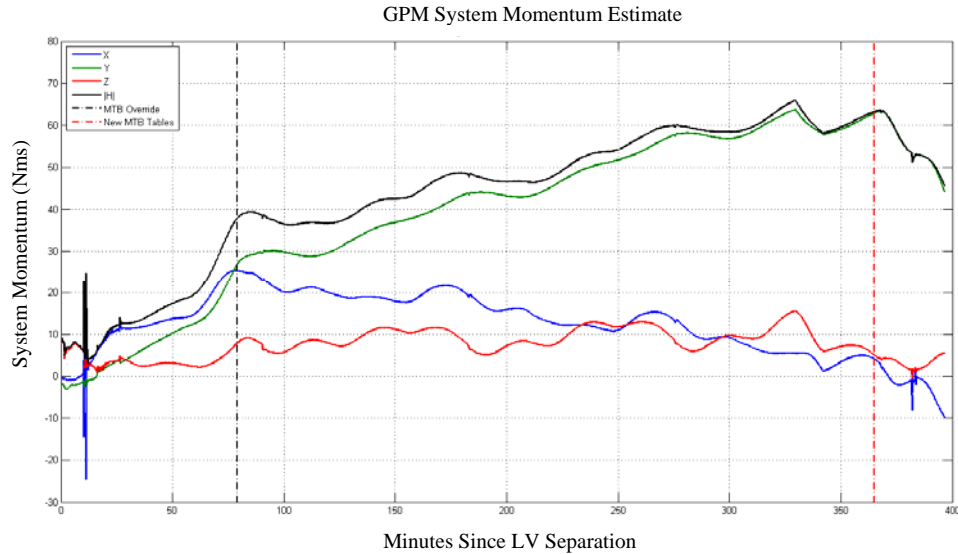
was complete. The upload sequence took about 20 minutes and 6 hours and 5 minutes after separation from the launch vehicle, the new tables took effect. Within 30 minutes, the total system momentum had decreased by 30%. Nominal momentum levels were reached less than an orbit after the new tables took effect. The new tables were burned into EEPROM on both processor sides so that any further entry into Safehold would be in the correct momentum management configuration, allowing for fault tolerance.

Figure 4: System Momentum Trend During MTB Anomaly.

After GPM commissioning activities were concluded, an investigation into the cause of the phasing issue was conducted. This investigation looked into the vendor documentation, test equipment, and testing documentation. Ultimately, it was determined that the anomaly occurred because of both incorrect assumptions about the field direction as stated in the MTB documentation and an incorrect understanding of the ground test magnetometer instrument. The test campaign should have caught the issues, but the test was not properly set-up to distinguish phasing errors in the spacecraft body axes. Also, the same team that defined the test approach was also the team who reviewed the results of the phasing tests. Any incorrect assumptions that went into designing the test were also used in determining the success criteria. No external project review of the phasing test procedures and results was conducted, which likely would have flagged the approach as a potential issue.

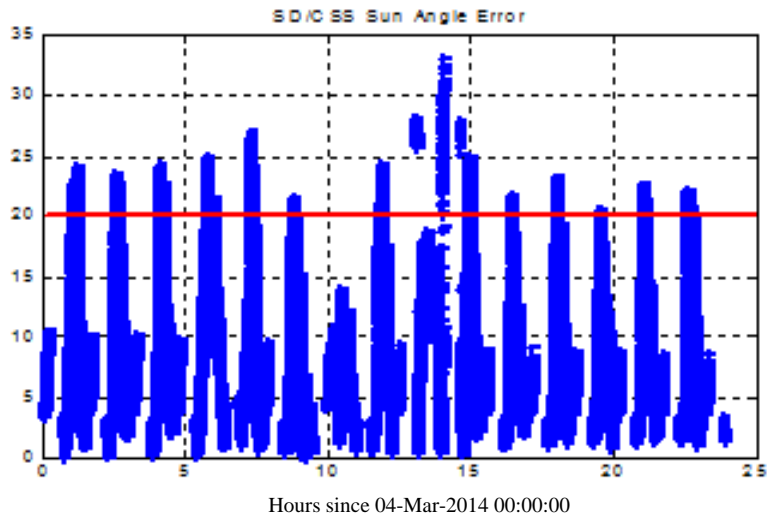
Figure 6, shows the angular error between the CSS Sun vector and the SD/OM Sun vector for one day's worth of orbits. As can be seen in the Figure, the FDC limit was being exceeded almost every orbit. As designed, the FDC test was not going to work effectively. New limits and persistence would have to be established prior to enabling that particular FDC again. Because the GN&C team also believed that the error could also be dependent on Beta angle and season, it was decided to collect data for a long period of time prior to selecting new limits.

Figure 6: State Determination/CSS Sun Angle Error.

Using data collected over several months, the GN&C team suggested increasing the angular error limit to 30 degrees and the persistence to 5 minutes. Even though angular errors greater than 30 degrees had been seen, it was felt that increasing the limit more than that would effectively disable the FDC check entirely. It was believed that increasing the persistence to 5 minutes would account for potential exceedences. These changes were implemented shortly thereafter, but, since there were other FDCs in place to monitor the performance of the State Determination, it was decided to leave the Sun Vector FDC in passive mode for a while longer to monitor the new limit and persistence. At this point in time, the FDC is still in passive mode.
