Shell-NASA Vibration-Based Damage Characterization

John Michael Rollins

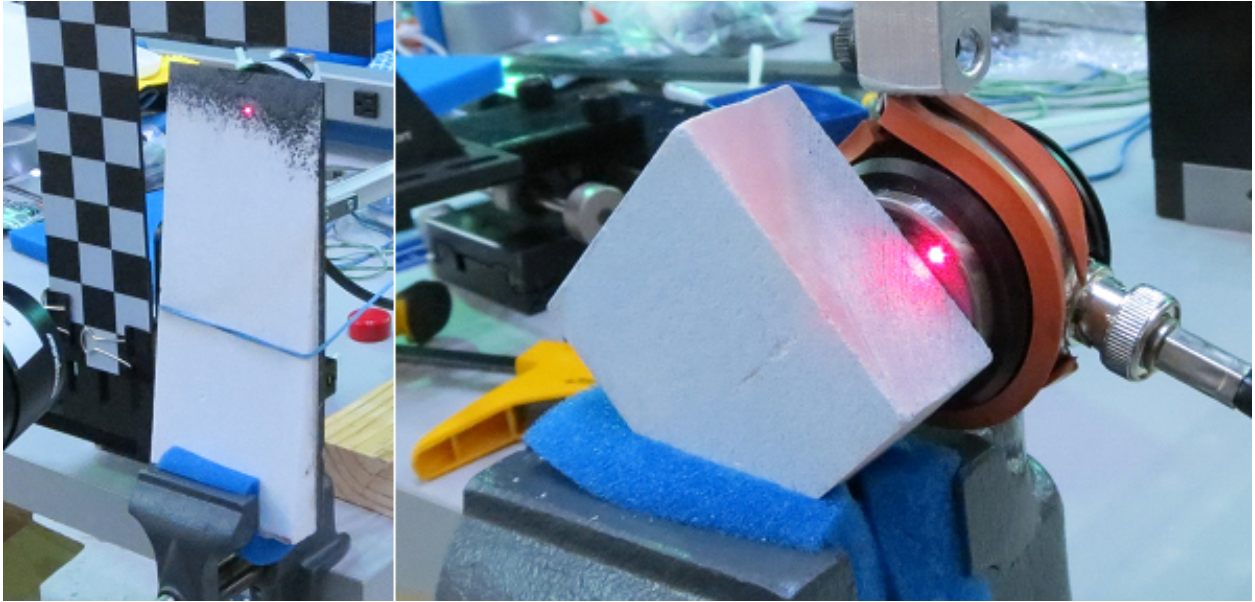
Figure 1.– (Left to right) Tile wedge and low-density tile slab with a vibrometer laser spot hitting the transducer.

Each trial consisted of attaching an ultrasonic transducer near or onto one surface of a test article and reading the response with the laser vibrometer. The test data was collected by Polytec vibrometer analysts (using their equipment) and analyzed by the project lead scientist from Shell, who had designed the test procedure.

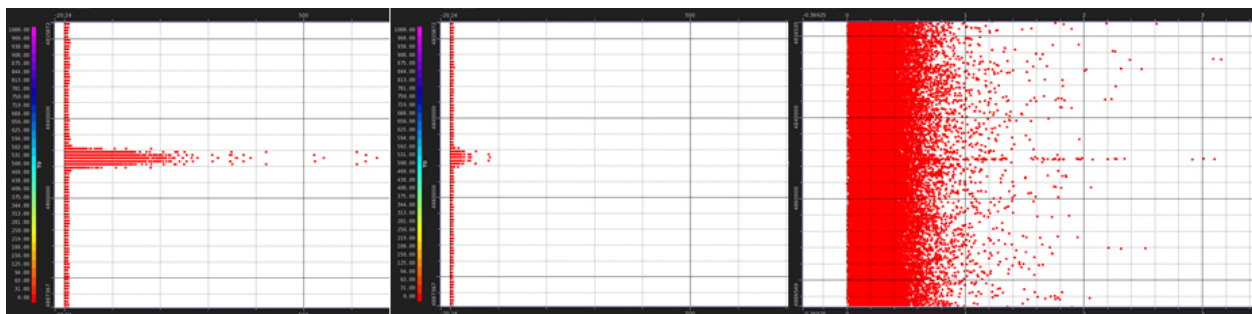
Figure 2.– Plots showing the relative amplitude of an ultrasonic signal propagating through the tile wedge, after transmission through (left to right) 0.16-in., 0.40-in., and 0.87-in. of thickness, respectively. Note that the amplitude is practically in the noise for a signal traveling through less than an inch of tile. Courtesy of Shell IE&P.

For through-transmission testing with the tile wedge, extremely large attenuation (1000x amplitude damping per inch of thickness) was observed in comparing ultrasonic excitation with response amplitudes (after propagation through tile material). Given these results, ISAG has no further plans to pursue such a method for spacecraft damage characterization. Results were more promising for at least one test article from Shell, and Shell may pursue such analysis further.
