Remote Sens. **2014**, *6*, 11607-11626; doi:10.3390/rs61111607

Article

Landsat-8 Thermal Infrared Sensor (TIRS) Vicarious Radiometric Calibration

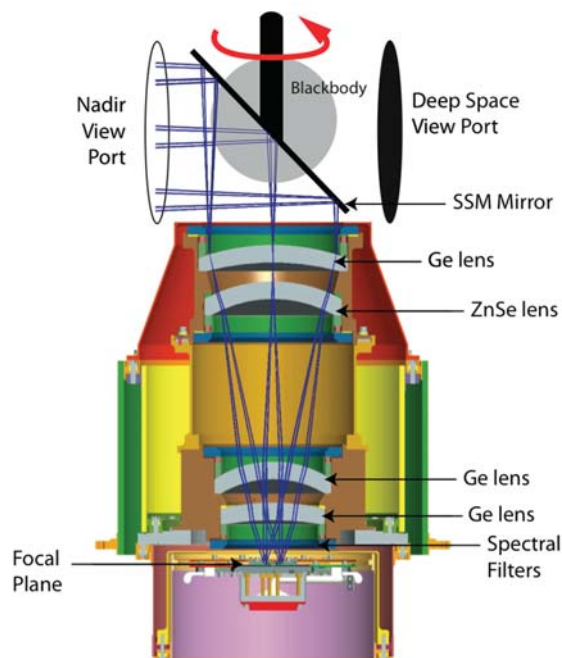
Figure 1. TIRS optical diagram. The SSM mirror rotates between the nadir viewport, blackbody and deep space viewport to provide calibration at least once an orbit.

The instrument features a four-element refractive optics telescope, with three germanium (Ge) elements and one zinc selenide (ZnSe) element, which directs the incoming energy onto the focal plane (Figure 1). A flat mirror at the front of the telescope, the Scene Select Mechanism (SSM), switches the field of view between the earth and the two internal calibration positions for view of deep space and the on-board blackbody.

The internal calibration system consists of a variable temperature blackbody, a port by which the instrument can view deep space, and a Scene Select Mechanism (SSM) that allows the sensor to view the blackbody, deep space or the earth (see Figure 1). The blackbody and deep space views are acquired at the bottom of the descending pass and at the top of the ascending pass every orbit. During these opportunities, the SSM is moved so that the instrument captures a one-minute image of deep space. The mirror flips to the blackbody position for a one-minute image and then back to the deep space for another one minute image. The blackbody is nominally kept at a single temperature (295 K). Details of the on-board calibration methods can be found in [10]. The purpose of discussing them here is to demonstrate that the TIRS instrument appears to be stable based on the on-orbit internal calibrator results. A responsivity metric g , of the on-board stability is calculated from the response to the blackbody and deep space for individual calibration sequences:

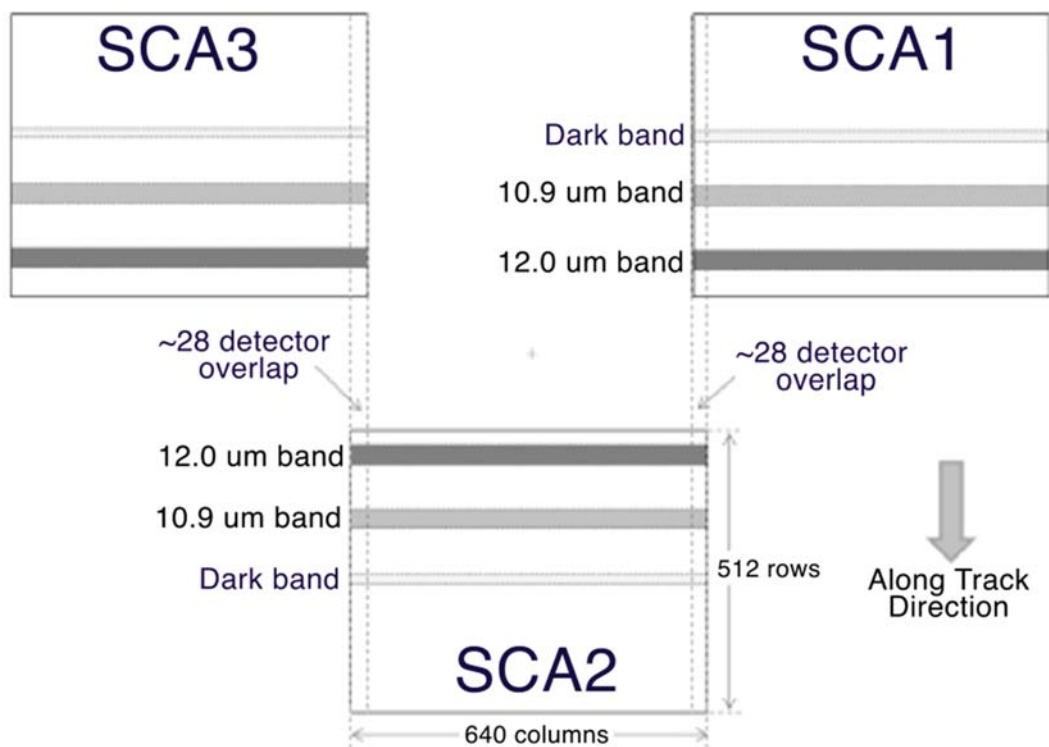
Figure 2. TIRS focal plane diagram. The areas of the three SCAs covered by the spectral filters are indicated, along with the region on each SCA used to measure the dark signal.

The pushbroom focal plane consists of three separate Sensor Chip Assemblies (SCAs), each 512 \times 640 pixels. Figure 2 shows the layout of the chips on the focal plane; two SCAs are slightly offset from the third in the along-track direction by about 300 rows in Band 10 and 200 rows in Band 11. The SCAs overlap in the across-track direction by 28 pixels. The temperature of the focal plane is controlled by the cryocooler to \sim 40 K and maintained to within \pm 0.01 K [9]. The spectral interference filters lay on top of the SCAs, covering about 30 rows of the 512-row chip. Of these 30 rows, only one row per-band is read out to generate the standard image product. A second row per-band is designated as backup, in case a detector in the primary row fails. Several rows outside of the spectral filter are completely blocked from incoming energy and are used to characterize the internal instrument dark signal.

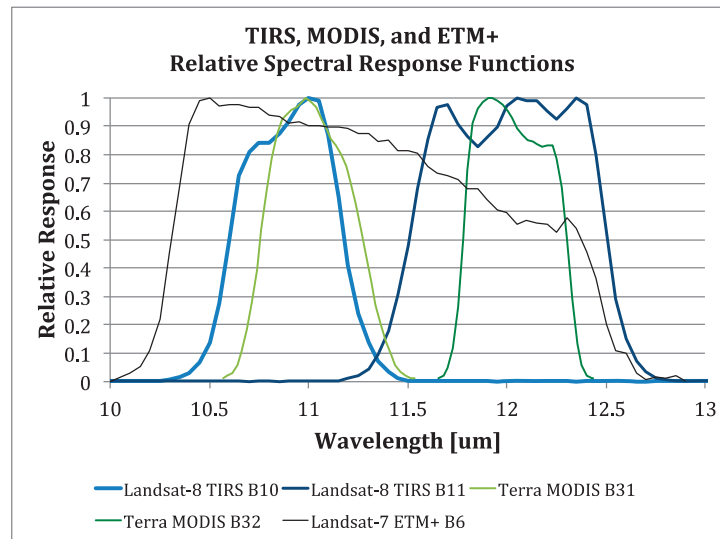
Figure 3. The relative spectral responses (RSR) of the TIRS bands (B10 and 11). Also shown for comparison are the RSRs of ETM+ band (B6) and the equivalent MODIS bands (B31 and 32). The TIRS and ETM+ RSRs are band-average but the MODIS RSRs are each for a specific detector (detector 5 in both cases).

The spectral interference filters were designed to provide the optimal band combination for use in a split-window atmospheric correction algorithm [11]. Figure 3 shows the final band-average TIRS relative spectral responses (RSRs) for each band.

The three sensors, TIRS, ETM+ and MODIS, cover the same spectral regions but don't have identical RSRs (Figure 3). Sensor reaching radiance can be converted to top-of-atmosphere brightness temperature using the Planck function.

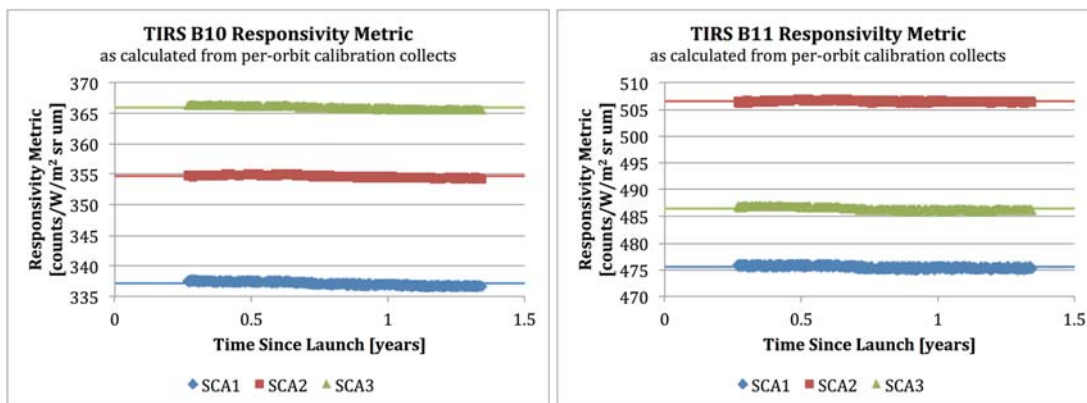
Figure 4. The SCA-average per-calibration sequence responsivity metric for both TIRS bands along with the per-SCA lifetime average. Based on this and other metrics, the TIRS instrument is internally stable.

where Q_{BB} is the bias-subtracted, linearized digital counts extracted from the blackbody image, Q_0 is the instrument offset which incorporates instrument and electronic biases, L_{BB} is the spectral radiance of the blackbody as converted from the monitor thermistor readout and L_{space} is the spectral radiance of deep space, assuming a 4 K background. The metric is calculated per-SCA since all detectors on a single SCA share electronics. Note that this is not the actual gain equation. Instrument gain and bias are covered in detail in [12]. Since launch, the SCA-average metric may have a slowly decreasing trend (maximum of $-0.28\%/year \pm 0.005\%/year$ in the worst case) but the total variability over the lifetime is still only 0.08% (1σ) for the worst case (Figure 4).

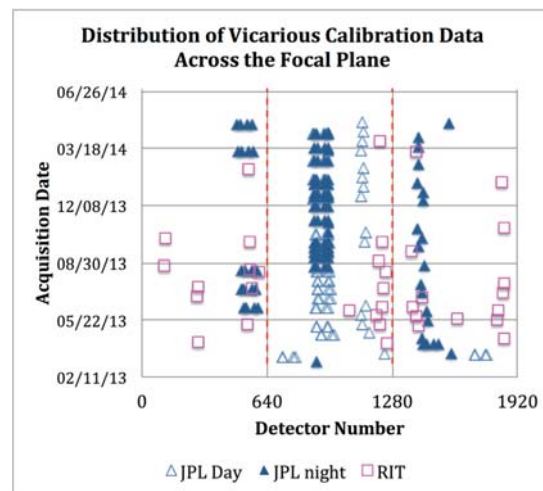
Figure 5. Distribution of vicarious calibration data across the TIRS focal plane. Dashed red lines indicate the boundaries between SCAs; SCA1 consists of detectors 1–640, SCA2 contains detectors 641–1280, and SCA3 is detectors 1281–1920. Note that all the JPL day data since April 2013 falls in SCA2 and for most of the night acquisitions, the satellite has been pointed such that Tahoe falls in SCA2. The RIT acquisitions are based on eight different buoys and are distributed across the focal plane.

angle. As the lakes naturally fall in SCA2 during the day acquisitions, the JPL data are heavily concentrated in SCA2 (Figure 5).

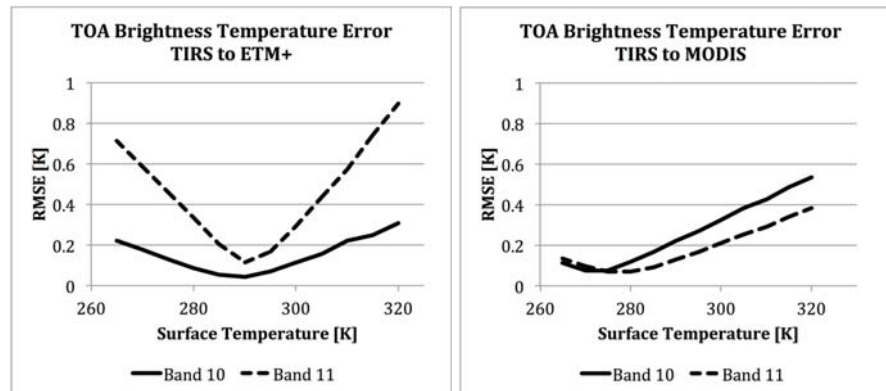
Figure 6. The estimated root-mean-squared error (RMSE) error in comparing the ETM+ (left) or MODIS (right) to TIRS brightness temperatures over a range of surface temperatures and through a variety of atmosphere types. The largest errors are due to less likely conditions, *i.e.*, a very warm surface in a very cold atmosphere.

A study simulating the difference between spectral radiance and brightness temperature was performed to verify the ability to compare data between two different calibrated sensors. Using MODTRAN to perform the radiometric propagation, four North American Regional Reanalysis (NARR) atmospheres [19] were processed to test the difference between brightness temperature for ETM+ or MODIS and the TIRS bands. The NARR atmospheres were selected to cover a wide range of atmospheric conditions, from hot and dry to cold and wet. When compared in terms of apparent temperature, Landsat-7 Band 6 temperatures and Landsat-8 Band 10 or 11 temperatures over water should agree to within ± 0.5 K for most realistic conditions and within ± 1 K for extreme conditions (e.g., very warm moist air over very cold water) (Figure 6). The agreements are better between MODIS Band 31 and TIRS Band 10 and MODIS Band 32 and TIRS Band 11, where even the worst cases should be within ± 0.5 K.

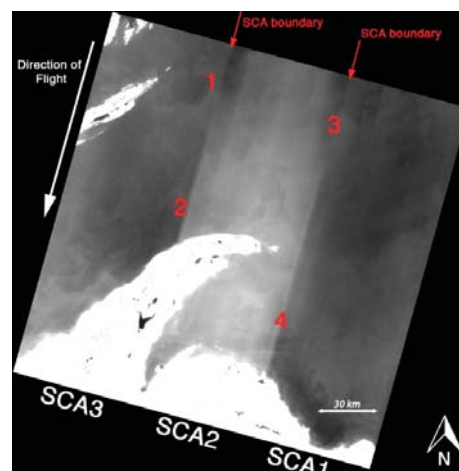
Figure 7. TIRS Band 11 image of Lake Superior (47.5N, 88W) illustrating the discontinuities between the Sensor Chip Assemblies (SCAs) and time-varying nature of the difference. The edges of the SCAs are clearly defined (red arrows) and the differences between the SCAs change from north to south in the image. In a stable system, even with a calibration error, the differences between the SCAs should remain constant for the length of the lake. However, in this example, SCA3 is warmer than SCA2 by 0.2 K at the region marked 1 but is cooler by 0.8 K at region 2. SCA1 is warmer than SCA2 by 0.2 K at region 3 but cooler than SCA2 by 0.7 K at region 4.

The first hint that there was a problem with TIRS was in the discontinuity between SCAs over what should be a uniform target. It was clear from the images that the overlap between adjacent SCAs was not smooth, manifesting itself as a discrete step in the image (Figure 7). Also, the difference appeared to change over time, as the satellite traveled through space. In Figure 7, this is apparent as at the top of the lake, SCA3 is warmer than SCA2 but further south in the image, closer to the peninsula, the contrast flips and SCA2 is warmer.

The extent of the stray light contribution was defined by lunar scans so the source of the stray light in the vicarious calibration imagery can at least be examined. Lake Tahoe and the Salton Sea are both relatively small water bodies, surrounded by land. The out-of-field contribution for these targets comes in large part from the arid desert regions of Nevada and southern California (Figure 8). For many of the RIT sites, the buoys are largely surrounded by water, though some, as in Figure 7, are inland buoys.

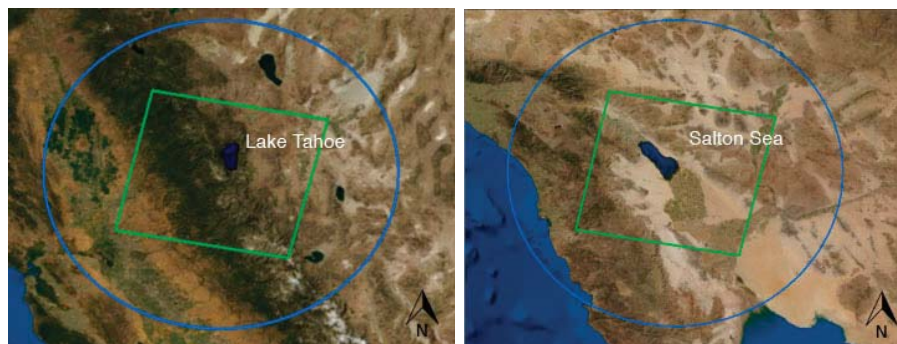
Figure 8. The 185 km wide scene boundaries of the standard Lake Tahoe, located at 39N, 120W (**left**), and Salton Sea, located at 33.3N, 115.8W (**right**), image frames are indicated by the green box. The blue circle indicates the 15° ring source of stray light (though the stray light does not necessarily come from the whole circle). In both cases, the source of the stray light is primarily from land (given that no snow or clouds are covering the surface) outside the area observed by Landsat-8.

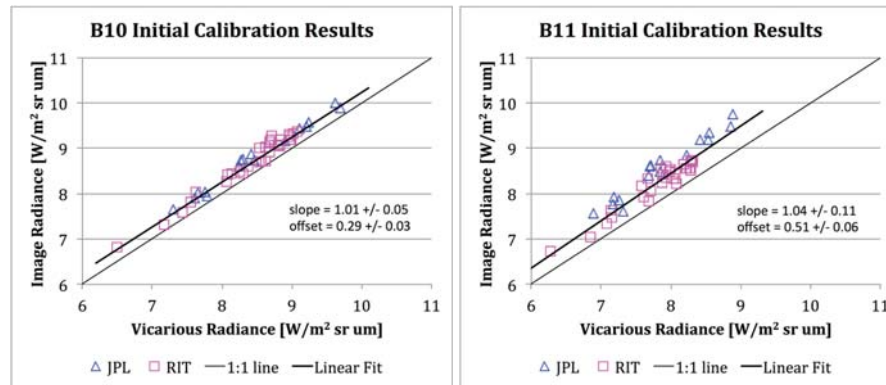
Figure 9. The initial vicarious calibration results for both TIRS bands, based on the day JPL and RIT buoy data. If the instrument were perfectly calibrated, the data would fall scattered about the 1:1 line. All results for both bands are above the 1:1 line indicating that the instrument is predicting too high.

The initial calibration error was calculated in November 2013, based on all the available daytime buoy data from JPL and RIT. The TOA-predicted radiance (vicarious radiance) was compared to the TIRS estimated radiance (image radiance) point for point. The data were spread amongst all three SCAs, though all of the JPL data falls on SCA2. All data from both teams and the three SCAs were treated as one data set and the slope and offset were assessed to determine the calibration error (Figure 9). The slope of the trend was not statistically significant, indicating that there was not likely an error in the calibration gain. However, the data were all above the 1:1 line, indicating that the instrument is predicting a radiance that is too high. This bias error was calculated as the average difference between the vicarious radiance and the TIRS image radiance for all data points for each band.

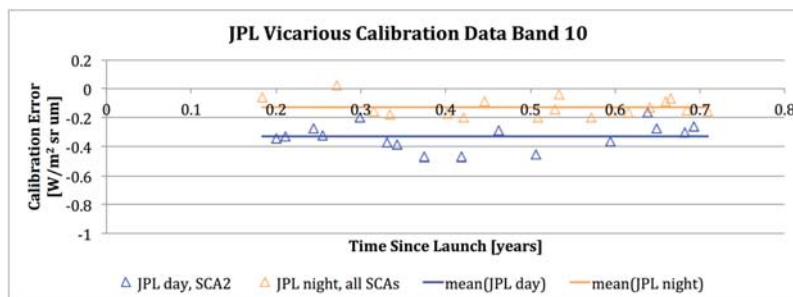
Figure 10. The initial vicarious calibration results for Band 10, based on the JPL data only, displayed as difference between the predicted vicarious radiance minus the image radiance. The data are split into the day and night series. There is a statistically significant difference between the day and night results so only the results for the day data were used to calculate the bias error.

Figure 10 and Table 2 show the calculated calibration error for just the JPL data, broken down by day and night, for all data acquired before November 2013. This difference between day and night acquisitions is also thought to be an effect of the stray light; the solar loading results in the temperature difference between our water targets and the land being greater during the day than at night. Since there is a statistically significant difference between night and day populations and Landsat primarily acquires data during the day, it was decided to determine the bias error from just the day population of data.

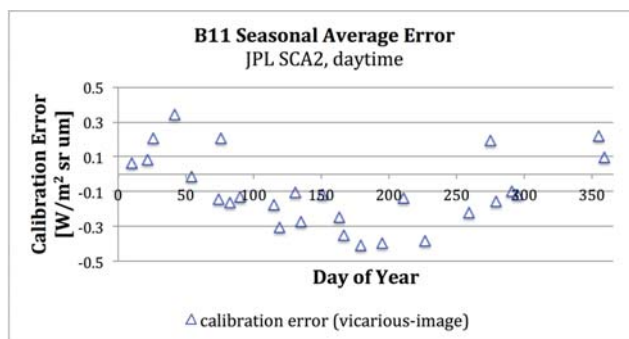
Figure 11. Seasonal effect of the residual bias error for the Band 11 JPL data (includes both Lake Tahoe and Salton Sea). Data are plotted versus day of year so the change in the residual error over the year is apparent.

Figure 11 shows the residual bias error over the year for the JPL day data. The out-of-field surround is very consistent for both the JPL targets: the dataset only includes Lake Tahoe and Salton Sea data and the water bodies are consistently on the same place on the focal plane. Therefore, the surfaces from which the out-of-field contribution is originating are always the same (barring the presence of clouds or snow).

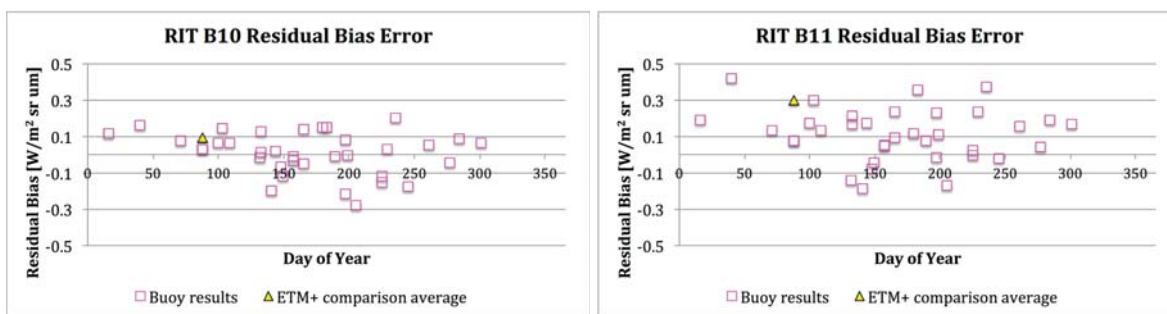
Figure 12. Seasonal effect of the residual bias error for the RIT data, including the average error for the ETM+ comparison. Data are plotted versus day of year but the seasonal effect is not as apparent in the RIT data as in the JPL data (Figure 11). The ETM+ comparison data point sits within the residual errors of the buoy data.

Figure 12 shows the residual error for the buoy data over day of year. The ETM+ comparison has been added as a single point and it falls within the distribution of data for that time of year.

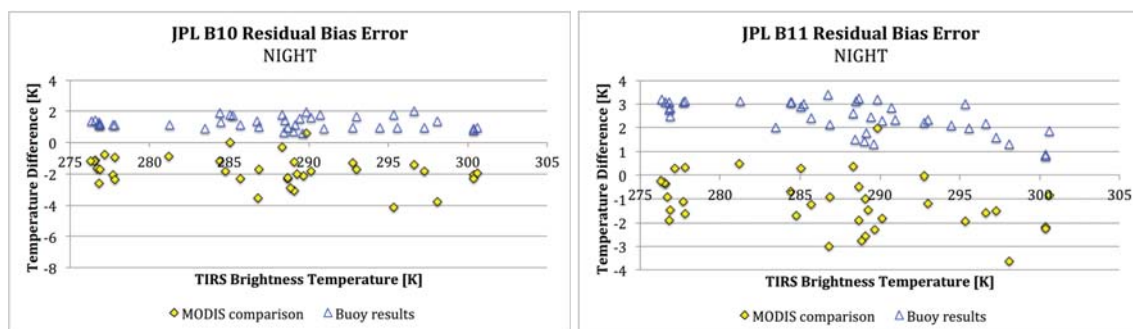
Figure 13. JPL buoy and MODIS comparison results plotted versus target brightness temperature. The trends do not overlap but they both indicate that the residual error is not dependent on target temperature. The trend in the Band 11 data is a function of the seasonal effect of the stray light.

The JPL MODIS to TIRS comparison illustrates how the biases are different day and night, how there is more scatter in the day than night data and how there is more scatter with Landsat-8 band 11 than with Landsat-8 band 10. The fact that there is a larger scatter than with the buoy comparisons can be attributed to mismatch in the acquisition times between the two sensors (Figure 13) and highlights why these sensor-to-sensor comparisons do not provide a substitute for validation against in-situ data. As noted in the introduction, the next step in this analysis will be to derive the surface skin temperature from the MODIS data and use that in a similar manner to the way the buoy data are used to remove the RSR differences.

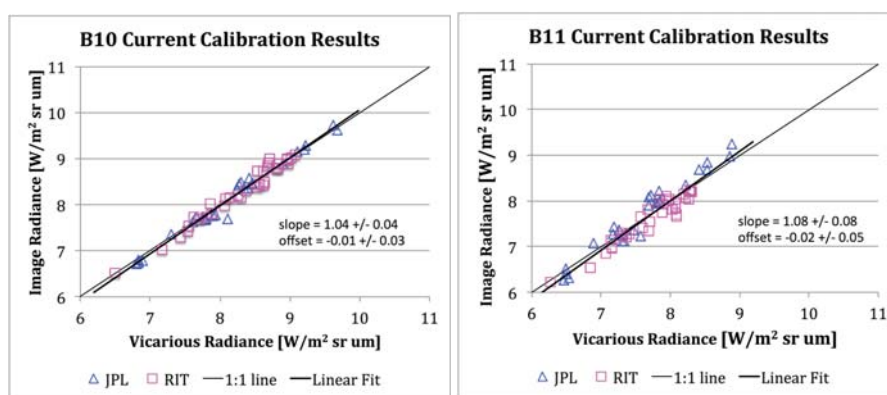
Figure 14. Current vicarious calibration results for the two TIRS bands, including both RIT and JPL data for all SCAs, but only displaying day data. The data are scattered about the 1:1 line, indicating that the residual error has been removed. Neither the slope nor the offset is statistically significant.

on the collected dataset now does not have a statistically significant bias error (Figures 14 and 15 and Table 4).

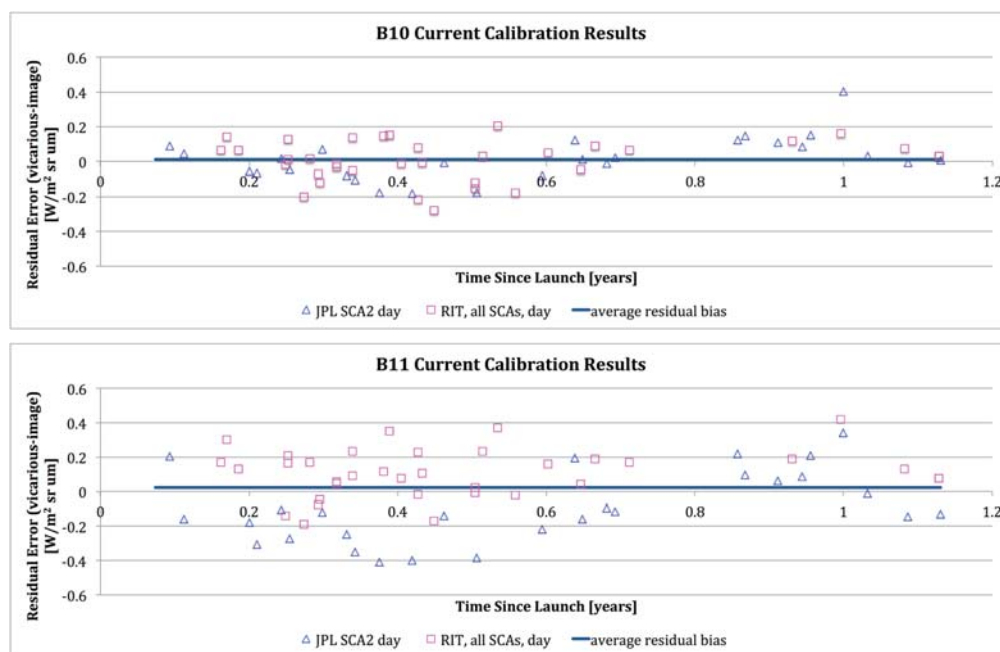
Figure 15. Current vicarious calibration results for the two TIRS bands over time. The residual difference between the vicarious radiance and the image radiance is scattered about the zero axis.
