Creep Burst Testing of a Woven Inflatable Module

A woven Vectran inflatable module 88 inches in diameter and 10 feet long was tested at the NASA Johnson Space Center until failure from creep. The module was pressurized pneumatically to an internal pressure of 145 psig, and was held at pressure until burst. The external environment remained at standard atmospheric temperature and pressure. The module burst occurred after 49 minutes at the target pressure. The test article pressure and temperature were monitored, and video footage of the burst was captured at 60 FPS. Photogrammetry was used to obtain strain measurements of some of the webbing. Accelerometers on the test article measured the dynamic response. This paper discusses the test article, test setup, predictions, observations, photogrammetry technique and strain results, structural dynamics methods and quick-look results, and a comparison of the module level creep behavior to the strap level creep behavior.

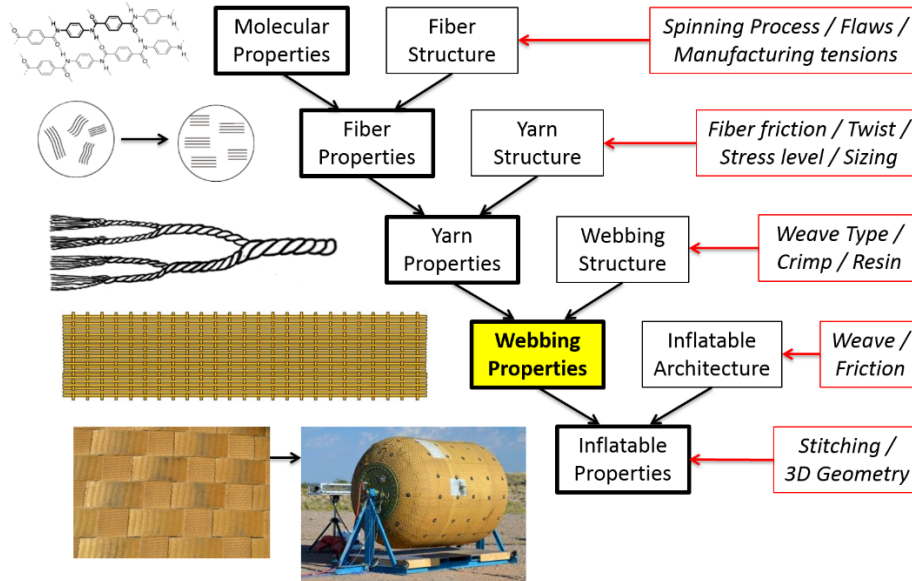
Figure 1. Structural Hierarchy and Characteristics in a Softgoods Inflatable Module

Four webbing variants have been studied in two strengths and two materials: 6,000 lbf and 12,500 lbf rated Kevlar and Vectran. A specific construction (or "architecture") for each webbing strength is defined via the Mil-T-87130 specification⁸ and was used for both materials. The webbings and full-scale module are part of a complex structural hierarchy that strongly influences the properties of the final inflatable structure. Unlike metallic structures whose macro-properties are based directly on their molecular properties, softgoods inflatables consist of multiple layers of interacting structural elements, from fibers and yarns to the webbings and final module. Figure 1 illustrates the relationships between the properties and structures at each hierarchical level and the influence of manufacturing, fiber and yarn interactions and weave in both the webbings and inflatable module. This hierarchy leads to higher levels of variance in material behavior and creep life at the webbing level and consequently in the full-scale structure as well.

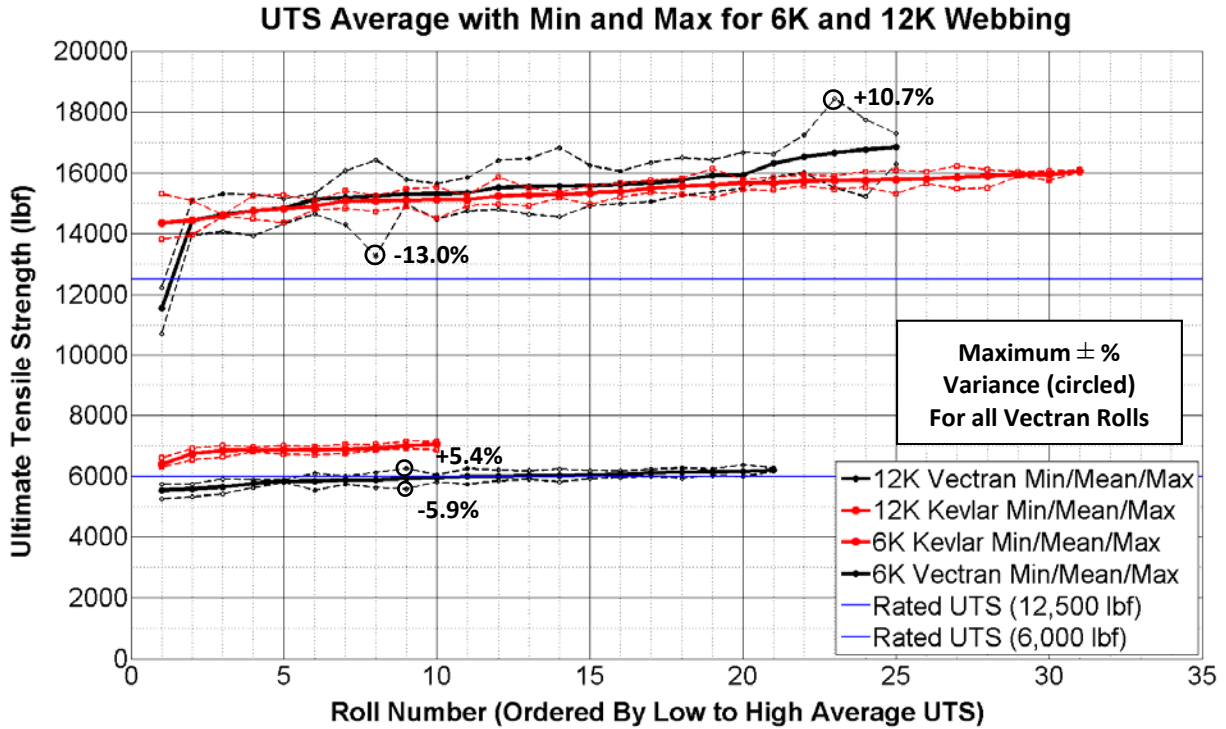
Figure 2. Kevlar and Vectran, 6,000 lbf and 12,500 lbf rated webbings. Minimum, average and maximum UTS points for each roll tested are shown. Solid lines are the average, dashed lines are the min/max.

The primary series of short-term tests performed before any creep tests are executed are Ultimate Tensile Strength (UTS) tests. Each of the four webbing variants are manufactured in a run of several thousand yards and are then cut into rolls of material, 25 to 60 yards long. Five UTS tests are performed on each roll to give an average breaking strength. This average UTS can then be used to set the load level for a webbing creep test as a percentage of that average. UTS tests also provide data on strength and stiffness variance across a manufacturing run and provide load vs. strain plots for each roll. Figure 2 plots the minimum, average and maximum UTS for every roll of material tested, along with lines representing the two strength ratings. The Vectran webbings (black) display greater variance in strength than the Kevlar (red) webbings. The Vectran webbings that were rated at 12,500 lbf, exhibit a 9.4% average total variance about the mean, versus 3.7% average total variance in the 12,500 lbf Kevlar. Creep life in these materials increases exponentially with a linear decrease in the applied load, thus a large variance in strength can significantly broaden the creep life range. One can also observe the fidelity in which each webbing variant meets the rated load. The Kevlar webbings in both strengths easily exceed the required minimum and do so over a smaller variance in absolute breaking strengths than the Vectran. The 6,000 lbf rated Vectran meets the specification in less than half the rolls (9-of-21), while the 12,500 lbf rated Vectran exceeds the minimum by up to 48% (18439 lbf), with one roll below the minimum. Both Kevlar and Vectran in the higher strength rating, exceeded the rated load on average by approximately 23%. This indicates the architecture is not well optimized, and Vectran has greater variance (up to twice the range of average UTS values for 12,500 lbf-rated) than Kevlar under the Mil-T-87130 specification. It should be noted that Mil-T-87130 is specified for para-aramids (*aromatic polyamides*), and although in a similar class of materials, Vectran (an aromatic polyester) is not an aramid. More research is needed on the manufacturing process and specific architectures of these webbings to reduce the variance observed and increase predictability in their strength. Specifically, the tensions, temperatures, yarn paths and coatings used throughout the process would need to be carefully documented and the effects of different weave architectures with the same goal strength would need to be tested and compared to the current webbings to identify optimization approaches. The goal would be a well-documented and repeatable manufacturing approach that could produce several webbing architectures that maintain low variances in both strength and stiffness behavior.

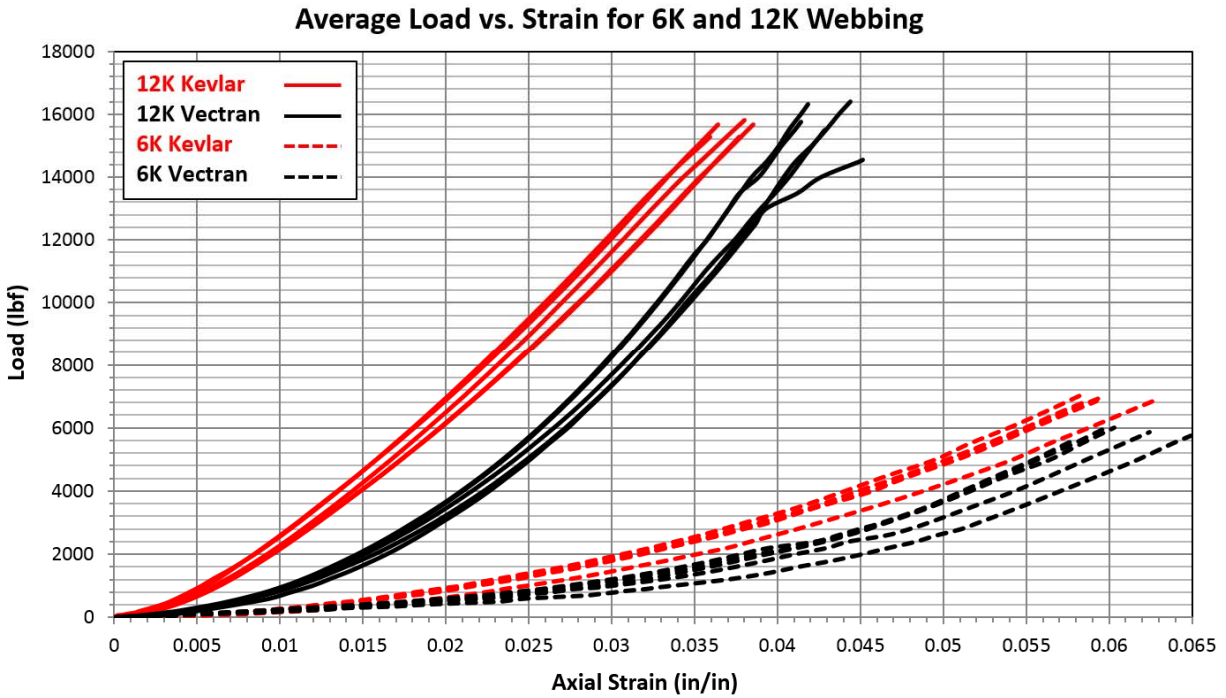
Figure 3. Kevlar and Vectran, 6,000 lbf and 12,500 lbf rated webbings. Average Load vs. Strain curves for five rolls of each webbing variant. Each curve represents the average of five webbings.

Load versus Strain data from the UTS tests can be used to characterize the stiffness behavior of the webbings and provides a means for converting measured strains into loads during testing of a full-scale module. Once these data are gathered for a given roll or run of webbing, they can be used in coordination with a strain measurement system such as photogrammetry to back-out the loads in the webbings of an inflatable module, as detailed later in this paper. Load is used rather than stress in plots of webbing behavior due to the difficulty in measuring stress precisely from a pliable cross-section. Figure 3 illustrates the variance in stiffness behavior for five rolls of each webbing variant. Given that each roll of a webbing variant is from the same manufacturing run and has the same number of axial fibers (i.e. same architecture), the more compliant curves suggest fewer of those fibers are being loaded and it is likely those rolls would then fail at lower strengths due to higher distributed fiber stresses. This tends to hold true on average for all webbings and is most likely a result of slightly uneven loading of the fibers during load up due to: stick-slip and friction between fibers and yarns, uneven decrimping and fiber-lock, and micro-level differences in the number of flaws. If a better understanding of the mechanisms behind the variance in stiffness behavior can be found, it could elucidate the cause of the high variance in the strength of these webbings. Studying these mechanisms would require instrumentation that could measure small differential movements between fibers and yarns over the length of the test section, and microscopic examination of the fibers for observable flaws over the webbing cross-section. Photogrammetry instrumentation doesn't have the resolution to perform this level of measurement over the full length of the test section, but zooming in and observing only a small area of the webbing precludes the capture of uneven differential movement of the fibers in other areas of the test section. The study of the micro-level behavior of the webbings is therefore currently beyond the scope of this research.

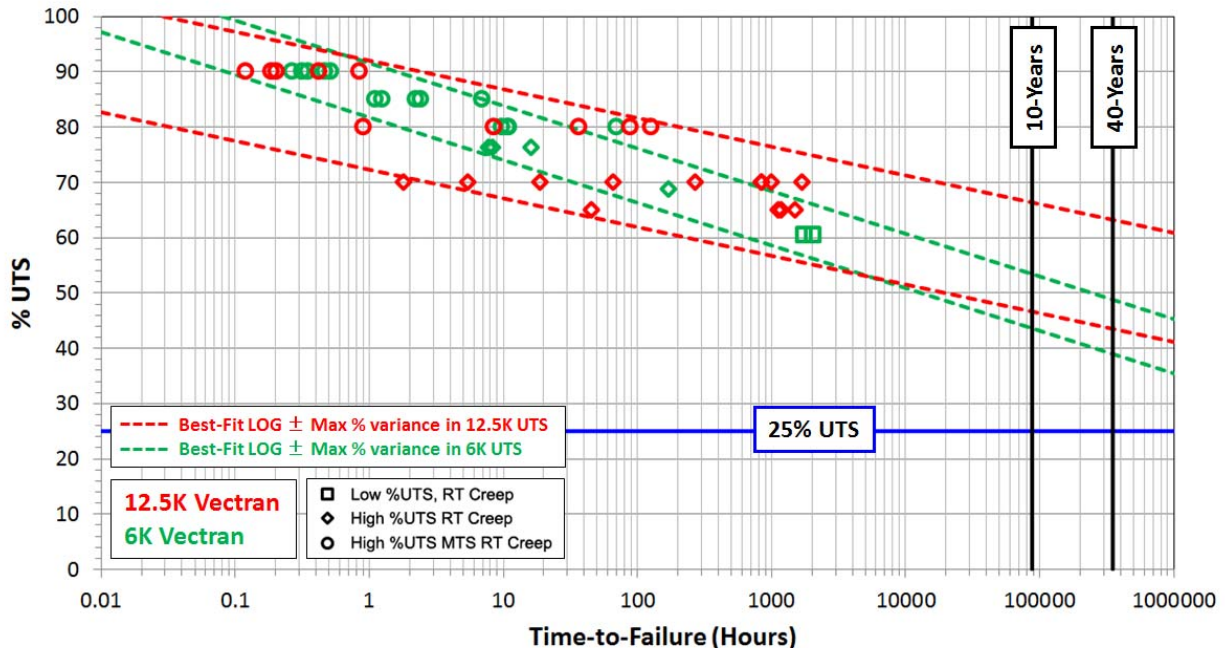
Figure 4. 6,000 lbf and 12,500 lbf rated Vectran. %UTS vs. Creep Life Time-to-Failure

It can be observed that using the maximum UTS variance as the shift factor for the best-fit creep life curve, bounds the data points extremely well. This illustrates the direct link between the variance in short-term properties and their effects on the long-term behavior of the webbings. It should be noted that if only a few rolls are tested,

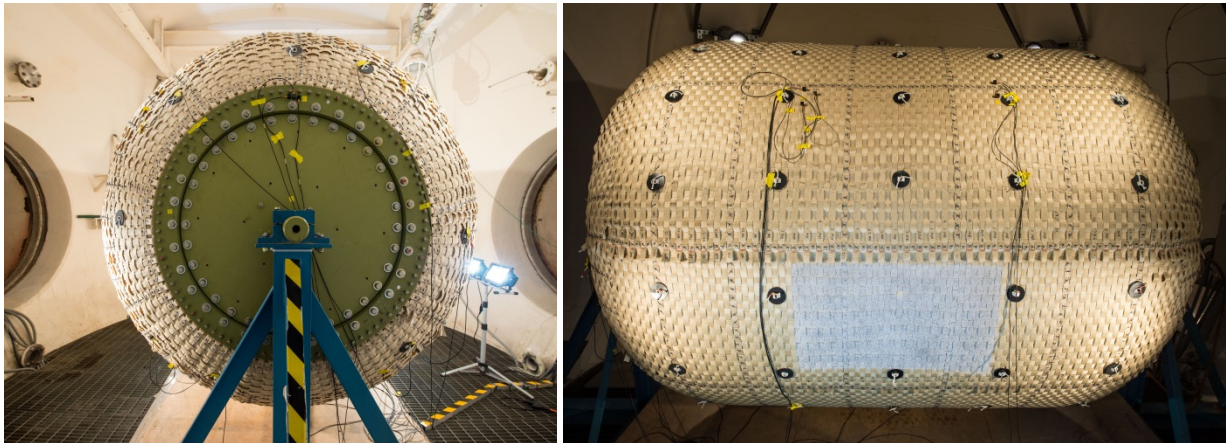
Figure 5. The Creep Burst Test Article. The module is shown inside the test chamber.

The test article was fabricated from a weave of one-inch wide Vectran webbing, in the same style developed during NASA's TransHab project. The webbing was manufactured per MIL-T-87130 with the exception that it was fabricated from Vectran. The webbing is woven together in a basket weave pattern^{1,5}. Axial straps, running from bulkhead to bulkhead, have a rated strength of 6,000 lb/in. Hoop straps in the cylindrical region of the structure have a rated strength of 12,500 lb/in. The test module is 88 inches in diameter and 10 feet long. There are metal bulkheads on each end with trunnions along the central axis. The module rests on the trunnions in a cradle stand. Interior to the restraint layer is a urethane coated nylon air bladder that is oversized to ensure the restraint layer carries the structural loads and the bladder is not loaded.

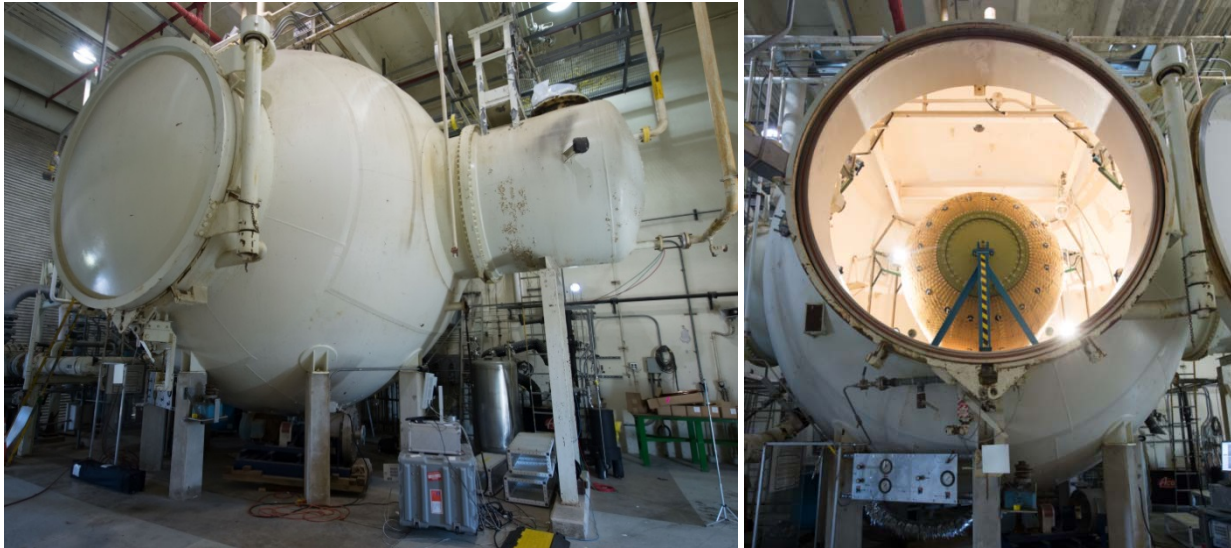
Figure 6. The test chamber at the JSC Energy Systems Test Area where the Creep Burst Test was performed.

It was desirable to use high speed cameras to capture video footage of the burst event, but this was not practical due to the possibility of a long test. High speed cameras would have difficulty running continually for such a long period of time, and there was not expected to be any indication that a burst was imminent in the moments before a burst occurred. Also, for safety reasons, personnel were not allowed in the test chamber, or the test cell surrounding the chamber, after the test article pressure surpassed 5 psig. The test setup had to be configured such that no modifications were required in the test cell if the test continued for several months. For these reasons, it was decided to record video footage on three cameras at 60 FPS. Two cameras were inside the chamber in the “ears” on the east and west sides of the chamber, 180 degrees apart. The third camera was outside the chamber on the top, looking through a viewing window. The east ear also contained a pair of additional cameras to record still images for photogrammetry. Photogrammetry is described in detail in Section V. Protective enclosures were built for all of the cameras inside the test chamber. Lighting was provided by eight LED lamps mounted to the walls of the chamber.

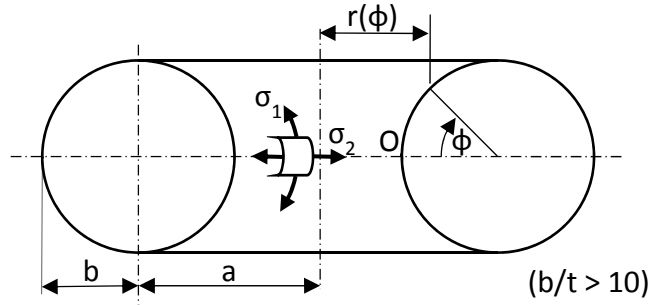
Figure 7. Toroid shape diagram.

Figure 8. Cylinder diagram.

$$\sigma_1(\varphi) = \frac{qb r(\varphi) + a}{2t r(\varphi)} \quad (3)$$

$$\sigma_2 = \frac{qb}{2t} \quad (4)$$

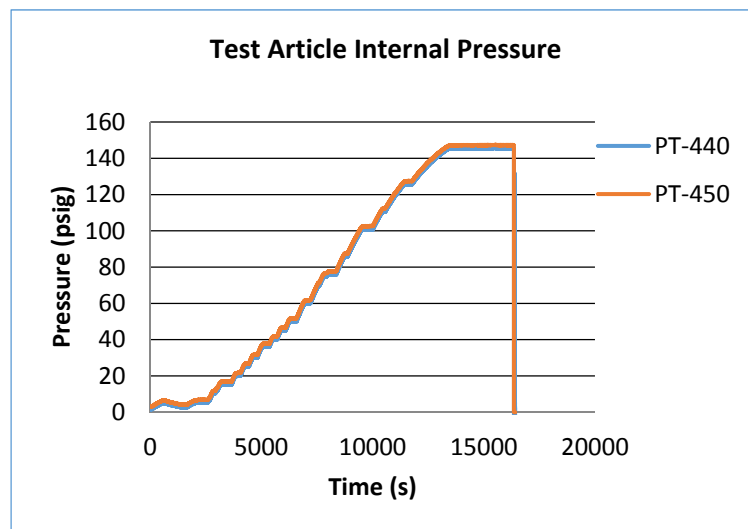
Figure 9. Test Article Internal Pressure vs. Time.

during the pressurization for the purposes of collecting accelerometer data. At each hold point, the pressure was held constant for several minutes. These holds occurred at 5, 15, 36, 50, 75, 100, and 125 psig. Upon reaching the target pressure of 145 psig, the pressure was held constant. Actual pressure readings on the two test article internal pressure gages were 145.55 psi and 147 psi. During the pressurization, sounds could be heard that can best be described as “pops”. These sounds have been heard in other pressurization tests of woven inflatable test articles. The pops are believed to be the straps overcoming static friction and sliding relative to each other. These events were picked up by the accelerometers and are discussed in more detail in Section VI.

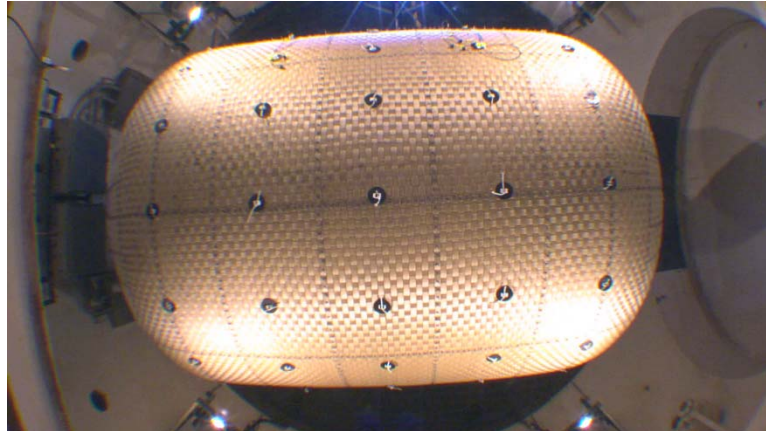
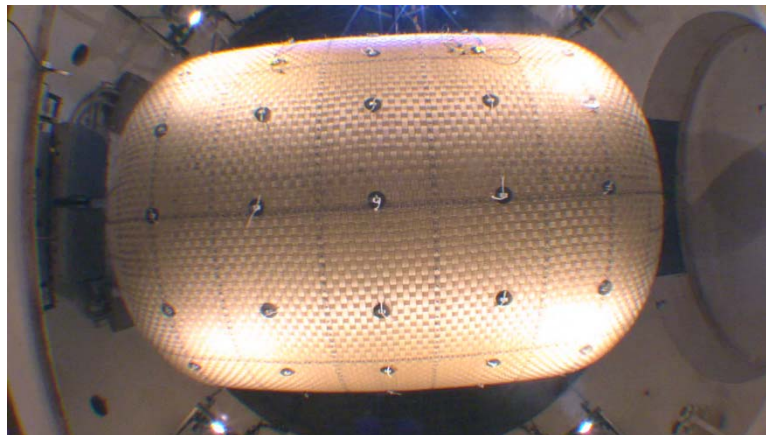
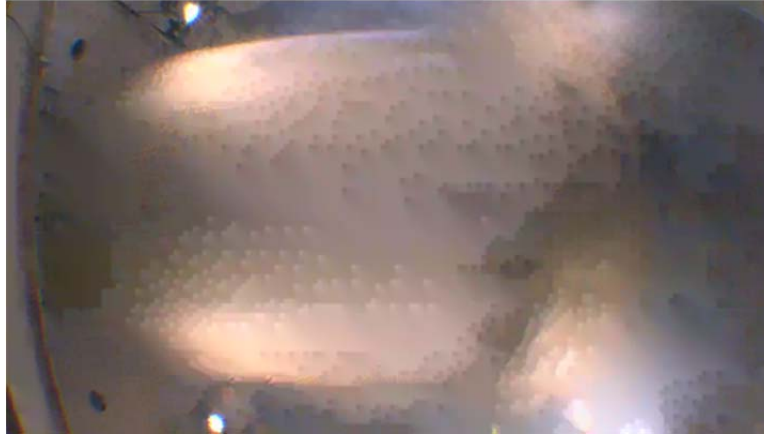
Figure 10. Video of burst – Frame 1.

Figure 11. Video of burst – Frame 2.

Figure 12. Video of burst – Frame 3.

After 49 minutes holding at the test pressure, the test article experienced a dramatic burst event. The event occurred in a fraction of a second, and produced an explosion loud enough to shake the building. Immediately before the burst event, personnel monitoring the test from the control room did not observe any signs indicating that a failure was imminent. The final frames of the test video are shown in Figure 10, Figure 11, and Figure 12.

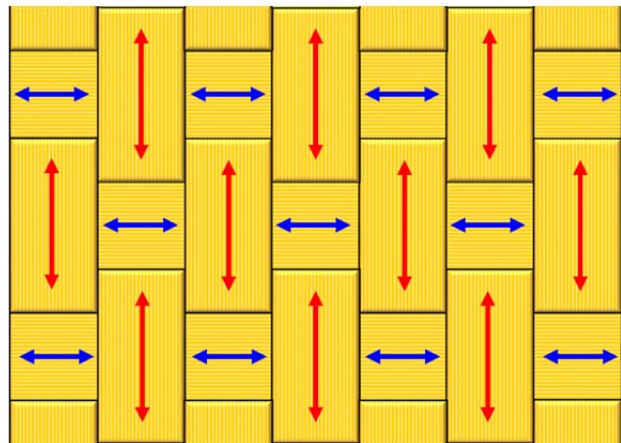
Figure 13. Weave pattern and the strain direction for each of the straps.

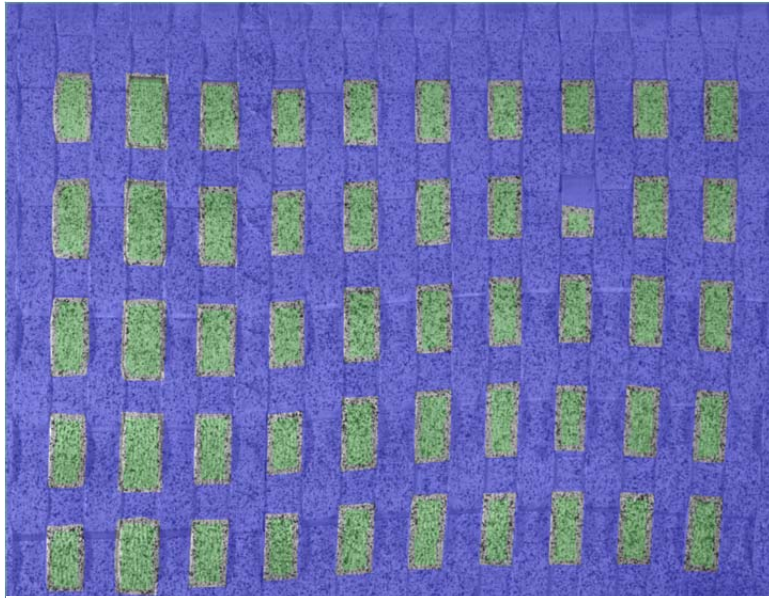
Figure 14. Masking technique to isolate the Hoop straps prior to processing.

To avoid interaction between adjacent straps, masking around the chosen straps is necessary (see Figure 10). Once the mask is created, the individual areas can now be correlated and processed into 50 sections for the Hoop straps and 28 sections for the Axial straps. The results are two different sets of measurements, one for each axis the strap is tensioning. As an outcome, we receive a better result in the data where the strain is not being influenced by the movement of adjacent straps.

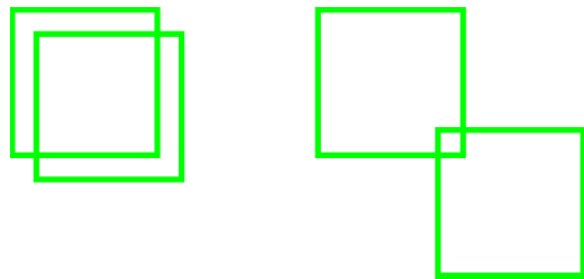
Figure 15. Showing the difference between facet steps for a given size facet. Large overlap (left), and small overlap (right).

deformation of the test specimen¹⁰. To increase the amount of data points, a higher overlap between facets is crucial. This is called a “Facet Step”. As an example (Figure 11) a square facet size of 15 pixels and step size of 4 pixels will have an overlap of 73% while one with a step size of 11 pixels will have an overlap of 27%. Therefore the 15 pixel by 4 pixel parameters will create a denser population of data points for each section of strap.

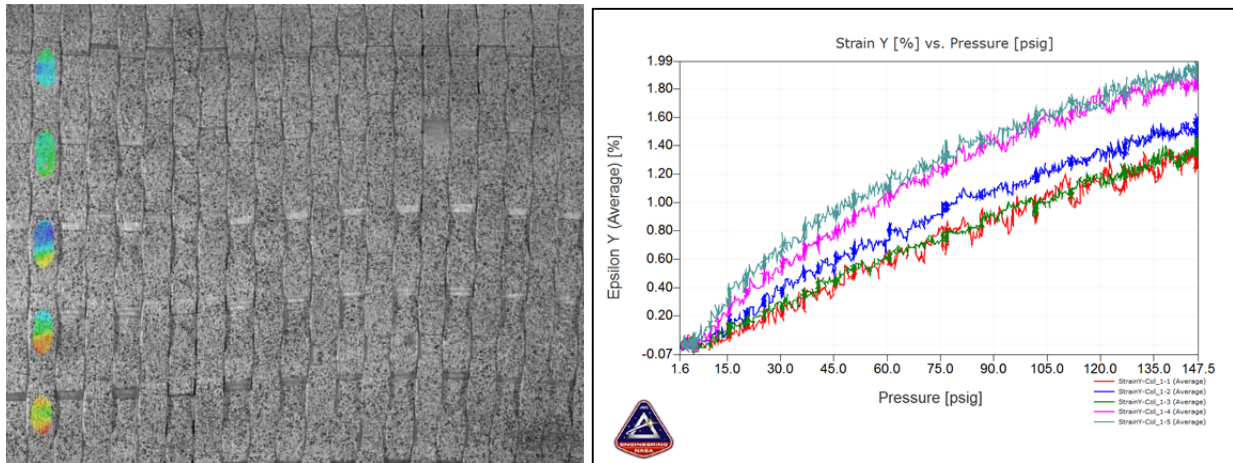
Figure 16. Hoop strain in the Y axis with data overlay and its respective plot.

During the analysis, an average of the data points in each section of the strap was computed. The statistical analysis tool within the Aramis software is used to calculate the average strain for each section of each strap for a specific strain axis. The results can be plotted (see Figure 16) within the Aramis software or exported for further analysis with other tools. The data acquired through photogrammetry will be discussed in Section VII.

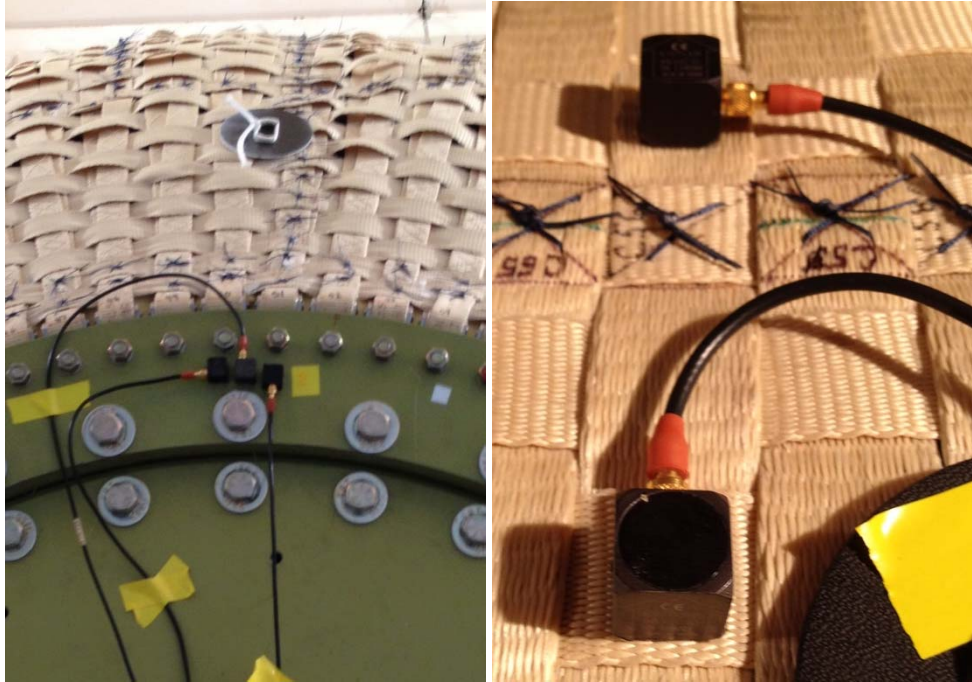
Figure 17. Close-up Images of Installed Accelerometers on the Creep Burst Test Article

Fifteen Kistler 8632C10 PiezoBEAM cube accelerometers were mounted on the test article while inflated at 2 Psi delta pressure. These piezoelectric sensors were rated to measure 10 g of acceleration in either direction and were configured as a cube with a .56-in x .56-in x .56-in footprint. Previously, these sensors were used for structural health monitoring measurements on the Space Shuttle Orbiters as part of the Shuttle Modal Inspection System (SMIS)¹³. The sensors were not expected to survive the failure of the test article. Figure 5 shows global context images of the sensors and the associated cabling installed on the test article. Figure 17 shows close-up images of sensors installed on the soft goods and metallic core of the test article. Figure 18 and Figure 19 show schematics of the test article with the accelerometer locations and directions denoted.

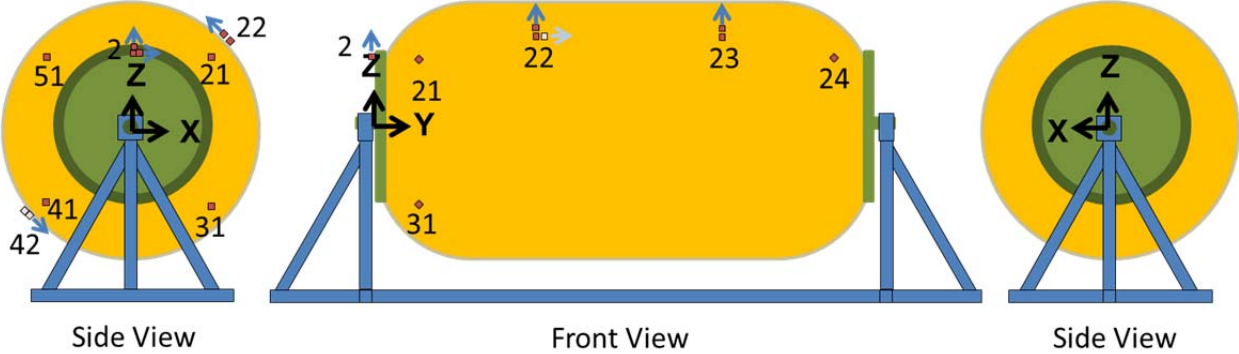
Figure 18. Location and Direction Schematic of Installed Accelerometers (Three Views)

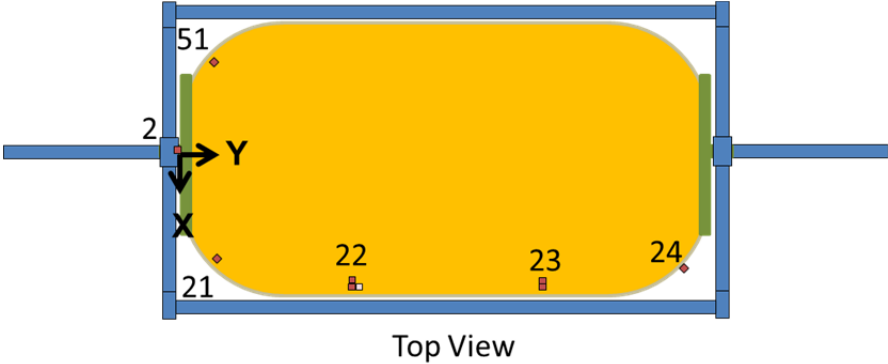
Figure 19. Location and Direction Schematic of Installed Accelerometers (Top View)

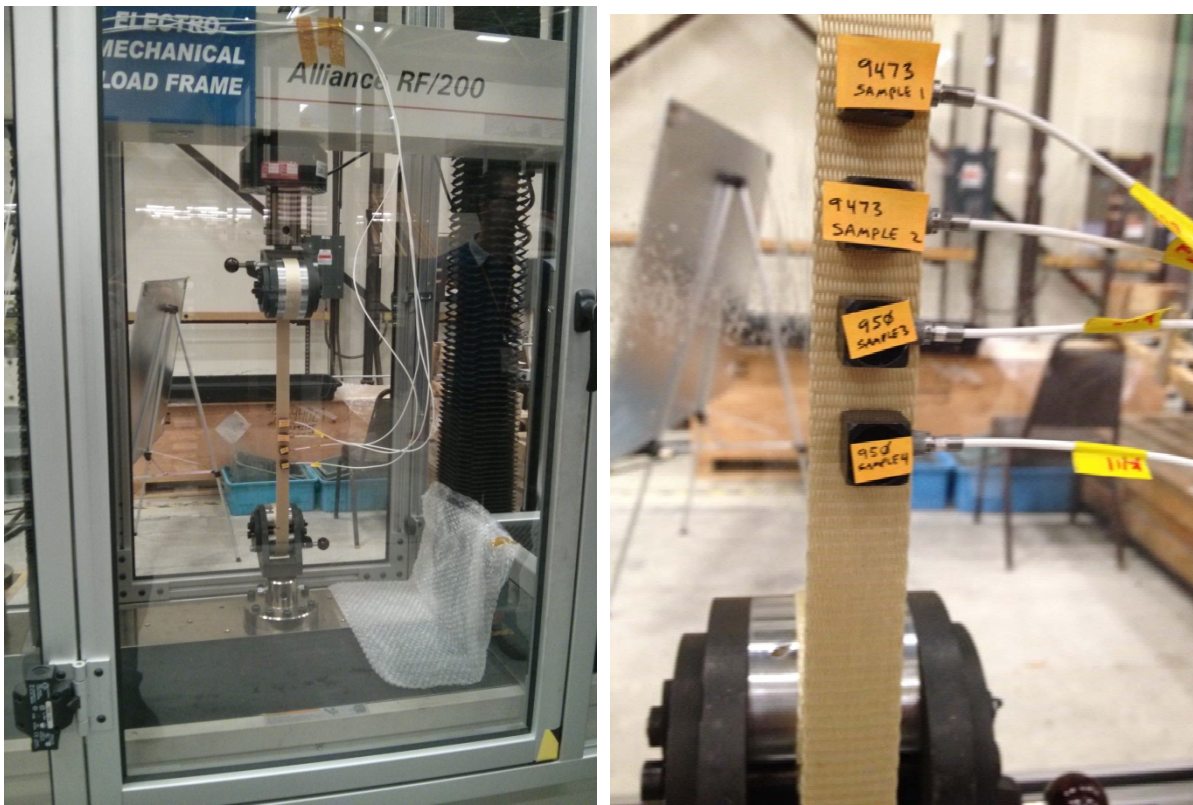
Figure 20. The Single Strap Test to Assess Adhesive Accelerometer Mounting Systems

A test using a single strap of the restraint layer material loaded in a tensile test machine was used to assess installation techniques. Two different adhesive tapes (which had previously been tested for other long-term sensor installation applications) were assessed. Each adhesive was assessed using an installation with and without back pressure being applied during installation. The single strap was loaded with the equivalent force that a similar strap would see on the test article with an internal pressure of 2 psig. Four sensors were installed in each of these test case combinations and then the tension was increased to the equivalent of the 146 psig test pressure. Both adhesive systems performed well during the test both with and without back pressure. However, the 3M F9473PC adhesive tape appeared to be a more tenacious application with no back pressure and was selected for use to mount the accelerometers in the test.

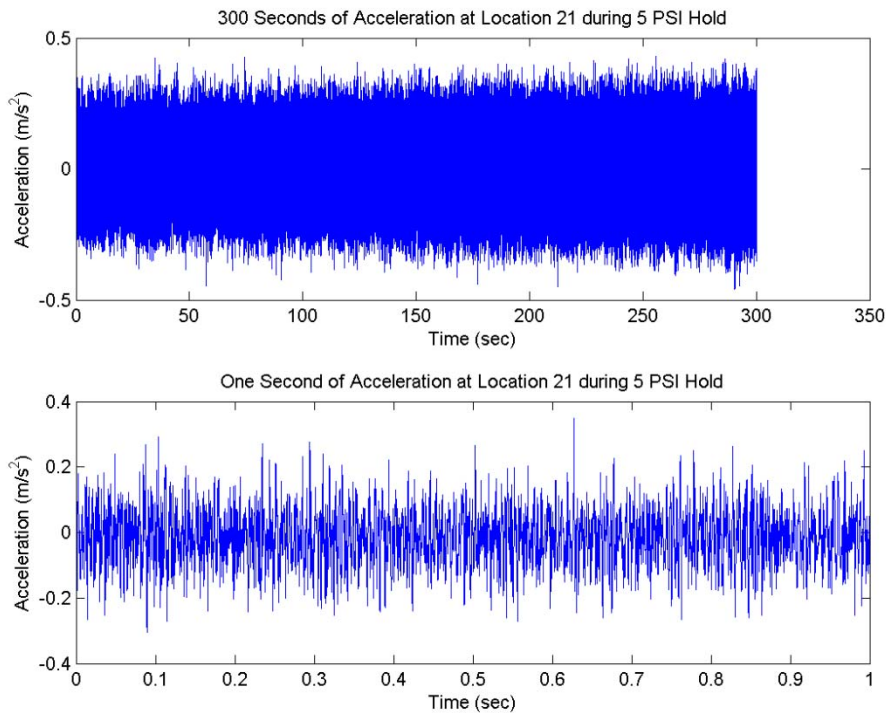
Figure 21. Five Minute and One second Accelerometer Time History at 5 PSI Hold

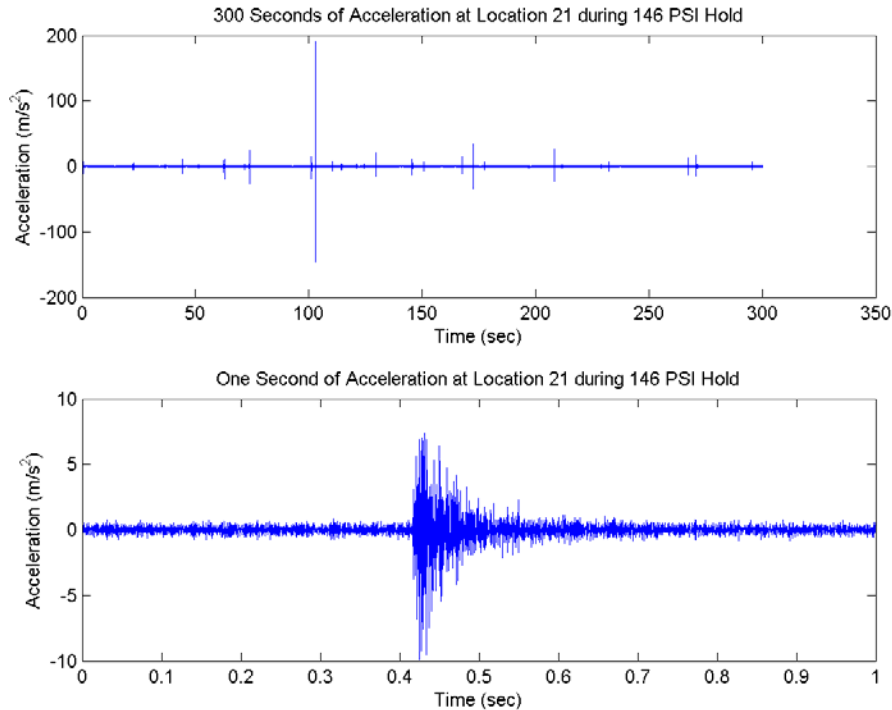
Figure 22. Five Minute and One second Accelerometer Time History at 146 PSI Hold

These impulse events, as seen in Figure 22, make a traditional modal analysis of these data challenging. However, techniques to effectively process the data have been developed and are reported in the companion paper¹². One feature that has been extracted from the vibration noise floor is a fairly consistent 1000 Hz dynamic phenomena. This feature can be found in the data throughout the entire test. The interesting aspect of this feature is that it does vary throughout the test (including the run-up to failure). Figure 23 shows the quick-look estimation of the frequency of this phenomena during several of the constant pressure data sets. The frequency increase from around 1000Hz to approximately 1013Hz suggests that this phenomena is a feature of the test article and does not have an external or electrical source. The low damping and consistent presence suggest that there might be any number of sources including a leak or an acoustic phenomena. However, a lightly damped and easily excited mode of the test stand/metallic core is also a possibility. Efforts continue to understand this phenomena and to more fully characterize the other phenomena in the data. As a note, there are a rich set of dynamics phenomena in the 100 to 400Hz region in certain directions as well as some electrical harmonics that appear in the data.

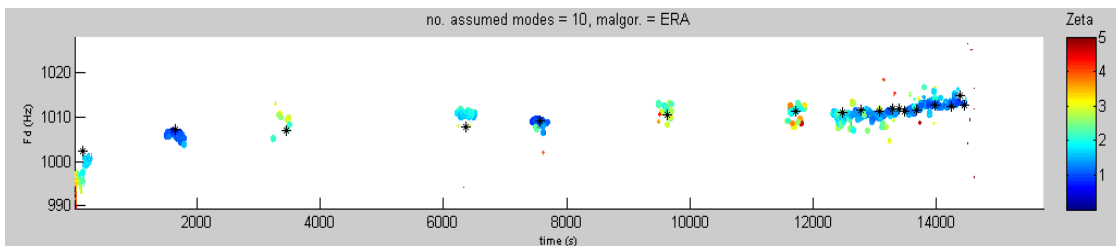
Figure 23. Trend of Increasing Frequency of the 1000 Hz Phenomena with Time

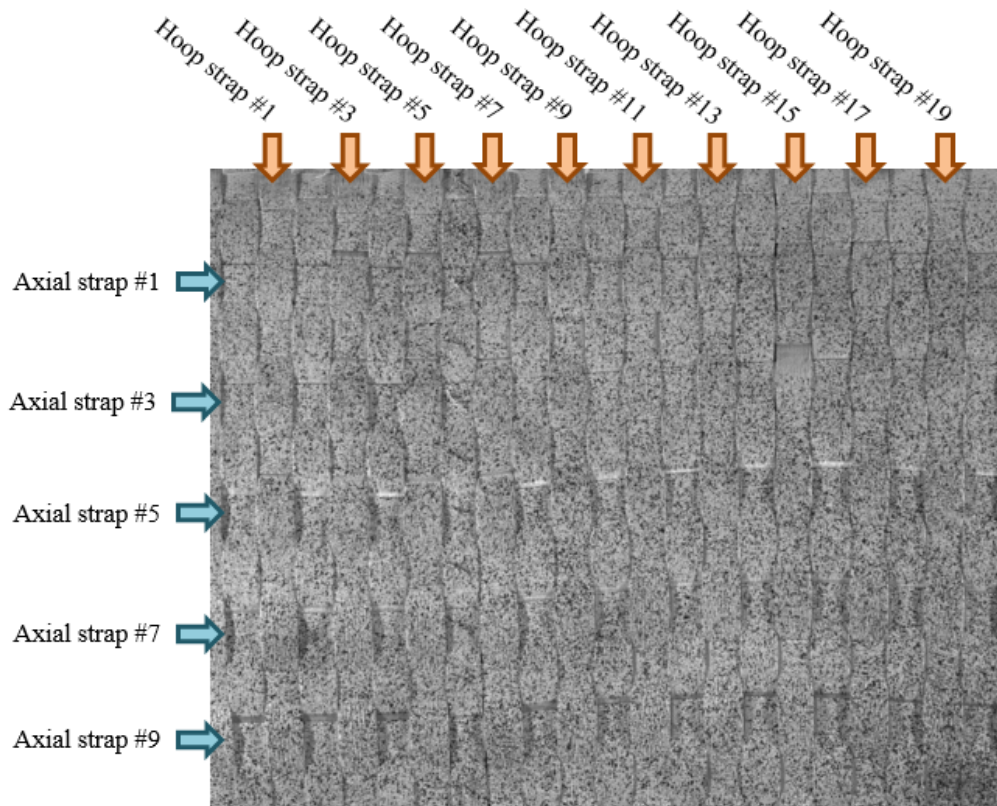
Figure 24. Location of Hoop Straps and Axial Straps measured

Strain data were obtained from the photogrammetry images, as described in Section V. Five Axial straps (shown horizontally in Figure 24) and ten Hoop straps (shown vertically in Figure 24) were selected for the first round of analysis. Strain measurements were taken at ten locations across each Axial strap and 5 locations across each Hoop strap, as seen in Figure 10 and Figure 16. Figure 25 shows the strain measurements at each of the locations on Axial strap 1. The plots for the other straps look similar to Figure 25. The strain is converted to load using the load vs. strain equations generated in the strap level testing (Section IIA and Figure 3) and the average load for the strap is calculated (Figure 26). Figure 27 shows the average load in each of the Axial straps (Axial straps 1, 3, 5, 7, 9), and the comparison to the predicted load. The analytical prediction is determined as described in Section III E. The curve labeled “burst prediction” is determined based on the typical average ultimate tensile strength seen in strap level tensile testing, and the hydrostatic burst pressure observed in previous burst tests of this same restraint layer design. The hoop strap plots shown in Figure 28 and Figure 29 were generated by the same process used for the axial straps.

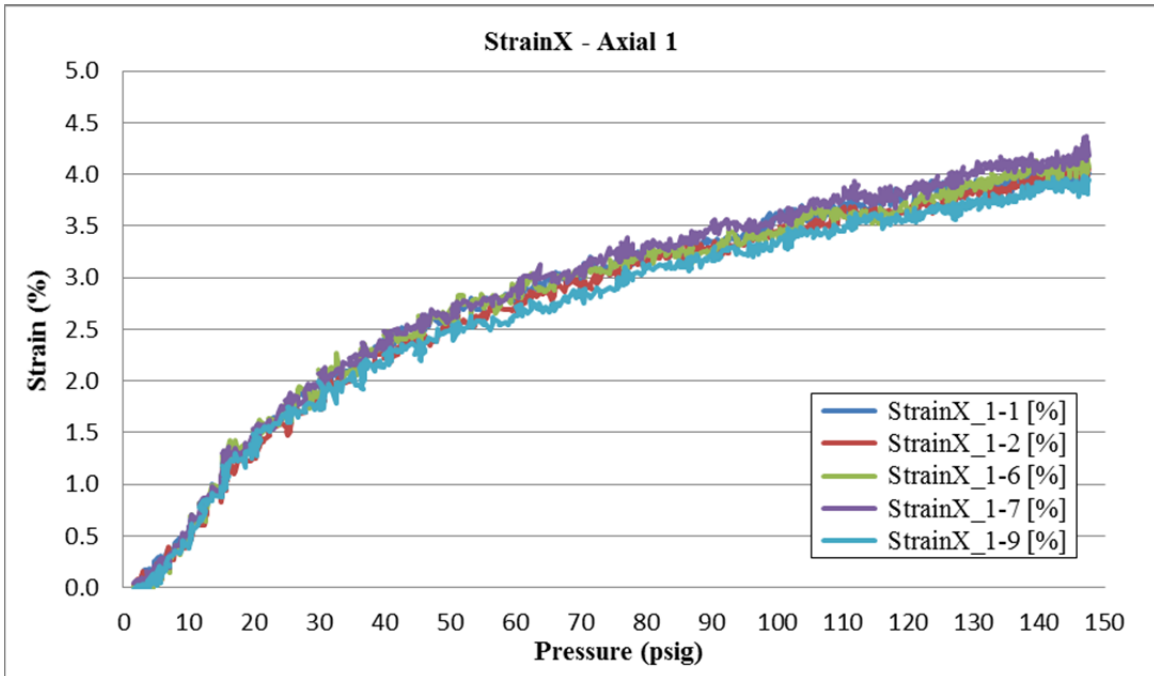
Figure 25. Strain on Axial Strap 1.

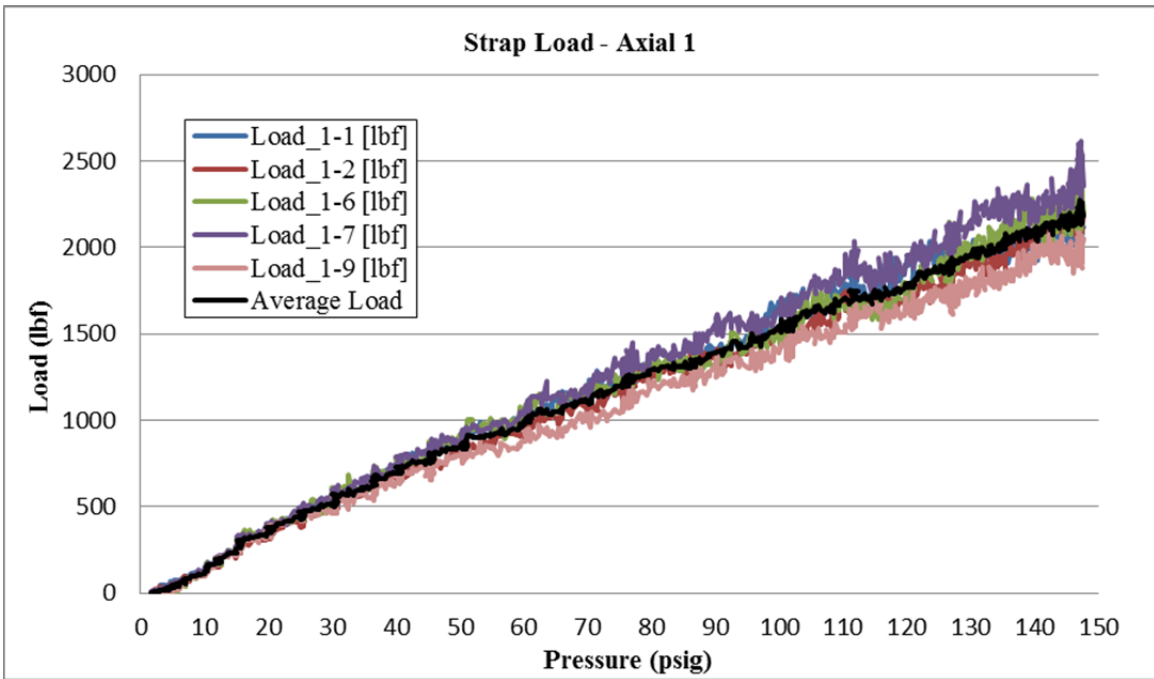
Figure 26. Load on Axial Strap 1.

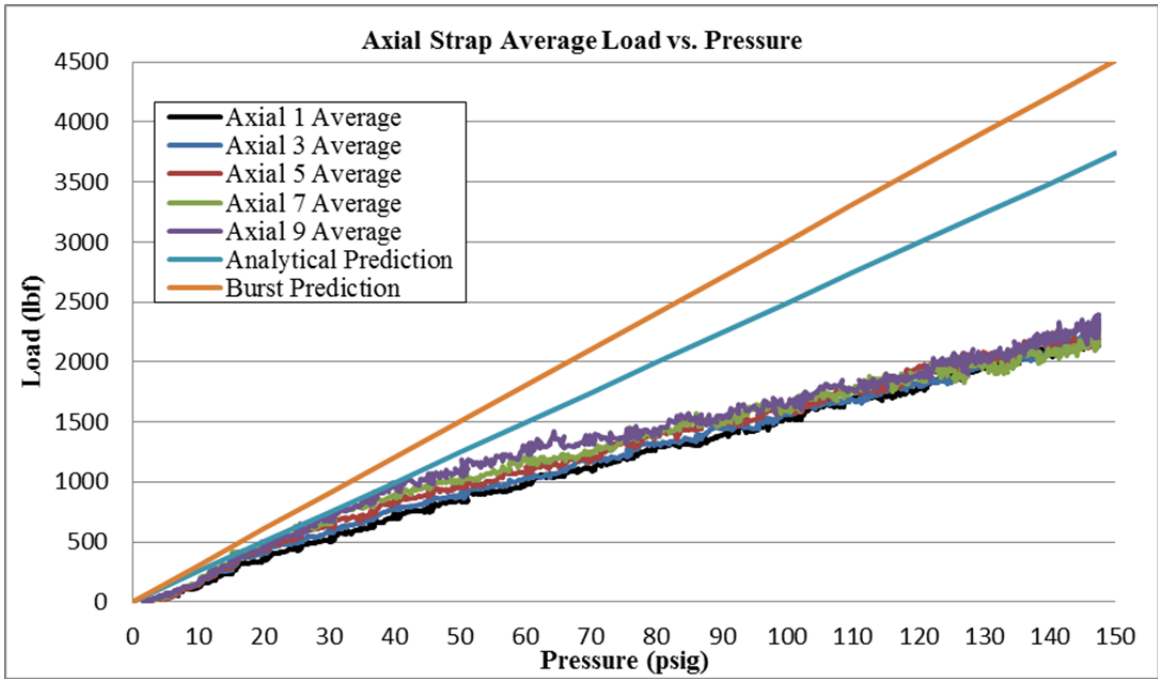
Figure 27. Axial Strap Average Load vs. Pressure.

The strap load data obtained from Photogrammetry measurements falls below the prediction curves for both the axial straps and the hoop straps. This is consistent with observations from previous tests. More work is necessary to perfect the technique of photogrammetry on tightly woven softgoods, to identify alternate means of measuring the strap load without disturbing the restraint configuration, and to develop more accurate analytical methods.

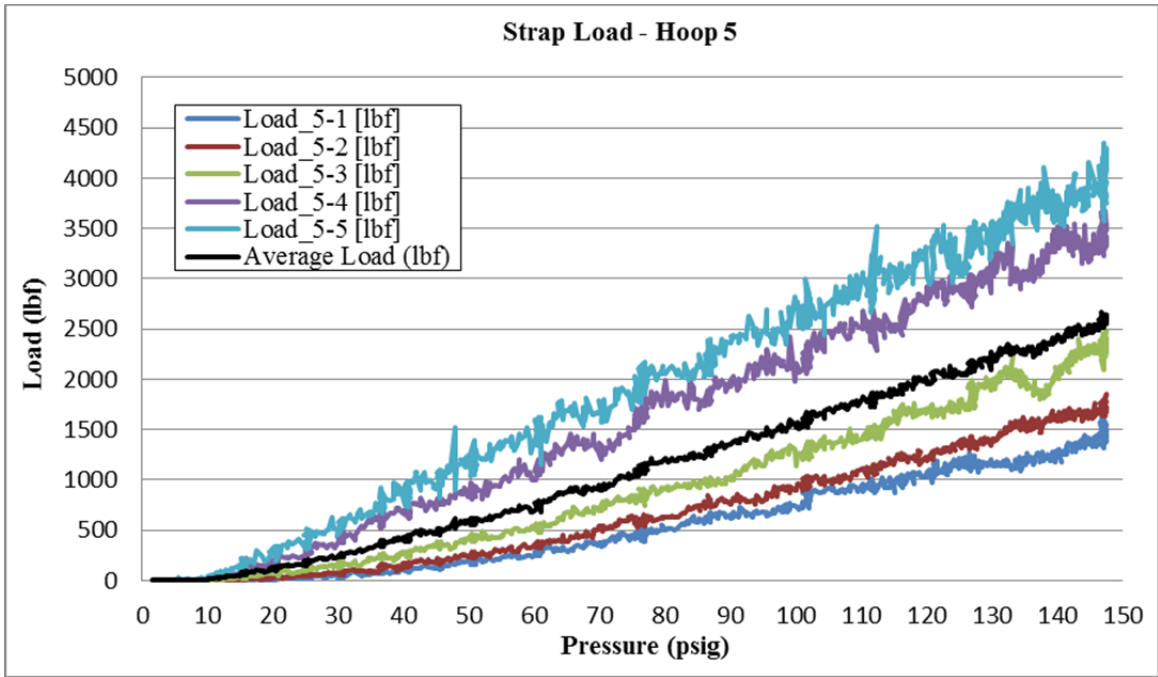
Figure 28. Strain on Hoop Strap 5.

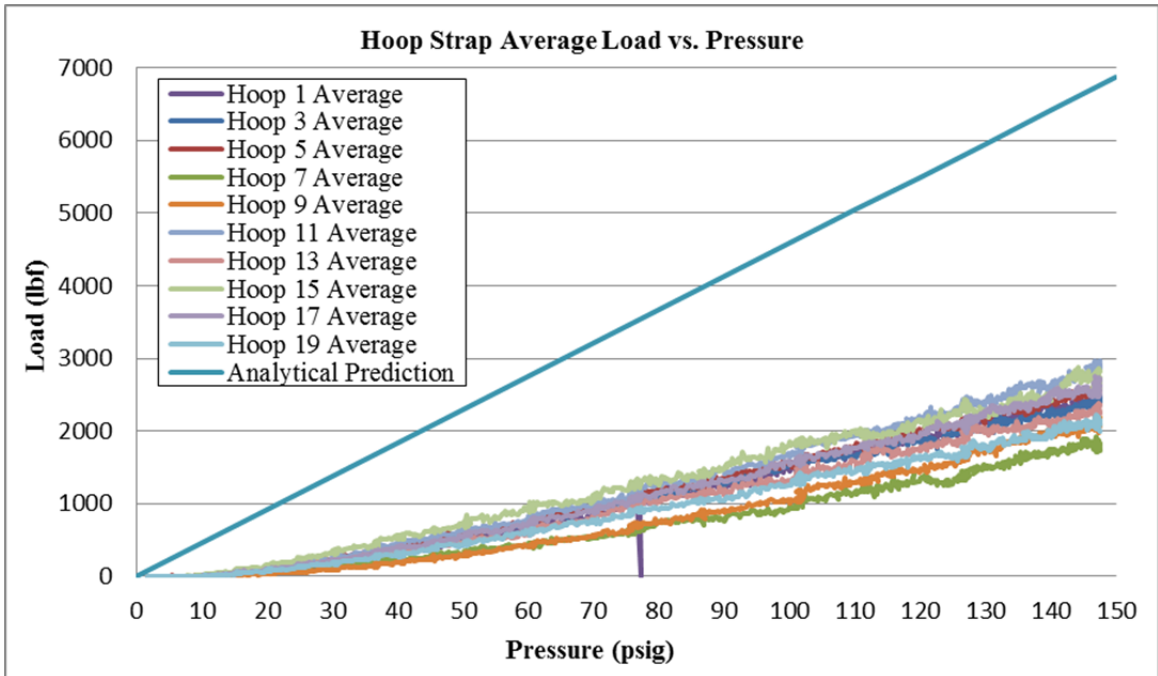
Figure 29. Hoop Strap Average Load vs. Pressure.

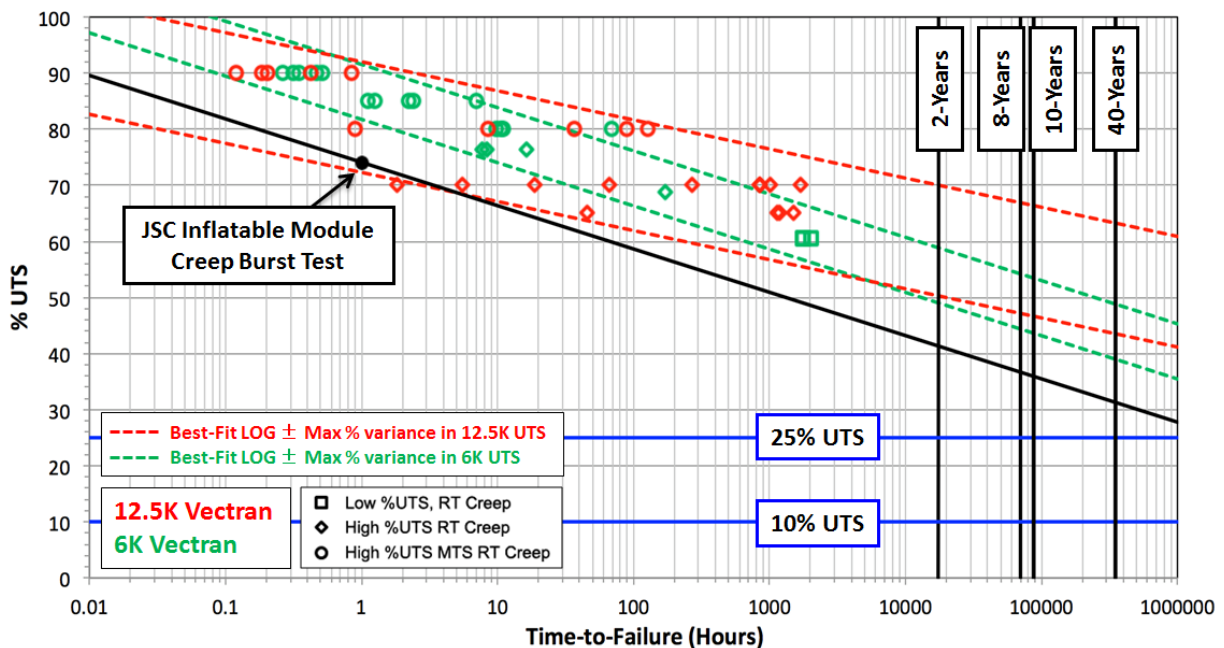
Figure 30. Vectran creep curve projections.

When the module level creep results are plotted with the strap level creep results, the effects of the multi-strap architecture are observed. Figure 30 is a plot of Creep life versus percent of ultimate loading for 6,000 lb/in (shown in green) and 12,500 lb/in (shown in red) for Vectran webbing procured by NASA. The vertical axis shows the percent of ultimate strength and the horizontal axis shows time-to-failure on a log-scale. Also shown (black dot) is where the 88-inch diameter inflatable module burst.

Based on prior tests and analysis, it was determined that the first failure mode of the assembled module was in one of the 6,000 lb/in structural webbings. For the 6,000 lb/in webbings there is a large failure range for webbings loaded between 60% and 90% of ultimate. That range is bound by the two dashed green lines and projected for longer durations. The black line is drawn through the point where the test article failed and parallel to the dashed green lines that bound 6,000 lb/in webbing failures.
