NASA/TM-2014-218169

Impact Testing and Simulation of Composite Airframe Structures

*Karen E. Jackson, Justin D. Littell, Lucas G. Horta, and Martin S. Annett
Langley Research Center, Hampton, Virginia*

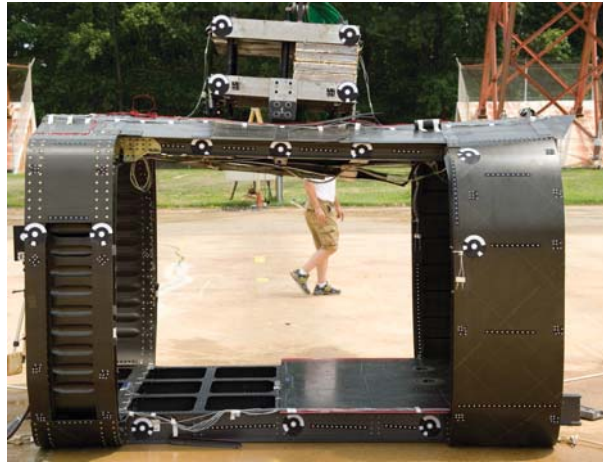
Figure 1. Post-test photograph of the SARAP TVA following the 2008 vertical drop test.

Post-test inspection of the TVA indicated that damage was primarily limited to the roof area, with little or no damage found in the subfloor, or the forward framed fuselage section. Following the test, the TVA was moved to AATD, located at Ft. Eustis, VA. In 2010, NASA Langley obtained the residual SARAP hardware for testing under the NASA Subsonic Rotary Wing (SRW) crashworthiness research program. In May 2011, NASA and Sikorsky signed a Space Act Agreement [2] allowing for cooperation between the two organizations to pursue common research interests, including: composite material and airframe structural testing under dynamic loading; development of accurate and robust material models to predict aircraft structural response using LS-DYNA; and, validation of analytical models through test-analysis correlation.

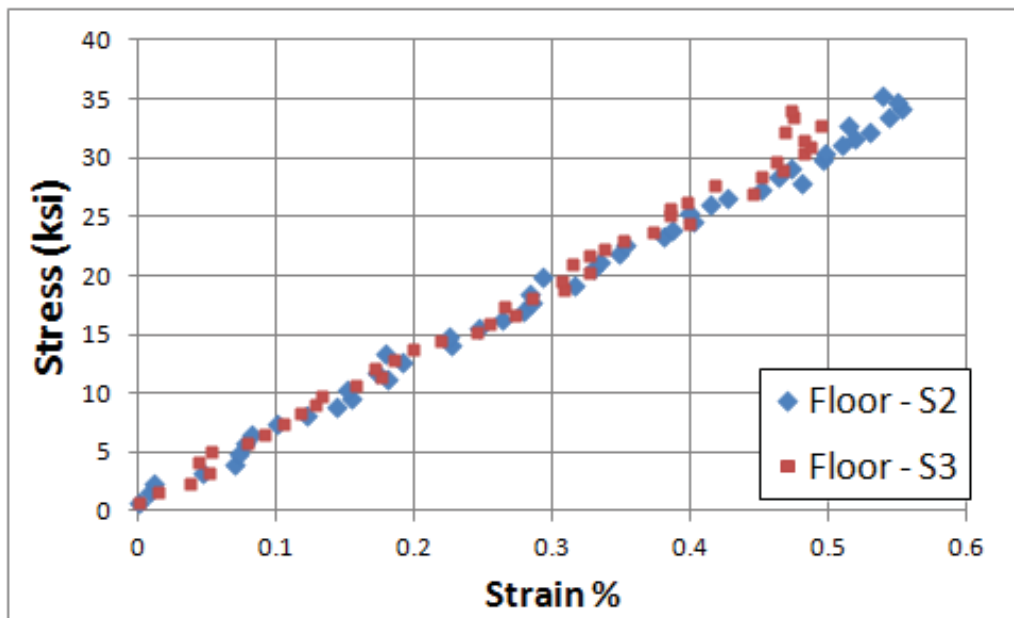
Results show that the failure strain and the maximum stress at failure of the composite floor coupons in compression are approximately half of the corresponding property values in tension. The average modulus is slightly higher for the compressive coupons, but the scatter in the data suggests that the modulus is the same in compression as it is for tension. Sample compressive stress-strain curves are plotted in Figure 6.

Figure 6. Compressive stress-strain curves of laminated floor coupons fabricated of unidirectional tape.

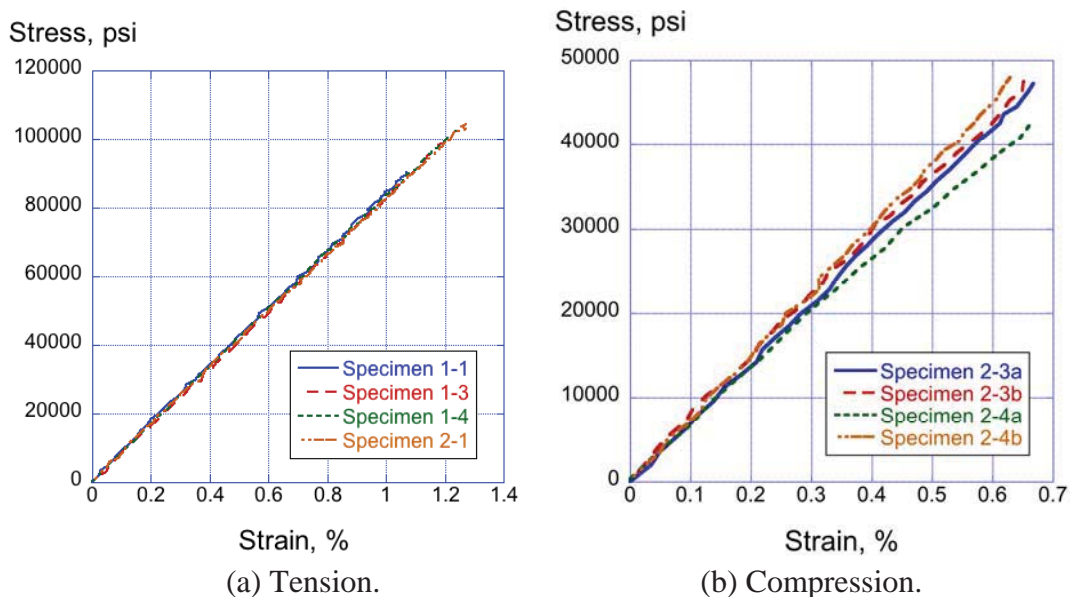
Four coupons were tested in tension and the stress-strain data are plotted in Figure 7(a). Based on analysis of the data, the average Young's modulus was 8.173×10^6 -psi, the tensile strength of the composite laminate was 99,147-psi, and the strain-to-failure was 1.2%. Likewise, four specimens were tested in compression and the stress-strain data are plotted in Figure 7(b). Based on data averaging, the Young's modulus was 7.0×10^6 -psi, the compressive strength was 47,300-psi, and the compressive strain-to-failure was 0.64%. Note that the compression specimens were less than half the length of the tensile coupons, with an unsupported gage length of 2-in. Finally, it is important to note that these properties are for fabric laminates, not fabric material.

Figure 7. Fabric coupon responses to tensile and compressive loading.

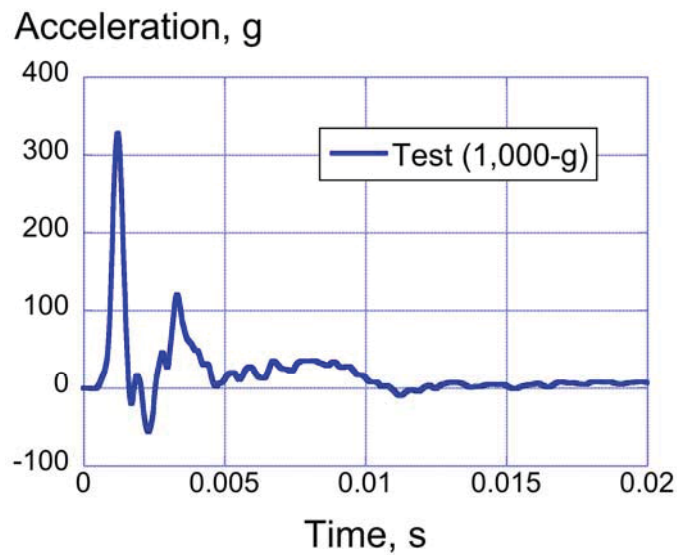
Figure 21. Drop mass acceleration from the 2-ft T-section test.

The drop mass acceleration shows a large initial spike peaking at 325-g at approximately 1-ms after initial impact. This initial spike represents first contact between the drop mass and the specimen. Unlike the previous I-beams, the T-sections did not have a trigger to initiate crushing. Thus, the initial spike represents the peak load before specimen failure. This peak is followed by a second peak of 114-g at 3.2-ms after impact. After 10-ms, the drop mass has reached its maximum crush displacement, and the acceleration trace shows no significant acceleration after this point. The maximum crush displacement, as measured by photogrammetry, was 0.44 inches, as shown in Figure 22. This plot also shows the displacement response obtained by double integration of the acceleration data. The integrated acceleration response shows a higher maximum crush displacement of 0.48-in. A considerable rebound is evident in Figure 22

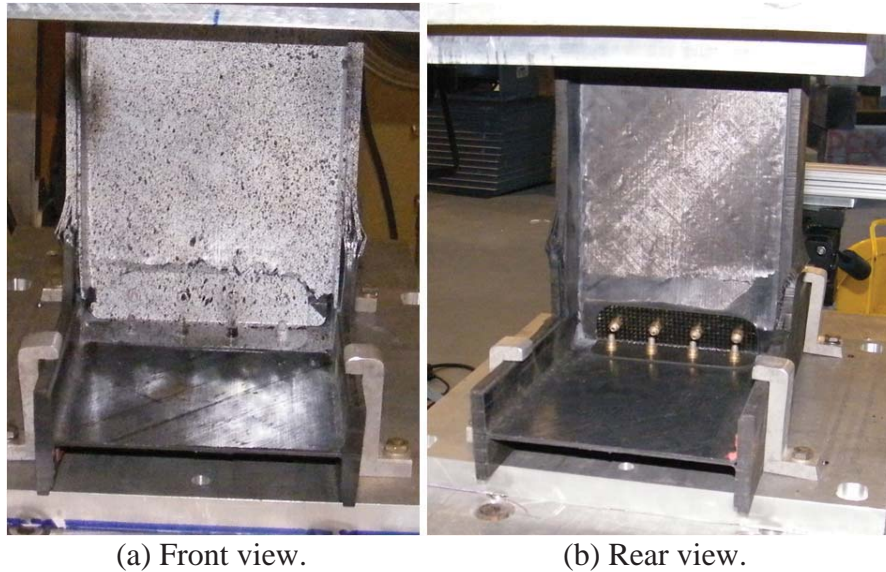
Figure 24. Post-test photographs of the 2-ft T-section test specimen.

The post-test photographs shown in Figure 24 confirm photogrammetric data for failure. Both the front and back views show a distinct failure line running horizontally right above the doubler on the web. Furthermore, these photographs show composite layer delamination and localized bending of the vertical flanges, near the transition region between vertical and horizontal. This evidence supports the conclusion that the specimen failed through crushing near the boundary edges and delamination of the vertical flanges.

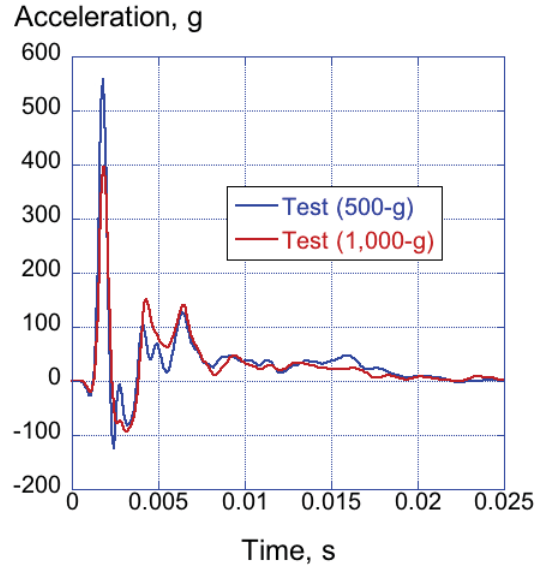
Figure 38. Drop mass acceleration from the 8-ft cruciform test.

Maximum accelerations ranged from 400- to 550-g and occurred at a time of 1.2-ms after initial impact. Two smaller peaks ranging in magnitude from 100- to 145-g occurred after the initial spike. Following these two smaller peaks, the acceleration stabilizes at approximately 40-g and remains at that level for approximately the next 10-ms. At 17-ms after impact, the acceleration response decays and reaches zero at 20-ms. This acceleration response is very similar to the cruciform test which was conducted at a lower impact velocity. Even though the energy is two times greater in this case, both specimens required approximately the same peak acceleration to initiate failure and similar trends are observed in the acceleration time histories after initial failure. However, the extra kinetic energy is absorbed through specimen crushing, as evidenced by the higher maximum displacement of the drop mass, shown in Figure 39.

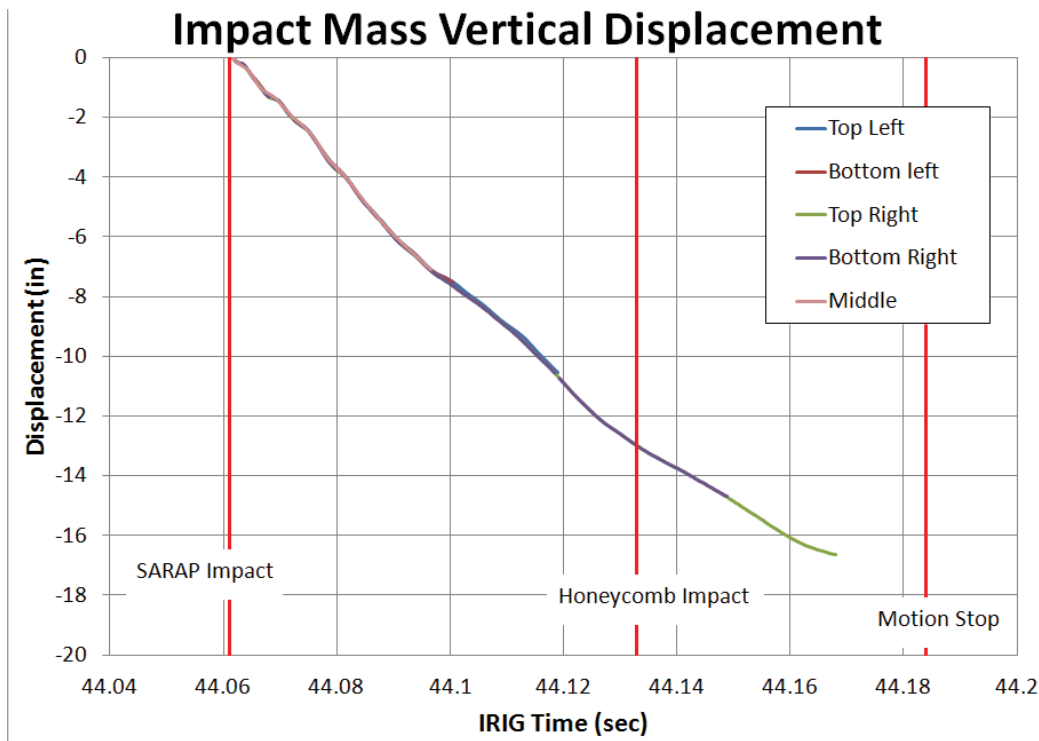
The displacement of the drop mass was also measured using the photogrammetric techniques to investigate crush displacement of the test article, as plotted in Figure 54. The displacement response shows that the subfloor crushed approximately 13 inches before the honeycomb stops engaged, which occurred at 0.071-s. The displacement of the subfloor base was next examined using full-field strain photogrammetric techniques. Out-of-plane displacement is shown in Figure 55. Note that the lower left portion of the base could not be tracked.

Figure 54. Drop mass vertical displacement of the subfloor.

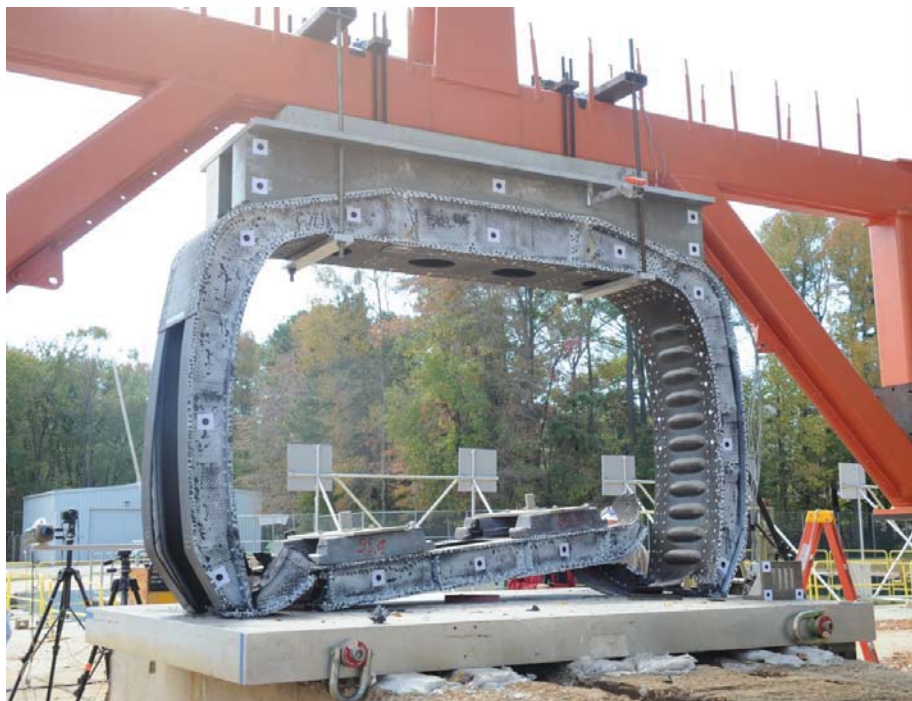
The framed fuselage section came to rest shortly after impacting the surface. A post-test photograph is shown in Figure 70.

Figure 70. Post-test photograph of the framed fuselage section test article.

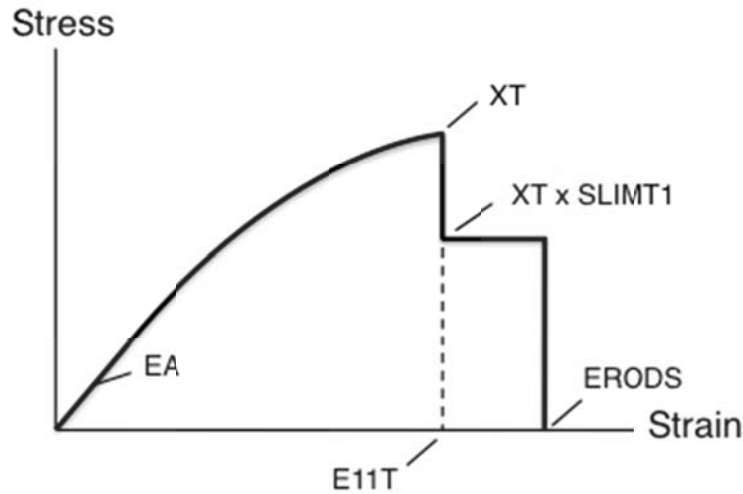
Figure 74. Typical in-plane tension stress-strain curve used for material within Mat 58.

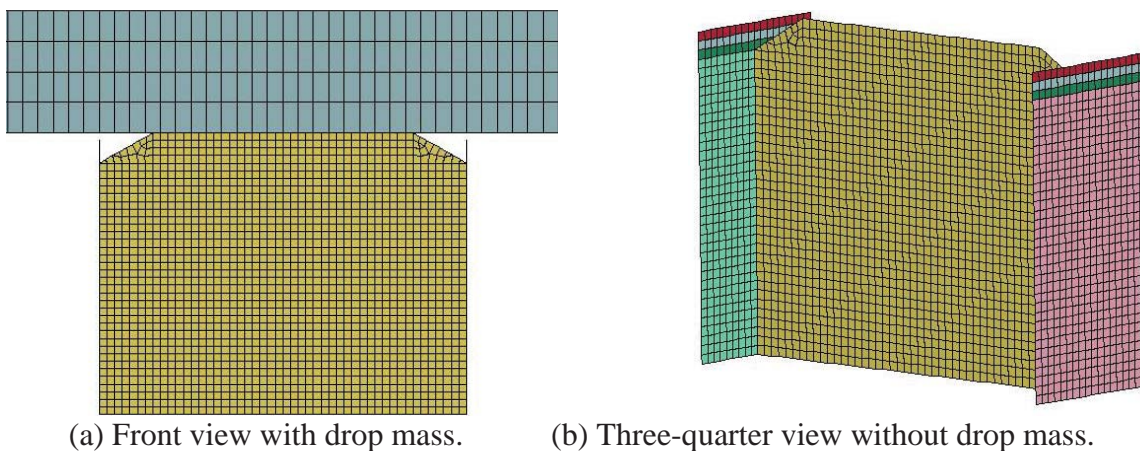
Figure 83. LS-DYNA model of the I-beam component.
