NASA/TM-2014-218505/Volume II
NESC-RP-13-00852

Evaluation of Agency Non-code Layered Pressure Vessels (LPVs)

Appendices

*William H. Prosser/NESC
Langley Research Center, Hampton, Virginia*

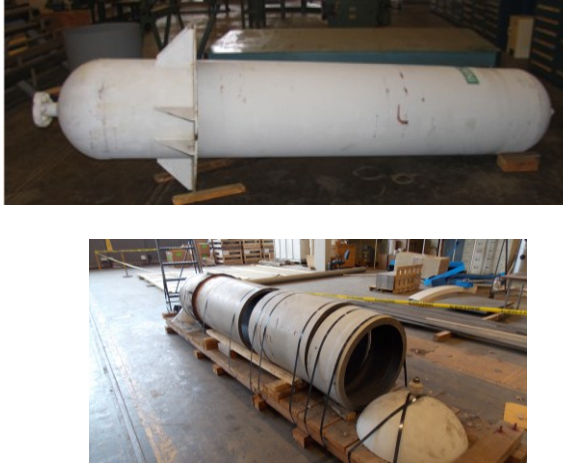
MSFC Materials and Processes Laboratory Flash Report		<small>MSFC Engineering Directorate Materials and Processes Laboratory</small>	
<p>Vessel V0125 pre- and post- dissection.</p>

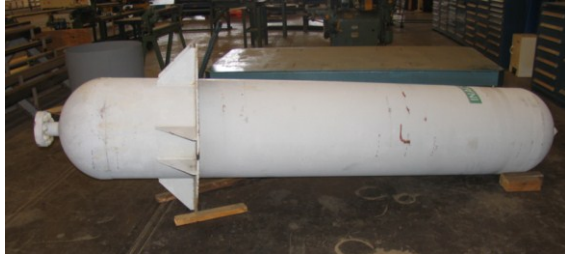
MSFC Materials and Processes Laboratory Flash Report	MSFC Engineering Directorate Materials and Processes Laboratory		
<h2 style="margin: 0;">Current Testing</h2>				
<ul style="list-style-type: none"> ■ MSFC Vessel V125 <ul style="list-style-type: none"> ■ CB&I, Liner plus 3 wraps ■ Typical construction

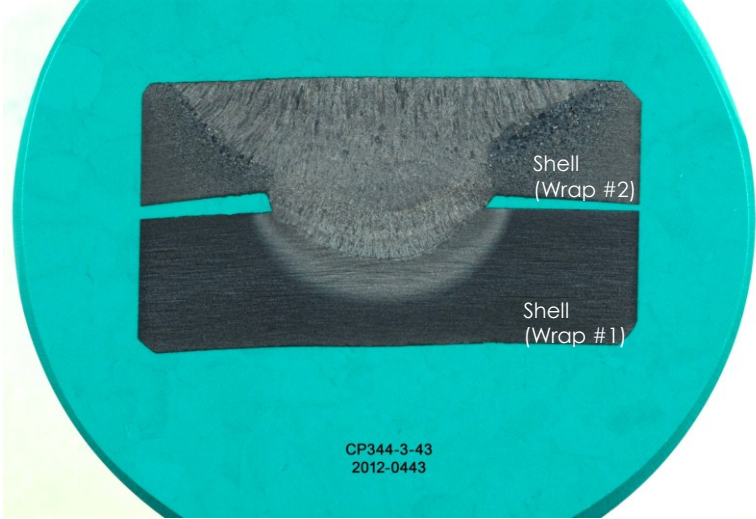
CP344-3-43
2012-0443

Cross-section micrograph of multi-pass axial shell weld

Shell (Wrap #2)
Shell (Wrap #1)

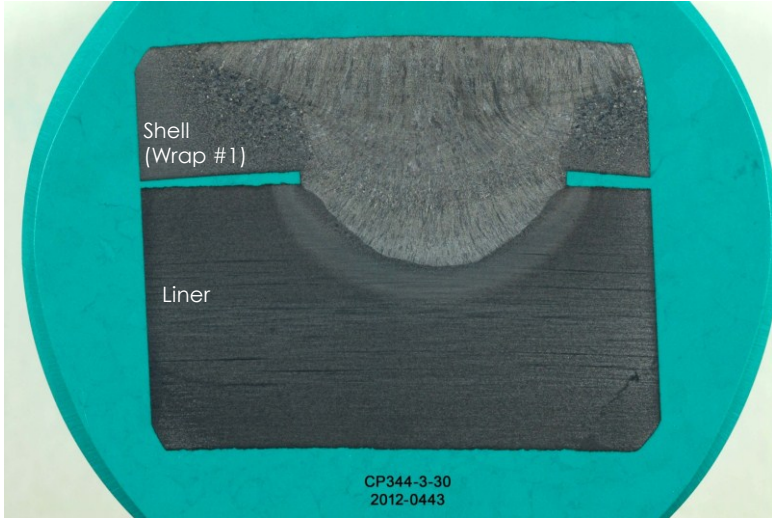
CP344-3-30
2012-0443

Cross-section micrograph of multi-pass axial shell weld

Shell (Wrap #1)
Liner

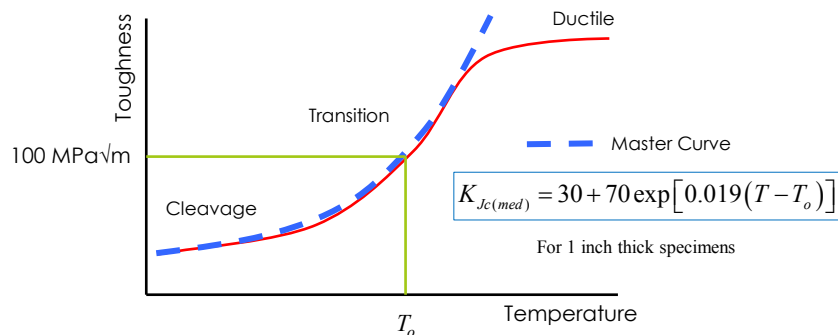
- The master curve concept is used to describe the transition in fracture toughness due to cleavage mechanisms as temperature decreases to the lower shelf

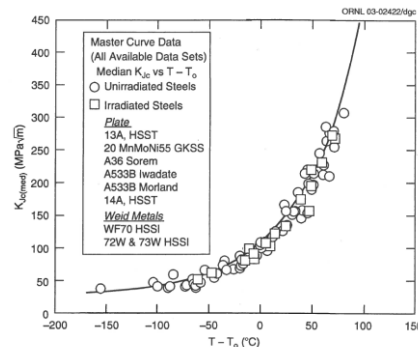
$$K_{Jc(\text{med})} = 30 + 70 \exp \left[0.019(T - T_o) \right]$$

Fig. 5—Median K_{Jc} values from eight data sources; all data have been converted to IT equivalence, and test temperature normalized to T_o temperature.

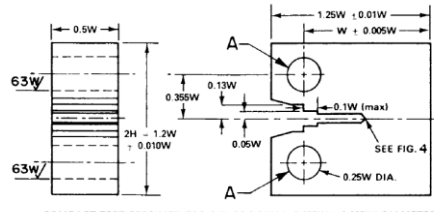
<p>COMPACT TEST SPECIMEN FOR PIN OF 0.24W (+0.000W/ -0.005W) DIAMETER</p>

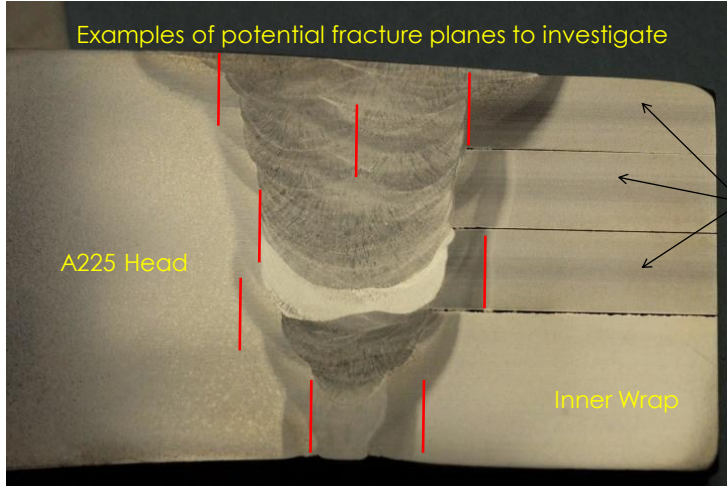
MSFC Materials and Processes Laboratory Flash Report		MSFC Engineering Directorate Materials and Processes Laboratory	
<p>Examples of potential fracture planes to investigate</p>

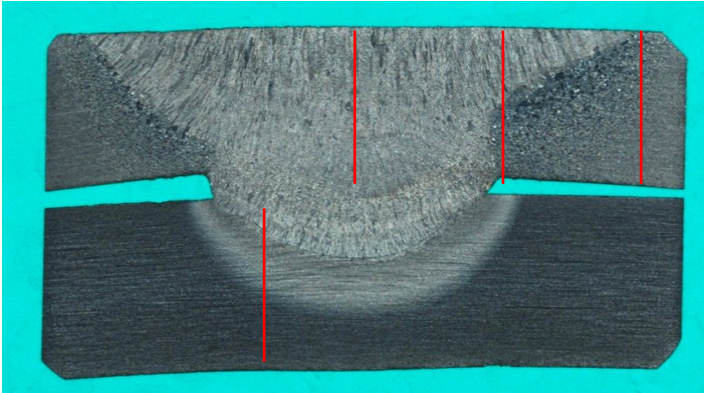
MSFC Materials and Processes Laboratory Flash Report		MSFC Engineering Directorate Materials and Processes Laboratory	
<p>Examples of potential fracture planes to investigate</p>

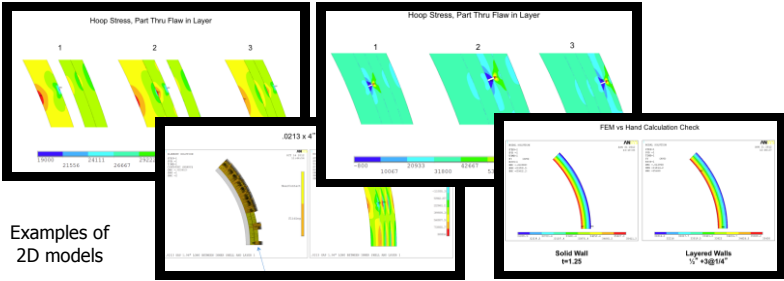
<p>Examples of 2D models</p>					
Title: MSFC Layered Pressure Vessel Analysis Activities/ LAPVAT		SBU Controlled? NO	Number: MPFR-14-006	Page 2

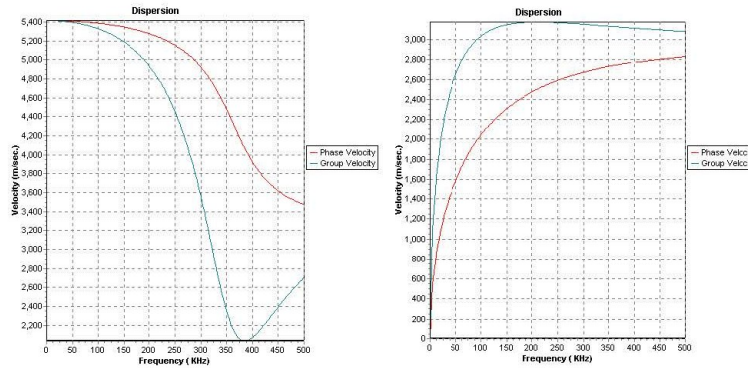
different frequency dependence, and thus there are separate dispersion curves for each. These are shown in Ref. 1, Fig. 3, and are reproduced below for 0.25 inch steel plate.

Dispersion curves for 0.25 inch thick steel plate. The extensional mode curve is on the left, the flexural mode curve is on the right [Ref. 1]

Therefore, in 2001 and during every test since, DWC determined which wave mode was being timed during the PLB tests (elongation, since it is faster and arrives first), and calculated it's velocity based on the time of flight from the break location to a remote sensor that captured the acoustic wave. They then determined the frequency of the waveform that was captured. The first arriving elongation mode velocity was measured to be about 4600 m/s (Ref 1, page 4), and this was verified in the subsequent tests at ARC with some variation up to about 5200 m/s. As stated in the 2001 test report, Section III, it was initially unknown whether a plate wave resulting from a surface lead break would travel only in the outer layer or through the entire thickness of the vessel. The first arrival wave was measured to have a frequency of 23 KHz. From the dispersion curve for a ¼ inch plate (shown above on the left), the theoretical extension mode frequency is 5400 m/s and flexure mode is 2100 m/s, vs. the 4600 m/s velocity actually measured. However, the dispersion curve for a 2.75 inch thick plate (see below) shows the extensional mode velocity to be 4800 m/s, very close to the measured 4600 m/s, and a flexure mode velocity of 2500 m/s.

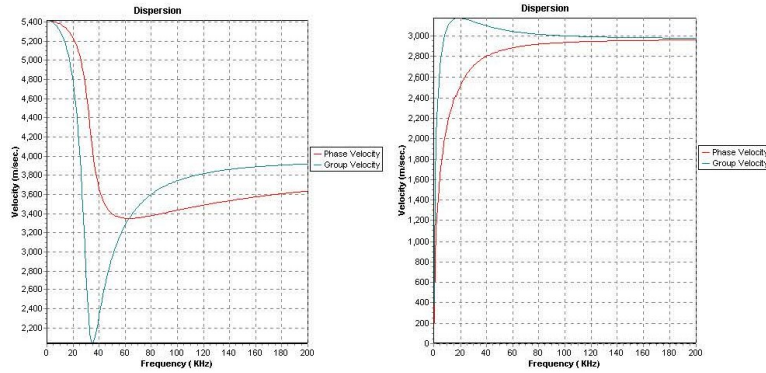
Dispersion curves for a 2.75 inch thick steel plate. The extensional mode curve is on the left, flexural mode curve is on the right [Ref 1, Fig 4]

As an additional check on validity, the wavelength can be calculated based on the propagation frequency and velocity. For this case, $\text{wavelength} = \text{velocity} / \text{frequency} = 4600 \text{ m/s} / 23,000 \text{ Hz} = 0.2$ meters, or 7.9 inches. Thus, since the wavelength is much larger than the plate thickness, plate modes rather than bulk wave propagation should occur.

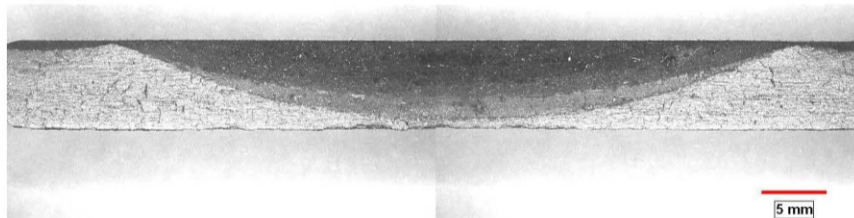
As stated above, the initial test on this vessel involved pressure cycling to grow a crack from a radiused starter notch. The initial notch was 2.01 inches long and 0.172 inches deep, which was about 70% through the thickness of the shell layer. The resulting final fatigue crack was 1.78 inches long. A stereomicroscopic image of one surface of the crack is shown below.

The initial surface crack (SC) growth exhibited typical non-critical fatigue crack extension which was followed by rapid crack extension and ductile fracture through the remaining small ligament. This coincided with the yield-level stress at the end of the test series, and although the crack transitioned to a through-crack (TC) at this point, there was no further crack growth since the test was terminated. A suite of scanning electron microscope and stereomicrographs are available in the Phase 1 report.

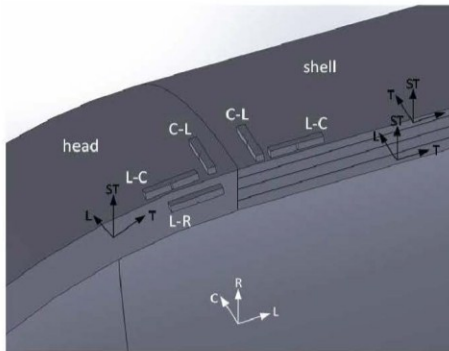
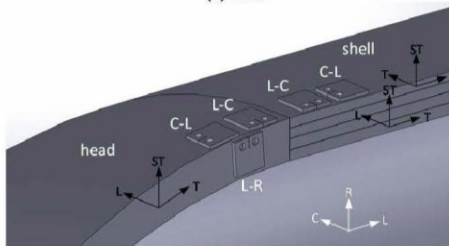
Significant emphasis was placed on understanding the plate rolling directions and flaw growth directions in the material test results, and the following graphic is provided for reference when reviewing the following summaries.

(a) CVN

(b) Toughness and FCG
