NASA/TM-2014-218514

Review of Research on Angle-of-Attack Indicator Effectiveness

Lisa R. Le Vie
Langley Research Center, Hampton, Virginia

August 2014

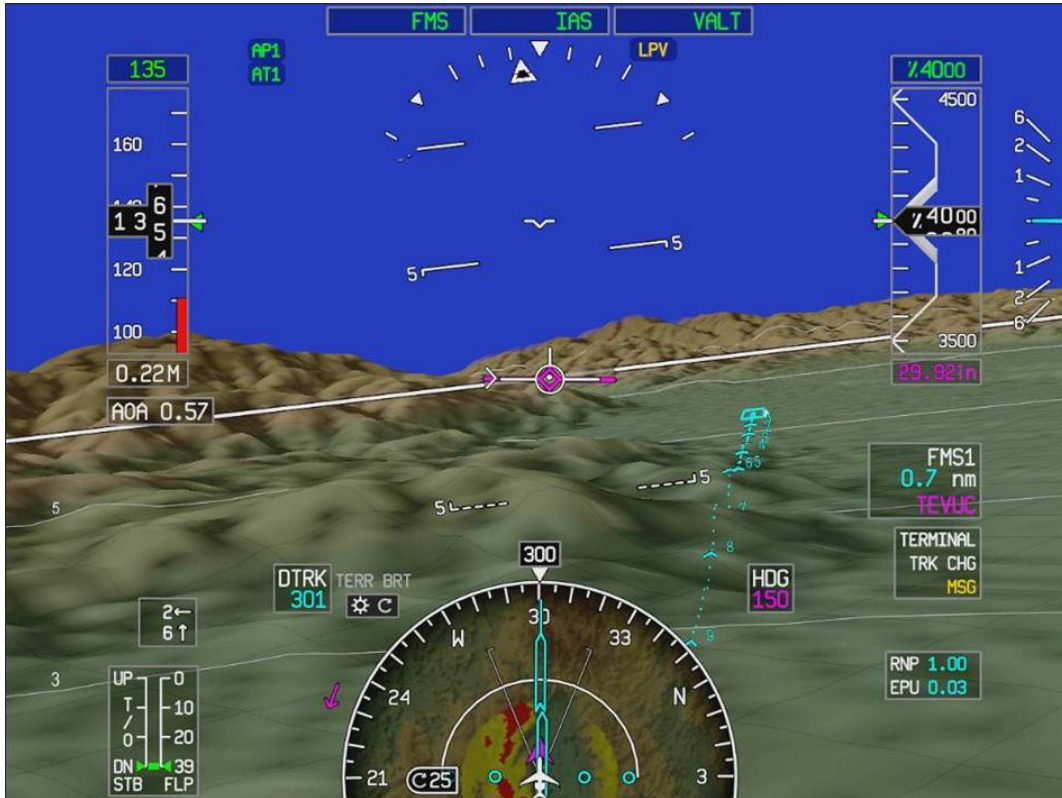
Other aircraft manufacturers are also offering AoA indicators. Gulfstream displays AoA as a computed, normalized value ranging from 0.00 to 1.10 with 0.00 corresponding to zero lift, while 1.00 is the stick pusher activation threshold. This normalized AoA information is displayed on the primary flight display (PFD) below the airspeed tape (Figure 22). The AoA number can change color from white, during normal operations, to amber for approach to stall, and to red to indicate a stall. When used together with the airspeed tape, pilots can use these as indications of low speed and/or high AoA situations (Gulfstream, 2003).

Figure 22: Gulfstream PFD AoA Located Under Airspeed Tape (Gulfstream, 2003)

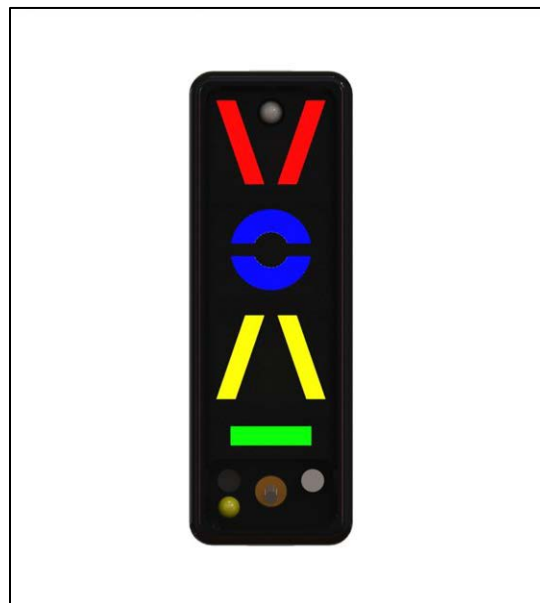
Alpha Systems has a chevron Style AoA display (Figure 27) that will display a green bar to indicate normal operations for cruise and that AoA is low, and no action is required. A blue donut lights up to indicate “Optimum Alpha Angle” which is a 30 percent margin above stall. A yellow chevron lights up indicating a relatively high AoA and the need to take action to reduce AoA. And finally, a red chevron indicates an AoA that is too high; immediate action is required to reduce the AoA and stall recovery procedures should be performed. The display also has sixteen different brightness levels and four different audio options. Each AoA display is calibrated to the aircrafts specific lift curve (Alpha Systems, 2014).

Figure 27: Alpha System AoA Griffin Chevron Display (Alpha Systems, 2014)

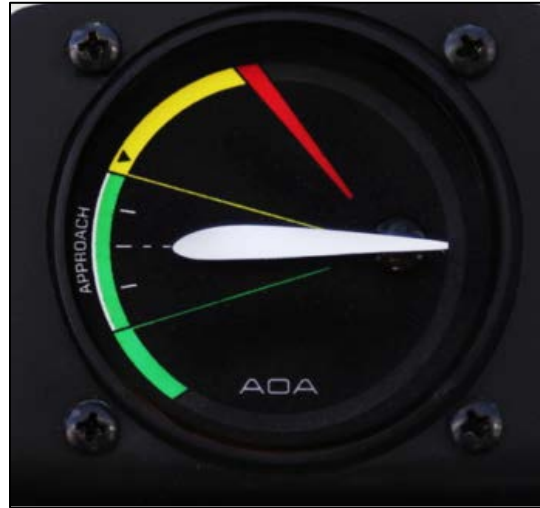
ICON Aircraft offers an AoA system on its A5 Light Sport Aircraft (Figure 28) that is currently in production. It is an analog display that gives graphical information about how much lift is available from the wing before it stalls. The indicator uses green, yellow, and red sectors to give a direct indication of the performance of the wing in real time (ICON, 2013).

Figure 28: ICON A5 Light Sport Aircraft AoA indicator (ICON, 2013)
