# **Investigation of the Semicoa 2N7616 and 2N7425 and the Microsemi 2N7480 for Single-event Gate Rupture and Single-event Burnout**

Leif Scheick  
Jet Propulsion Laboratory  
Pasadena, California

JPL Publication 14-2 01/14

NASA Electronic Parts and Packaging (NEPP) Program  
Office of Safety and Mission Assurance

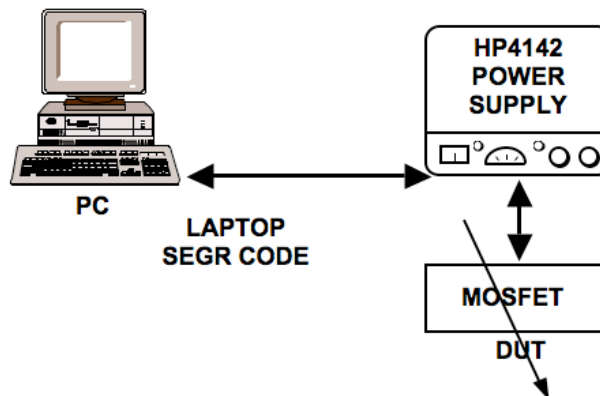
**Figure 2.3-1.** Schematic of experimental setup.

Figure 2.3-1 shows the schematic of the experimental setup used during the SEE testing. All devices were biased and measured with the HP4142B Modular DC Source/Monitor Unit (SMU) connected to a personal computer (PC) via a general-purpose instrument bus (GPIB). SMUs were used with 24-in coaxial cables that could source current with a current limit of 10 mA, with no stiffening capacitance or choke inductance added into the test circuit. The type of SEE (gate-to-drain SEGR, gate-to-source SEGR, or SEB) was noted, as well as the fluence at the voltage in which the SEGR/B occurred and the total fluence the part endured. The current and voltage changes were measured at approximately 100 ms increments; the maximum current resolution of the SMU was 1 nA. Background noise in a virgin device typically had an amplitude of <10 nA.

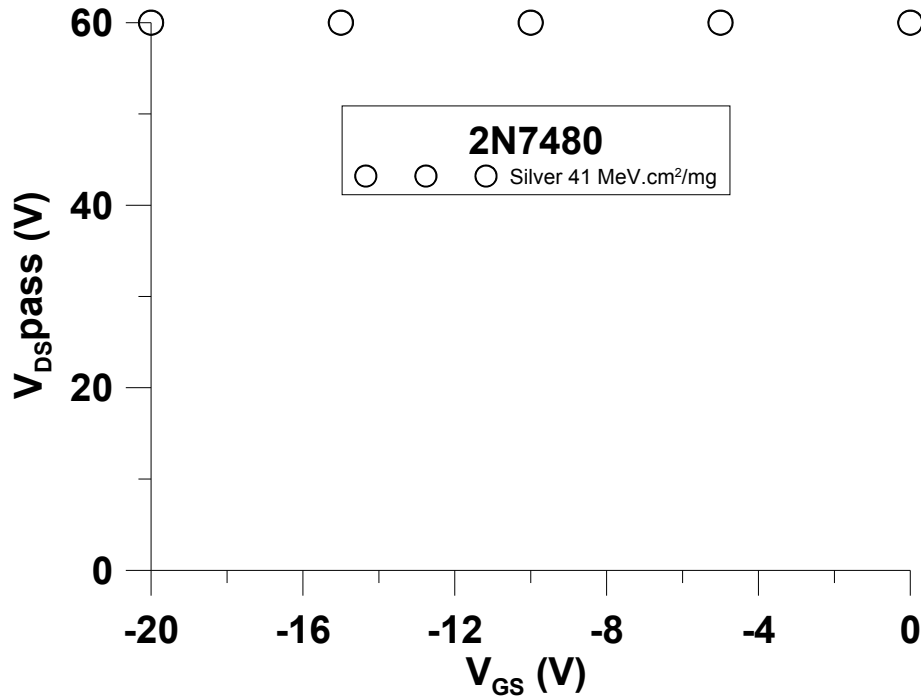
Figure 3.1-1. SEE response of the Microsemi 2N7480 for silver ions.

These parts performed better than others of this device rating. The 2N7480 is an n-channel 60 V power MOSFET based on the /703 slash sheet. The parts tested here were fabricated on the new RH2 process development. These parts performed much better than parts tested from the previous fabrication lines. The test ion was undegraded 41 MeV-cm<sup>2</sup>/mg silver. Figure 3.1-1 presents the results.

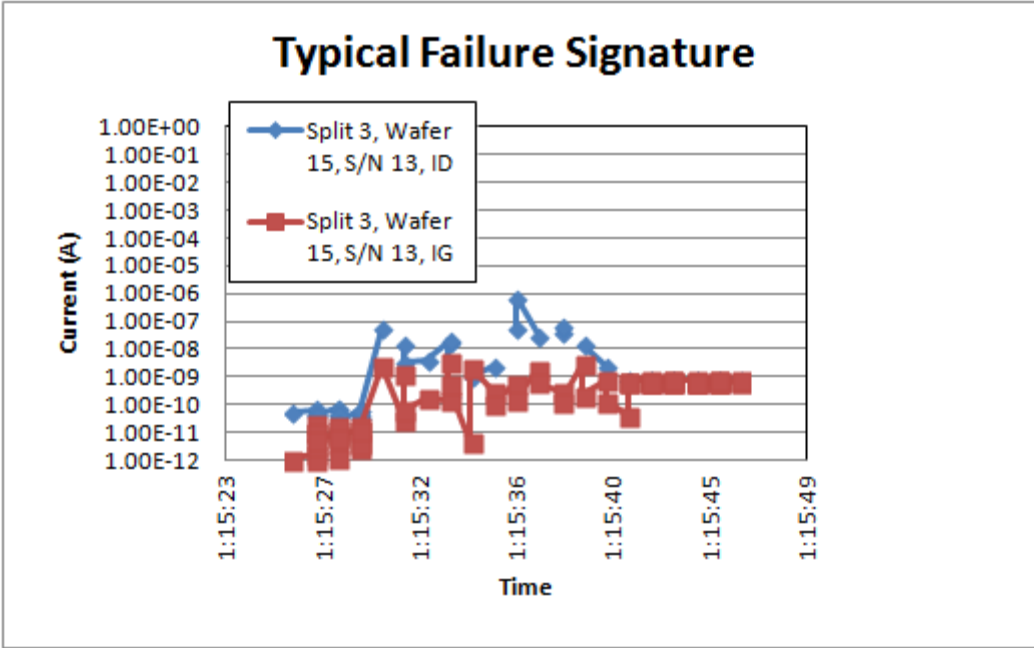
Figure 3.2-1. Part shows no problems during exposure but fails the Gate Stress Test after the run.

Figures 3.2-1 through 3.2-13 present the test results for the Semicoa 2N7616. The parts tested here were first generation parts for Semicoa's line, which is an epitaxial-based process, produced with a rad-hard process developed for products from 100 V to 500 V. The SEE response of these parts is comparable to other 500 V rated parts. Four different wafer splits were tested. Wafer split is the primary production lot for Semicoa. Split 5 had the best performance, but Split 5 demonstrated Single Event Gate Rupture and Burnout. Almost 89% of failures were during the ion exposures and only 11% from PIGS; this is completely reversed from previous testing and could be due to the improved oxide quality. All of the failures from Split 4 and 5 were during the ion runs. The limited PIGS failures were only from Split 1 (13) and 3 (3).

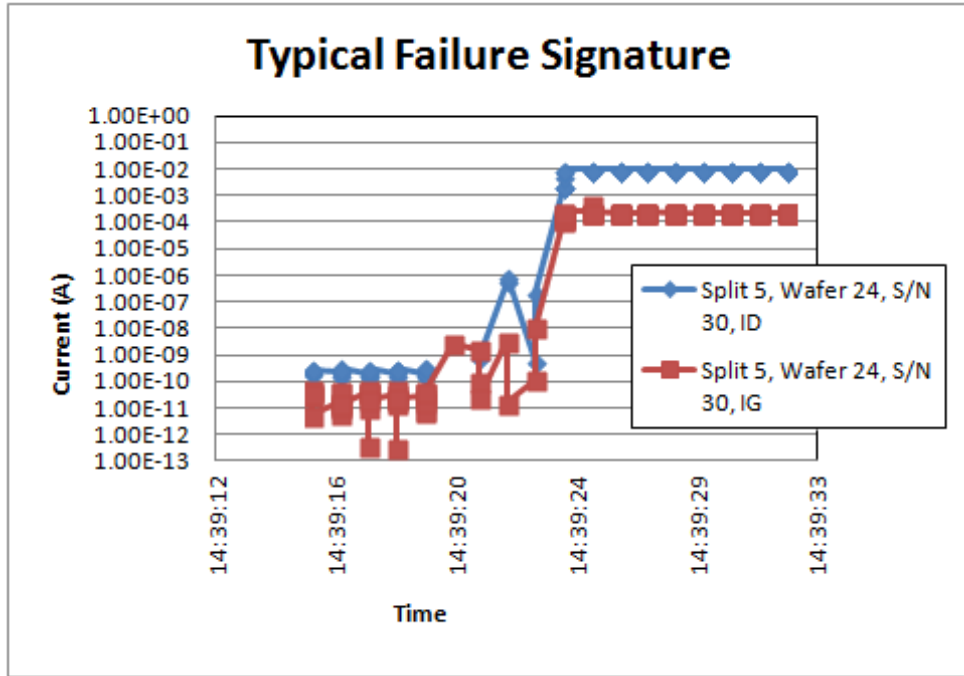
Figure 3.2-4. IG and ID during exposure and at some point the part breaks and exceeds specification. In this test, 51.7% of failures were this type

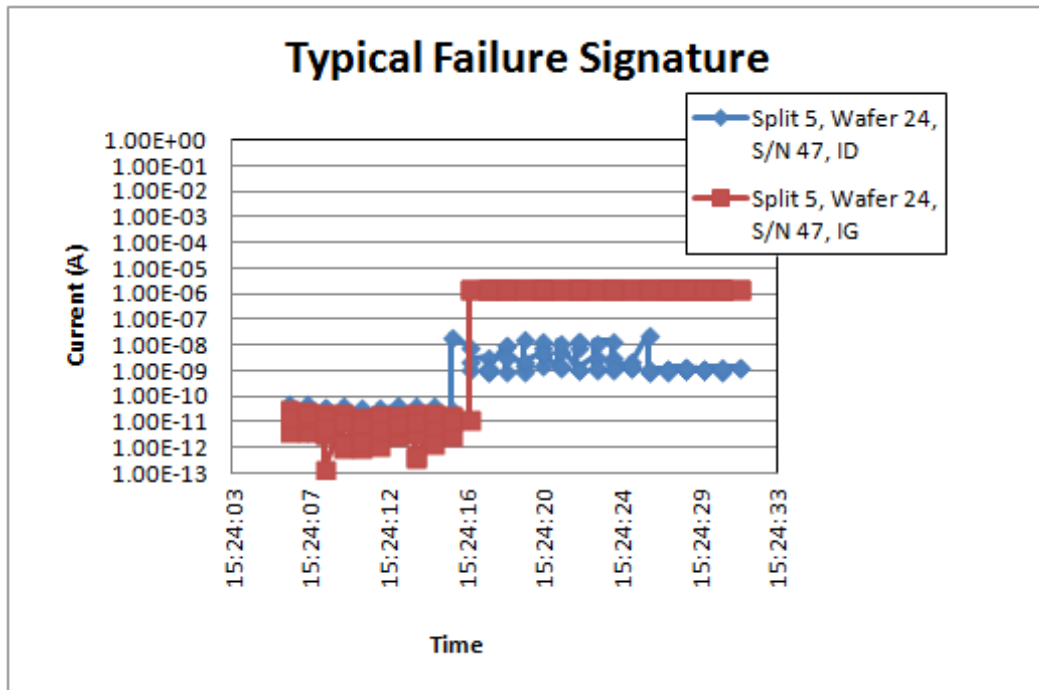
Figure 3.2-5. Both the Drain and Gate become leaky but only IG fails its spec. this test, 40.6% of failures were this type.

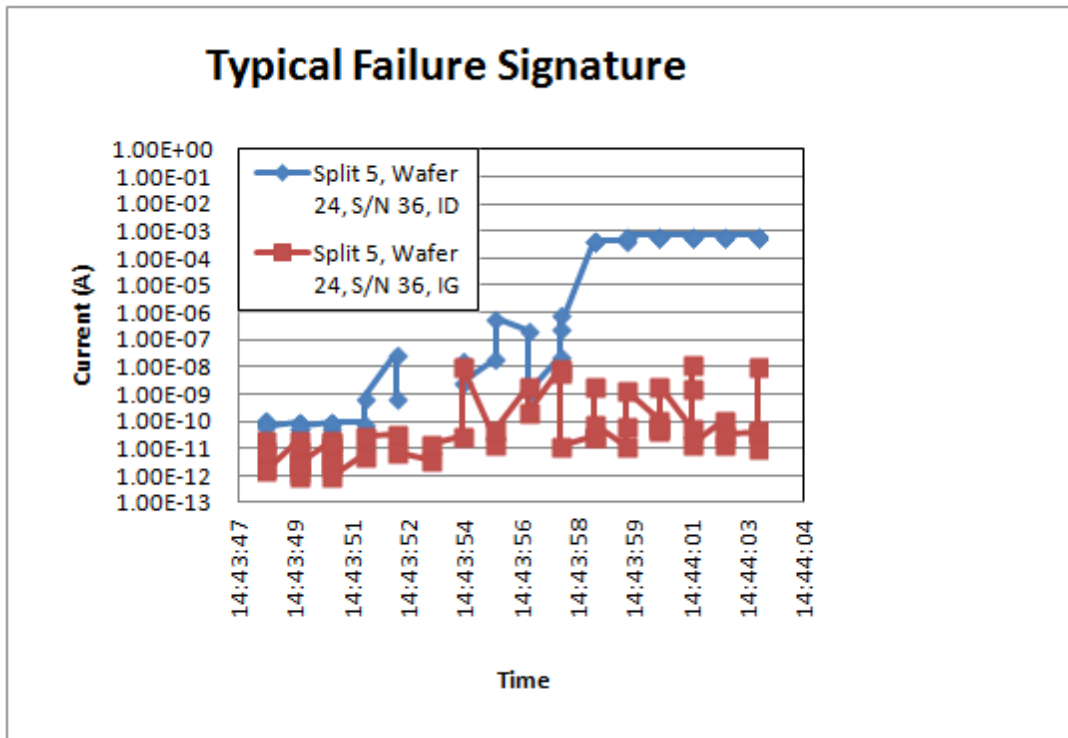
Figure 3.2-6. This is a Single Event Burnout, the Gate is not ruptured. There were 11 of these failures – two in Split 4 and nine in Split 5. In this test, 7.7% of failures were this type

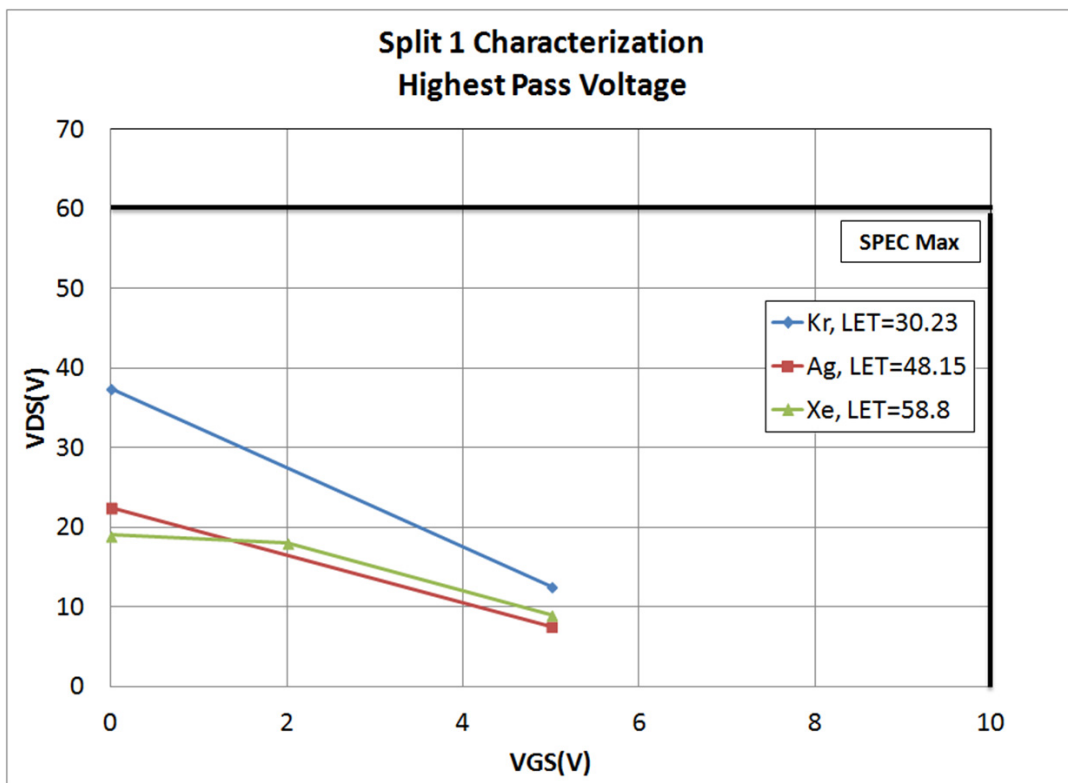
Figure 3.2-7. SEE response of split 1.

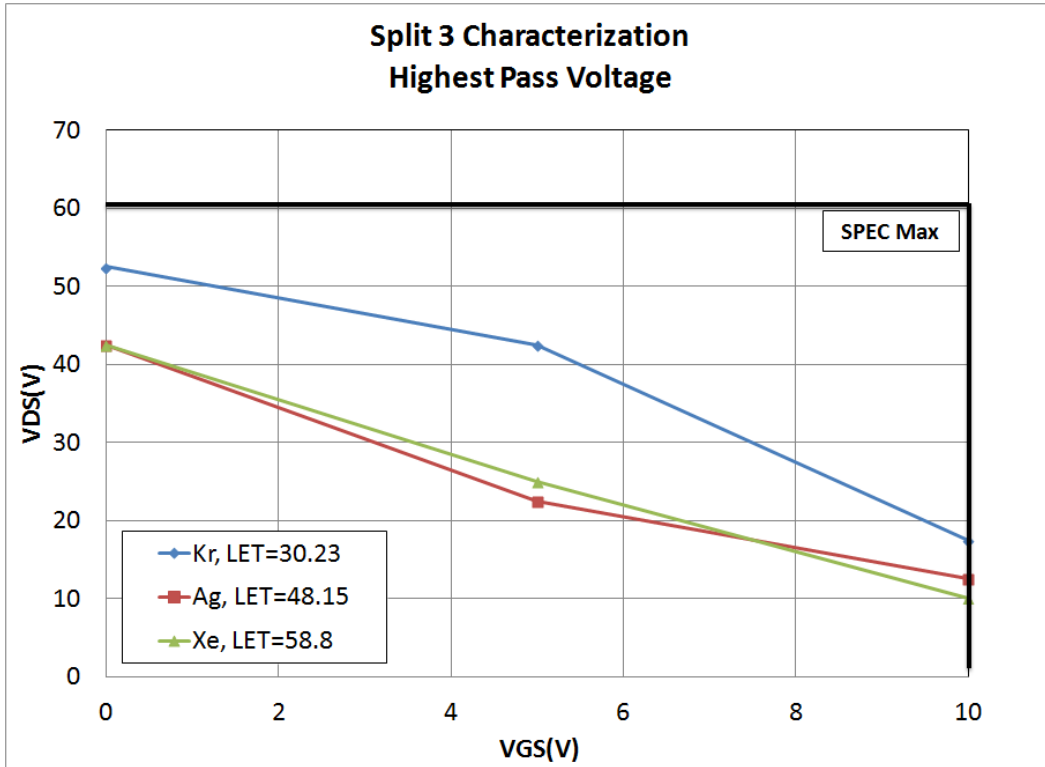
Figure 3.2-8. SEE response of split 3.

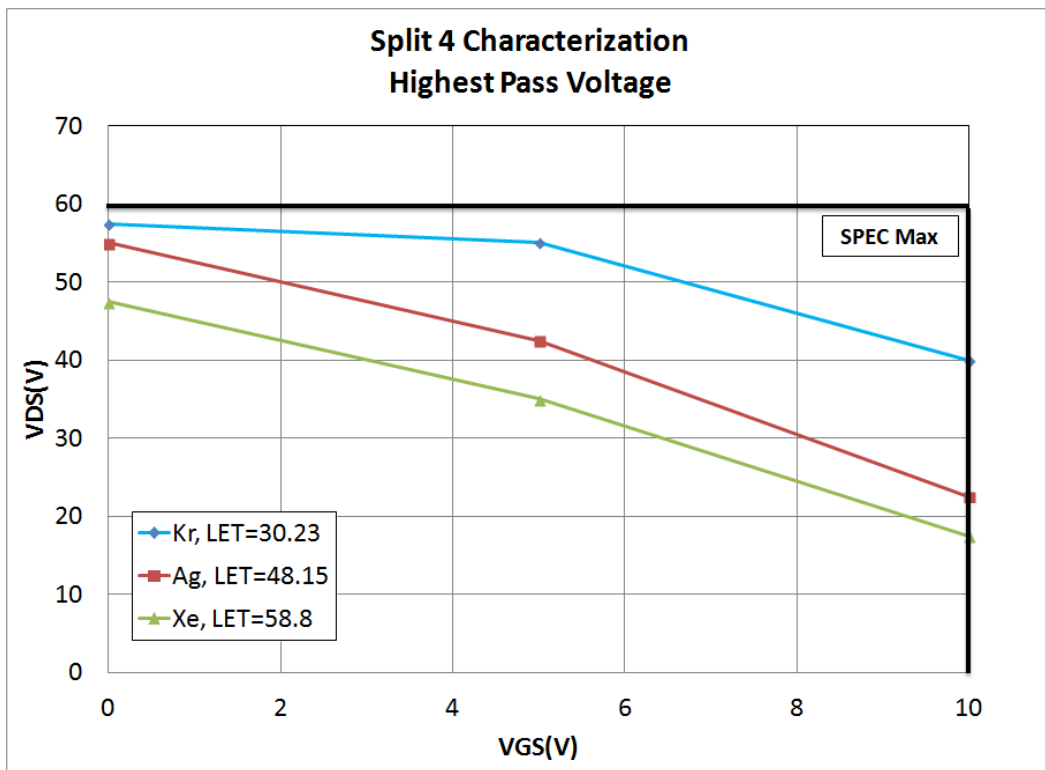
Figure 3.2-9. SEE response of split 4.

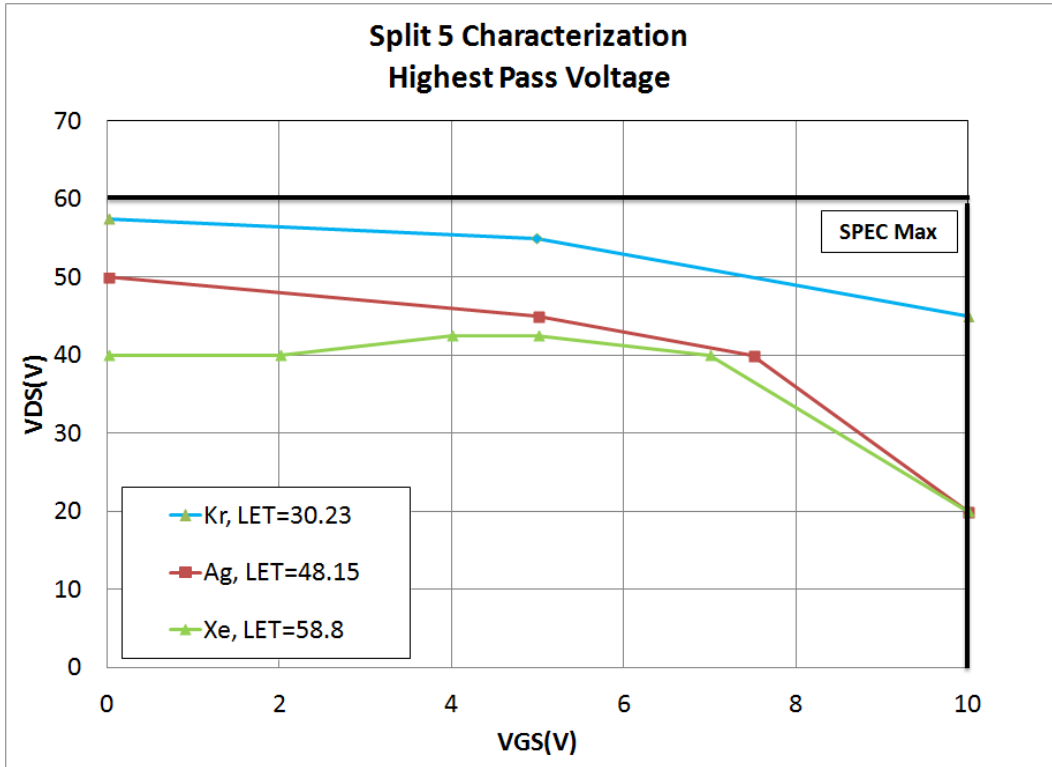
Figure 3.2-10. SEE response of split 5.

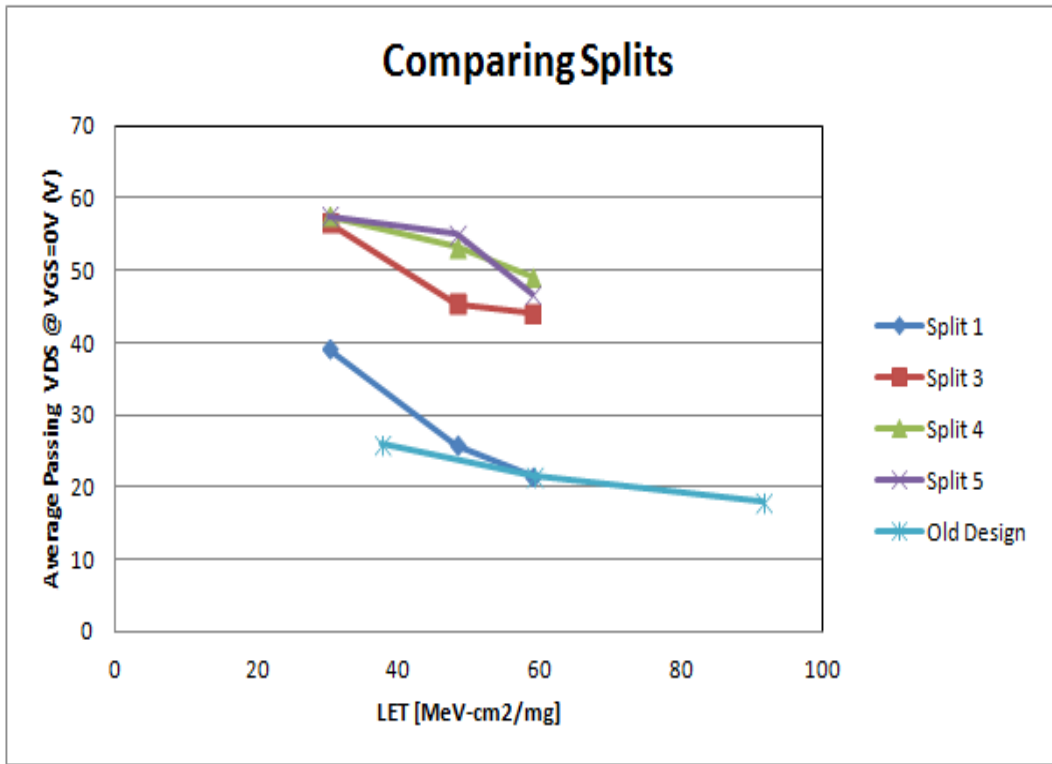
Figure 3.2-11. Graph shows performance for all four splits tested with  $V_G=0$  V.

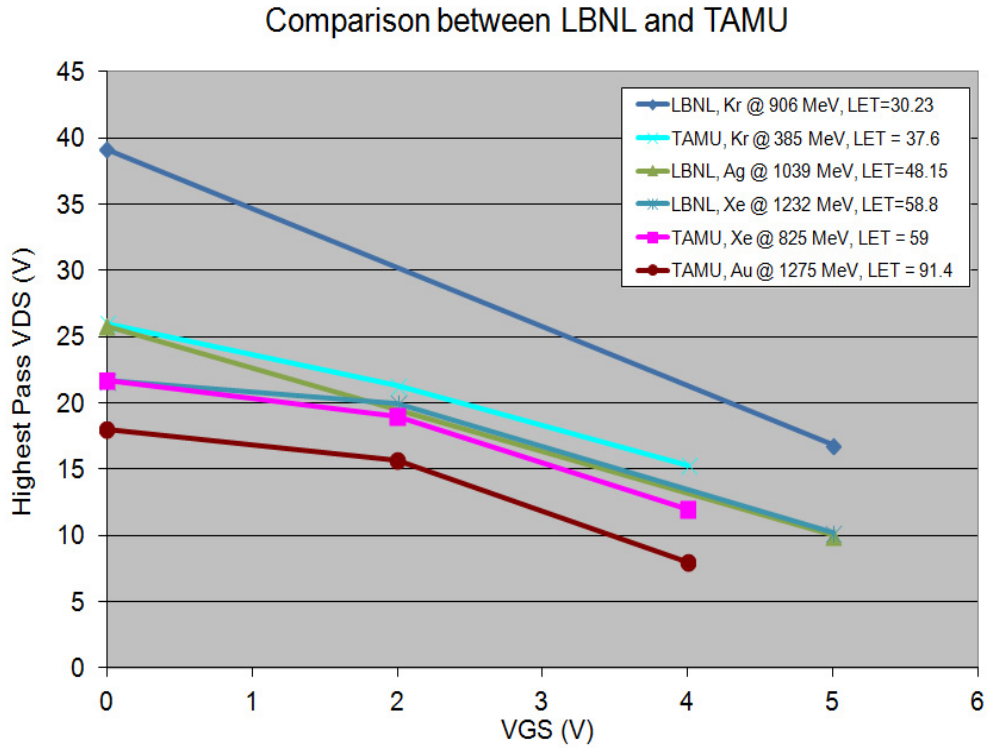
Figure 3.2-12. Testing at both heavy ion facilities. The TAMU data tuned the Bragg Peak to the epi/substrate interface.

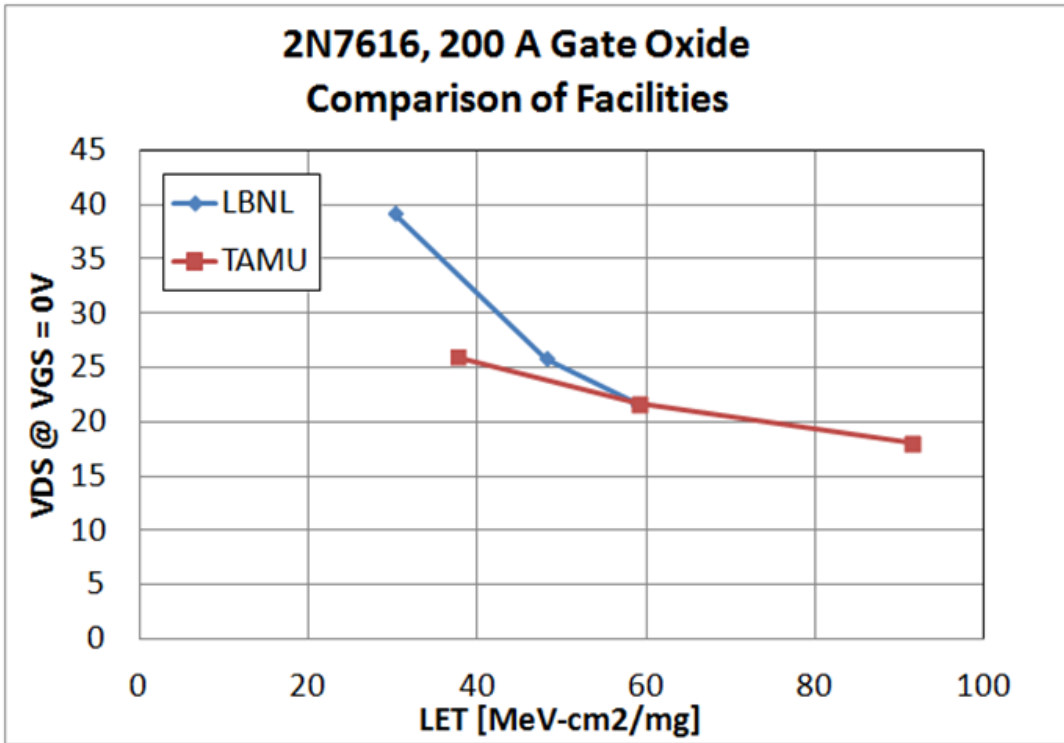
Figure 3.2-13. Testing at both heavy ion facilities. The TAMU data tuned the Bragg Peak to the epi/substrate interface.

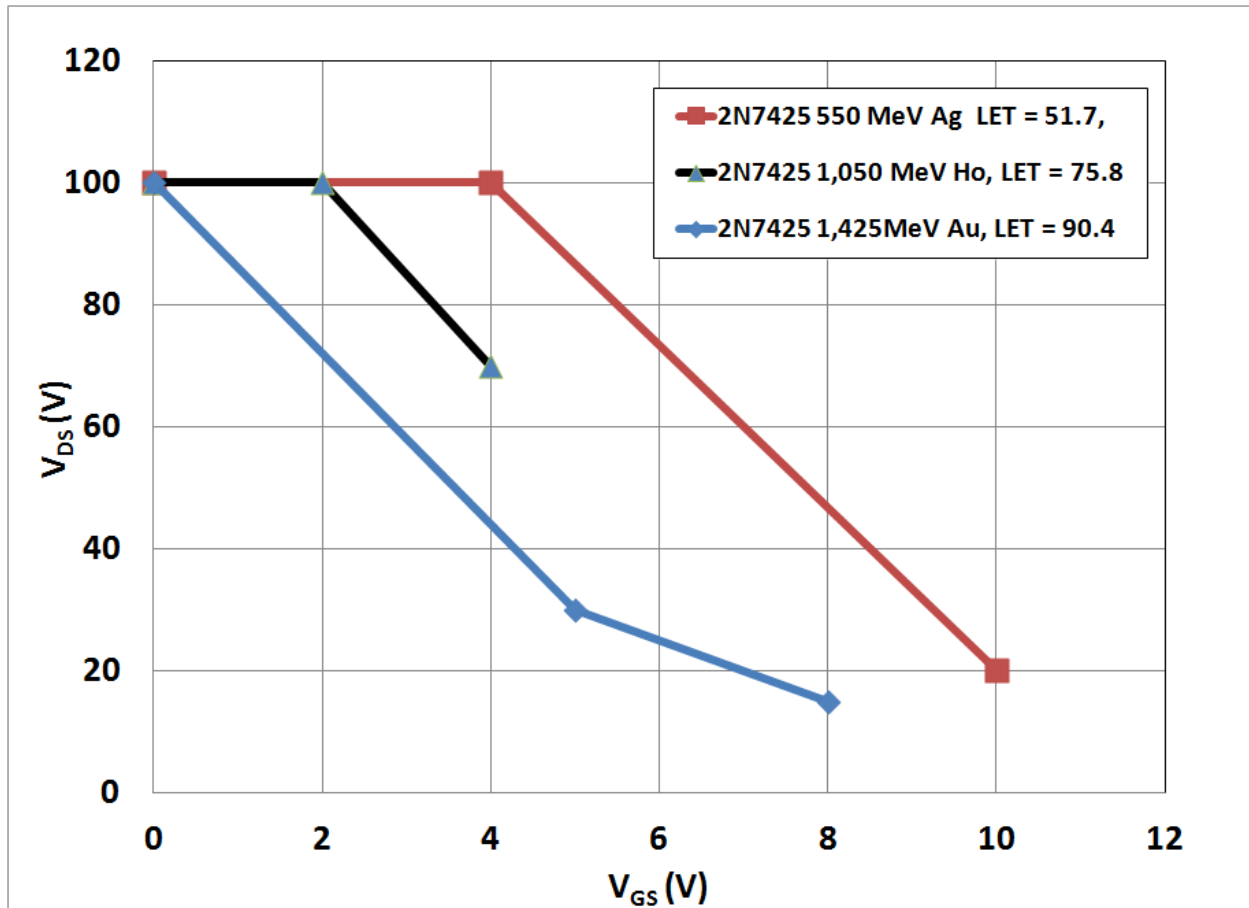
Figure 3.3-1. SEE results for 2n7425 (N-Channel). Note VDS is negative in the graph above.

Figure 3.3-1 presents the test results for the Semicoa 2N7425. The 2N7425 is an n-channel 450 V, 11 A device. The parts tested here were first generation parts for Semicoa's line, which is an epitaxial-based process, produced with a rad-hard process developed for products from 100 V to 500 V. The beam was degraded to place the Bragg Peak at the Epi/Substrate interface. Tested device was 2N7425, 100 V P-Channel MOSFET, Wafer Lot J36753.3. Three ion species were used: Ag @ 550 MeV with surface LET was 51.7 MeV-cm<sup>2</sup>/mg, Ho @ 1,050 MeV with surface LET was 75.8 MeV-cm<sup>2</sup>/mg, and Au @ 1,425 MeV with surface LET was 90.4 MeV-cm<sup>2</sup>/mg. Tested a sample size of three at each VGS and VDS point. Performed a posttest gate/drain stress test per MIL-STD-750, Test Method 1080.1.
