NASA/TM—2013-216610

Investigation of Sideband Index Response to Prototype Gear Tooth Damage

Paula J. Dempsey
Glenn Research Center, Cleveland, Ohio

November 2013

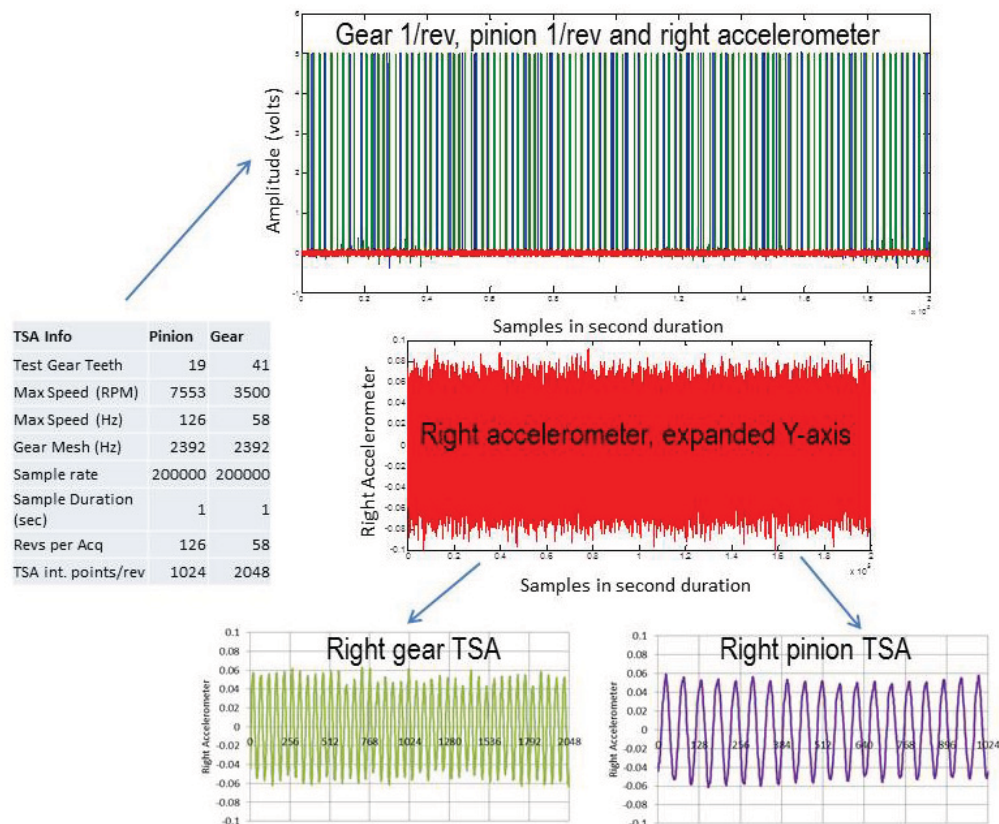
Figure 3 illustrates the information used to calculate the TSA for the right gear and pinion. Using the sample rate of 200 KHz for 1 sec duration and the speed of both shafts, the number of TSA averages for each acquisition is determined. Each average consists of 1 revolution of the shaft. Each average is made up of the number of linearly interpolated points rounded down to a power of two. A power of two is used because it eases the future use of the Fast Fourier Transform (FFT) to transform the time domain signal for the time domain to the frequency domain. Per Figure 3, the top figure displays the right accelerometer data sampled for one second at 200,000 samples/second. The green and blue lines are pulses from the gear and pinion 1/rev signal measured for each shaft rotation during this one second period. Only the right accelerometer is plotted in the next figure with an expanded y-axis scale. The two lowest plots are the TSA signal calculated from the 1/rev and vibration data for the right gear and pinion. Pulses from the 41 tooth gear and the 19 tooth pinion can easily be seen within these two plots.

Figure 3.—Information used to calculate TSA.

Figure 5 illustrates the steps required to calculate RMS and SI for each reading. RMS uses the interpolated TSA data per Figure 3 to calculate the RMS of the TSA. SI uses the TSA to calculate an FFT. Then the amplitudes of the FFT on either side of the gear mesh (GM) are used to calculate SI indexes. Note that the x-axis of the plot showing the FFT of the right gear is in shaft orders or multiples of shaft speed. For example, since the gear has 41 teeth, the gear mesh frequency (teeth \times rpm) shows up at 41 shaft orders.

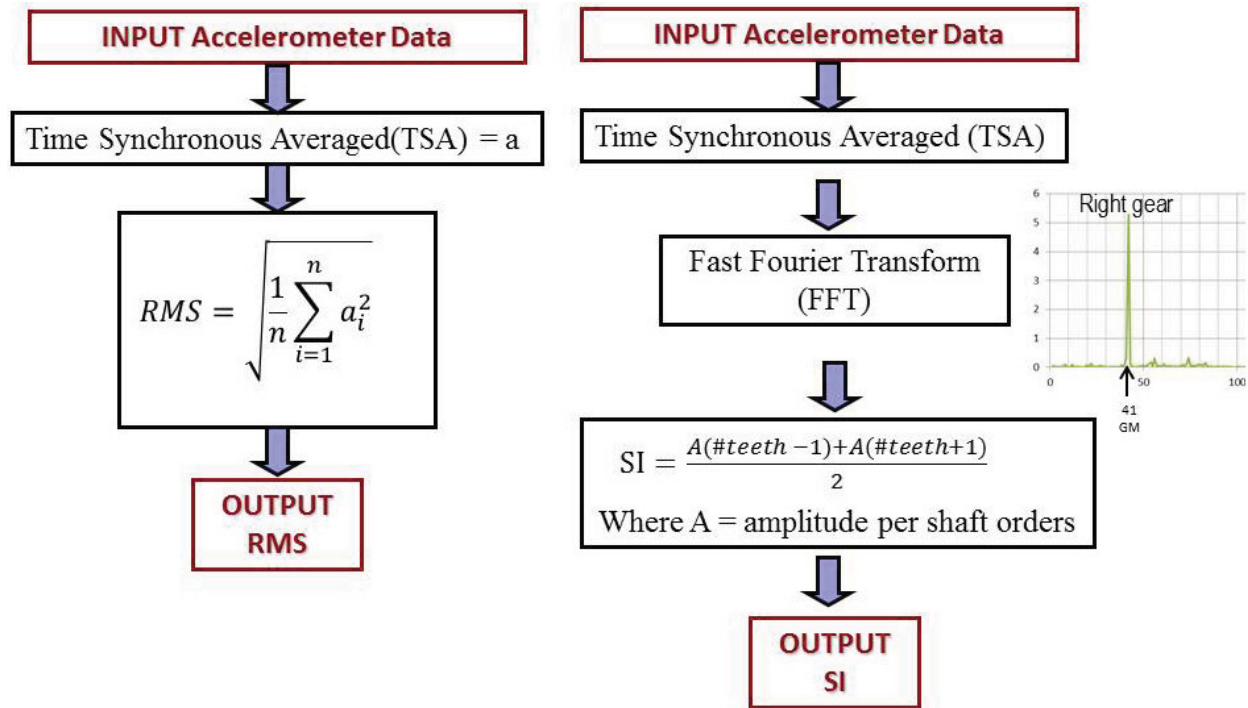
Figure 5.—RMS and SI calculations.

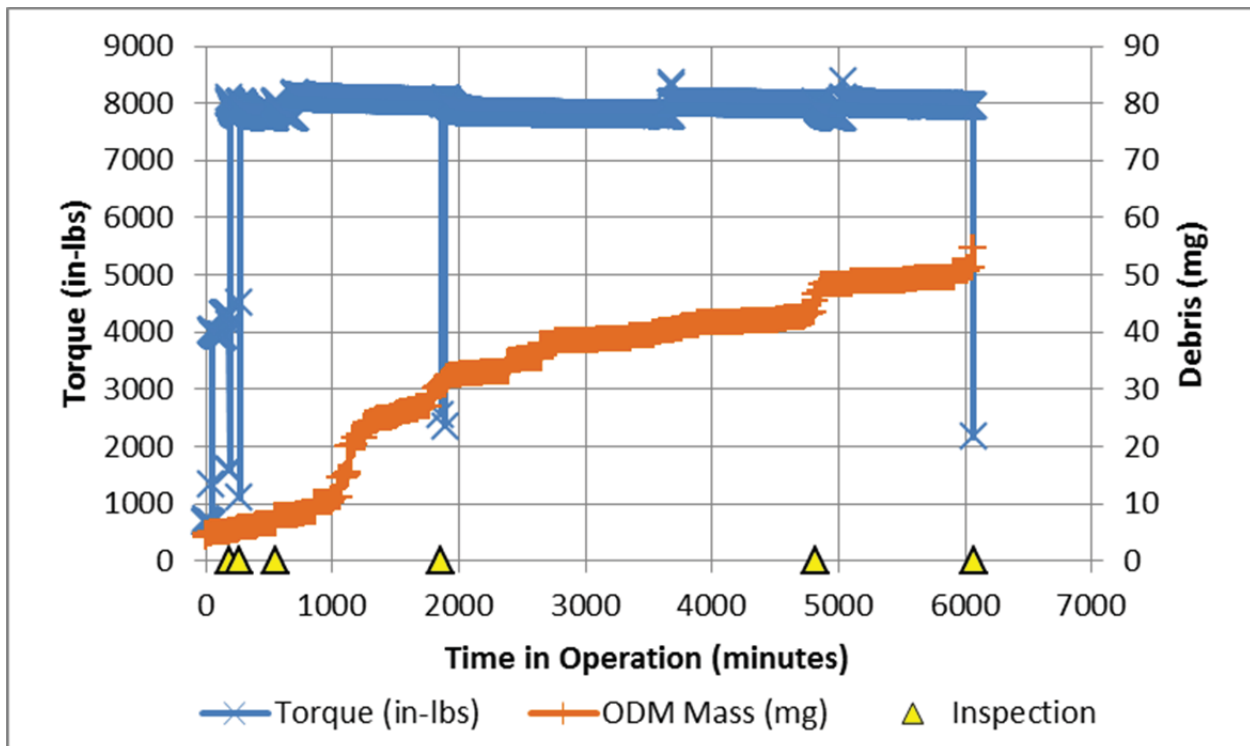
For test 1, per Figure 6, the rate of debris generation measured was 1.9 mg/hr at reading 1862, when spalling macropitting (4.3.4) was first observed on one left pinion tooth, although per Table 2, other types of damage occurred during this inspection interval on the right gear teeth. The rate decreased to 0.4 mg/hr when macropitting was observed on all of the teeth.

Figure 6.—Debris generated and torque during test 1.

Figure 6 is a plot of debris generated and the torque during test 1. Figure 7 is a plot of RMS during test 1. Tooth damage photos for the gear and pinion during the inspection intervals can be found in Figures A.1.1 to A.1.5.

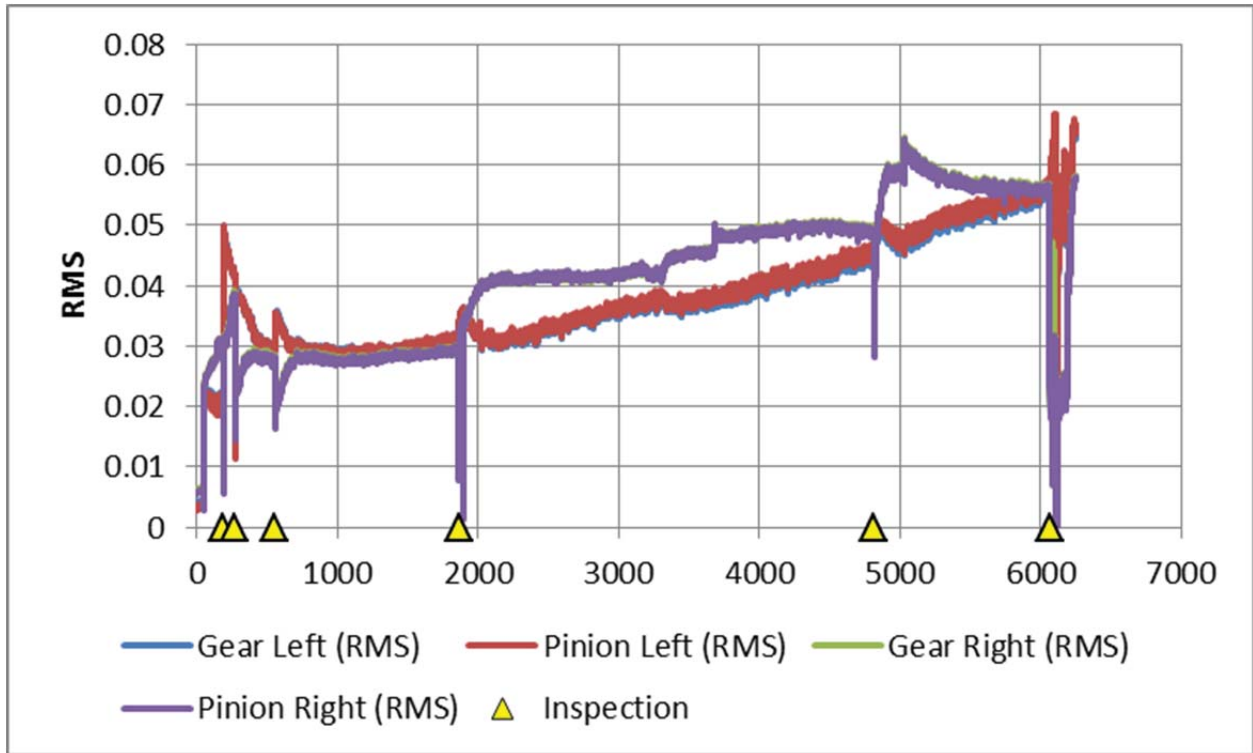
Figure 7.—RMS during test 1.

Per Figure 7, RMS could not be used to isolate the pinion from the gear on the left and right side of the test rig. The left gear and pinion RMS values tracked each other very closely as did the right gear and pinion. Both responded to the restarts after inspections, but the right side was significantly more sensitive than the left. The left RMS values trended well with damage progression.

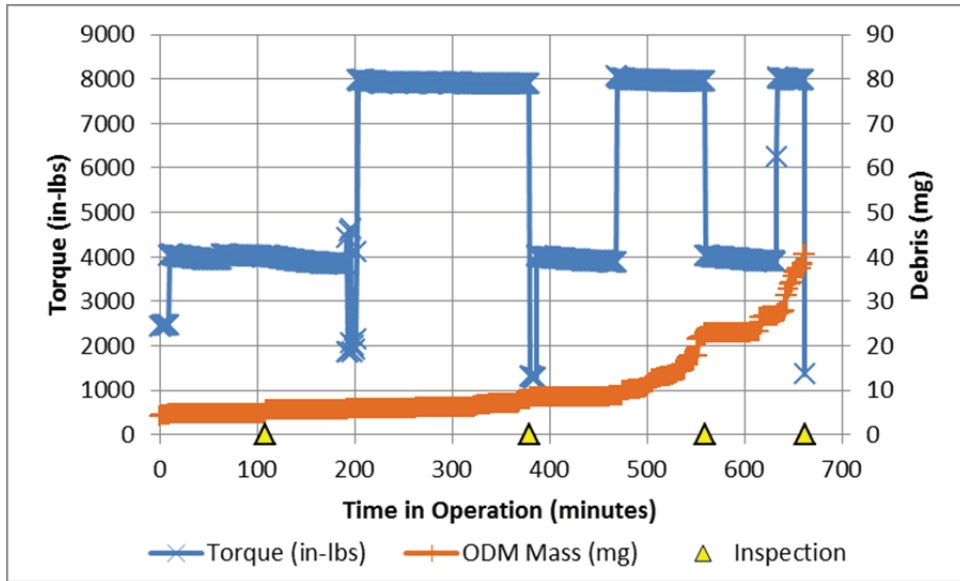
Figure 8.—Debris generated and torque during test 2.

Figure 8 is a plot of debris generated and the torque during test 2. Figure 9 is a plot of RMS during test 2. Tooth damage photos for the gear and pinion during the inspection intervals can be found in Figure A.2.1.

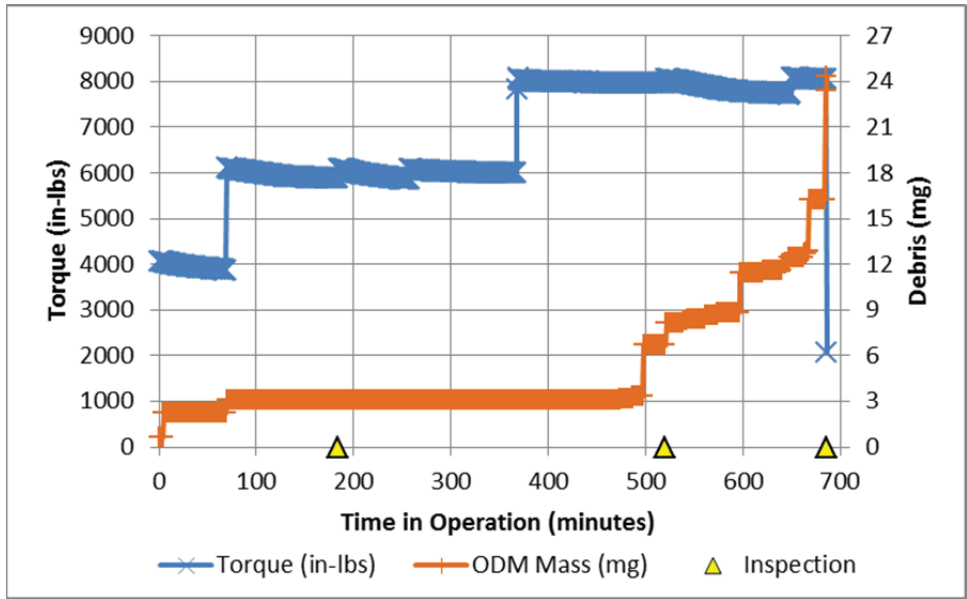
For test 3, per Figure 10, the rate of debris generation measured increased when torque increased from 6,000 to 8,000 in.-lb. For this test, the torque was not decreased when the macropitting was observed on the teeth. The 6.37 mg/hr rate of debris generation when spalling macropitting (4.3.4) was observed at 8,000 in.-lb was higher than the 3.75 mg/hr rate of debris generation when spalling macropitting (4.3.4) was observed at 4,000 in.-lb for test 2.

Figure 10.—Debris generated and torque during test 3.

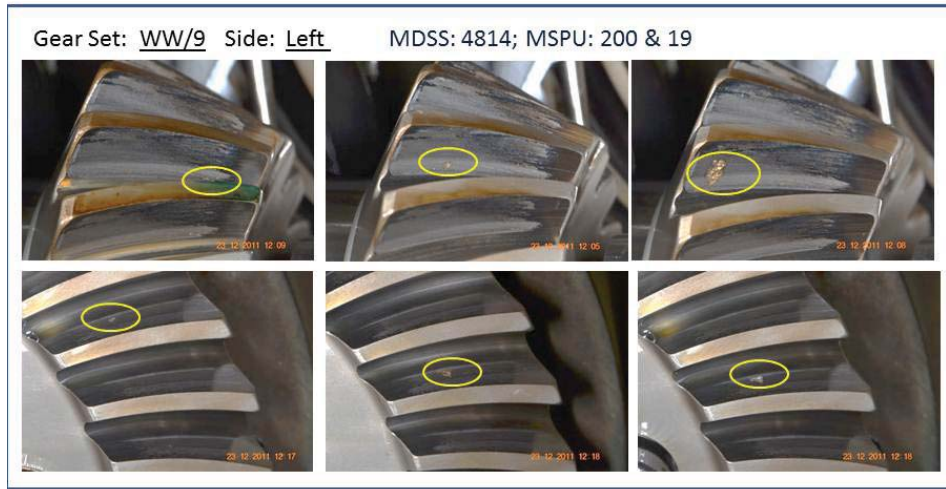
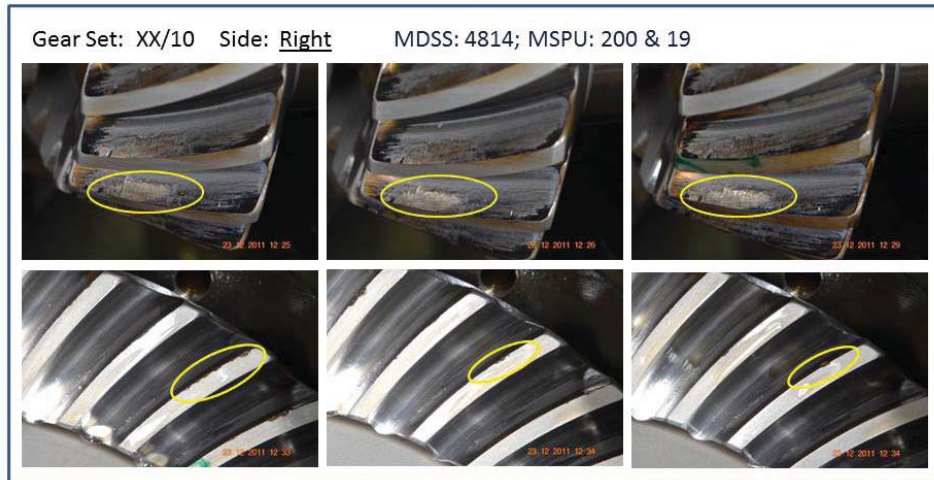
For test 1, Figures A.1.1 to A.1.5 illustrate the progression of damage on the gear and pinion teeth. For the left pinion, macropitting was observed on one pinion tooth at reading 1862 and on two teeth at reading 4814. For the left gear, macropitting was observed on three teeth at reading 4814 and five teeth at reading 6065. Macropitting was also observed on the right gear and pinion at reading 6065, the end of the test.

Figure A.1.1.—Test 1 gear and pinion damage modes.

Figure A.1.2.—Test 1 gear and pinion damage modes.

Figure A.1.3.—Test 1 gear and pinion damage modes.

Figure A.1.4.—Test 1 gear and pinion damage modes.

Figure A.1.5.—Test 1 gear and pinion damage modes.

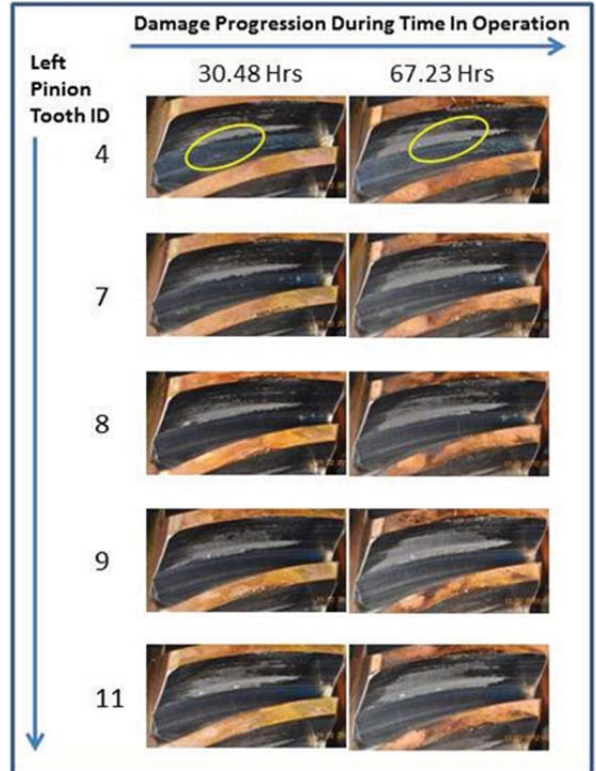
Figure A.4.1.—Test 4 gear and pinion damage modes.

Figure A.4.2.—Test 4 gear and pinion damage modes.

Figure A.4.3.—Test 4 gear and pinion damage modes.
