Low-Cost, Risk-Reduction Testing of Class D Spacecraft Photovoltaic Systems

The LADEE Approach

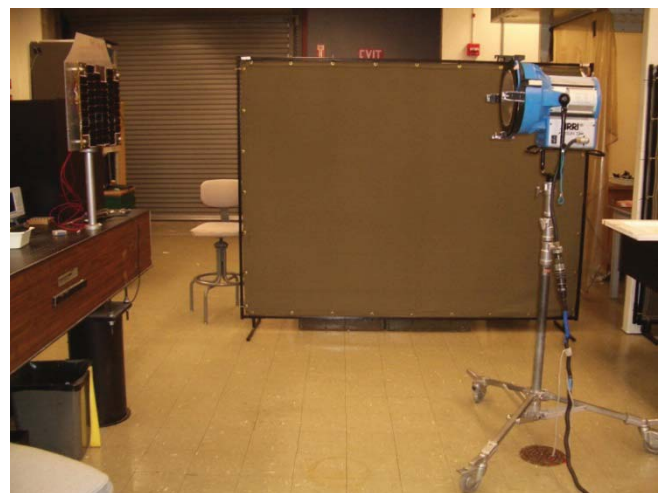
Figure 7: Experimenting with the Qualification Panel

Fortunately, lamps of this type are easily rented by theatre supply houses. The EPS team rented a couple lamps at a relatively inexpensive rate (~\$750 per week) and ran experiments on a flight qualification panel (Figure 7). Relatively few NASA engineers are theatre lighting operators; the qualification (qual) panel was ideal for this experiment. The qual panel is a factory-tested unit from the same lot as the flight panels; any results translate easily to the spacecraft test. Being a non-flight spare panel, testing can occur outside of a cleanroom environment, with plenty of space and no major concerns regarding damage or degradation. The team built a panel test fixture and mounted the whole assembly to an optical bench. Connections were provided measuring current and embedded-sensor temperature (Figure 7). Testing involved iterative adjustment of the lamp distance, focus, and on-time to find a combination of single-panel spot size and sufficient current, at a safe temperature. Table 3 shows the parameters the team chose for a safe system test: [7]

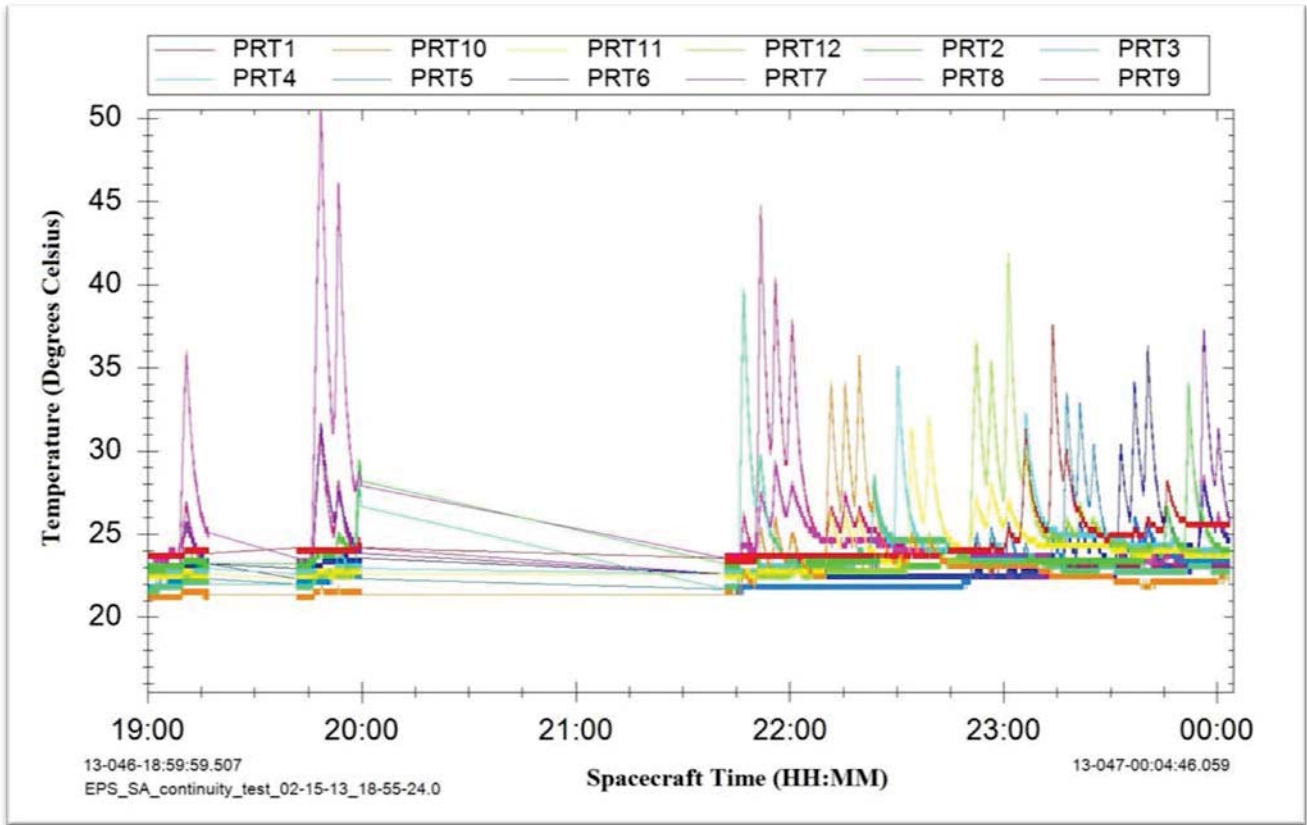
Figure 10: Solar Array Test Temperatures

The first test occurred just after final observatory integration, and was straightforward to execute. The test time was about four hours, and required three staff to operate. The EPS-4 295W requirement was not met due to de-rating the lamp. Figures 9 and 10 are time series of all panel currents and temperature sensors during the test.

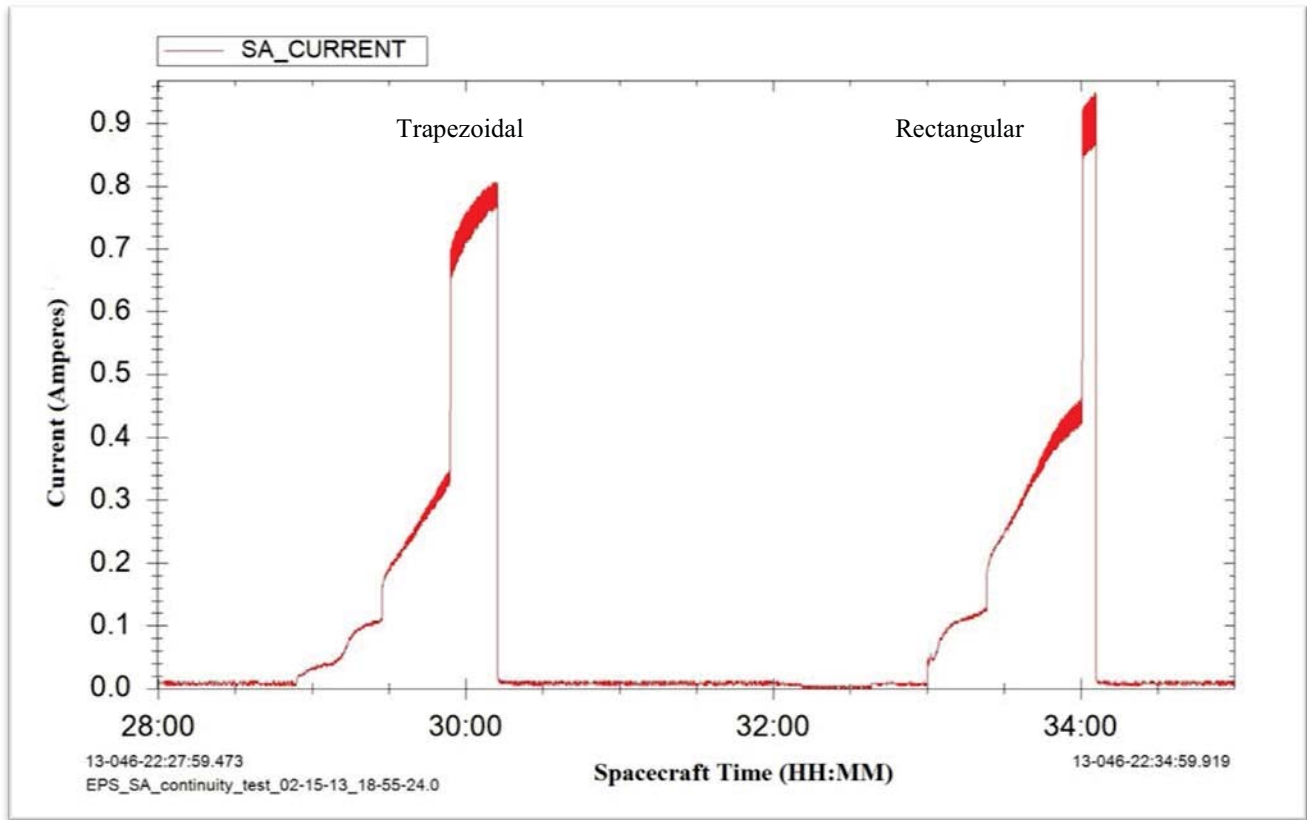
Figure 11: Typical Current Signature

Figure 11 shows a typical ‘step’ current signature for each panel type. Note the signature shows evidence that the lamp warm-up persists beyond one minute. All panels measured above the 0.5A requirement, with most between 70-75% of maximum. Typical panel temperatures hovered around 45° Celsius (Figure 12), with the hottest at about 59° Celsius. The test was considered a success, and LADEE Risk #87 was subsequently closed.

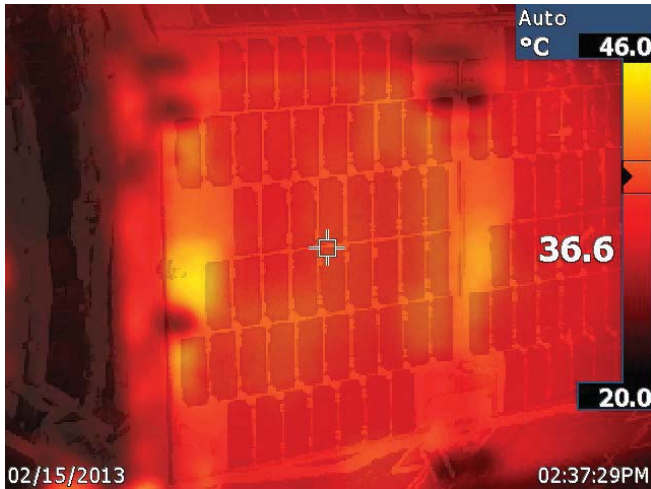
Figure 12: Infrared Image of a Panel during Test

to the first flight test. Though the metal-halide bulbs better approximate the sunlight spectrum, they still generate infrared. Both the panel and surrounding flight hardware require real-time monitoring to prevent thermal-related damage. Only 40% of the LADEE panels carry embedded temperature sensors. To maintain hardware safety, the test requires use of a calibrated, handheld thermal imager. The specific imager used (Fluke Ti25) is essentially an infrared digital camera. The entire panel can be monitored and saved for offline analysis. The test limit for panel temperature is 70° Celsius, driven by the mounting bushings. This proved good for nominal safety measurements, but limited for precision use due to surface reflections.

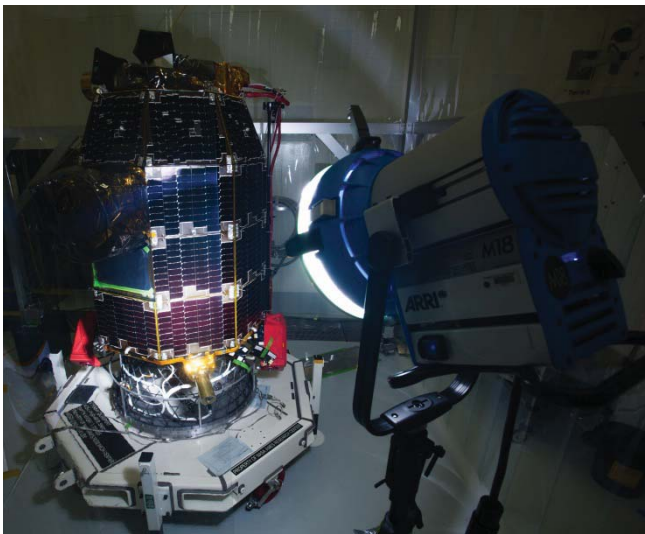
Figure 13: Final LADEE Test

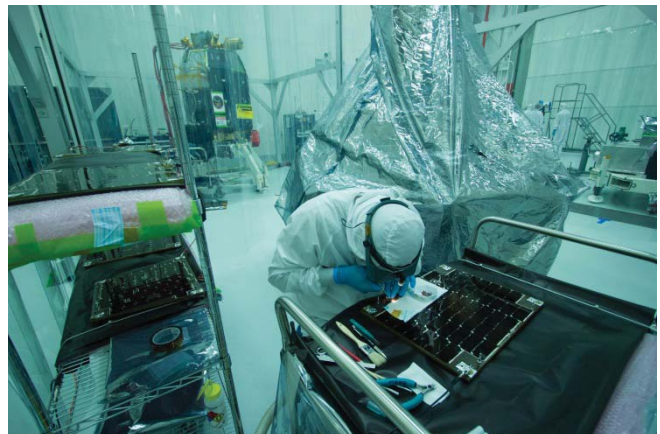
Figure 15: Cell Repair at the Launch Facility

Island, the repair team was able to fix all affected panels with no issues (Figure 15). The simplicity, portability, and ease of operation of the lamp test fixture made it easy to re-evaluate all repaired panels prior to launch. Note the inspections and final test were not part of the project's original (observatory-LAPSS test) plan.

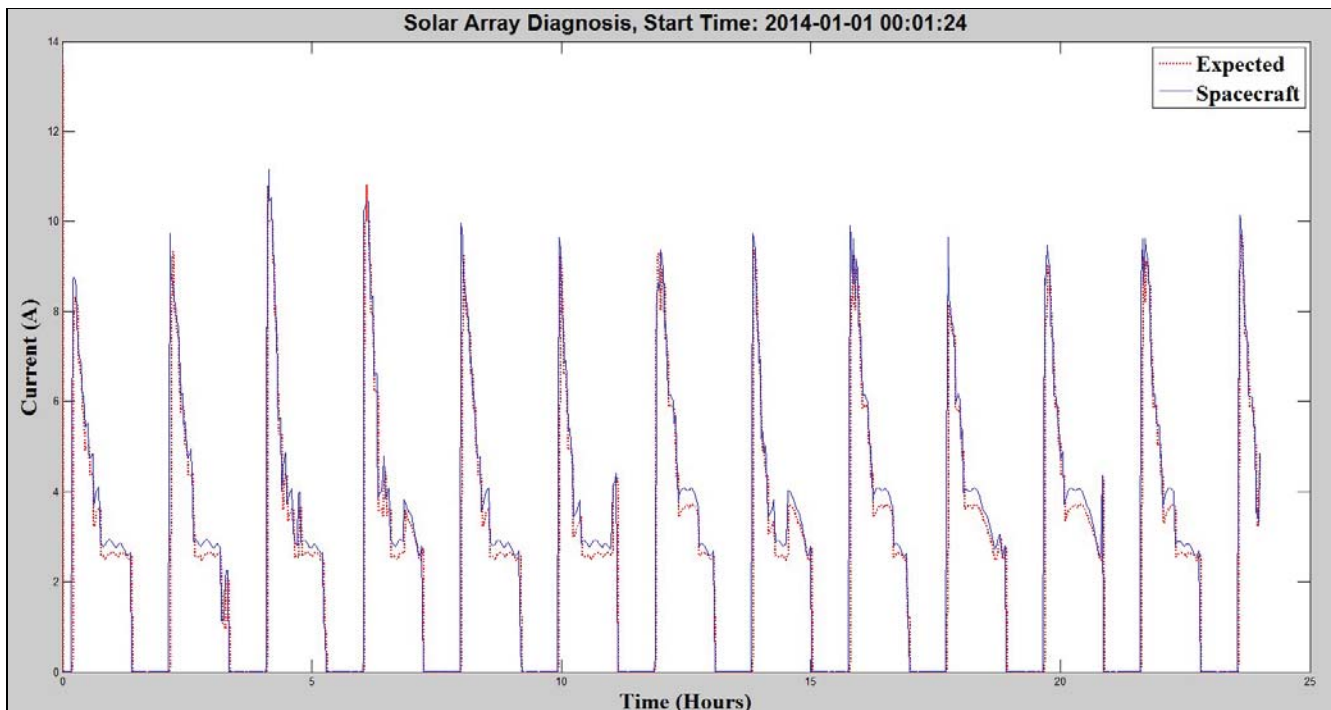
Figure 16 – Mission Operations Tool Overlays Expected and Actual Generated Array Current

During Operational Readiness Training (ORTs), the LADEE EPS team developed a method to evaluate panel performance throughout the mission. The approach illuminates the interdisciplinary nature and value of mission operations experience, even for the hardware designer. In this case, the ORT campaign engendered collaboration between the EPS and Guidance, Navigation, and Control (GNC) teams that led to a solution. The EPS team discovered that the GNC system design includes calculation and storage of the spacecraft sun vector as part of its attitude determination process. As mentioned, the EPS subsystem records the solar array current and number of closed switches. The EPS analysis tool simply combines the downlinked sun vector with the EPS data and a geometrical spacecraft model to determine an expected array current, and the derived error (Figure 16). Observation of the spacecraft over a combination of attitudes can be used to back out the behavior of individual panels, thereby updating the manufacturer's data.

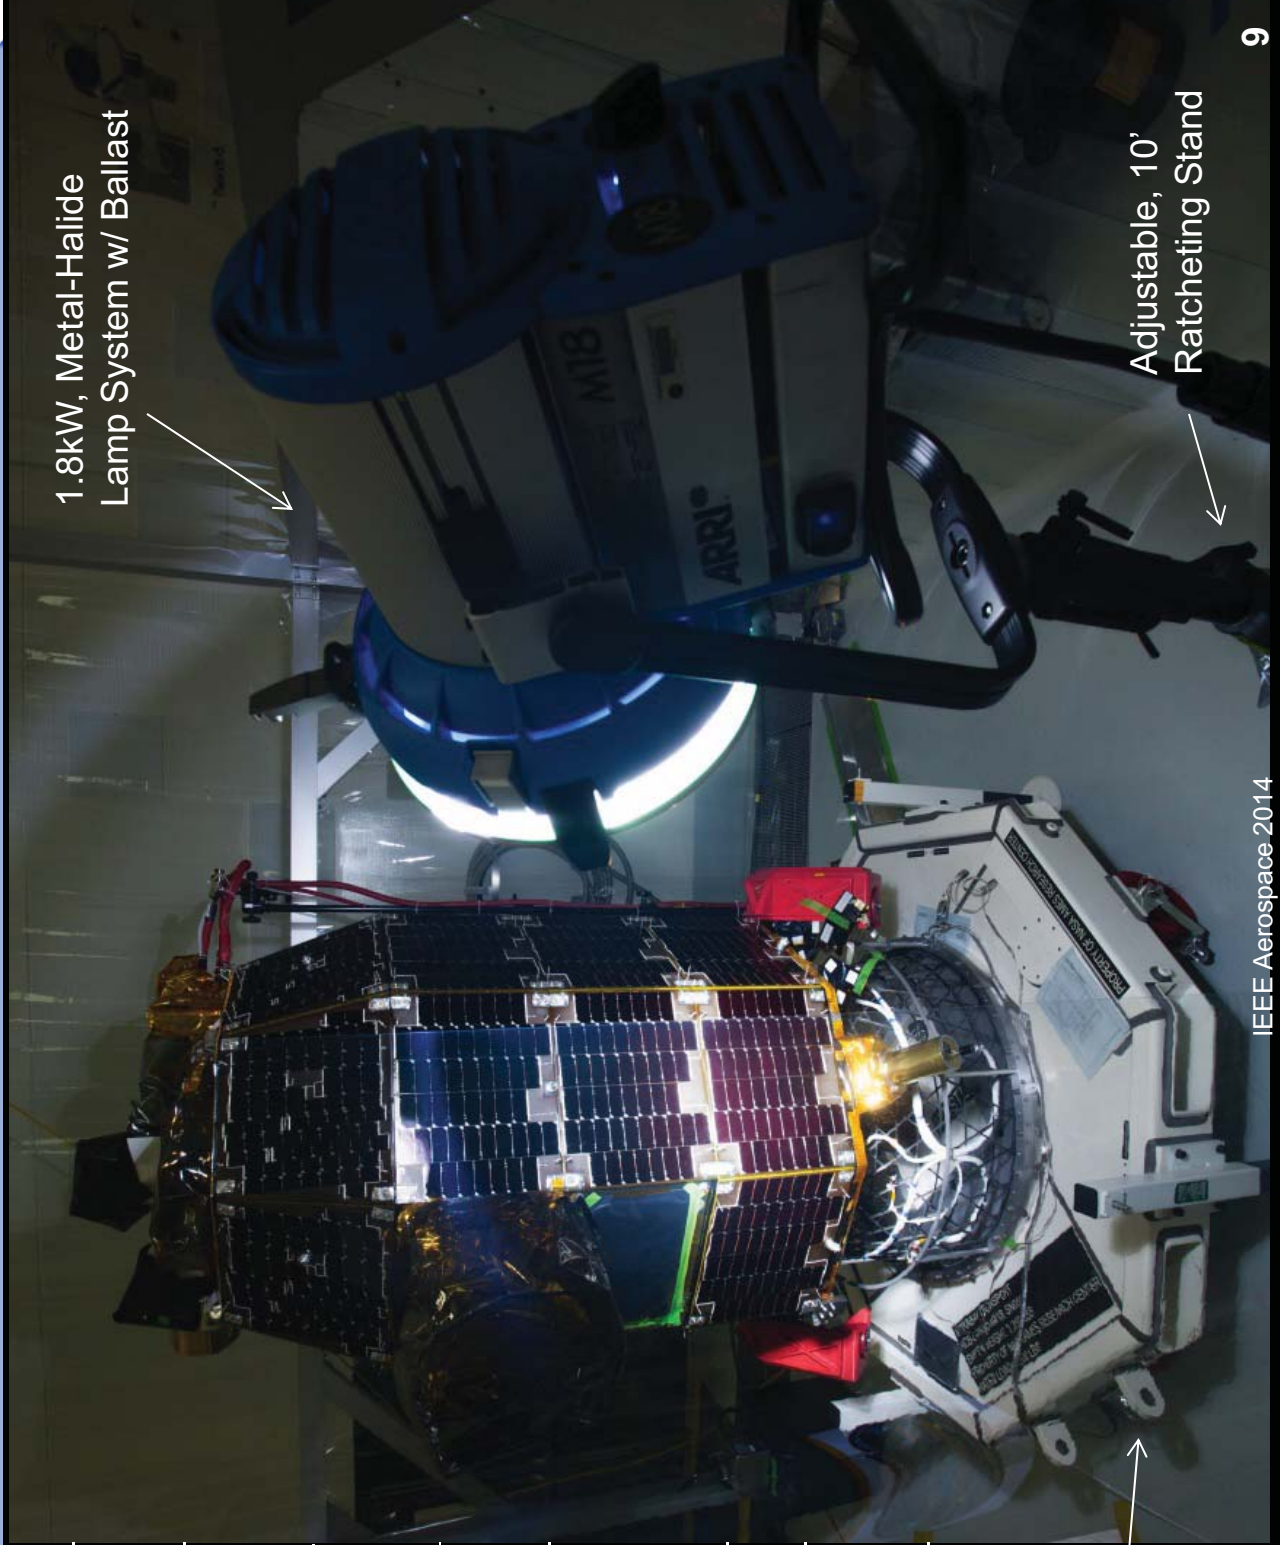
Observatory Test

295W req. verified!

Thermal imagers monitor temperature

ANSI z87.1 glasses protect from UV

Test repeated 3 times before launch

Easy to perform inside 10k clean tent

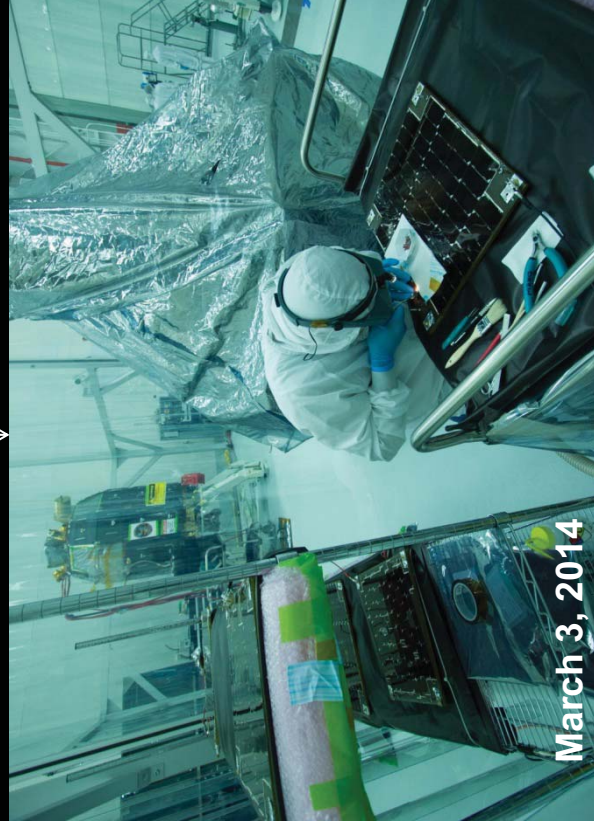
Avionics measures only one current for entire array – based on spacecraft attitude, can track each panel's degradation during ops

Launch-site panel inspection yielded 5 cracked cells – repair & retest at launch site!
