Accelerated Aging Experiments for Prognostics of Damage Growth in Composite Materials

ABHINAV SAXENA, KAI GOEBEL, CECILIA C. LARROSA, VISHNUVARDHAN JANAPATI, SURAJITROY, AND FU-KUO CHANG

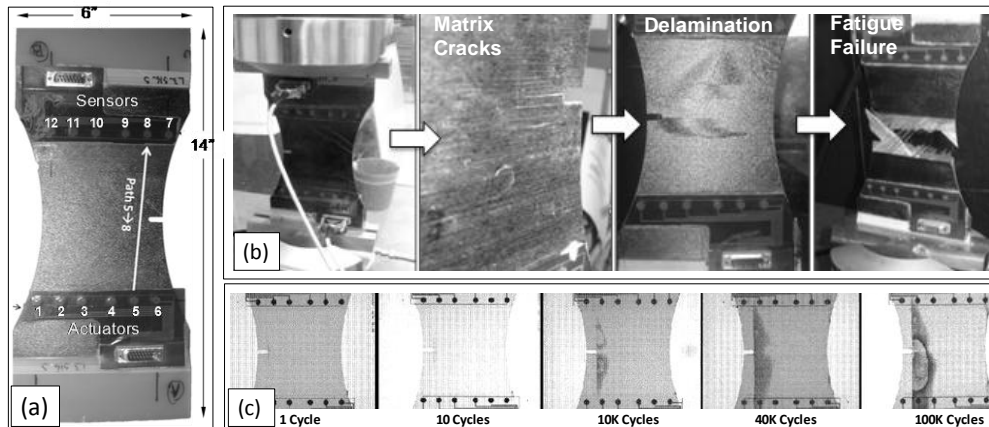
Figure 1(a) Coupon specimen, SMART Layers location, and diagnostic path from actuator 5 to sensor 8. (b) Development of matrix cracks and delamination leading to fatigue failure. (c) Growth in delamination area during the course of fatigue cycling experiment.

The fatigue cycling experiments serve several objectives– (i) ability to collect run-to-failure data with periodic system health data using health monitoring sensors, (ii) ability to collect ground-truth data for the damage to validate measurement data analysis, (iii) accounting variations between samples of same internal structure (layup), and (iv) characterizing variations between sample of different internal structures. Three symmetric layup configurations were chosen to account for the effect of ply orientation: *Layup 1*: $[0_2/90_4]$, *Layup 2*: $[0/90_2/45/-45/90]$, and *Layup 3*: $[90_2/45/-45]_2$. Torayca T700G uni-directional carbon-prepreg material was used for 15.24 cm x 25.4 cm coupons with dogbone geometry and a notch (5.08mm x 19.3mm) to induce stress concentration. Two six-PZT-sensor SMART Layer® from Acellent Technologies, Inc (Figure 1(a)). were attached to the surface of each sample. This configuration allows six actuators and six sensors to monitor wave propagation through the samples, Figure 1(a) shows one such path from actuator 5 to sensor 8 (path 5→8) that will be used as an example throughout this paper.

150-450 KHz, with an average input voltage of 50 volts and a gain of 20dB. These frequencies were selected so that the fundamental symmetric and anti-symmetric modes can be as distinguishable as possible based on the differences in their phase velocities. Static failure load (σ_s) was determined through static tests run-to-failure for two or three samples of each layup to determine maximum fatigue load (σ_f) that was set to 75-85% of σ_s . All tests were performed on an MTS machine with a load ratio (R) of approximately 0.14, following ASTM Standards D3039 and D3479 [11, 12]. The fatigue tests followed a sinusoidal load profile at a frequency of 5Hz. The fatigue cycling tests were stopped every 50,000 cycles to collect PZT sensor data for all paths and interrogation frequencies. X-rays of the samples were taken using a dye-penetrant to enhance X-ray absorption. The main goal of this test procedure is to be able to acquire sensor data as a function of damage progression; Figure 1(c) shows increasing level of damage in the X-ray images.

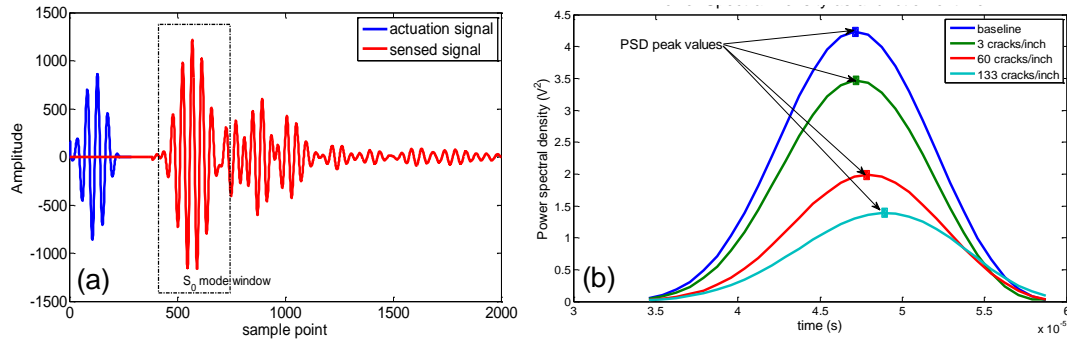
Figure 2(a) Isolating the first S_0 mode by windowing the sensed signal. (b) Change in Power Spectral Density curves with increasing matrix crack density.

sensor path lengths were used to approximate an S_0 mode window as shown in Figure 2(a). Following CIs were computed from the windowed signals.

Change in Power Spectral Density - Power Spectral Density (PSD) as a function of time for a given actuation frequency was extracted from Short Time Fourier Transform (STFT) for the signal. The peak value within the specified S_0 mode window decreases as a function of the matrix cracks that developed (see Figure 2(b)). Change in the PSD peak value normalized by the baseline PSD peak was computed. This feature, referred to as the Δ PSD throughout this paper, has been shown to correlate well to matrix micro-cracks on any given actuator sensor path [13].

Scatter Energy - Scatter energy measures wave energy dispersed into the medium along the path due to discontinuities and obstructions. Growth in delamination area increases the scatter proportional to the size of delamination. It is computed as the energy difference for the S_0 mode (Figure 2(a)) between the measured signal and the baseline signal (obtained initially in damage free condition). Normalized scatter energy is calculated as the ratio of scatter energy to baseline signal energy.

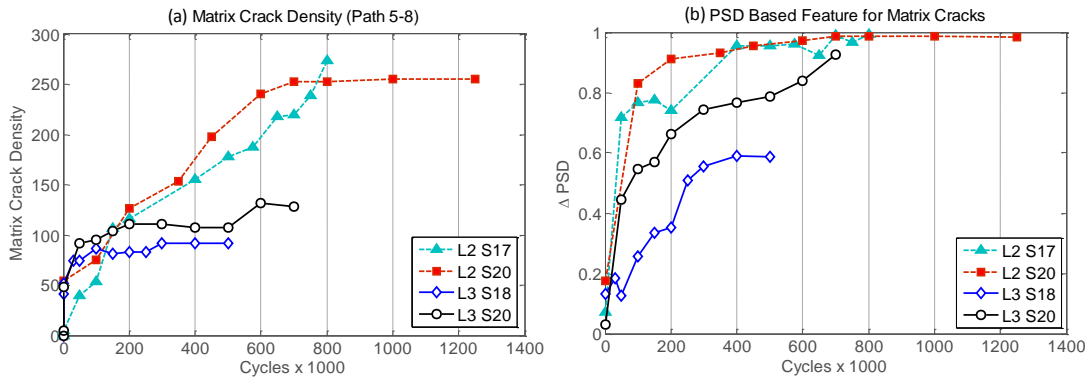
Figure 3. (a) Growth in matrix crack density as observed from X-ray images. (b) PSD based feature to track growth in matrix crack density.

In the search for increasing trends representing damage growth, several features were computed and compared to the trends obtained from X-ray analysis with increasing number of fatigue cycles. The X-ray analysis shows that matrix crack density grows very quickly initially and then flattens out for both layup types (Figure 3 (a)). The cracks grow rapidly again when the loads are ramped up; for instance at cycle 450K when load was increased from 6 to 7 kips for L3S20. The Δ PSD feature plotted in Figure 3(b) follows the same matrix crack density growth trends. It is also noticeable how the matrix crack growth difference between layups is captured by the Δ PSD.

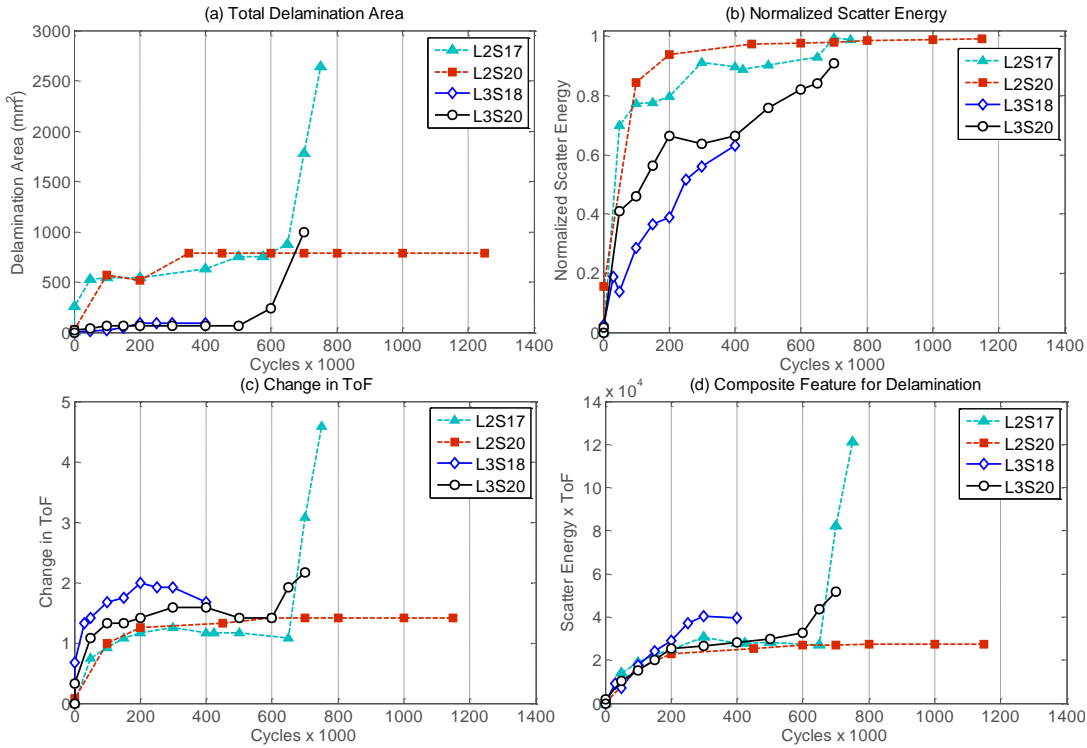
Figure 4. (a) Delamination area as observed from X-ray (b) Normalized scatter energy. (c) Time of flight and (c) Composite feature for delamination.

Figure 4 shows corresponding features extracted to track delamination growth. Figure 4(b) shows the normalized scatter energy through cycles for L_2 and L_3 layups. It was observed that the normalized scatter energy for L_2 Layup was relatively higher than that for L_3 layup, which is consistent with the delamination sizes shown in Figure 4(a), but the growth trend is not accurately captured. The change in ToF for L_2 and L_3 layups as a function of cycles is plotted in Figure 4(c). It was observed that the increase in ToF for L_3 Layup was relatively higher than that for the L_2 layup. This is due to the fact that in the case of L_3 layup, stiffness degradation comes from delamination at the $90/45$ ply interfaces and matrix cracking in the outer 90° plies. Whereas for L_2 Layup, the overall stiffness degradation is not as significant due to the presence of the 0° outer plies. Despite this mismatch, the monotonically increasing growth trends are observed, for example, L2S17 in Figure 4(a) delamination grows early, then flattens out and as the fatigue loading was ramped up after 600Kcycles, delamination increases significantly. From Figure 4(c) a very similar growth trend is seen in the change for ToF.

Even though these two parameters did not match well individually with the delamination area growth observed from the X-rays, they are promising as signatures of delamination growth trend. A preliminary study on combining these two features indicates that a composite feature such as a product of normalized scatter energy and Δ ToF (shown in Figure 4(d)) has well matching trends with delamination area growth. This composite feature shows good correlations to the trends observed in the X-rays for both L_2 samples (L2S17 & L2S20). Likewise for L_3 layups (L3S18 & L3S20) these trends look repeatable, for instance an increase in load at 600K cycles for L3S20 results in increased delamination area, which is also well reflected in the corresponding feature. However, the magnitudes of the delamination features do not correspond to the similar levels for the two layups, i.e. the feature shows similar values for very different magnitudes of delamination area. These differences could be attributed to several reasons that require further investigation: (i) difference in layup types, ($L_2:[0/90_2/+45/-45/90]_2$ vs. $L_3:[90_2/+45/-45]_{2s}$) and hence effect of delamination geometry and orientation on sensor signals, (ii) errors in the delamination area measurement from the X-ray images, especially if the delamination appears on different interfaces, which is not detectable from X-rays but still affects the signal significantly. Therefore, the layup type should be an important factor in interpreting the results and a good repeatability within a single layup type is desirable. Further studies need to be conducted to assess the accuracy of this composite feature.
