NASA/TM—2012-216027

# Addressing Machining Issues for the Intermetallic Compound 60-NITINOL

*Malcolm K. Stanford and Walter A. Wozniak  
Glenn Research Center, Cleveland, Ohio*

## Abstract

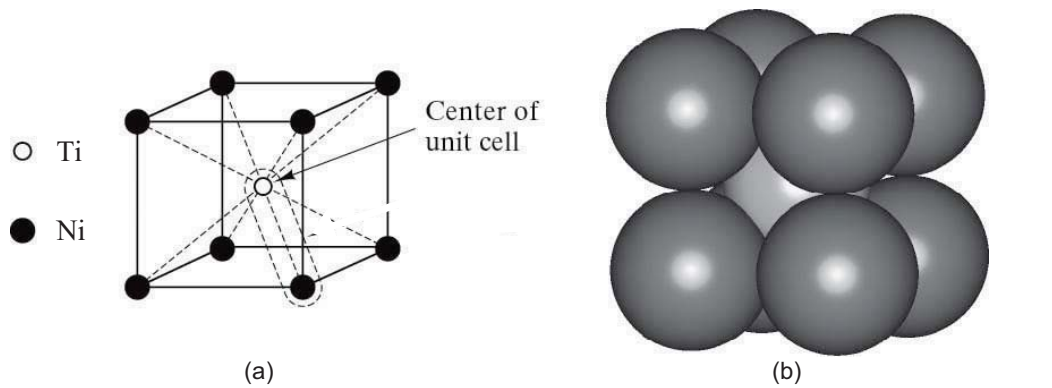
Figure 1.—60-NITINOL B2 unit cell showing (a) atomic arrangement and (b) relative size of atoms in the unit cell (Image generated with Materials Studio modeling package from Accelrys Software, Inc.).

60-NITINOL is an ordered intermetallic with the CsCl-type B2 crystal structure. In this arrangement, atoms of one type (i.e., Ni) are at the eight corners of a cubic unit cell and an atom of another type (i.e., Ti) sits at the center of the cube, as depicted schematically in Figure 1. Though composed of metallic atoms, the high degree of atomic ordering in this material causes it to behave more like a covalently bonded ceramic with intrinsic brittleness. However, this atomic structure also enables precipitation hardening that results in hardness equivalent to that of conventional bearing materials. This collection of unique properties gives this material a myriad of potential aerospace applications never before explored with intermetallic materials.

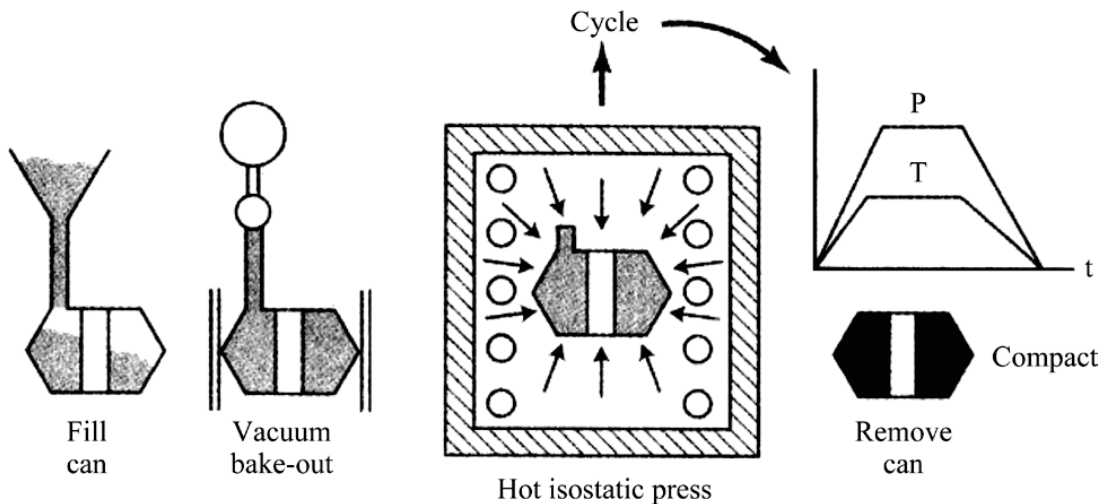
Figure 2.—Schematic description of the steps involved in the hot isostatic pressing (HIPping) process (Ref. 8).

The powder was consolidated into a compact by hot isostatic pressing (HIPping) as depicted in Figure 2. After HIPping, the cylindrical stainless steel container was machined away from the compact and the material was sectioned diametrically into slices approximately 6 mm thick. Blanks for inner and outer bearing races were subsequently sectioned from these slices. All of the machining was done by wire electrical-discharge machining (EDM).

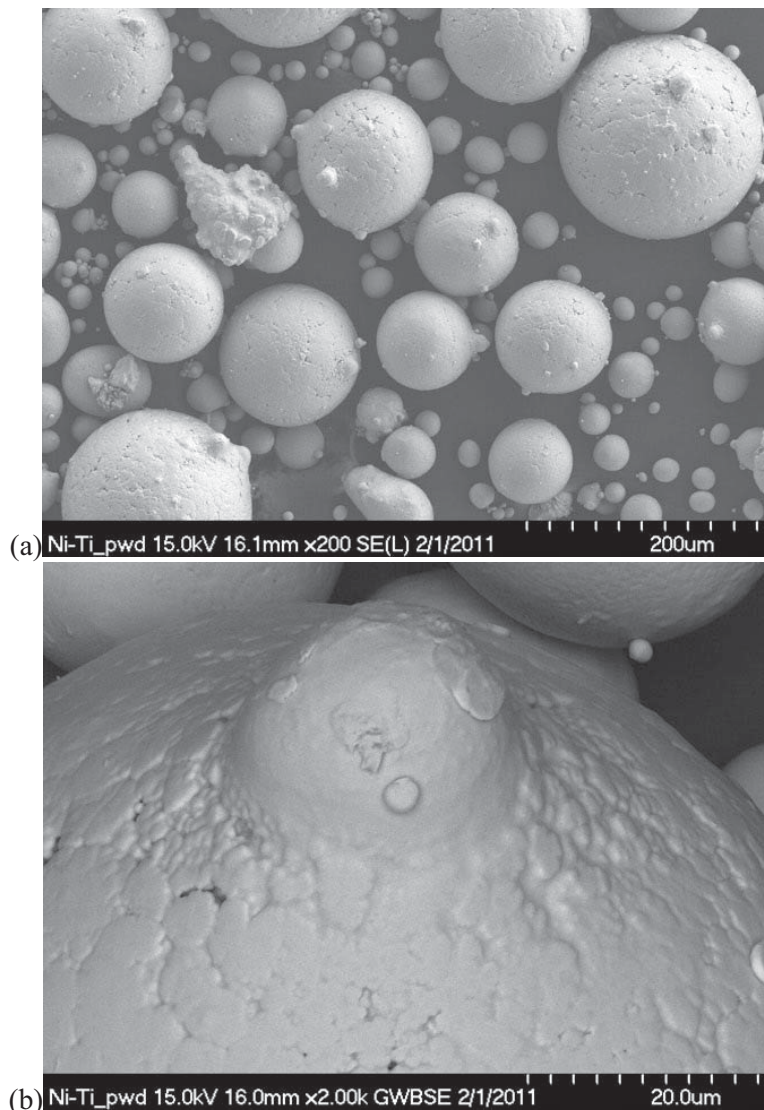
Figure 3.—Scanning electron photomicrograph of the 60-NITINOL powder characterized in Table I shown at (a) 200X original magnification and (b) 2,000X original magnification.

Scanning electron photomicrographs of the 60-NITINOL powder are shown in Figure 3. The generally spherical shape of the powder is typical of gas atomized powders. Some larger particles have satellites from where smaller particles impacted with them before they were completely solidified (see Figure 3(b)). There is also a small portion of irregularly shaped particles within the powder, which is not abnormal with this powder fabrication technique, though these particles are typically removed during the screening step. Images of powder particle cross-sections are shown in Figure 4. The remaining powder characterization data is listed in Table I. One important item to note is the relatively high level of oxygen, iron, aluminum and copper impurities.

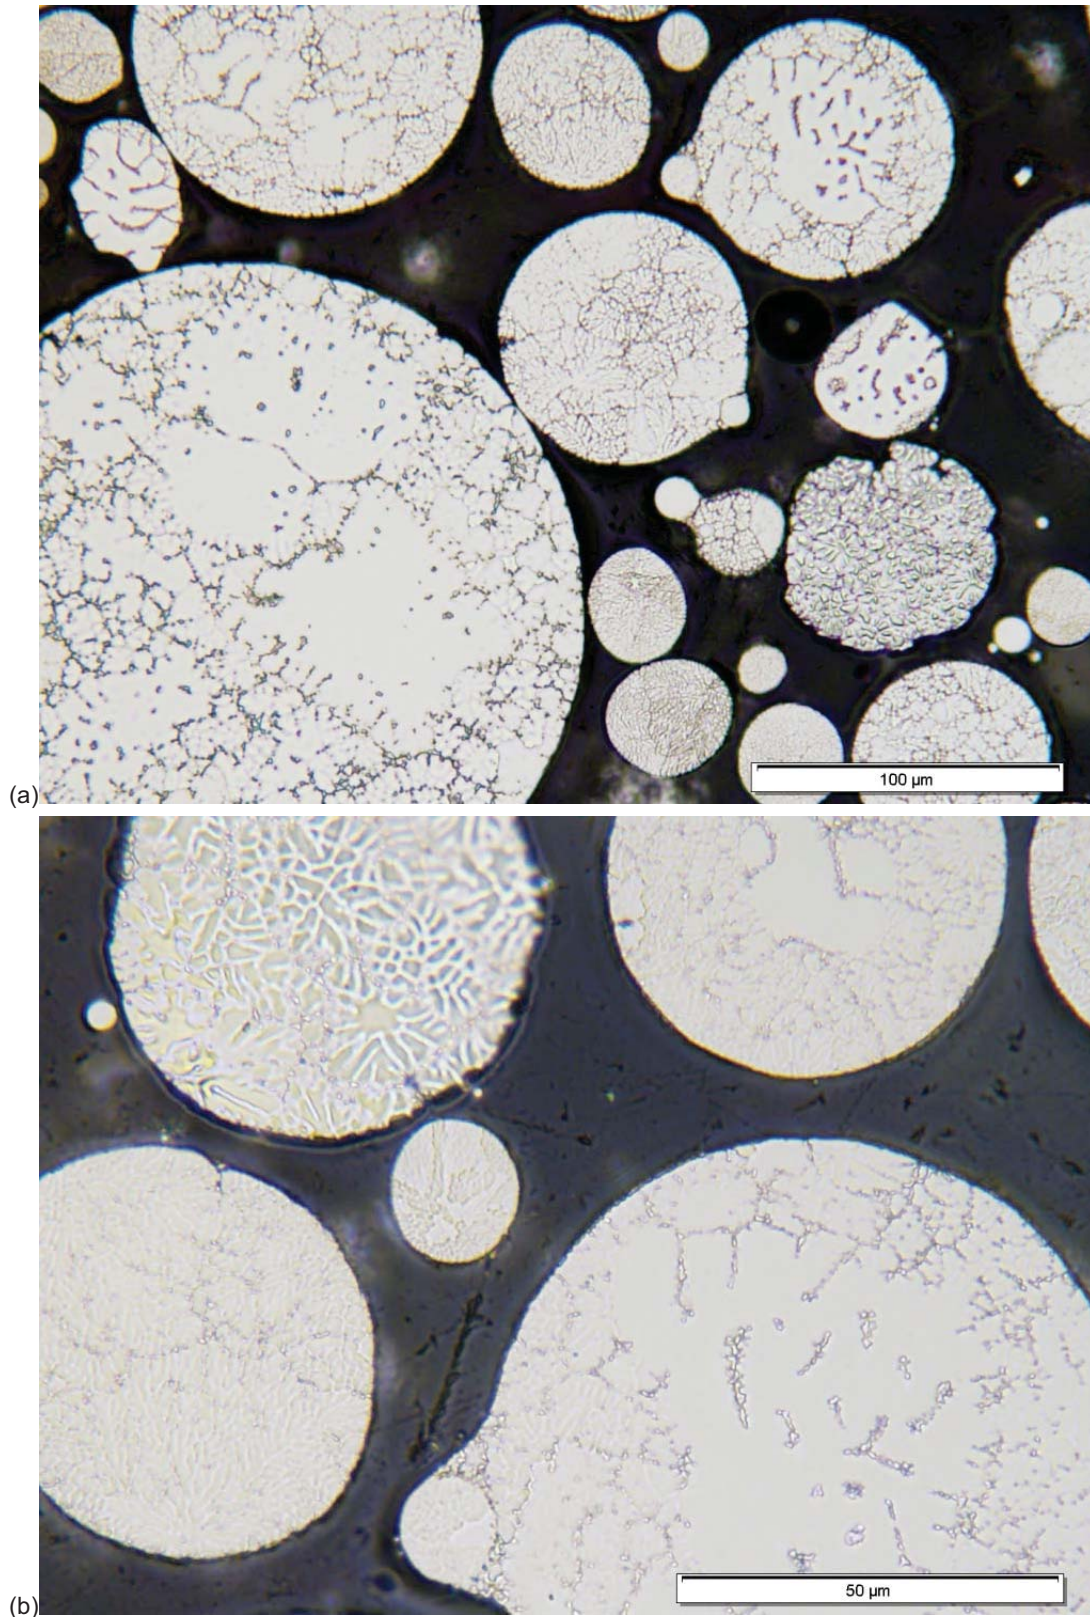
Figure 4.—(a) Optical photomicrographs of cross-sections of the 60-NITINOL characterized in Table I shown and (b) a higher-magnification image. The polished specimen was swab-etched with a room temperature solution composed of  $1\text{HF}+4\text{HNO}_3+5\text{H}_2\text{O}$ .

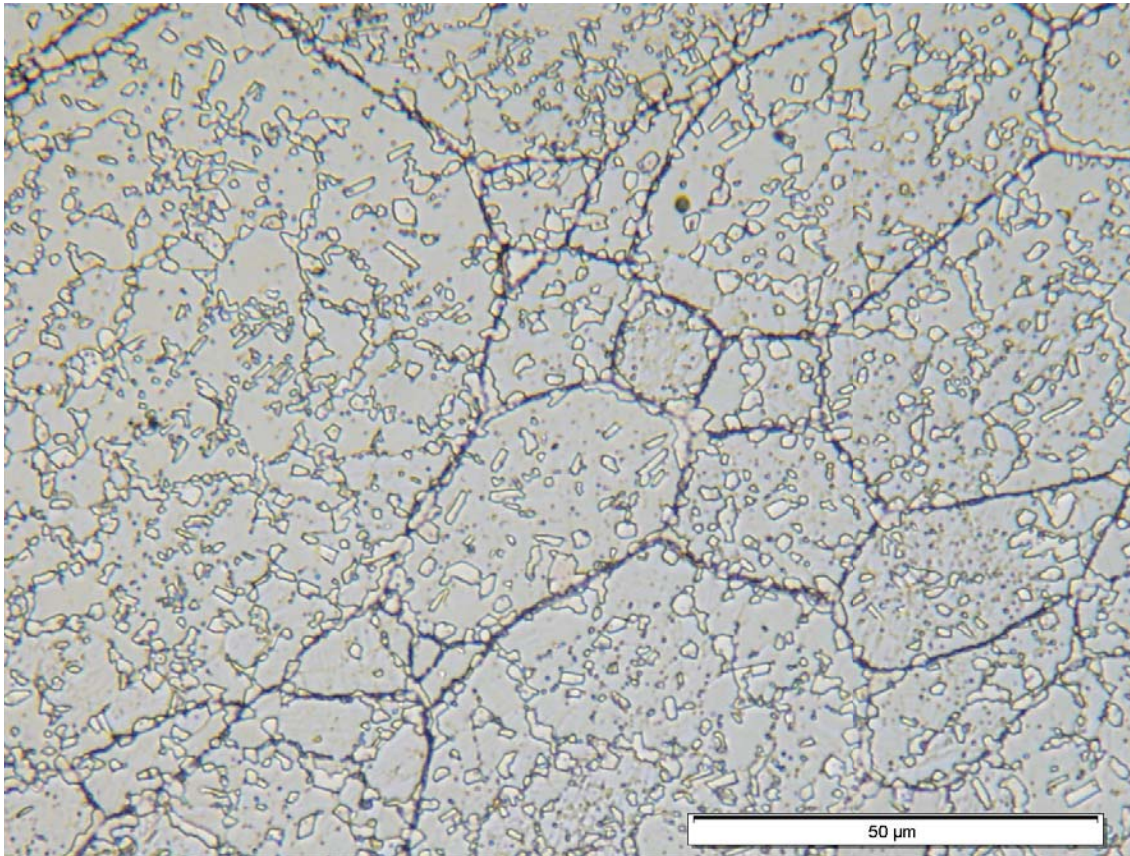
Figure 5.—Optical photomicrograph of 60-NITINOL compact after hot isostatic pressing. The polished specimen was swab-etched for 20 seconds with a room temperature aqueous solution composed of 10 vol.% HF and 5 vol.% HNO<sub>3</sub>.

XRD determined that the two phases present in the compact are cubic NiTi and orthorhombic Ni<sub>3</sub>Ti. The microstructure of the as-received HIPped 60-NITINOL material is shown in Figure 5. EDS was used to confirm that the parent phase is NiTi and the light grey second phase dispersed throughout the microstructure is Ni<sub>3</sub>Ti. The grain boundaries represent the prior particle boundaries. An SEM photomicrograph and an elemental dot mapping of the 60-NITINOL compact near the stainless steel HIPping can are shown in Figure 6. The can is visible along the left of the image. These images merely

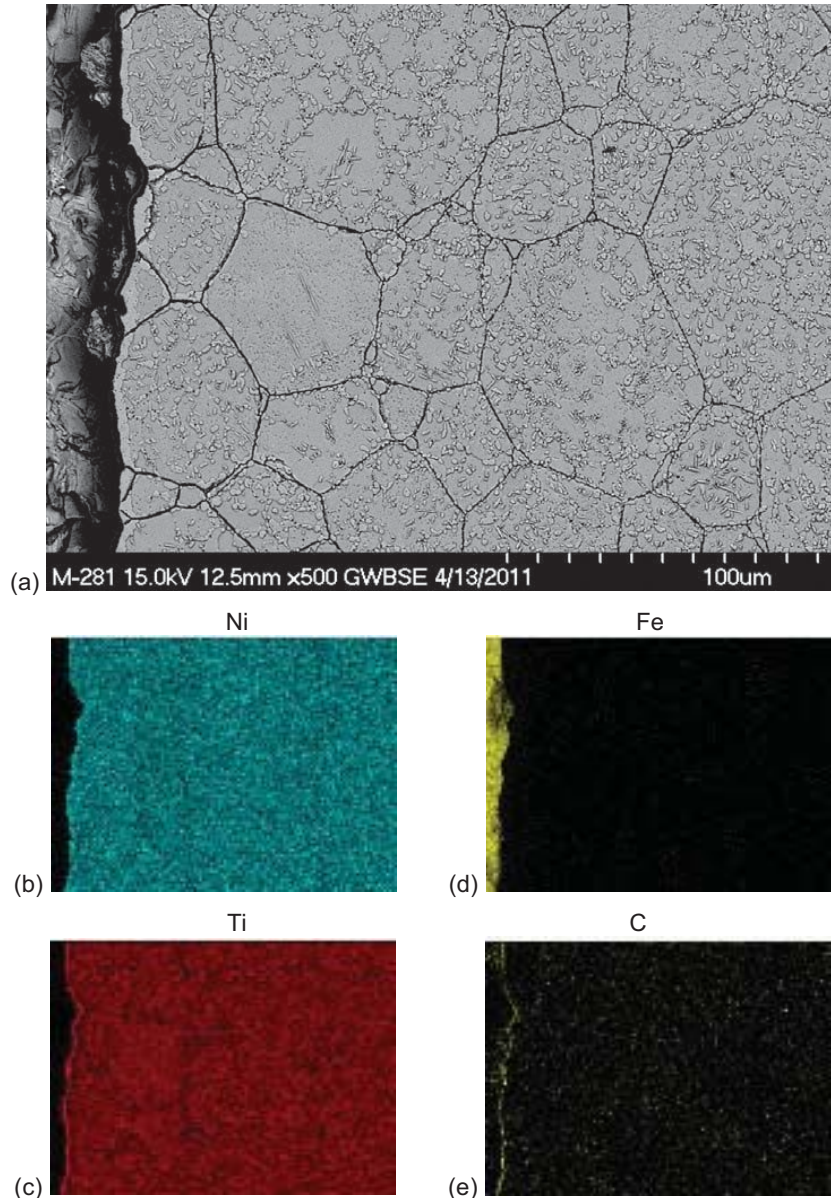
help to confirm that the composition of the material is uniform within the compact. Additional compact characterization data, including the bulk chemical composition, is listed in Table II. Again, the levels of oxygen, iron, aluminum and copper (detected at levels on the order of hundreds of parts per million) should be noted.

Figure 6.—(a) SEM photomicrograph of the 60-NITINOL compact near the stainless steel container (seen on the left of image) and (b) to (e) x-ray elemental dot maps from this image showing the major elements present.

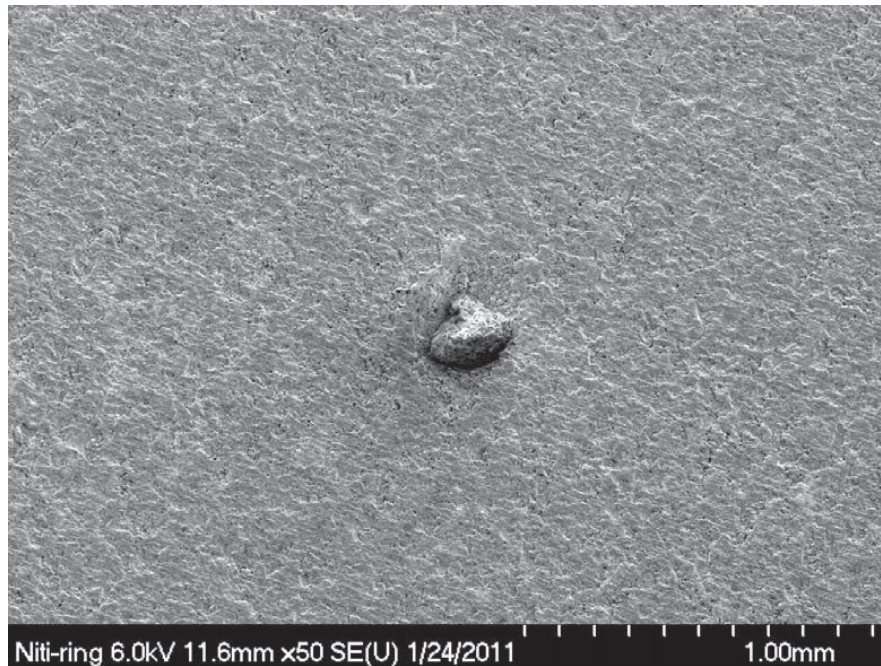
Figure 7.—SEM photomicrograph of an inclusion discovered on the inner diameter of an outer bearing race blank.

Upon closer examination of the irregularity suspected to be involved in an EDM wire breakage, it was identified as a particle embedded in the material (see Figure 7). As shown in Figure 8, the particle was composed of aluminum and oxygen. The ratio of these two elements indicates that the particle is aluminum oxide ( $\text{Al}_2\text{O}_3$ ). The particle was also splattered with a small amount of a copper alloy (brass), which was transferred from the EDM wire (see Figure 9).

This finding provides an opportunity to highlight an important issue. Due to the brittle nature of intermetallics, material cleanliness is extremely important. It is especially important to prevent ceramic inclusions because they tend to be hard and faceted, which makes them excellent crack initiators. Any tensile stress near such an inclusion could lead to a failure. This issue is discussed in a recent publication that addresses quench cracking of 60-NITINOL due to  $\text{ZrO}_2$  contamination (Ref. 9). The alumina contamination studied here was easily eliminated by modifying the HIP container preparation procedure.

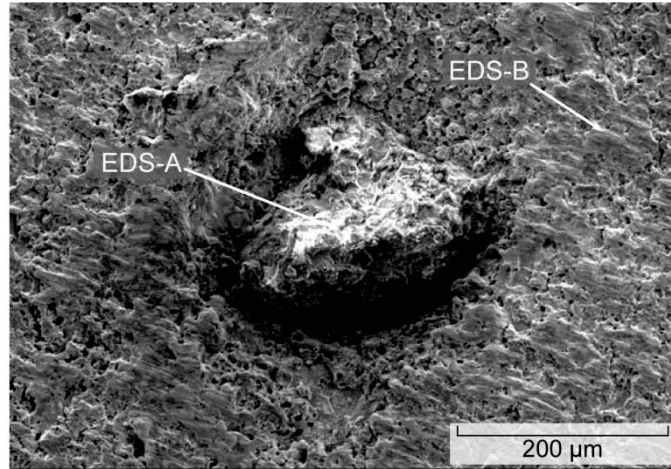
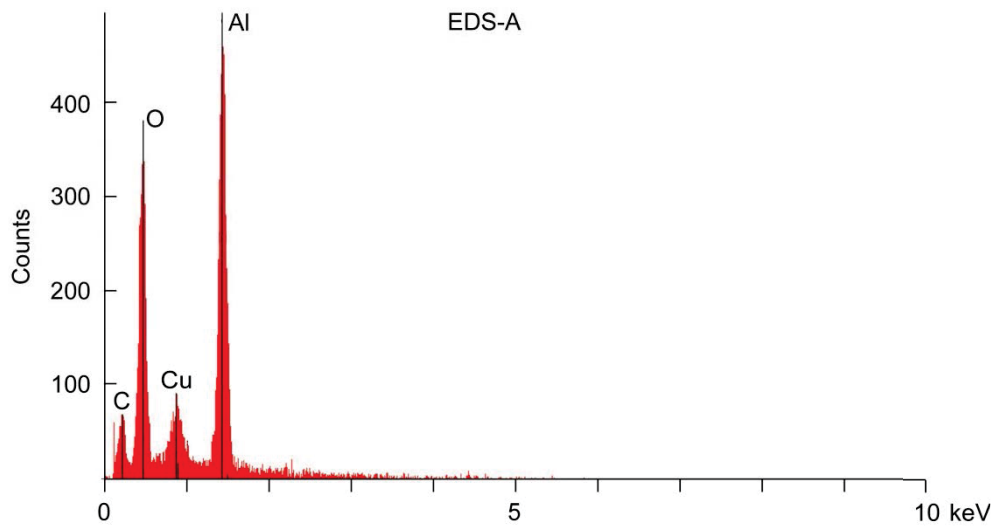
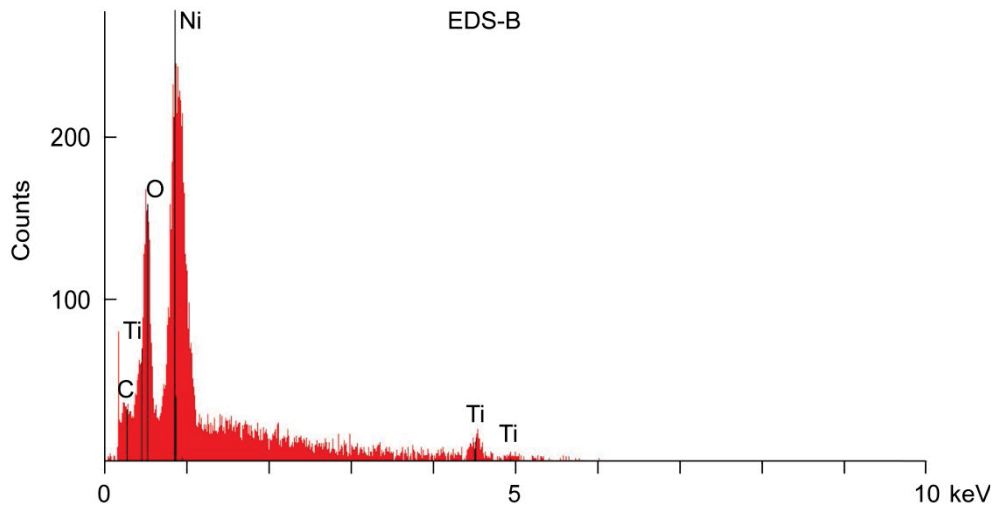
Figure 8.—SEM photomicrograph of the embedded particle. The first x-ray spectrum (EDS-A) indicates that the particle is composed of aluminum and oxygen in a ratio that follows the weight percentage of these elements in alumina. The second spectrum (EDS-B) confirms that the parent phase is 60-NITINOL.

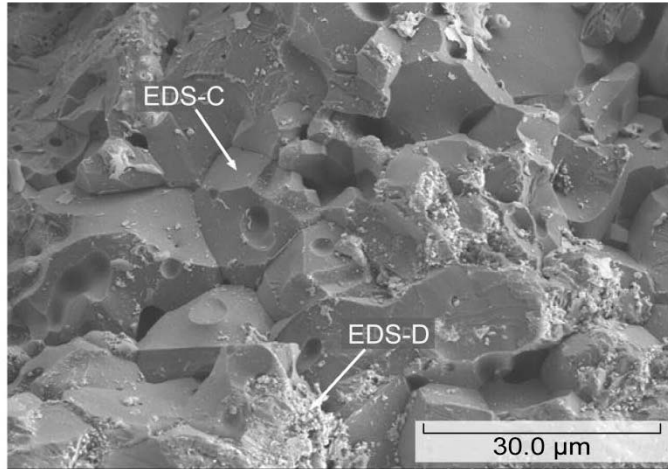
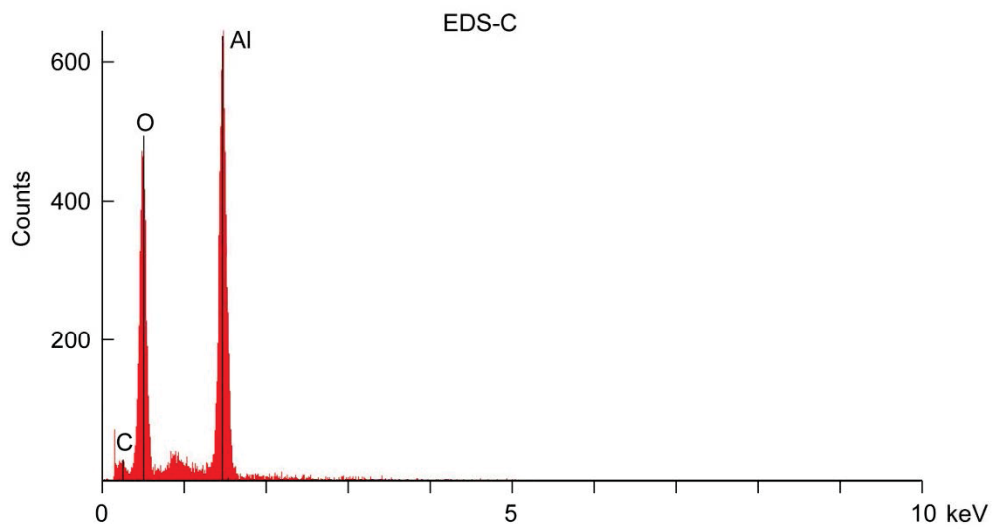
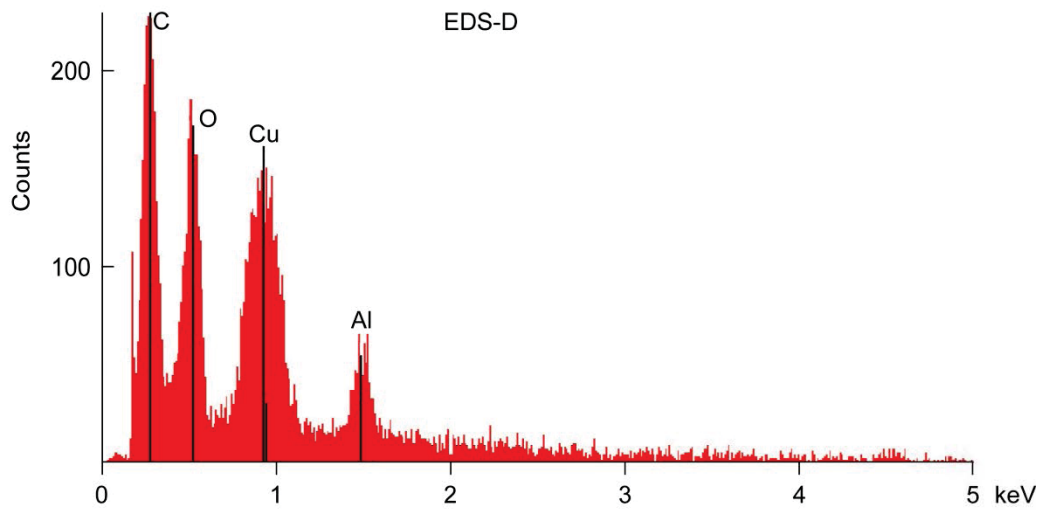
Figure 9.—SEM photomicrograph of surface of embedded particle shown in Figure 8 with EDS spectra indicating a composition of alumina (EDS-C) splatter with brass from the EDM wire (EDS-D).

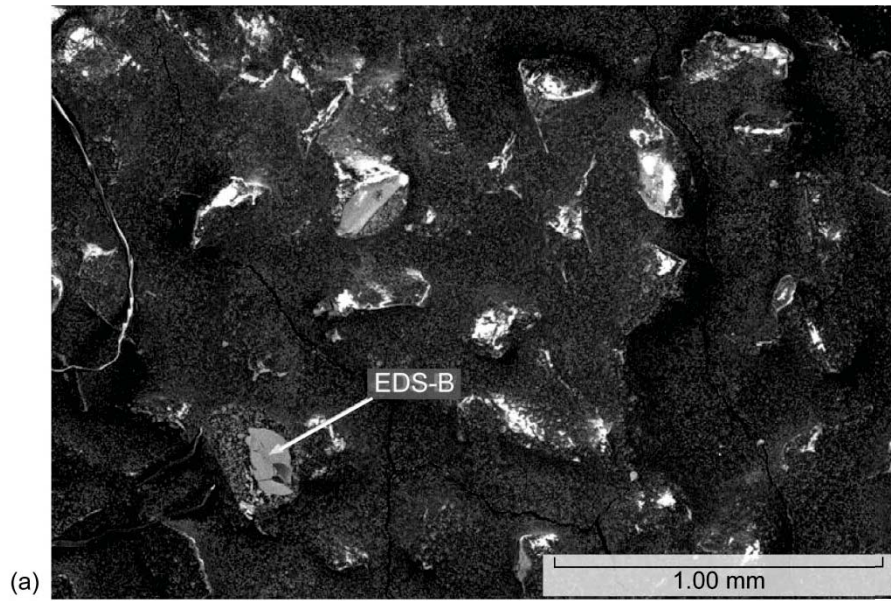
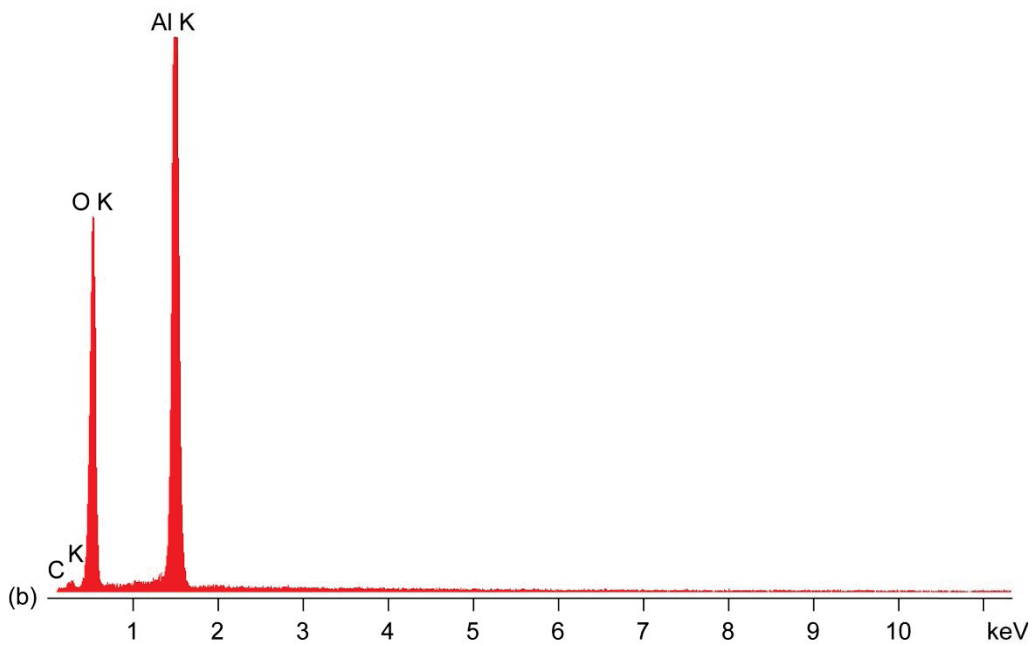
It was later discovered that an abrasive flap wheel had been used during the procedure used to prepare the HIP container. A sample of the flap wheel abrasive was obtained. The abrasive particles were found to be embedded in an adhesive material and then covered with a coating that allows the abrasive to be exposed gradually during its intended use. The coating was dissolved away with acetone to facilitate SEM analysis of the abrasive particles. Figure 10 shows the abrasive particles partially exposed through the coating. These particles are on the order of hundreds of microns in size and develop static charge when probed with the SEM electron beam. A typical x-ray spectrum of one of these particles (Figure 10(b)) indicates that they are indeed the same composition as the particle embedded in the 60-NITINOL (namely,  $\text{Al}_2\text{O}_3$ ). This partially accounts for impurities detected in bulk chemical analyses (i.e., Al and O). Clearly, the EDM wire breakage was caused in this case because the wire was unable to pass through this electrically insulating inclusion. This was most likely the case with most (if not all) of the other wire breakages.

Figure 10.—(a) SEM photomicrograph of surface of flap wheel abrasive paper showing abrasive particles partially exposed and (b) the EDS spectrum of one such particle as indicated in the figure.
