NASA/TM—2013-218091

# Calcium-Magnesium-Aluminosilicate (CMAS) Reactions and Degradation Mechanisms of Advanced Environmental Barrier Coatings

Prepared for the  
40th International Conference on Metallurgical Coatings and Thin Films (ICMCTF 2013)  
sponsored by AVS Advanced Surface Engineering Division  
San Diego, California, April 29–May 3, 2013

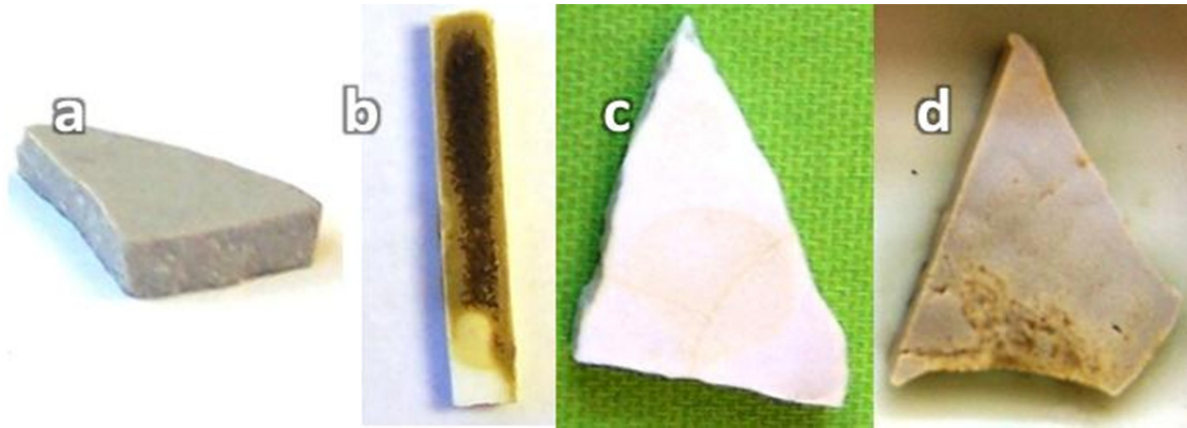
Figure 2.— $\text{Yb}_2\text{SiO}_5$  reacted with CMAS. Macro-photographs of  $\text{Yb}_2\text{SiO}_5$  specimens (a) as-sintered; and reacted with CMAS for (b) 5 h, (c) 50 h, and (d) 200 h. There is visibly much less of the reacted material on the 50 h and 200 h tested specimens, suggesting that the CMAS components may be highly volatile at 1500 °C in atmospheric pressure in air.

Figure 2 shows images of Yb<sub>2</sub>SiO<sub>5</sub> before and after CMAS reactions. The dark areas in the 5 h tested specimen (Fig. 2(b)) are Yb<sub>2</sub>SiO<sub>5</sub>-CMAS reaction products. There is visibly much less of this reacted material on the 50 and 200 h tested specimens, suggesting that the CMAS components may be highly volatile at 1500 °C and atmospheric pressure in air.
