Fatigue Crack Growth Behavior in the Threshold Region

R.G. Forman^{1, a*} and M. Zanganeh^{1, b}

¹NASA Johnson Space Center, Houston, Texas, USA

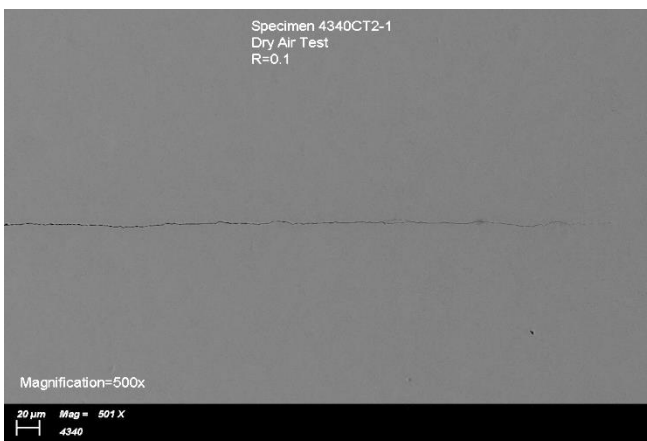
Fig. 1, Threshold region crack growth in a C(T) 4340 steel specimen tested at $R=0.1$ (501x mag).

Effects of Crack Tightness and Material Yield Strength. In the SEM investigations by JSC, such as shown in the 500X photo in Fig. 1, the photo shows that the threshold region crack in the AISI4340 steel specimen tested in dry air is seen to be very tight and straight when compared with the threshold crack in the 6156-T6 aluminum specimen shown in Fig. 2. Since the fanning in 4340 steel dry air tests was insignificant compared to that of the aluminum specimen tests, this illustrates that when a load threshold crack is straight and tight with very limited forking, no fanning behavior occurs in the threshold data.

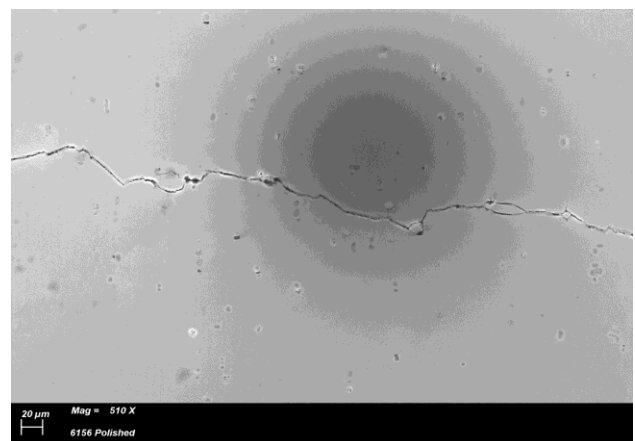
Fig. 2, Threshold region crack growth in an ESE(T) Al 6156-T6 specimen tested at $R=0.1$ (510x mag).

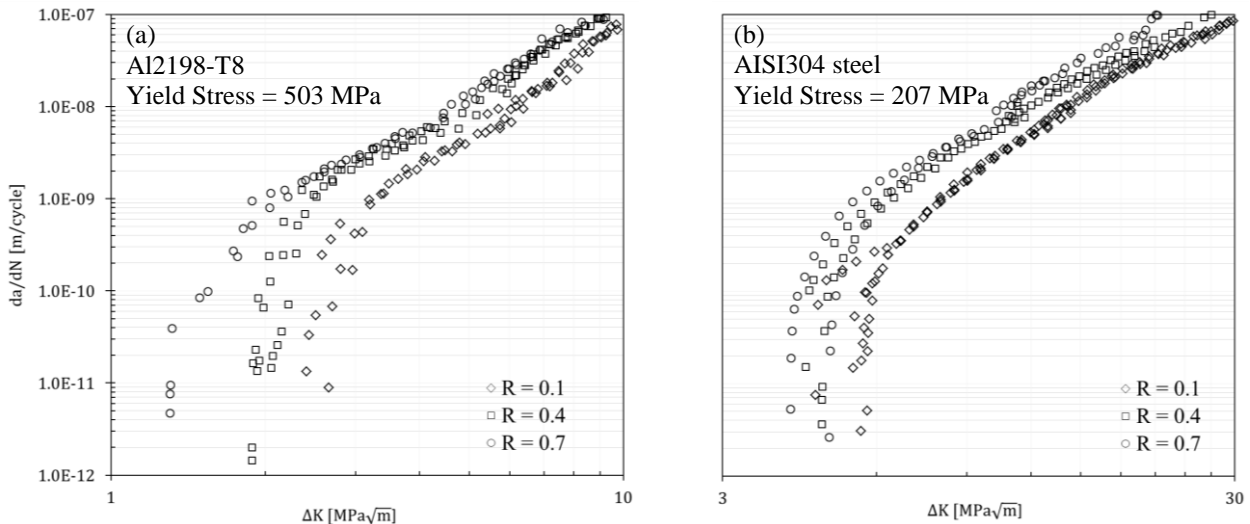
Fig. 3, ESE(T) specimen type FCGR data for (a) Al 2198-T8 in lab air with L-T grain orientation and (b) AISI304 steel in dry air with T-L grain orientation

Since plastic wake effects are believed by some to be the cause of fanning, materials with low yield strengths should have the greatest amount of fanning. To investigate this assumption, AISI304 steel and 2198-T8 aluminum (with yield strength of 207MPa and 503MPa) specimens were also tested. The results of these tests are shown in Fig. 3. This finding confirms that the plastic wake does not play an influential role in the fanning behavior observed for the aluminum alloys tested, but that the microstructure characteristics of a material is most important.

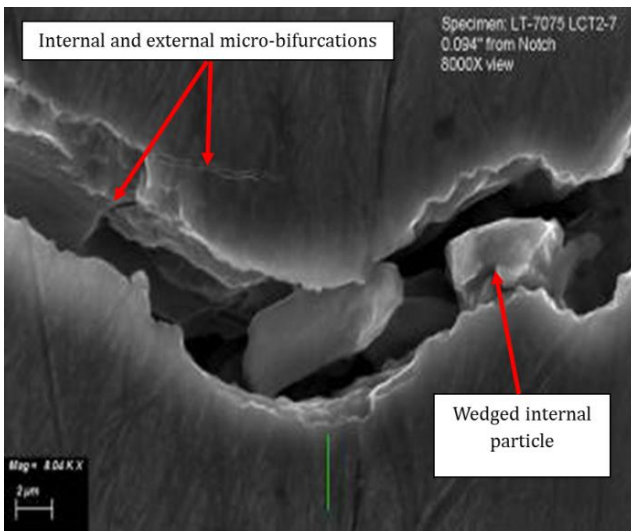
Fig. 4. Al 7075-T7351 specimen showing micro-bifurcations and internal debris (8000x mag).

Crack Closure From Internal Particles and Debris in Cracks. Another observation made for aluminum alloy specimens was the presence of debris particles that had broken loose from the crack surfaces. Upon investigation, certain specimens clearly had micro-bifurcations forming along the inside and outside area of the crack region, and in some cases these micro-bifurcations had led to small pieces of material breaking loose and being wedged in the crack. This occurrence was noted for both ΔK increasing and ΔK decreasing test types. Fig. 4 and Fig. 5 show an Al 7075-T7351 specimen for which this behavior was seen in a ΔK increasing test. The photograph of the specimen (Fig. 4) was taken at a point 2.4mm from the notch, which corresponds to an area of slow crack growth ($<2.5e-8$ m/cycle). This implies that micro-bifurcations and debris separation along a crack are independent of whether ΔK is decreasing or increasing, but rather depend on how slowly the crack propagates.

The fact that micro-bifurcations can be seen on the inner crack surface in Fig. 4 indicates that a number of debris particles may be present out of sight beyond the face of the crack. The number of particles generated by this type of fracture behavior can cause early crack closure and therefore cause significant fanning of data during fatigue crack growth testing. Wasén [7] also notes this

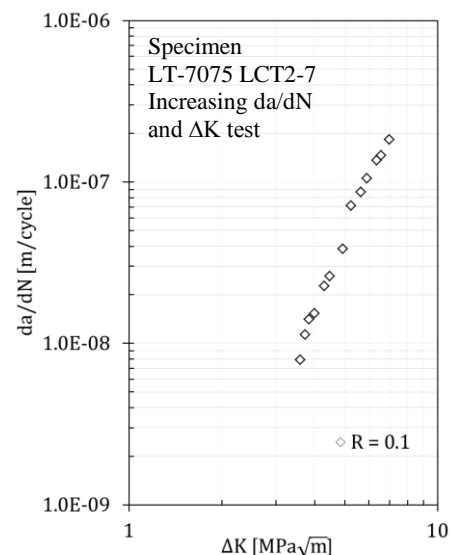
Fig. 5. FCGR data for Al 7075-T7351 specimen with micro-bifurcations and internal debris.

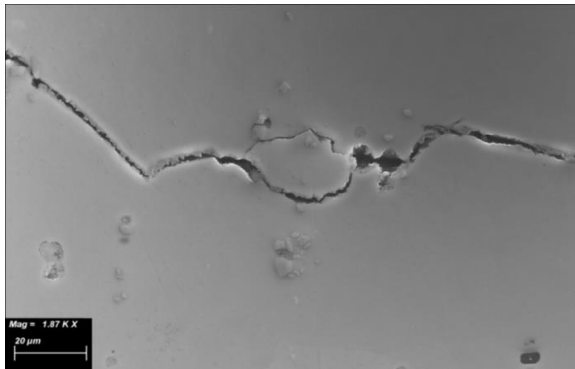
Fig. 6. Aluminum 6156 specimen showing sharp turns and particle separation (1870x mag).

Threshold Region Crack Bifurcations and Sharp Turns in Aluminum Alloy Specimens. A general characteristic observed in each of the different aluminum alloys tested was that extensive crack bifurcation behavior and sharp 90 degree turns occurred for crack growth in the threshold region. This behavior is shown in Fig. 6 and Fig. 7 and would have obviously caused localized contact points that would alter crack closure. This general behavior did not occur for the steel specimens where the cracks were much straighter.

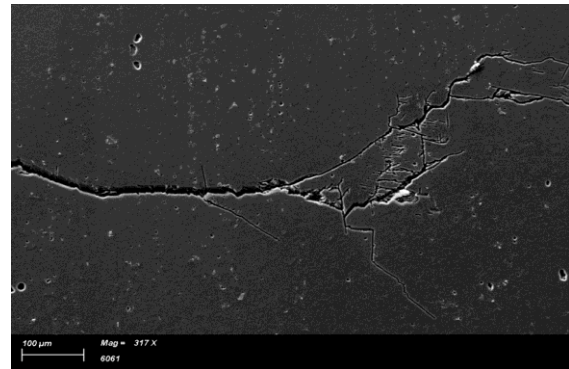
Fig. 7. Aluminum 6061 specimen threshold crack tip (317x mag).

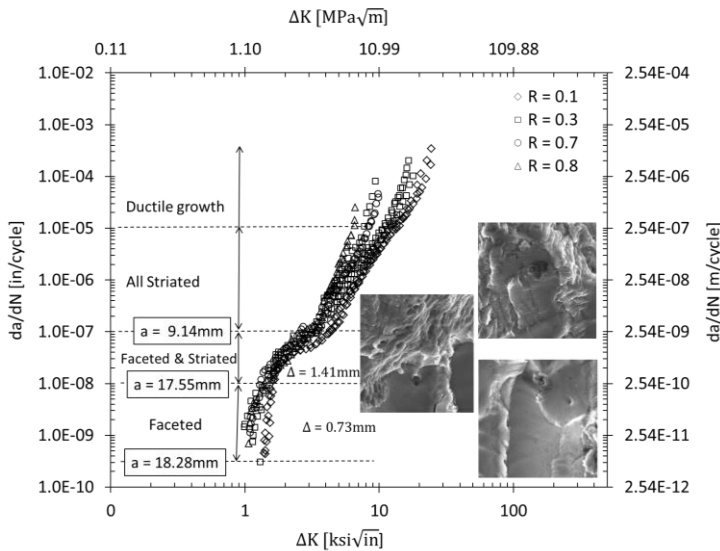
Fig. 8, Morphology transition for different crack growth rate regions in a 7050-T7451 aluminum specimen.

In the first SEM investigations of threshold test specimens performed at JSC, the studies quickly confirmed the change in crack surface morphology in the final threshold region of crack growth. The JSC results, shown in Fig. 8, also showed that the morphology change was dependent on the growth rate, and particularly when the crack tip yield zone size became less than the material grain size [8]. Also, the behavior was found to be the same at both $R=0.1$ and $R=0.7$ fatigue stress ratios. Since the fanning is highest for low R -ratio test data and the surface morphology is the same for both ratios, this confirms that the fanning is principally a function of the crack surface morphology and thus a function of the difference in closure between $R=0.1$ and $R=0.7$ load ratios.

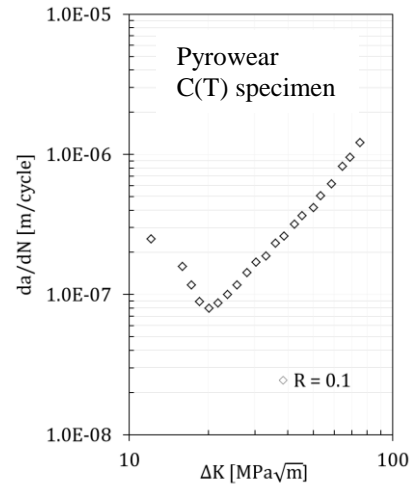
Fig. 9, Initial decrease in crack growth rate for an increasing ΔK test.

Fig. 9 shows this initial decrease in crack growth for a Pyrowear C(T) specimen that was tested in lab air. This caused the da/dN data to be invalid for a major portion of the increasing ΔK test phase. After understanding the cause of the problem, later tests procedures were changed to eliminate the problem. This was accomplished by extending the initial machined notch in a specimen by sawing about 1.27mm past the threshold crack tip with a 0.3mm thick razor saw. This worked very well because the simple straight notches were cut by 0.254mm diameter EDM wire
