NASA Electronic Parts and Packaging (NEPP) Hermeticity Task Overview

NEPP Program Task 13-294: Hermeticity Correlation Study

NASA MSFC/GSFC

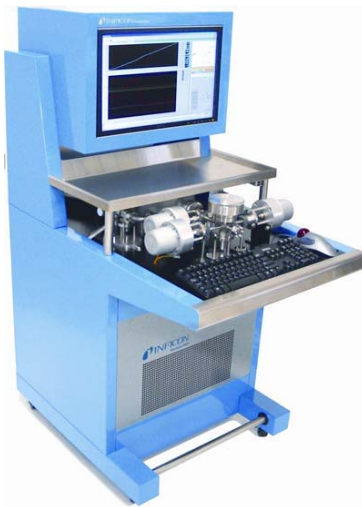
CHLD
(Pernicka 700H System)

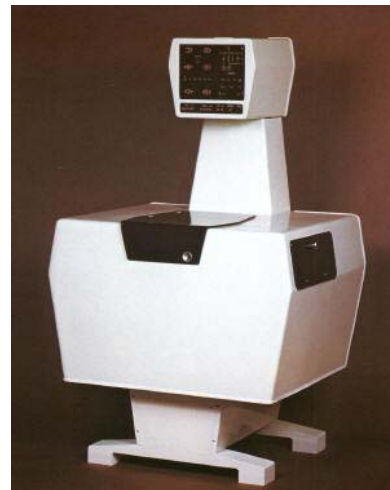
Krypton-85
(IsoVac Mark V Bomb Station)

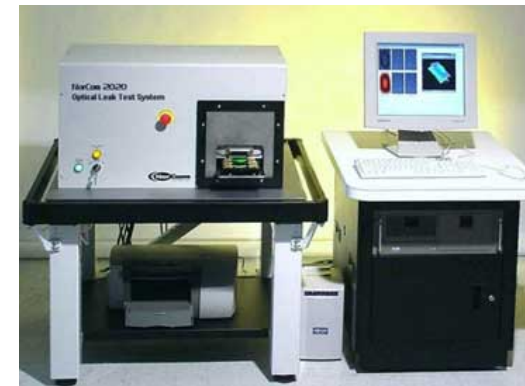
OLT System
(NorCom 2020 Optical Leak Test System)

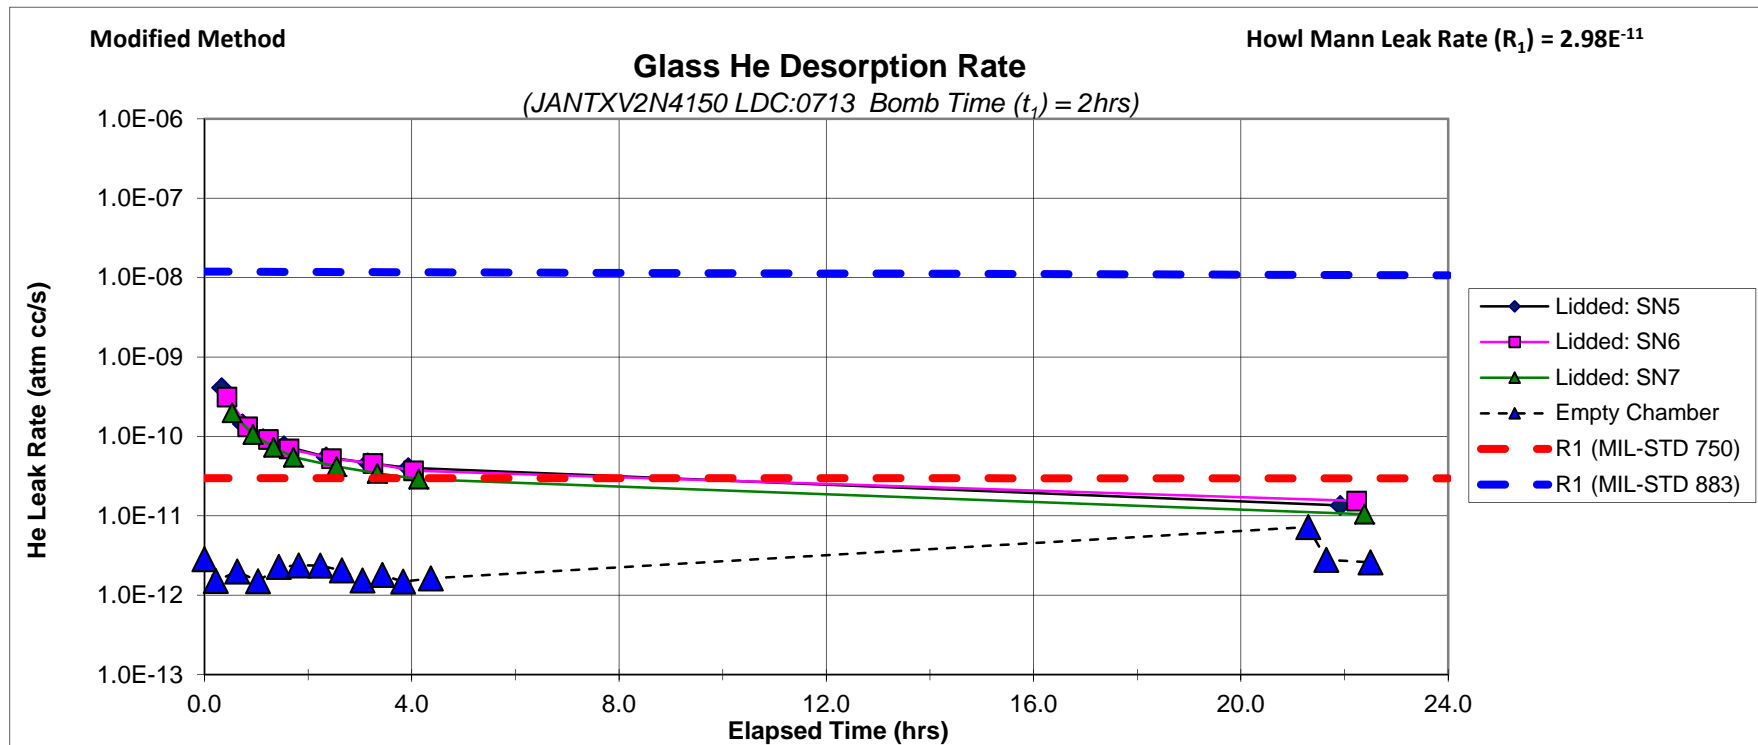
- **Three JANTXV2N4150 LDC0713 transistors tested**
 - L1 = 5×10^{-9} atm cc/s (air), Bomb pressure = 60 psig, Bomb time 2 hours, Volume = 0.22 cc
 - Howl Mann He leak rate limit for these conditions:
 - $R_1 = 2.98 \times 10^{-11}$ atm cc/s for 0 hour dwell time
 - $R_1 = 2.97 \times 10^{-11}$ atm cc/s for 24 hour dwell time
- **Glass He desorption rates (atm cc/s He)**
 - After ~4 hours: 2.90×10^{-11} to 4.03×10^{-11} (Empty chamber: 1.63×10^{-12})
 - After ~24 hours: 1.05×10^{-11} to 1.54×10^{-11} (Empty chamber: 2.59×10^{-12})

- MSFC purchased a CHLD system in 2008 that has the sensitivity to test to the tightened fine leak rate requirements of MIL-STD-750.
- MSFC discovered that glass feedthroughs exhibit different levels of surface desorption after He bombing resulting in false failures not evident prior to tightening.
- Therefore MSFC developed a method to characterize devices for desorption which allows the establishment of optimum bombing conditions while taking into consideration CHLD instrument sensitivity.
- As written the test method is inadequate to address this issue. MSFC will propose this change in the next revision.

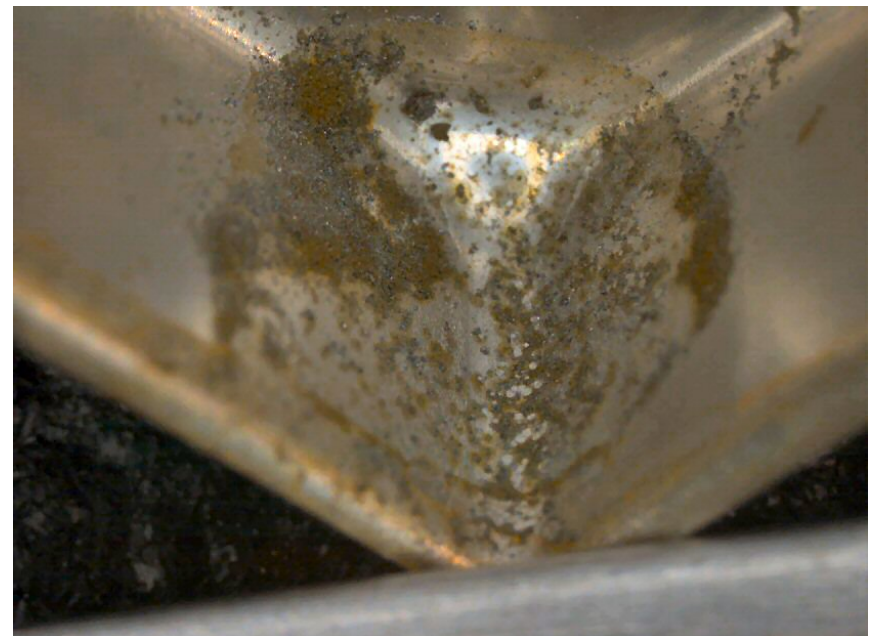
Sample M – Lid

Evidence of corrosion along the edge and inside corner of the device lid

- Crane Electronics identified a process control issue which resulted in an investigation of a subset of 3000 hybrid microcircuit devices. The devices were originally tested to MIL-STD-883 leak limits and passed. The devices were retested to MIL-STD-750 and numerous failures were discovered.
- Crane requested MSFC to support the internal inspection of four samples that had failed hermeticity and exhibited electrical parametric shifts.
- MSFC found evidence of corrosion and ionic contamination.
