# Flexible Metallic Overwrap Concept Developed for On-Orbit Repair of Space Shuttle Orbiter Leading Edges

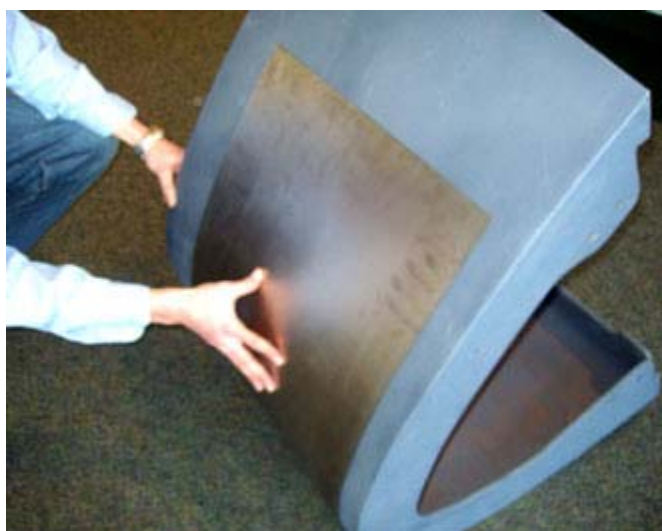
*Representation of concept for a refractory metal overwrap. Mockup of the space shuttle orbiter RCC panel 9.*

One possible idea for the on-orbit repair of the reinforced carbon/carbon (RCC) leading edges is an overwrap concept that would use a metallic sheet flexible enough to conform to the contours of the orbiter and robust enough to protect any problem area from catastrophic failure during reentry. The preceding photograph shows a simplified view of the application of a refractory metal sheet over a mockup of shuttle orbiter panel 9, which experiences the highest temperatures on the shuttle during reentry. The metallic overwrap concept is attractive because of its versatility as well as the ease with which it can be included in an onboard “repair kit.”
