High-Performance Acousto-Ultrasonic Scan System Being Developed

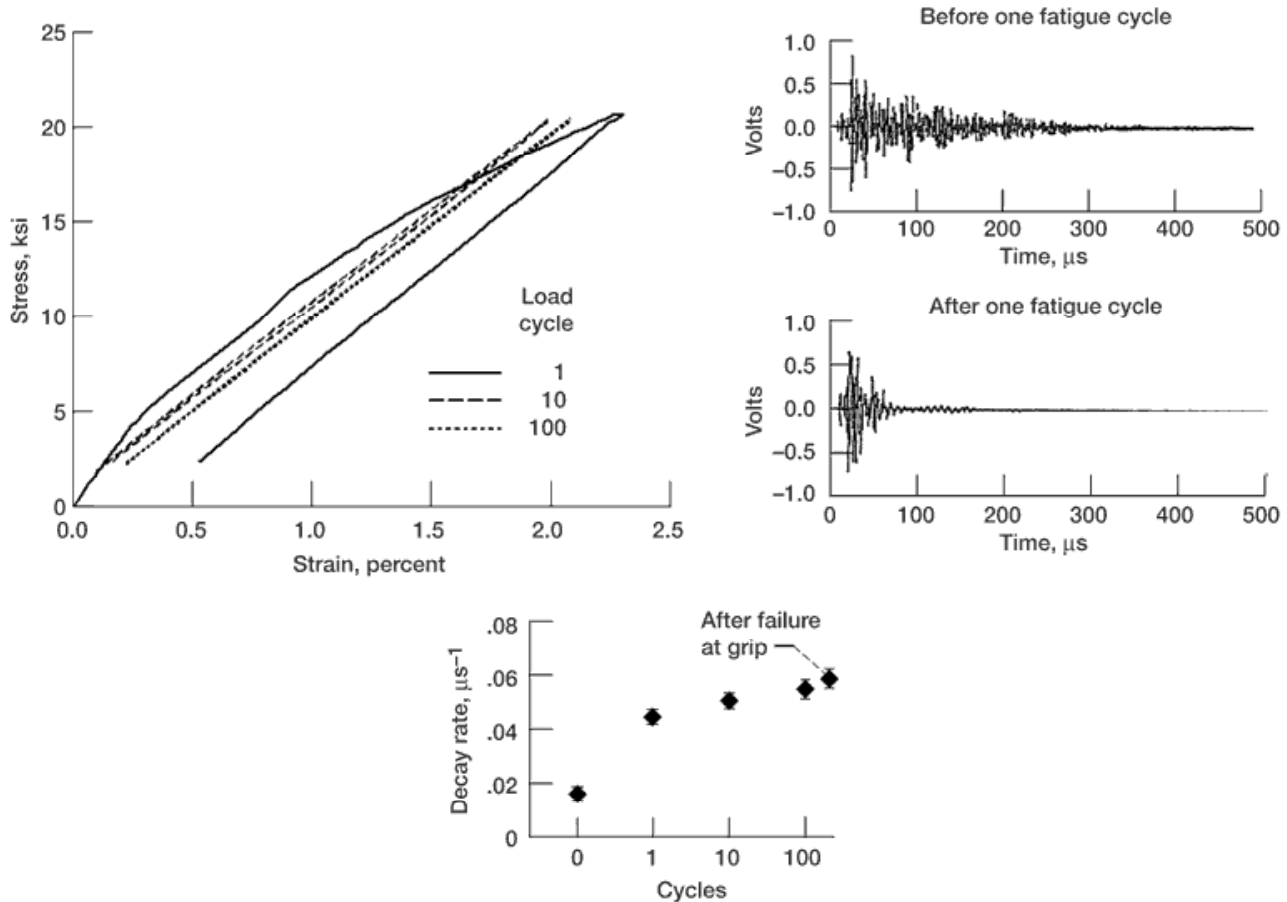
Top left: The stress-strain curves show the decrease in modulus (slope) with increase in strain upon application of the first cycle (note the curvature); subsequent fatigue cycle loading shows moduli similar to that after 1 cycle (note that the slopes of the different stress-strain curves are nearly parallel). Top right: Acousto-ultrasonic wavetrains before and after one fatigue cycle loading show a dramatic change correlating with the decrease in modulus. Bottom: Ultrasonic decay rate derived from waveforms in the top right graph shows a large increase after one fatigue cycle loading and only a moderate increase upon subsequent loading, in agreement with load curves in the top left graph.

One major success story at Glenn with AU measurements has been the correlation between the ultrasonic decay rate obtained during AU inspection and the mechanical modulus (stiffness) seen during fatigue experiments with silicon carbide/silicon carbide (SiC/SiC) ceramic matrix composite samples. As shown in the figure, ultrasonic decay increased as the modulus decreased for the ceramic matrix composite tensile fatigue samples. The likely microstructural reason for the decrease in modulus (and increase in ultrasonic decay) is the matrix microcracking that commonly occurs during fatigue testing of these materials. Ultrasonic decay has shown the capability to track the pattern of transverse cracking and fiber breakage in these composites.

The data in the figure were obtained over a small region of a specimen. Scanning capability would allow researchers and practitioners to focus in on exactly where damage is and is not occurring in samples and components that have been mechanically and thermally loaded. The AU scan system is planned to have both automated scan and interactive point measurement capabilities within one system. All functions will be automated with software interfaces replacing hardware instrument interfaces where possible. The scan capability is close to completion with regards to the basic operations of motion control, load control, data acquisition, online presignal and postsignal processing, and waveform data and image recording and saving. Currently, images of 18 different parameters (including ultrasonic decay) of the AU signal are formed in real time. Detailed system specifications are available upon request. We plan to develop the system to scan curved as well as platelike components.
