# Single-Crystal NiAl-X Alloys Tested for Hot Corrosion

Several single-crystal NiAl-X alloys (where X is Hf, Ti, Cr, or Ga) underwent hot corrosion testing in a Mach 0.3 burner rig at the NASA Lewis Research Center. Samples were tested for up to 300 1-hr cycles at a temperature of 900 °C. It was found that increasing the Ti content from 1 to 5 at.% degraded the hot corrosion behavior. This decline in the behavior was reflected in high weight gains and large corrosion mound formation during testing (see the figures). However, the addition of 1 to 2 at.% Cr to alloys containing 4 to 5 at.% Ti appeared to greatly reduce the susceptibility of these alloys to hot corrosion attack and negated the deleterious effect of the increased Ti addition.

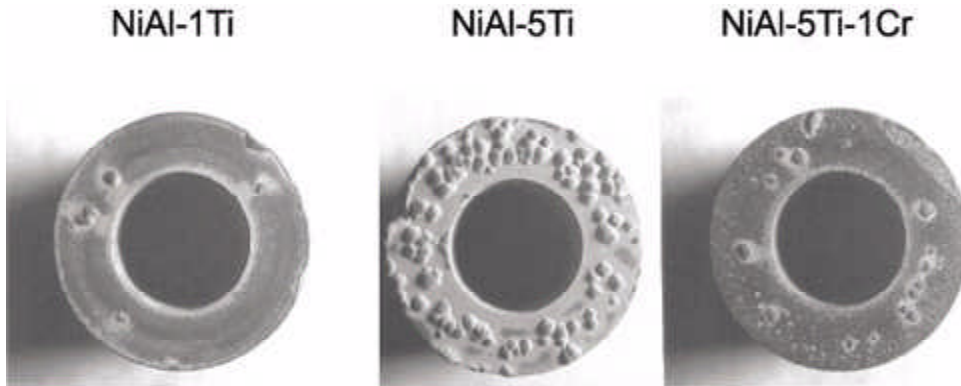
*Hot corrosion of three single-crystal alloys.*

After testing, the surface morphology consisted of either mounds or an inward, uniform attack that preserved surface features. The mounds initiated early and grew and coalesced through the 300 hours of testing. However, few new corrosion mounds were observed after 50 to 100 hours. Microstructurally, below the surface, the hot corrosion attack initiated as pits but evolved to a rampant attack consisting of the rapid inward growth of

Al<sub>2</sub>O<sub>3</sub> and TiO<sub>2</sub>. This attack stage progressed rapidly inward, totally depleting the Al and Ti in the degraded regions.
