TECHNICAL NOTE

D-1057

ANALYSIS OF X-15 LANDING APPROACH AND FLARE

By Gene J. Matranga

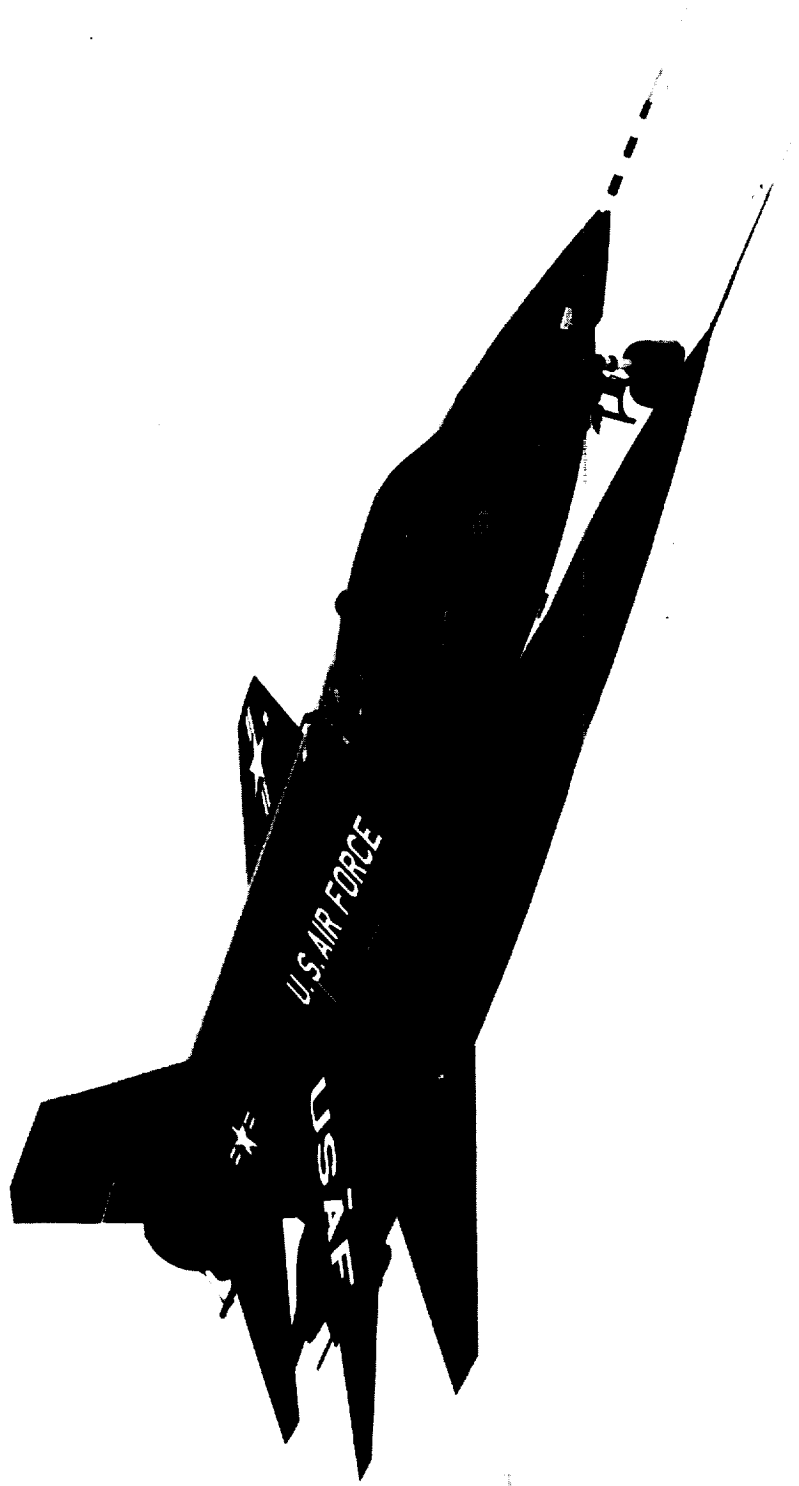
(a) In normal ground attitude.

Figure 2.- Photograph of the X-15 airplane.

(b) Just prior to main-gear touchdown.

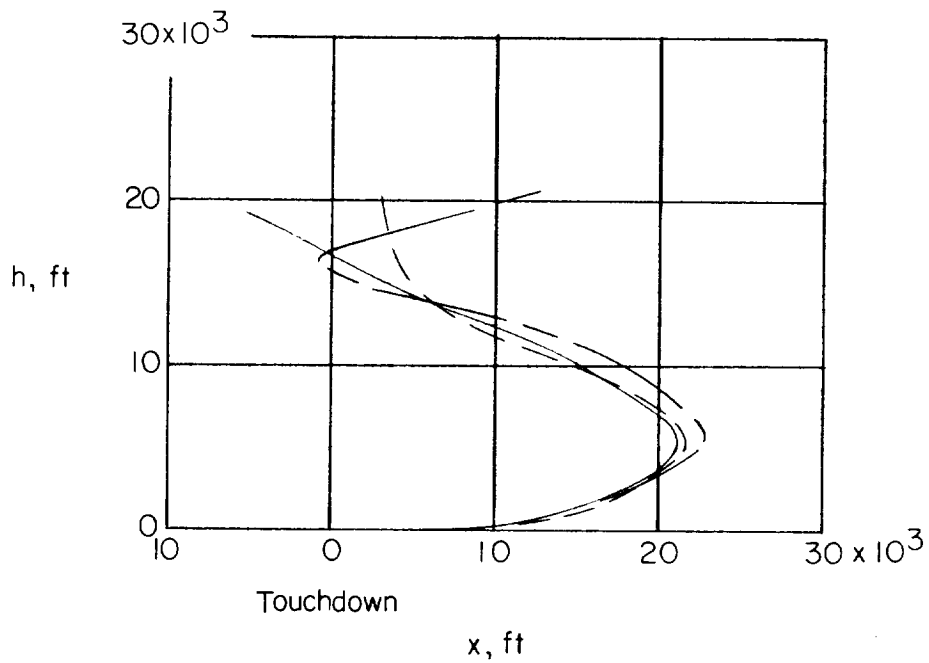
Pattern	Flight
—	S 1-16-29
- - -	270° 1-10-19
- · - · -	360° 2-5-12

Figure 6.- Representative X-15 landing patterns.

Several representative X-15 approach patterns are shown in figure 6 for approach speeds averaging about 300 knots indicated airspeed. An S-pattern and 270° and 360° overhead patterns are illustrated. For the 360° overhead pattern, the high key point is greater than 20,000 feet above the touchdown point. (In this paper, high key is defined to be the point where the pilot terminates his glide to the landing site and initiates his spiral turn to the touchdown point.) For the patterns shown, the average altitude is about 12,000 feet on the downwind leg and about 6,000 feet on the base leg. The average radius of turn in these patterns is of the order of 10,000 feet.
