# CAPP

International Research Project on the Effects of Chemical  
Ageing of Polymers on Performance Properties

## EFFECTS OF APPLIED STRAIN ON RATES OF AGEING Project overview

**Document no:** CAPP/M.15

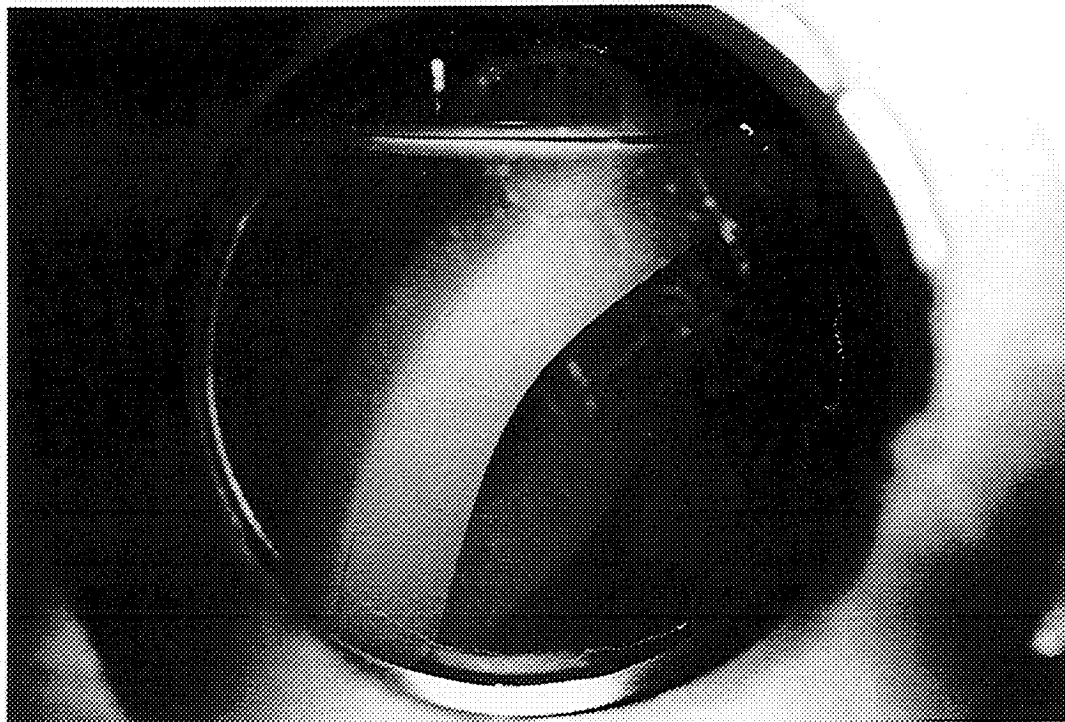
Fig.1(a) Coflon sample bent by end-constrained flexure at 140°C and vapour pressure - initial arrangement (x2.5 magnification)

FIGURE 1 Coflon sample during a methanol exposure test in a glass-ended cell

CAPP/M.6 Rev A described how the exposure of Coflon to 100% methanol (Fluid A) at 140°C and vapour pressure (conditions more severe than those likely to be met in service) resulted in its complete degradation to solution, and then to powder on cooling. The same result occurred for strained and unstrained samples; however, the strained (by end-constrained flexure - see Figure 1(a)) samples degraded *ca50%* more quickly than the unstrained, via a cracking mechanism (Figure 1(b)). The overall mechanism proposed was a physico-chemical one, the hot methanol dissolving amorphous PVDF as a first step. With strain, the onset of cracking right through the sample exposed more sections to the methanol for easy access and onset of dissolving. It can now be seen that the cracking process was an example of ESC; methanol displays a significant level of hydrogen-bonding  $\delta$  component. The fact that PVDF (in this context) is semi-amorphous rather than fully amorphous (cf

An advantage of end-constrained flexure for bringing about such failures is demonstrated by this work. As a colleague points out<sup>4</sup>, this bending mode, brought about using no jig but by means of the sample strip ends, maintains stress in mid-sample regions even if some stress relaxation occurs (see later).

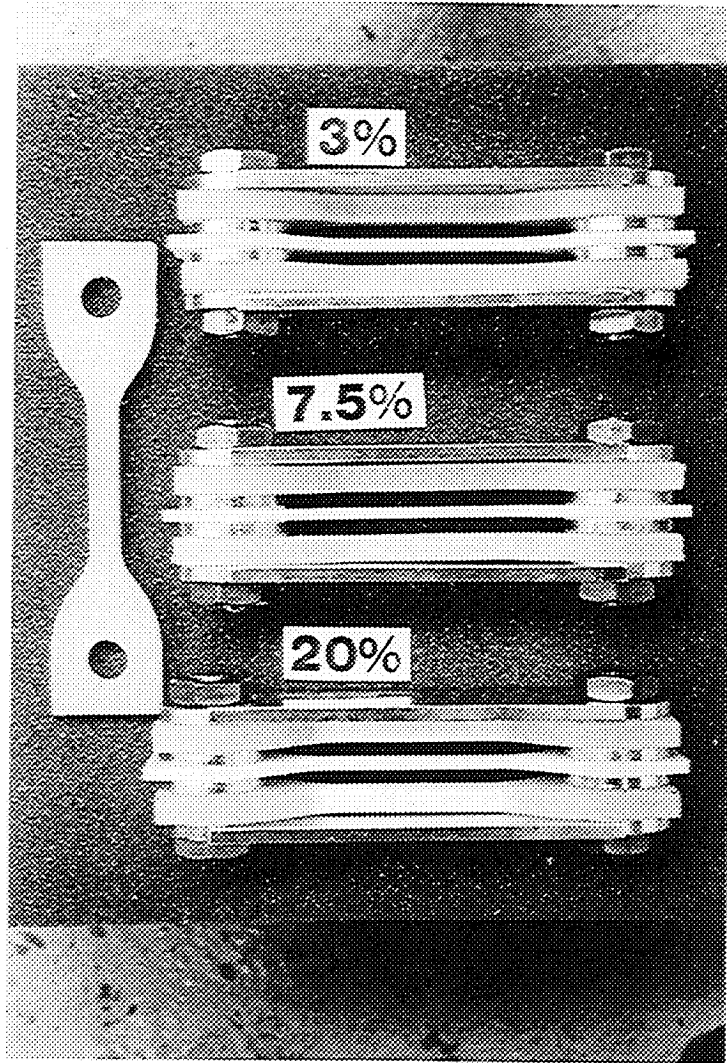
FIGURE 2 Standard tensile testpiece and the environmental applied-strain holding fixtures for exposure to high pressure fluids at 3%, 7.5% and 20% tension

Strains in the tensile mode were applied to samples whilst ageing in test fluids at various stages during the project. The jigs to do this are illustrated in Figure 2. Tables 1 and 2 show all of the data obtained for Coflon and Tefzel respectively, collated mainly from other CAPP reports, but also including a few previously-unreported results.
