INTERIM REPORT ON CHEMICAL AND THERMAL ANALYSIS

Prepared for: CAPP International Consortium

Document Number: CAPP/T.3
CONTENTS

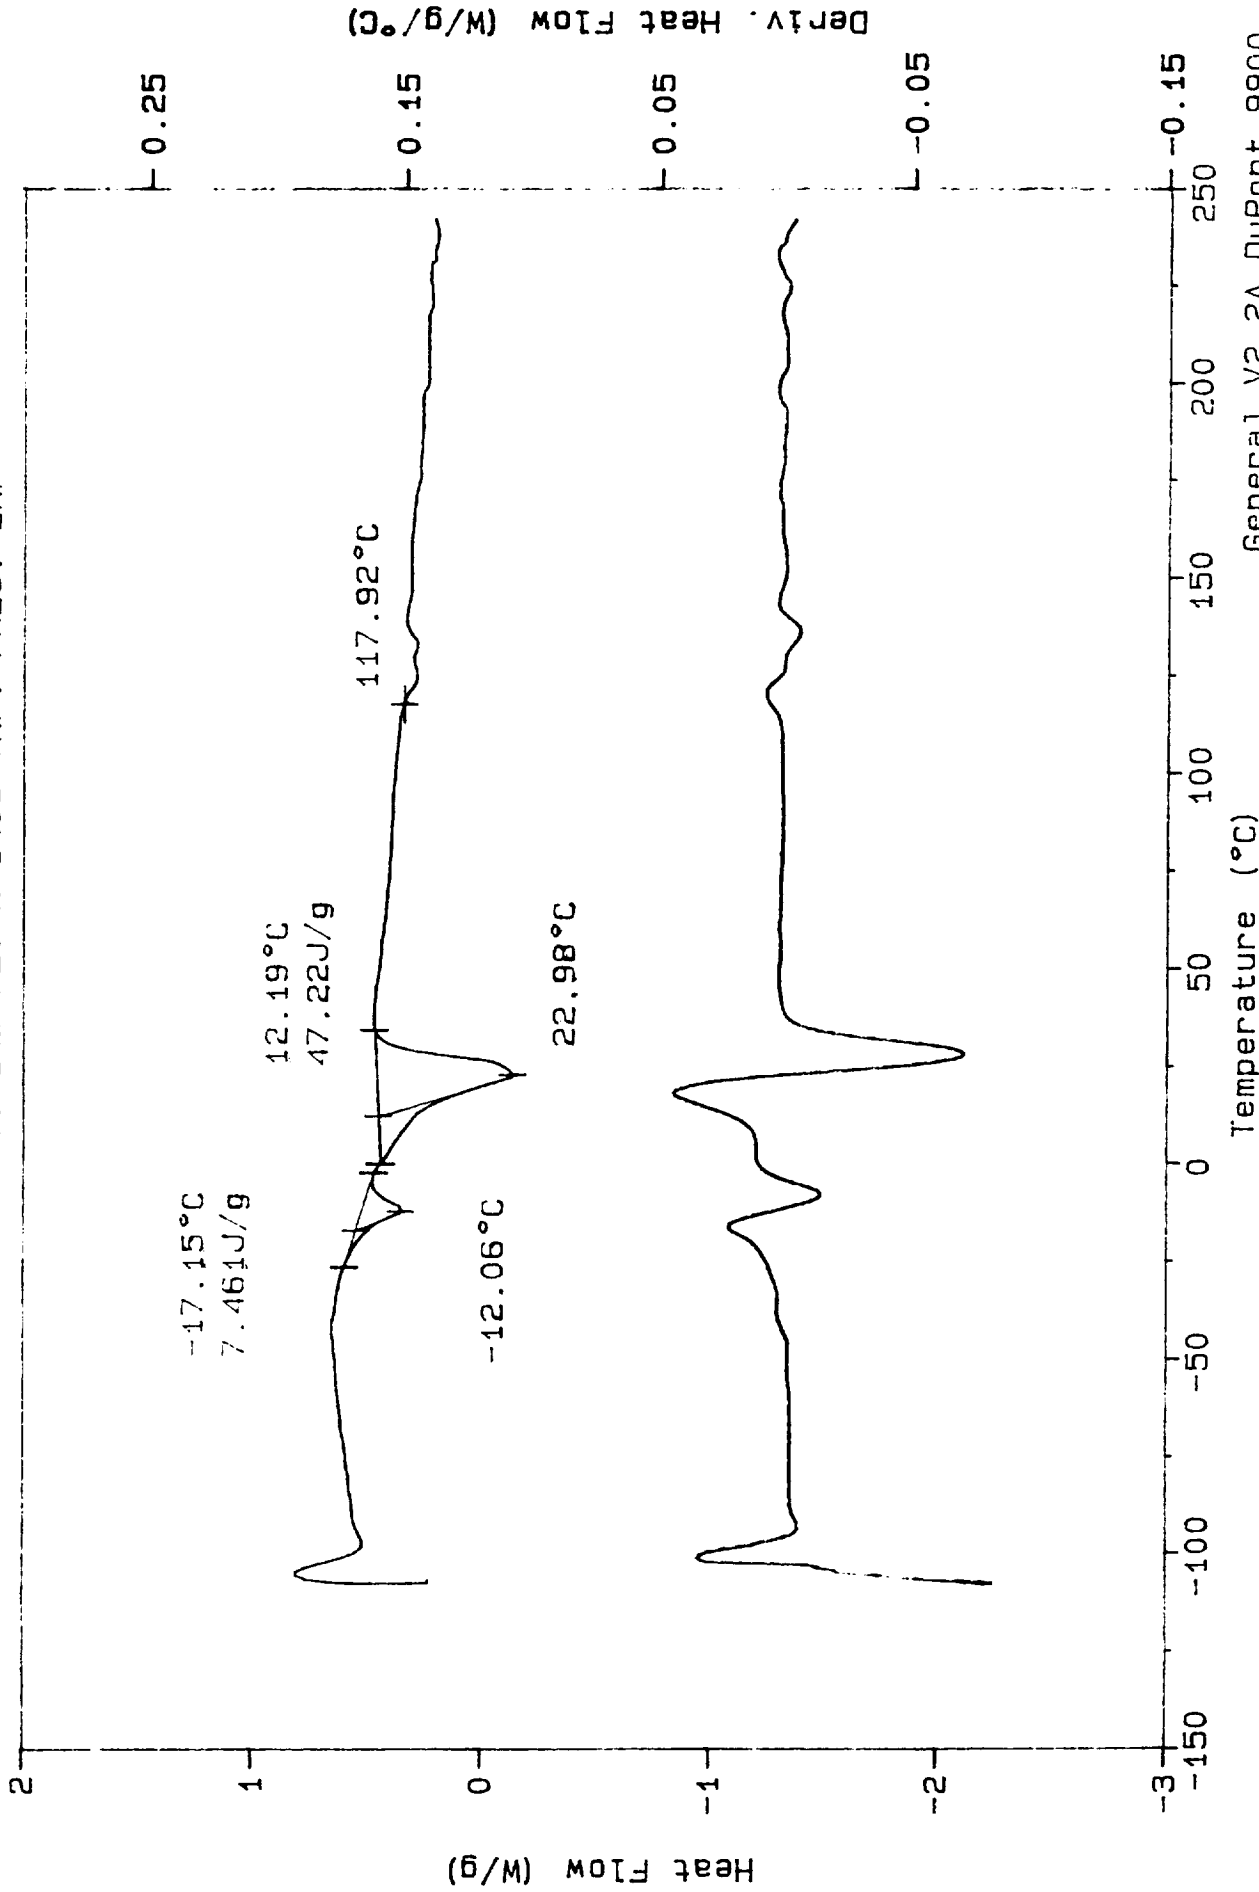
Sample: CAPP T-36 COFLON
Size: 8.4000 mg
Method: 10R250
Comment: RESIDUE FROM EVAP FLUID AFT. 14D FL. A 140C VAP. PRES. EXP

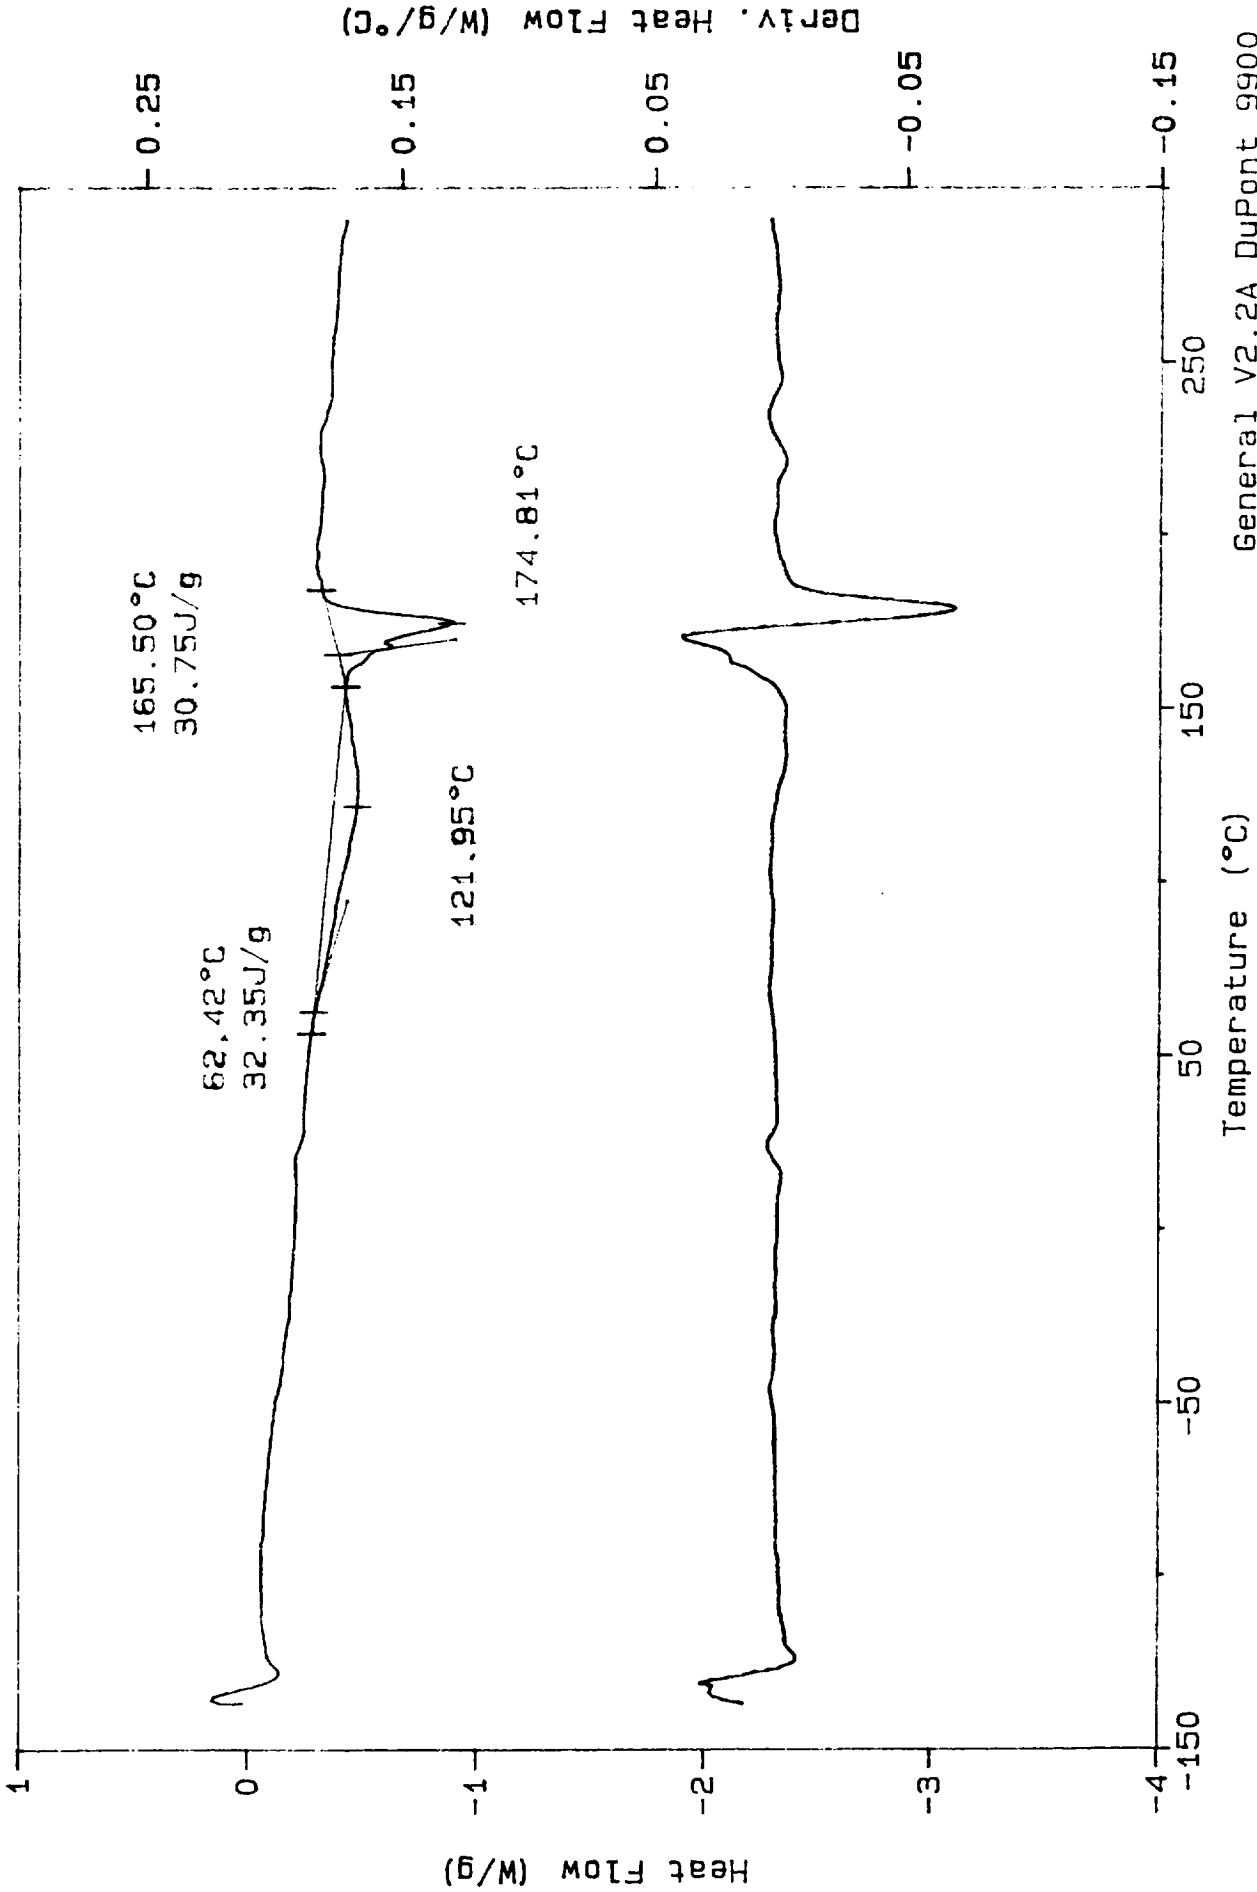
Sample: T-33 COFLON

Comment: 4 PT BND 12% STRAIN FLUID A 140C VAP. PRESS.14D

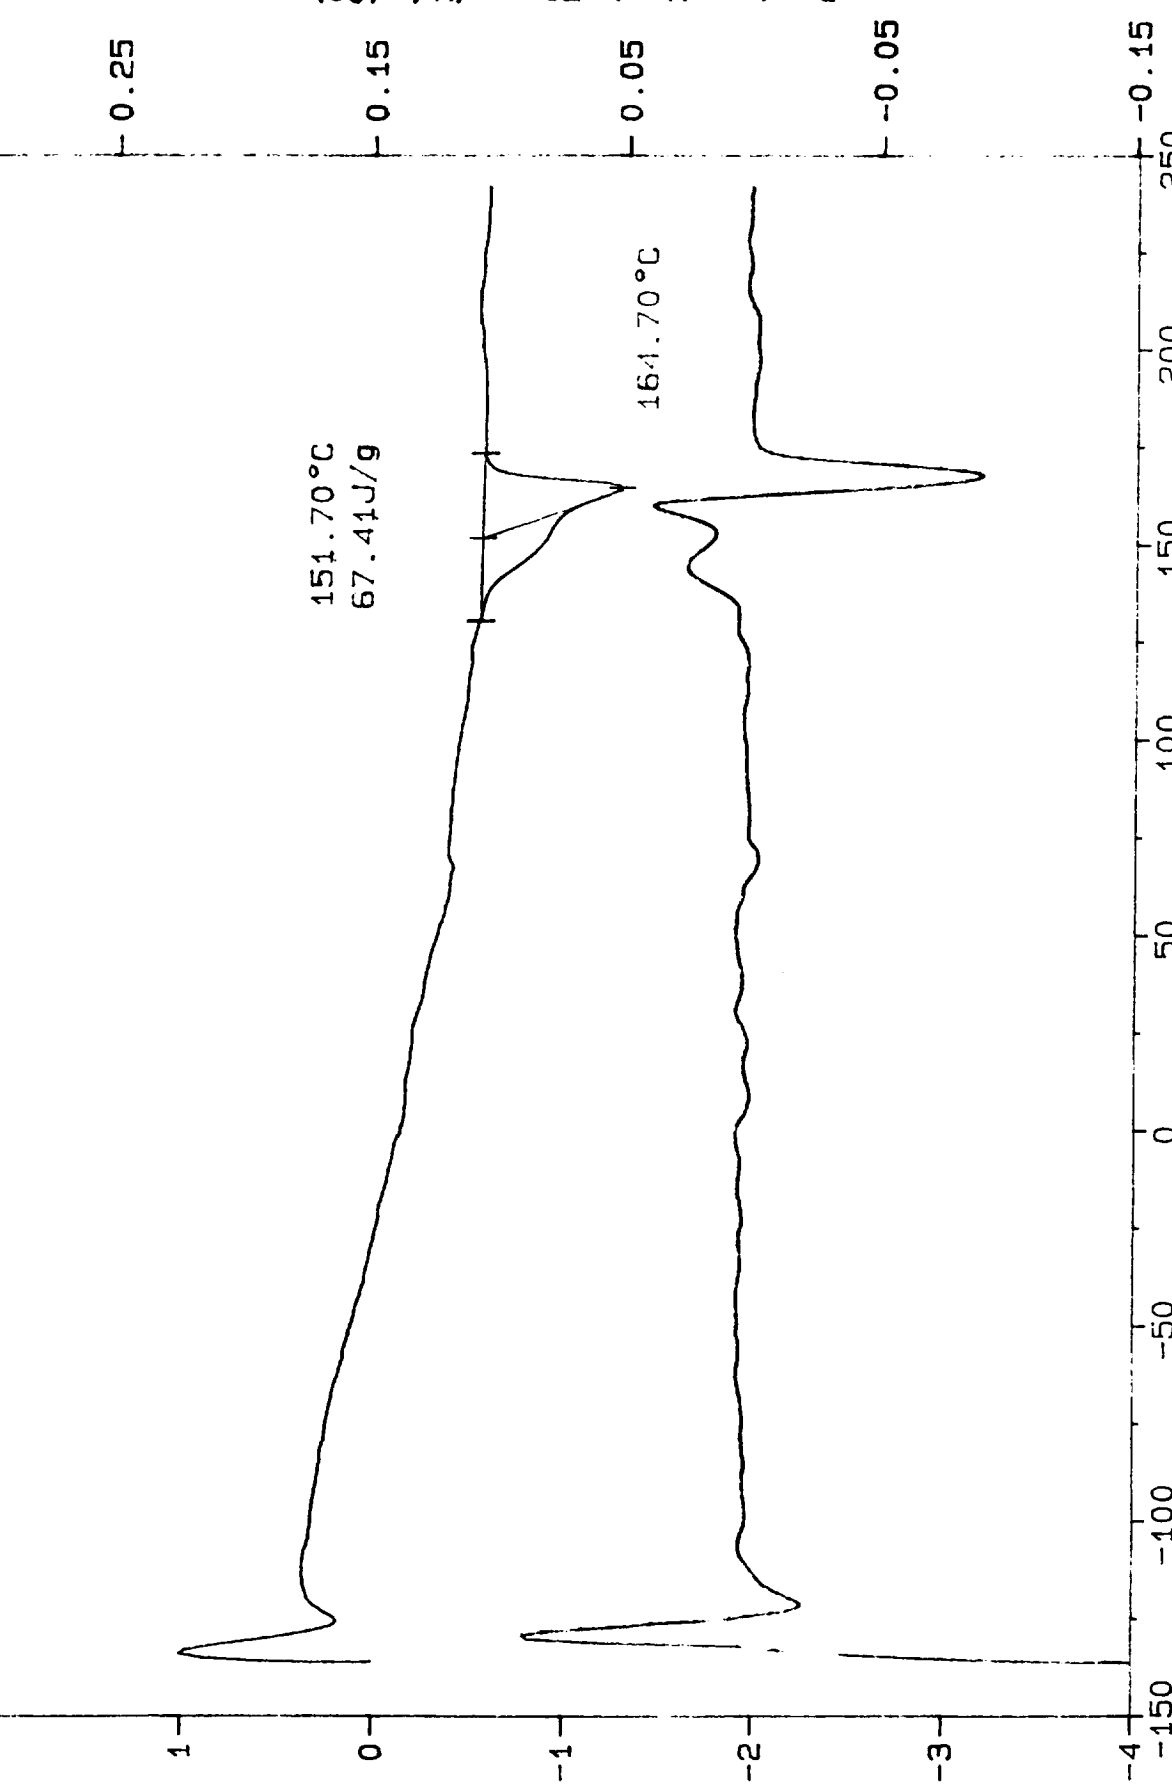
Sample: T32

Comment: RESIDUE FILTERED FROM METHANOL. 13D EXP COFLON 140C VAP PRESSURE

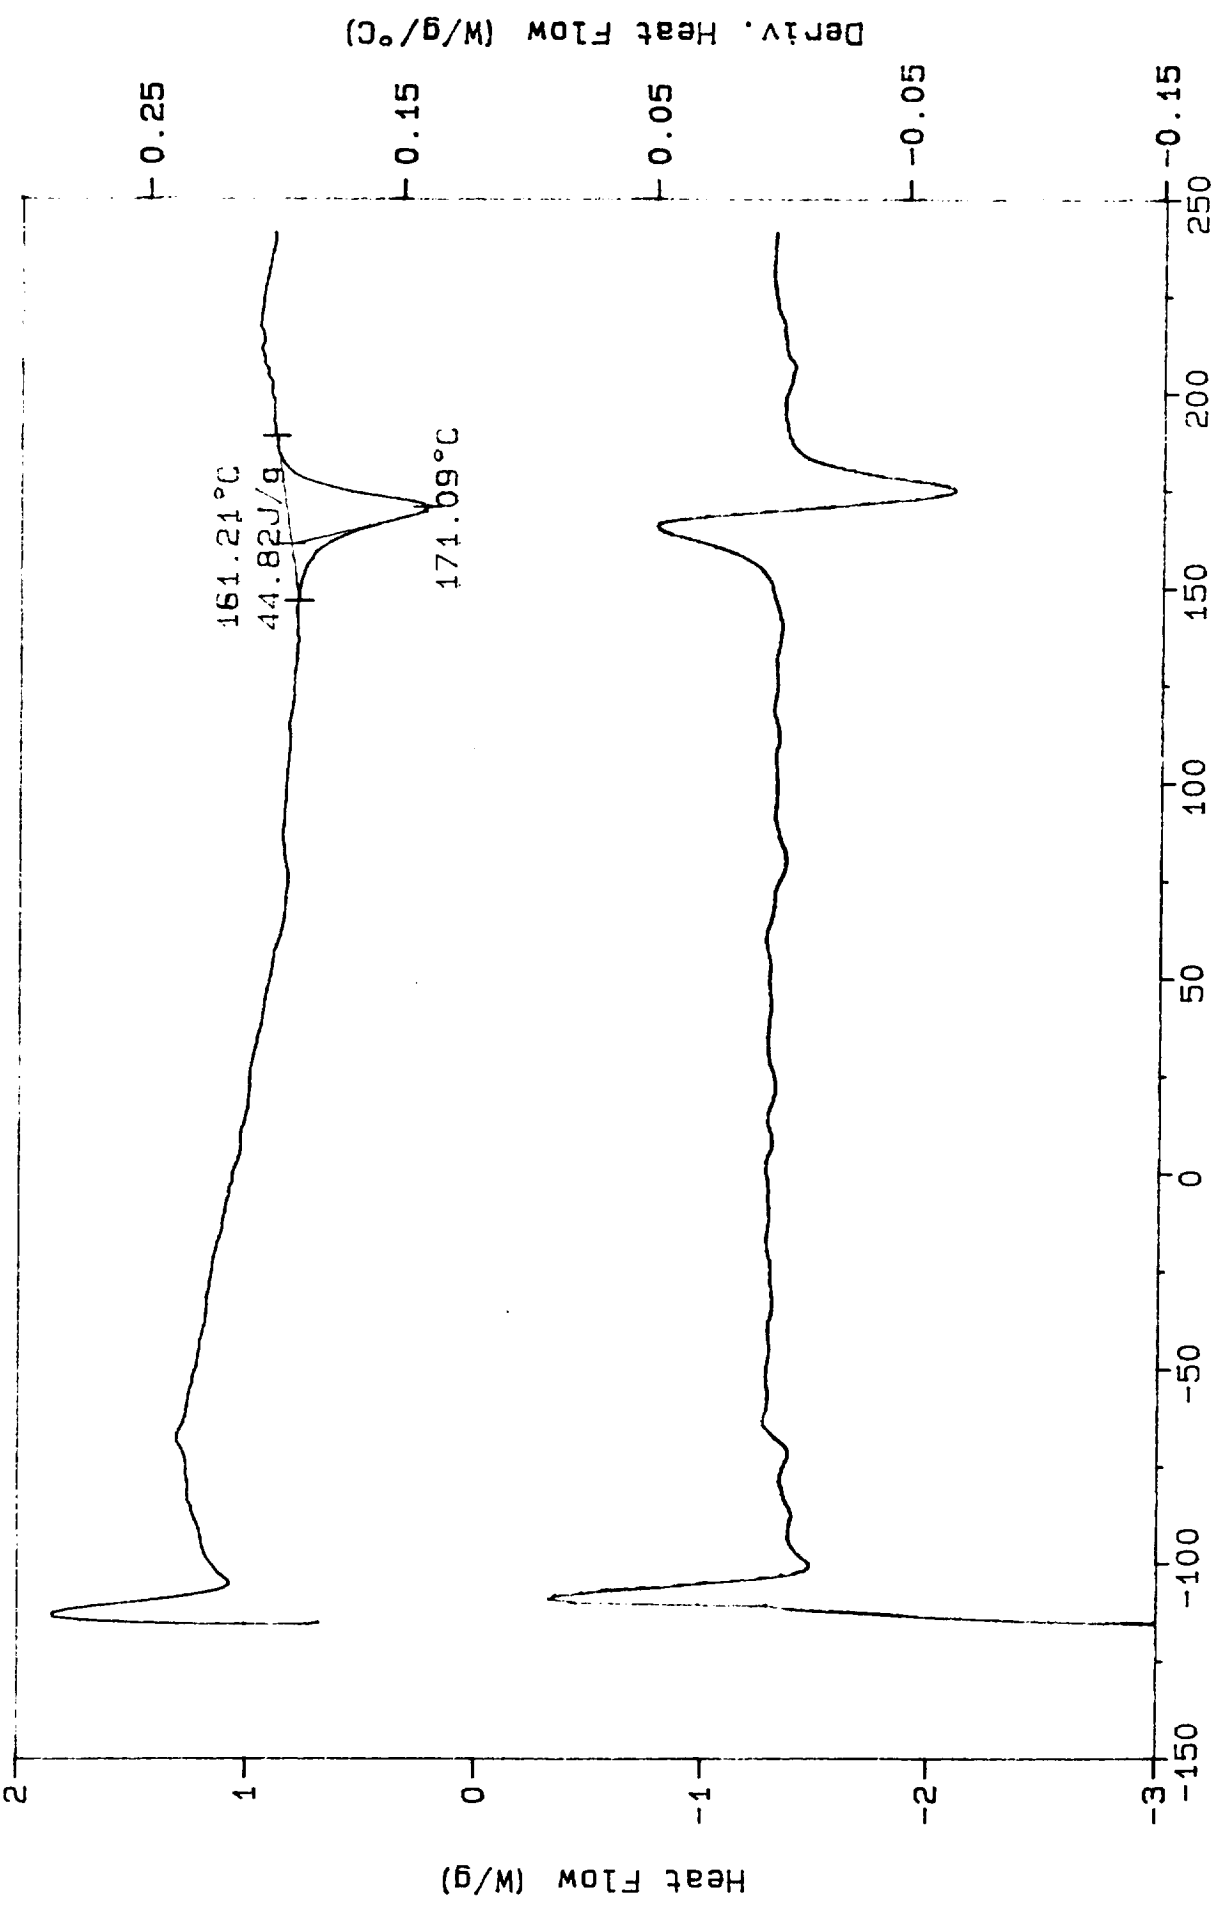
Sample: CAPP T-31 COFLON
Size: 4.2000 mg
Method: 10R250
Comment: DEPOSITED FROM 13 D FLUID A EXP. 140C VAPOR PRESSURE

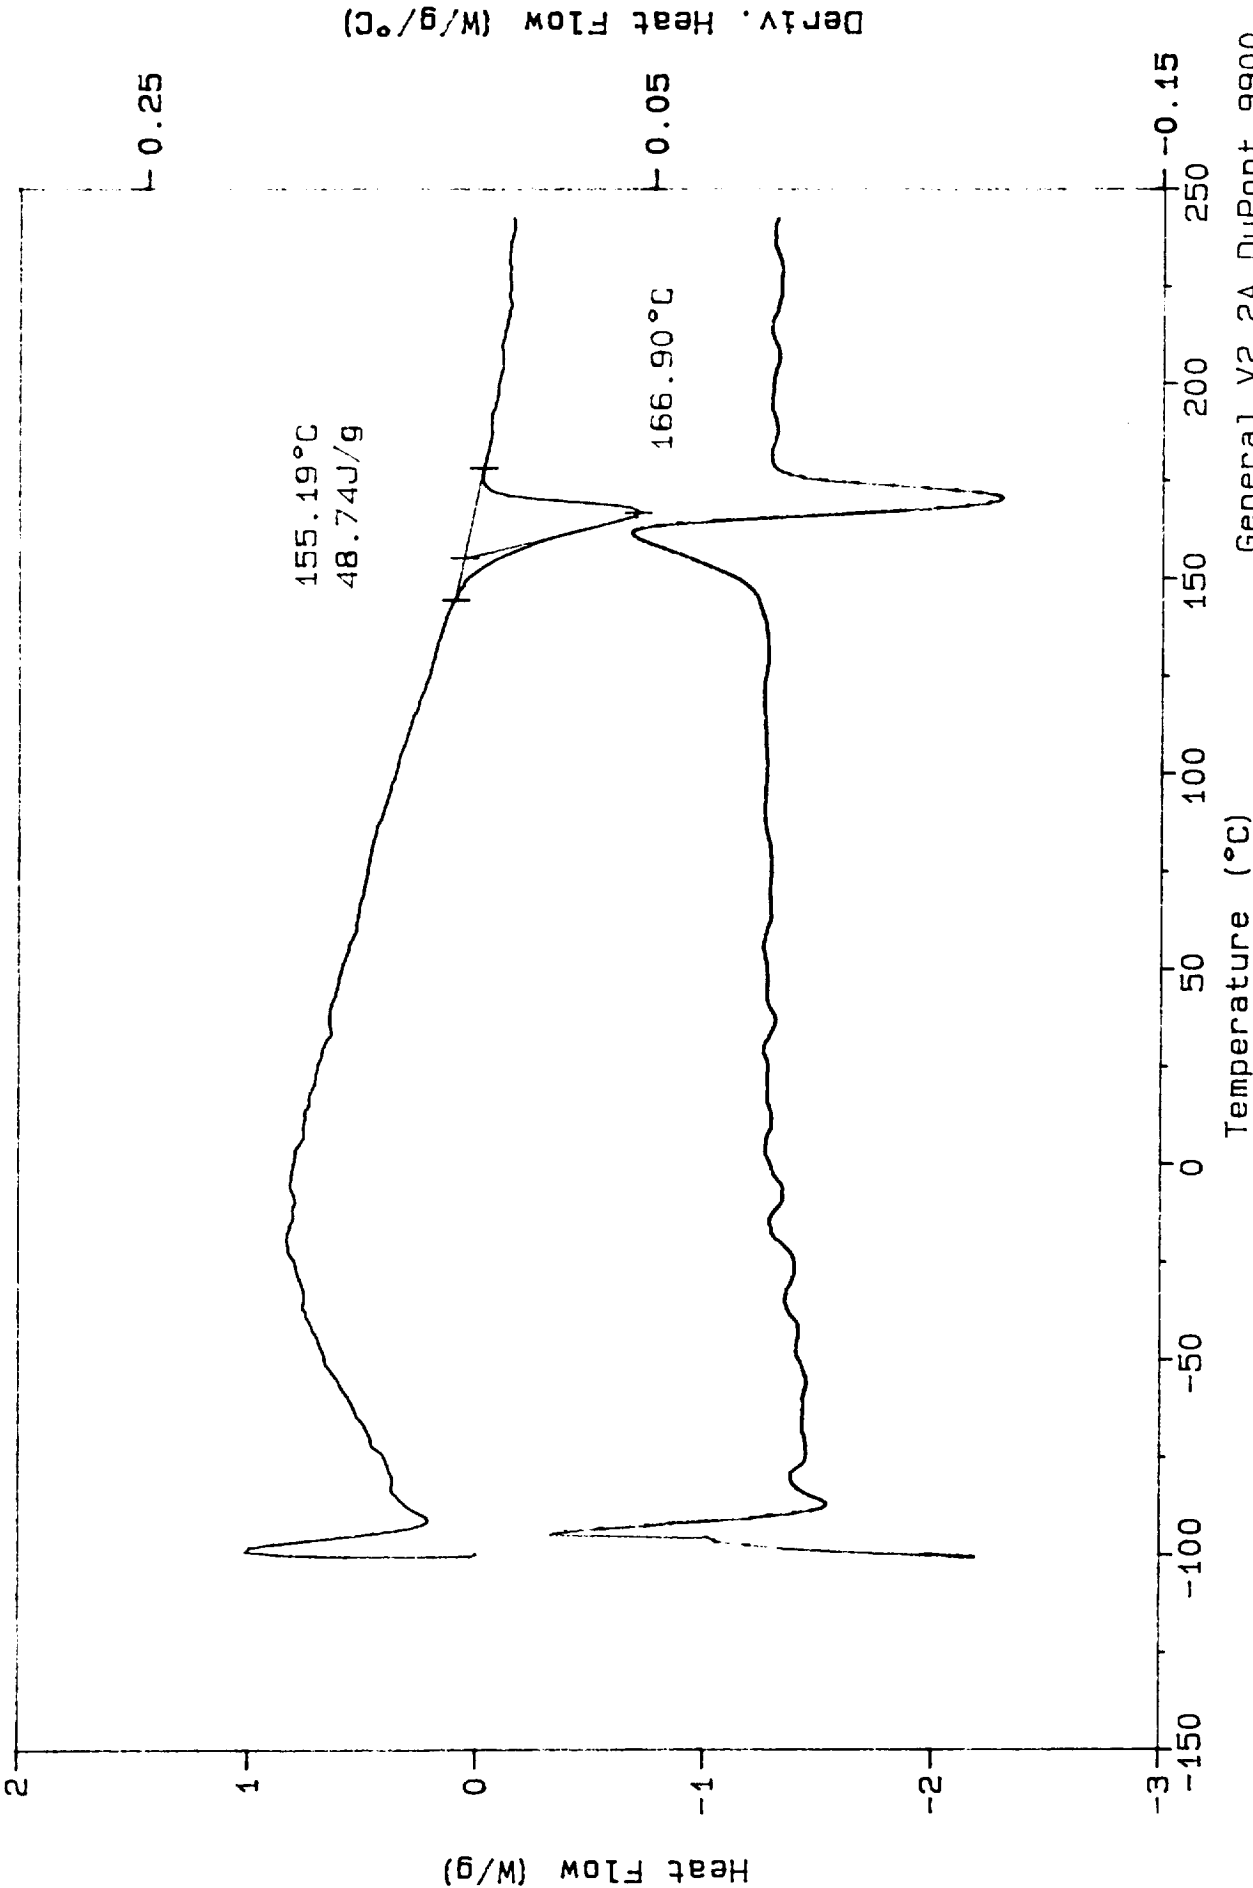
Sample: T-30

Comment: REMAINS OF COFLON 4 PT BEND AFTER 13D IN FLUID A AT 140C VAP PRS

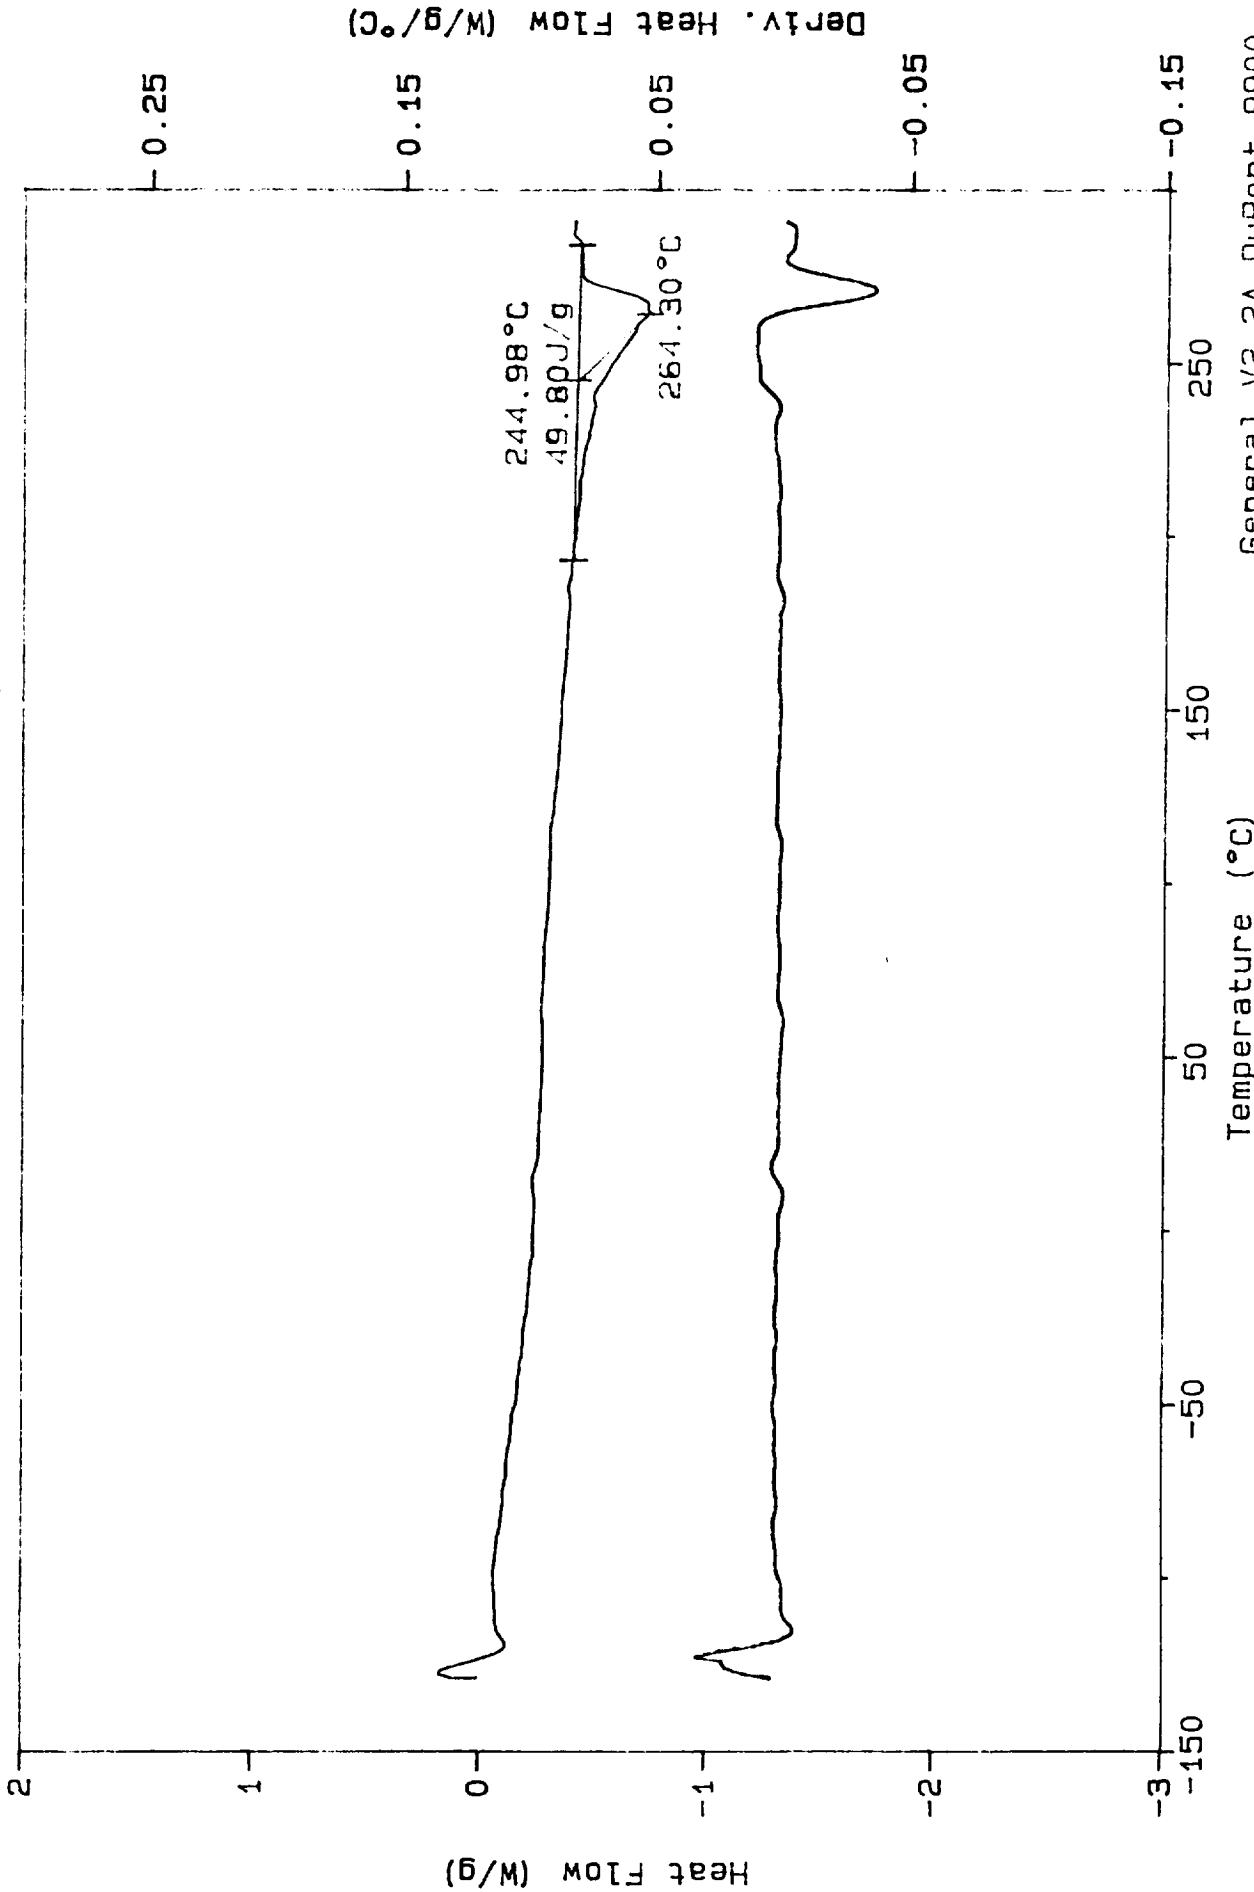
Sample: T-29 TEFZEL
Size: 5.9000 mg
Method: 10R300
Comment: 4 PT BND AFTER 6D IN FLUID A AT 140C VAP. PRESS.

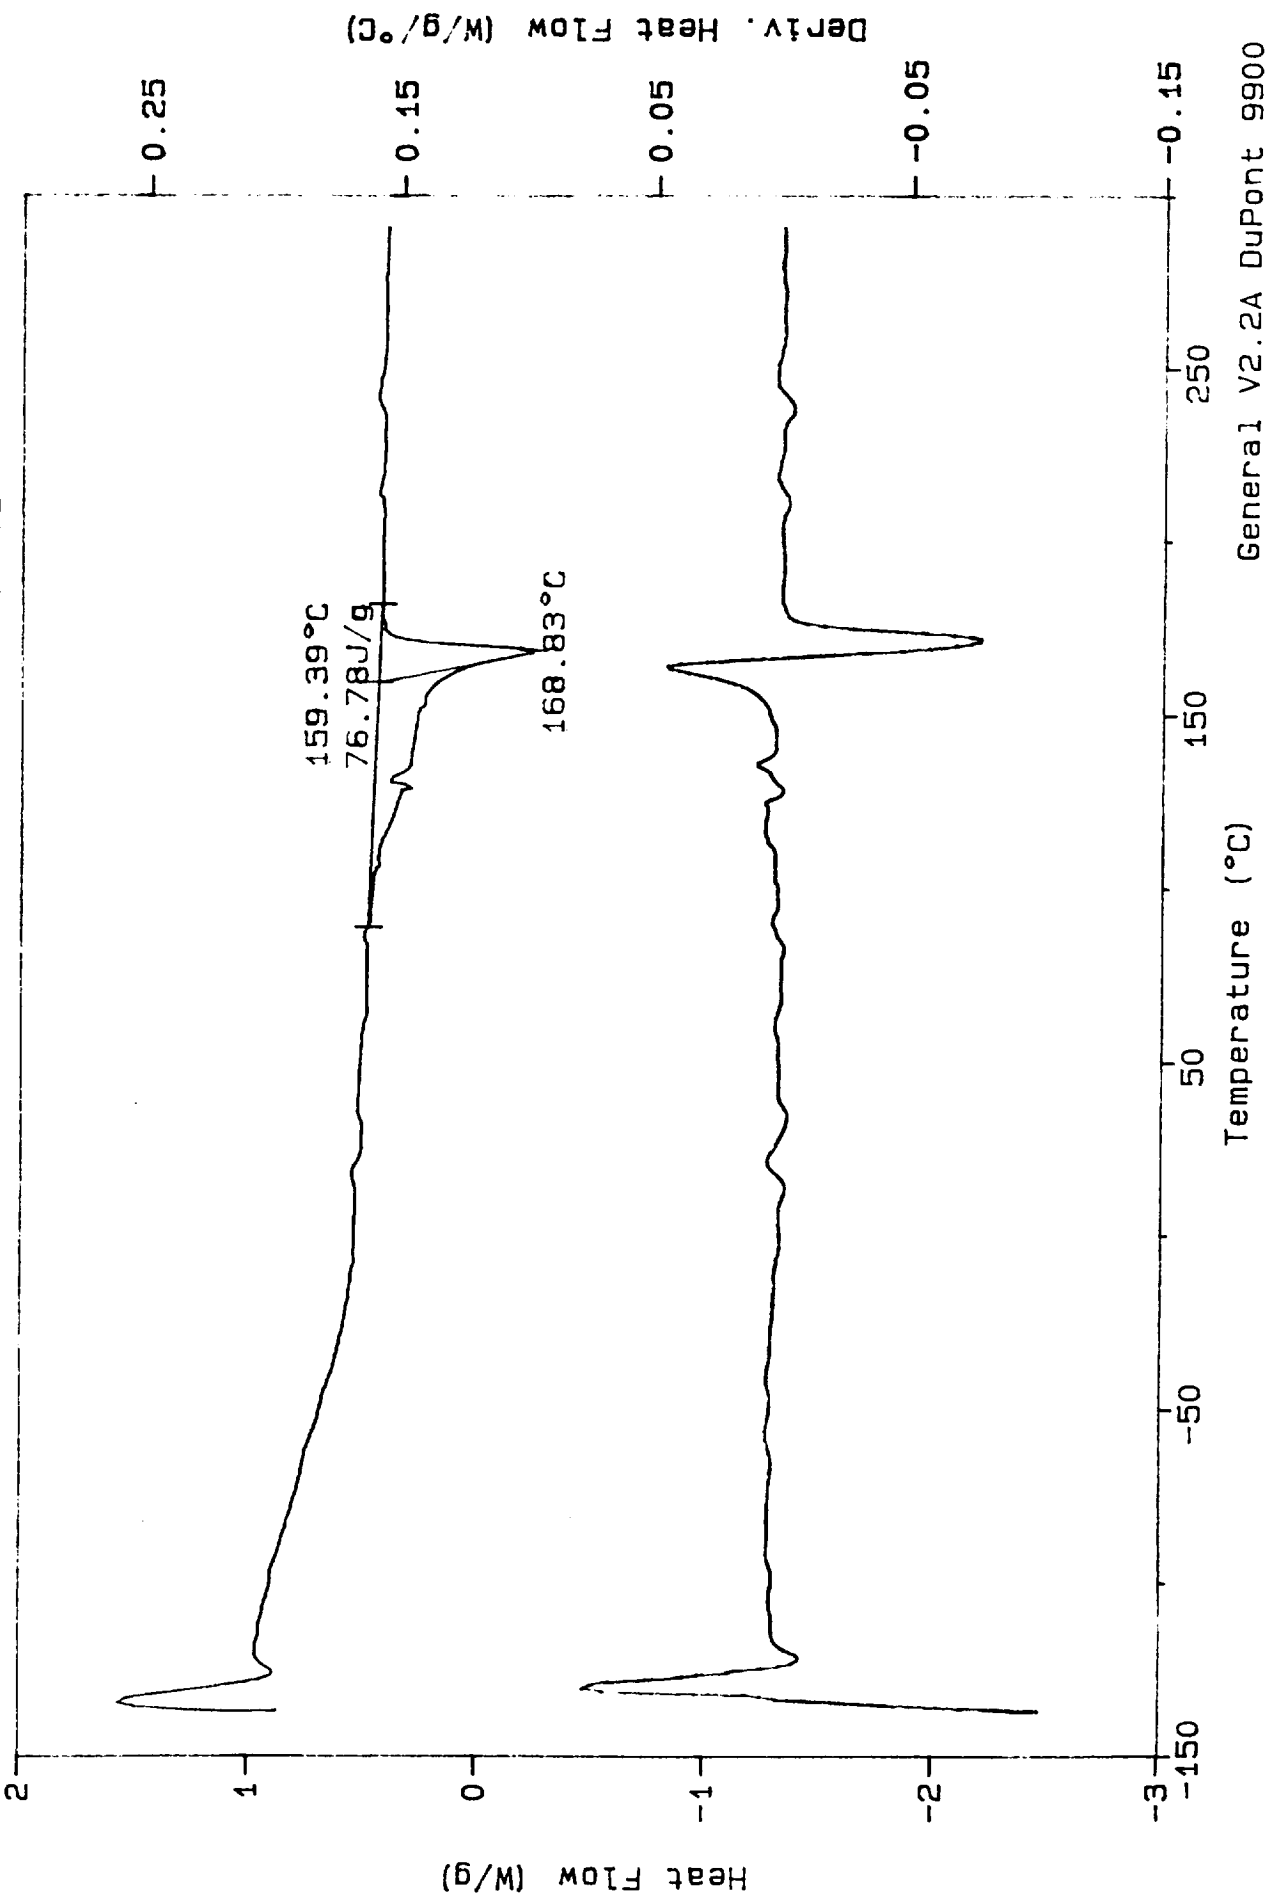
Sample: T-26 COFLON
Size: 4.3000 mg
Method: 10R300
Comment: COFLON TESTED AT 23C AFT. 140 IN FLUID B AT 140C 5000 PSI

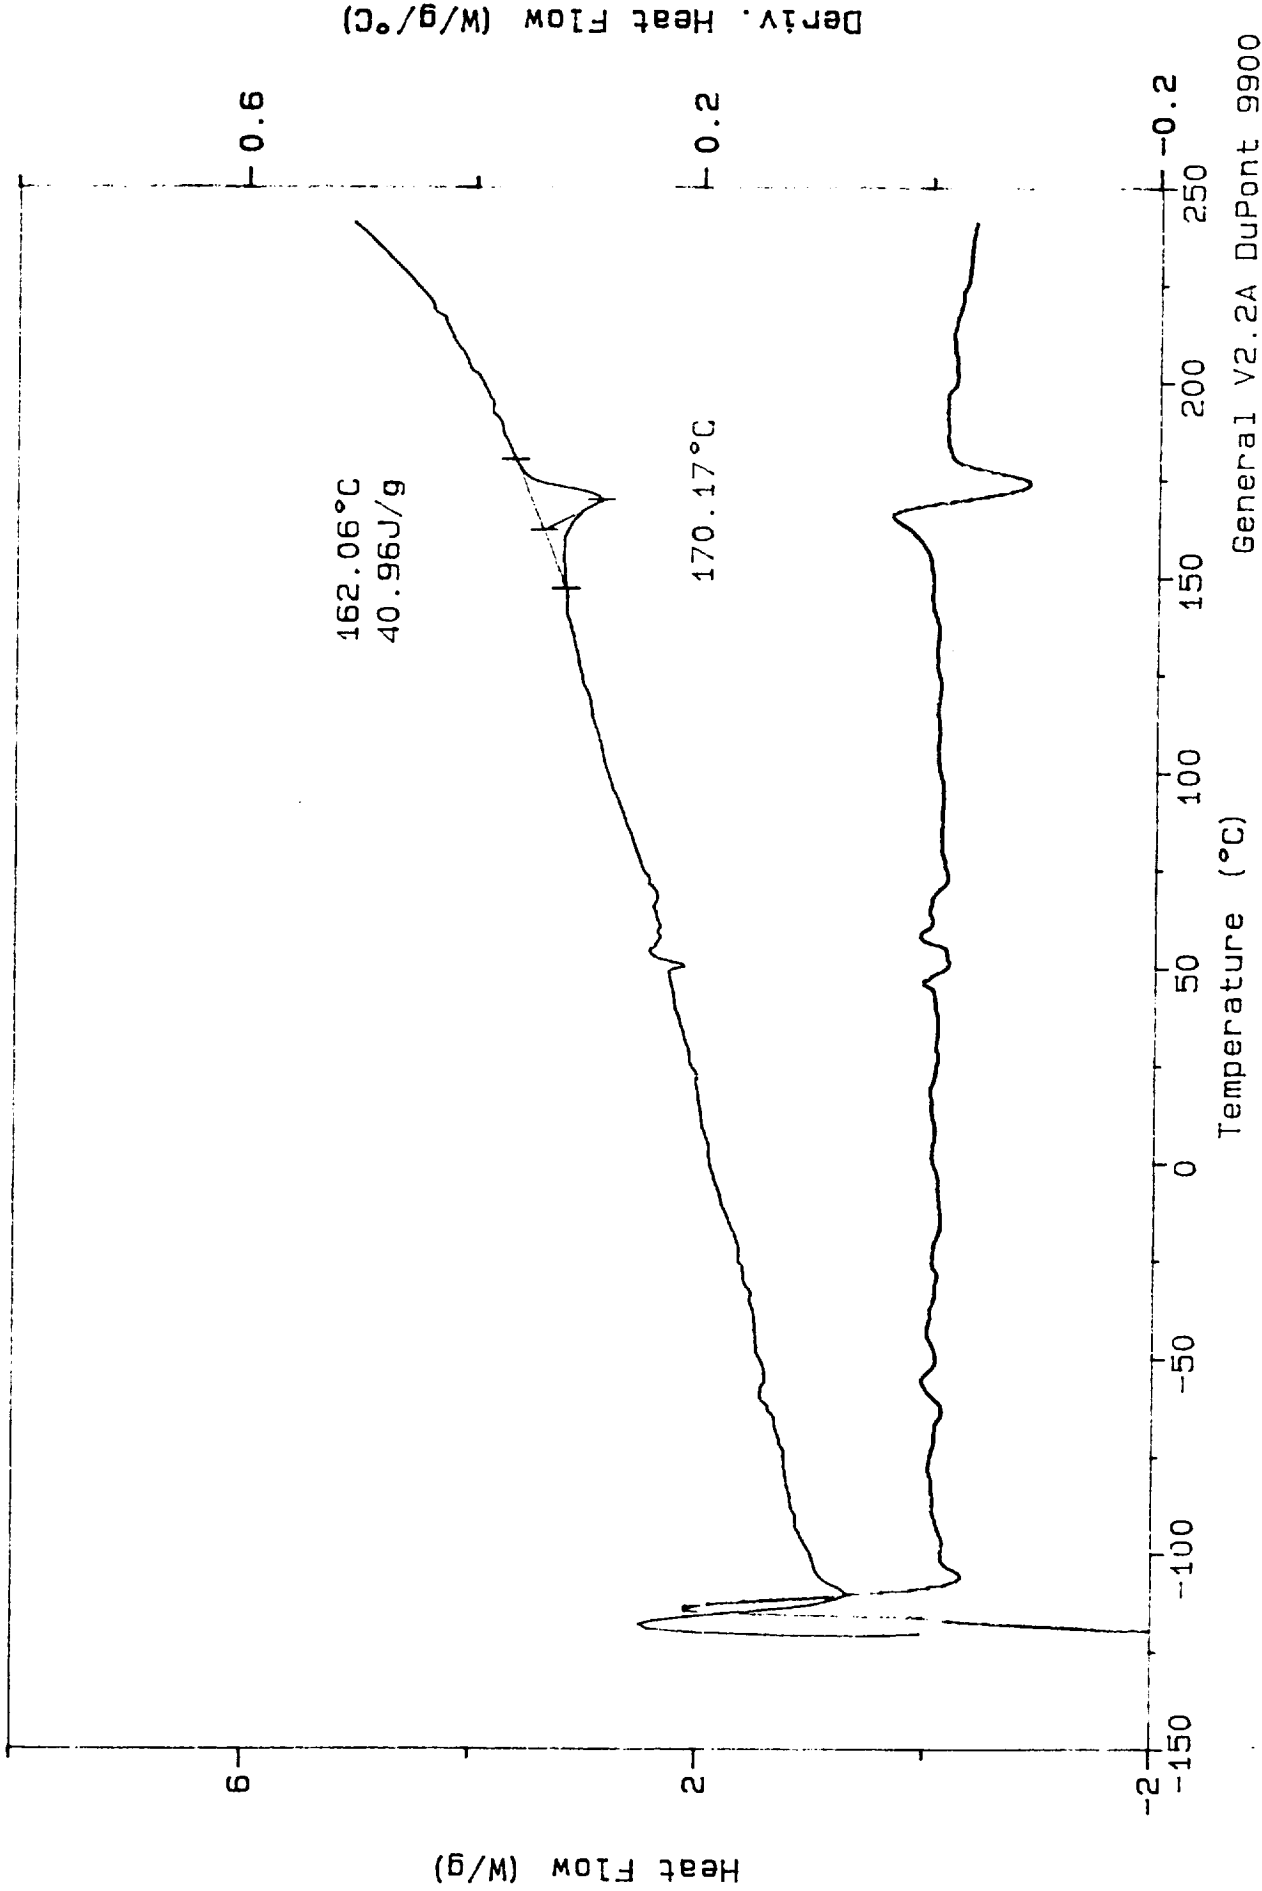
Sample: PVDF RECRYSTS. FROM DMAC (T-28)

Using the methods cited in the literature we dissolved PVDF in hot dimethylacetamide (DMAC) and cast a film drying the film at $\approx 70^\circ\text{C}$ for 16 hours. We next performed FTIR and DSC analysis of the resultant film. Films were prepared for virgin PVDF, and aged PVDF (T-28) and compared with a sample of PVDF not dissolved and cast from PVDF. Solution of the PVDF into boiling DMAC was effected within thirty minutes. The DSC analysis (Appendix 1) and the FTIR analysis (Appendix 2) indicate some differences in T_g and the integration areas of the two DSC peaks around 160°C

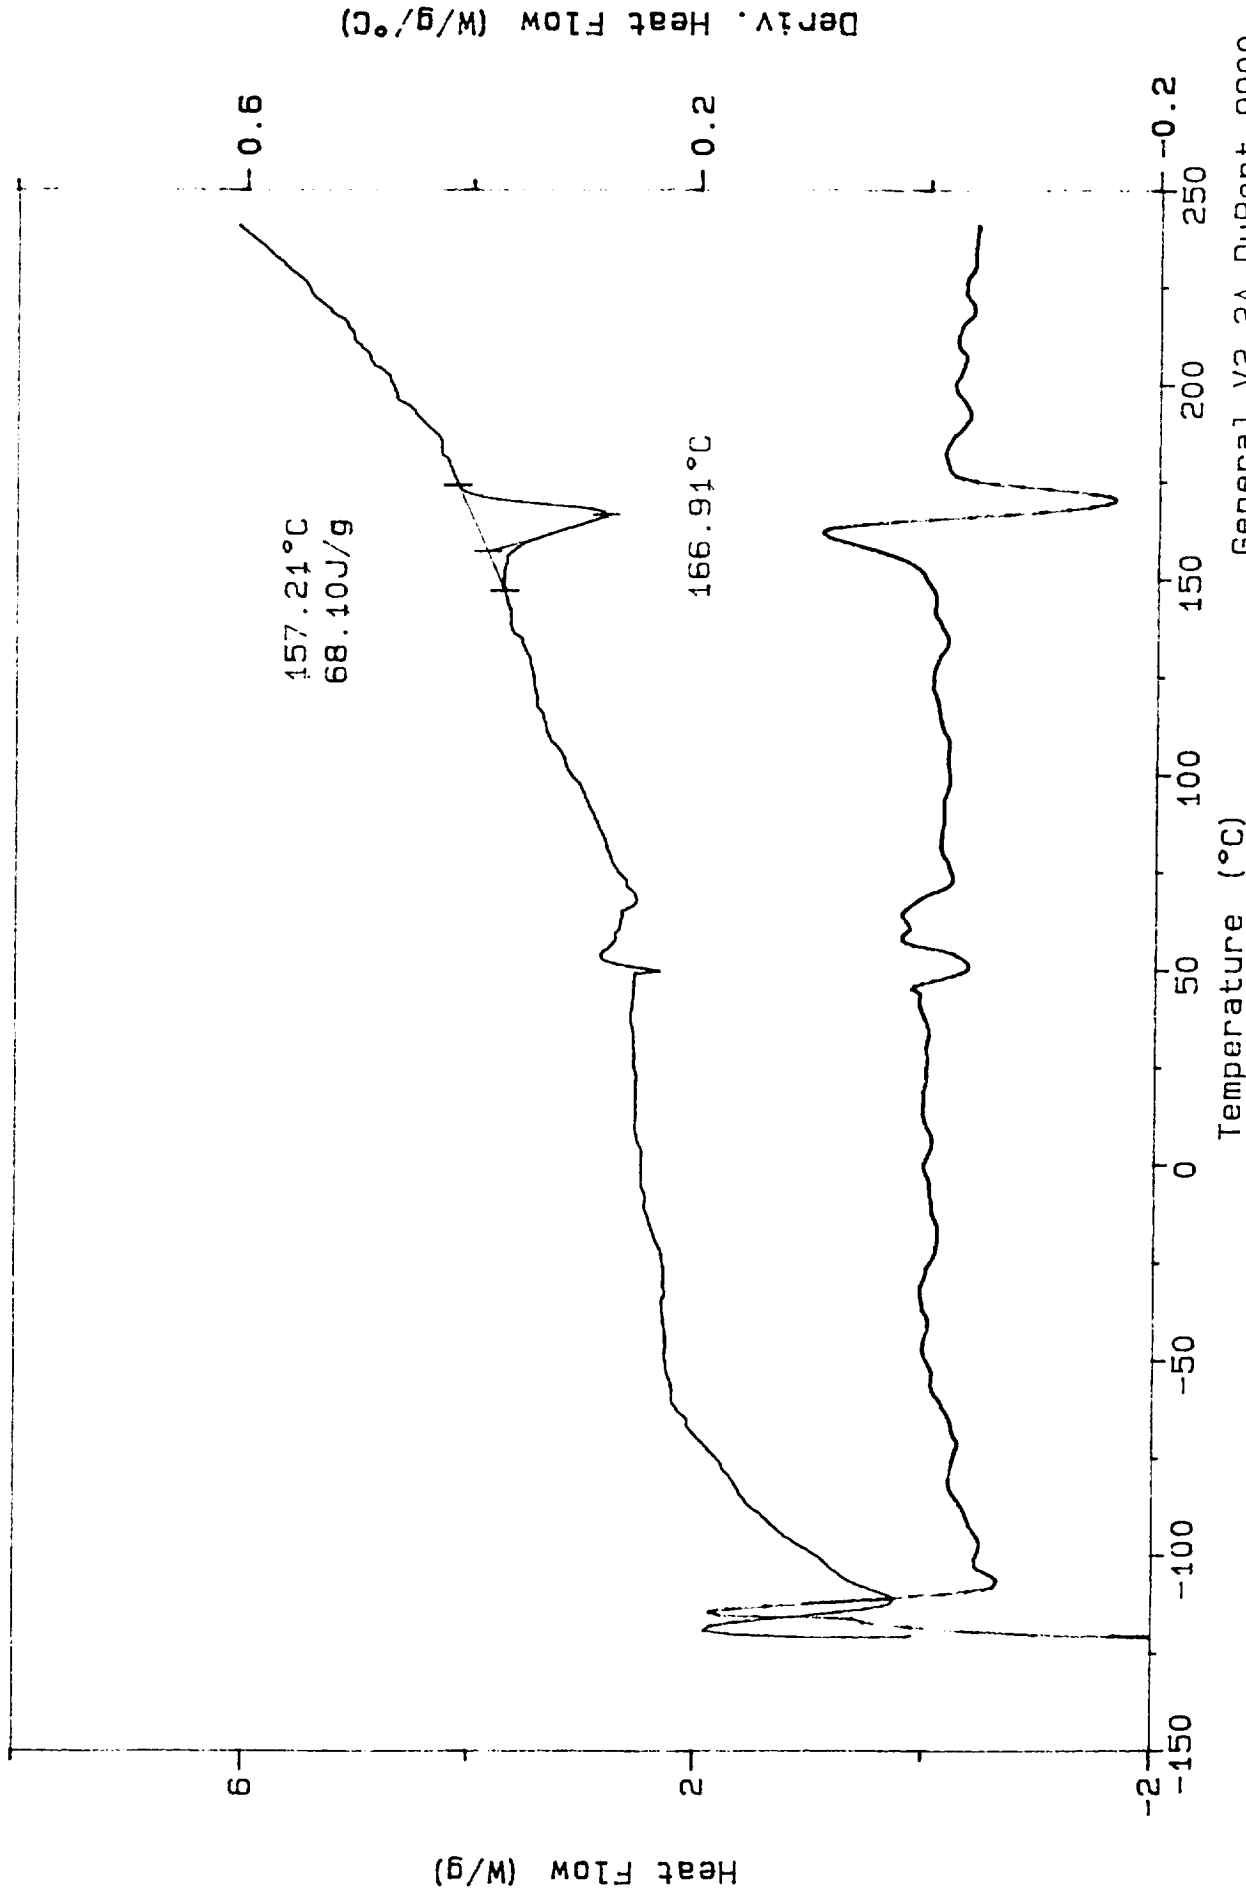
Sample: PVDF RECRY. FROM DMAC (VIRGIN) DSC
