INTERIM REPORT ON CHEMICAL AND THERMAL ANALYSIS

Prepared for: CAPP International Consortium

Document Number: CAPP/T.3
CONTENTS

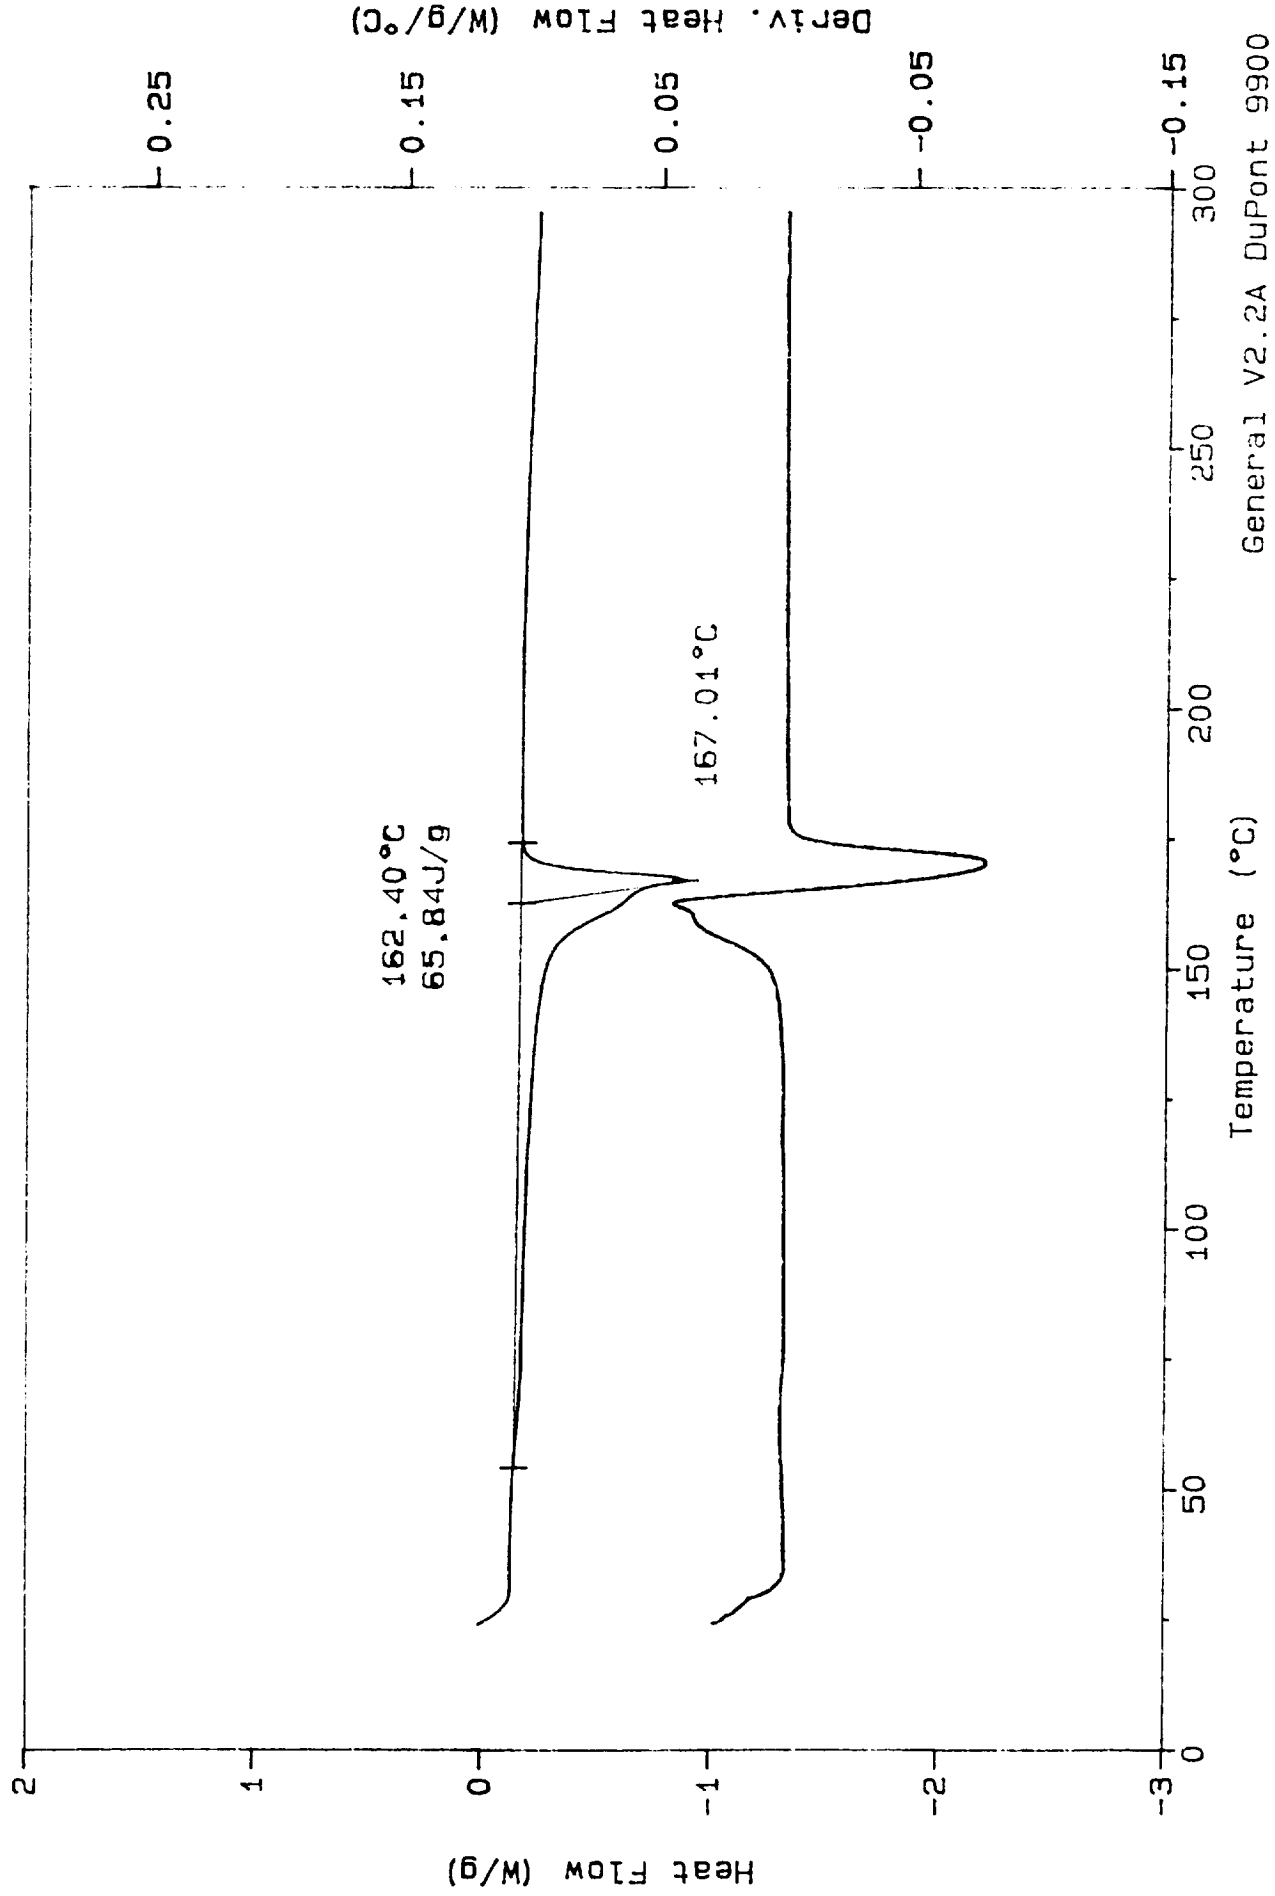
Sample: COFLON BASELINE NOT AGED
Size: 3.3000 mg
Method: 10R, 300

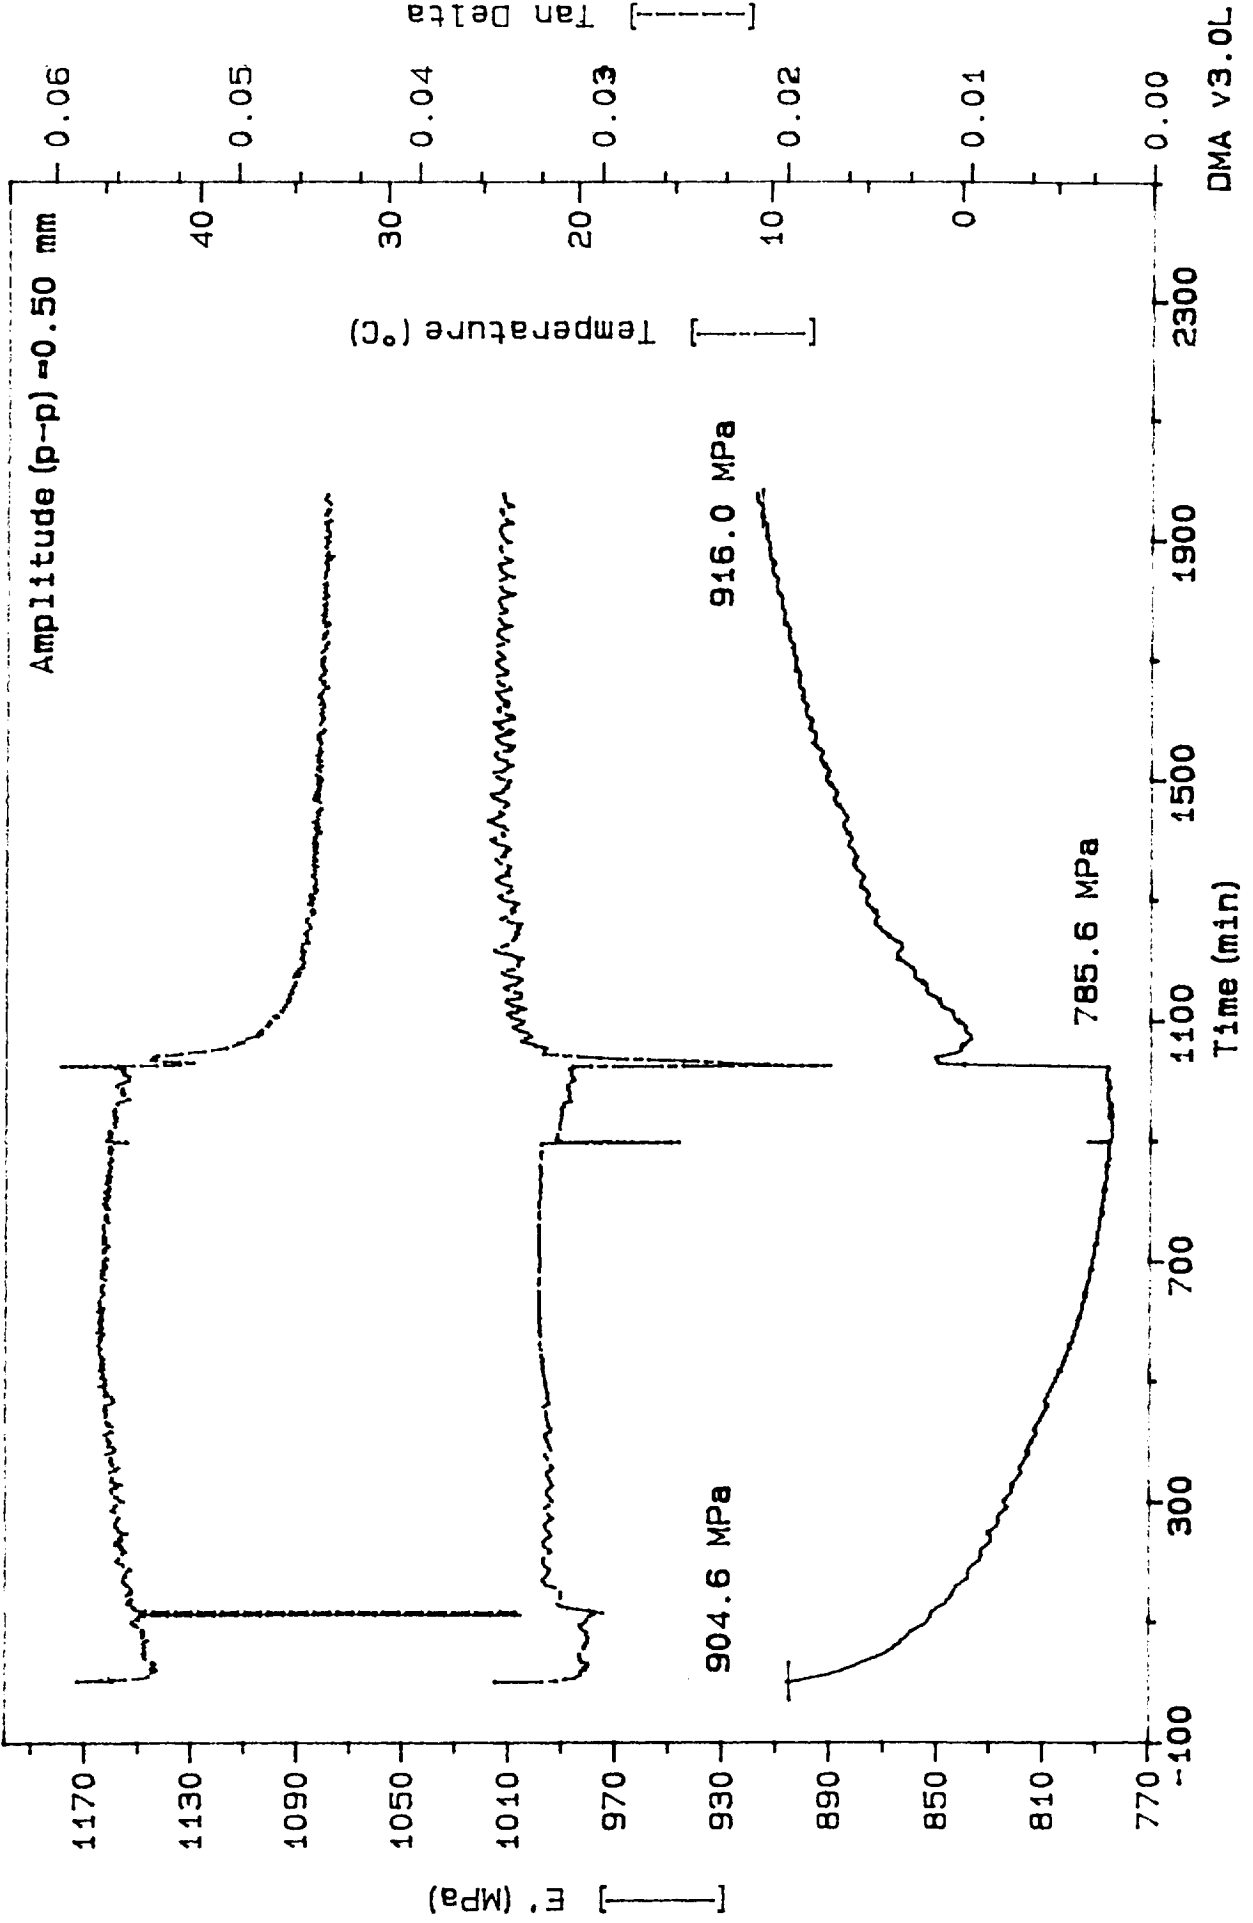
Sample : COFLON IN METHANOL
Size : 13.30 x 5.57 x 3.46 mm
Method : 1 HZ AMBIENT
Comment: SUBMERGED IN METHANOL

We also examined the viscoelastic response of Coflon using DMA while the sample was immersed in methanol at room temperature. During the first eighteen hours of immersion we notice a decrease in the flexural modulus indicating plasticization with methanol had occurred in the Coflon. The flexural modulus of the Coflon decreased over thirteen percent in the initial eighteen hours while immersed in methanol.

The sample was then removed from methanol and the dynamic mechanical analysis was continued in air for the next twenty two hours. We noticed an increase in the flexural modulus to a higher level than the initial value. The initial flexural modulus value had increased 1.3% at the end of twenty-two hours from the initial value. The increase in the flexural modulus at the end of the test could be due to the leaching of the plasticizer, an increase in crystallinity, or both of these processes.

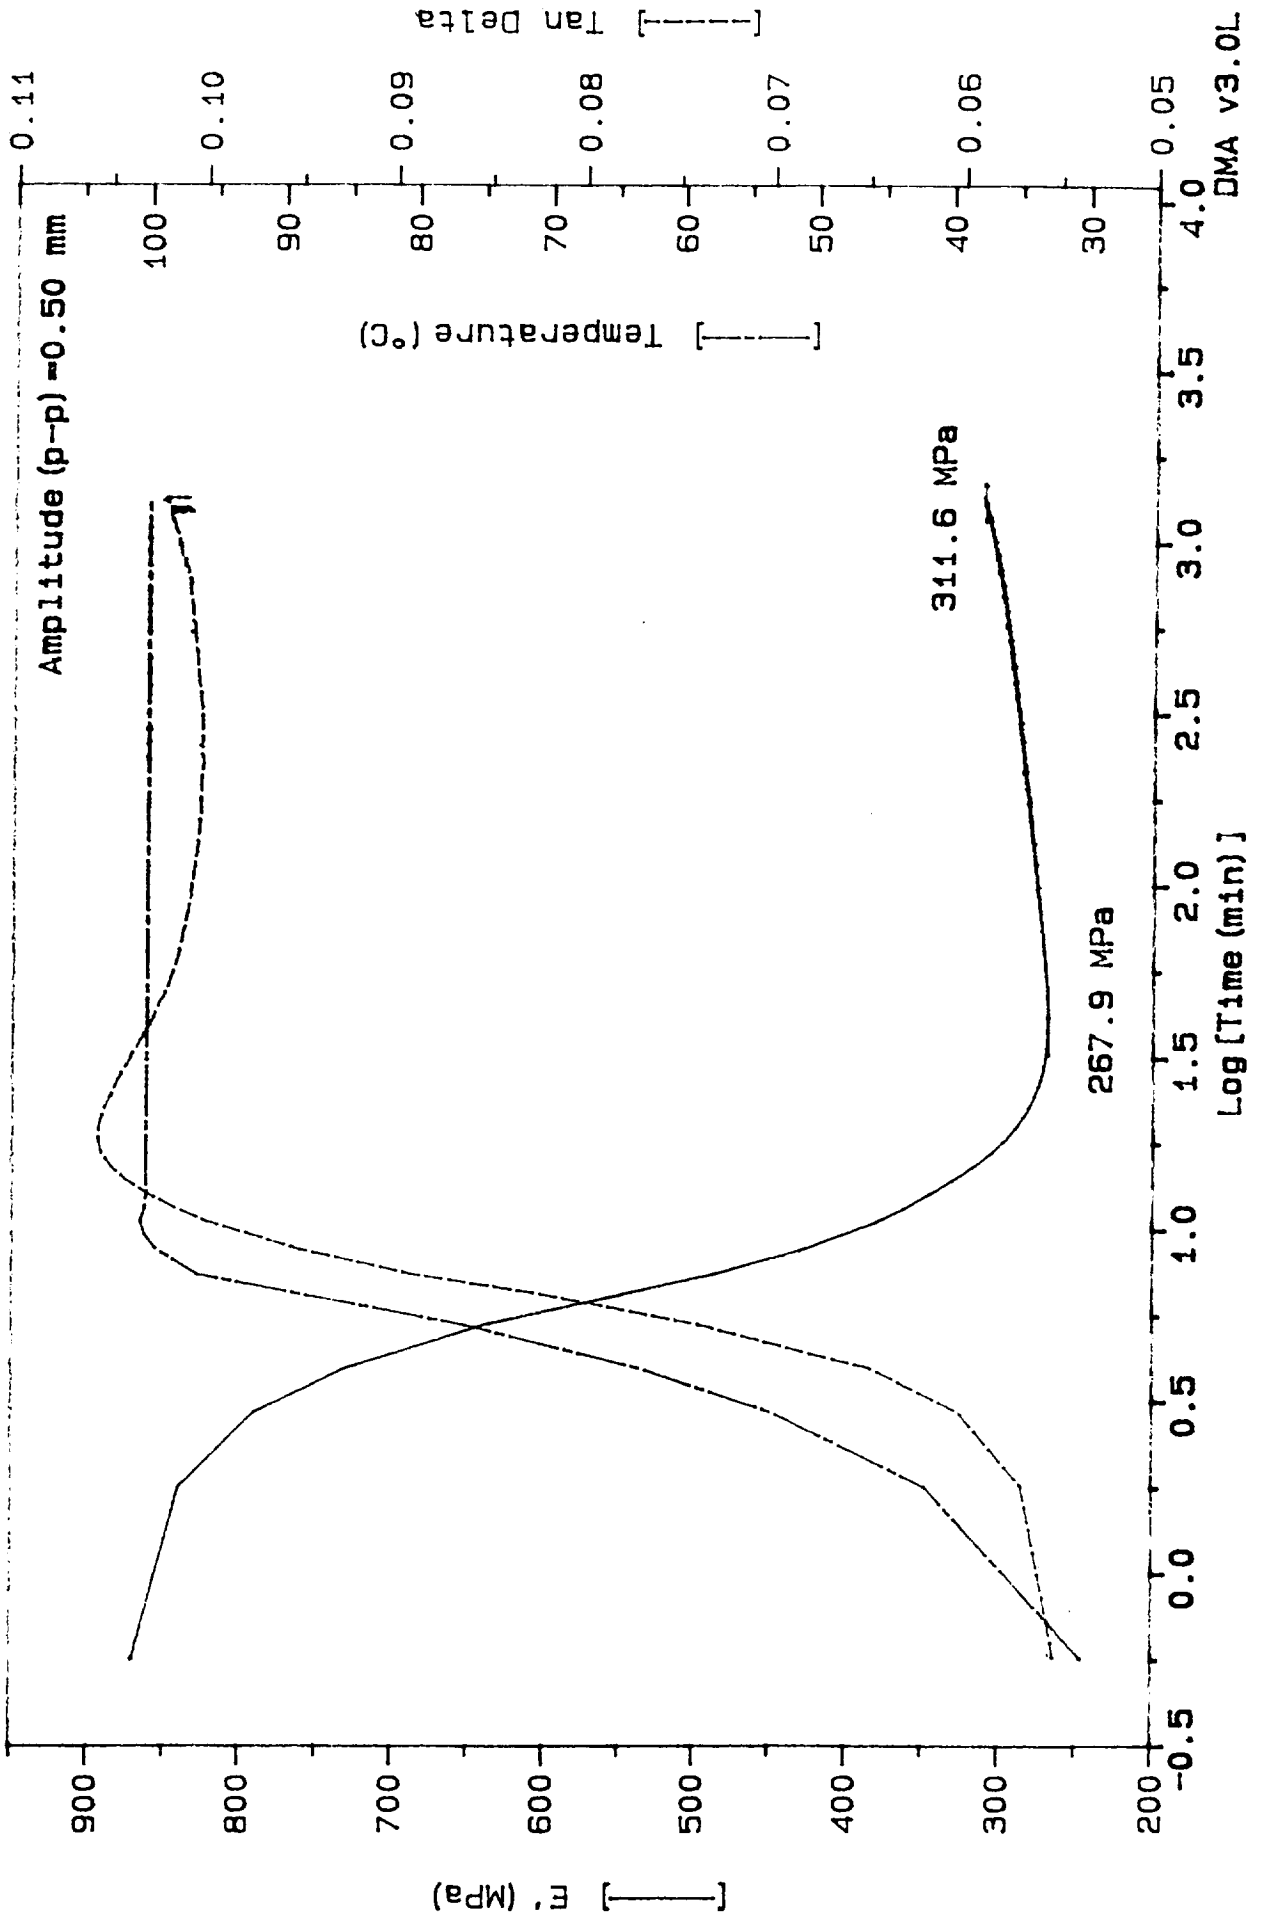
Sample : COFLON

Method : 1 HZ ISOTHERM ELEV TEMP

Dynamic Mechanical Analysis (DMA) of the Coflon material was carried out and is contained in Appendix 3. The initial flexural modulus was in good agreement with previously published information. Upon heating the flexural modulus drops to a low of 268 MPa. After which it was noted that the flexural modulus increased to 312 MPa. We believe that the increase is due to the deplasticization. We also noted that the tan delta increases (0.105) until the sample reaches 100°C and then decreases to (0.100). After a long period we again see the tan delta rise during deplasticization to (0.102), as the sample becomes more lossy.

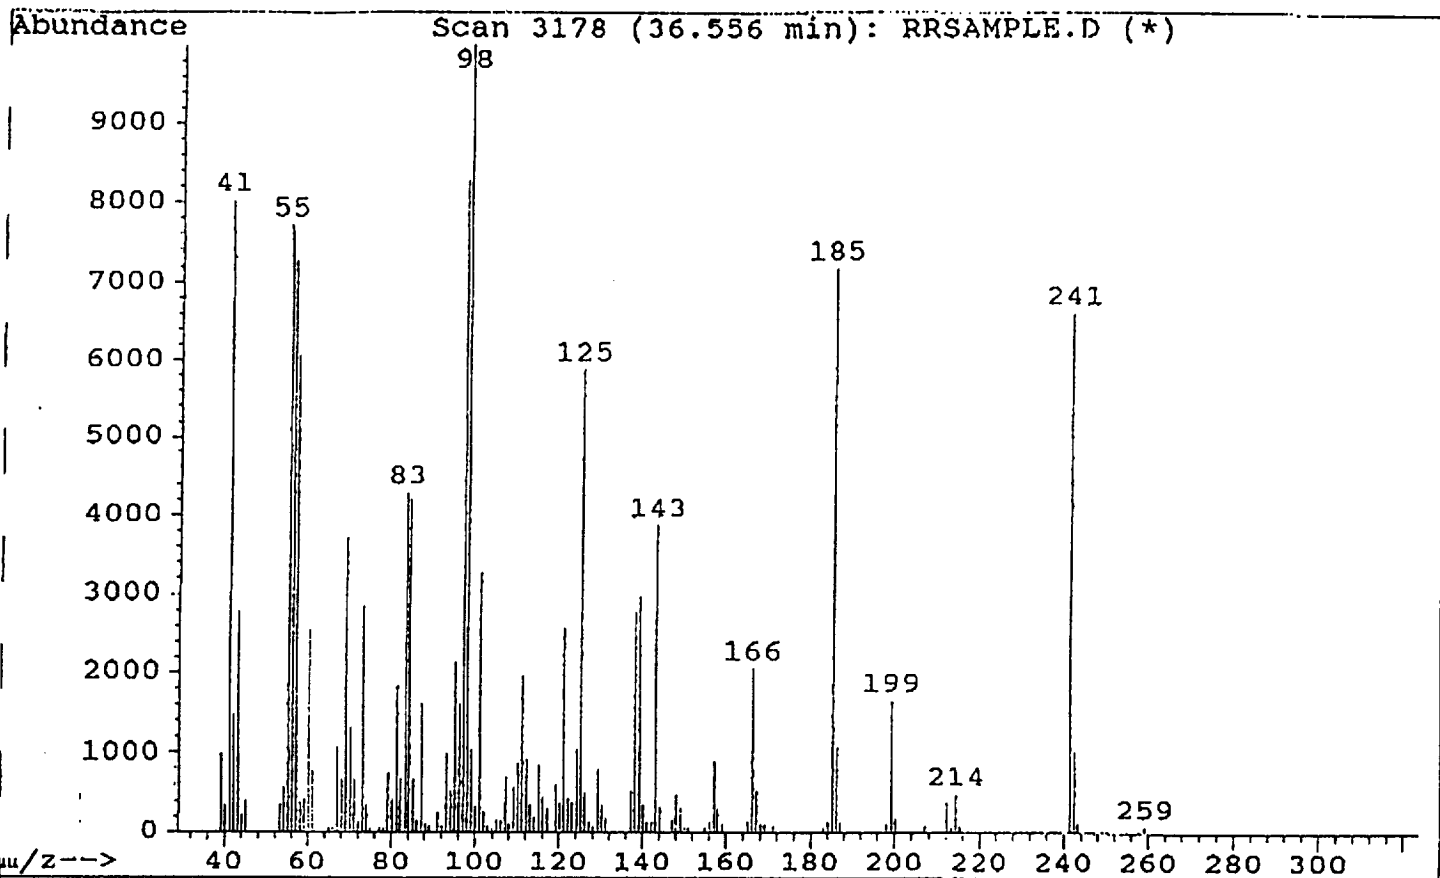
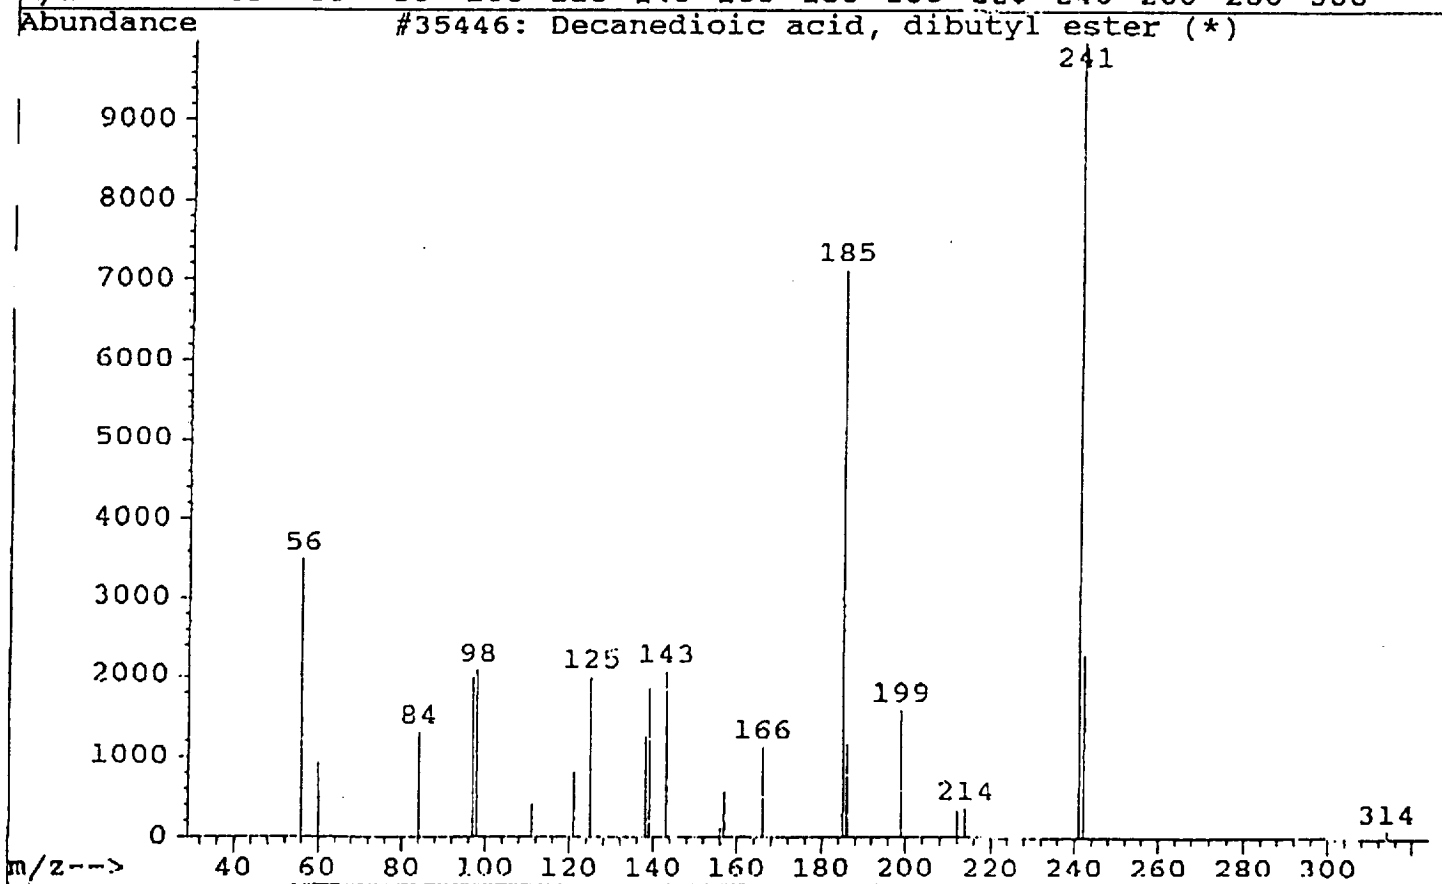
Library Searched : C:\HPCHEM\DATABASE\NBS49K.L
Quality : 38
ID : Decanedioic acid, dibutyl ester

We investigated accelerated high temperature aging of the Coflon material and analyzed the liquid exudate using gas chromatography coupled with mass spectrometry. The mass spectrum of the liquid exudate is provided in Appendix 5. The database search base provided the best match with a dibutyl ester of decanedioic acid. The search routine can only match those compounds catalogued in the library that is approximately seven hundred thousand compounds.

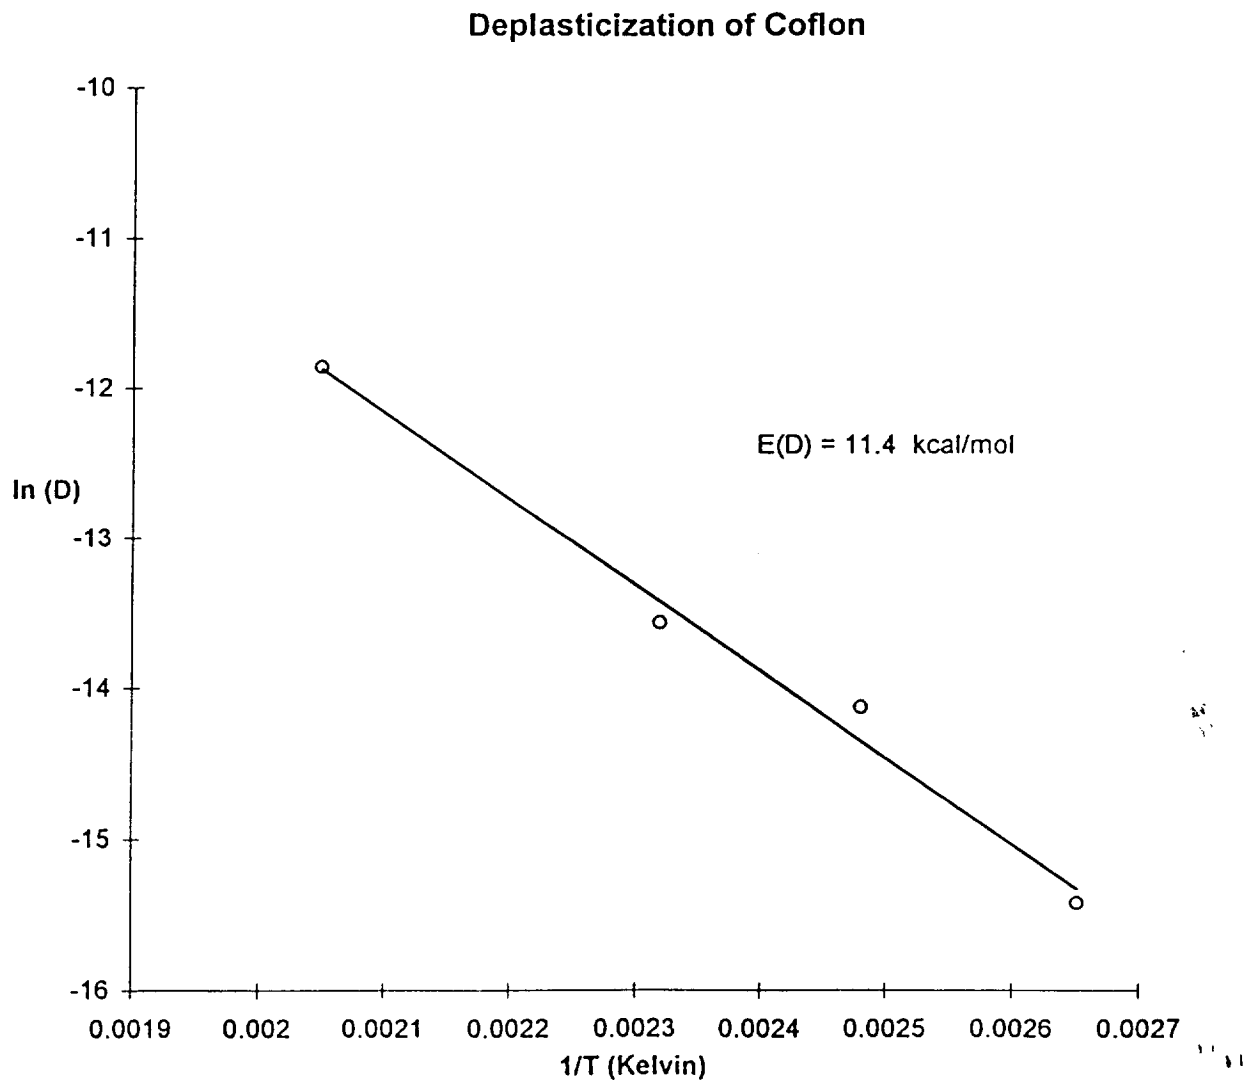
We reanalyzed the thermogravimetric information and recalculated the times associated with deplasticization for the Coflon pipe materials at specific temperatures. Below is the information that relates deplasticization of the Coflon to time and temperature.
