NASA Technical Memorandum 108539

# Random Vibration and Torque Tests of Fasteners Secured With Cable, Room Temperature Vulcanized (RTV) Rubber, and Closed Cell Foam to Support the Launch of STS-82

*V.H. Yost*  
*Marshall Space Flight Center • MSFC, Alabama*

August 1997

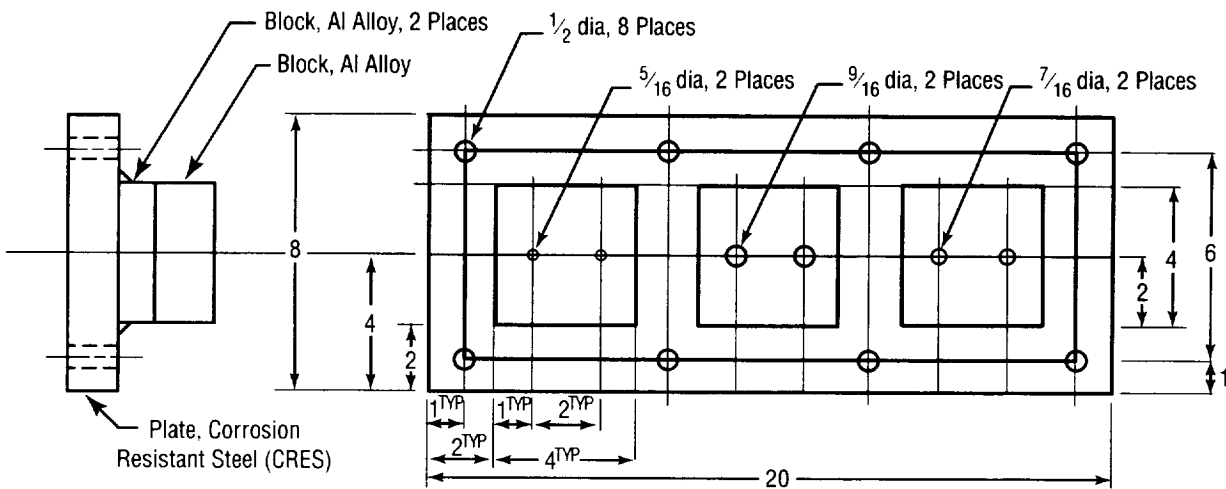
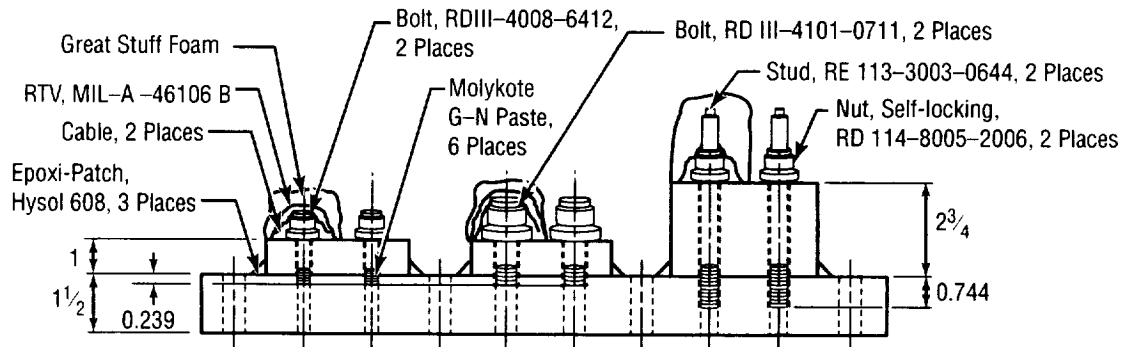
FIGURE 1.—Vibration test fixture (VTF).

Figure 1 shows the vibration test fixture (VTF). Prior to the first vibration test, the test conductor learned that the holes in the aluminum (Al) block were larger than they should be for aerospace specifications—0.312-inch diameter for the 0.250-inch diameter bolts, 0.500-inch diameter for the 0.4375-inch diameter bolts, and 0.4375-inch diameter for the 0.375-inch diameter studs. For aerospace application, through holes for bolts and studs are only a few thousandths of an inch larger than the bolt or stud. To prevent the blocks from sliding laterally during the vibration tests, the test conductor directed that a bead of Epoxi-Patch be placed around the perimeter of each block at the joint between the block and plate. Curing was accelerated with two heat guns.

Bolts, Cables, Foam, Nuts, RTV, and Studs are not shown in top and side views for clarity.

A comparison of the block height and each bolt and stud showed the thread engagement in the plate to be only 0.239 inch for the bolts. It should have been at least 1.5 times the diameter of the bolts, which is 0.375 inch for the 0.250-inch bolt and 0.656 inch for the 0.4375-inch bolt. The 0.375-inch diameter studs had a thread engagement of 0.744 inch, which is 0.181 inch more than is required. The threads of each bolt and stud were coated with Molykote G-N paste before installation.

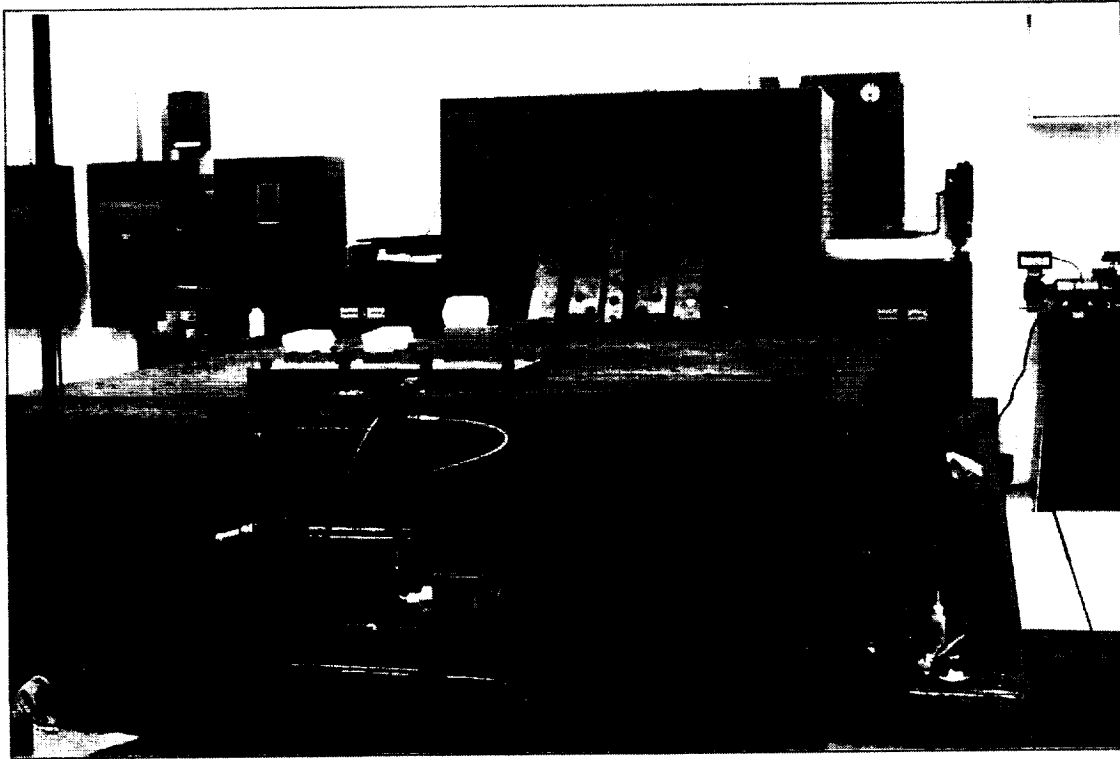
FIGURE 2.—Vibration machine with VTF.

Figure 2 shows the VTF bolted to the vibration machine table and the accelerometer used to measure the vibration to which the VTF was subjected. It also shows the bolts which were secured by cable, RTV, and Great Stuff Expanding Foam and those that were not, as well as the stud that was secured by RTV and foam and the stud that was not.

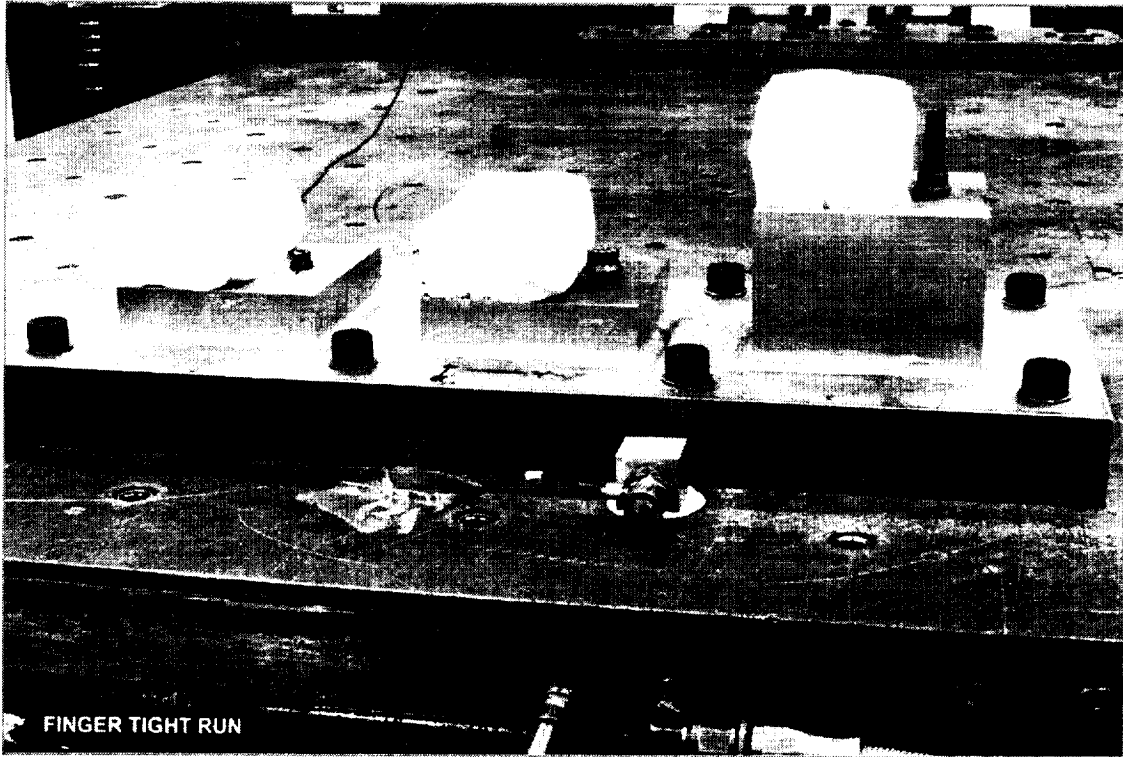
FIGURE 3.—VTF and loosened fasteners after run 1.

For the first vibration test (run 1), all bolts and studs were finger-tight. The random vibration requested was for the SSME Vibration Criteria, Zone D (see appendix B). Prior to this test, these random vibrations caused an electrical fusible link in another vibration machine to fail. So, for this test, the vibration machine shown in figure 2 was run at  $-3$  dB below the levels shown in appendix B (44.94 grms versus 63.48 grms). After 31 seconds at this level, the unsecured 0.250-inch bolt rotated counterclockwise (loosened) 80 degrees, and the 0.4375-inch bolt and 0.375-inch bolt loosened 60 degrees. The data recorded for this and all other vibration tests are in appendix C. Figure 3 shows the VTF and loosened bolts after run 1. Figures 4 and 5 show the loosening of 0.250-inch bolt and 0.375-inch stud at 80 and 60 degrees, respectively.

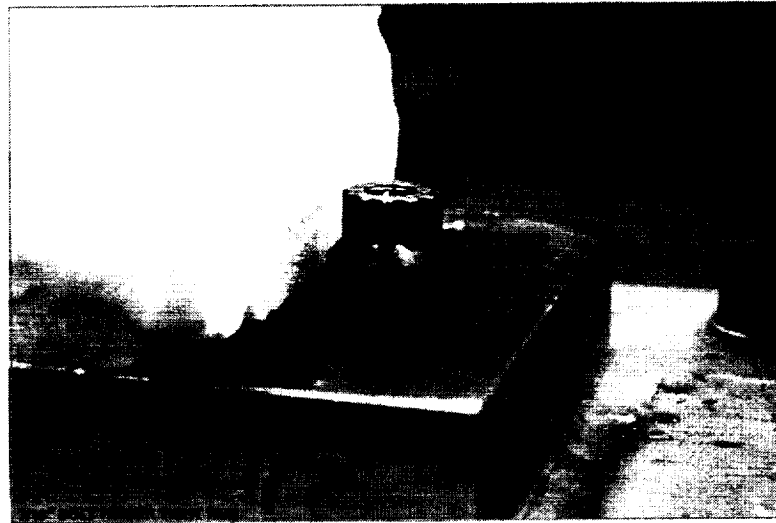
FIGURE 6.—VTF with loosened 0.4375-inch bolt after run 2.

For run 2, the bolts were left in the loosened positions at the end of run 1. They were then subjected to 48 seconds of the random vibration described in appendix B and presented graphically in appendix D, figure D-1. The unsecured 0.250- and 0.4375-inch bolts loosened an additional 10 and 740 degrees, respectively, and the 0.375-inch stud loosened an additional 210 degrees. Figure 6 shows the 0.4375-inch bolt loosened 800 degrees, 60 degrees from run 1 and 740 degrees from run 2.

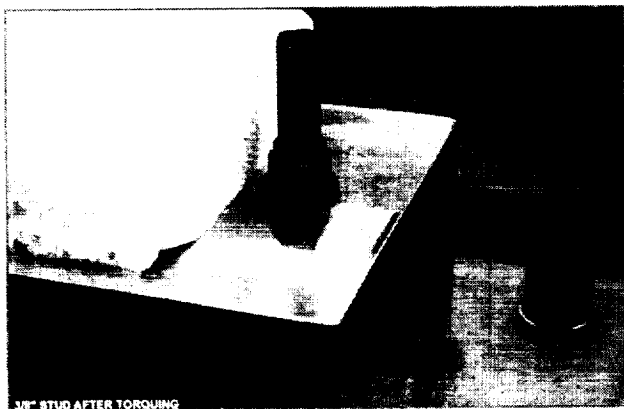
FIGURE 7.—VTF with loosened 0.375-inch stud after run 3.

Prior to run 3, the 0.250- and 0.4375-inch bolts were tightened to 45 and 420 inch-pounds, respectively, and the 0.375-inch stud to 150-inch pounds. These torques were obtained from MSFC-STD-486A. For run 3, the bolts and stud were subjected to 182 seconds of the random vibration criteria described in appendix B and presented graphically in appendix D, figures D-2 through D-6. Run 3 was made in five parts because the vibration machine was operating at essentially its maximum random composite reference level, and it electrically turned itself off at 42, 58, 104, 147, and 182 seconds. At 143 seconds, the 0.375-inch stud loosened (see fig. 7). Figure 8 shows the VTF, tight 0.250- and 0.4375-inch bolts, and a loosened stud. During the early part of this run, the bond between the plate and the Epoxi-Patch broke on the four sides of the three blocks.

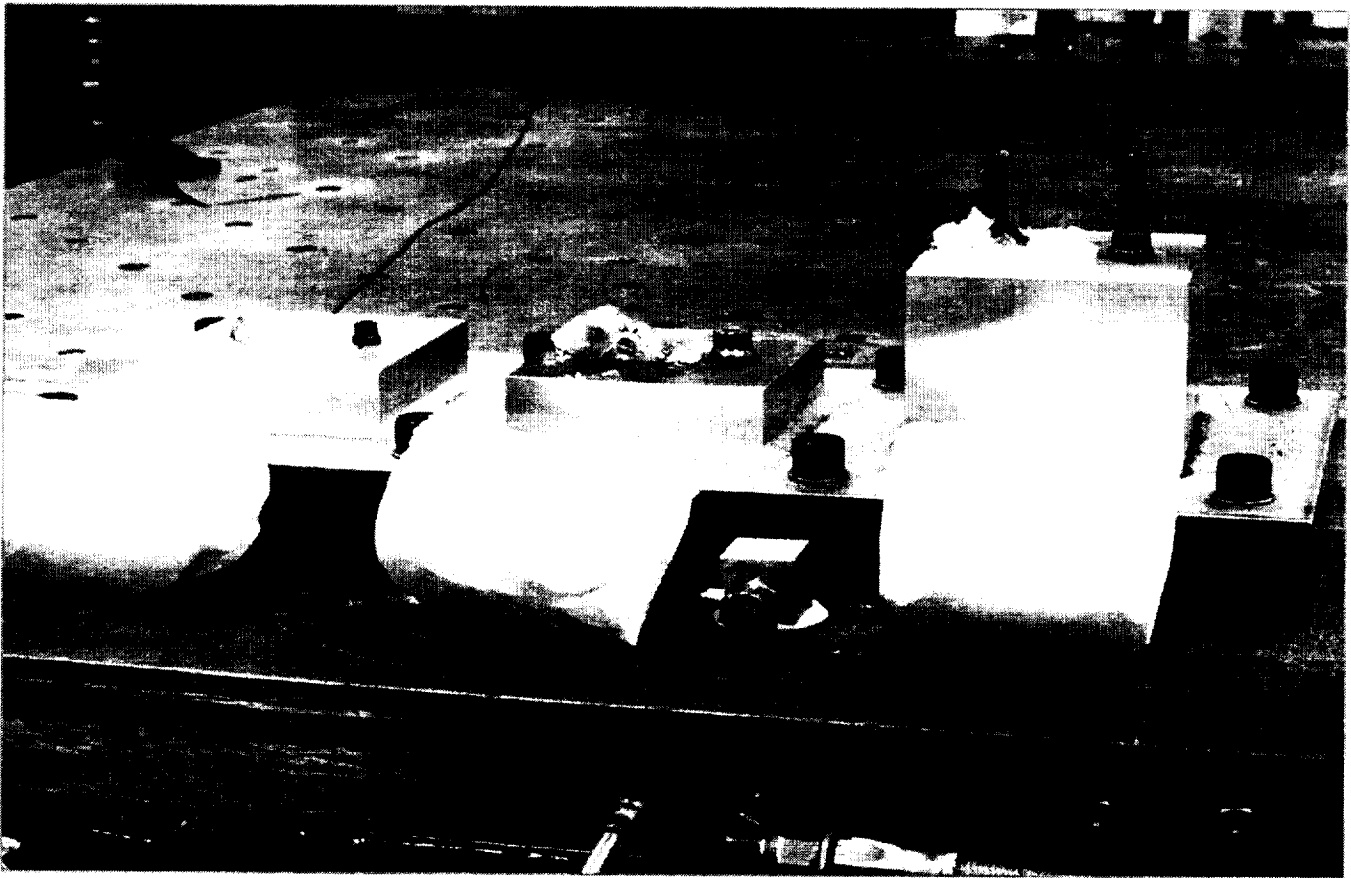
FIGURE 9.—VTF with foam removed after run 4.

After run 4, the foam was removed from the two bolts and one stud (see fig. 9). The 0.250- and 0.4375-inch bolts under the foam were secured with a 2-inch-long cable and RTV over the cables, bolt heads, and onto the VTF. The RTV was found to be only partially cured because the foam was sprayed over it immediately following the application of the RTV. This inhibited the RTV's absorption of moisture from the air which RTV needs to cure. Inspection of the bolts and stud, which were only finger-tight, showed they had not loosened. Figures 10, 11, and 12 show the bolts and stud with the RTV removed. The marks on the bolt heads, stud nut, and VTF were aligned after the four runs, a total of 300 seconds of random vibration.

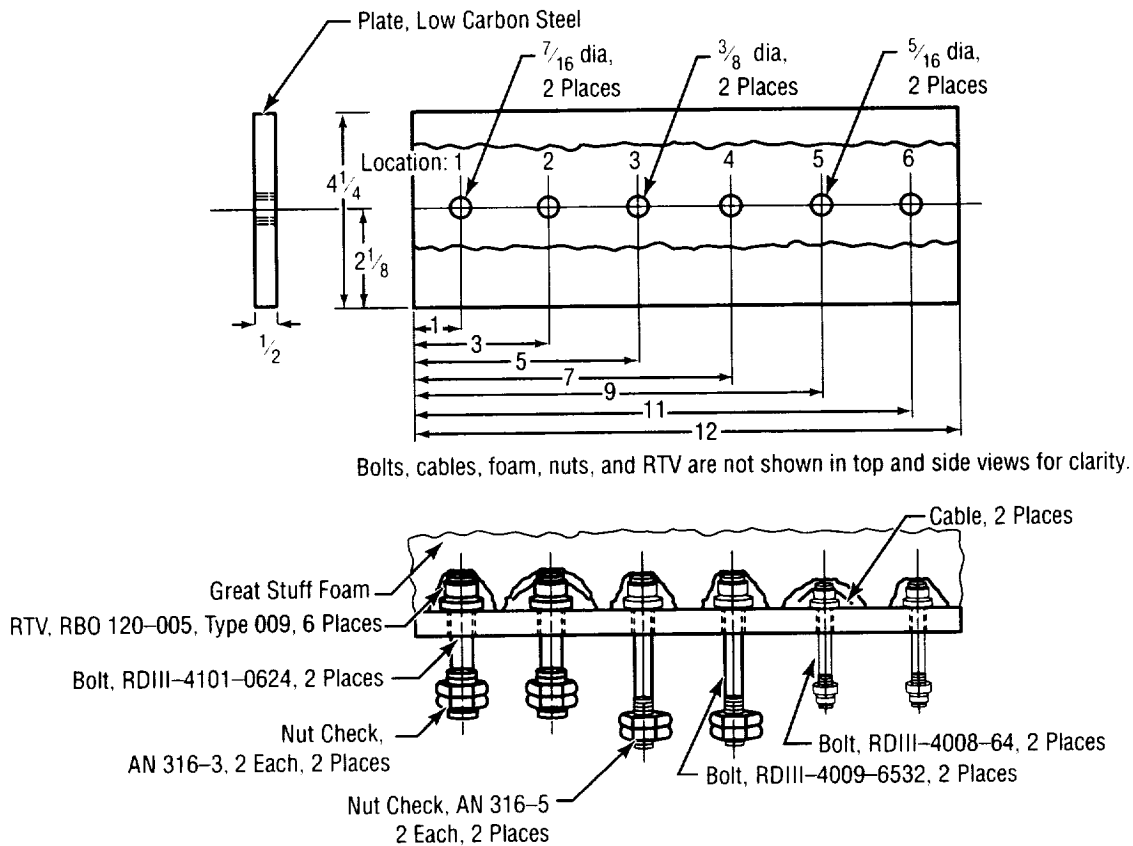
FIGURE 13.—Torque test fixture (TTF).

Figure 13 is an illustration of the torque test fixture (TTF) and the combination of cable, RTV, and foam for each bolt. The bolts at locations 1, 3, 4, and 6 did not have cables, so only RTV and foam were used to secure them.

The holes in the plate were larger than they should be for aerospace applications. Holes 1 and 2 were 0.4375-inch diameter for the 0.375-inch diameter bolts, holes 3 and 4 were 0.375-inch diameter for the 0.3125-inch diameter bolts, and holes 5 and 6 were 0.3125-inch diameter for the 0.250-inch diameter bolts.

The bolts were mounted in the plate and one cable, approximately 2 inches long, was threaded through a hole in the head of bolts 2 and 5. Then the bolt heads and cables were covered with RTV as described in appendix E. Next, RTV was cured in air for 6 hours. Finally, the bolt heads, cables, and RTV were covered with Great Stuff Foam, which was cured for 16 hours. Prior to the torque tests, the plate was laid foam-down on a bench so the torque wrench with the appropriate socket could be placed on the double nuts with the wrench dial facing up.

For the 0.375-inch diameter bolts, the break torque was 0.5 inch-pounds greater for bolt 2, which had the cable through its head, than for bolt 1 (7 versus 6.5 inch-pounds). However, once the bond with the plate was broken for these bolts, bolt 1, which did not have the cable, had the greater run torque (3 versus 2 inch-pounds). Bolts 3 and 4 are 0.3125-inch diameter and did not have cables, only RTV and foam. Like the 0.375-inch diameter bolts, the break torques were within 0.5 inch-pounds of each other (bolt 3, 4 inch-pounds, and bolt 4, 3.5 inch-pounds). The run torques were also within 0.5 inch-pound of each other. Bolt 3 had the lower torque (bolt 3, 1.5 inch-pounds, and bolt 4, 2.0 inch-pounds).

For the 0.250-inch diameter bolts, bolt 5—which was secured with a cable, RTV, and foam—had nearly twice the break torque as bolt 6, which was secured RTV and foam (bolt 5, 3.5 inch-pounds and bolt 6, 2 inch-pounds). Both bolts had a run torque about one-half the break torque (1.5 inch-pounds).
