*NASA Conference Publication 3312*

# Thermal Barrier Coating Workshop

*Proceedings of a conference held at  
NASA Lewis Research Center  
Cleveland, Ohio  
March 27-29, 1995*

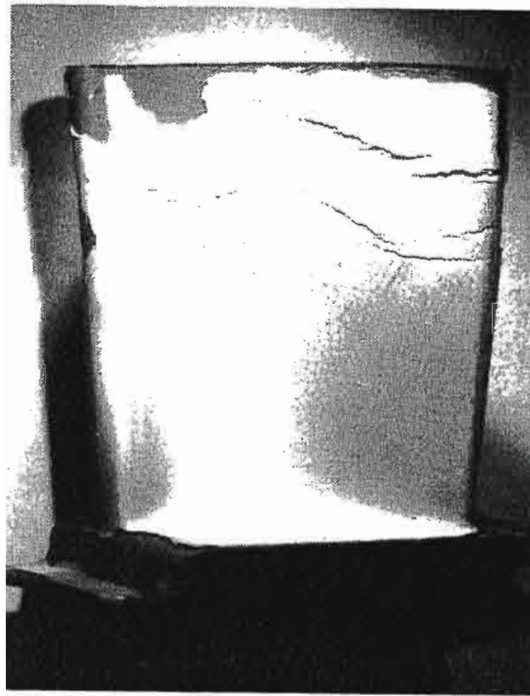
Figure 3. EB-PVD Ytria Stabilized Zirconia Coated Blade Showing Coating Distress and Cracking Near Trailing Edge

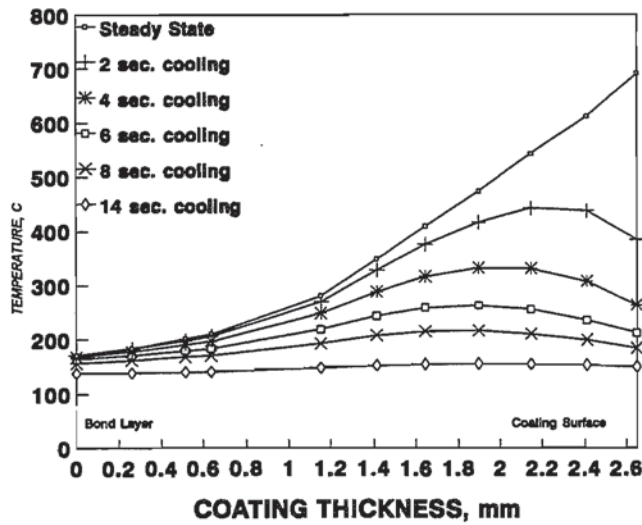
Figure 2. Coating Temperature Changes During Cooling from Steady State Engine Conditions.

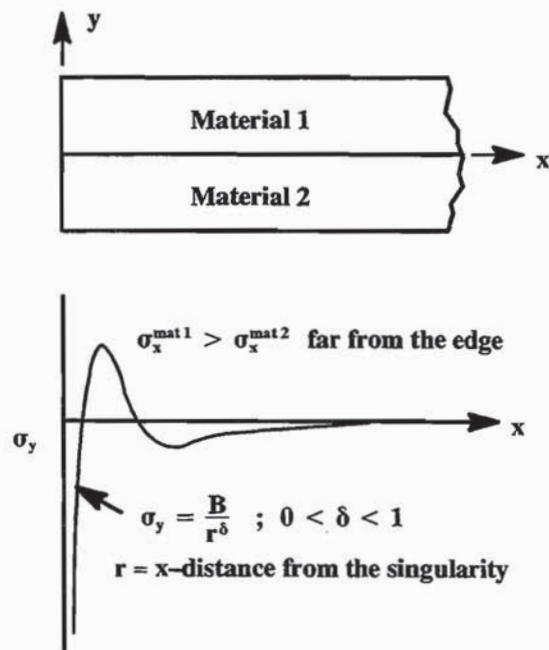
Figure 7: General Shape of the Normal Stress Singularity Along the Interface
