NASA Technical Memorandum 109168

# Flutter Clearance Flight Tests of an OV-10A Airplane Modified for Wake Vortex Flight Experiments

April 1995

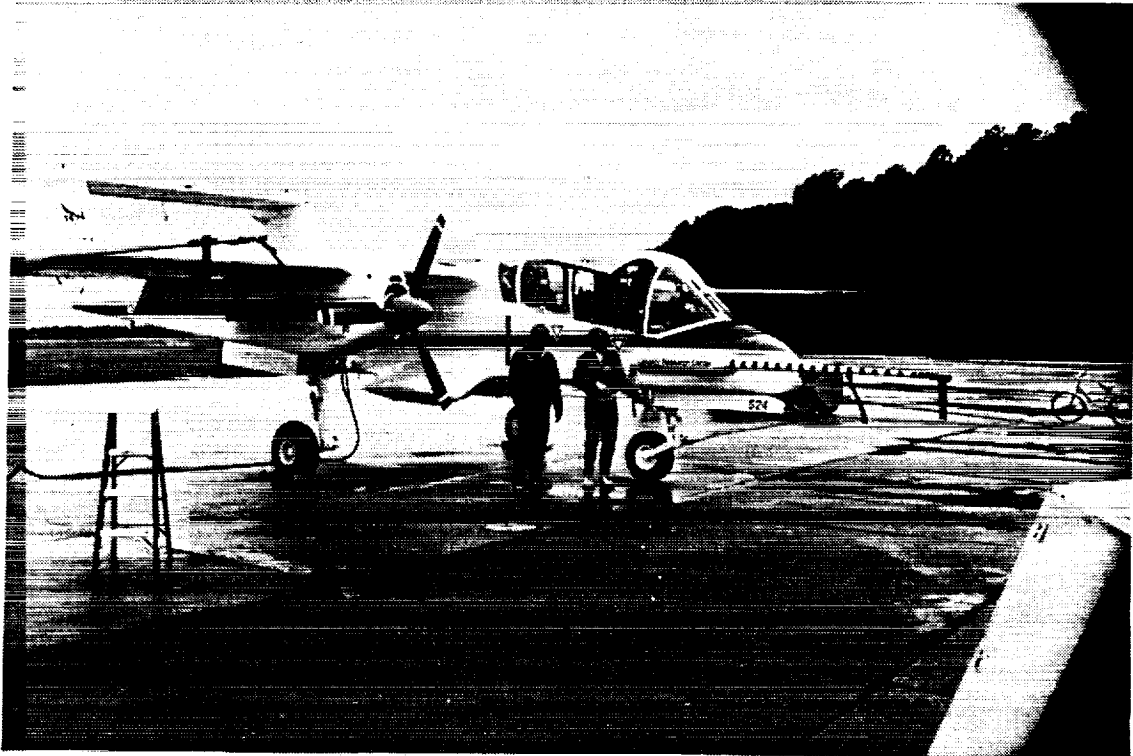
Figure 1. - Photograph of OV-10 airplane with booms.

As part of an ongoing research program to understand the effects of atmospheric characteristics such as turbulence and winds on wake vortex flows, NASA Langley has specially instrumented an OV-10A (NASA 524) airplane for use in flight research studies. Figure 1 is a photograph of this airplane.

The modifications of the basic OV-10A included the addition of three instrumentation booms and an onboard instrumentation pallet. A large, graphite-epoxy boom extending approximately one chord length forward of the leading edge of the wing was installed on each wing tip. At the end of each of these booms is a pair of vanes as well as a pitot-static probe. One vane was oriented to measure angle of attack; the other vane was oriented to measure angle of sideslip. A third forward-extending boom was mounted to the right side of the fuselage near the nose. A 5-hole pressure probe was mounted on the forward end of this boom to measure flow angles and velocity. These three systems are necessary to measure the severe flow gradients found in vortex flows.

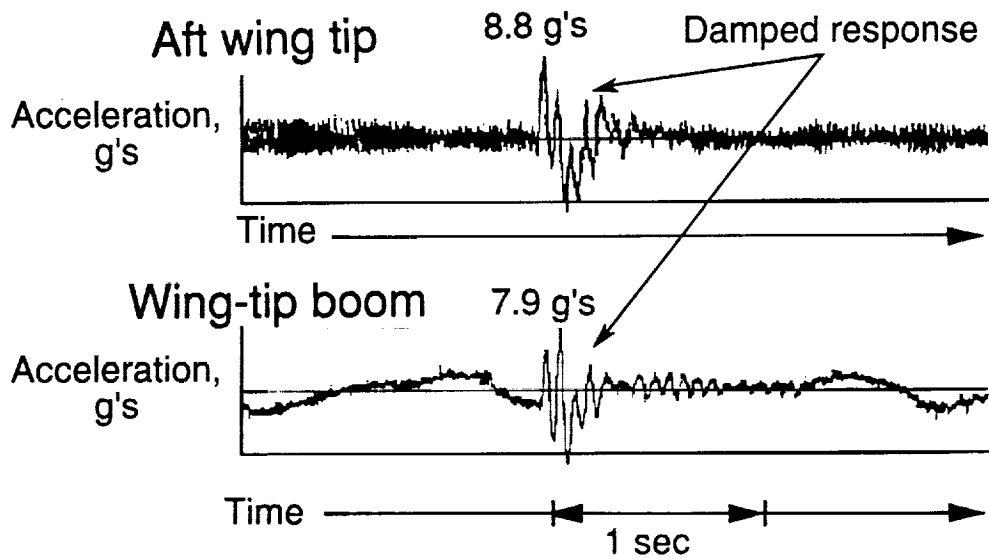
Figure 2. - Responses recorded on strip charts from aileron rap at 5000 ft altitude and 330 KEAS.

other maximum speed and starting altitude pairs were: 275 KEAS, 10,000 feet; 300 KEAS, 12,500 feet; 318 KEAS, 12,500 feet; and 330 KEAS, 12,500 feet. No unusual response was observed during these dives. Figure 2 is a reproduction of the strip chart recording of the response obtained for the 330 KEAS dive. Responses are given for the aft wing tip accelerometer, at the top in the figure, and the right wind-tip boom, at the bottom. The responses were relatively low level, of the order of 8 g's for both responses, and well damped. There was no extraordinary increase in response with increasing airspeed. The frequencies of the various structural modes participating in the response remained unchanged. There was no indication whatsoever that a flutter condition was being approached.
