NASA Technical Memorandum 4634  
ATCOM Technical Report 95-A-001

# Exploratory Flow Visualization Investigation of Mast-Mounted Sights in Presence of a Rotor

March 1995

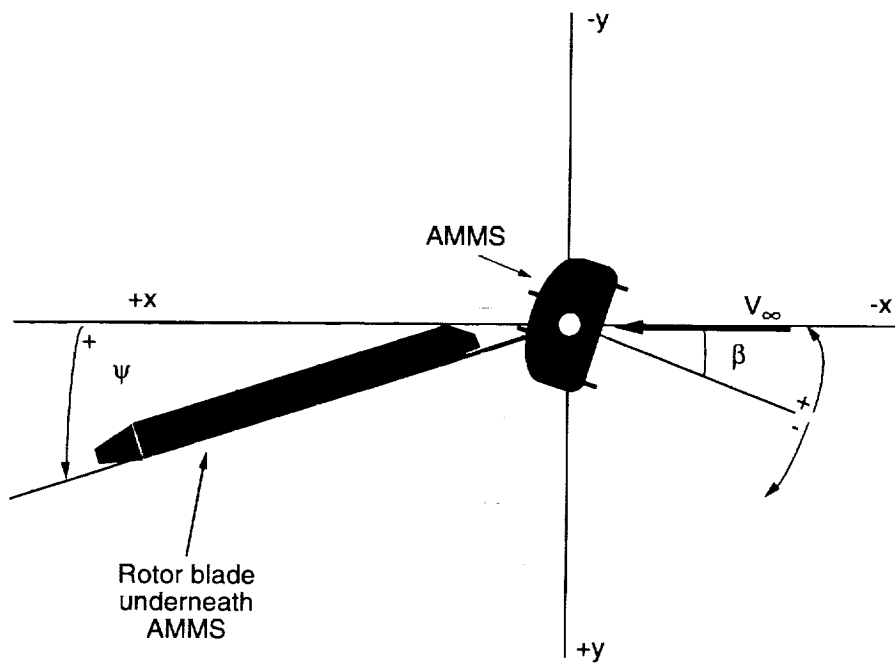
Figure 11. Sign convention of AMMS skew angle and rotor system.

Both the symmetric and the asymmetric mast-mounted sights were made of fiberglass epoxy and were geometrically (but not dynamically) scaled 27 percent to the full-scale sights. These sights were mounted to the hub with hardware adopted from a previous study. Figure 10 shows the sight components, and figure 11 shows the sign convention of the AMMS skew angle and rotor system.
