NASA Technical Memorandum 106768

# Tribology and Microstructure of PS212 With a Cr<sub>2</sub>O<sub>3</sub> Seal Coat

# TRIBOLOGY AND MICROSTRUCTURE OF PS212 WITH A CR<sub>2</sub>O<sub>3</sub> SEAL COAT

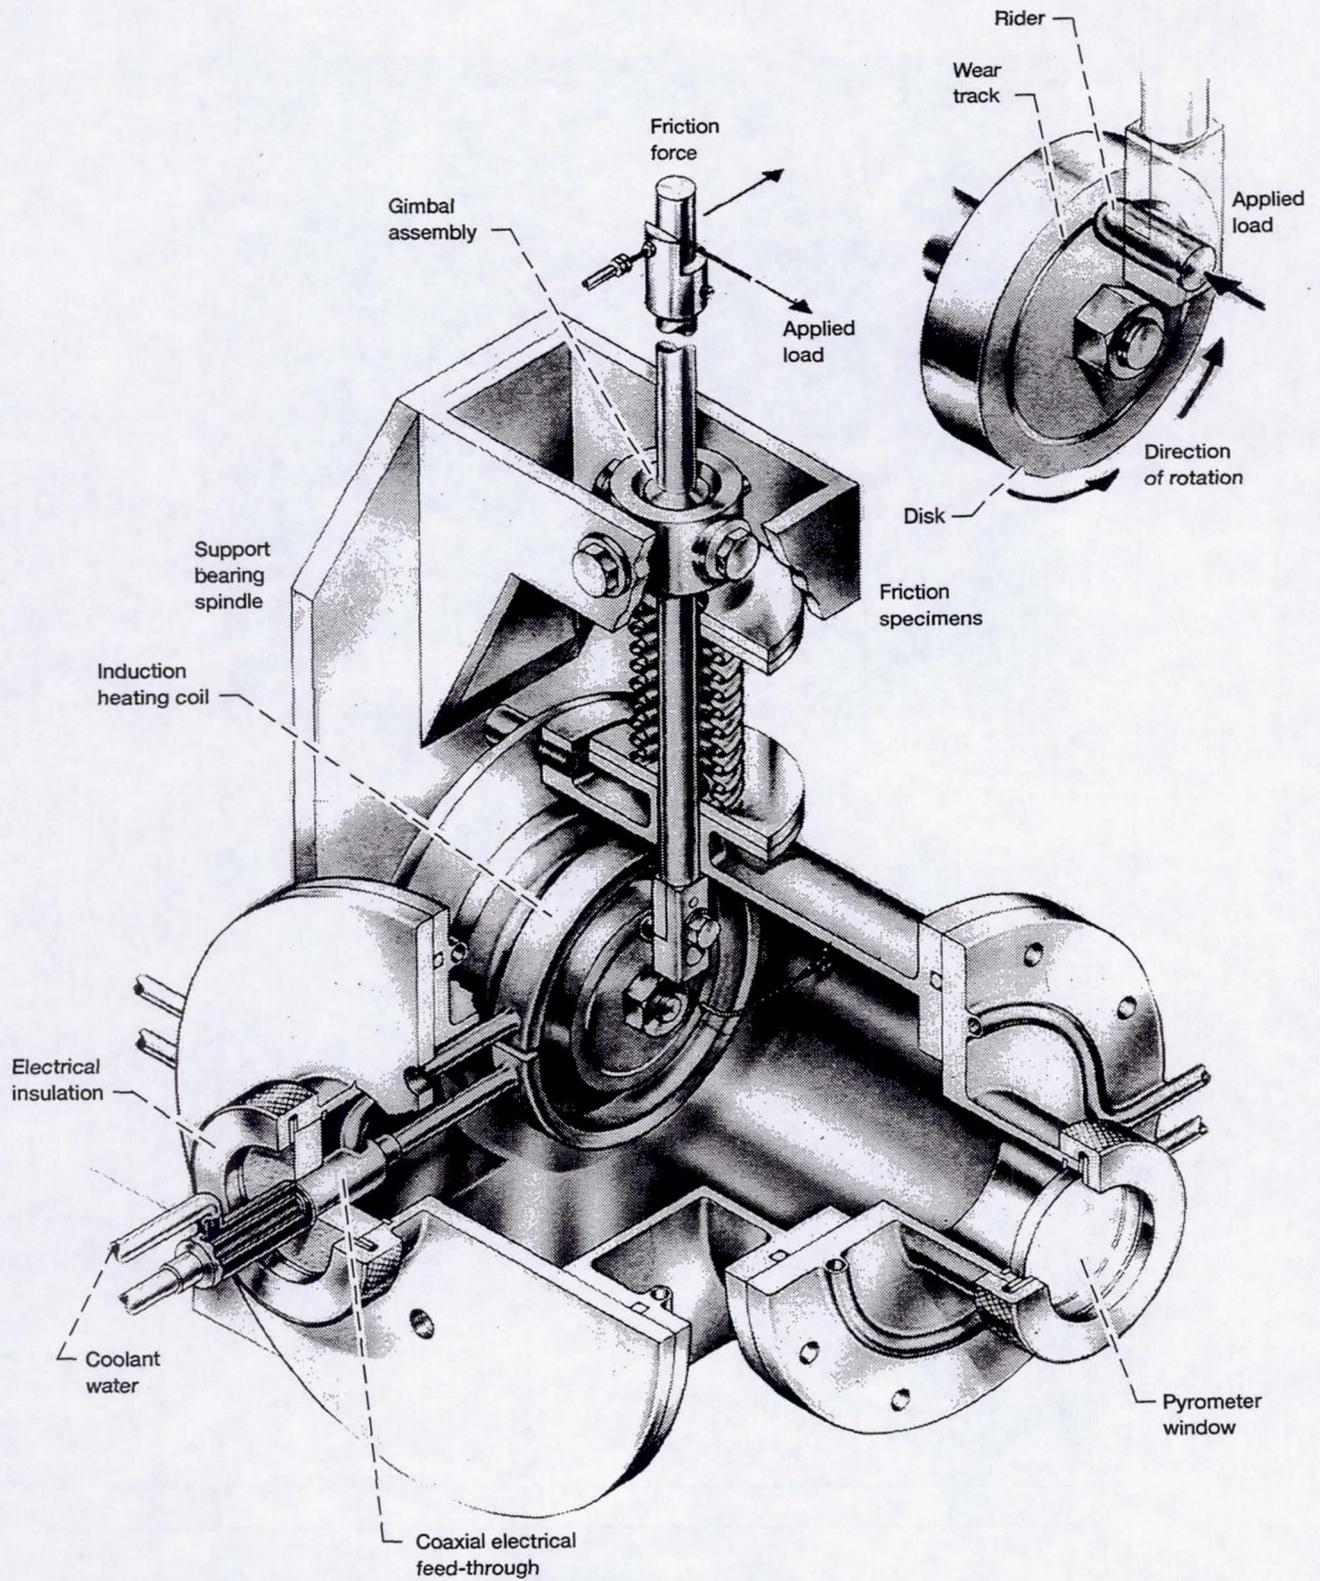
Figure 1.—High-temperature friction apparatus.

Pin on disk testing was done on the tribometer illustrated in figure 1. The pins were made of the nickel base turbine alloy Rene 41 hardened to Rockwell C-40 machined to a 4.76 mm hemispherical radius. Friction and wear testing was done on a total of eight wear disks. A series of three 30 min tests was run on each disk with pin and disk wear measurements taken after each 30 min test. Tests were performed at room temperature and at 800 °C under the following conditions: 9.8N load, 2.8 m/s sliding velocity at 1000 rpm, air atmosphere with 50 percent relative humidity.

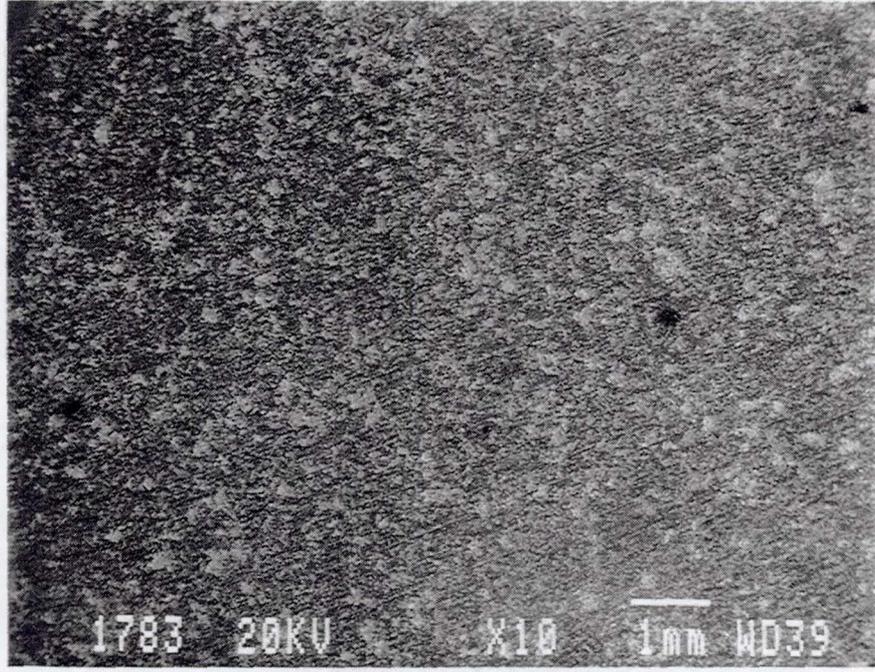
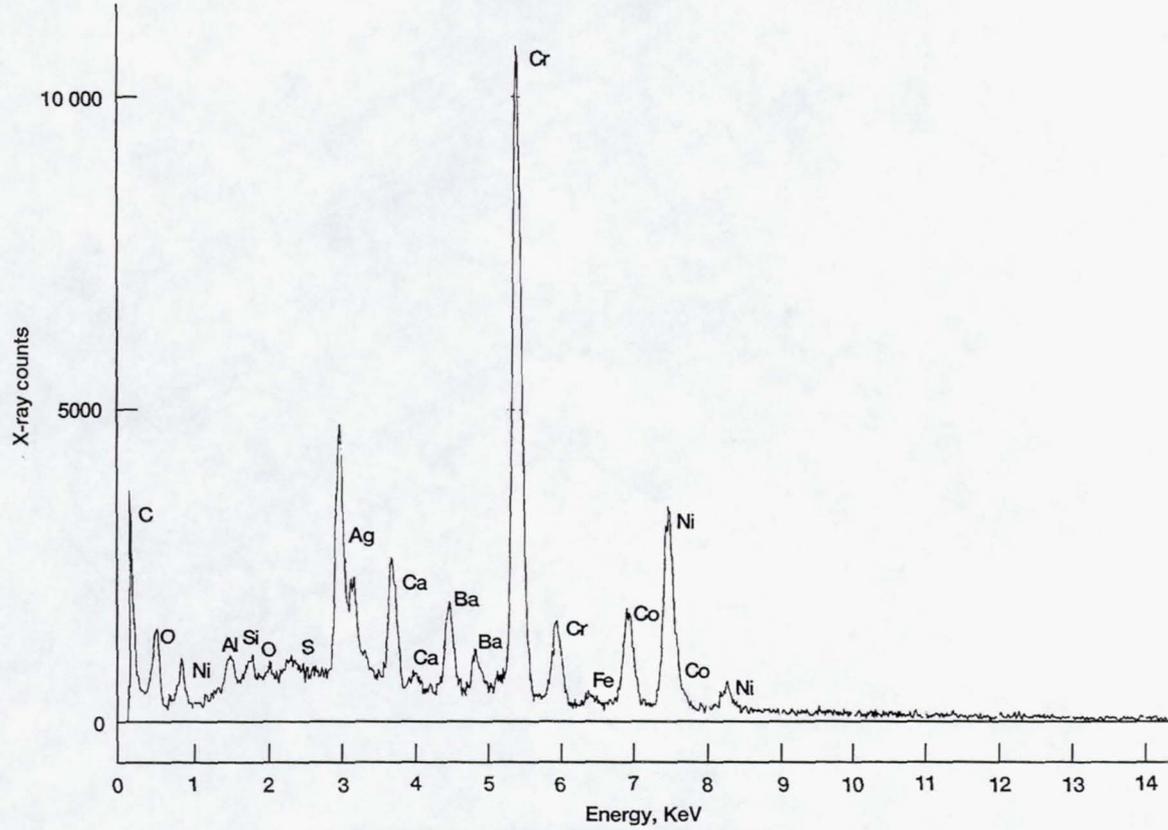
Figure 2.—SEM micrograph and EDS spectrum of baseline PS212 coating.

PS212 coatings.—Photomicrographs and EDS spectra of PS212 were obtained as a baseline for comparison with the seal coat, and with the ground seal coat (item 3 above). A low magnification SEM and the corresponding area averaged EDS spectra are shown in figure 2. The typical surface appearance of PS212 consists of a darker matrix of bonded chromium carbide with lighter areas of silver and fluoride eutectic dispersed throughout.

The EDS spectrum contains the peaks characteristic of PS212: a strong chromium peak, considerable silver along with calcium and barium and the principal elements of the metallic nickel-based binder. Significant carbon due to the carbide and a small oxygen peak are also present.

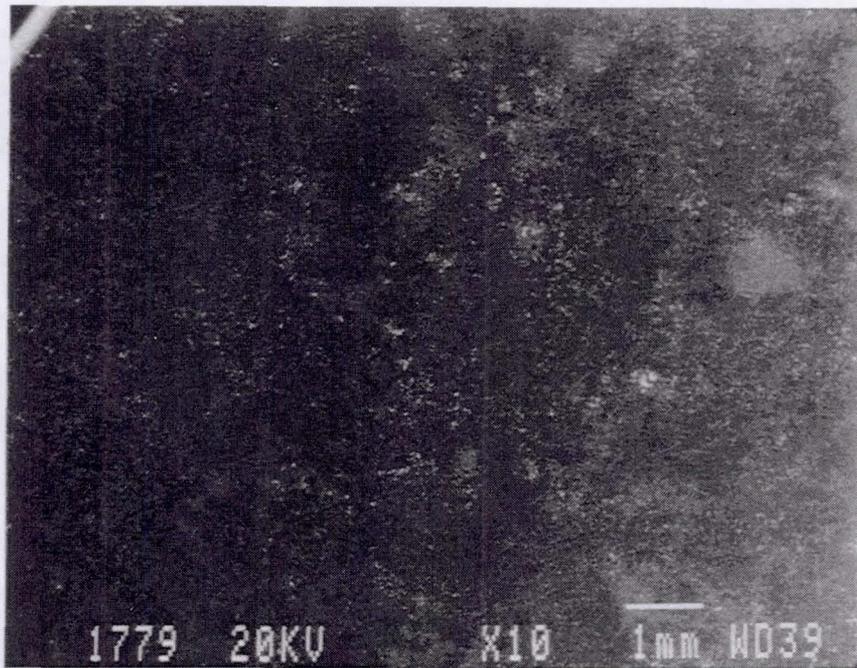
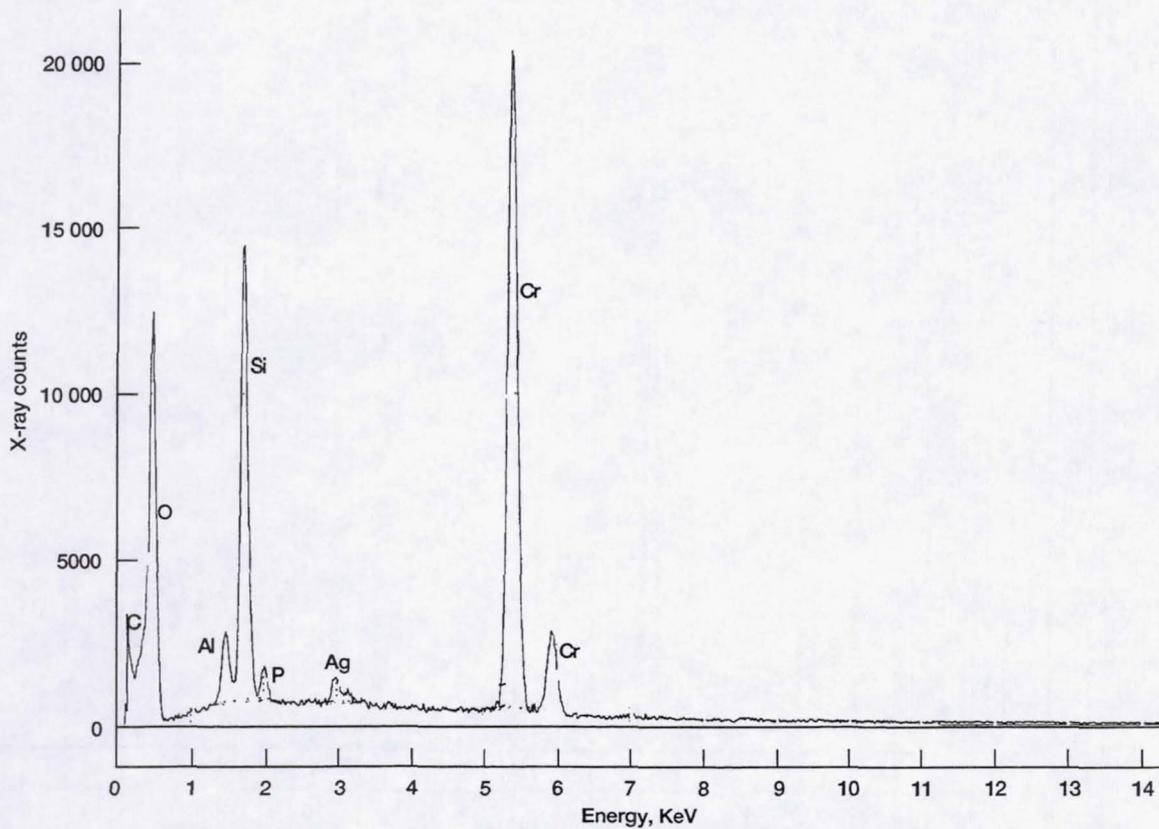
Figure 3.— (a) Low magnification SEM micrograph and EDS spectra of as received unground seal coated PS212 surface. (b) Higher magnification SEM micrograph of seal coating and EDS spectrum of displaced particle.

Seal coating.—A low magnification photomicrograph and EDS spectra of the as-received, unground surface of the seal coating are shown in figure 3(a). The coating appears to be a glassy matrix containing a finely dispersed phase. The EDS spectrum has a strong chromium peak along with significant silicon and oxygen and a weak carbon peak. Weak peaks for aluminum, phosphorus, and silver are also present. A higher magnification SEM micrograph is presented in figure 3(b) along with the EDS spectrum of the dispersed particle labeled "d". The spectrum contains strong chromium, significant oxygen, and very weak silicon peaks. This contrasts with the area analysis of figure 3(b) which shows a high concentration of silicon in the coating matrix. This comparison suggests that the seal coating consists of chromium oxide particles dispersed throughout a silicon-rich, possibly glassy matrix.

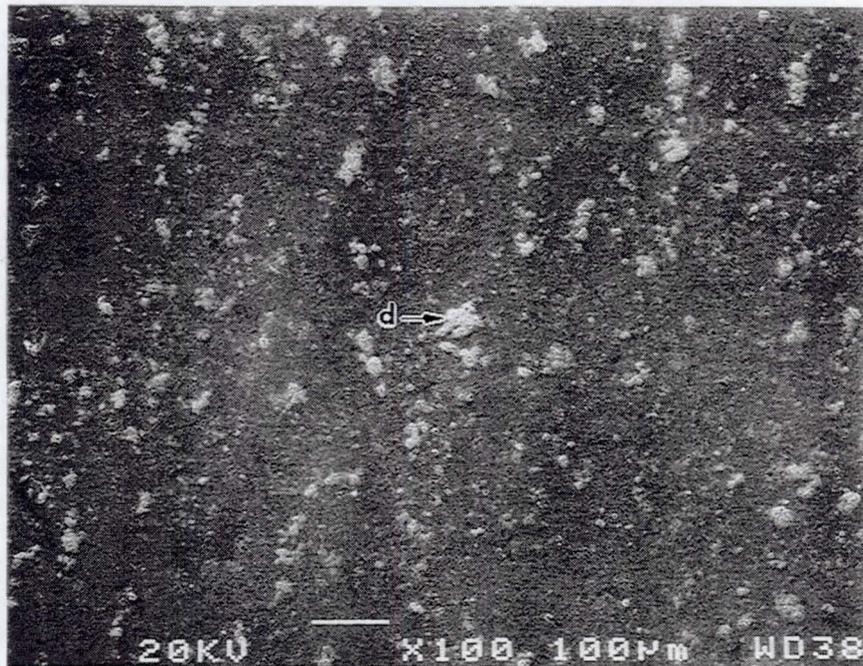
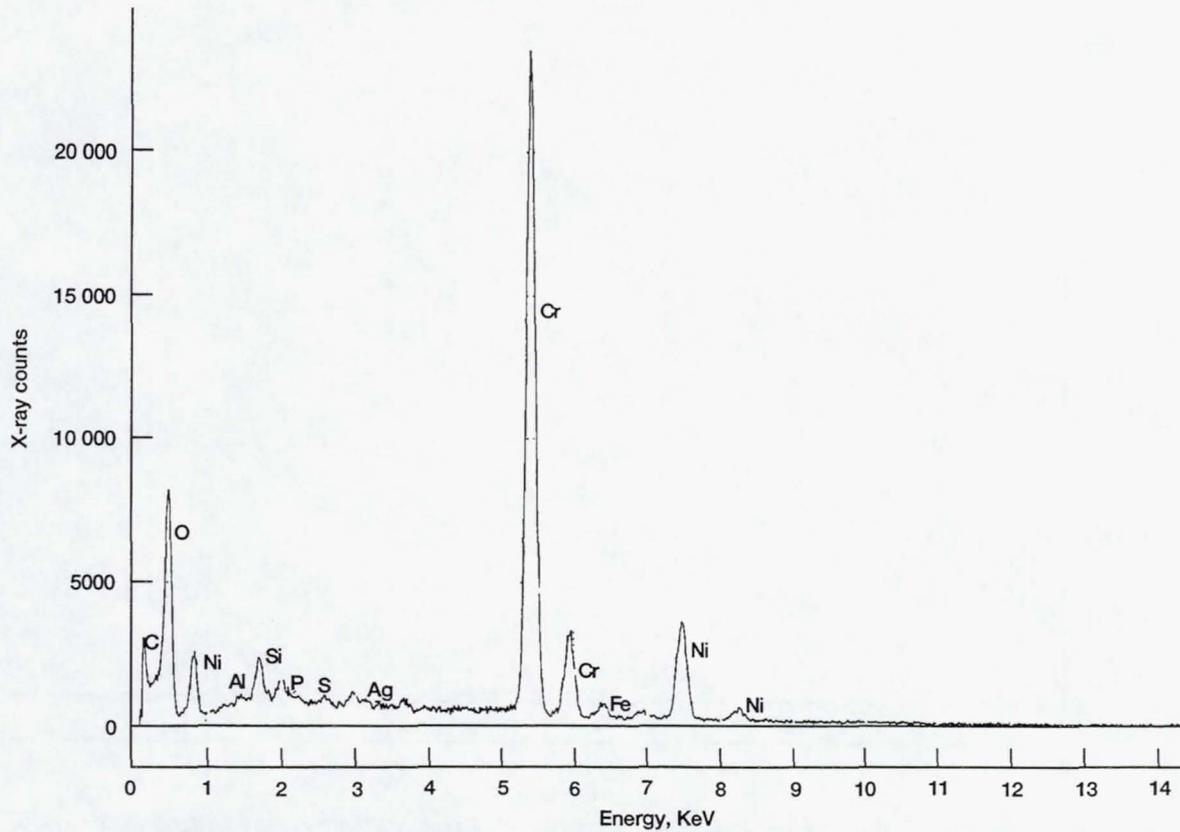
Figure 3.—Concluded. (b) Higher magnification SEM micrograph of seal coating and EDS spectrum of displaced particle.

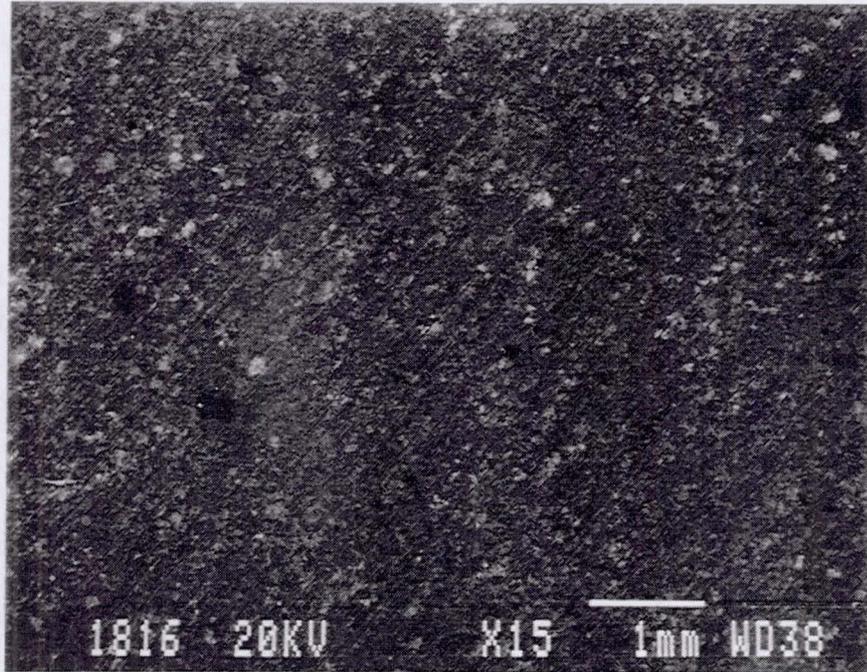
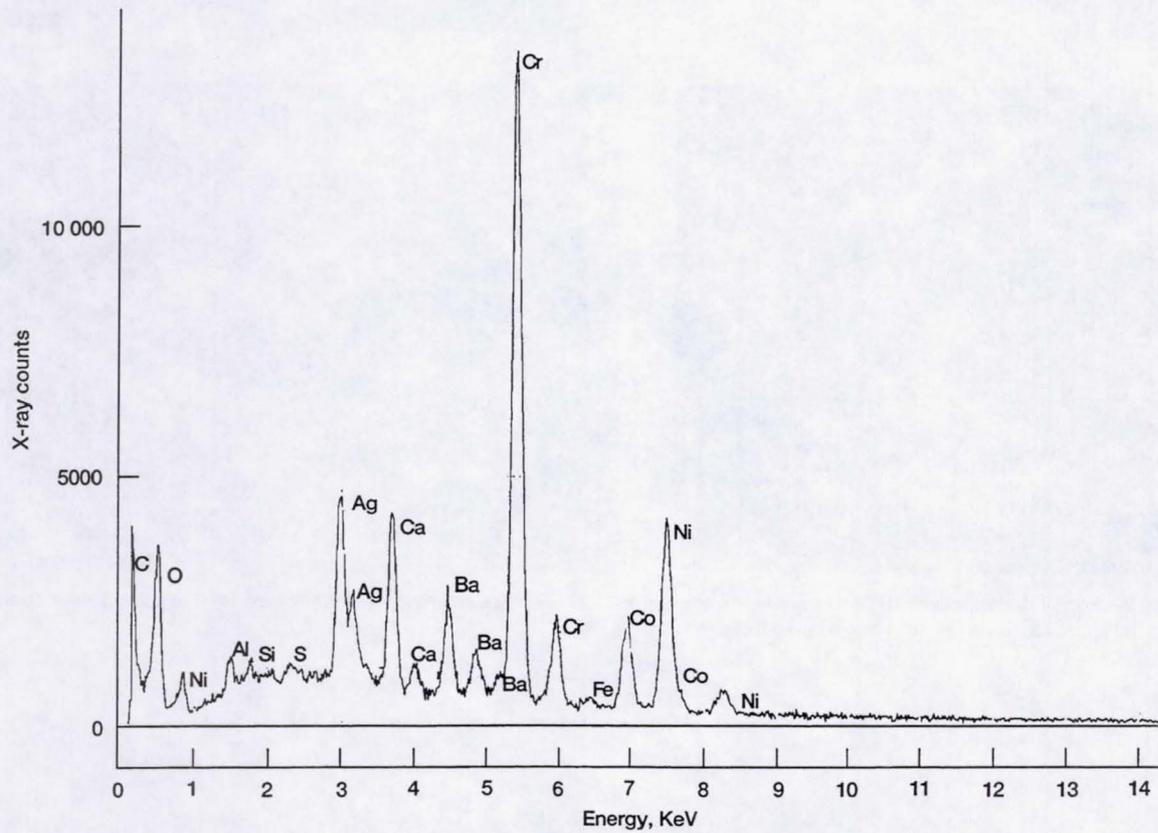
Figure 4.—SEM photomicrograph and EDS spectrum of Cr<sub>2</sub>O<sub>3</sub> seal coating/PS212 interfacial region.

Seal coating/PS212 Interface Region.—Photomicrographs and the EDS spectrum for this surface are presented in Figure 4. The oxygen peak is stronger and the silver peak is weaker than in PS212 indicating residual sealant material is still present; however, calcium, barium, and silver peaks characteristic of PS212 are also present. These EDS data are inconclusive. The visual appearance of the ground coating is at this time the only firm evidence for the presence of residual seal material.

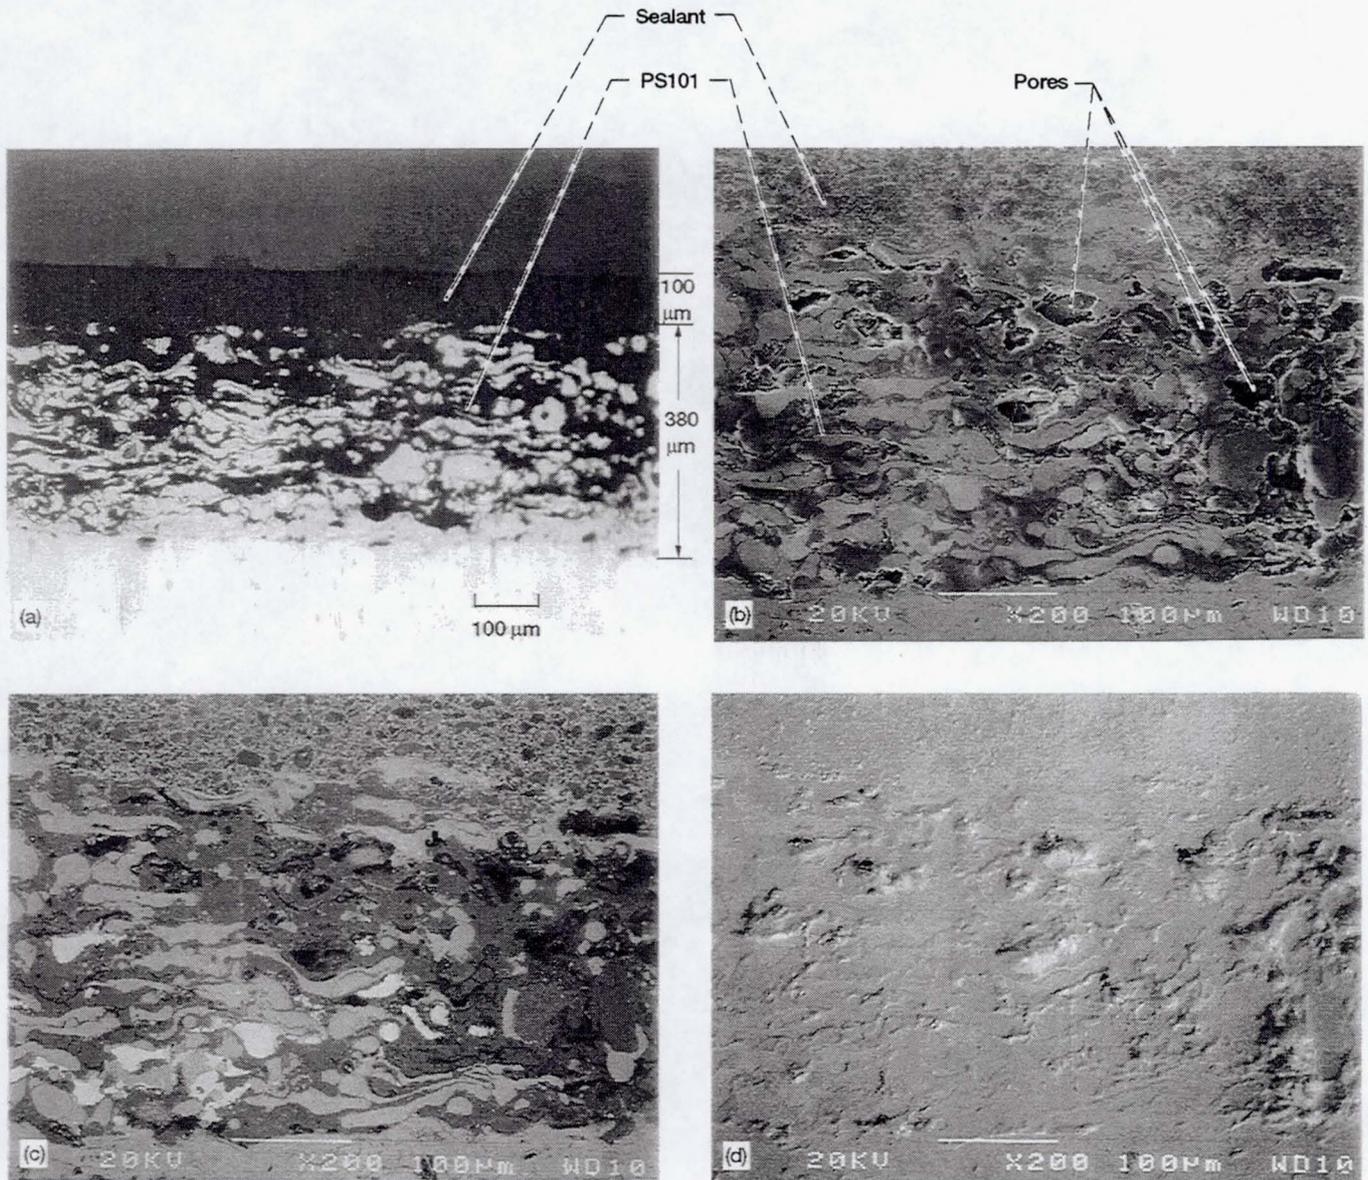
Figure 5.—Cross section of duplex sealant/PS101 coating on Inconel X-750 by various microscopy techniques. (a) Optical. (b) Secondary electron SEM. (c) Back scatter SEM. (d) Topographic SEM.

Figure 5(a) is an optical photomicrograph of a cross section through the duplex coating system consisting of a 380 micrometer thick layer of PS101 with a 100  $\mu\text{m}$  top coat of sealant. There is a very distinct interface of the two coatings.

Figures 5(b) and (c), and d are higher magnification images of the same area obtained by three different modes on a scanning electron microscope; secondary electron emission, back scatter compositional, and topographical. Figure 6 contains x-ray dot maps of the same area. All of these modes show that the seal coating very closely follows all of the interfacial topographical features of the PS101 coating indicating very good wettability of PS101 by the seal coat. This suggests that the sealant should penetrate any porosity that is continuous with the surface of the plasma-sprayed coating. However, there is no evidence that this occurred. The porosity in the PS101 coating is not continuous, but exist as isolated pockets. The pores appear as black areas as imaged by the SEM and back scatter modes. No continuity is seen between these micro voids. The isolated location of these voids is further confirmed by the topographic microstructure shown in figure 5(d).

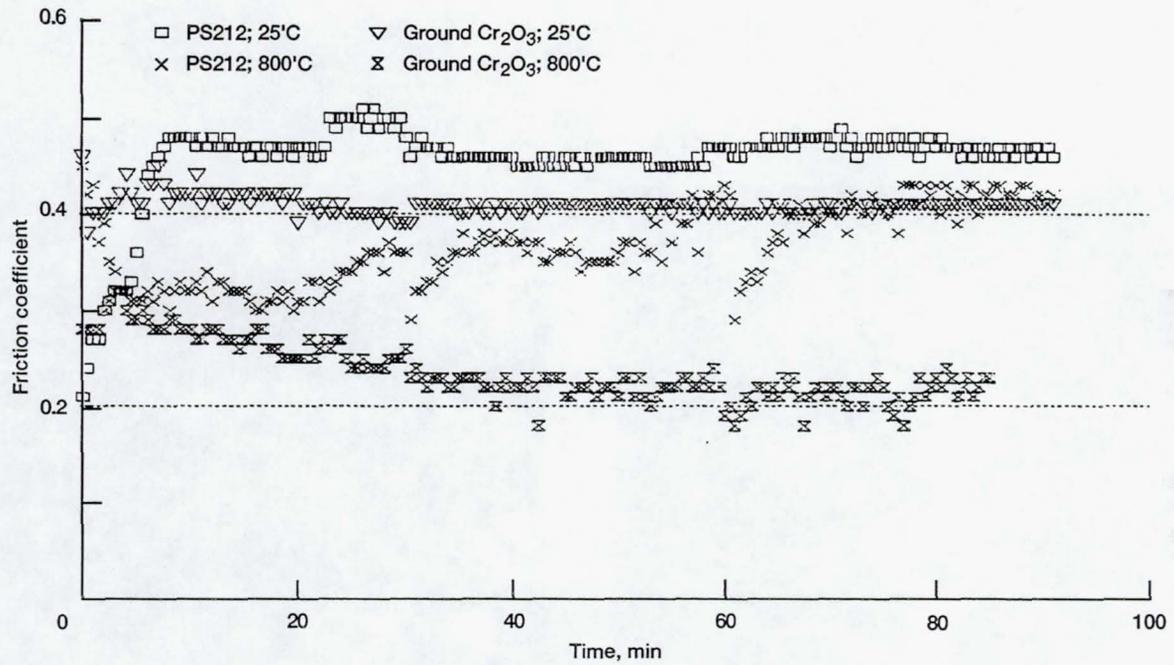
Figure 7.—Friction-time trends.

Friction coefficients during three 30 min consecutive tribotests are shown in figure 7. Within the scatter bands, friction coefficients did not vary significantly over 90 min of sliding with the exception of the 800 °C test of PS212 with a top coat of sealant that had been diamond ground to the seal coat/PS212 interface. In this case, friction coefficients decreased from about 0.3 early in the test to about 0.2 during the final 30 min.

Friction was slightly lower on both the ground and unground seal coated disks than on uncoated PS212 at room temperature: 0.41 versus 0.46. This may be due to data scatter since only one specimen of each type was tested. However, at 800 °C, friction was significantly lower on PS212 with a diamond ground seal coat than it was for PS212 without the sealant treatment: 0.23 versus 0.37.

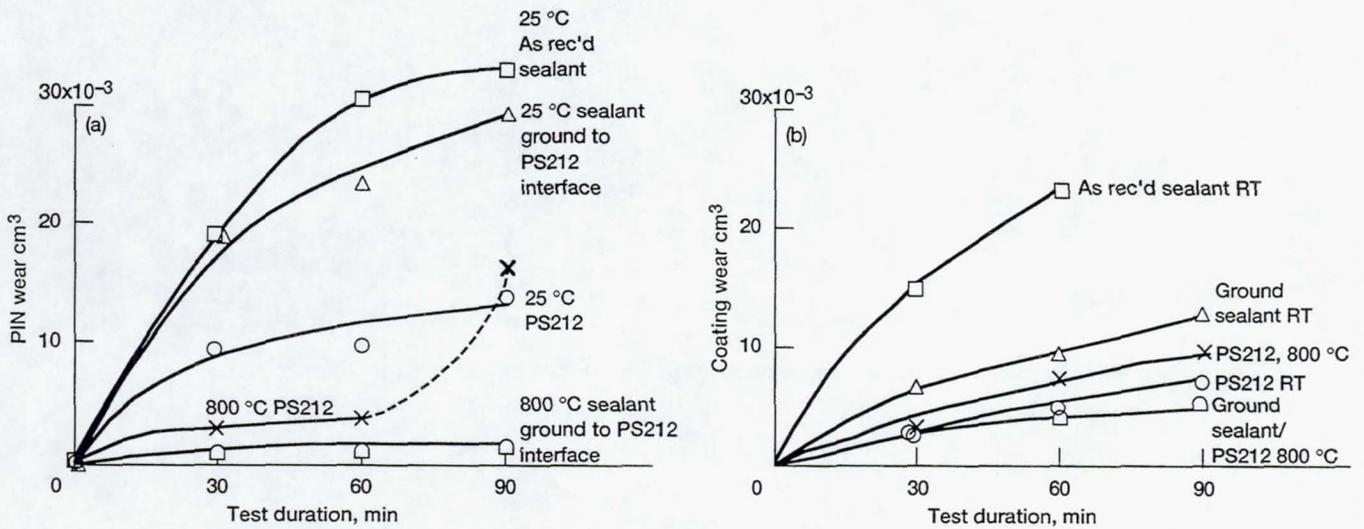
Figure 8.—(a) Comparisons of PIN wear. (b) Comparisons of disk wear.

Pin and disk wear are plotted as functions of test duration in figures 8(a) and (b). These data were used to compute pin and disk wear factors. Wear factors in figures 8(c) and (d) are incremental; each data bar is the wear factor for the 30 min test duration indicated.

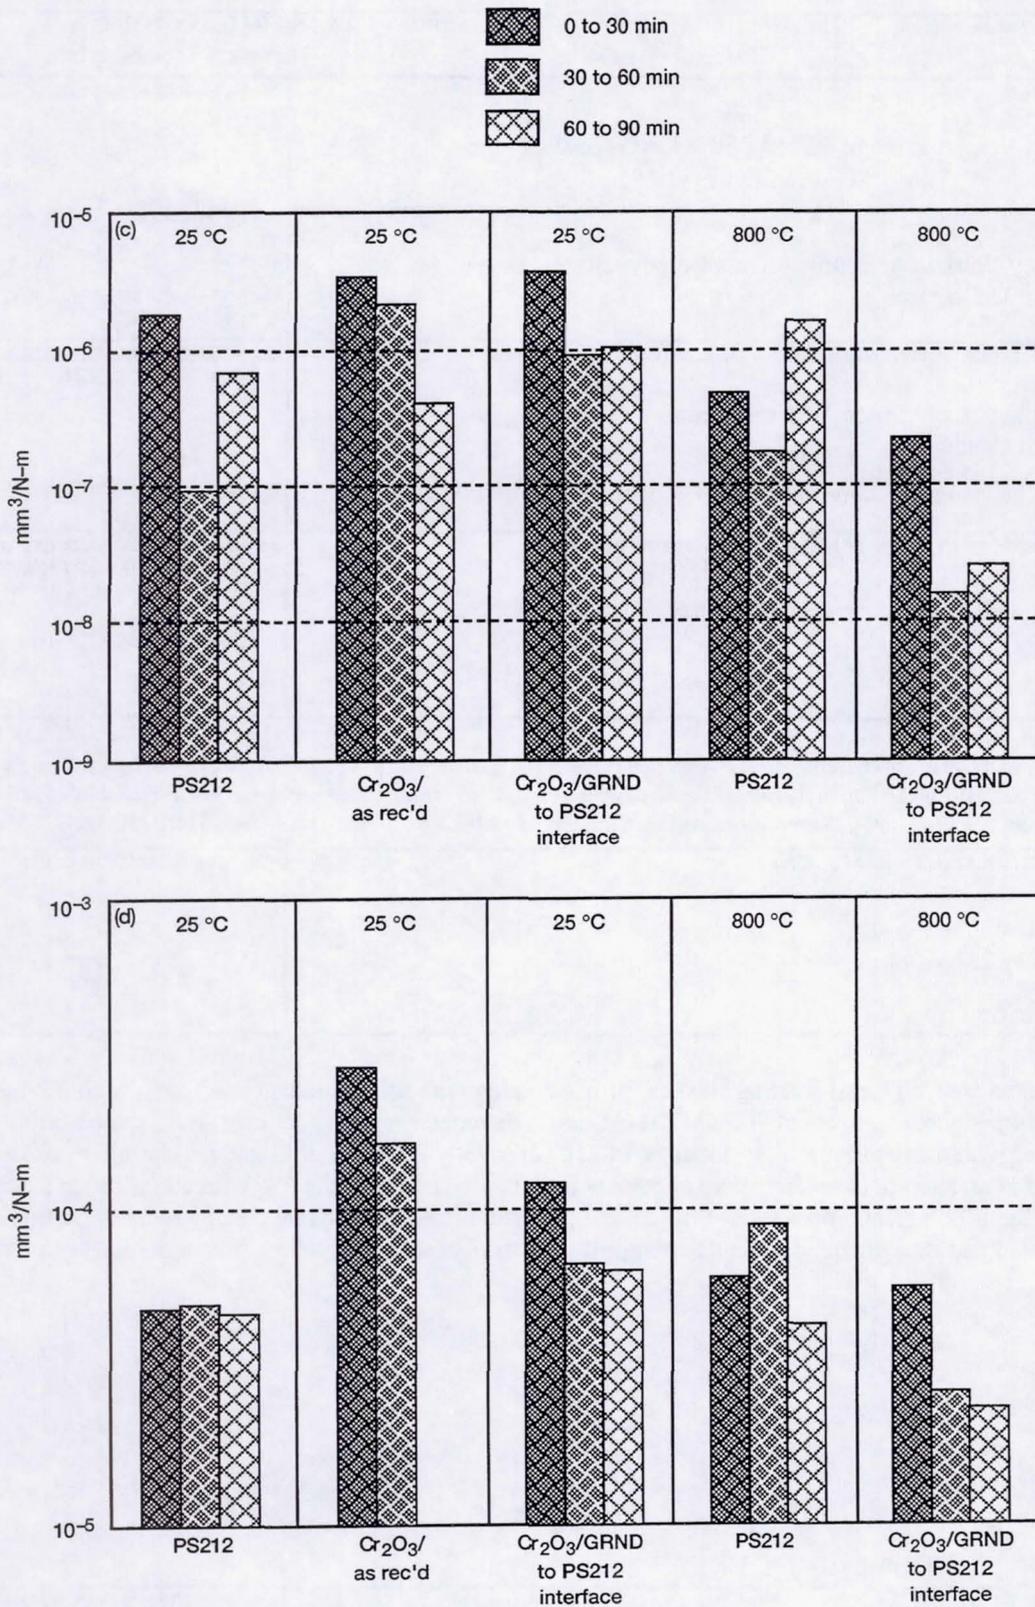
Figure 8.—(c) Pin wear factors for consecutive 30 minute tests. (d) Disk wear factors for consecutive 30 minute tests (mm<sup>3</sup>/N-m).

Wear factors for the pins,  $k_p$ , are given in figure 8(c). At room temperature the average  $k_p$  is  $0.9 \times 10^{-6} \text{mm}^3/\text{N-m}$  against PS212,  $2.2 \times 10^{-6} \text{mm}^3/\text{N-m}$  for the as-received, unground seal coat, and  $2.0 \times 10^{-6} \text{mm}^3/\text{N-m}$  for ground seal coat on PS212. At 800 °C, the pin wear factor, was an order of magnitude lower for sliding against the PS212 disk with the ground seal coat than the PS212 alone:  $1.1 \times 10^{-7}$  versus  $1.1 \times 10^{-6}$ . The as-applied (unground) seal coating was not tribotested at 800 °C because it spalled from PS212 upon cooling from high temperature.

Disk wear factors,  $k_d$ , are given in figure 8(d). At room temperature, the wear factor for the as-applied seal coating was at least five times that of PS212:  $2.4 \times 10^{-4}$  versus  $4.9 \times 10^{-5}$ . The wear of the seal coating was only measured after the first two 30 min tests because the wear depth was beyond the 100  $\mu\text{m}$  range of the profilometer after the third test. The wear factor of PS212 with a ground sealant top coat was  $8.6 \times 10^{-5}$ . At 800 °C,  $k_d$  for PS212 with a ground seal coat was about 60 percent that of PS212 alone;  $3.8 \times 10^{-5}$  versus  $6.8 \times 10^{-5} \text{mm}^3/\text{N-m}$ .
