## Can Salt on an Optical Rain Gauge Lens Affect Performance?

Larry F. Bliven  
Laboratory for Hydrospheric Processes  
NASA/GSFC

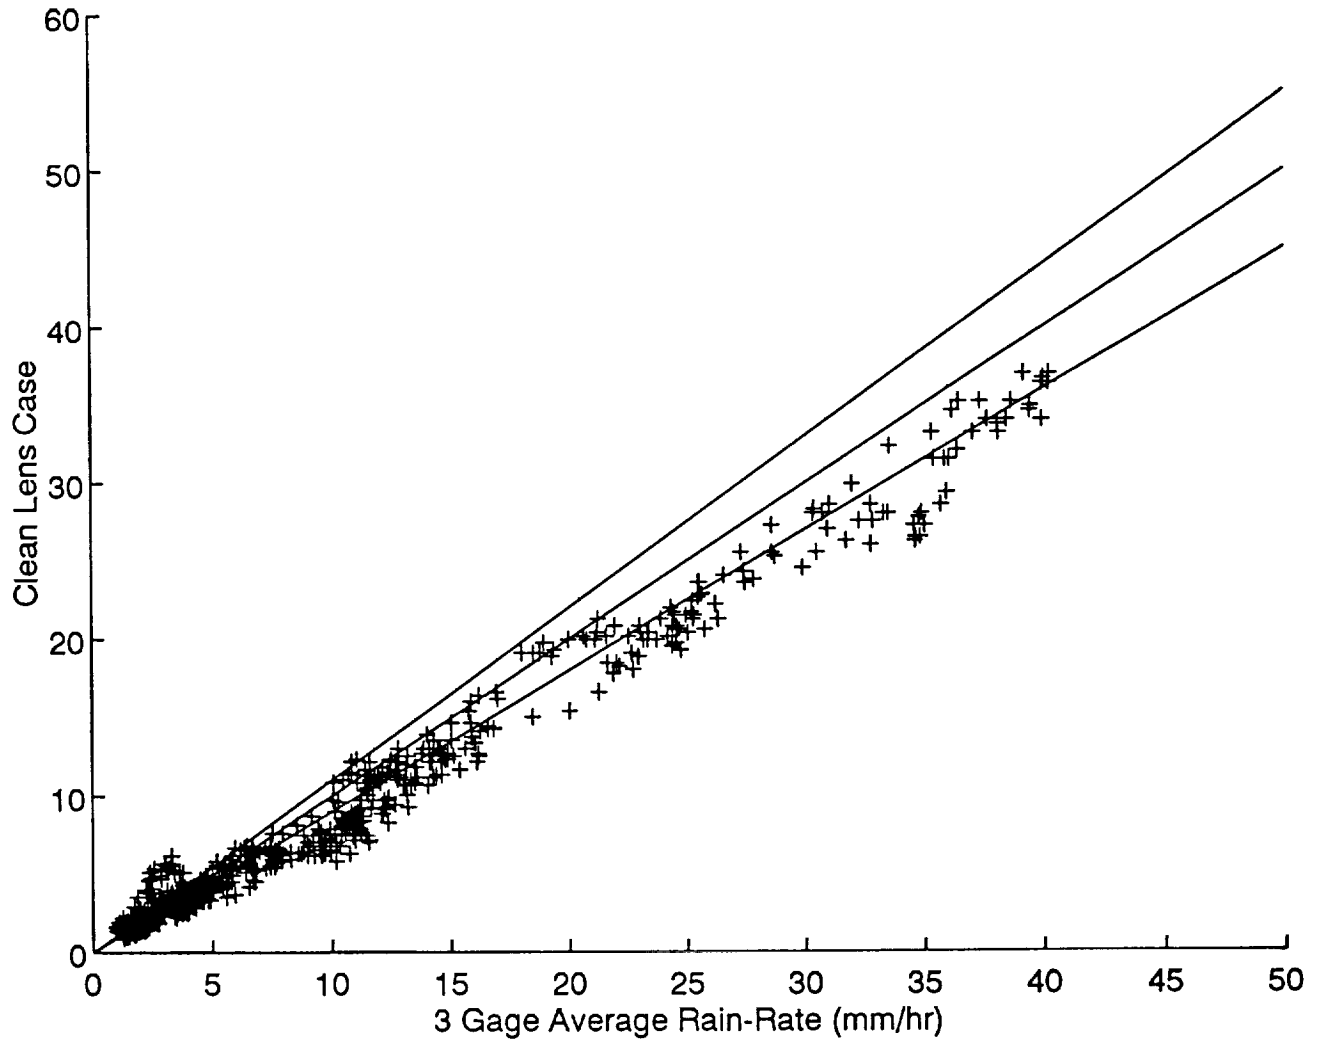
### Unperturbed Gage Comparison

In the control experiment, a sample ORG was compared to three other ORGs during natural rain events. The results of that experiment are shown in Figure 1, which reveals that the

unperturbed gauge measurements fall within 10 % of the average from three other ORGs. Thus the sample ORG is within specifications when operated under normal conditions.

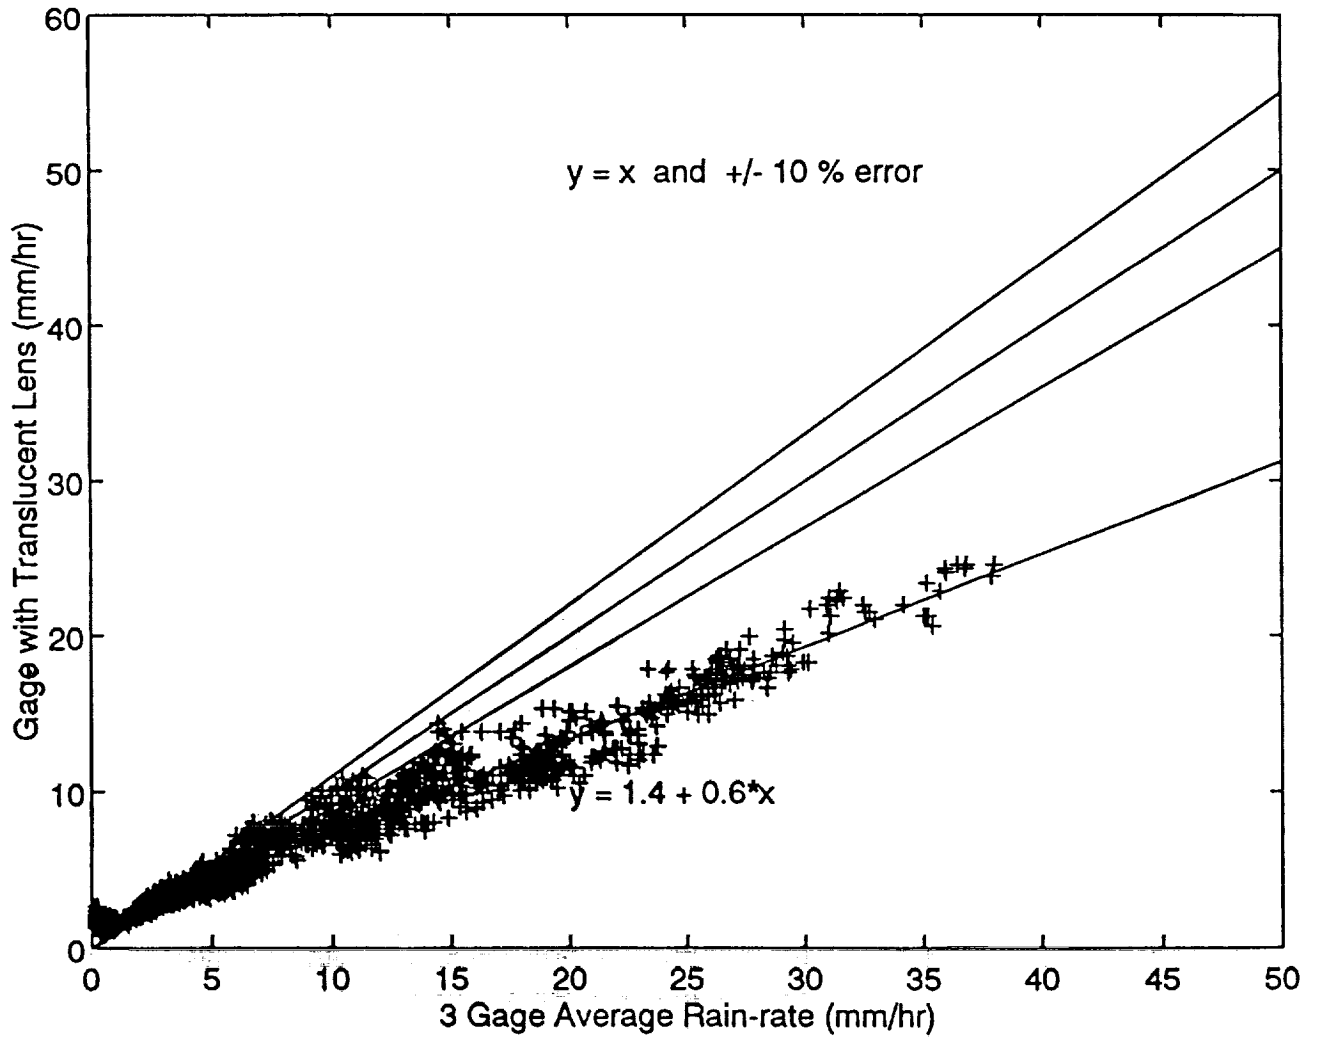
### Simulation of Sea Salt on Rain Gage Lens

Next the mask was placed on the transmitter lens of the sample ORG and again data were collected under natural rain conditions. The data from the perturbed ORG are plotted in comparison with the three other ORGs in Figure 2, which shows that the mask reduced the gain of the perturbed ORG by about 30%. The perturbed ORG operated rather well in that the mask only causes a change in the gain and does not cause data drop out at low rain rates. However, the reduced gain would seriously impact an assessment of rain statistics.
