FLIGHT TESTS OF VARIOUS TAIL MODIFICATIONS

ON THE BREWSTER XSBA-1 AIRPLANE

III - MEASUREMENTS OF FLYING QUALITIES

WITH TAIL CONFIGURATION 3

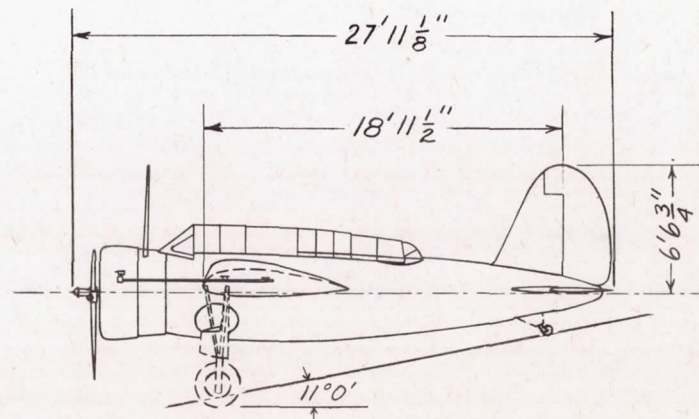
Figure 1.- Three-view drawing of Brewster XSBA-1 airplane with configuration 1.

three-view drawing of the airplane with tail configuration 1. Figure 2 is a side-view photograph of the airplane with tail configuration 3.

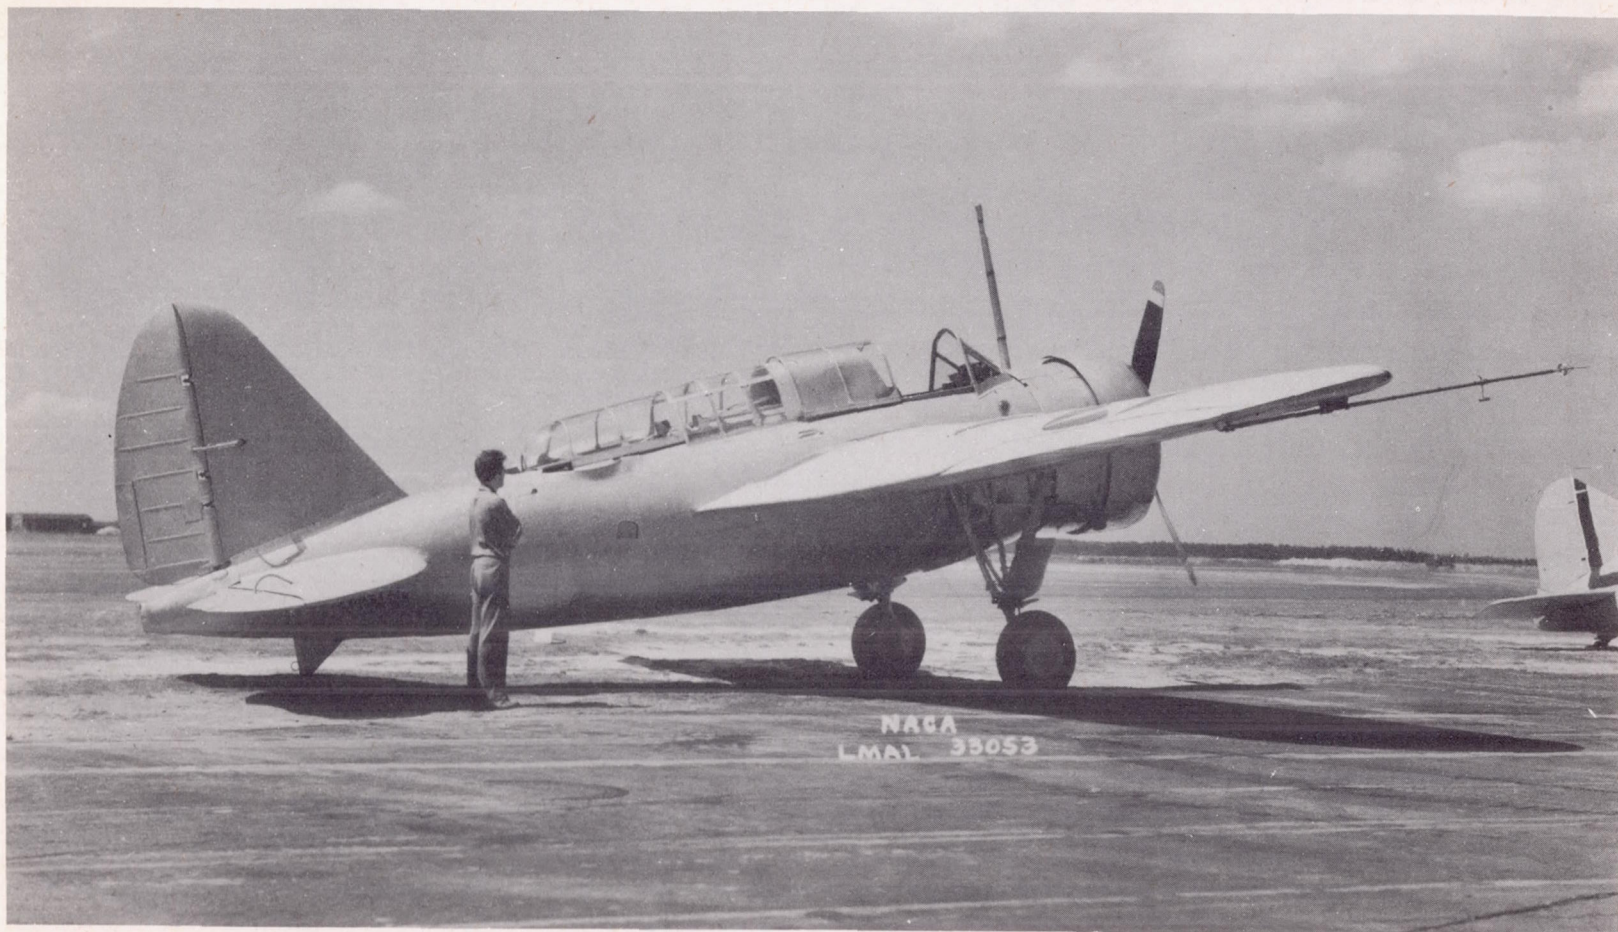
Figure 2.- Side view of Brewster XSBA-1 with tail configuration 3.

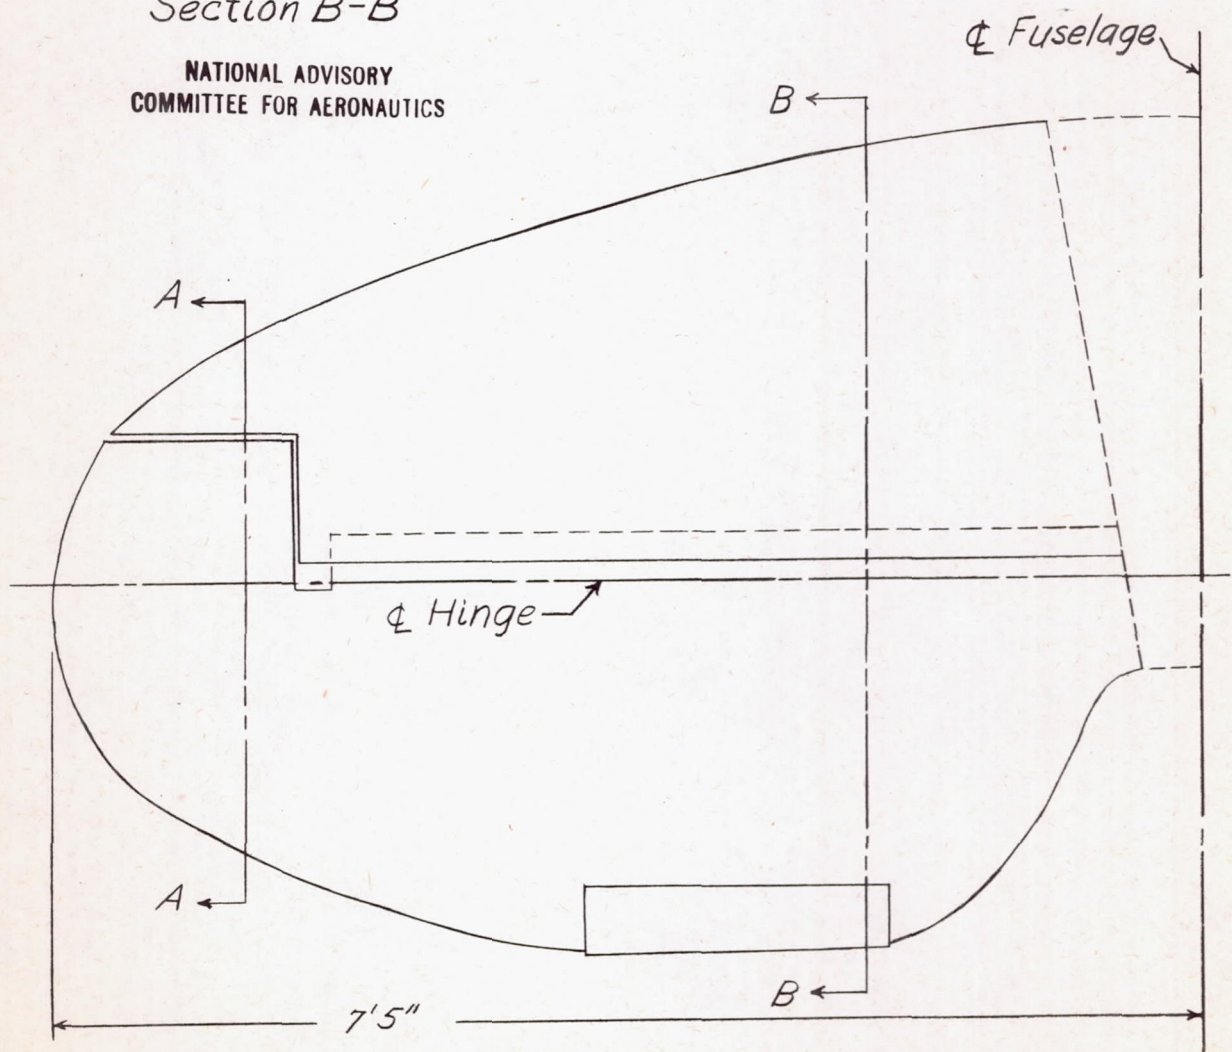
Figure 3.- Horizontal tail configuration number one. Brewster XSBA-1 airplane.

The surfaces of tail configuration 1, which are shown in figures 3 and 4, were horn-balanced and had approximately equal movable and fixed areas. The surfaces of configuration 2 (figs. 5 and 6) had approximately equal movable and fixed areas but were not horn-balanced. The elevator area of configuration 3 (figs. 7 through 10) was reduced to about 25 percent of the total horizontal area and the rudder area was reduced to 35 percent of the total vertical-tail area. Figure 11 shows trailing-edge sections of the various tail surfaces. The positions of the hinge lines with reference to the fuselage were the same in all cases so that the tail length of tail 3 was about 1 foot less in l_7 than that of tails 1 and 2.

1. As is shown in figures 3, 5, and 7, the elevator trimming tabs on the three tail configurations were of the same area. The power of the tab on tail 3 in pounds of stick force per degree of tab deflection, shown in figure 24, was about one-third that of the tabs on tails 1 and 2. With a deflection range of $\pm 11^\circ$ the elevator trimming tab on tail 3 was inadequate in the landing condition. For every 3.5° of tab deflection on tail 3, 1° of elevator deflection in the opposite direction was required to trim the airplane at a given speed.

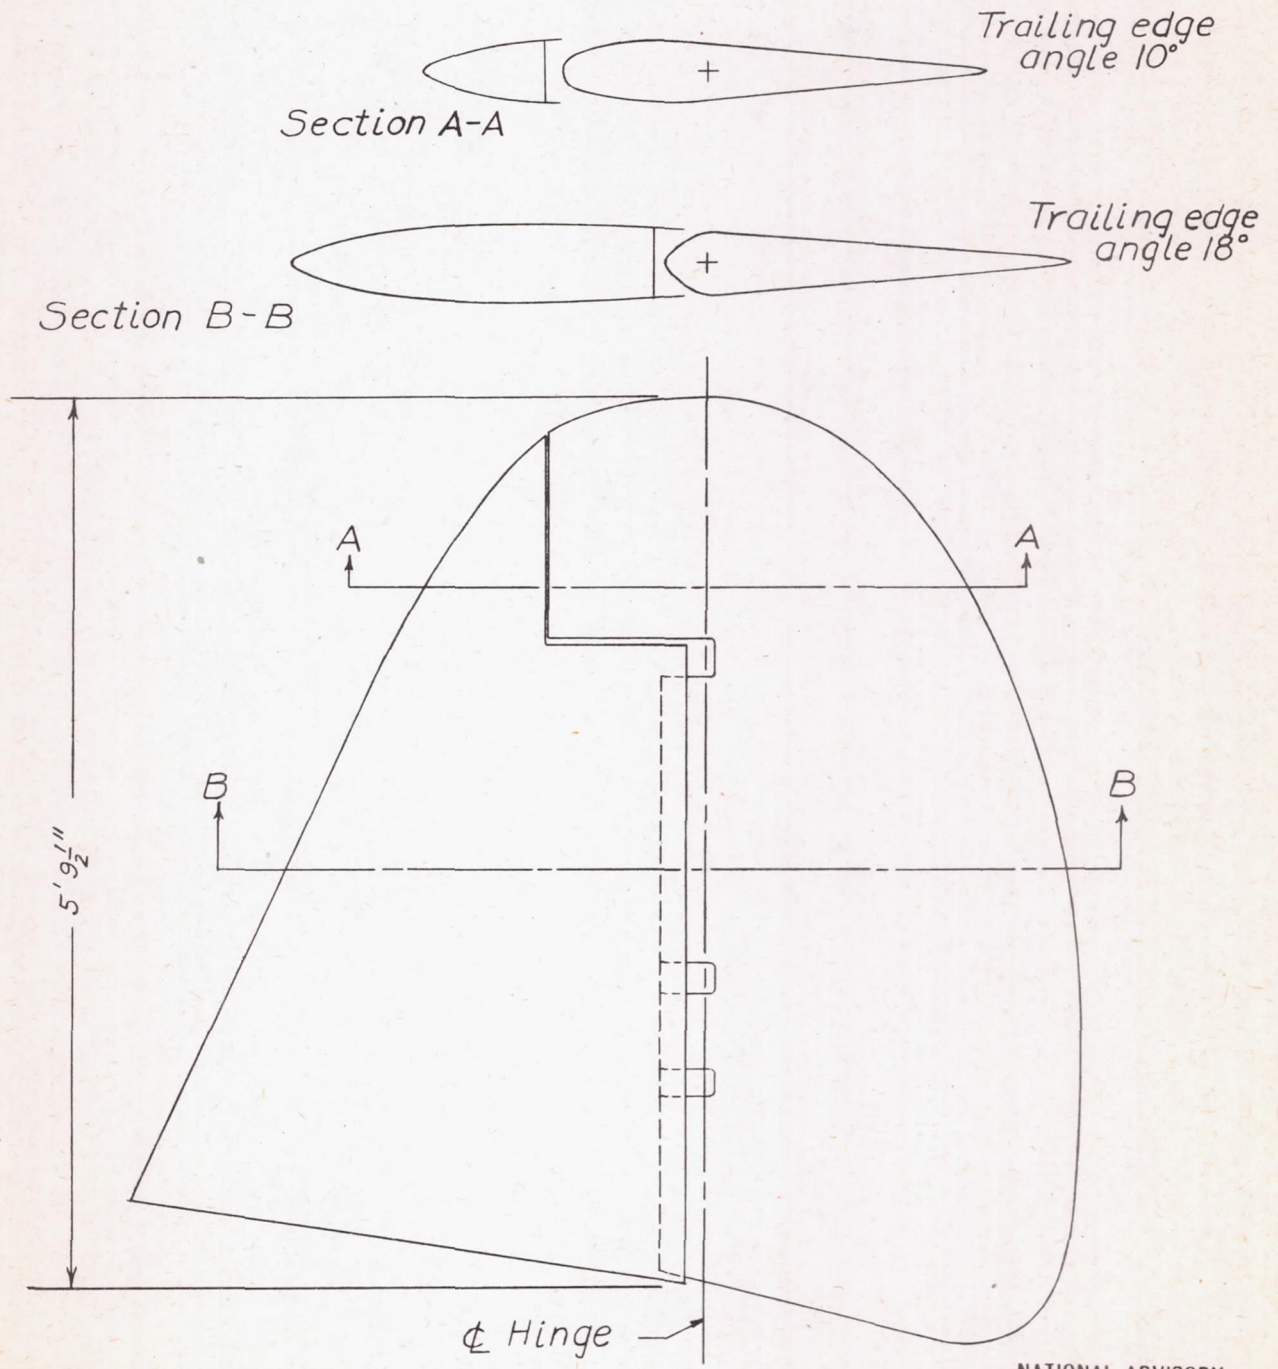
Figure 4.- Vertical tail configuration number one. Brewster XSB-1 airplane.

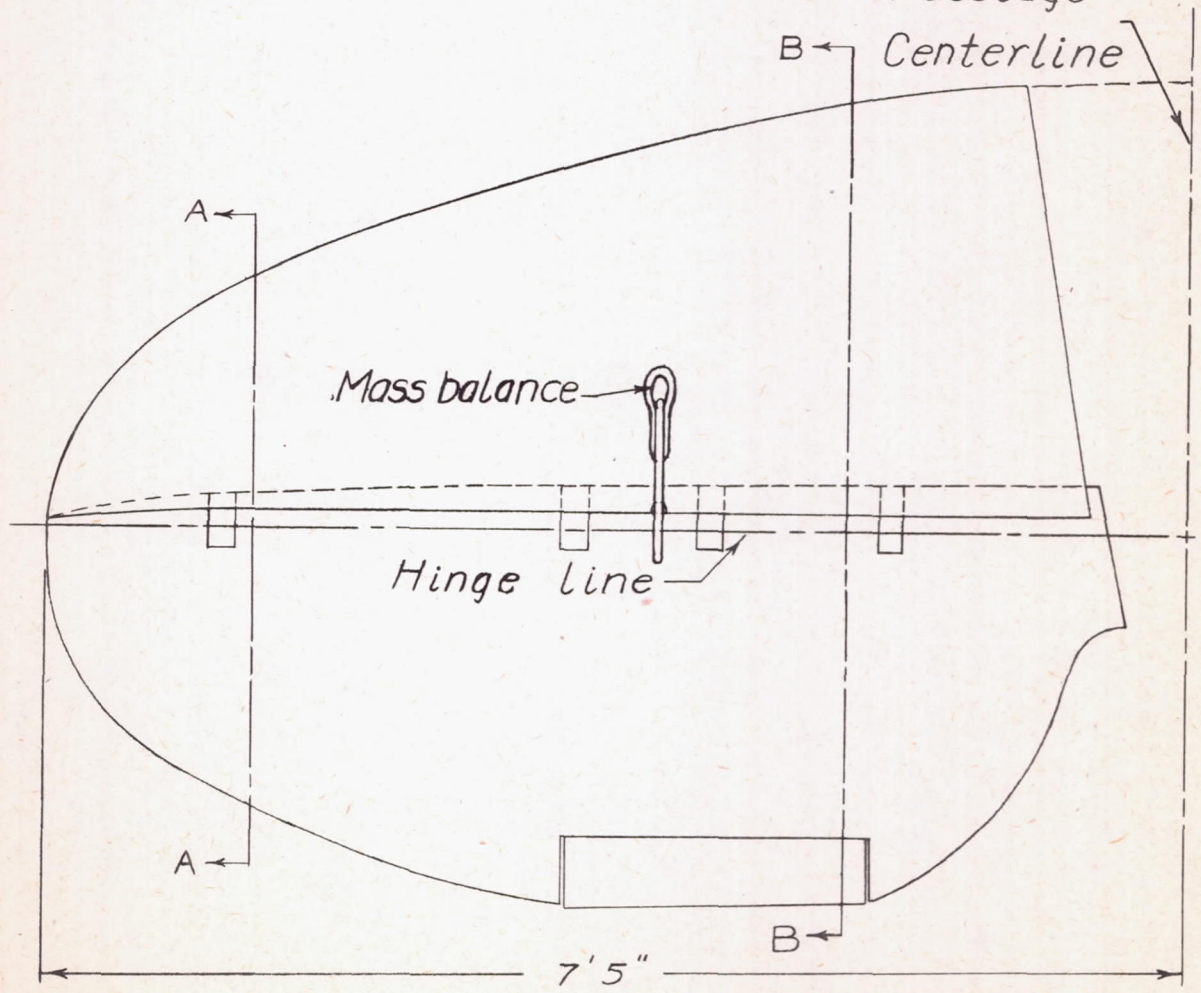
Figure 5.- Horizontal tail configuration number two. Brewster XSBA-1 airplane.

Section B-B

Trailing edge angle $8\frac{1}{2}^\circ$

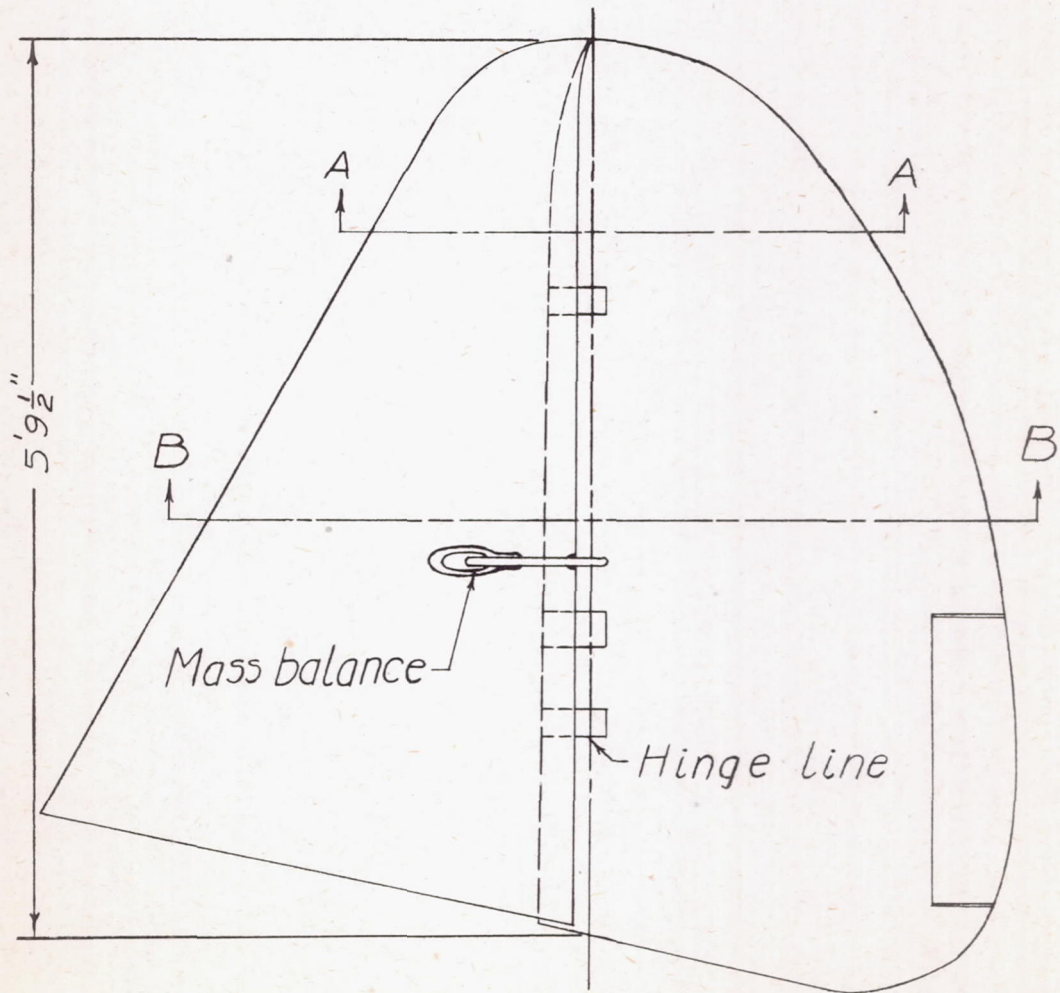
Figure 6.- Vertical tail configuration number two. Brewster XSBA-1 airplane.

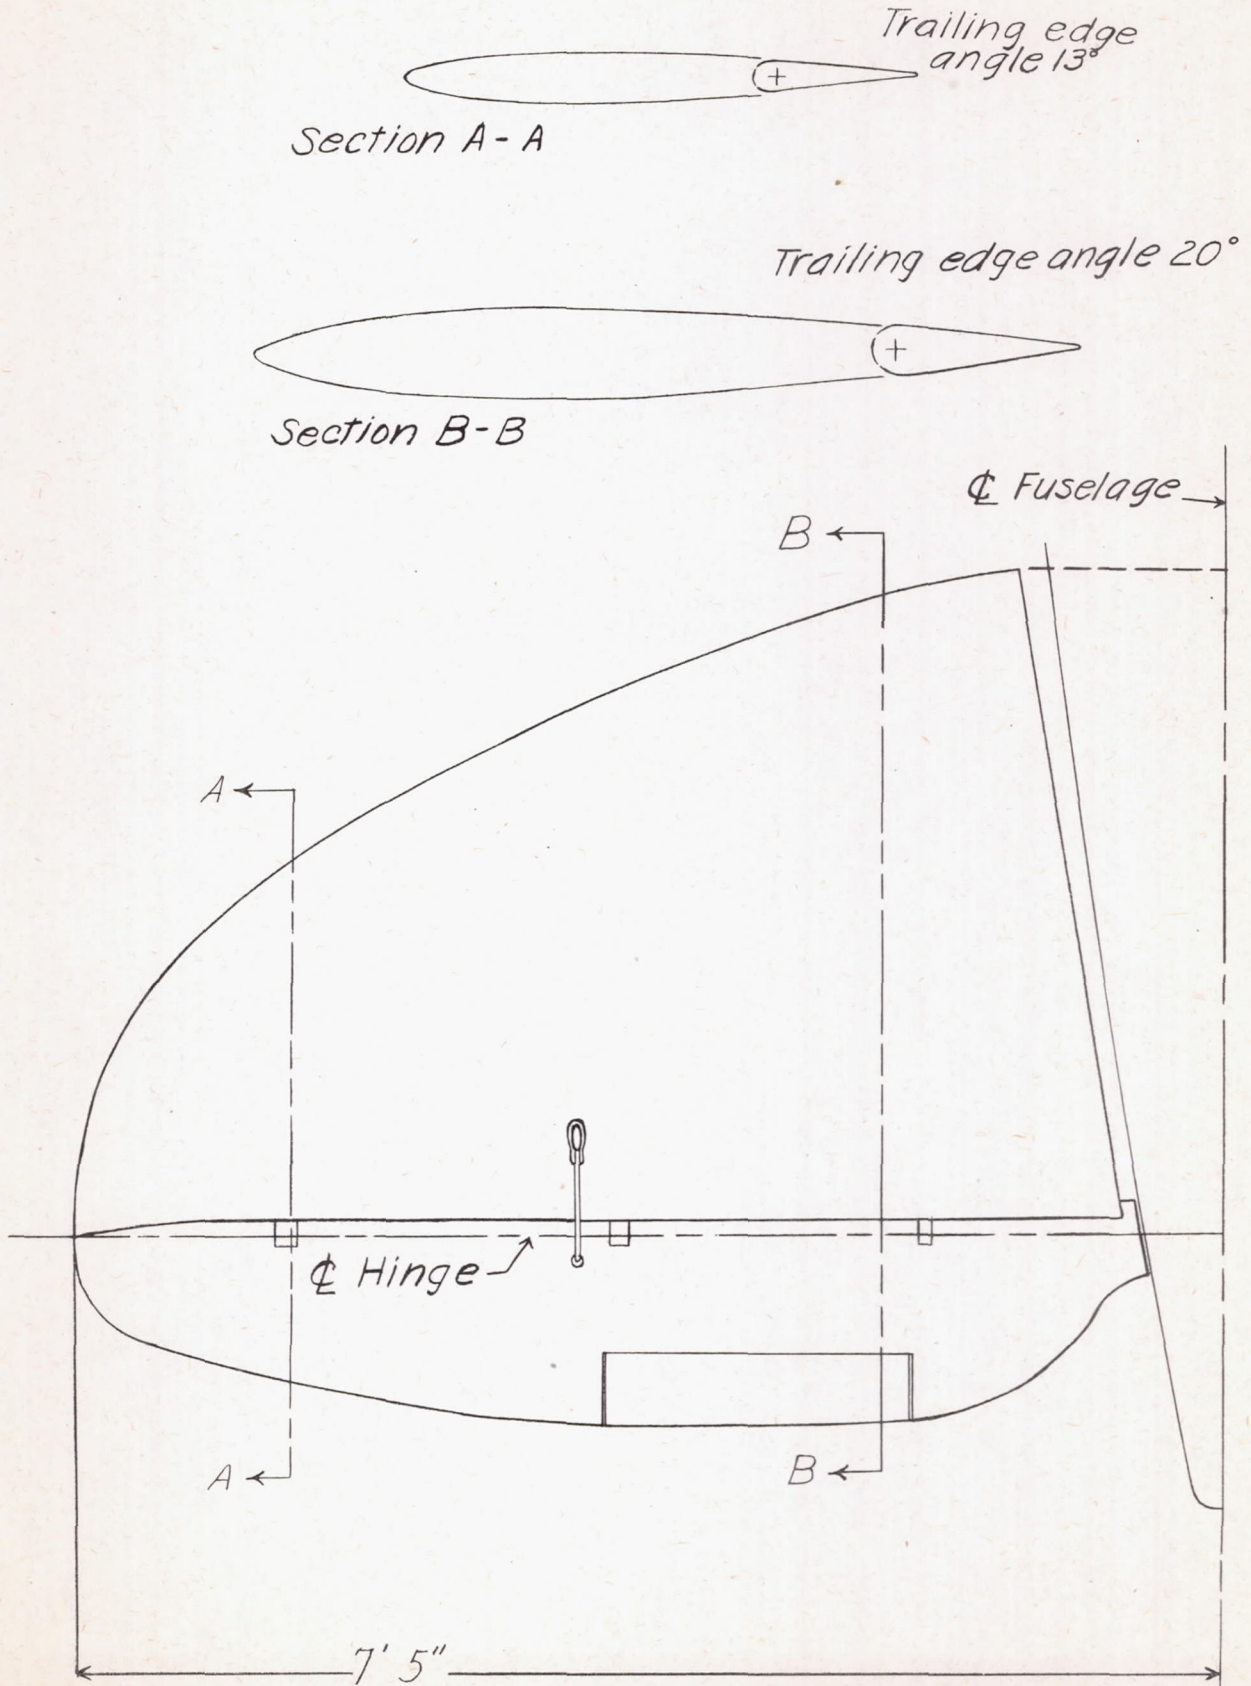
Figure 7.- Horizontal tail configuration 3; Brewster XSBA-1 airplane.

Trailing edge angle 12°

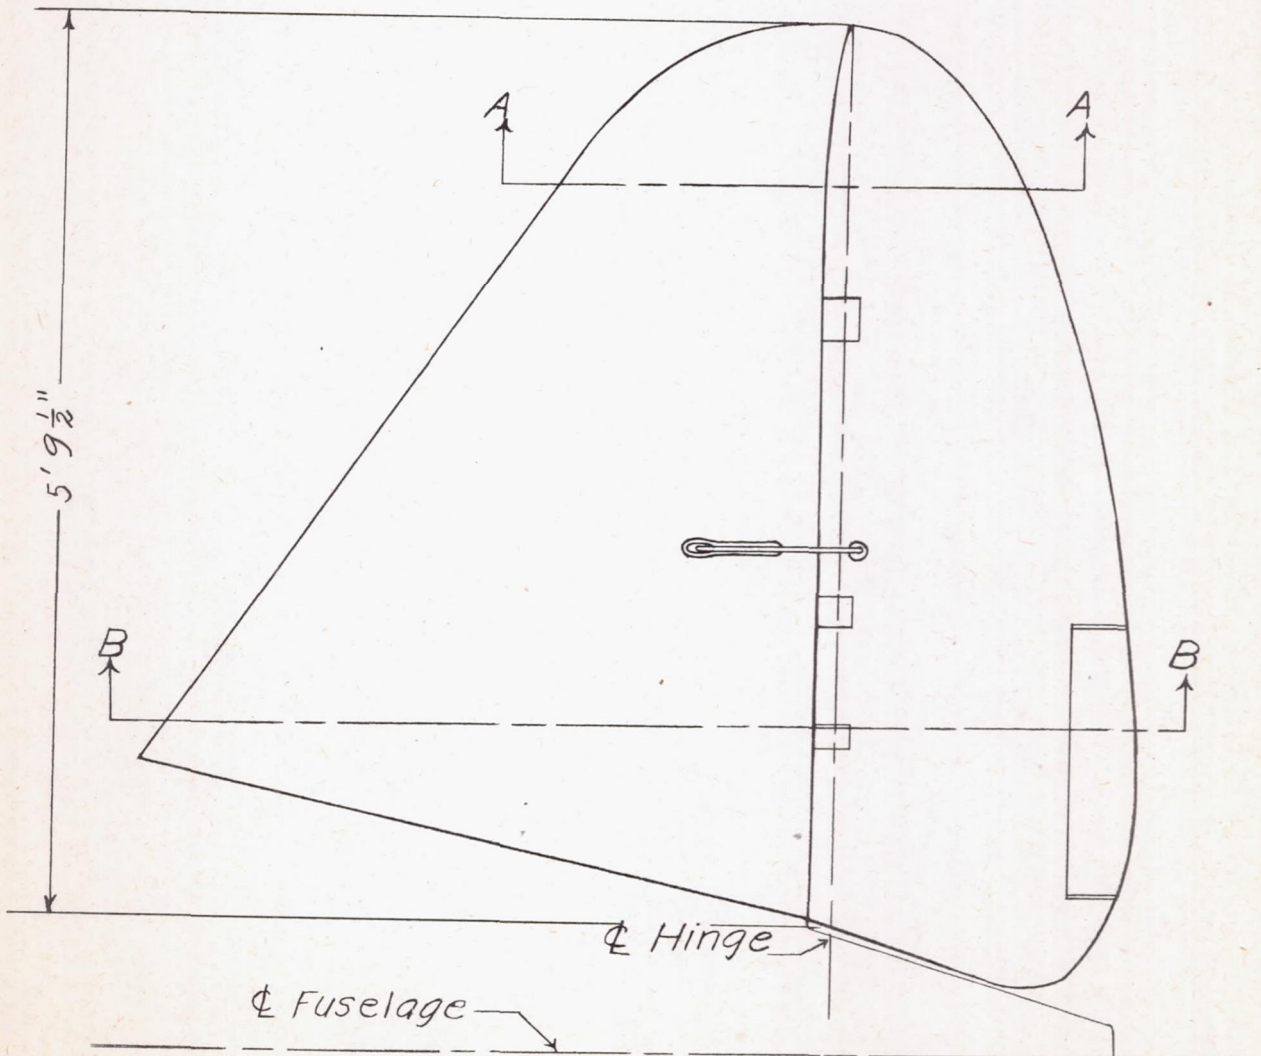
Figure 8.- Vertical tail configuration 3; Brewster XSBA-1 airplane.

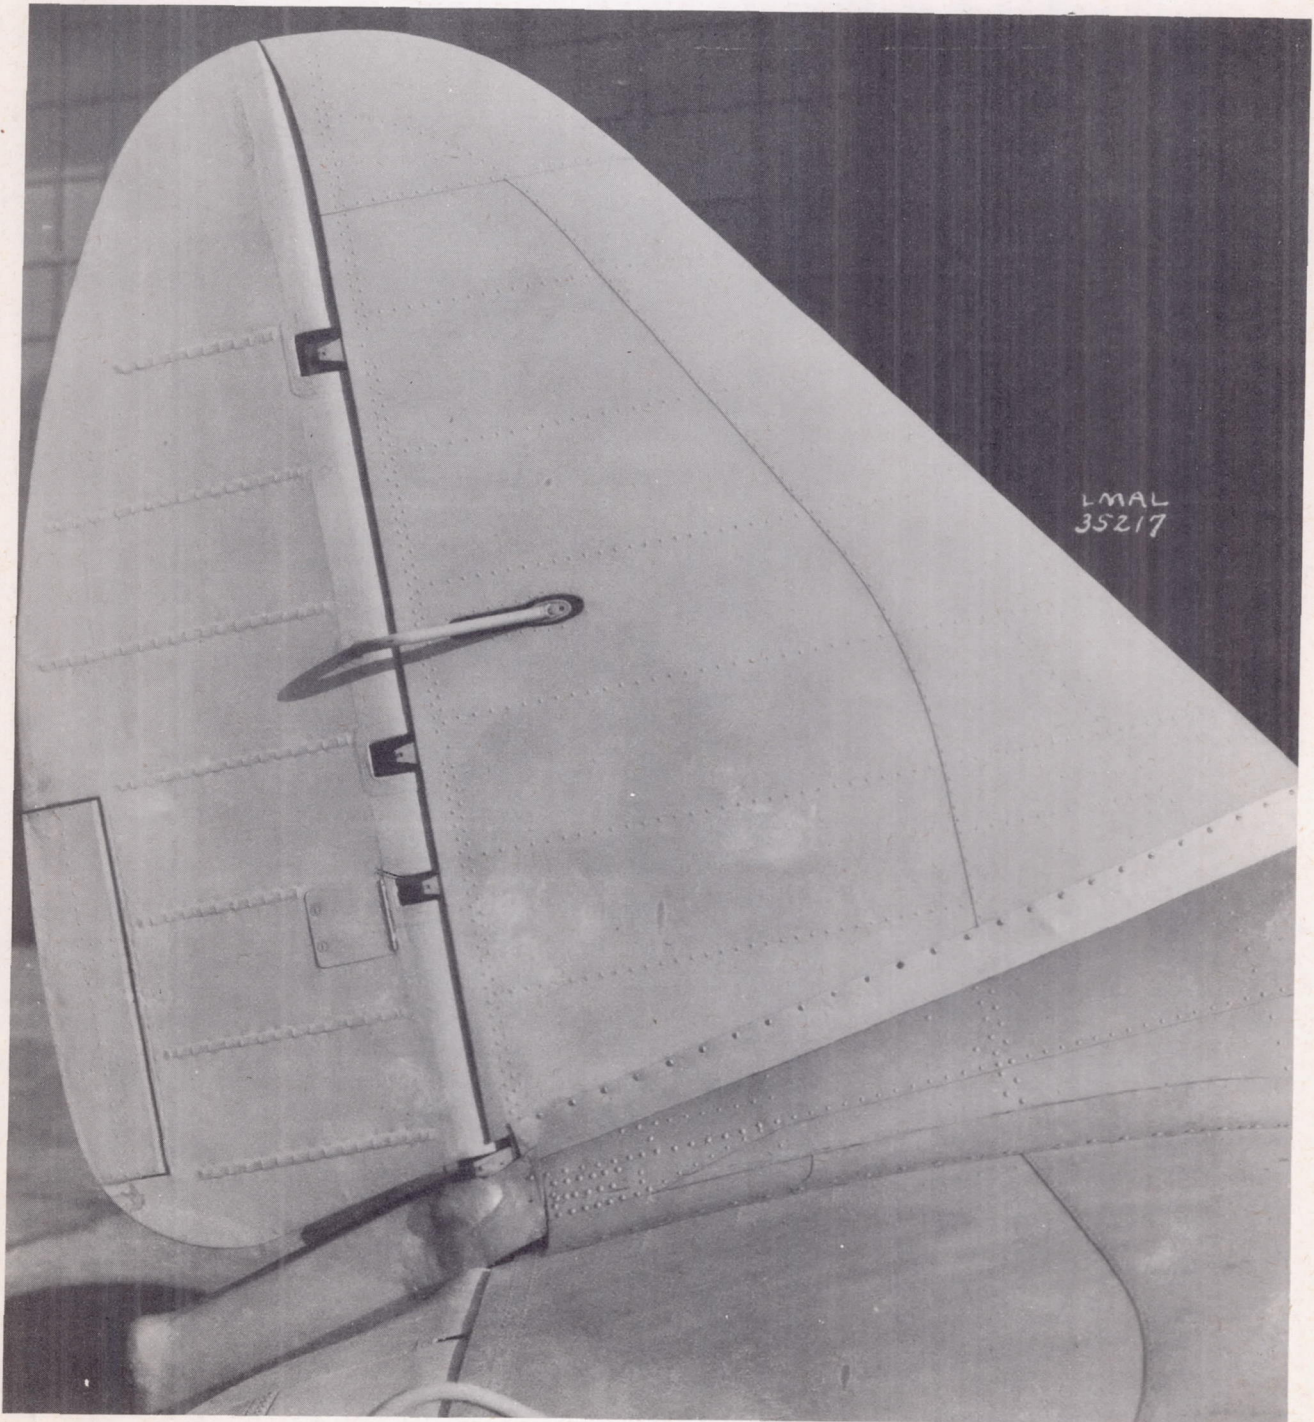
Figure 9.- Close-up of the vertical tail of configuration 3;
XSBA-1 airplane.

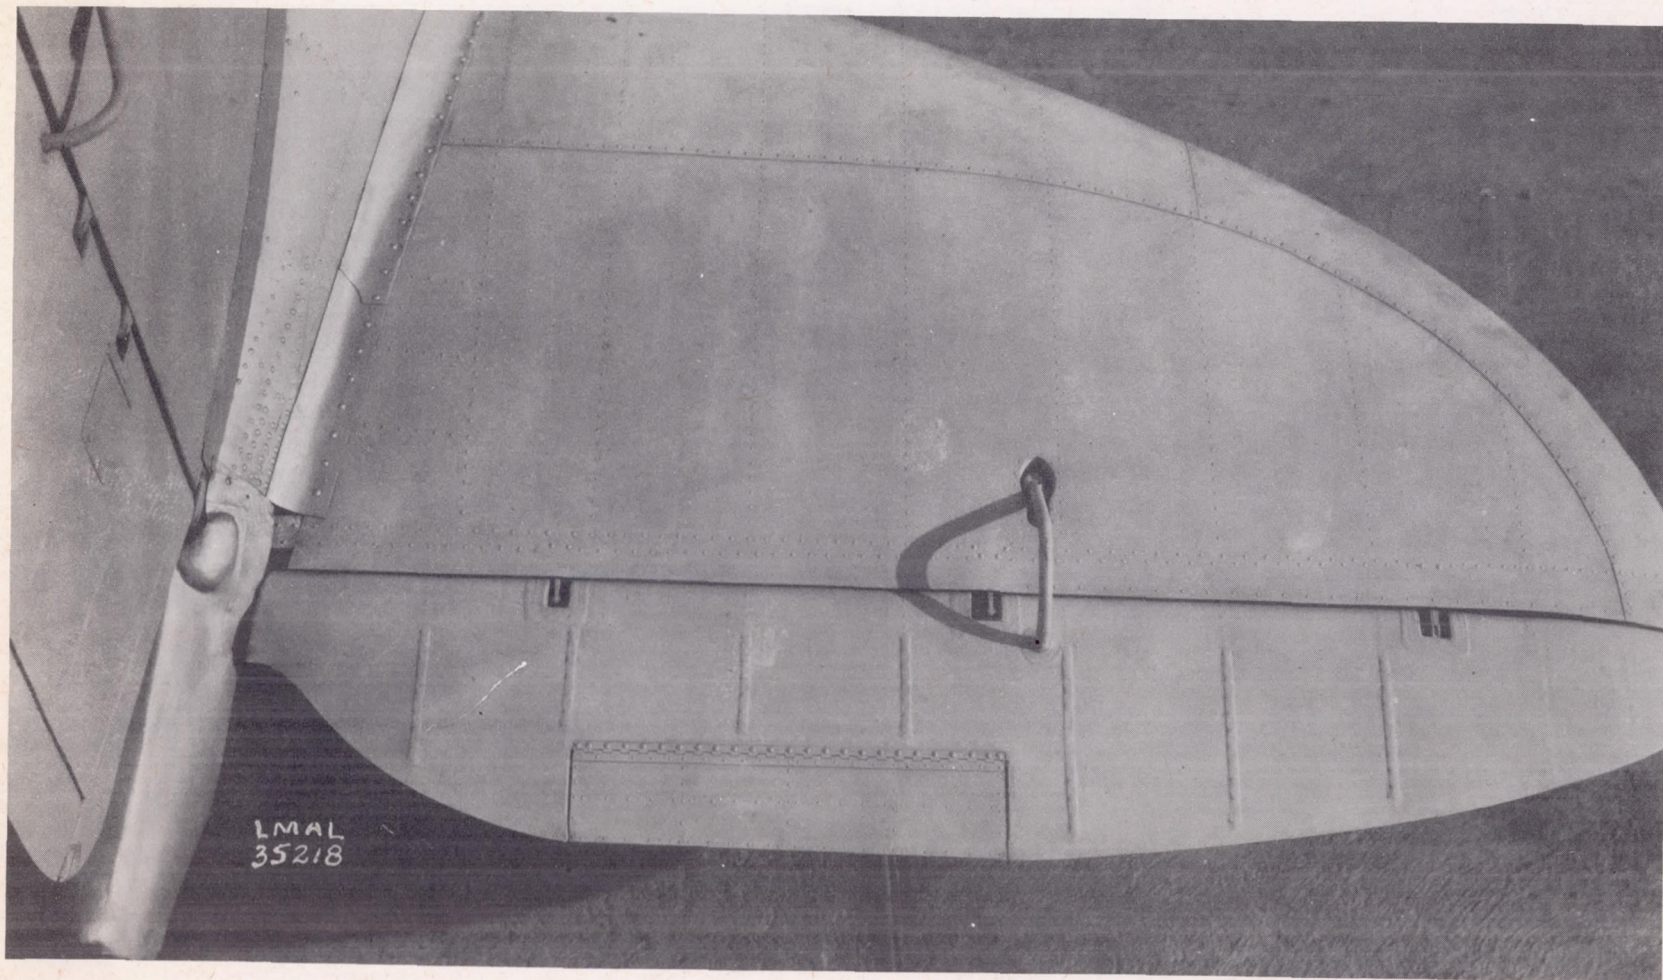
Figure 10.- Close-up of the horizontal tail of configuration 3; XSBA-1 airplane.

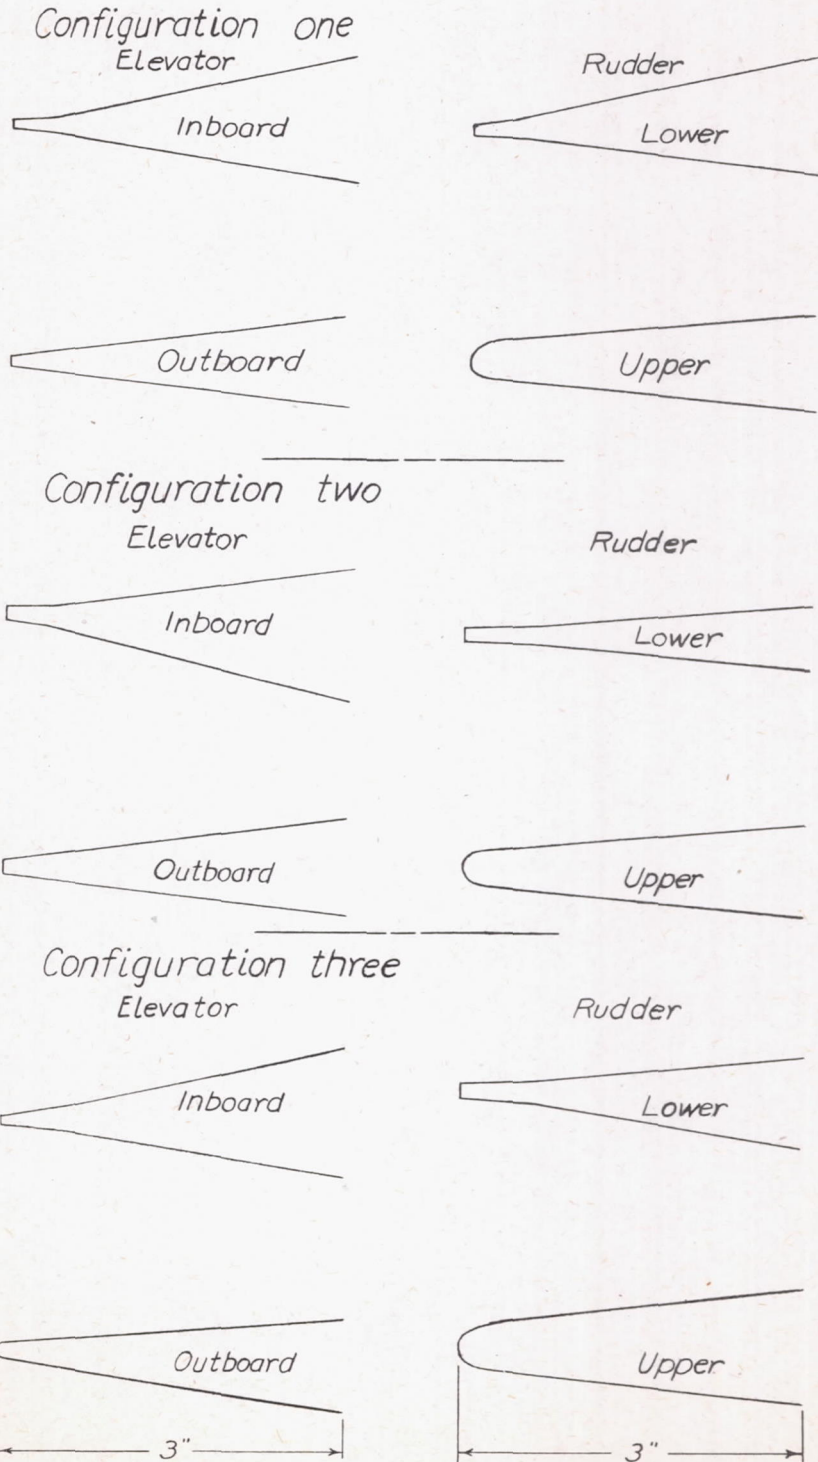
Figure 11.- Trailing edge sections of X8BA-1 tail surfaces at the stations indicated in figures 3 through 8.

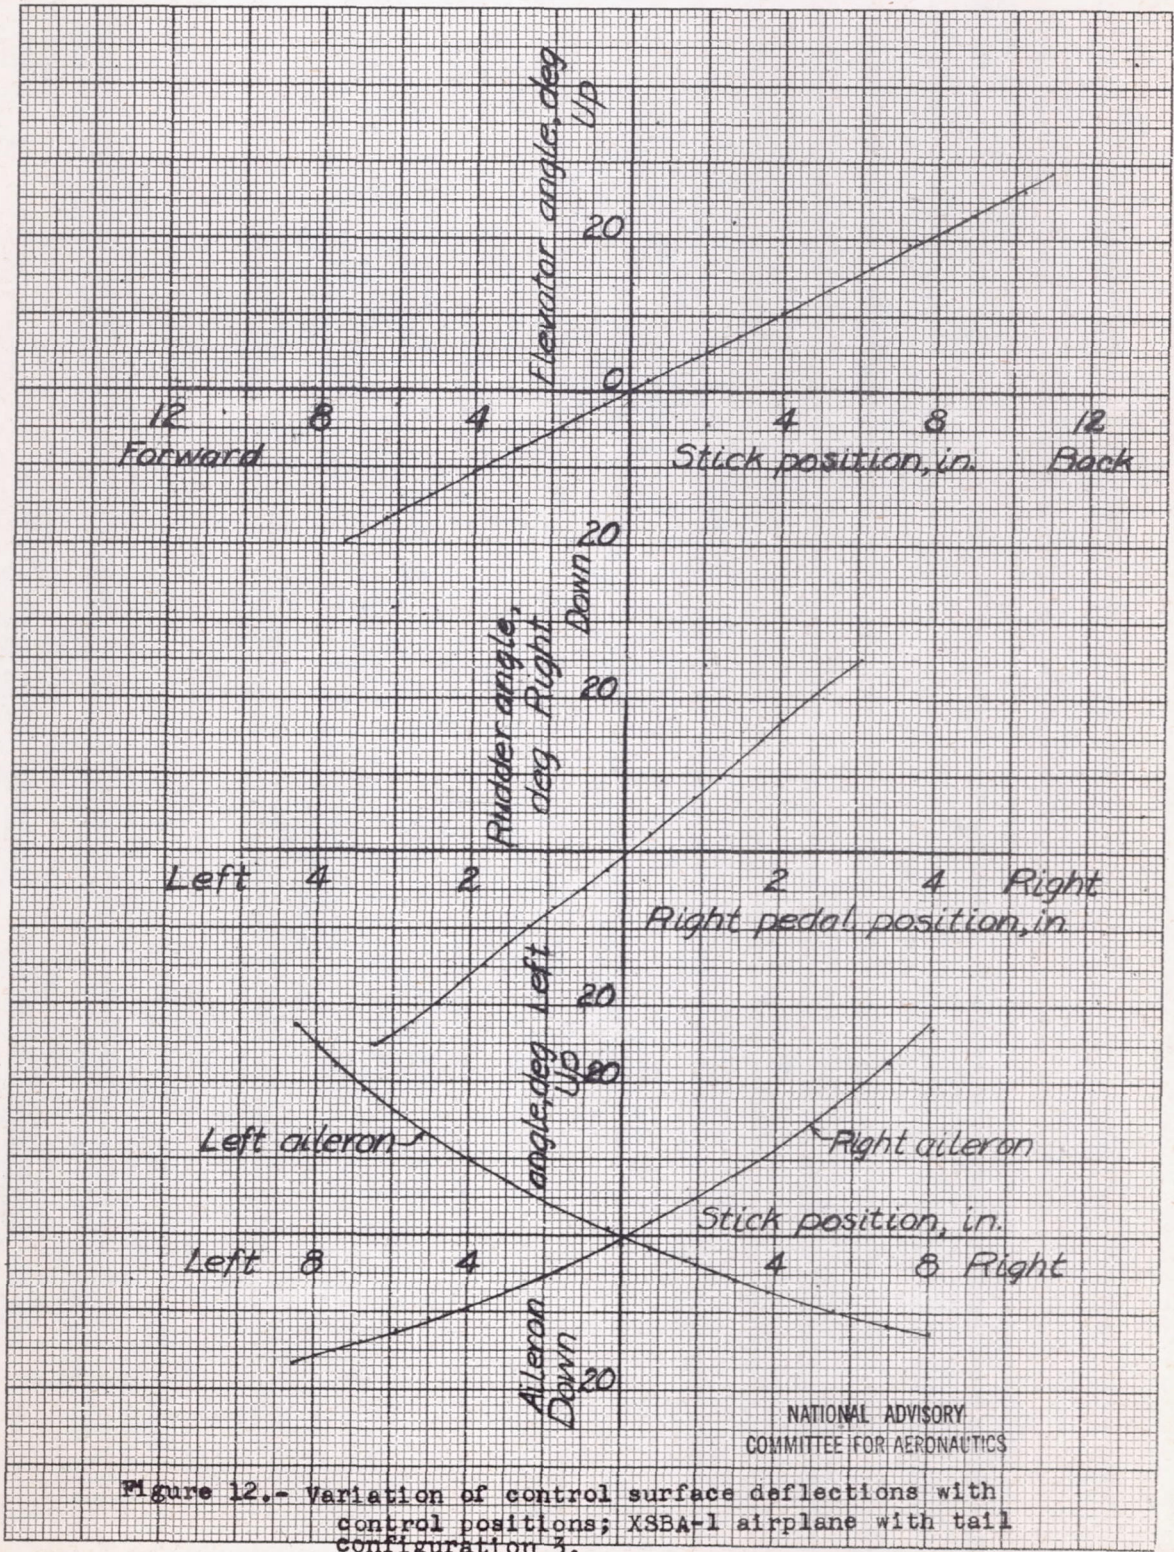
Figure 12.- Variation of control surface deflections with control positions; XSB-1 airplane with tail configuration 3.

The relations between control positions and control-surface deflections are shown in figure 12. Figure 13 is a calibration of the elevator trimming tab. The stabilizer incidence was 0° from the thrust axis. Elevator angles were measured from the thrust axis.

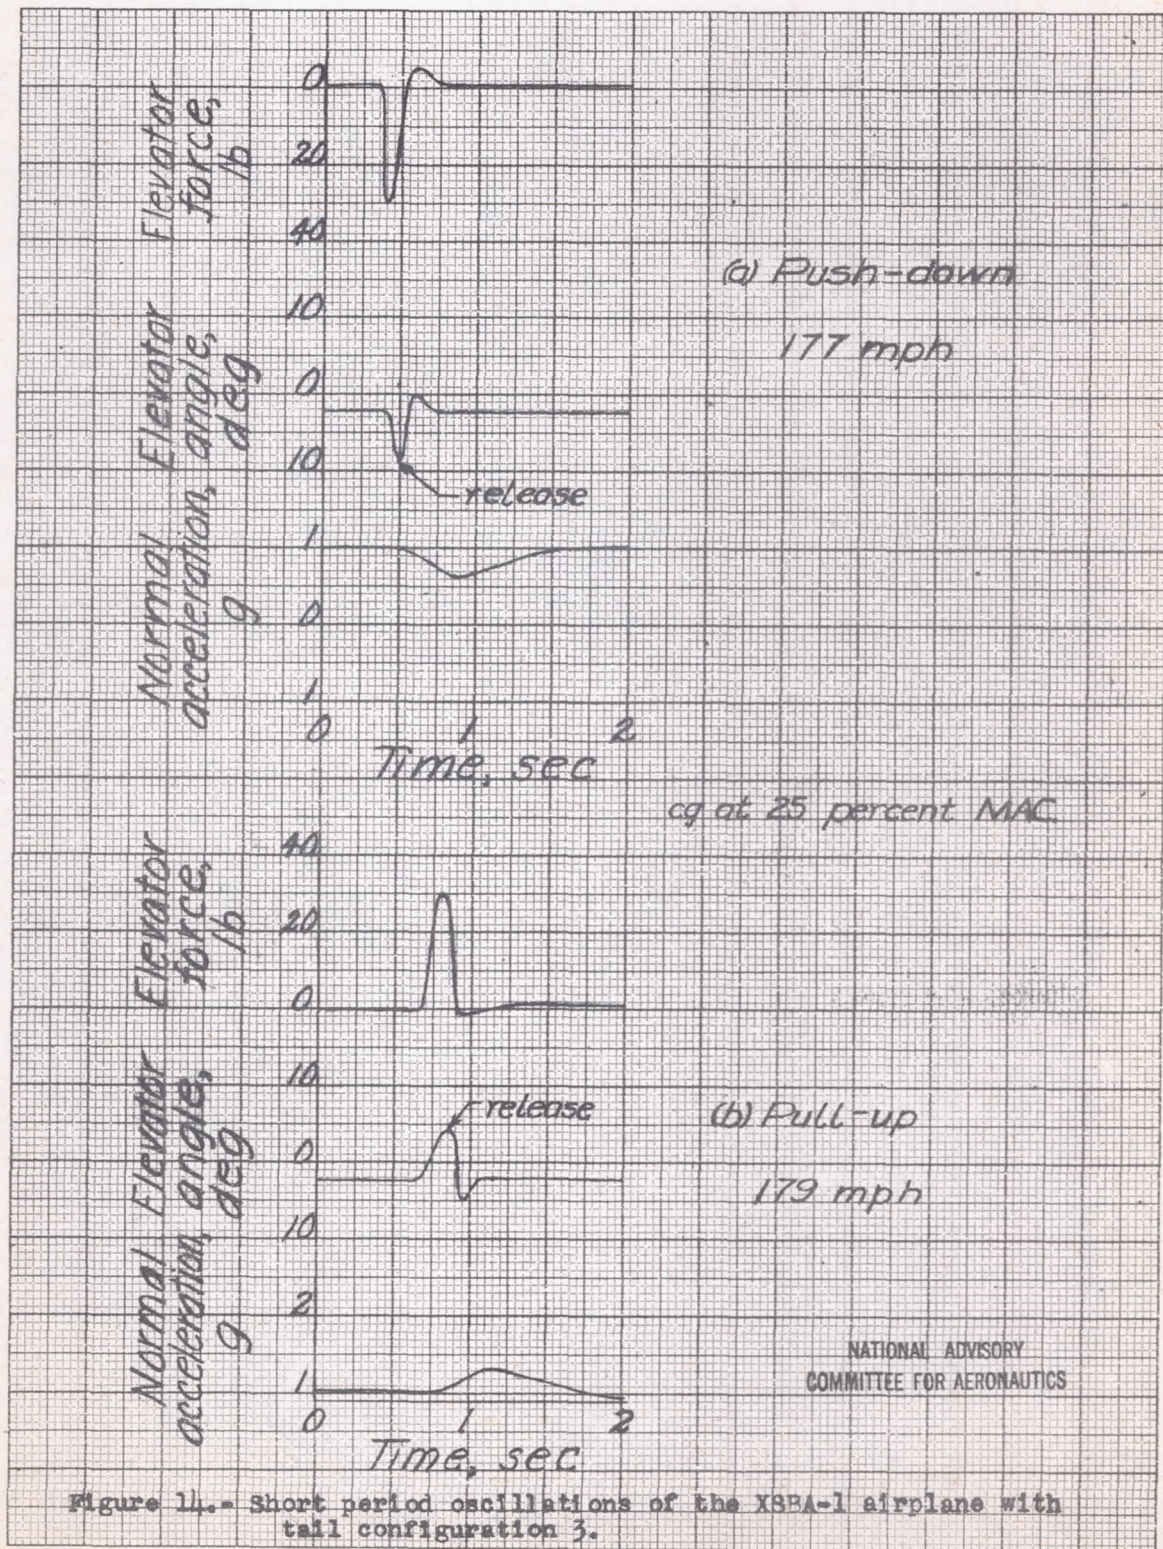
Figure 14.- Short period oscillations of the XSB-1 airplane with tail configuration 3.

The degree of damping of the short-period oscillation was determined by quickly deflecting and releasing the elevator in high-speed flight. For each of the tail configurations with the center of gravity at 25 percent mean aerodynamic chord, the requirement that the subsequent variation of normal acceleration and elevator angle should have completely disappeared after 1 cycle was satisfied. Figure 14 is a plot of two short-period oscillations with tail configuration 3.
