FLIGHT TESTS OF VARIOUS TAIL MODIFICATIONS

ON THE BREWSTER XSBA-1 AIRPLANE

III - MEASUREMENTS OF FLYING QUALITIES

WITH TAIL CONFIGURATION 3

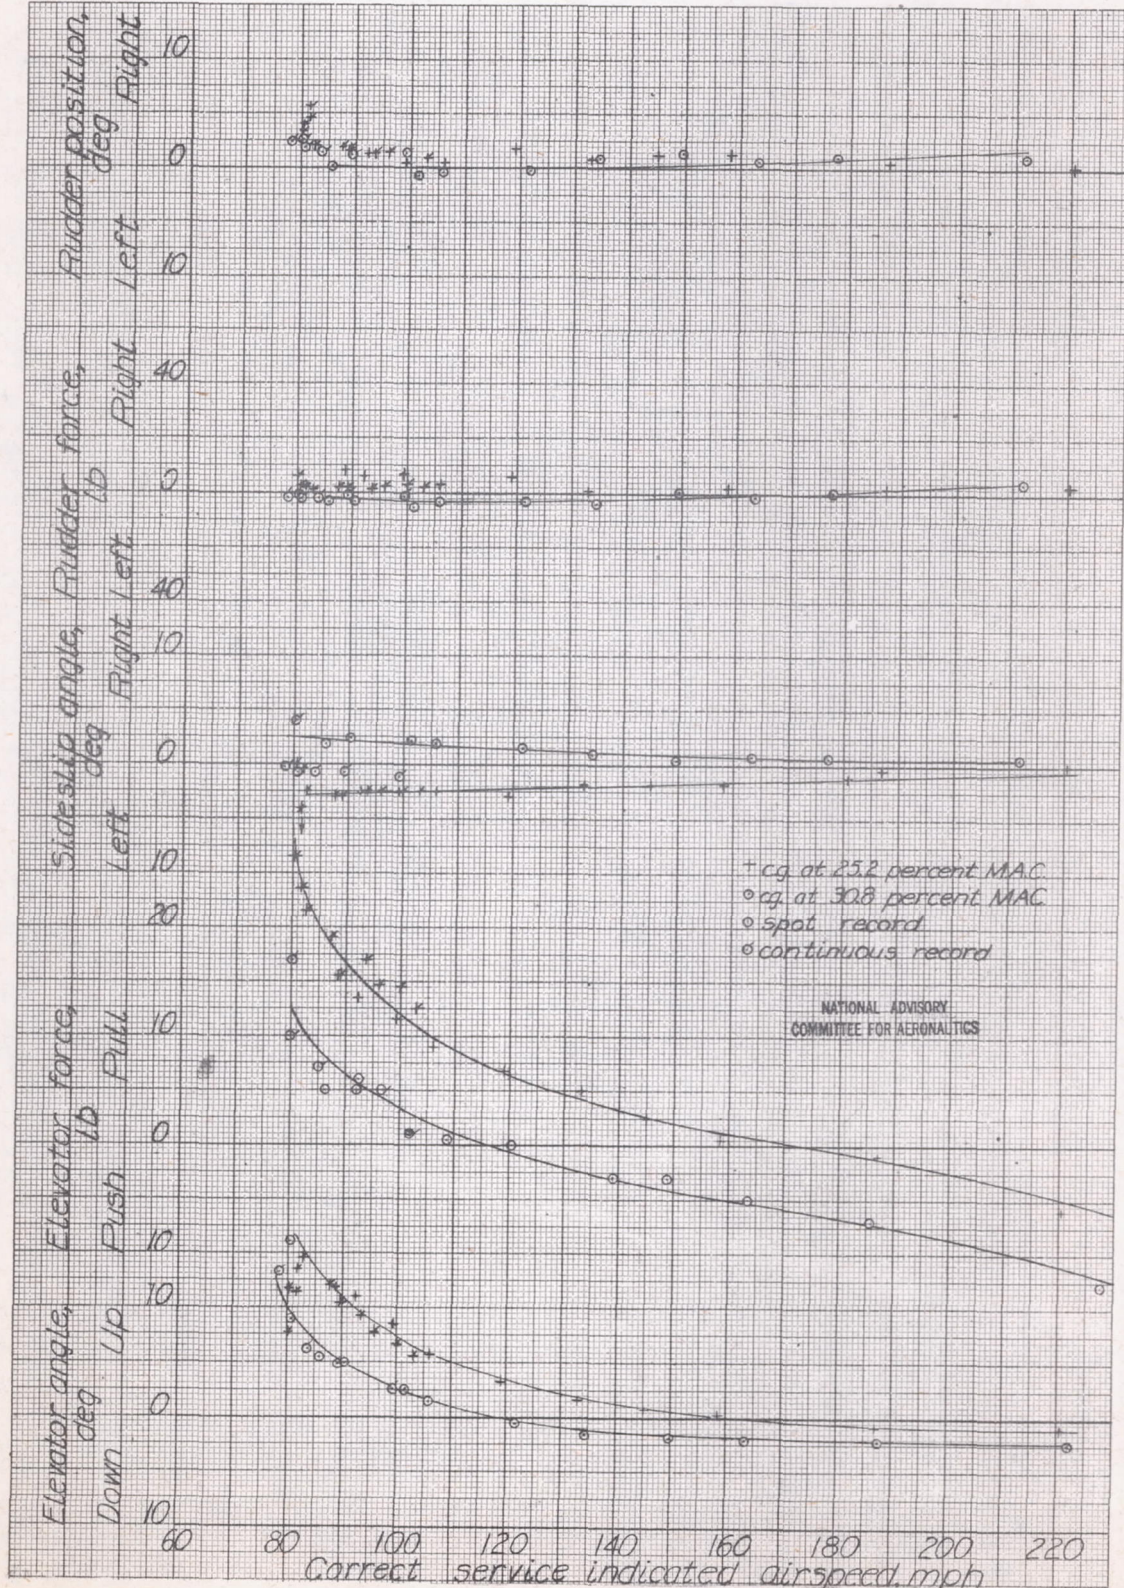
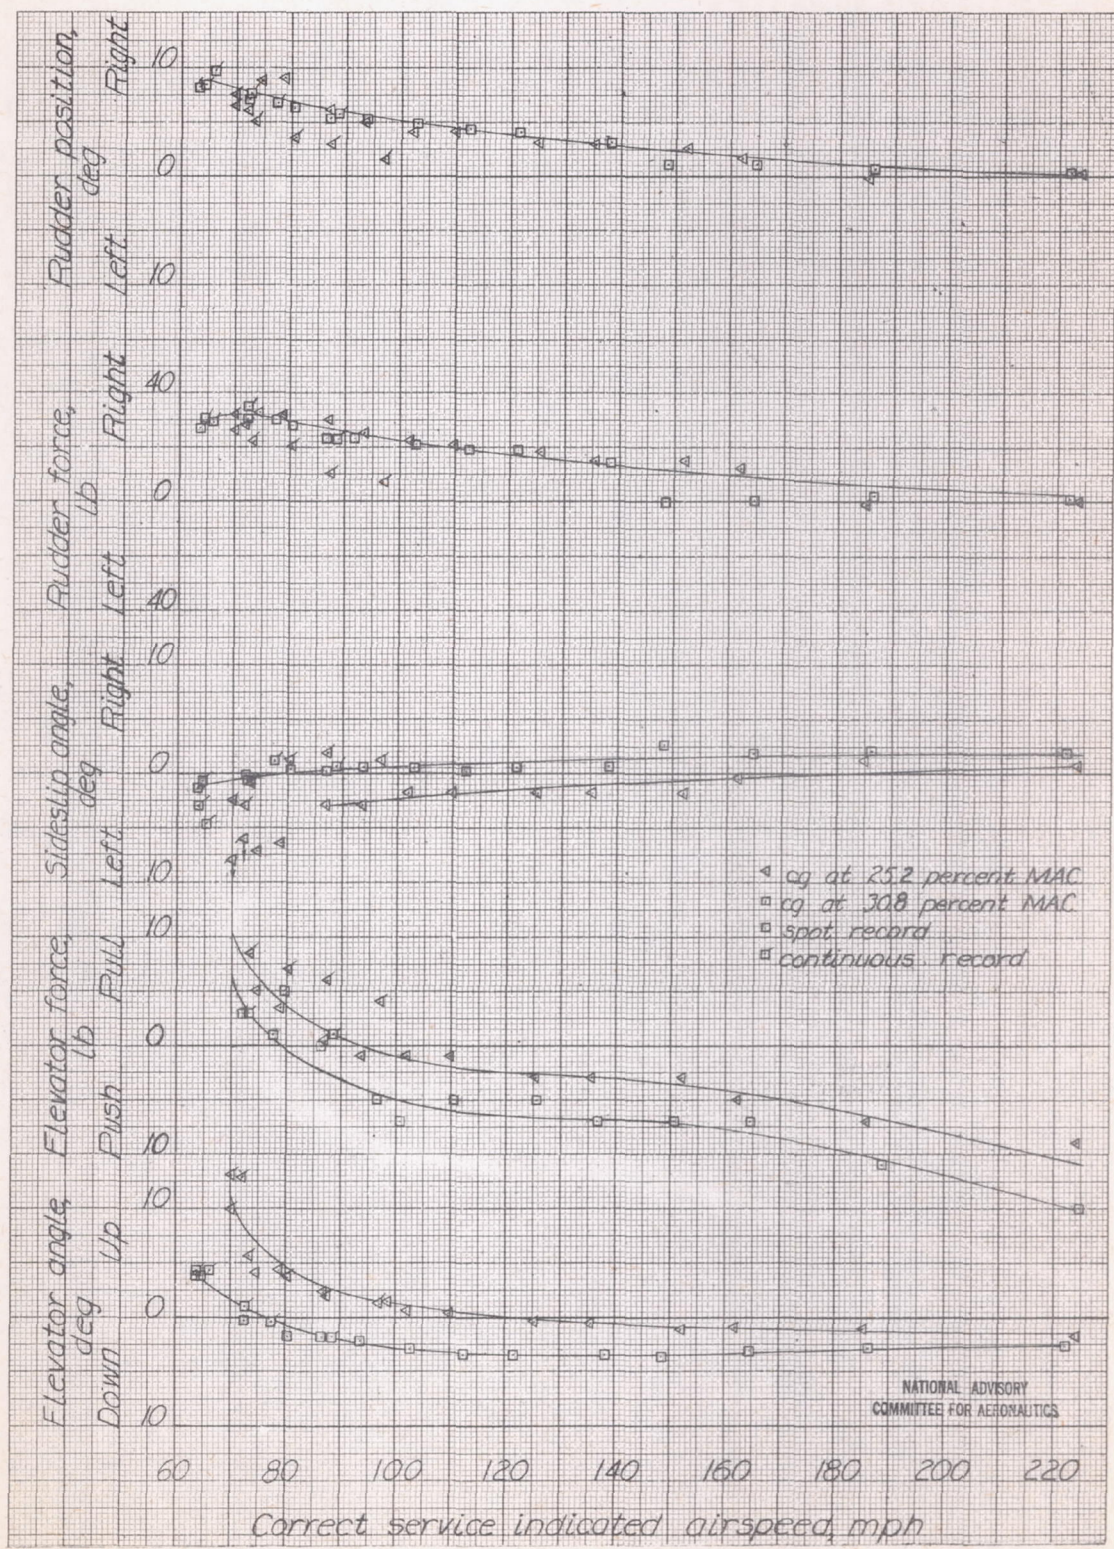
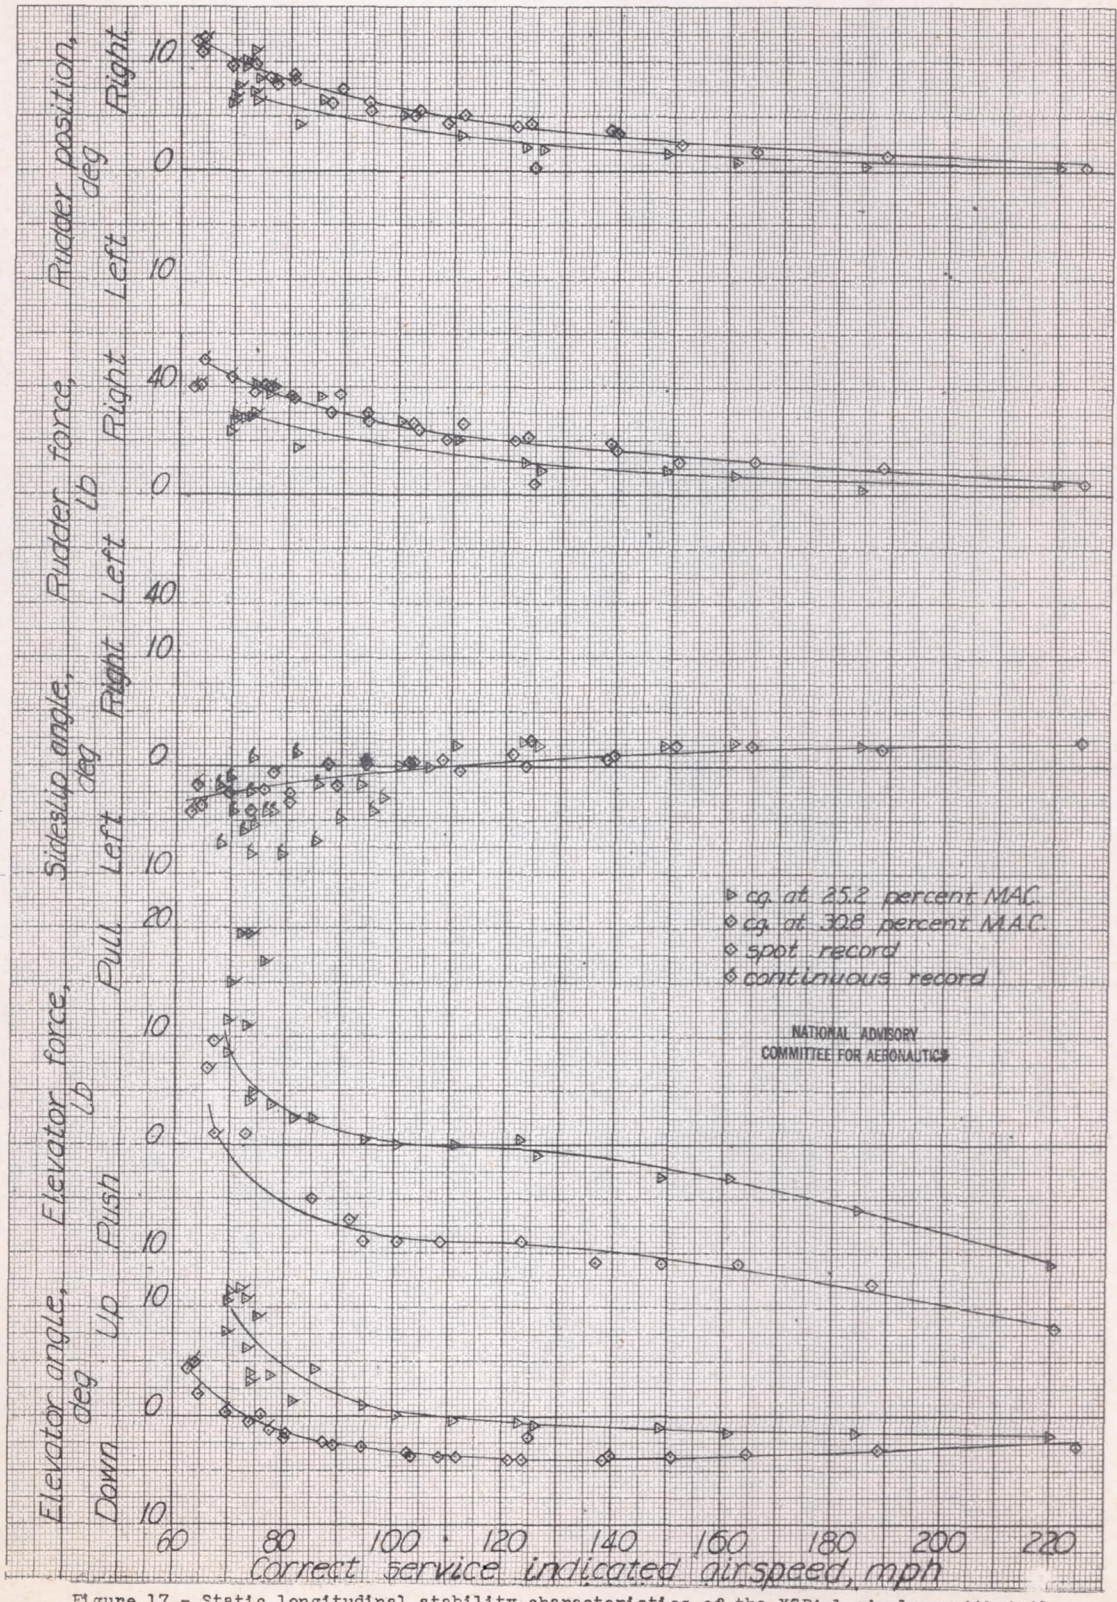
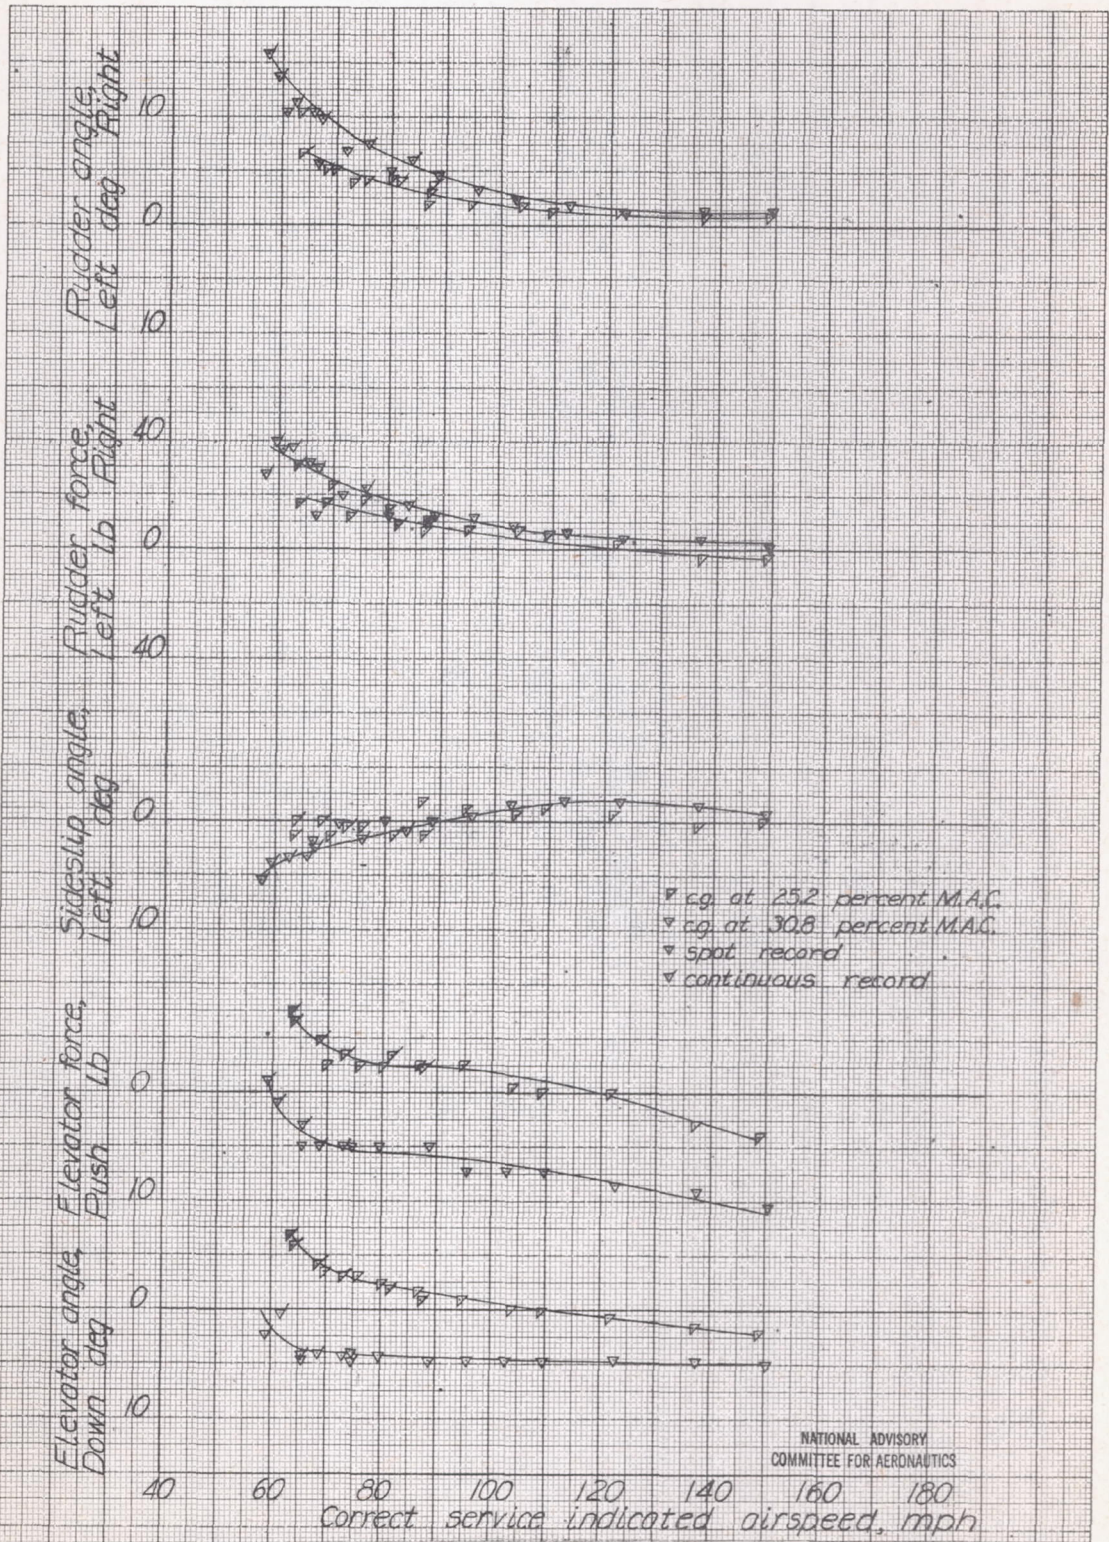
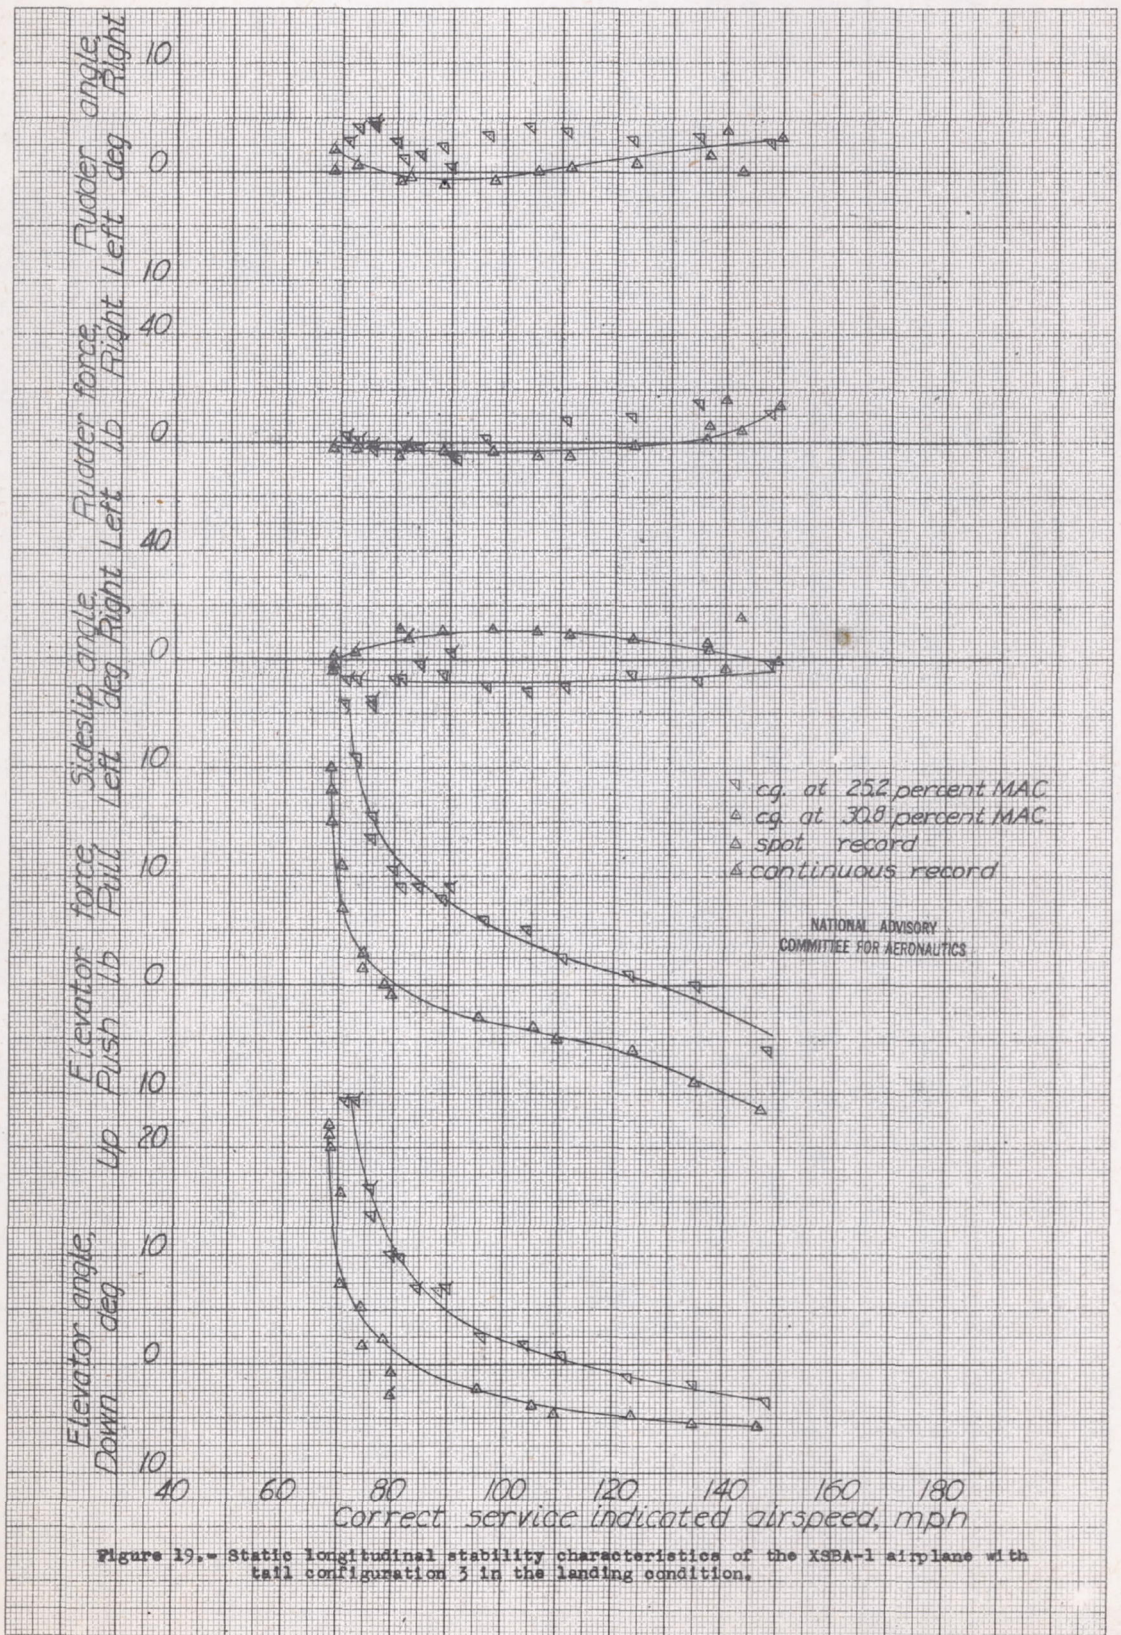
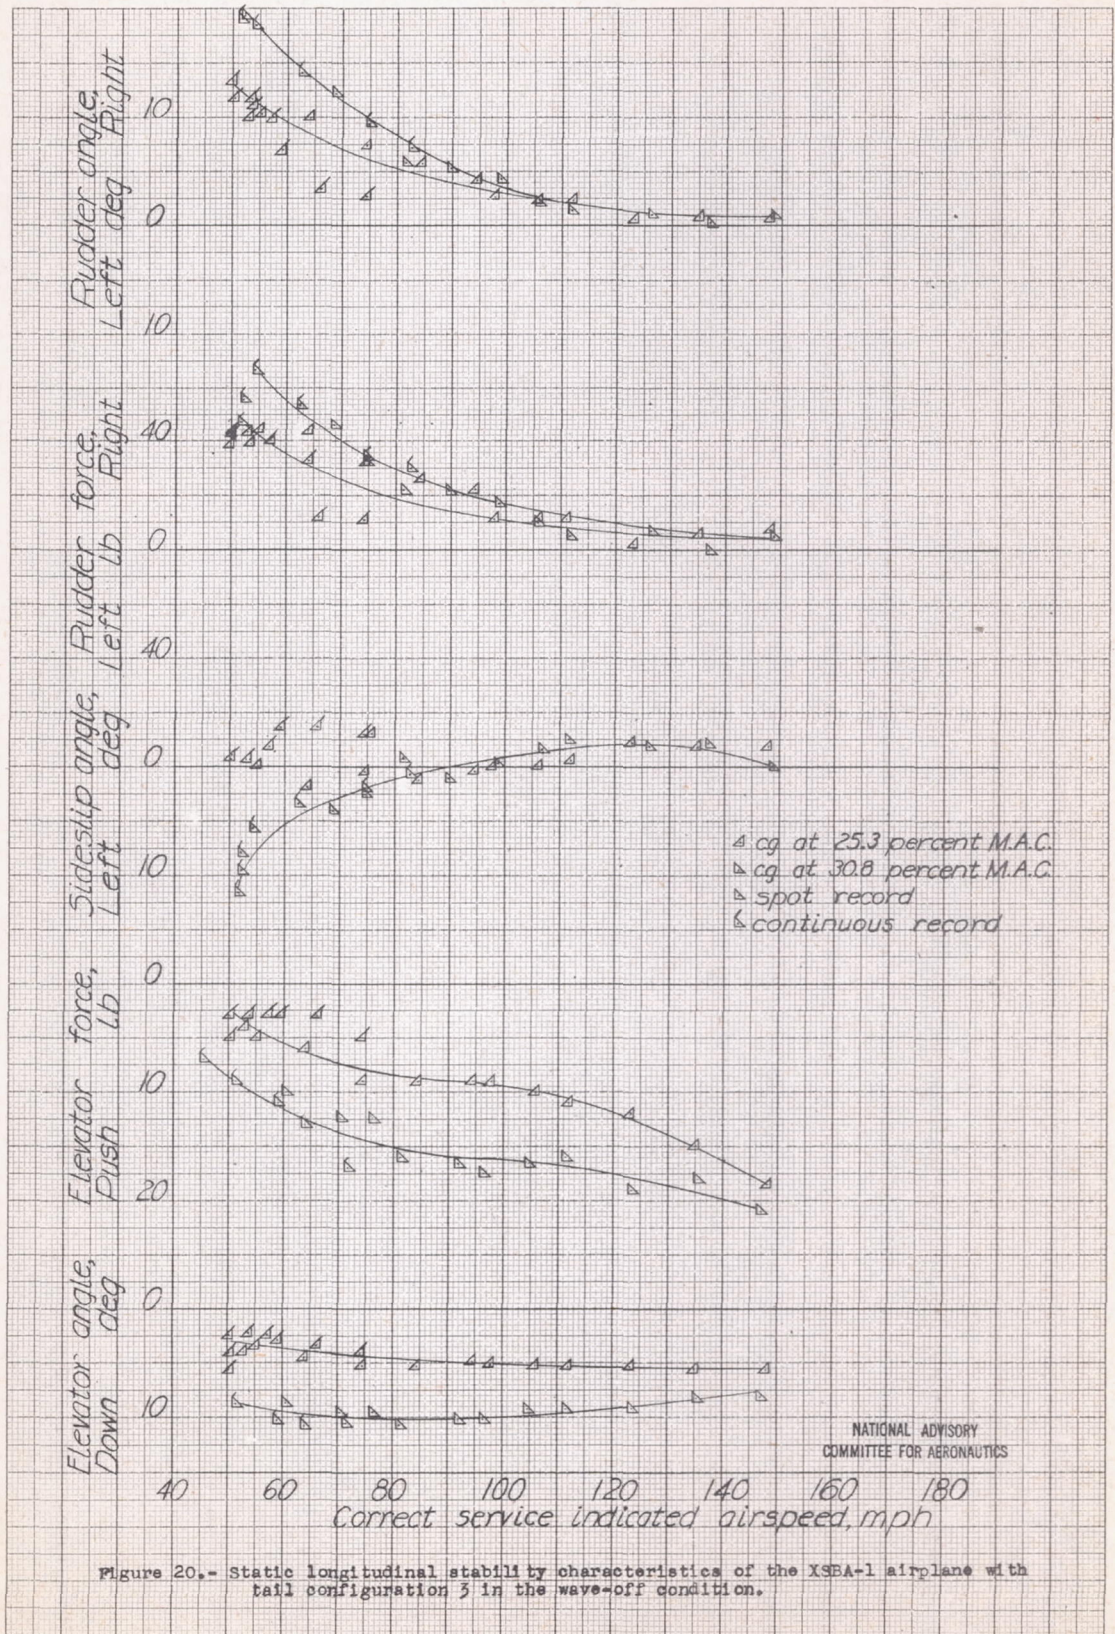
Figure 15.- Static longitudinal stability characteristics of the XSBA-1 airplane with tail configuration 3 in the gliding condition.

Figure 16.- Static longitudinal stability characteristics of the XSBA-1 airplane with tail configuration 3 in the cruising condition.

Figure 17.- Static longitudinal stability characteristics of the XSB-1 airplane with tail configuration 3 in the climbing condition.

Figure 13.- Static longitudinal stability characteristics of the XSEA-1 airplane with tail configuration 3 in the approach condition.

Figure 19.- Static longitudinal stability characteristics of the XSB-1 airplane with tail configuration 3 in the landing condition.

Figure 20.- Static longitudinal stability characteristics of the XSEA-1 airplane with tail configuration 3 in the wave-off condition.

the speed range, the stick-fixed static stability had decreased but was still at least slightly positive for all flight conditions. This is illustrated by the curves of elevator position against airspeed in figures 15 through 20.

2(a). The curves of elevator control force against indicated airspeed in figures 15 through 20 show the degree of stick-free static stability of the XSBA-1 airplane with tail configuration 3 with the trimming tabs undeflected. The force curves for the two center-of-gravity positions are parallel as would be expected with the same trimming-tab setting. With the center of gravity at 25 percent of the mean aerodynamic chord the airplane was stable, stick free, in all conditions except wave-off for any trim speed within the speed range for that flight condition. This statement is based on the calculated elevator force curves for various trim speeds which can be found using the power of the elevator trimming tabs as given by figure 24.

3. The amount of rudder deflection required to trim the airplane for level flight in various conditions is shown in figures 15 through 20. Considerably more rudder deflection was required with the narrow-chord rudder of tail 3 than with rudders 1 and 2. The pilot stated that in some runs he "ran out of rudder" near the stall in the wave-off condition with tail configuration 3 but did not consider the rudder control inadequate on this account. In these instances the correct rudder deflection was almost 20° compared with about 10° required with rudders 1 and 2. Because of differences in the gas loading in the wing tanks, there may have been differences in the lateral position of the center of gravity which would have affected the amount of rudder deflection required for trim. Inasmuch as no records were kept of the lateral loading conditions, the effects of this variable on the rudder deflection were not determined. Subsequent flight tests have shown that a lateral center-of-gravity shift of a few inches produces a large effect on the amount of rudder deflection required for trim near the stall.

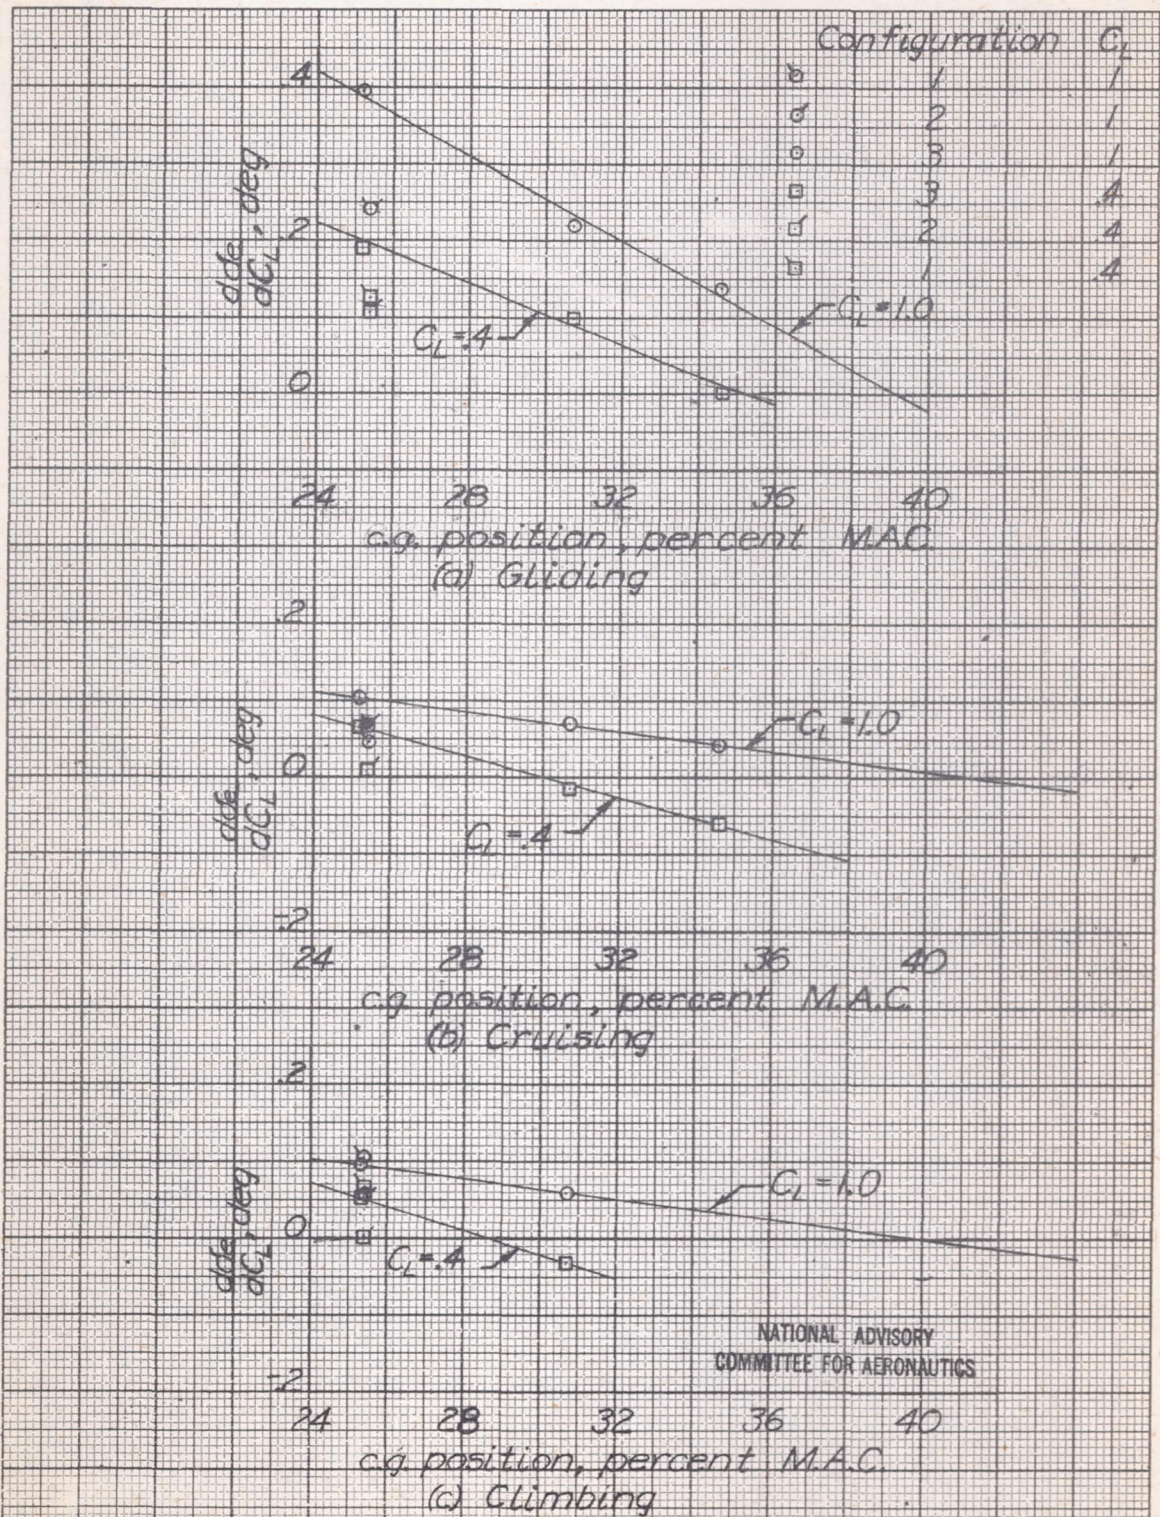
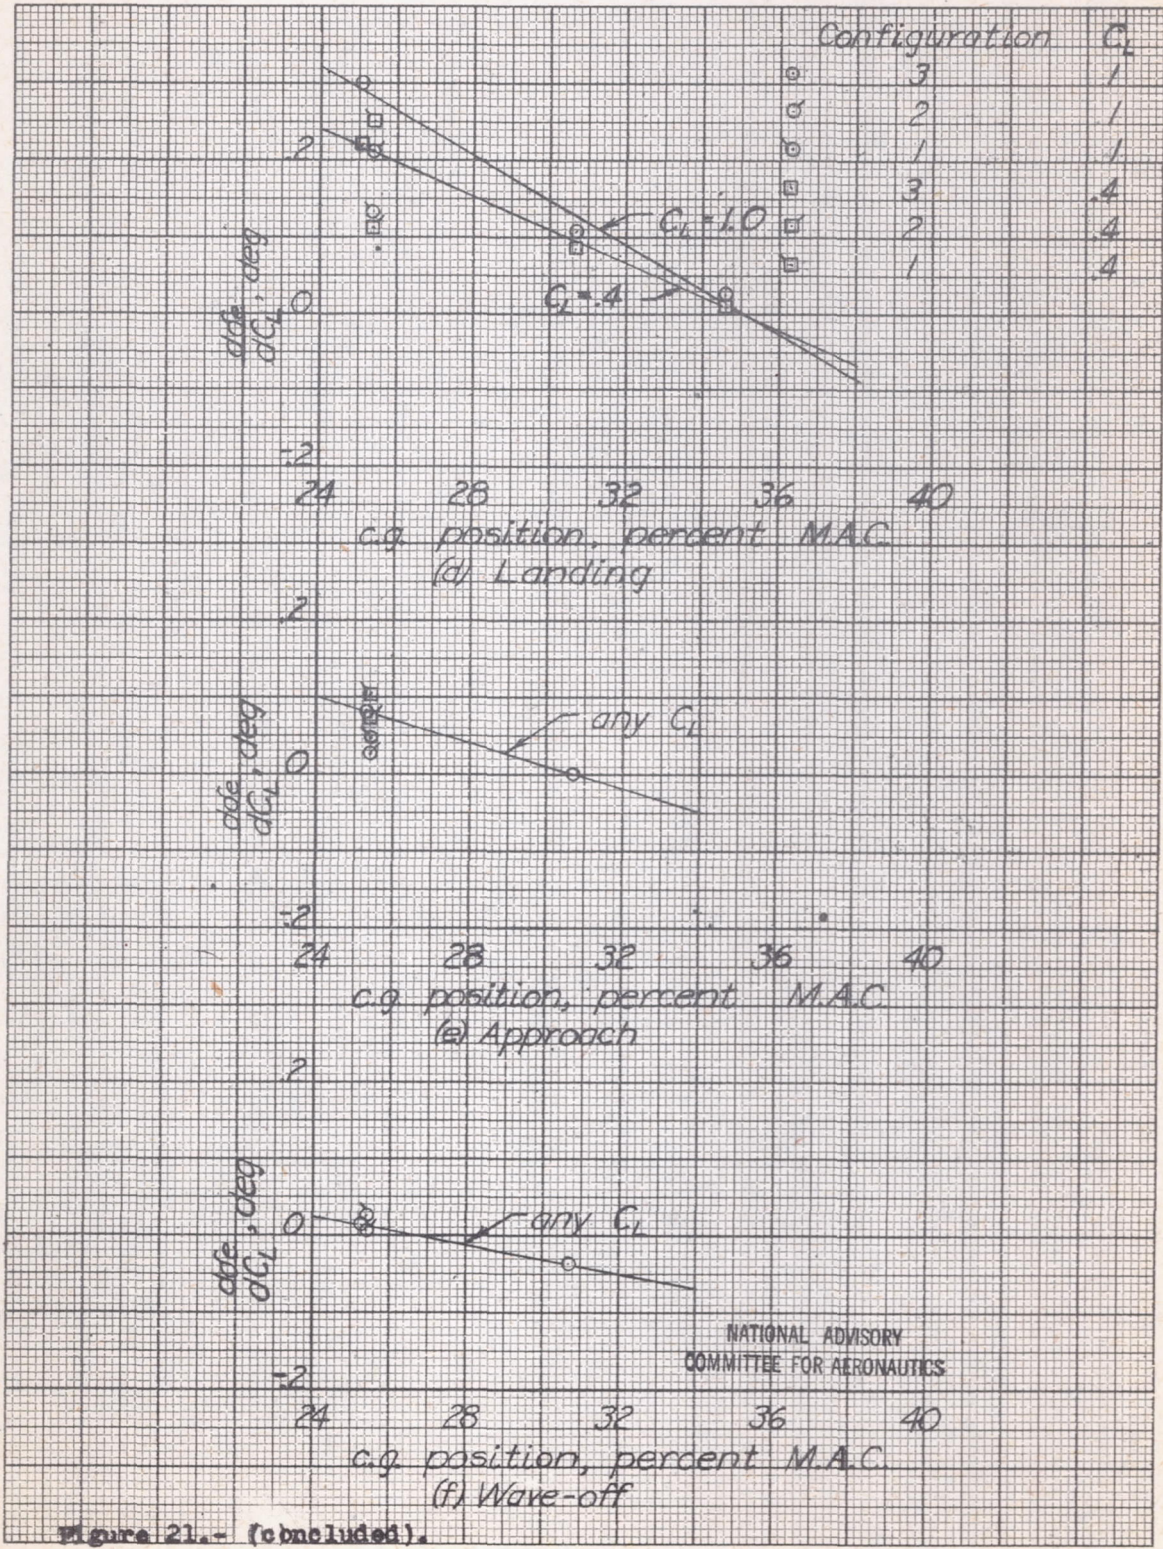
Figure 21.- Plots showing stick-fixed neutral points in various flight conditions for the XSBA-1 airplane.

1(b). The stick-fixed neutral points have been determined for the airplane with tail 3 at lift coefficients of 0.4 and 1.0 from flight tests at three center-of-gravity positions. Figure 21 contains the plots of $d\delta_e/dC_L$ against center-of-gravity position, where δ_e is elevator position and C_L is airplane lift coefficient, from which the stick-fixed neutral points were determined. Figure 22, a plot of δ_e against C_L , illustrates for one condition, landing, the intermediate step between the plots of elevator deflection against airspeed and the plots of $d\delta_e/dC_L$ against center-of-gravity position.

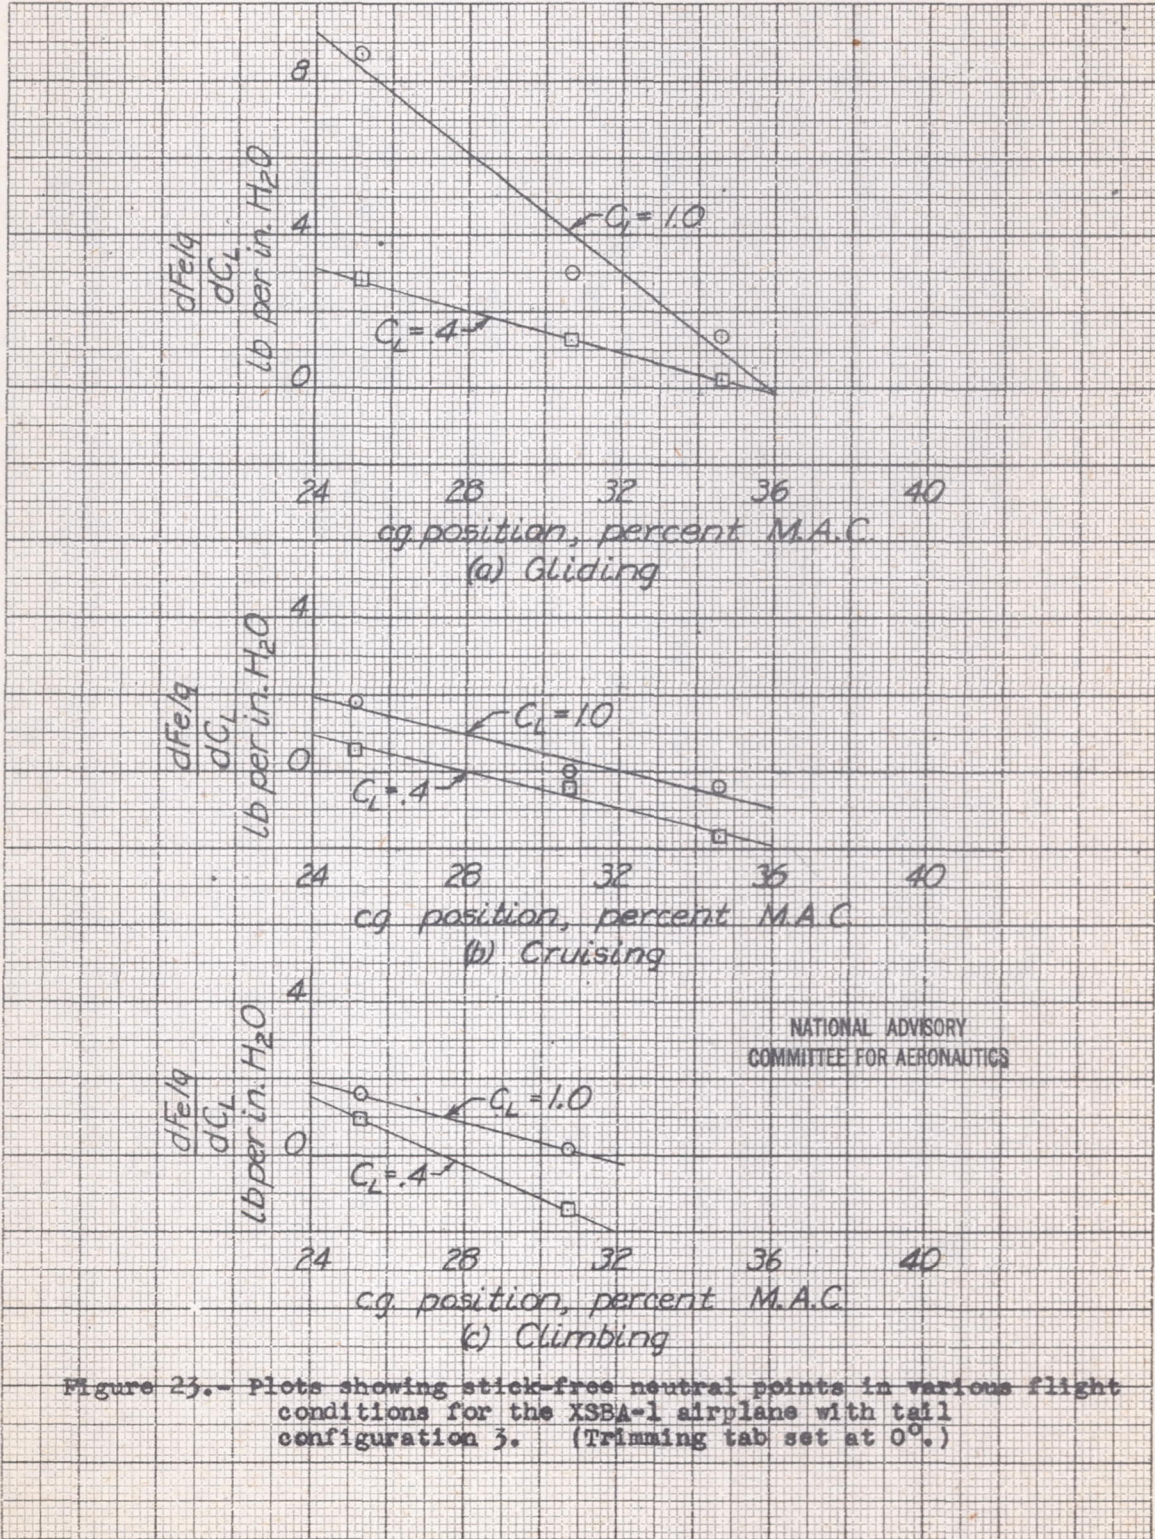
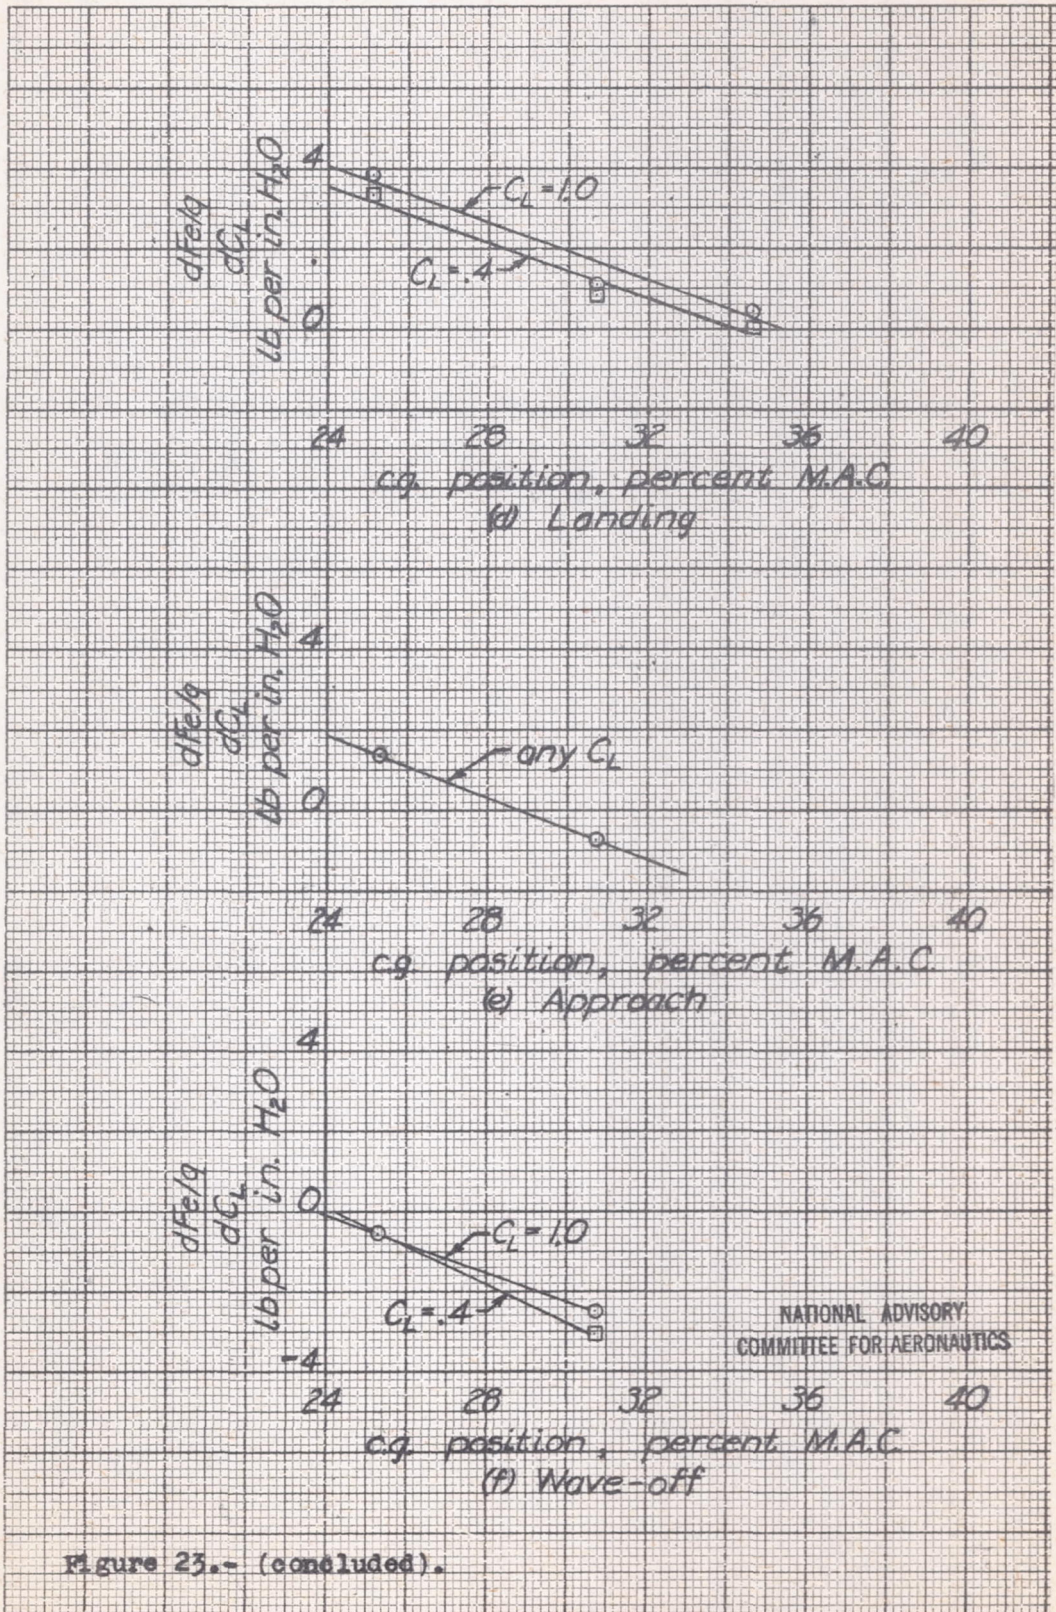
Figure 23.- Plots showing stick-free neutral points in various flight conditions for the XSBA-1 airplane with tail configuration 3. (Trimming tab set at 0°.)

2(b). The stick-free neutral points have been determined at lift coefficients of 0.4 and 1.0 for the airplane with tail configuration 3 from flight tests at three center-of-gravity positions. Figure 23 contains plots of the variation of F/q_c with C_L against center-of-gravity position, where F is elevator control force and q_c is impact pressure, from which the neutral points are determined. The intermediate step, a plot of F/q_c against C_L , is again illustrated for one condition by figure 22.

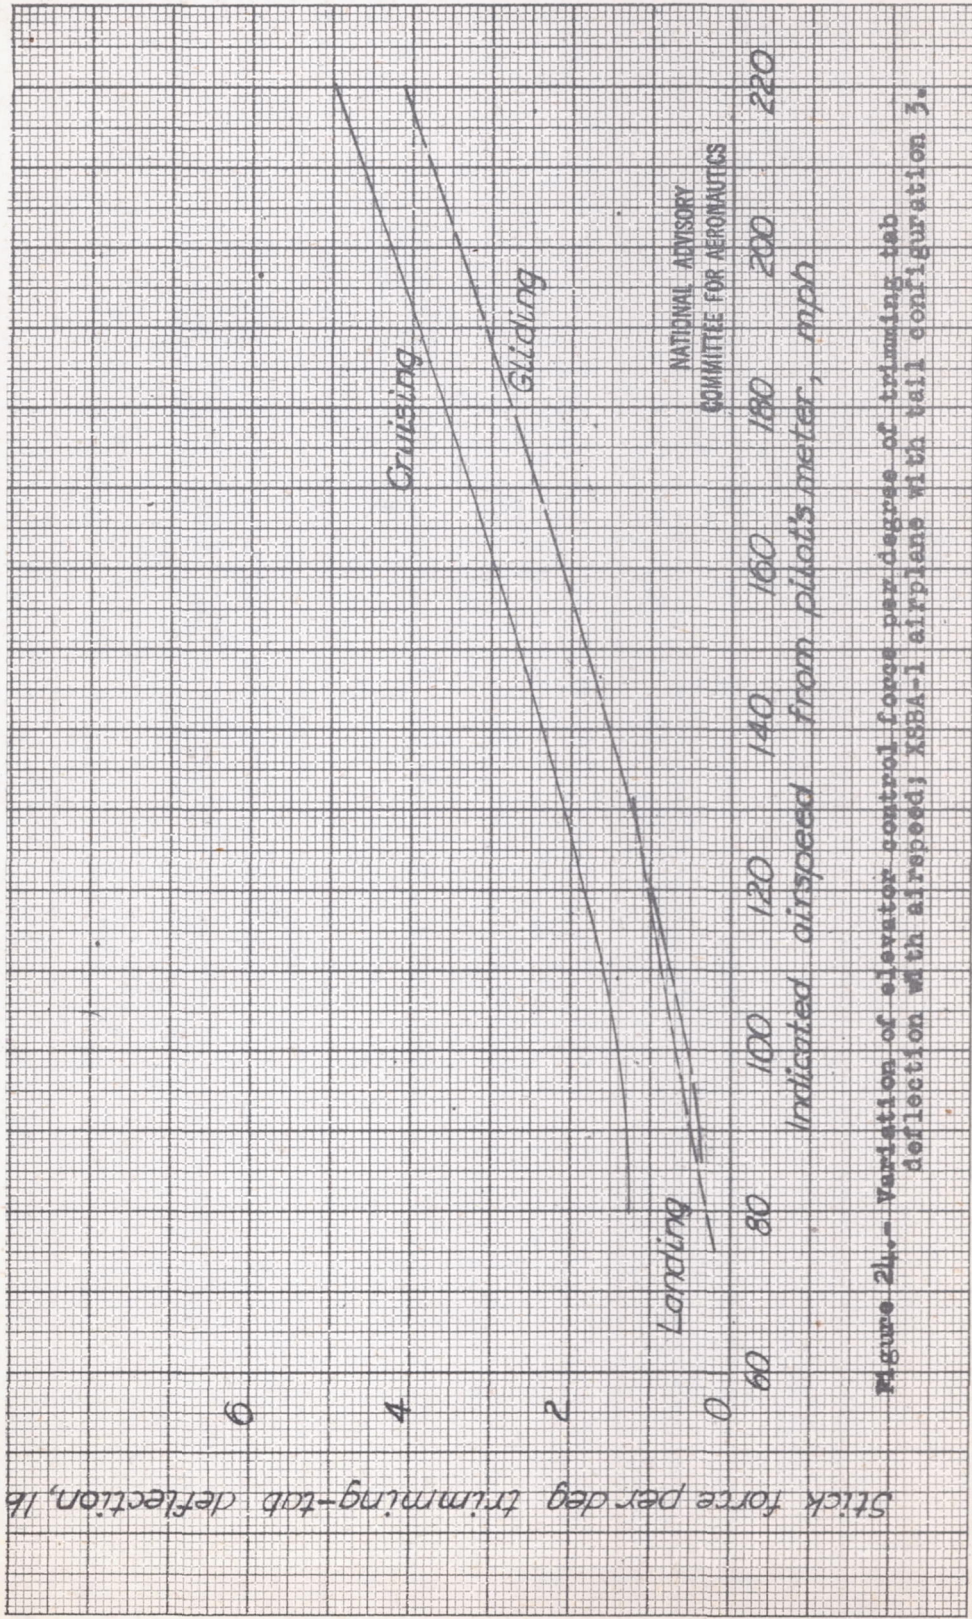
Figure 24.- Variation of elevator control force per degree of trimming tab deflection with airspeed; X8BA-1 airplanes with tail configuration 3.

1. As is shown in figures 3, 5, and 7, the elevator trimming tabs on the three tail configurations were of the same area. The power of the tab on tail 3 in pounds of stick force per degree of tab deflection, shown in figure 24, was about one-third that of the tabs on tails 1 and 2. With a deflection range of $\pm 11^\circ$ the elevator trimming tab on tail 3 was inadequate in the landing condition. For every 3.5° of tab deflection on tail 3, 1° of elevator deflection in the opposite direction was required to trim the airplane at a given speed.

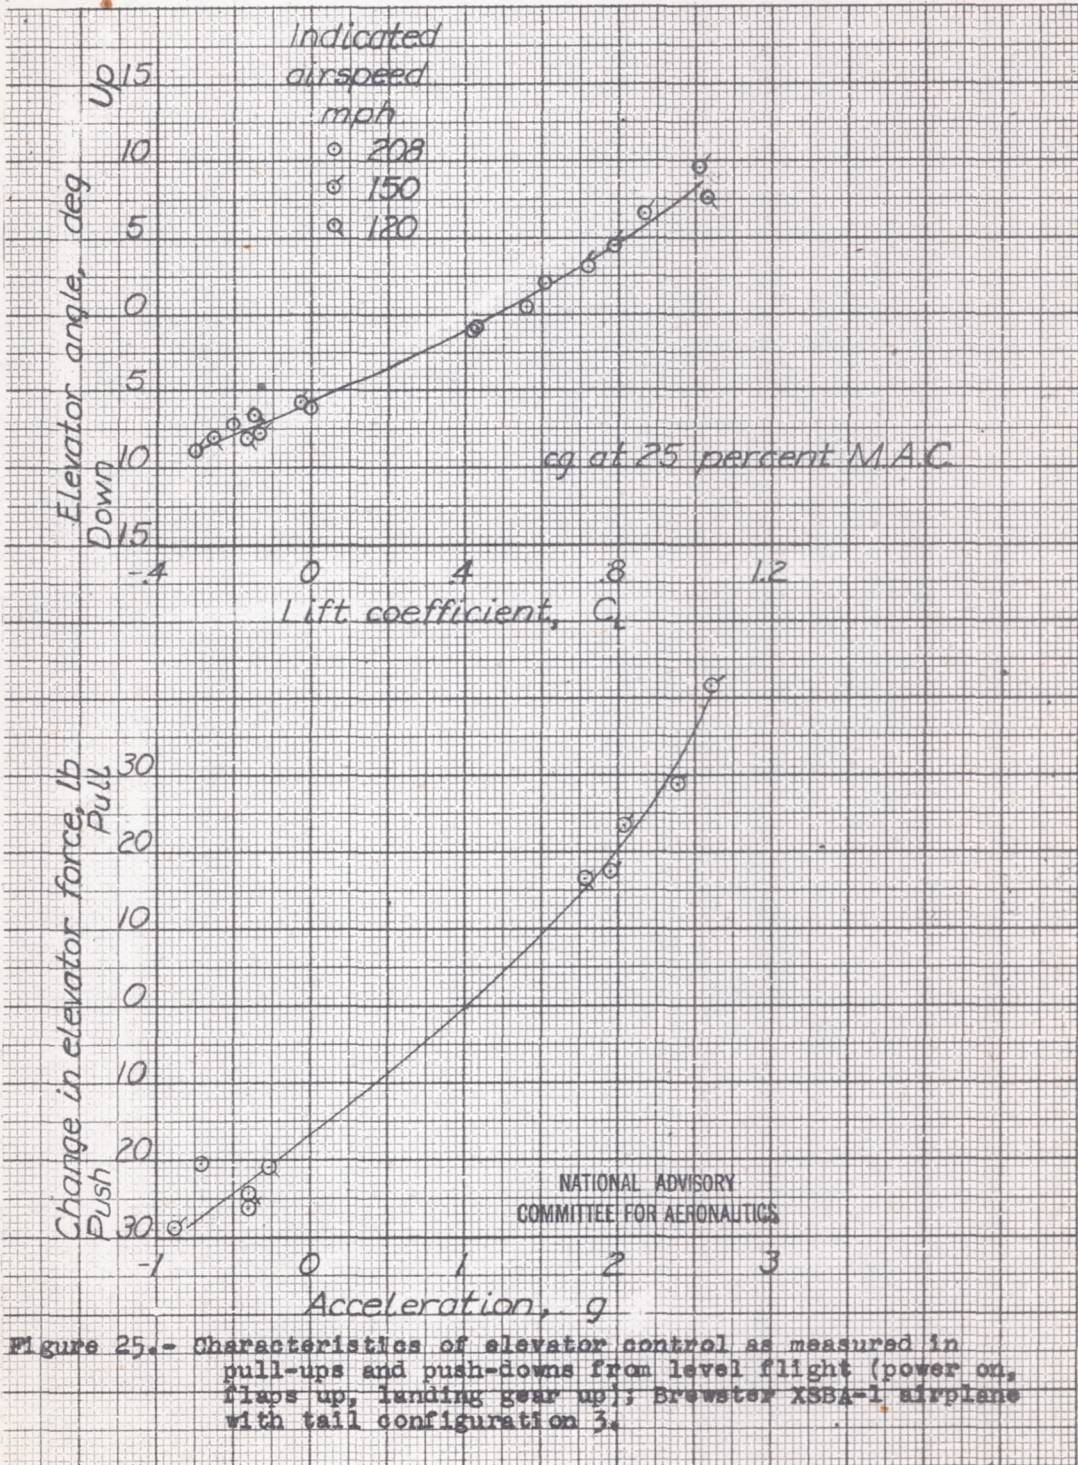
Figure 25.- Characteristics of elevator control as measured in pull-ups and push-downs from level flight (power on, flaps up, landing gear up); Brewster XSB-1 airplane with tail configuration 3.
