FLIGHT TESTS OF VARIOUS TAIL MODIFICATIONS

ON THE BREWSTER XSBA-1 AIRPLANE

III - MEASUREMENTS OF FLYING QUALITIES

WITH TAIL CONFIGURATION 3

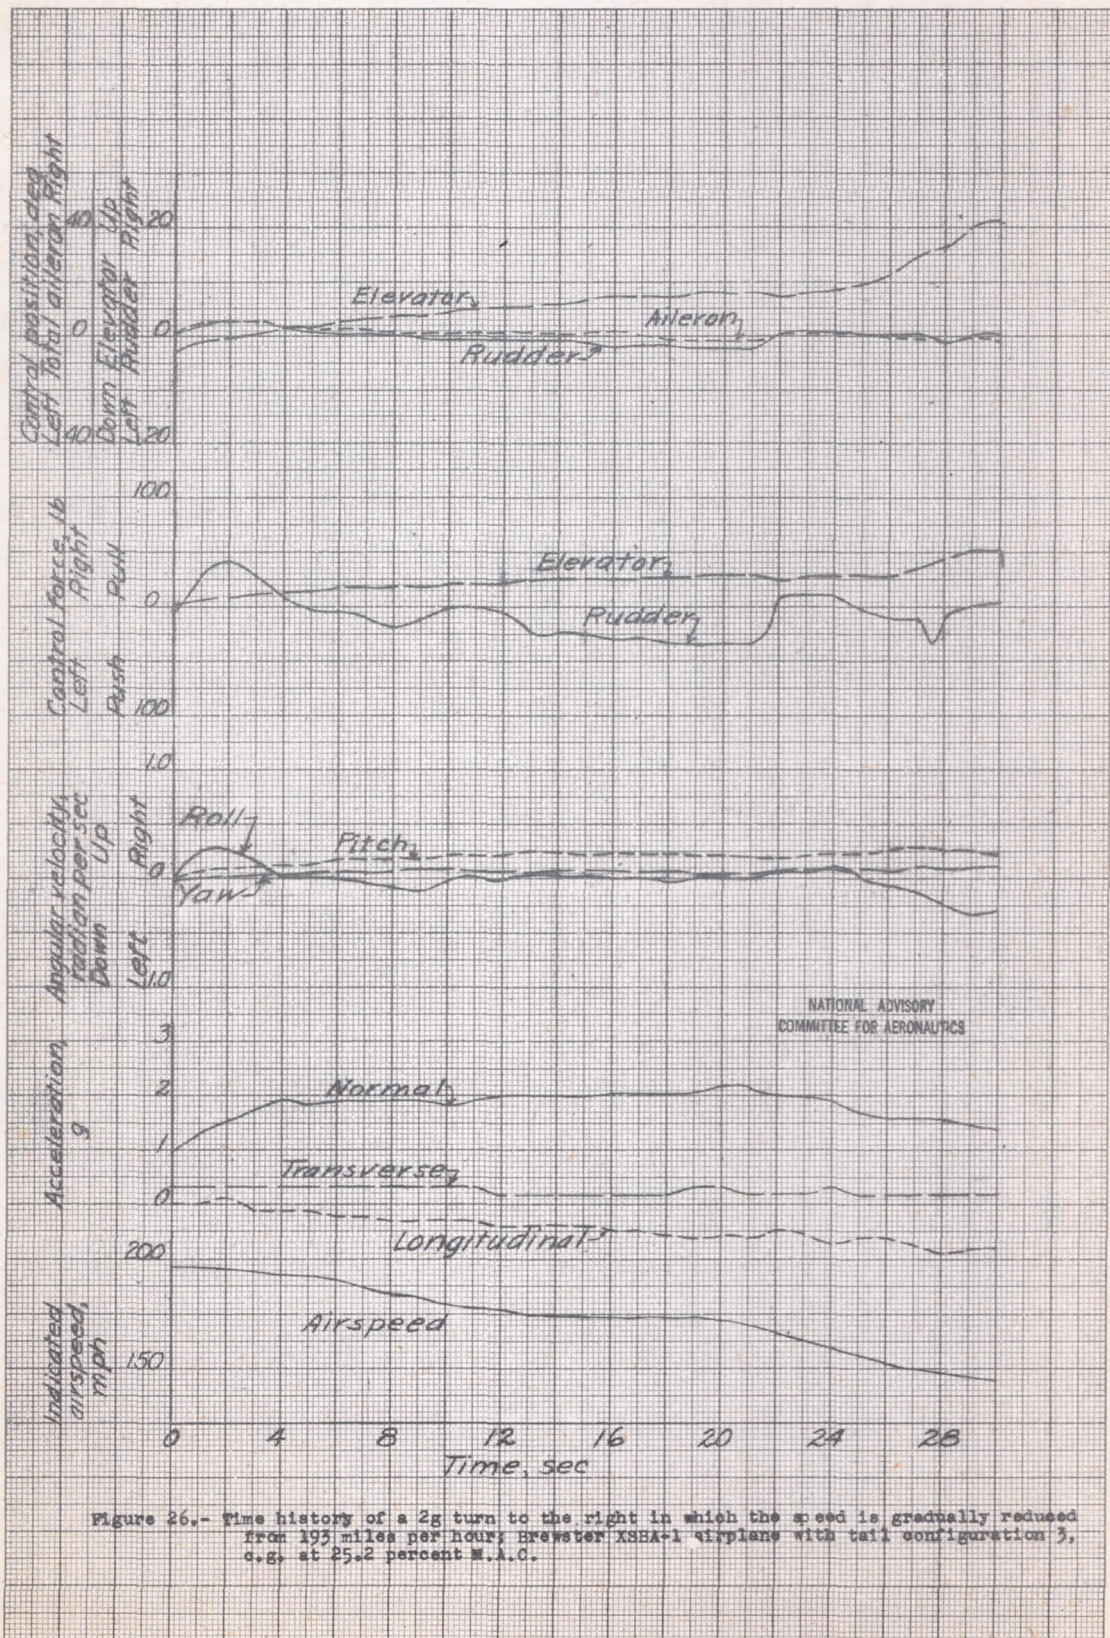
Figure 26.- Time history of a 2g turn to the right in which the speed is gradually reduced from 195 miles per hour; Brewster XSB-1 airplane with tail configuration 3, c.g. at 25.2 percent M.A.C.

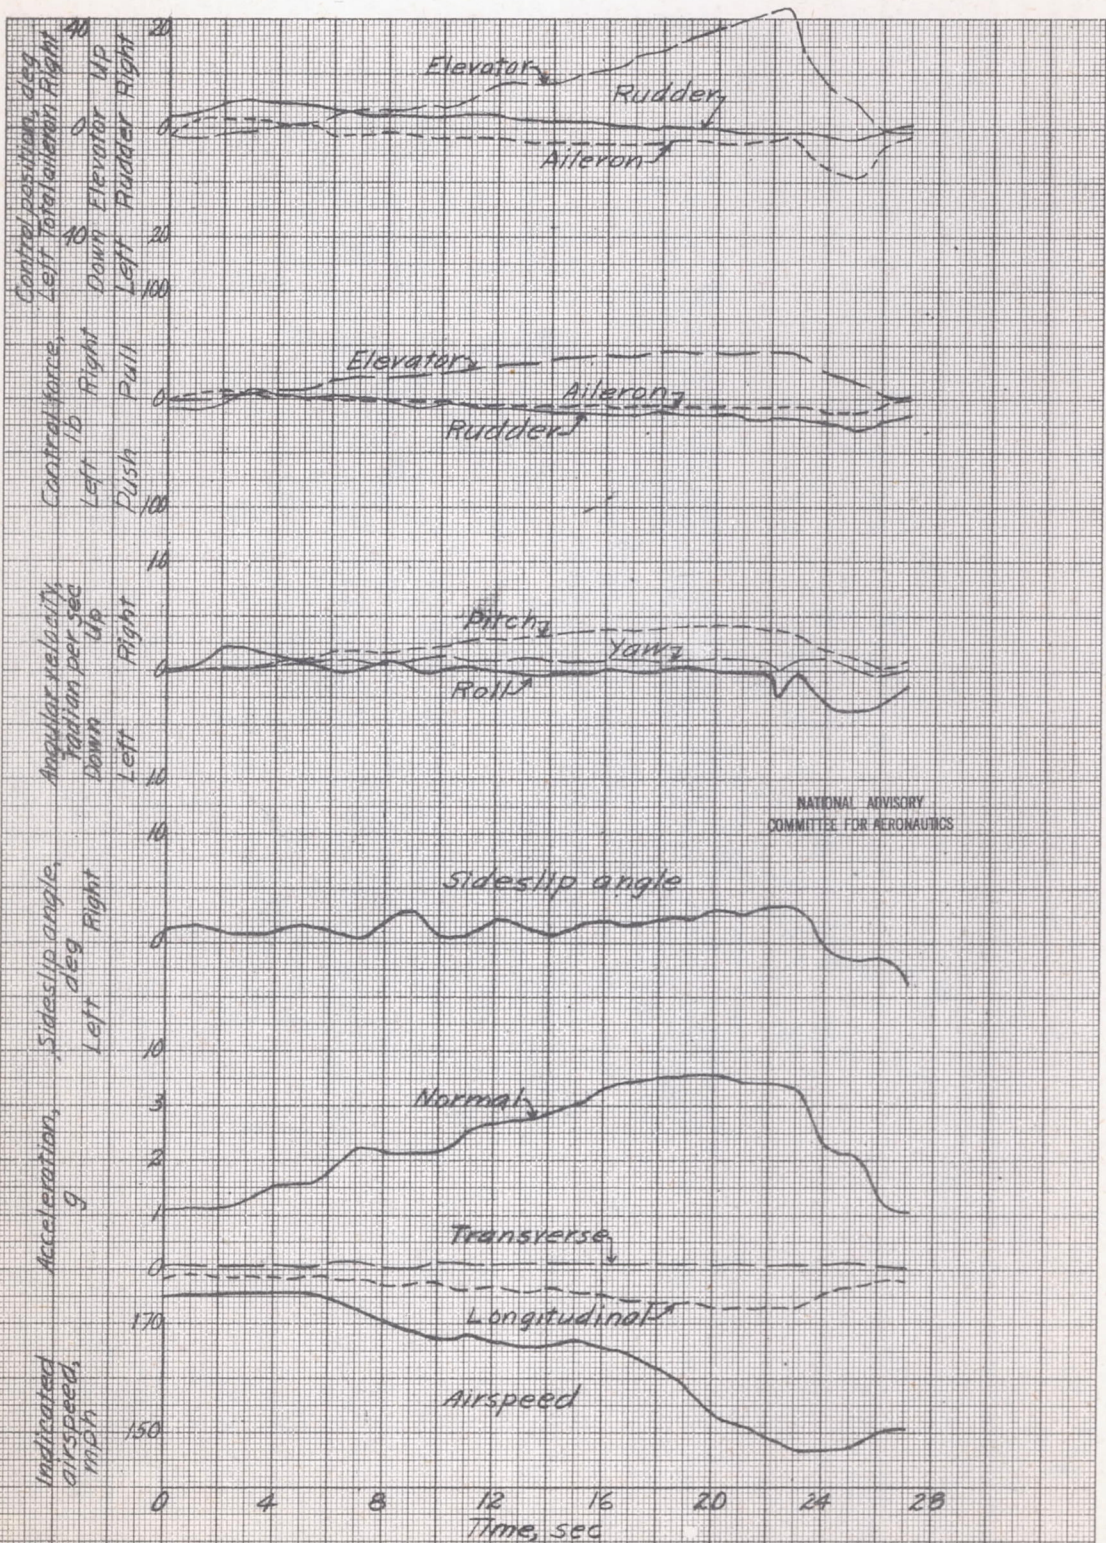
Figure 27.- Time history of a 3.5g right turn to the stall; Brewster XSBA-1 airplane with tail configuration 3; c.g. at 25.2 percent M.A.C.

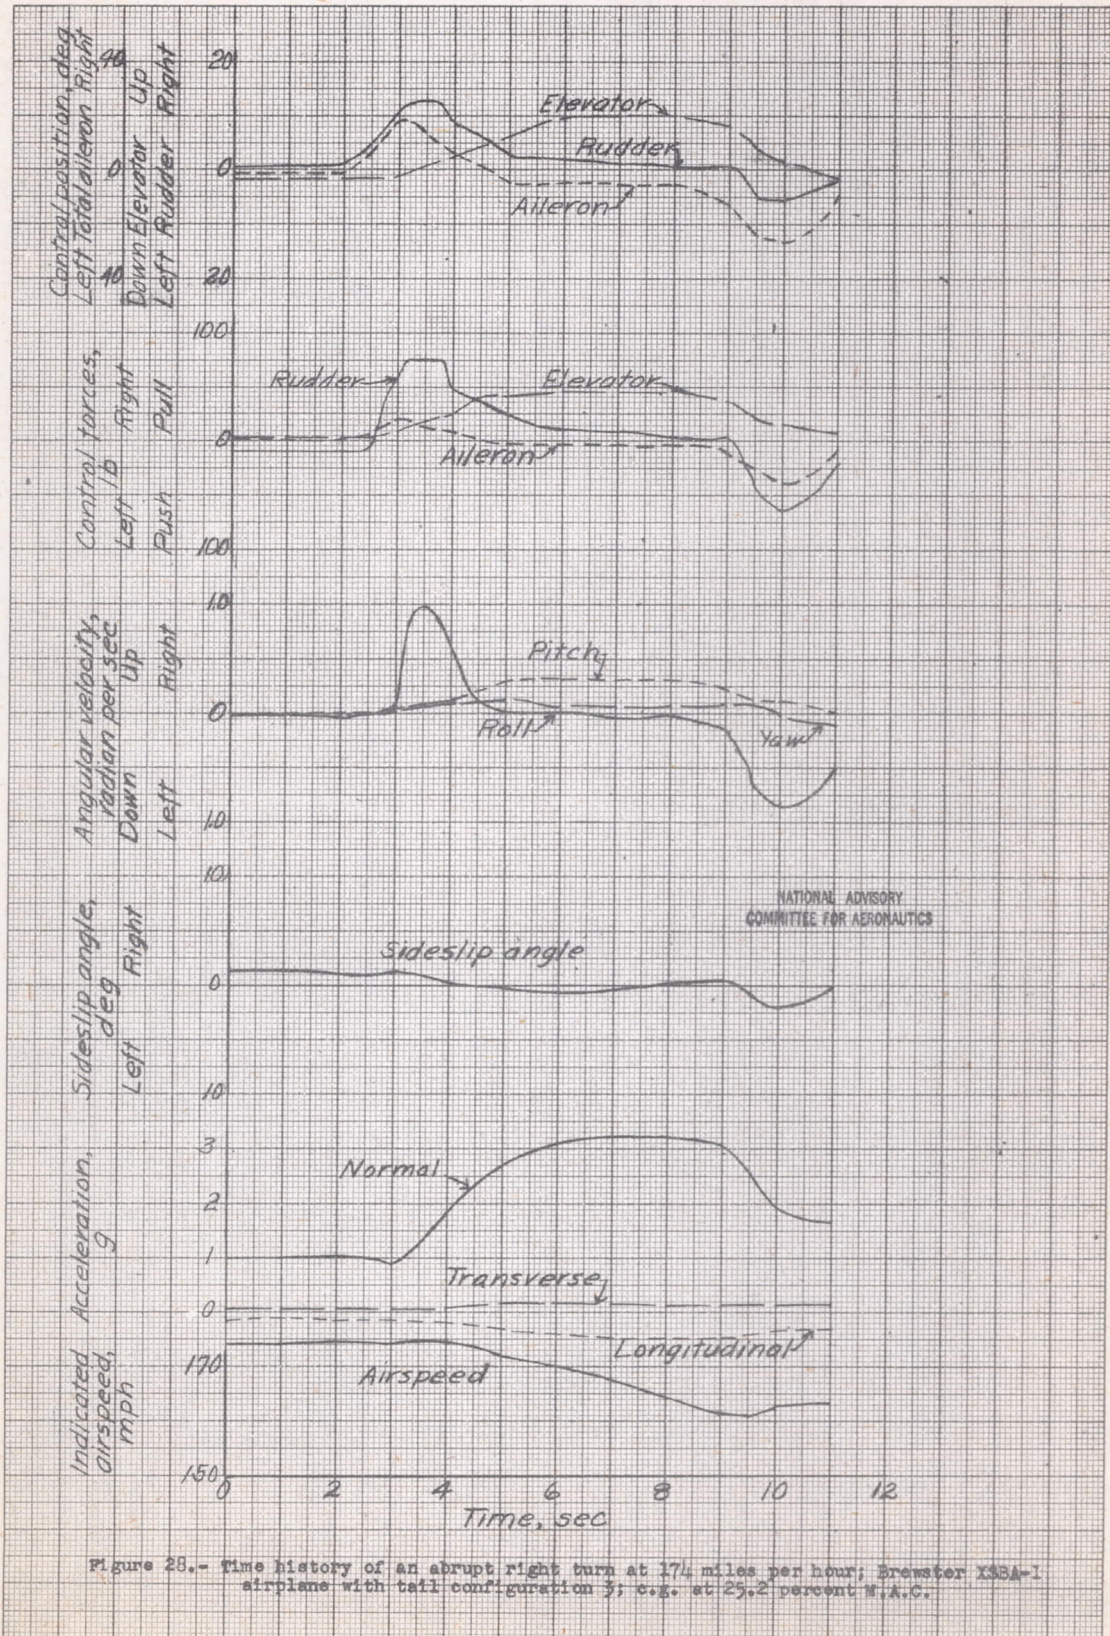
Figure 28.- Time history of an abrupt right turn at 174 miles per hour; Brewster X33A-1 airplane with tail configuration 3; c.g. at 25.2 percent M.A.C.

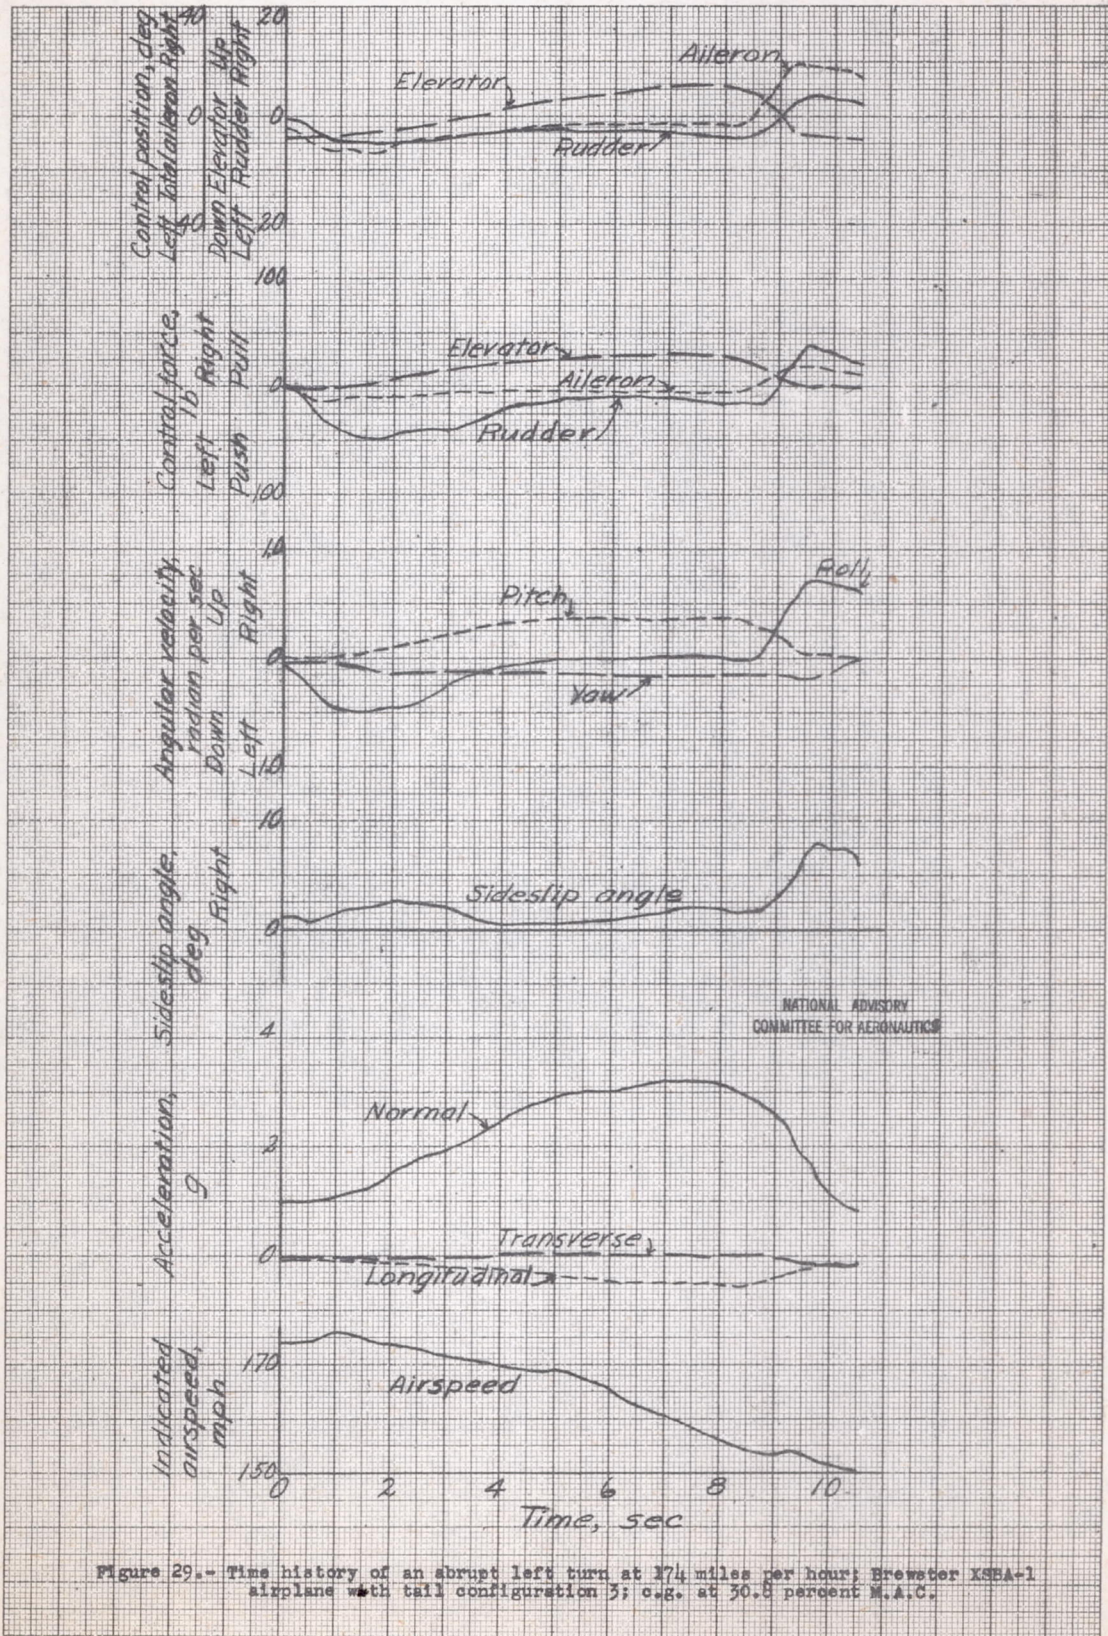
Figure 29.- Time history of an abrupt left turn at 174 miles per hour; Brewster XSEA-1 airplane with tail configuration 5; c.g. at 30.8 percent M.A.C.

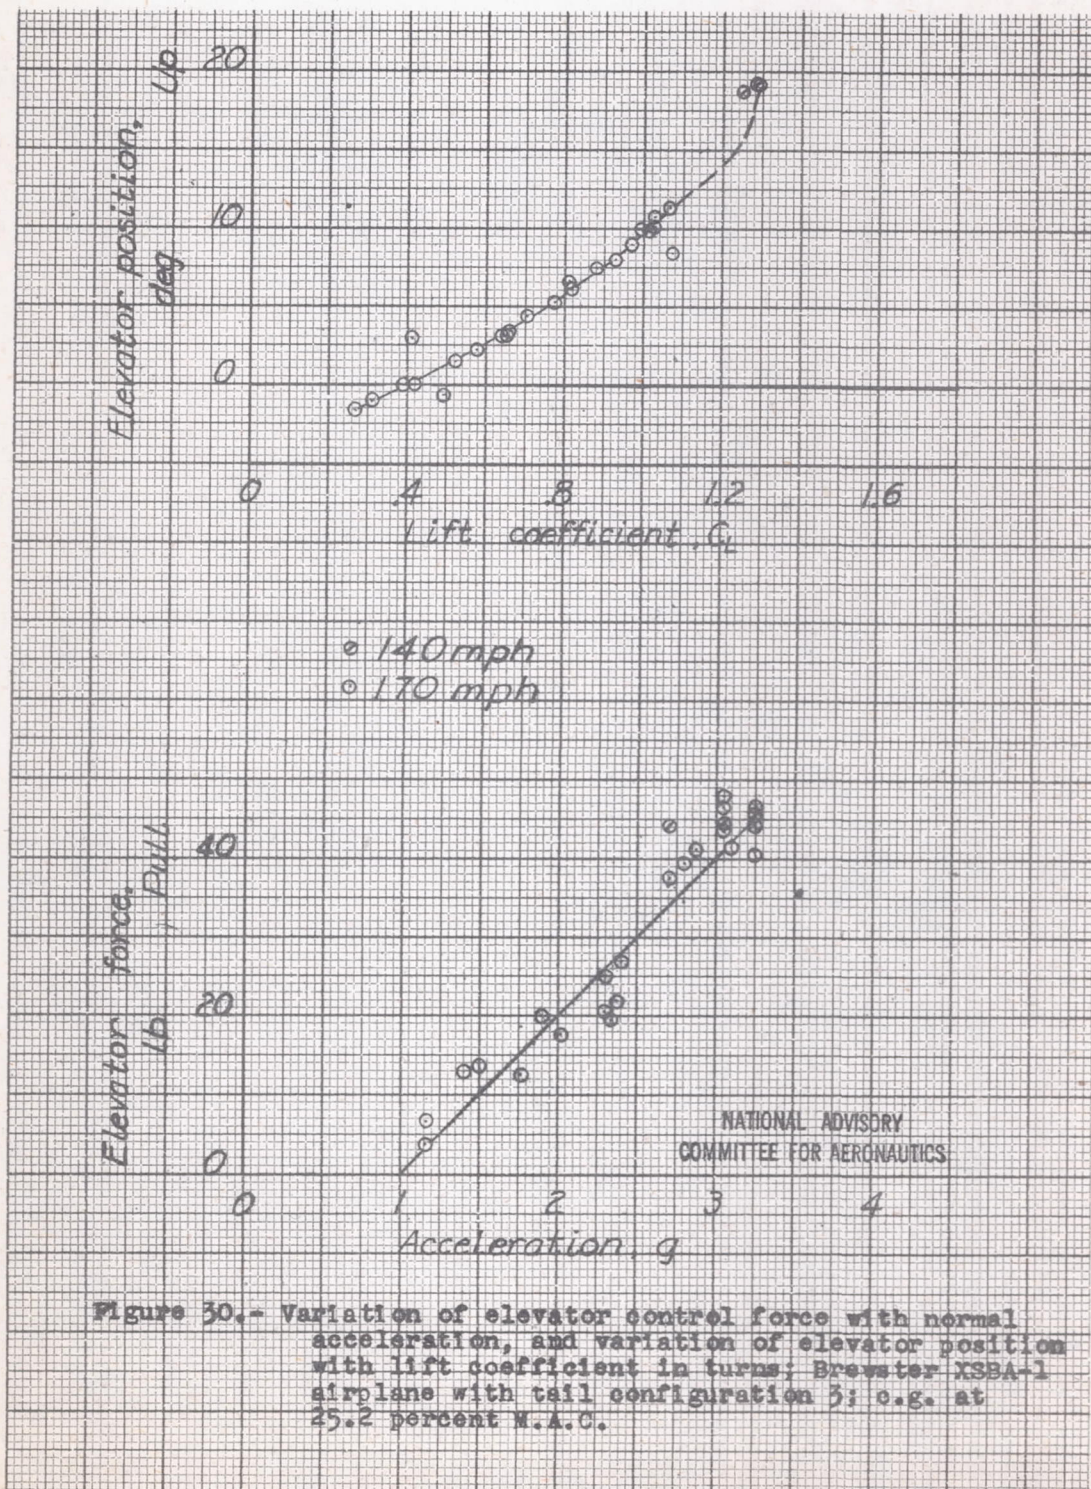
Figure 30.- Variation of elevator control force with normal acceleration, and variation of elevator position with lift coefficient in turns; Brewster XSBA-1 airplane with tail configuration 3; c.g. at 25.2 percent M.A.C.

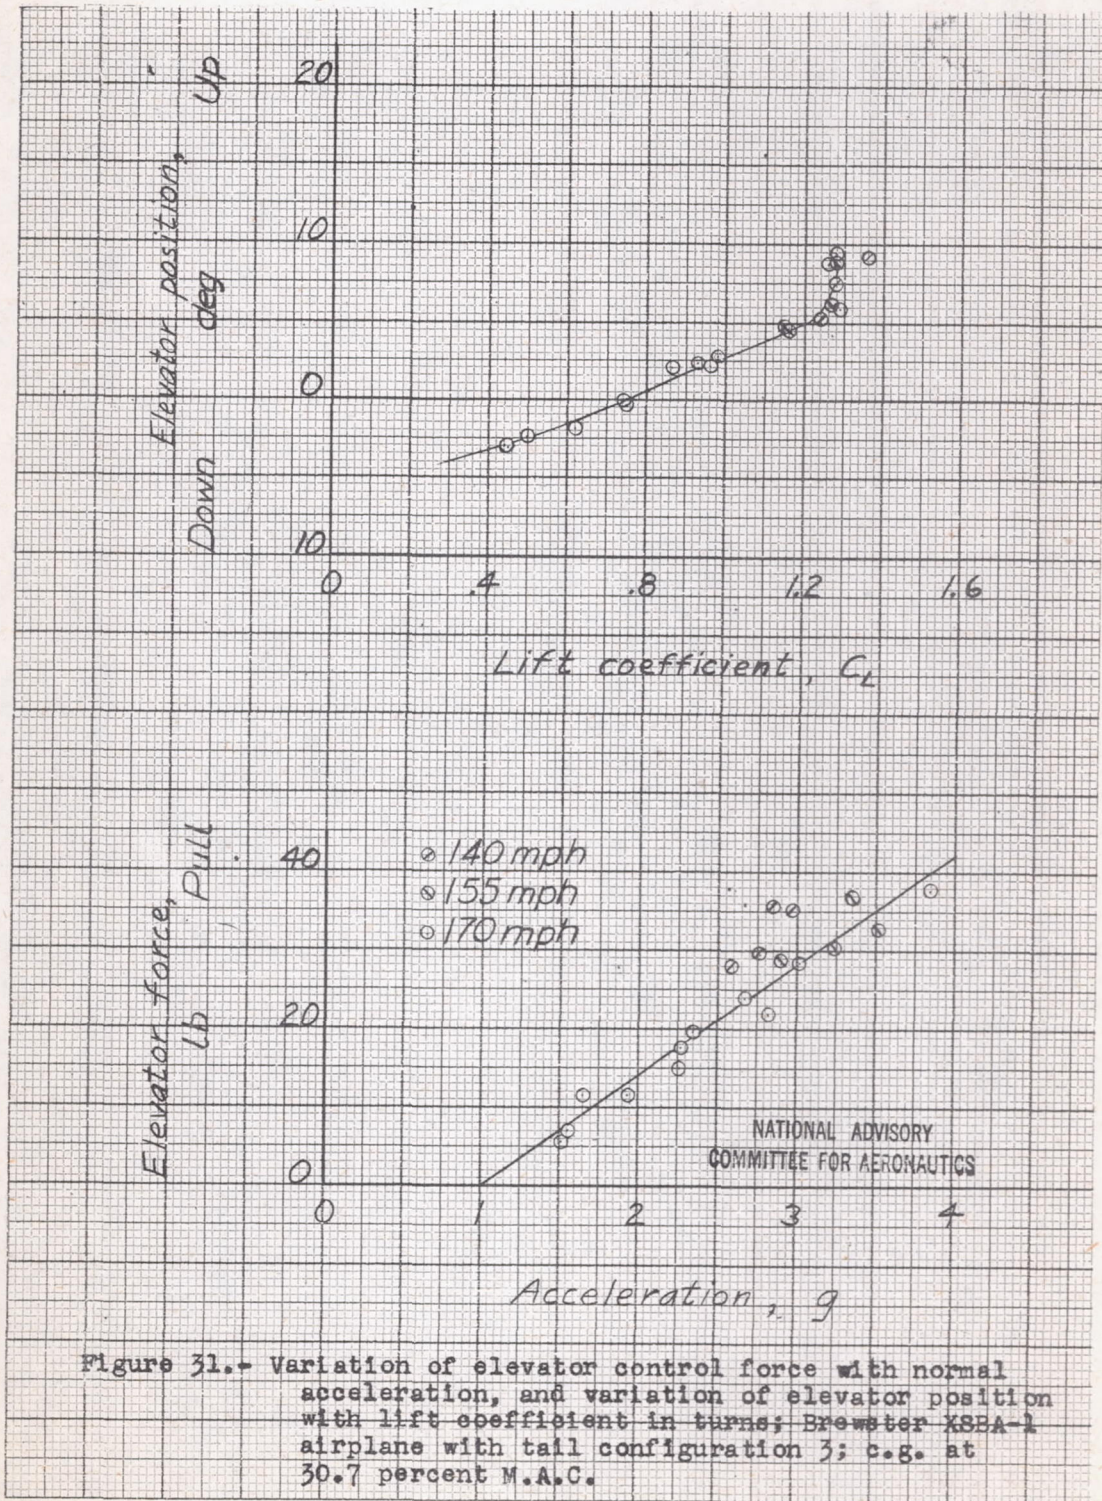
Figure 31.- Variation of elevator control force with normal acceleration, and variation of elevator position with lift coefficient in turns; Brewster XSEA-1 airplane with tail configuration 3; c.g. at 30.7 percent M.A.C.

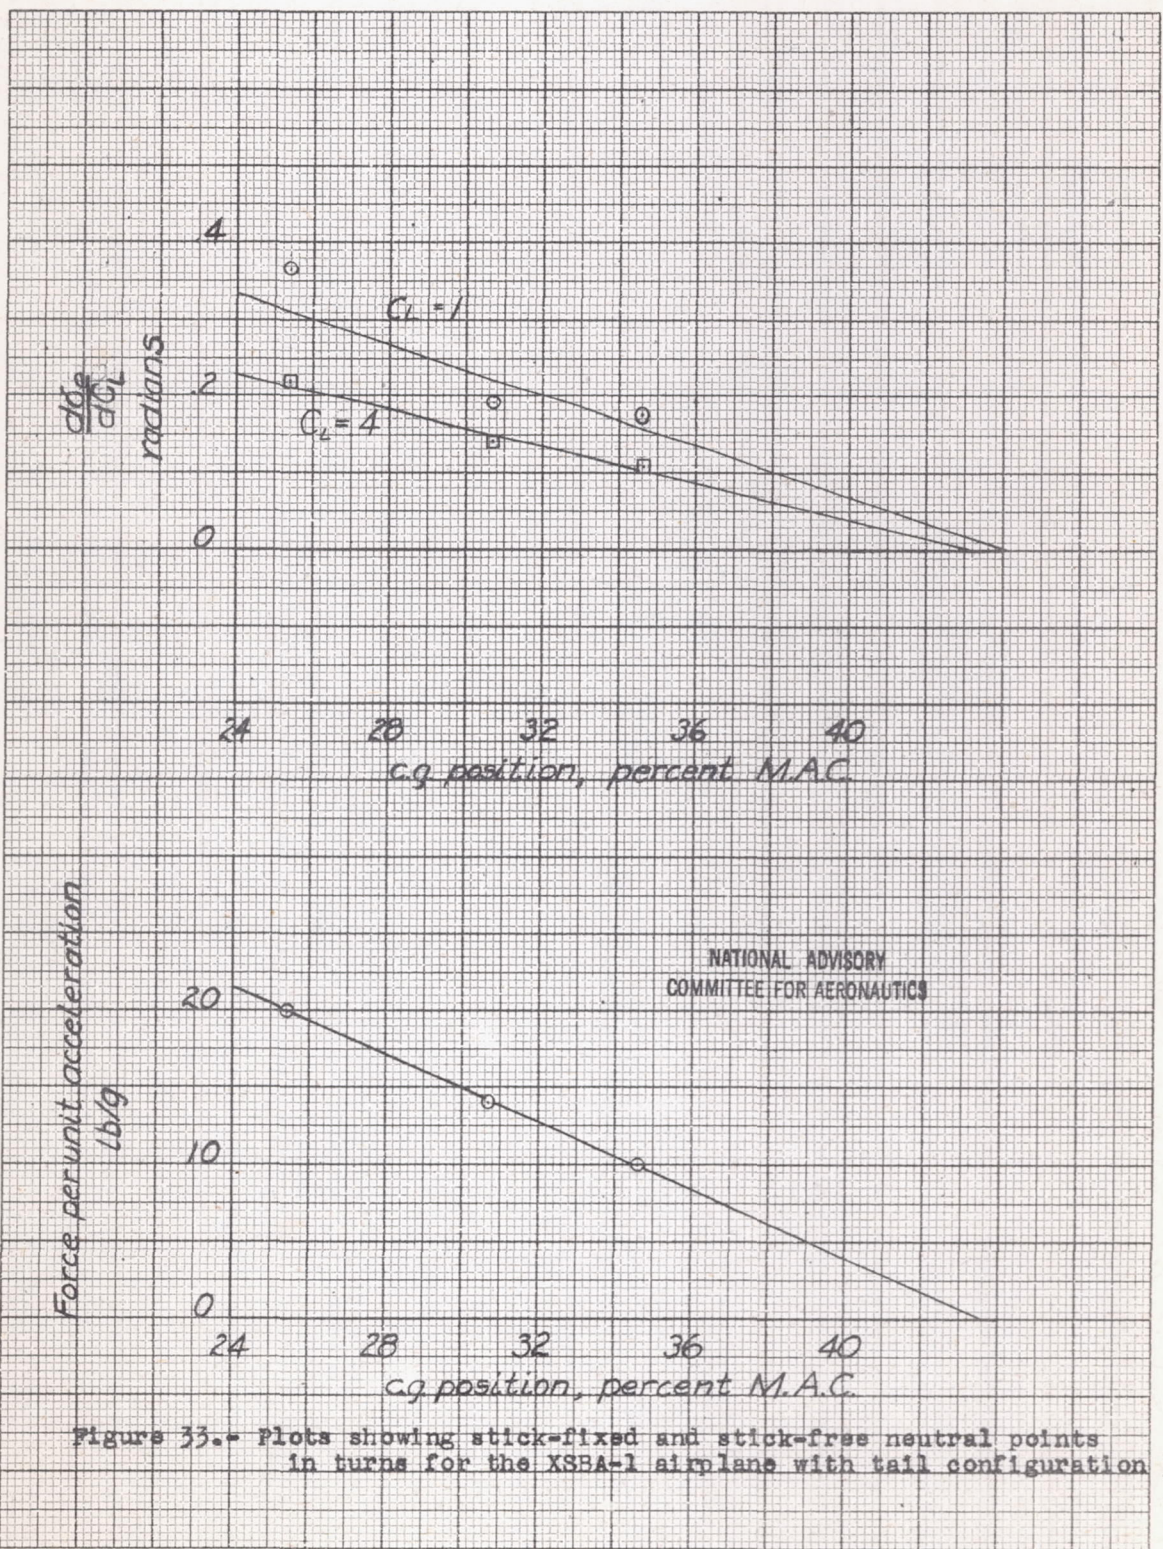
Figure 33.- Plots showing stick-fixed and stick-free neutral points in turns for the XSBA-1 airplane with tail configuration 3.

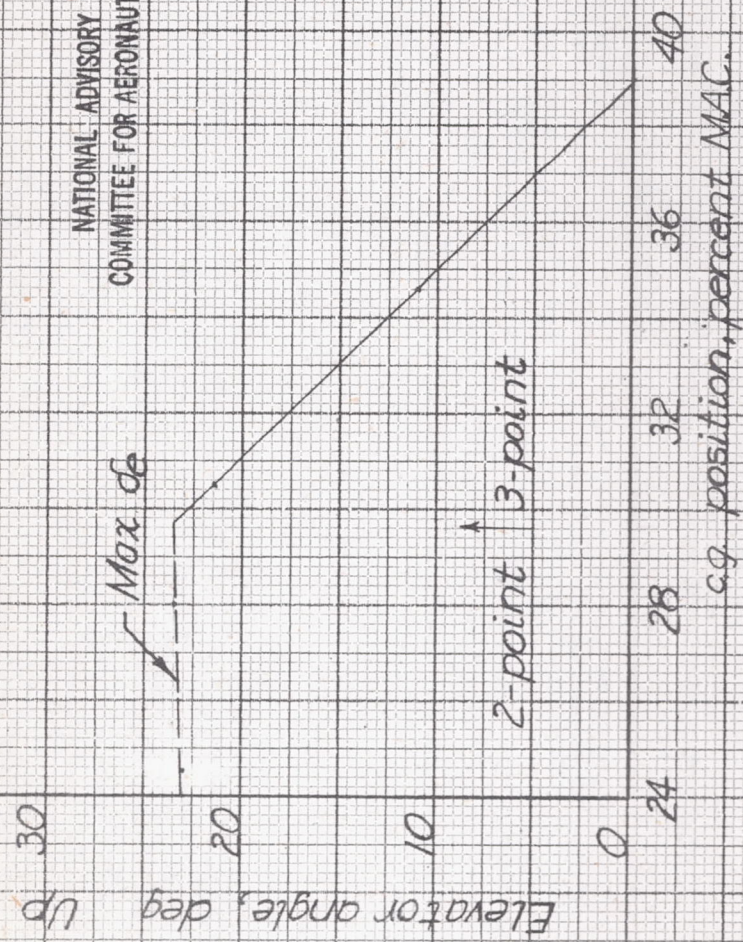
Figure 34.- Elevator deflection required to land XSEB-1 airplane with tail configuration 3 (power off, flaps down).

aerodynamic chord the elevator did not have sufficient power to stall the airplane in the landing condition either at altitude or during an actual landing, as shown by figures 22 and 34. With the wider chord surfaces of tails 1 and 2 the elevator angles required for trim were well within the available range for all flight conditions.

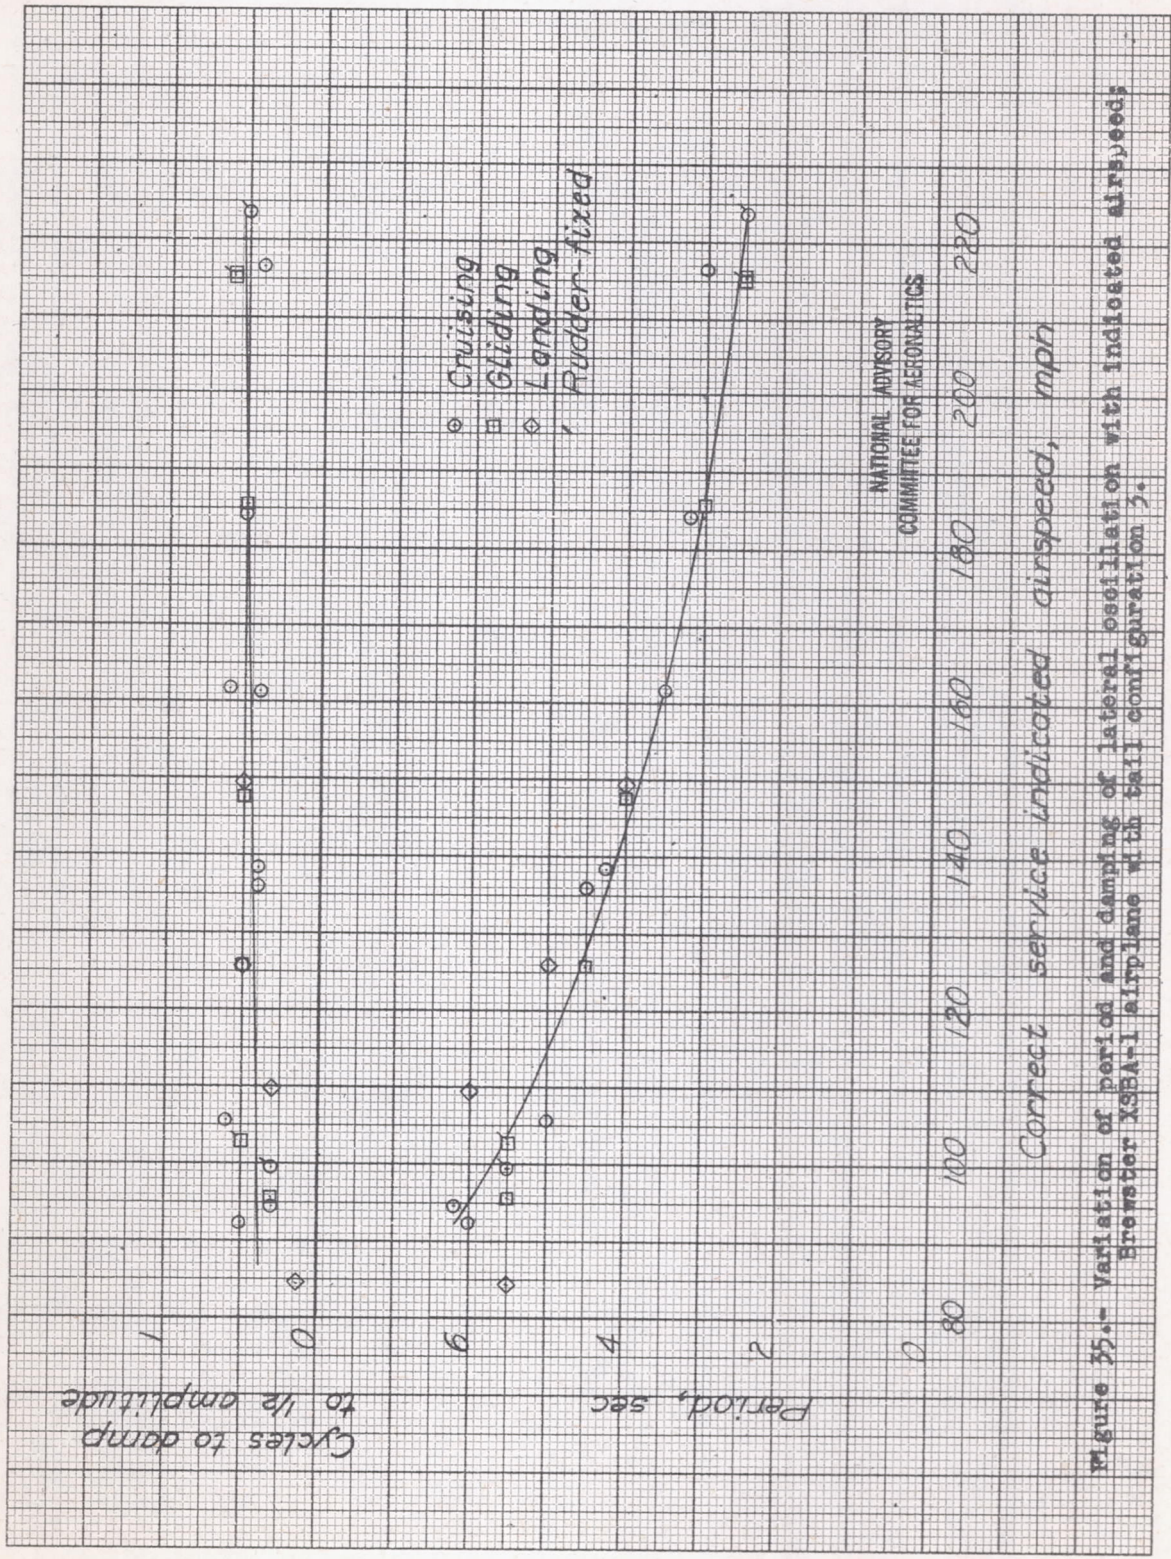
Figure 35.- Variation of period and damping of lateral oscillation with indicated airspeed; Frewster X3BA-1 airplane with tail configuration 3.

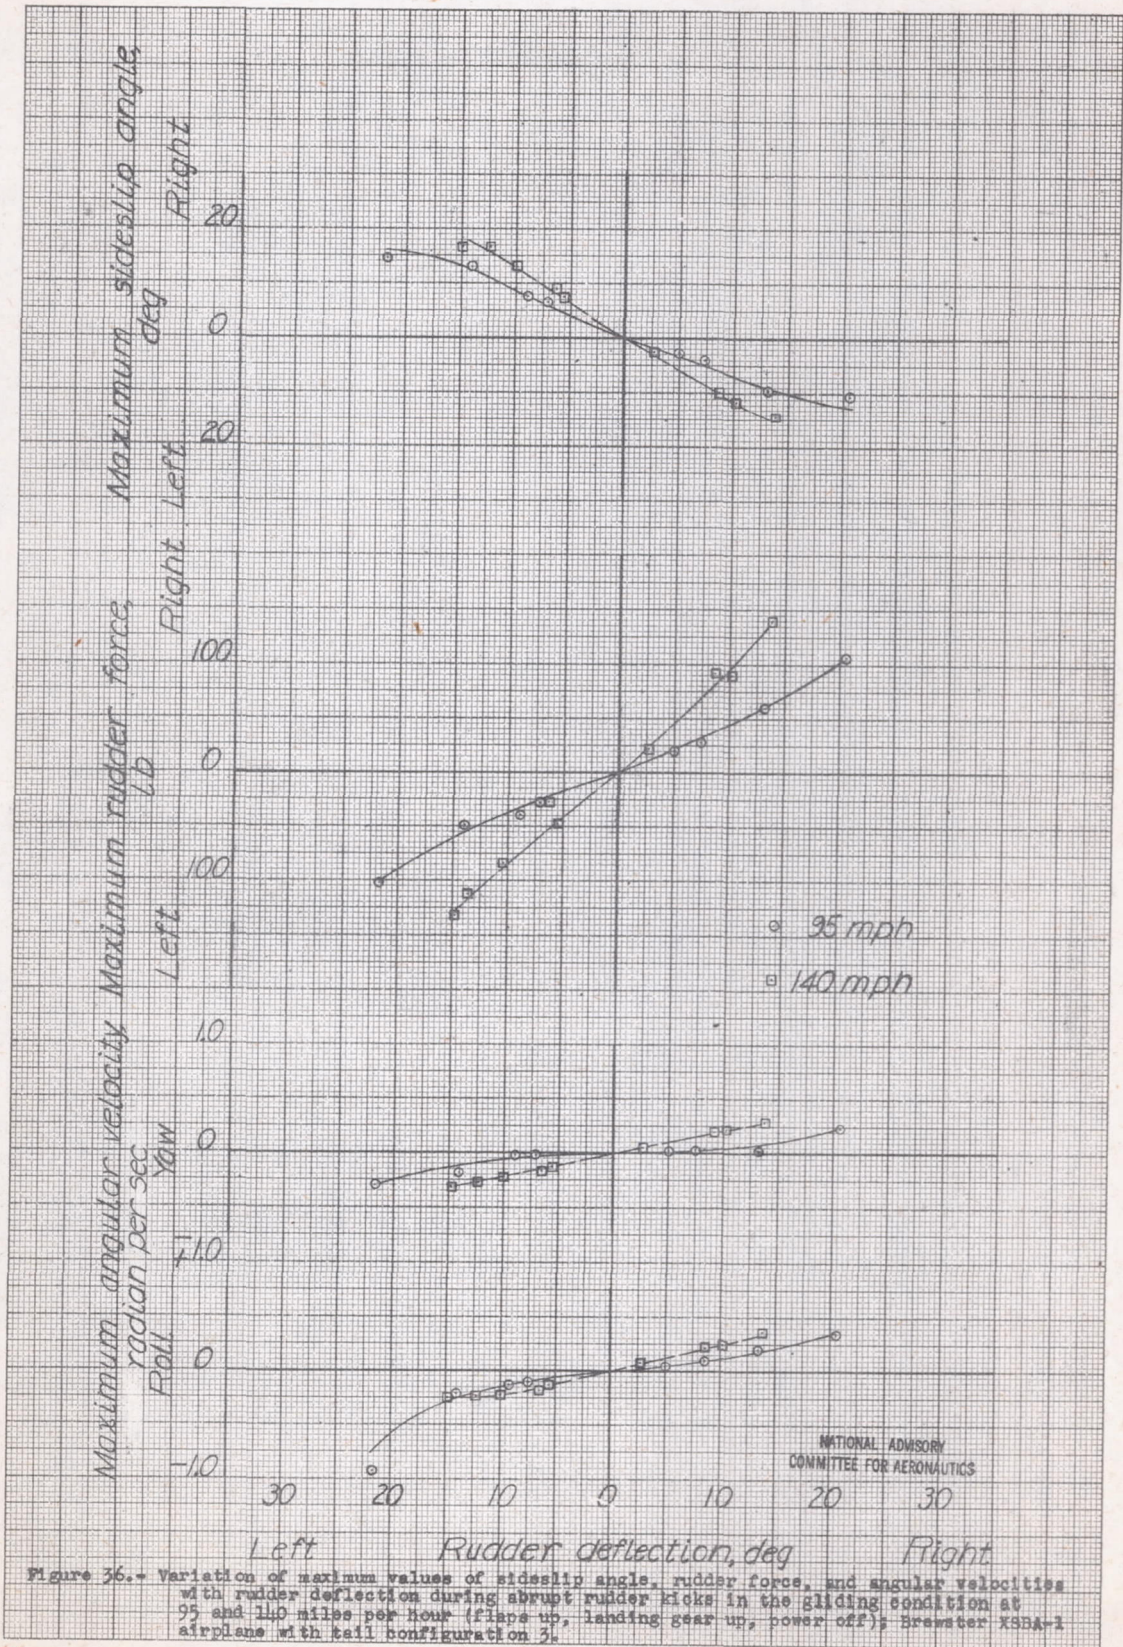
Figure 36. Variation of maximum values of sideslip angle, rudder force, and angular velocities with rudder deflection during abrupt rudder kicks in the gliding condition at 95 and 140 miles per hour (flaps up, landing gear up, power off); Brewster X3BA-1 airplane with tail configuration 3.

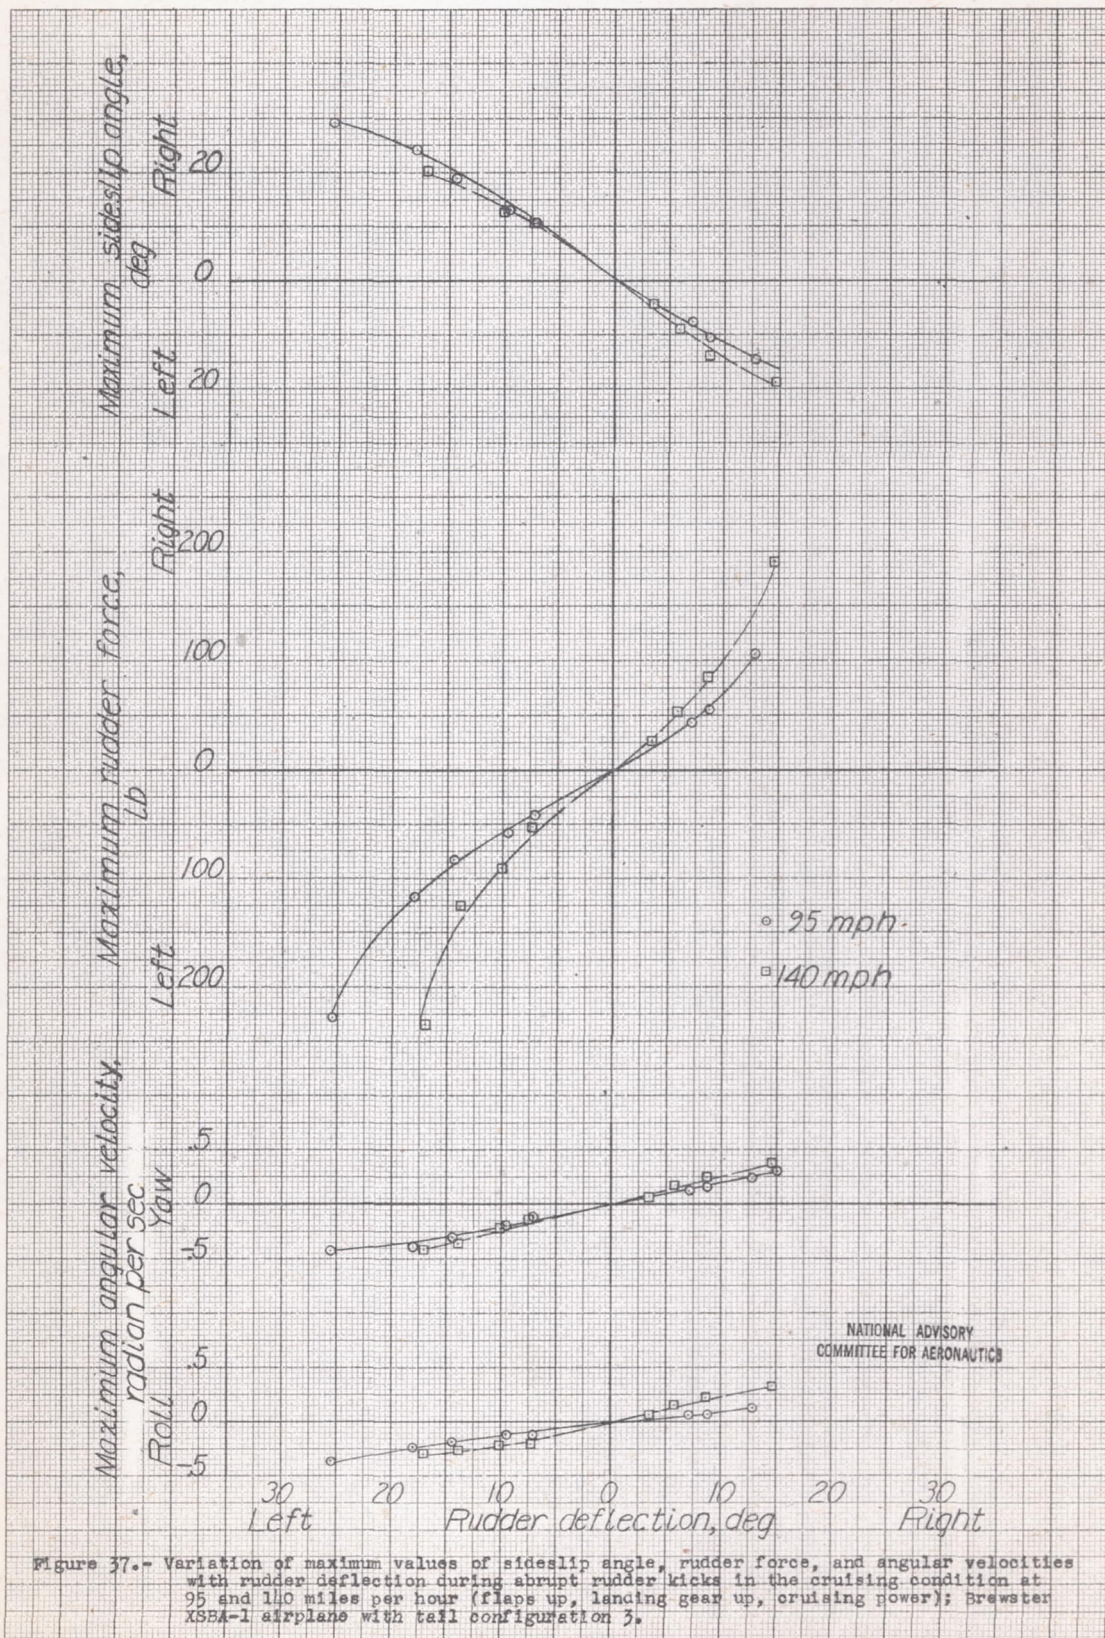
Figure 37.- Variation of maximum values of sideslip angle, rudder force, and angular velocities with rudder deflection during abrupt rudder kicks in the cruising condition at 95 and 140 miles per hour (flaps up, landing gear up, cruising power); Brewster XB5A-1 airplane with tail configuration 3.

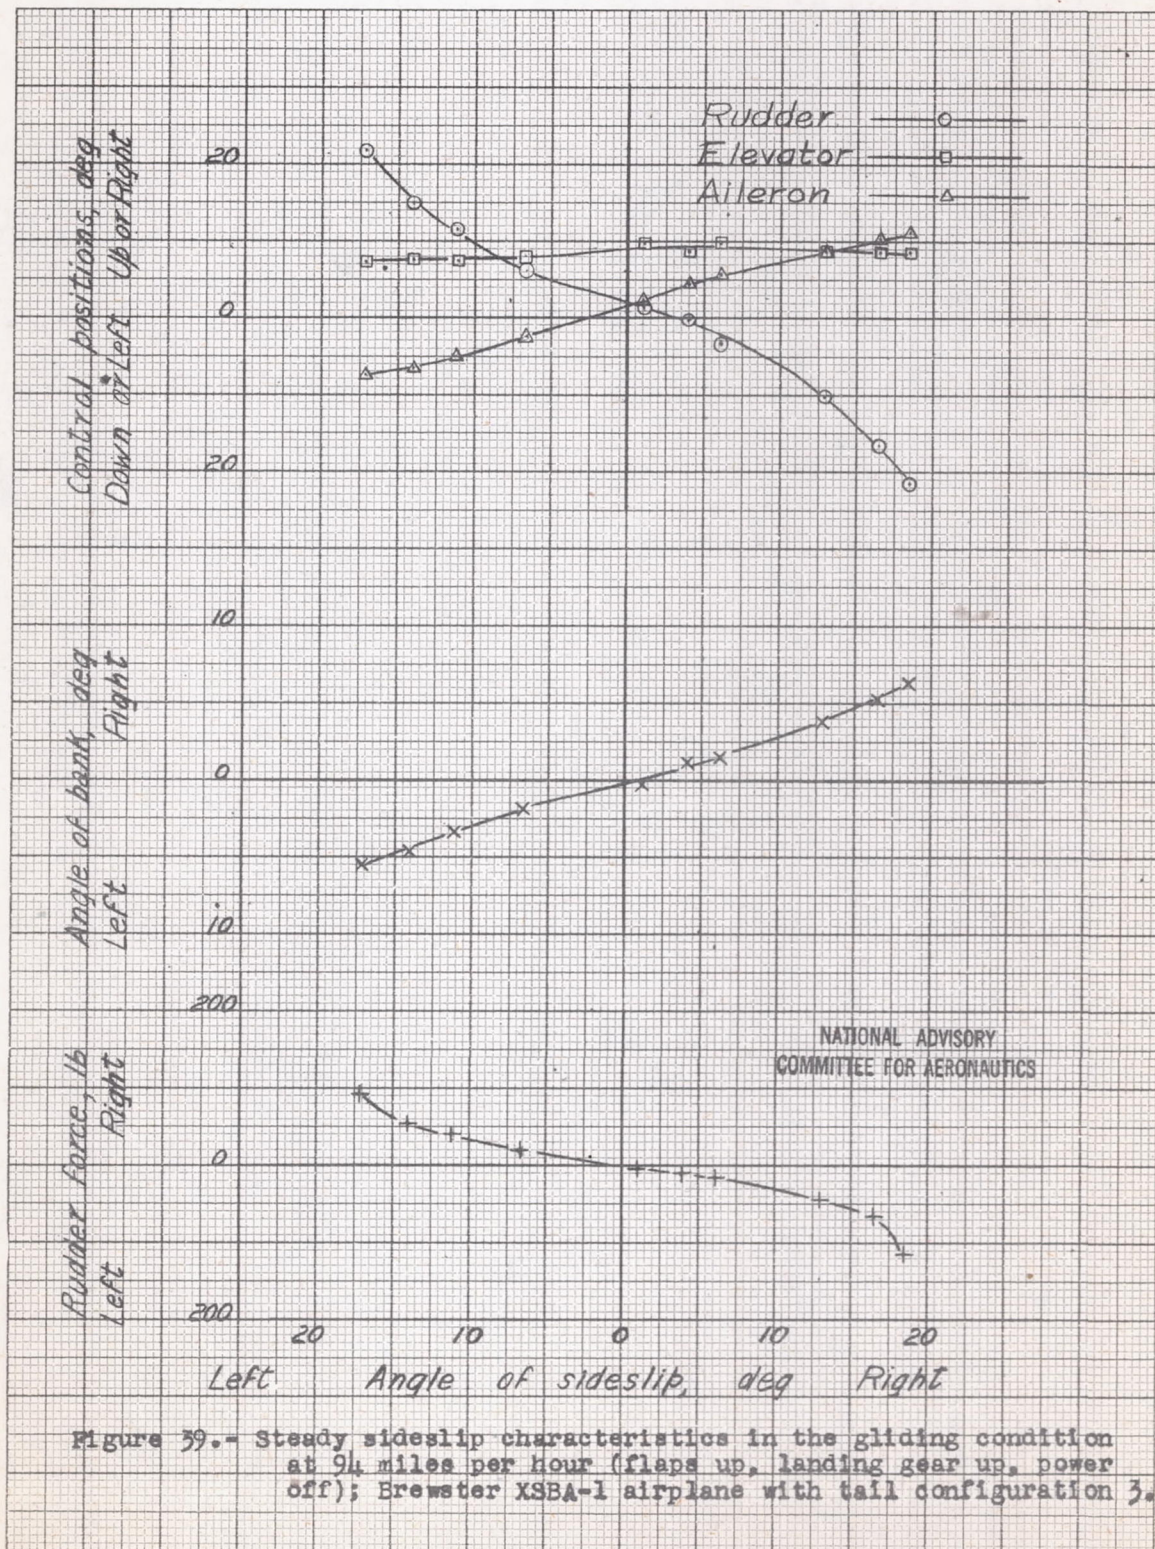
Figure 39.- Steady sideslip characteristics in the gliding condition at 94 miles per hour (flaps up, landing gear up, power off); Brewster XSBA-1 airplane with tail configuration 3.

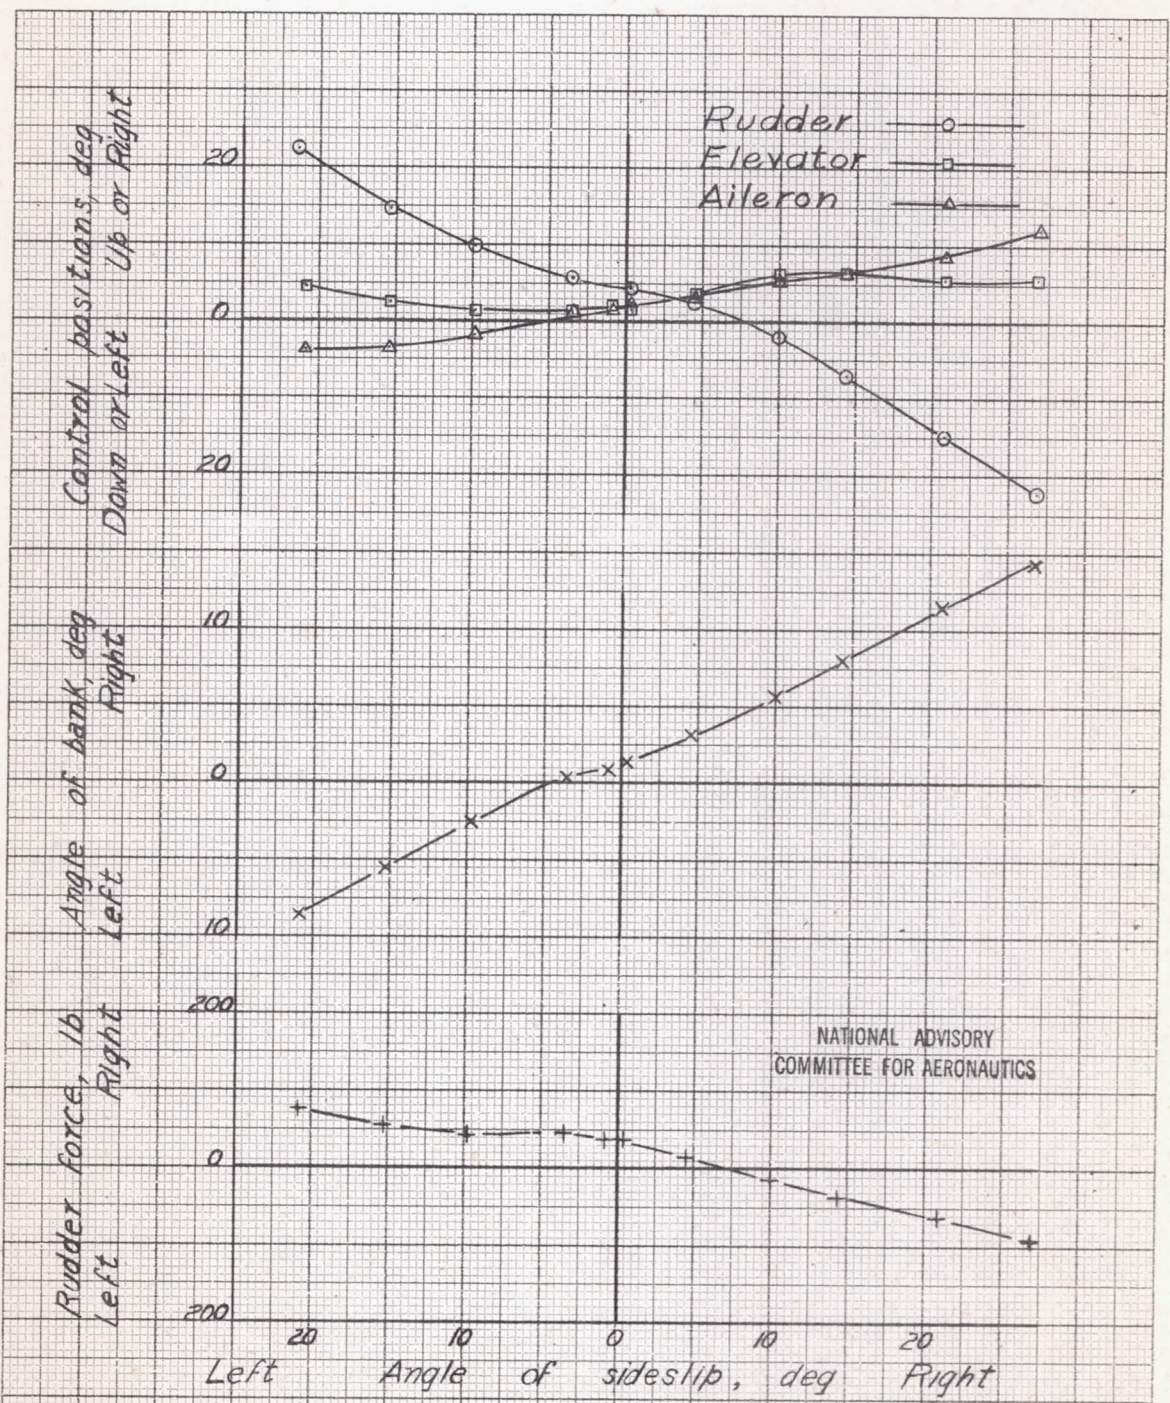
Figure 41.- Steady sideslip characteristics in the cruising condition at 87 miles per hour (flaps up, landing gear up, cruising power); Brewster XSBA-1 airplane with tail configuration 3.
