FLIGHT TESTS OF VARIOUS TAIL MODIFICATIONS

ON THE BREWSTER XSBA-1 AIRPLANE

III - MEASUREMENTS OF FLYING QUALITIES

WITH TAIL CONFIGURATION 3

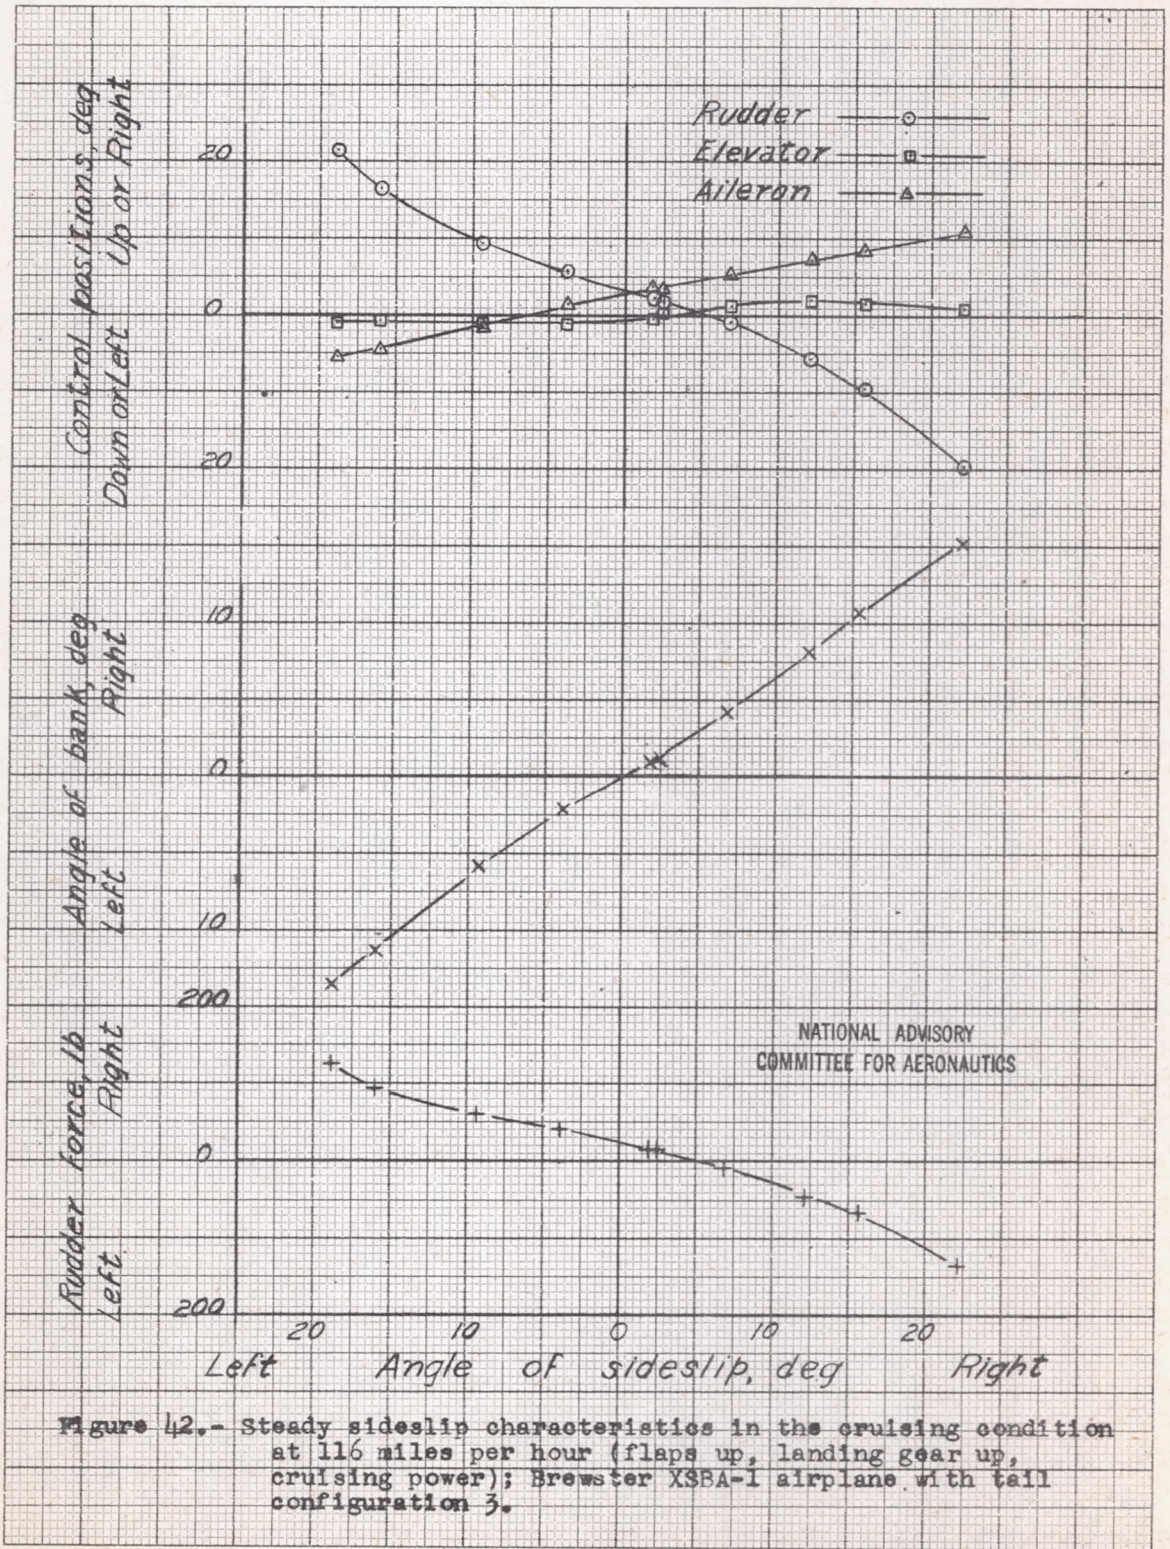
Figure 42.- Steady sideslip characteristics in the cruising condition at 116 miles per hour (flaps up, landing gear up, cruising power); Brewster XSBA-1 airplane with tail configuration 3.

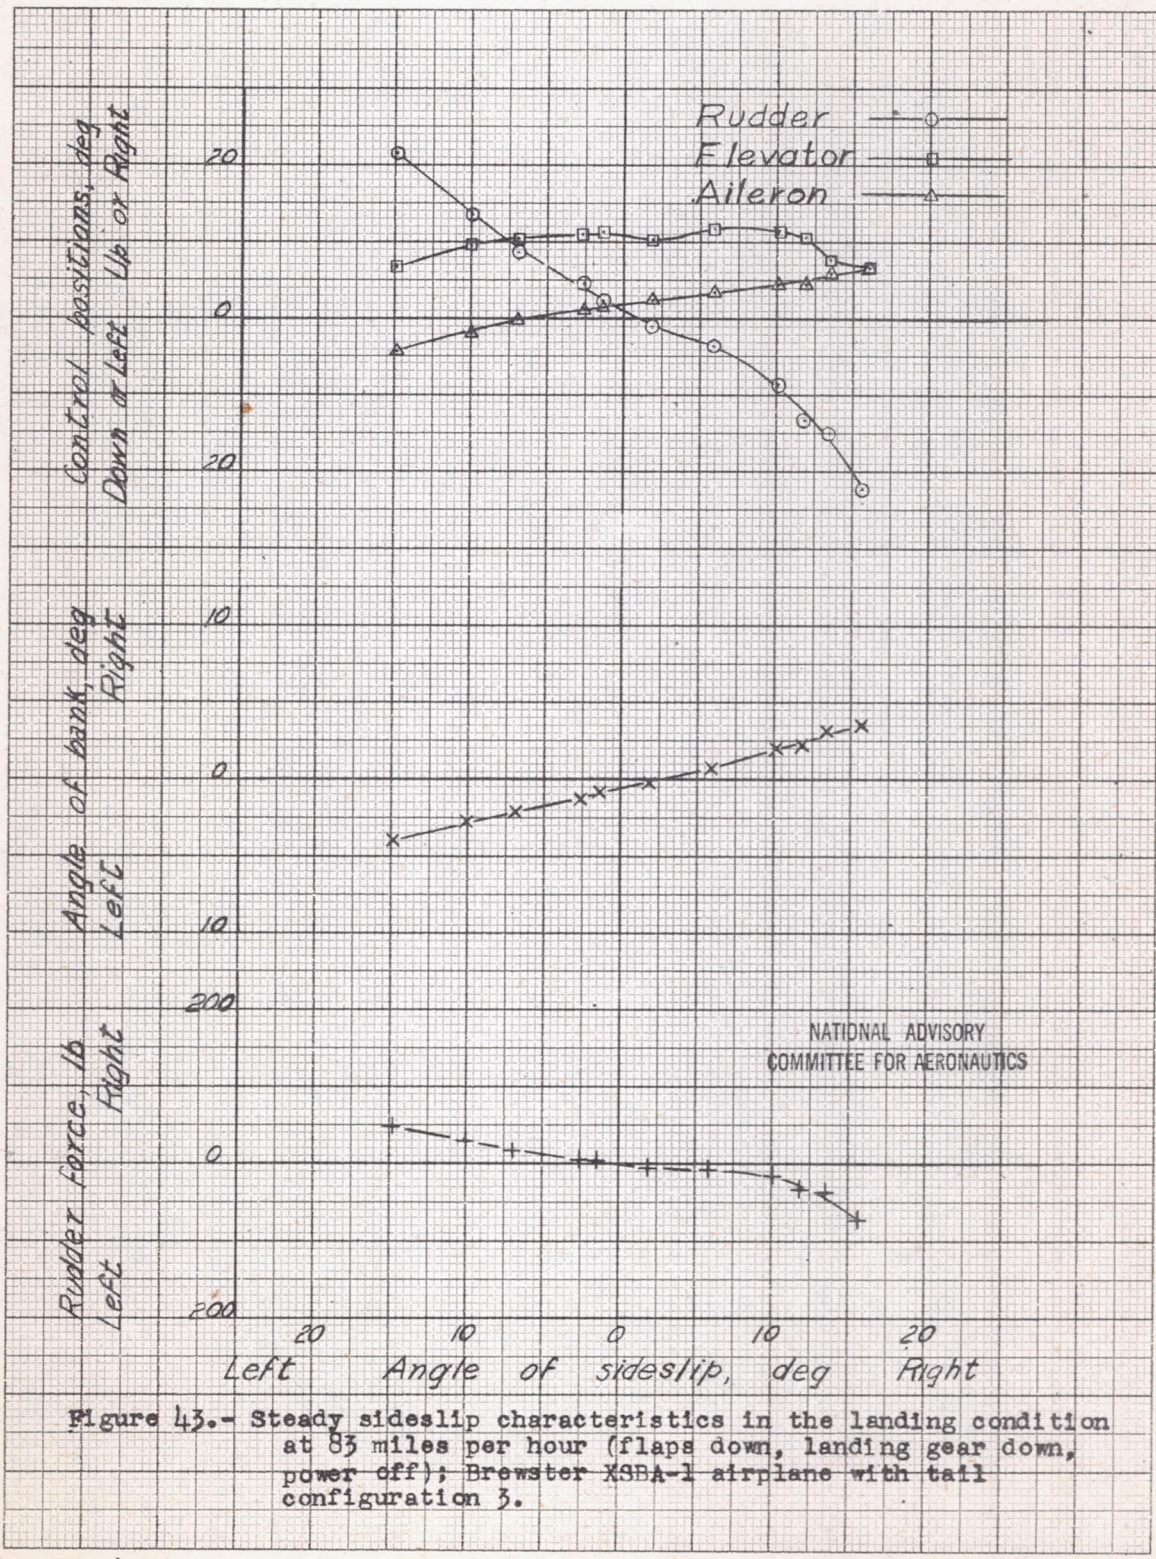
Figure 43.- Steady sideslip characteristics in the landing condition at 83 miles per hour (flaps down, landing gear down, power off); Brewster X3BA-1 airplane with tail configuration 3.

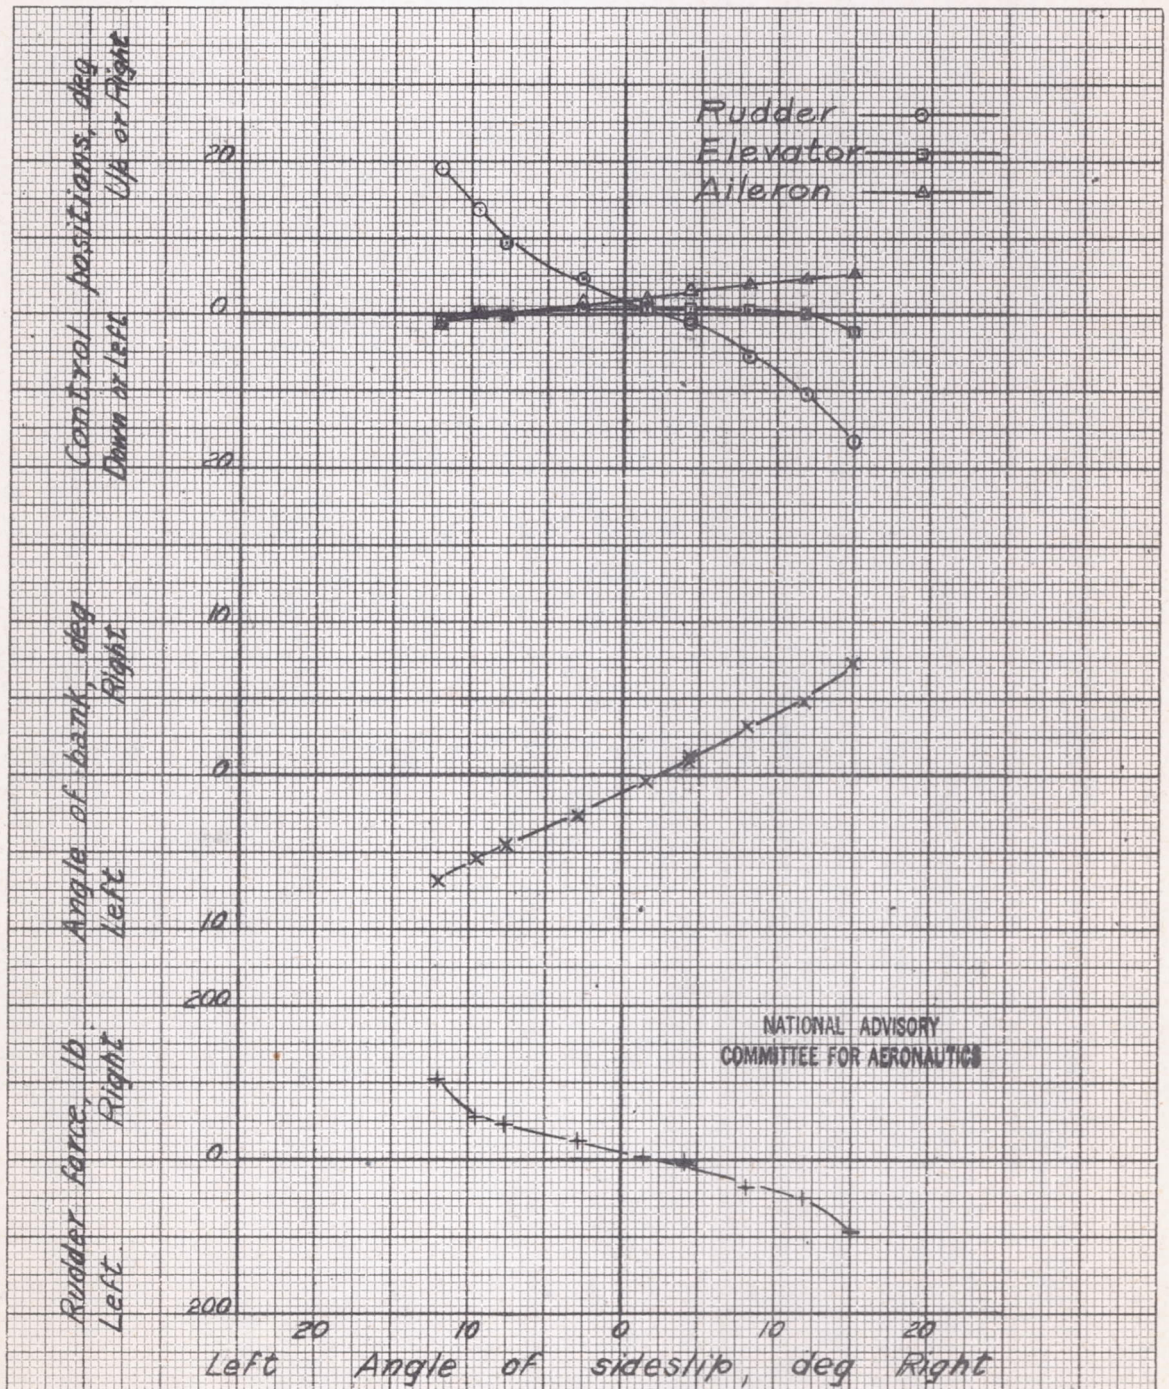
Figure 44.- Steady sideslip characteristics in the landing condition at 112 miles per hour (flaps down, landing gear down, power off); Brewster XSBA-1 airplane with tail configuration 3.

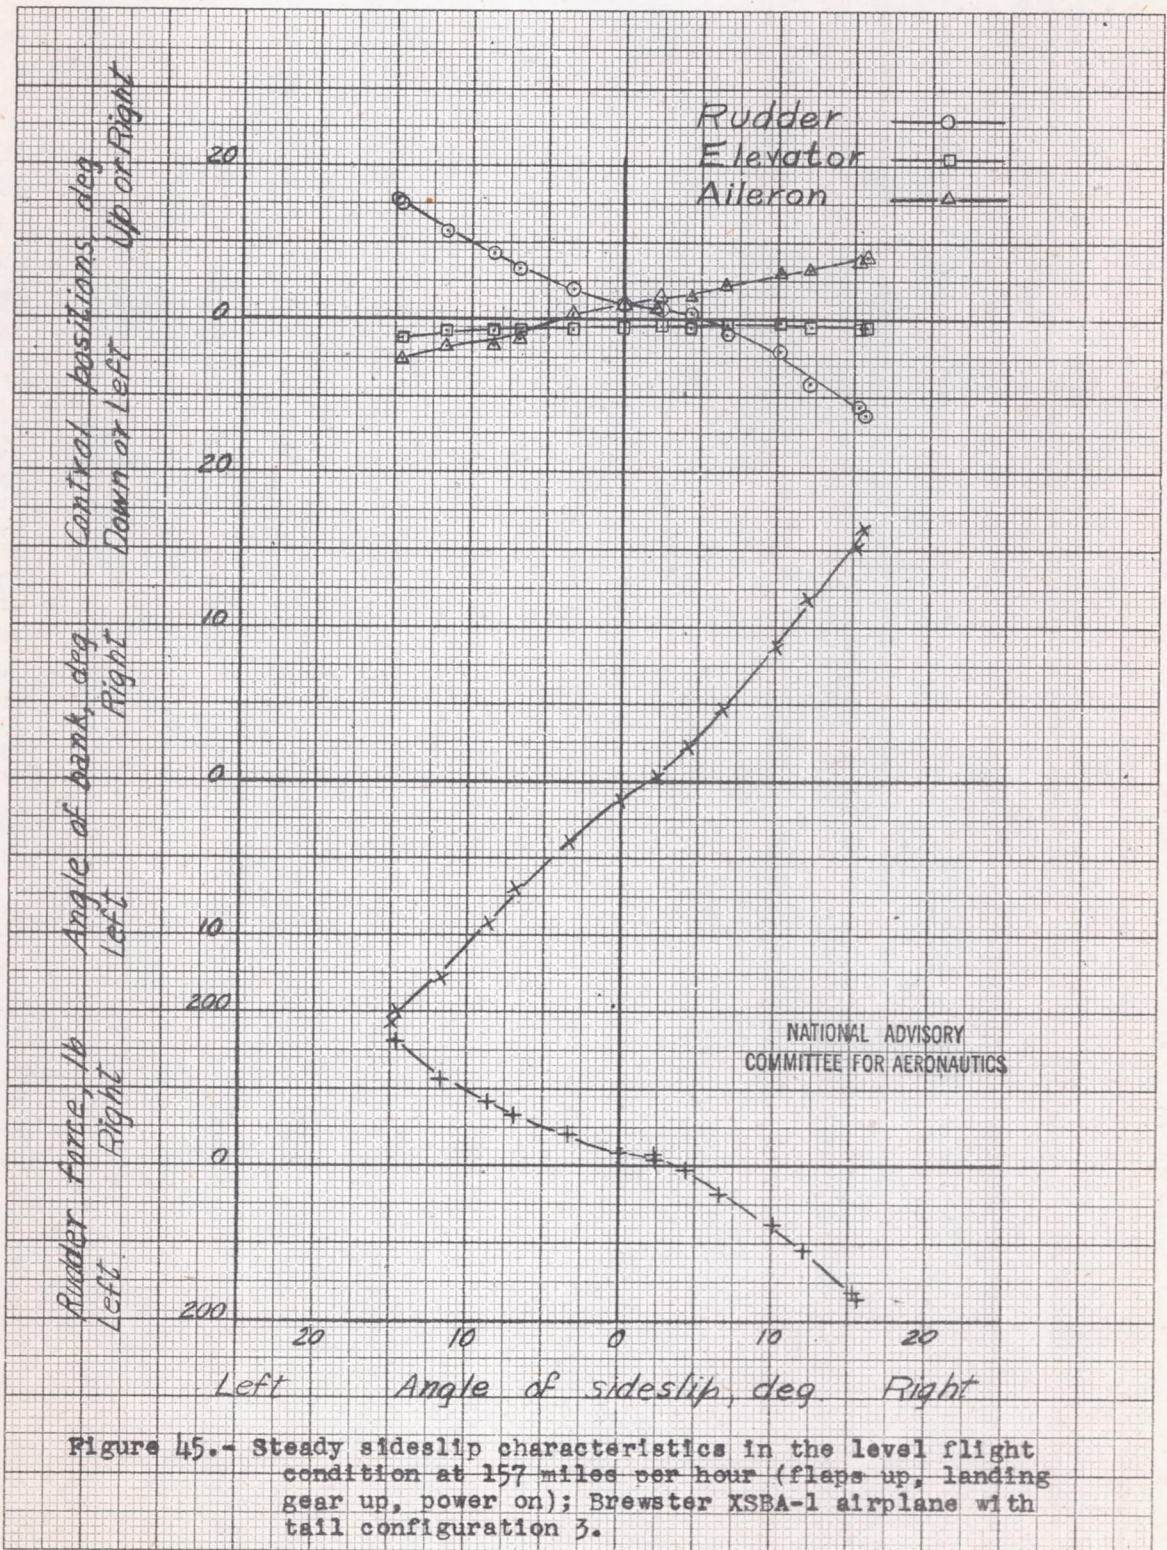
Figure 45.- Steady sideslip characteristics in the level flight condition at 157 miles per hour (flaps up, landing gear up, power on); Brewster XSBA-1 airplane with tail configuration 3.

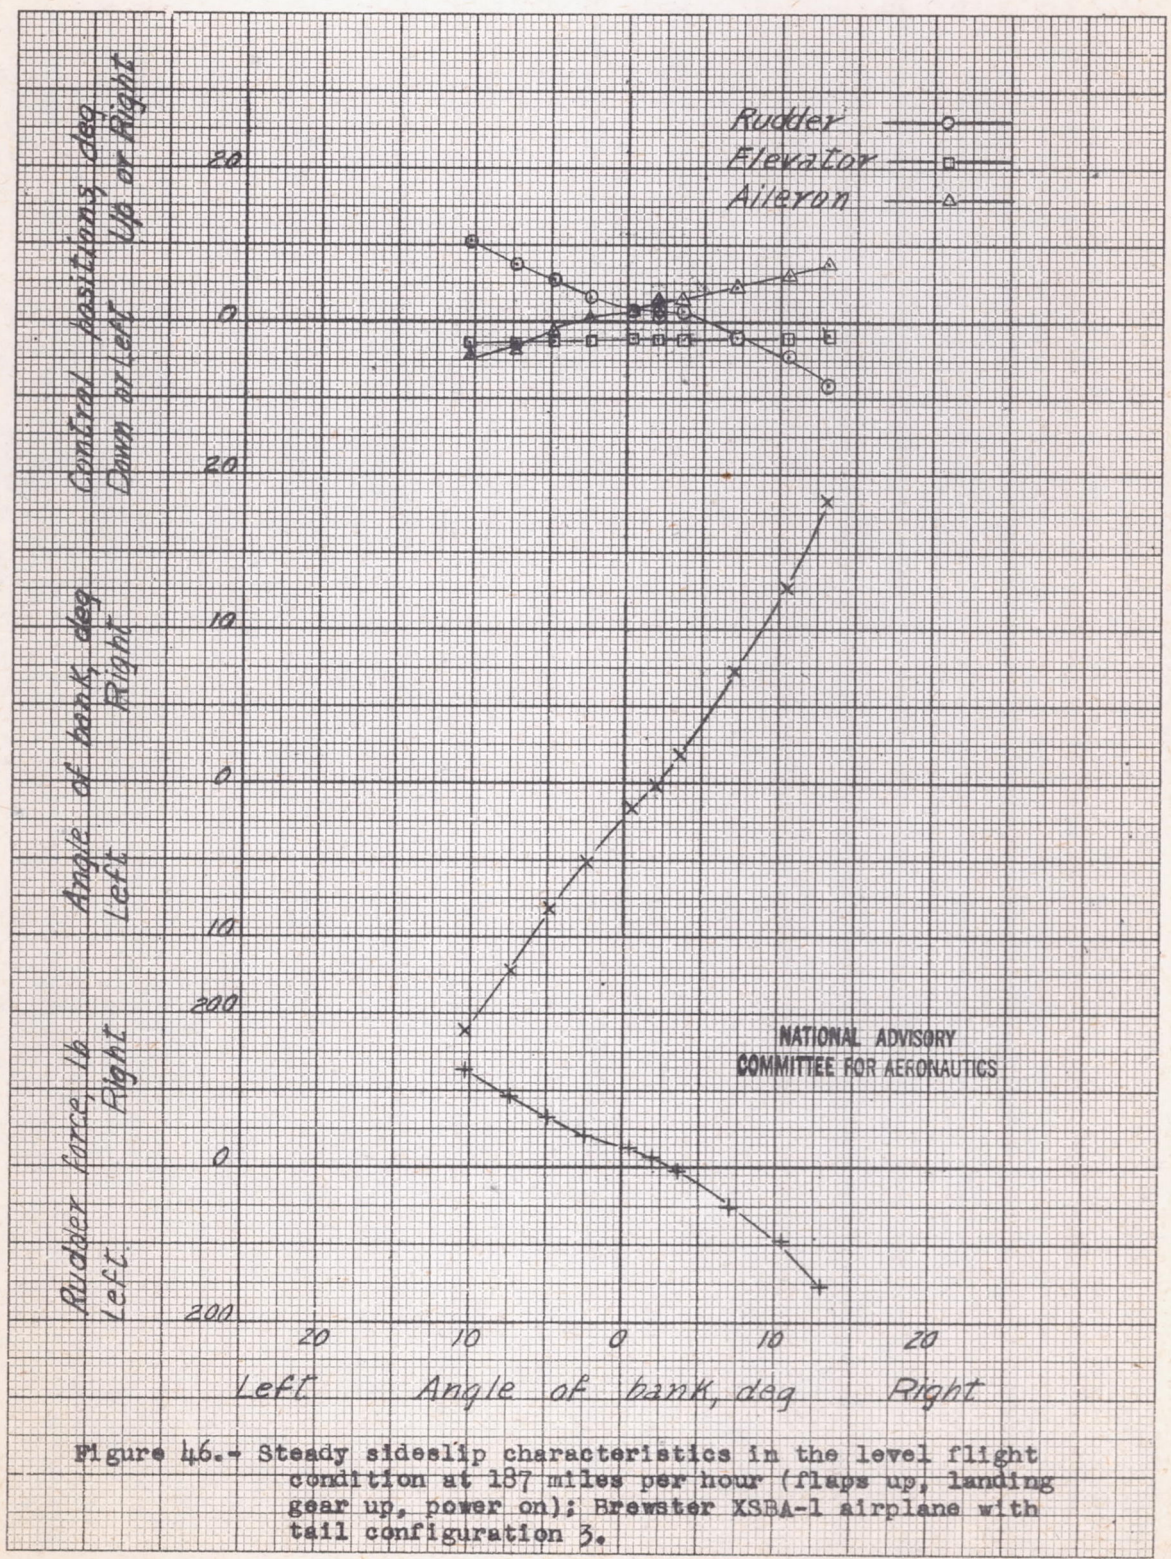
Figure 46.- Steady sideslip characteristics in the level flight condition at 137 miles per hour (flaps up, landing gear up, power on); Brewster XSBA-1 airplane with tail configuration 3.

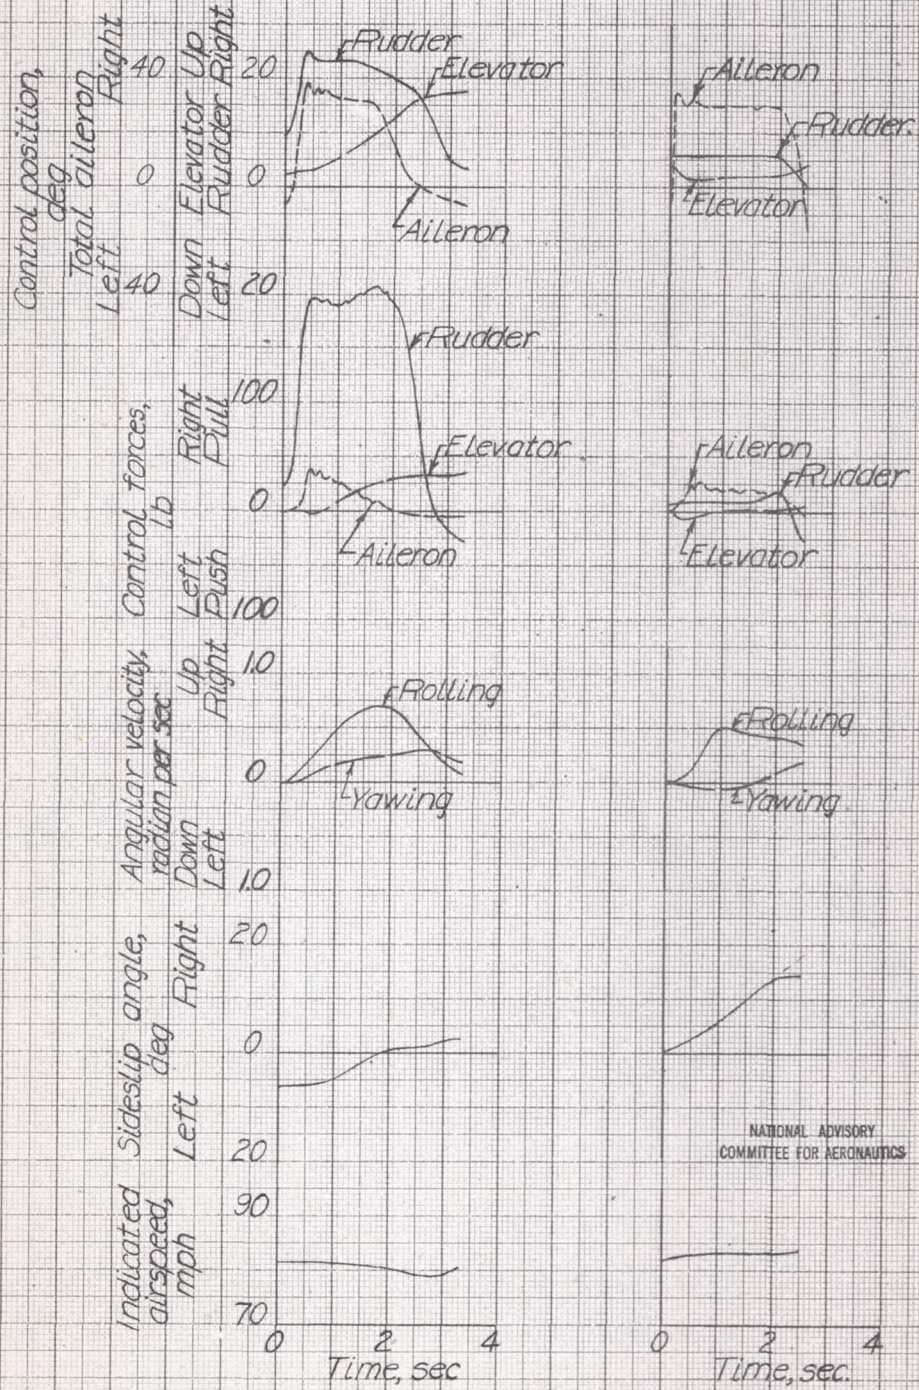
(a) Rudder used to maintain zero sideslip. (b) Rudder held in trim position.

Figure 48.- Time histories of right rolls with full aileron deflection in the cruising condition (flaps up, landing gear up, power on); Brewster XSB-1 airplane with tail configuration 3.

1. The rudder control with tail configuration 3 was not sufficiently powerful to overcome the adverse aileron yawing moment in all conditions tested. This is shown in figure 48(a), a right roll in the cruising condition at 82 miles per hour using full aileron

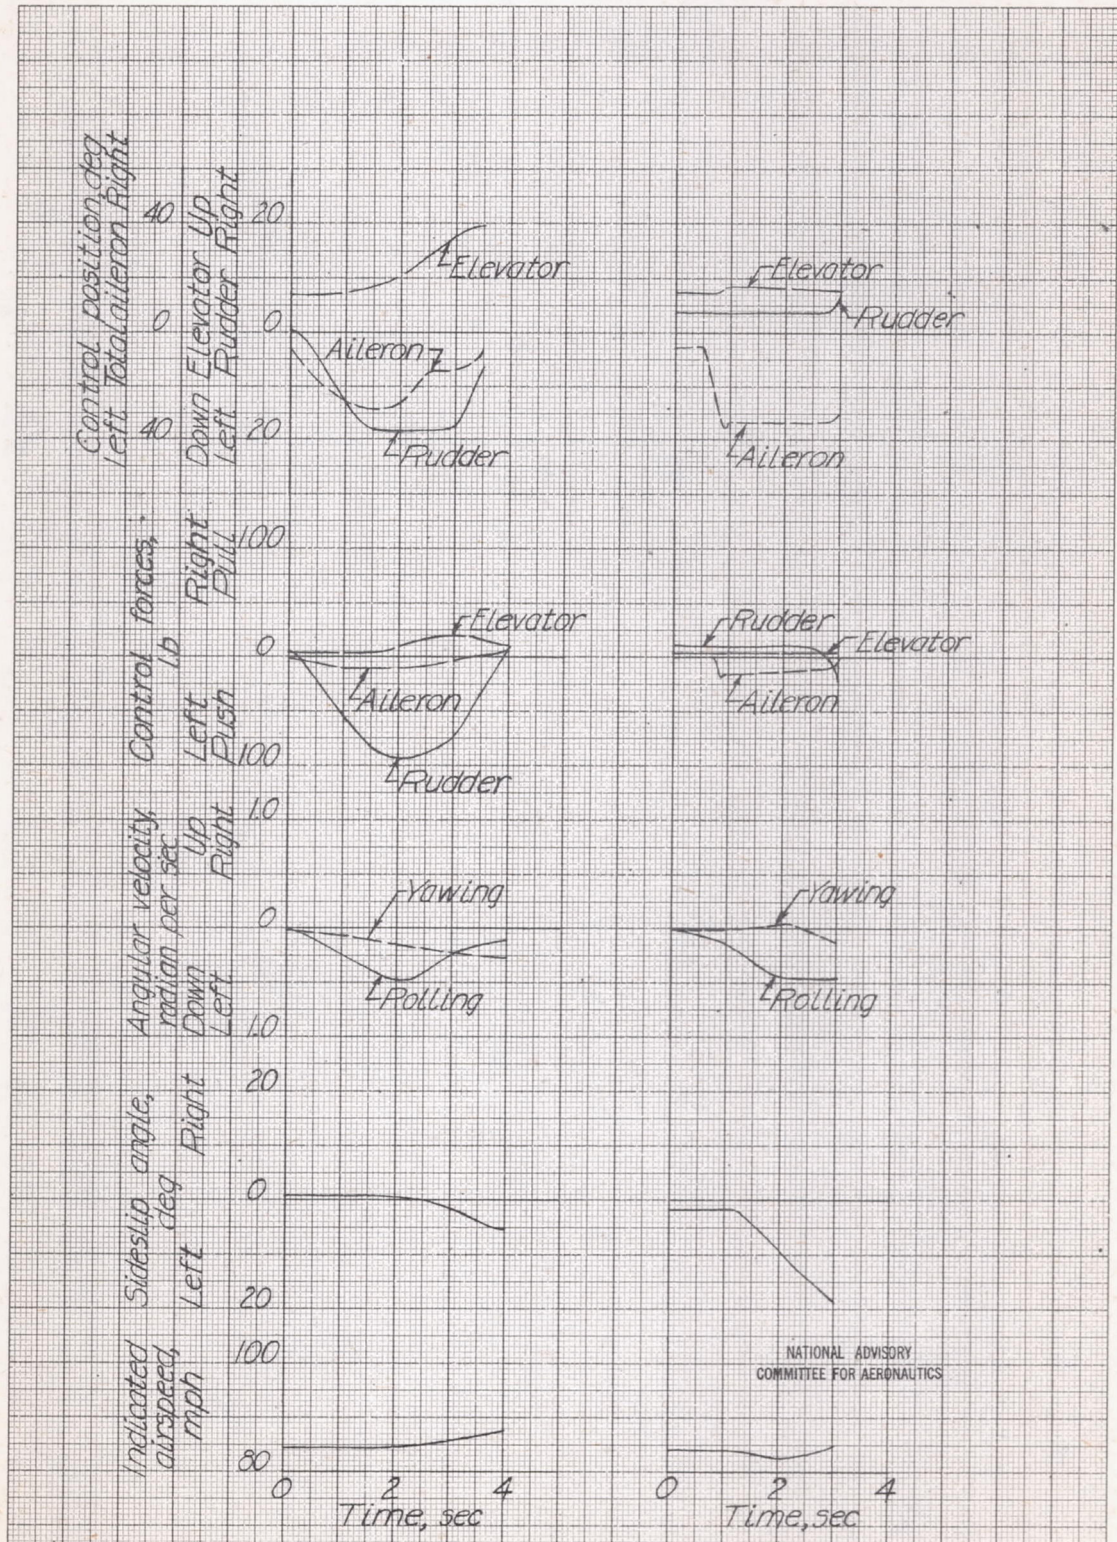
(a) Rudder used to maintain zero sideslip.

(b) Rudder held in trim position.

Figure 49.-- Time histories of left rolls with full aileron deflection in the landing condition (flaps down, landing gear down, and power off); Brewster XSBA-1 airplane with tail configuration 3.

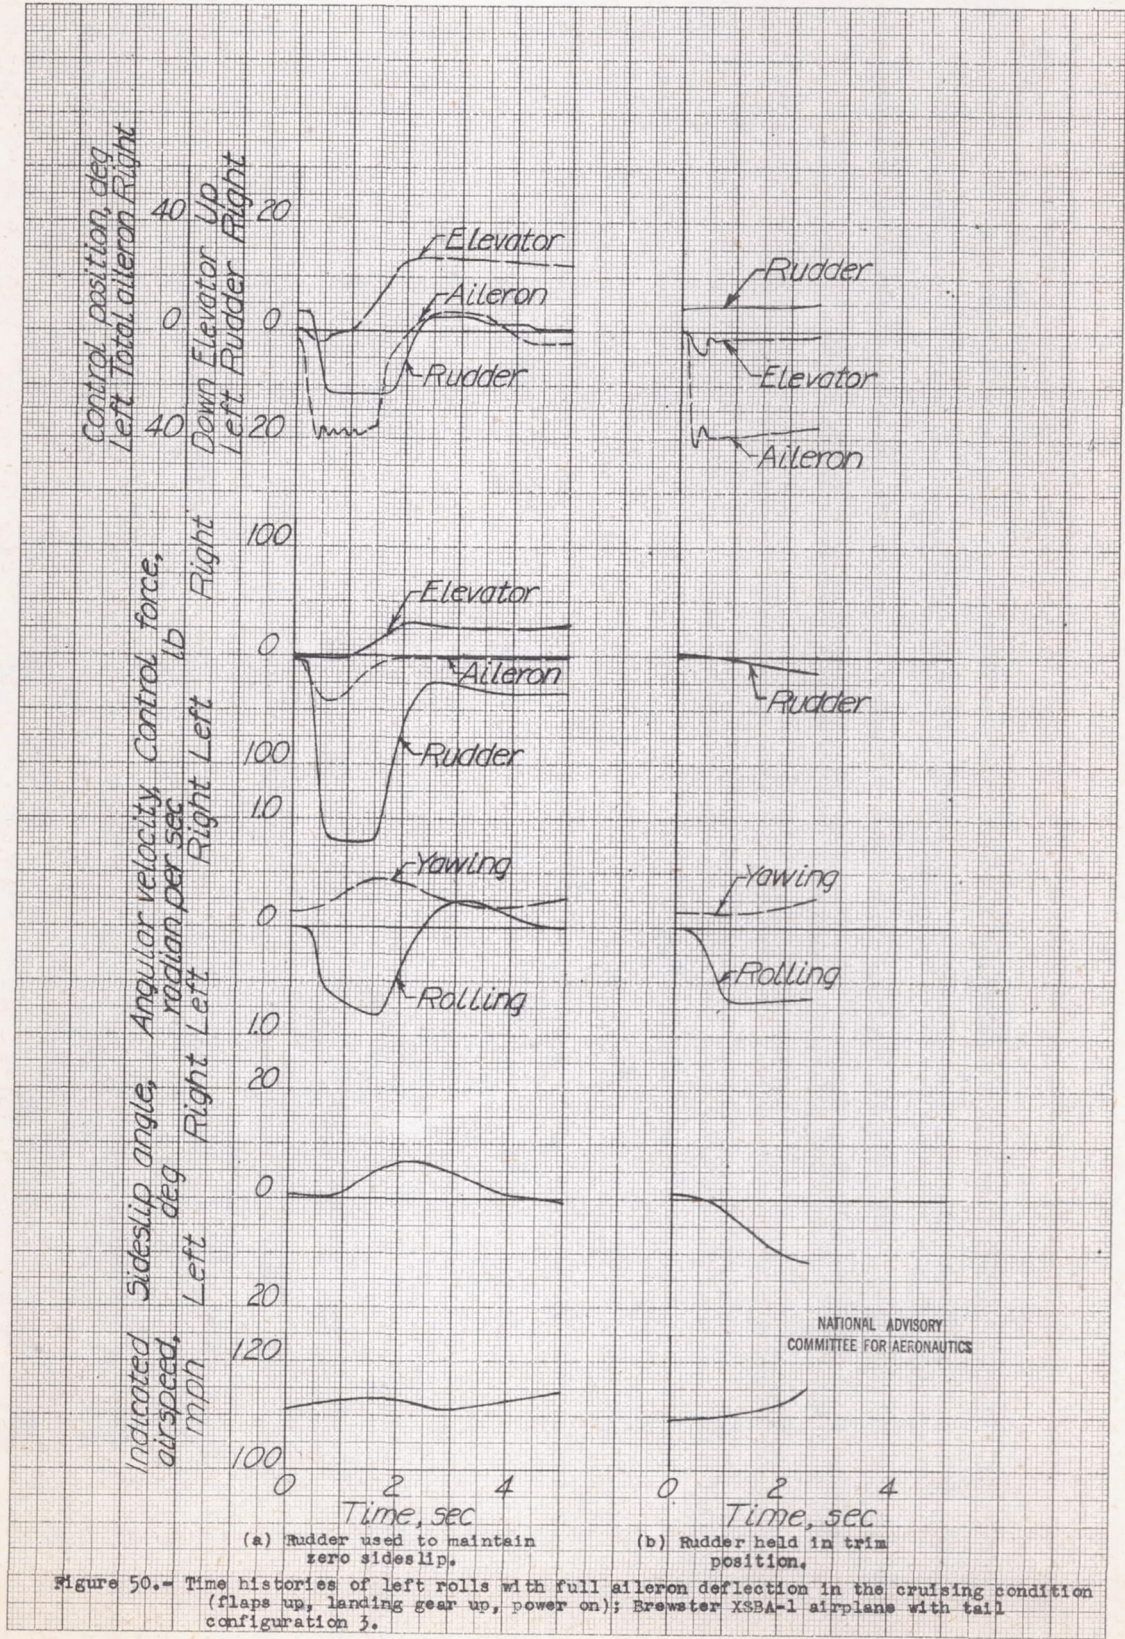
Figure 50.- Time histories of left rolls with full aileron deflection in the cruising condition (flaps up, landing gear up, power on); Brewster X3BA-1 airplane with tail configuration 3.

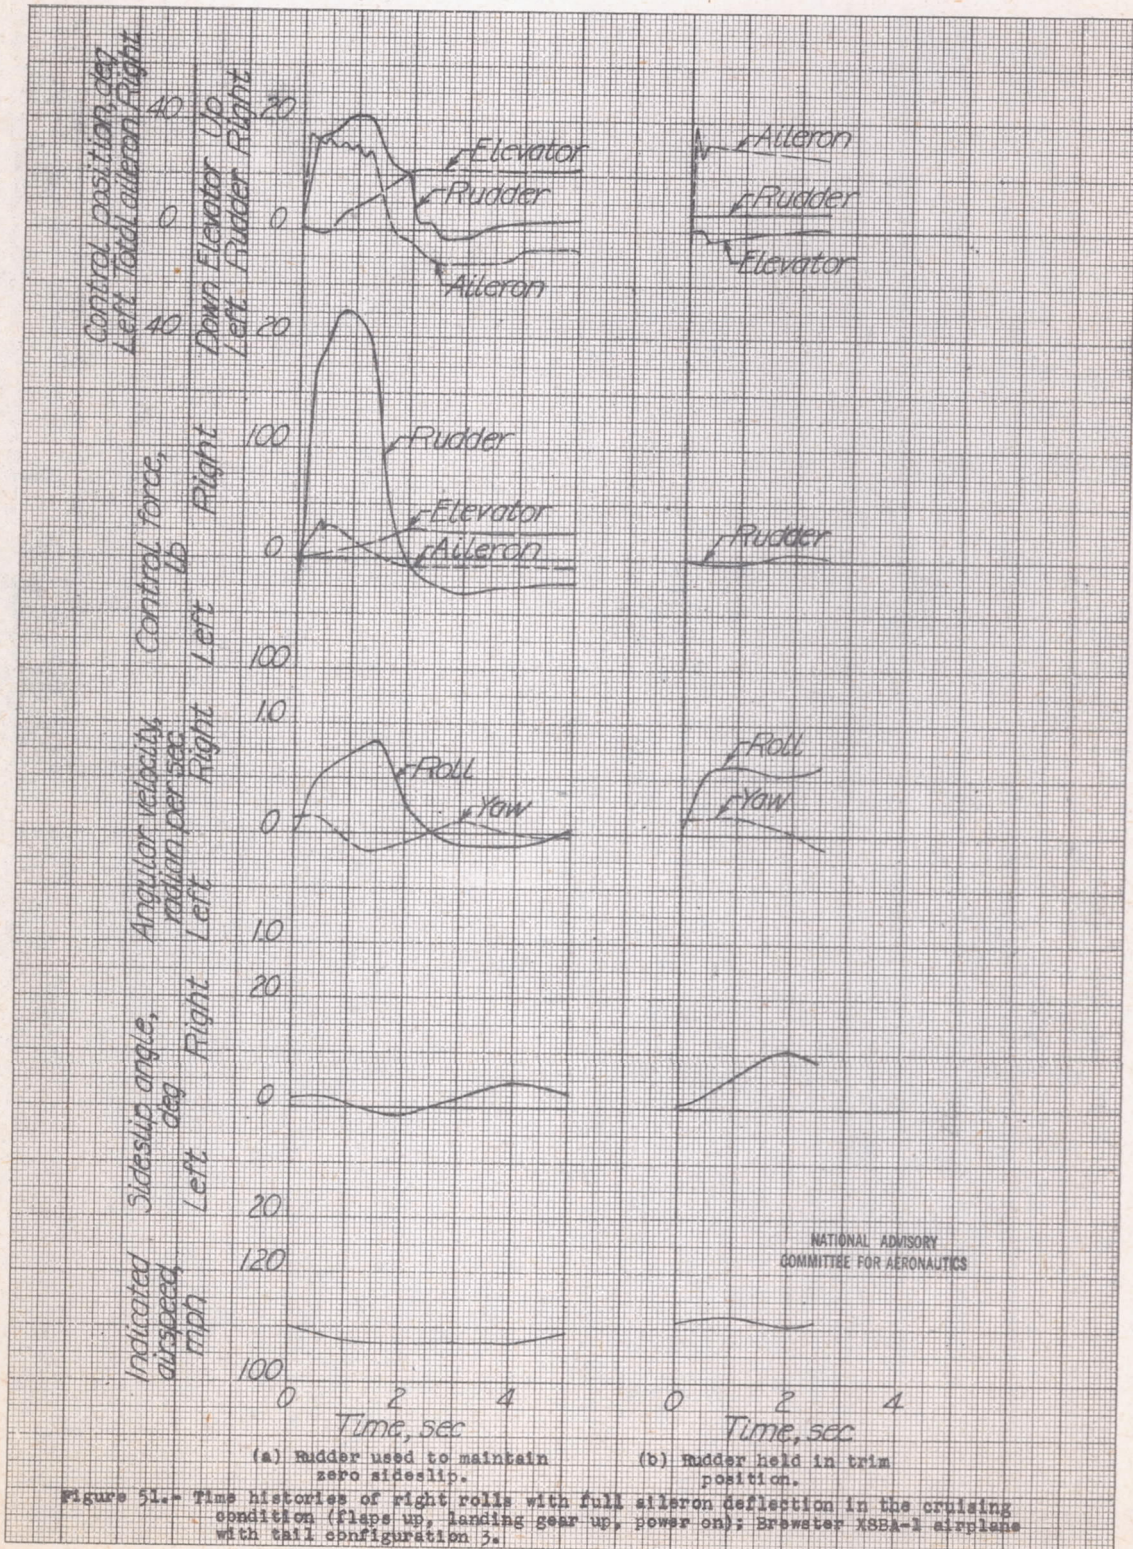
(a) rudder used to maintain zero sideslip. (b) rudder held in trim position.

Figure 51.- Time histories of right rolls with full aileron deflection in the cruising condition (flaps up, landing gear up, power on); Brewster XSB-1 airplane with tail configuration 3.

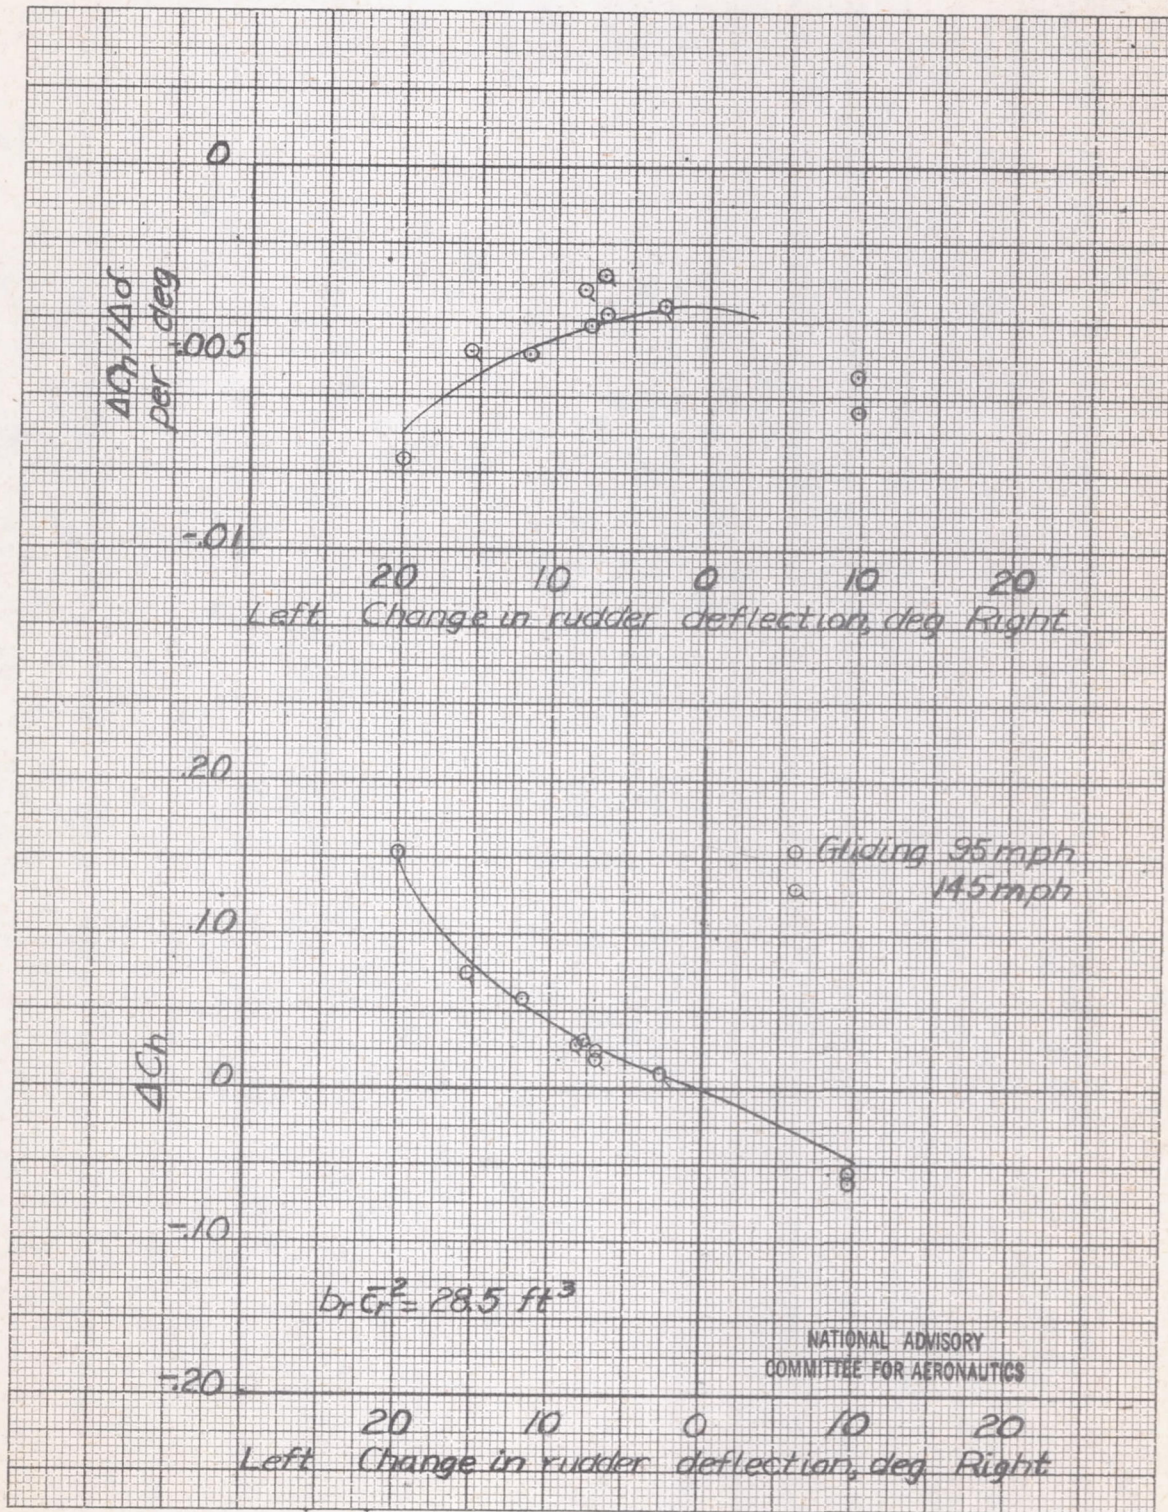
Figure 52.- Plots of $\Delta C_l / \Delta \delta$ and ΔC_l for constant α against change of rudder deflection during rudder kicks; XSB-1 airplane with tail configuration 1.

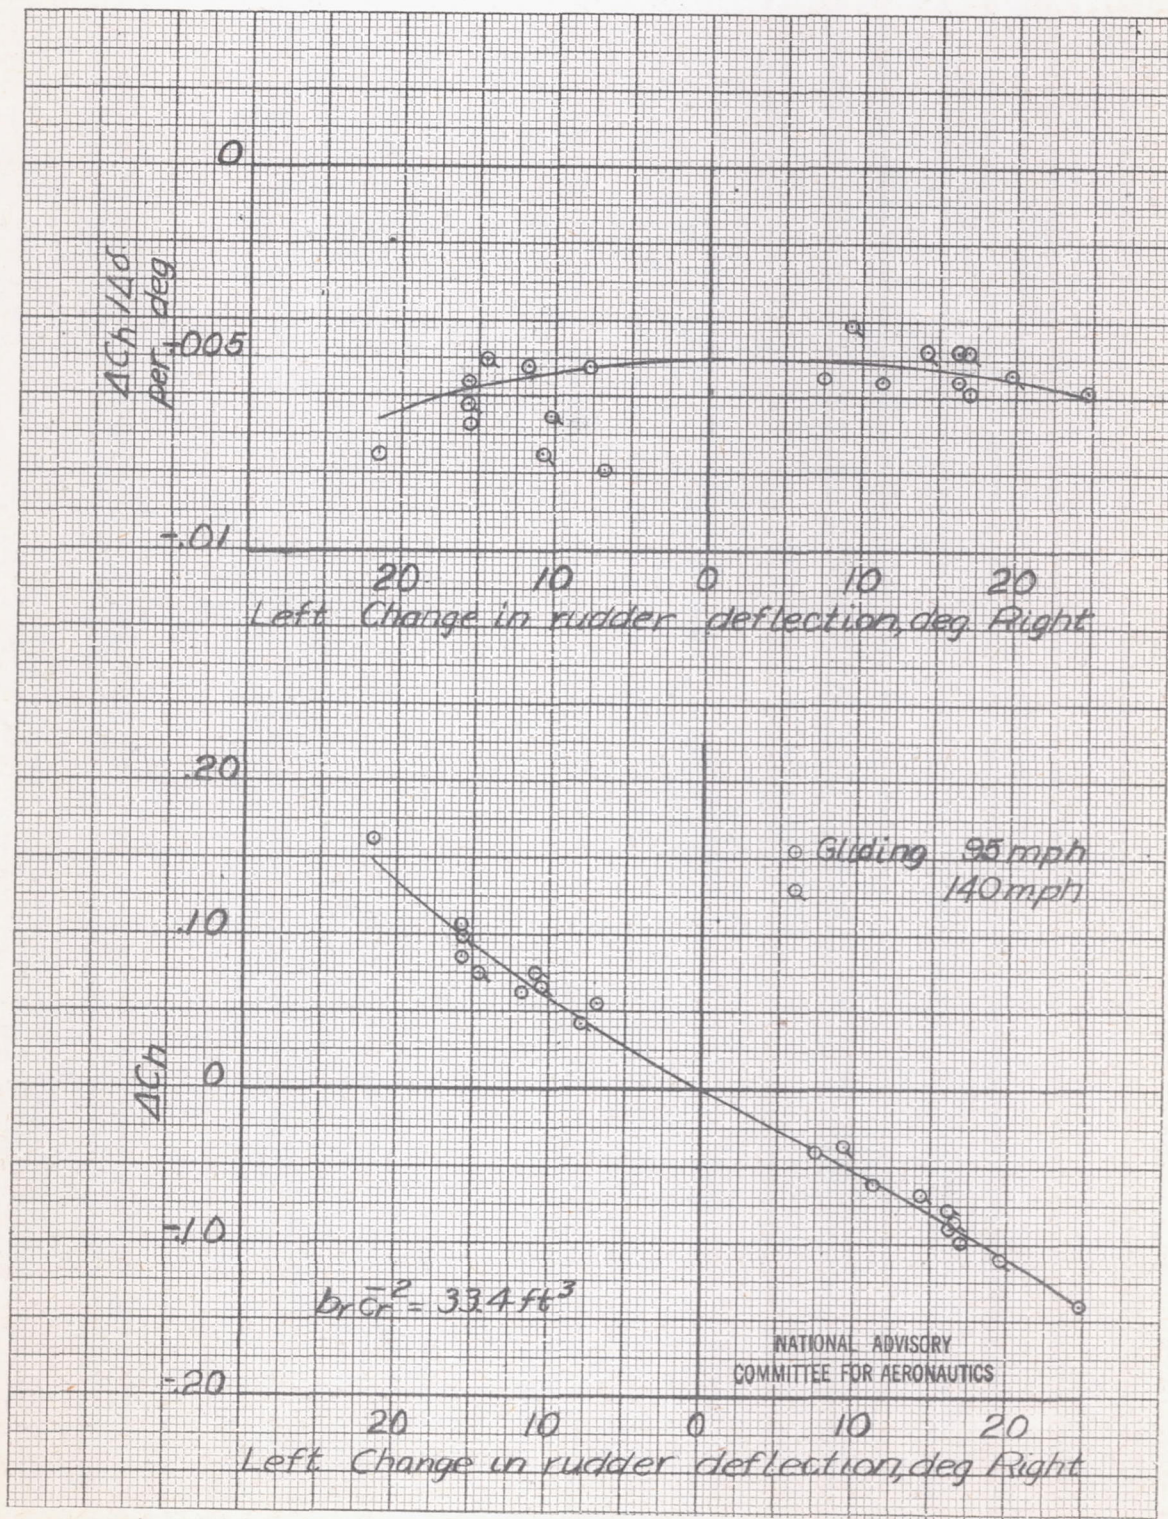
Figure 53.- Plots of $\Delta C_h / \Delta \delta$ and ΔC_h for constant α against change of rudder deflection during rudder kicks; XSBA-1 airplane with tail configuration 2.

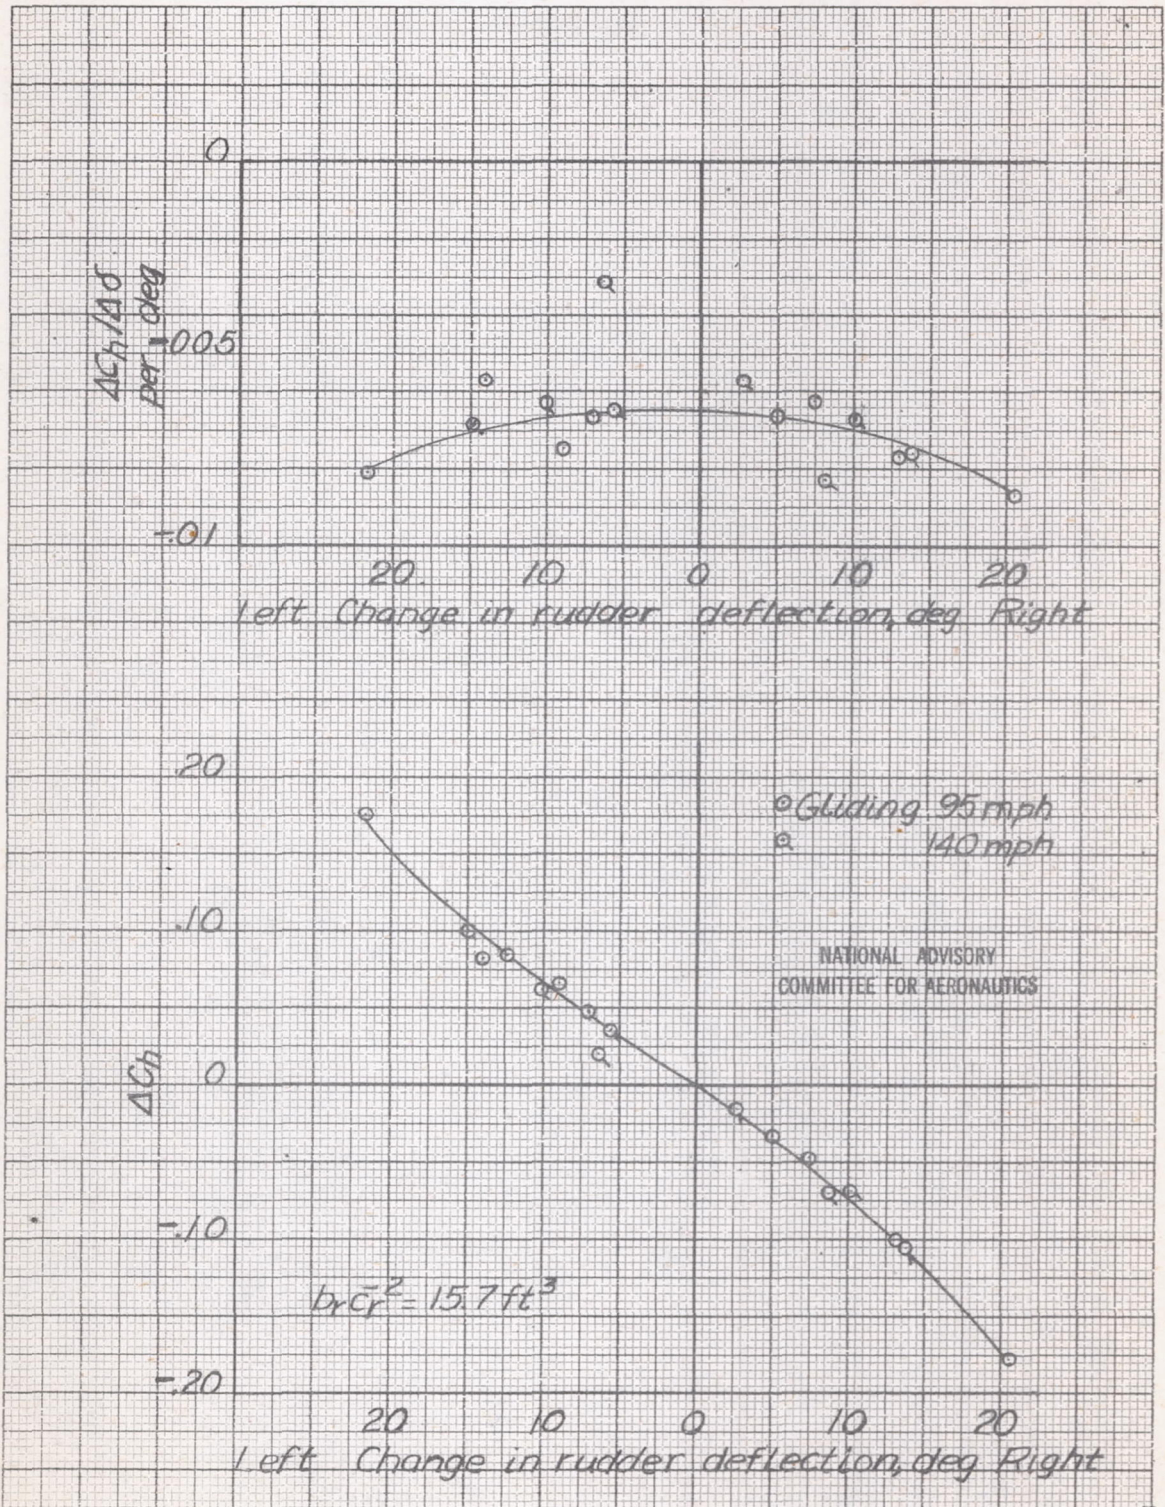
Figure 54.- Plots of $\Delta C_h / \Delta \delta$ and ΔC_h for constant α against change of rudder deflection during rudder kicks; XSBA-1 airplane with tail configuration 3.

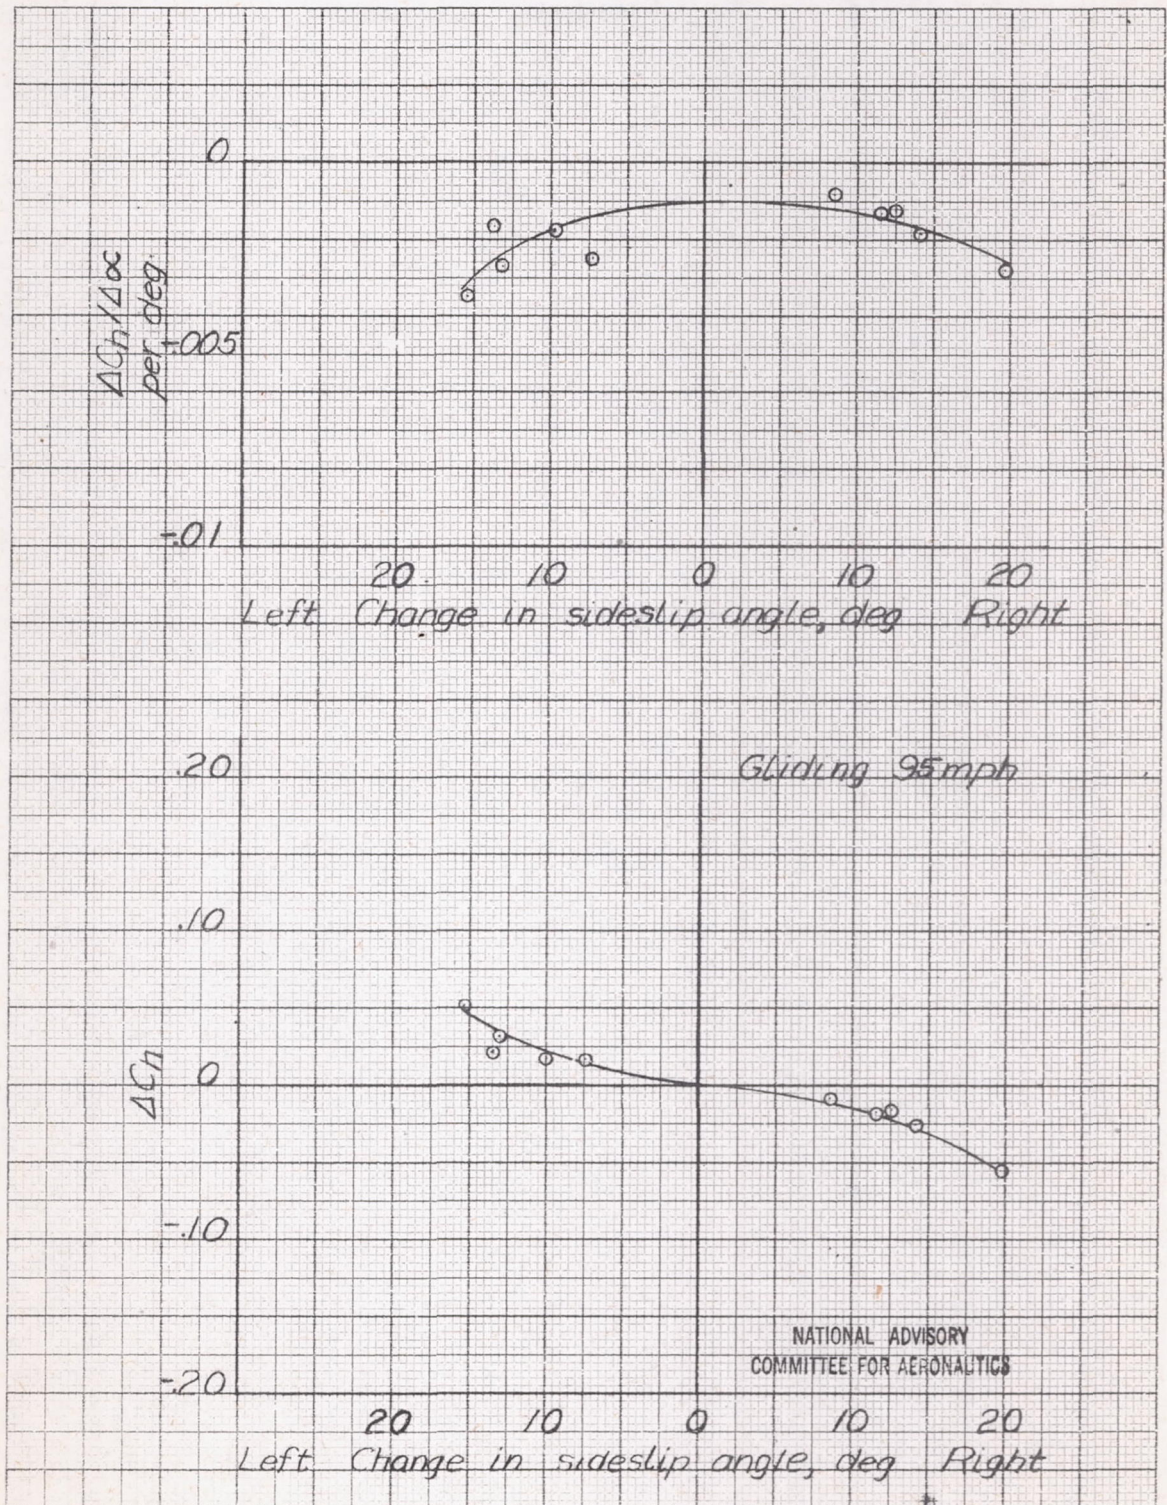
Figure 55.- Plots of $\Delta C_h / \Delta \alpha$ and ΔC_h against change of sideslip angle during rudder kicks; XSBA-1 airplane with tail configuration 2.
