FLIGHT TESTS OF VARIOUS TAIL MODIFICATIONS

ON THE BREWSTER XSBA-1 AIRPLANE

III - MEASUREMENTS OF FLYING QUALITIES

WITH TAIL CONFIGURATION 3

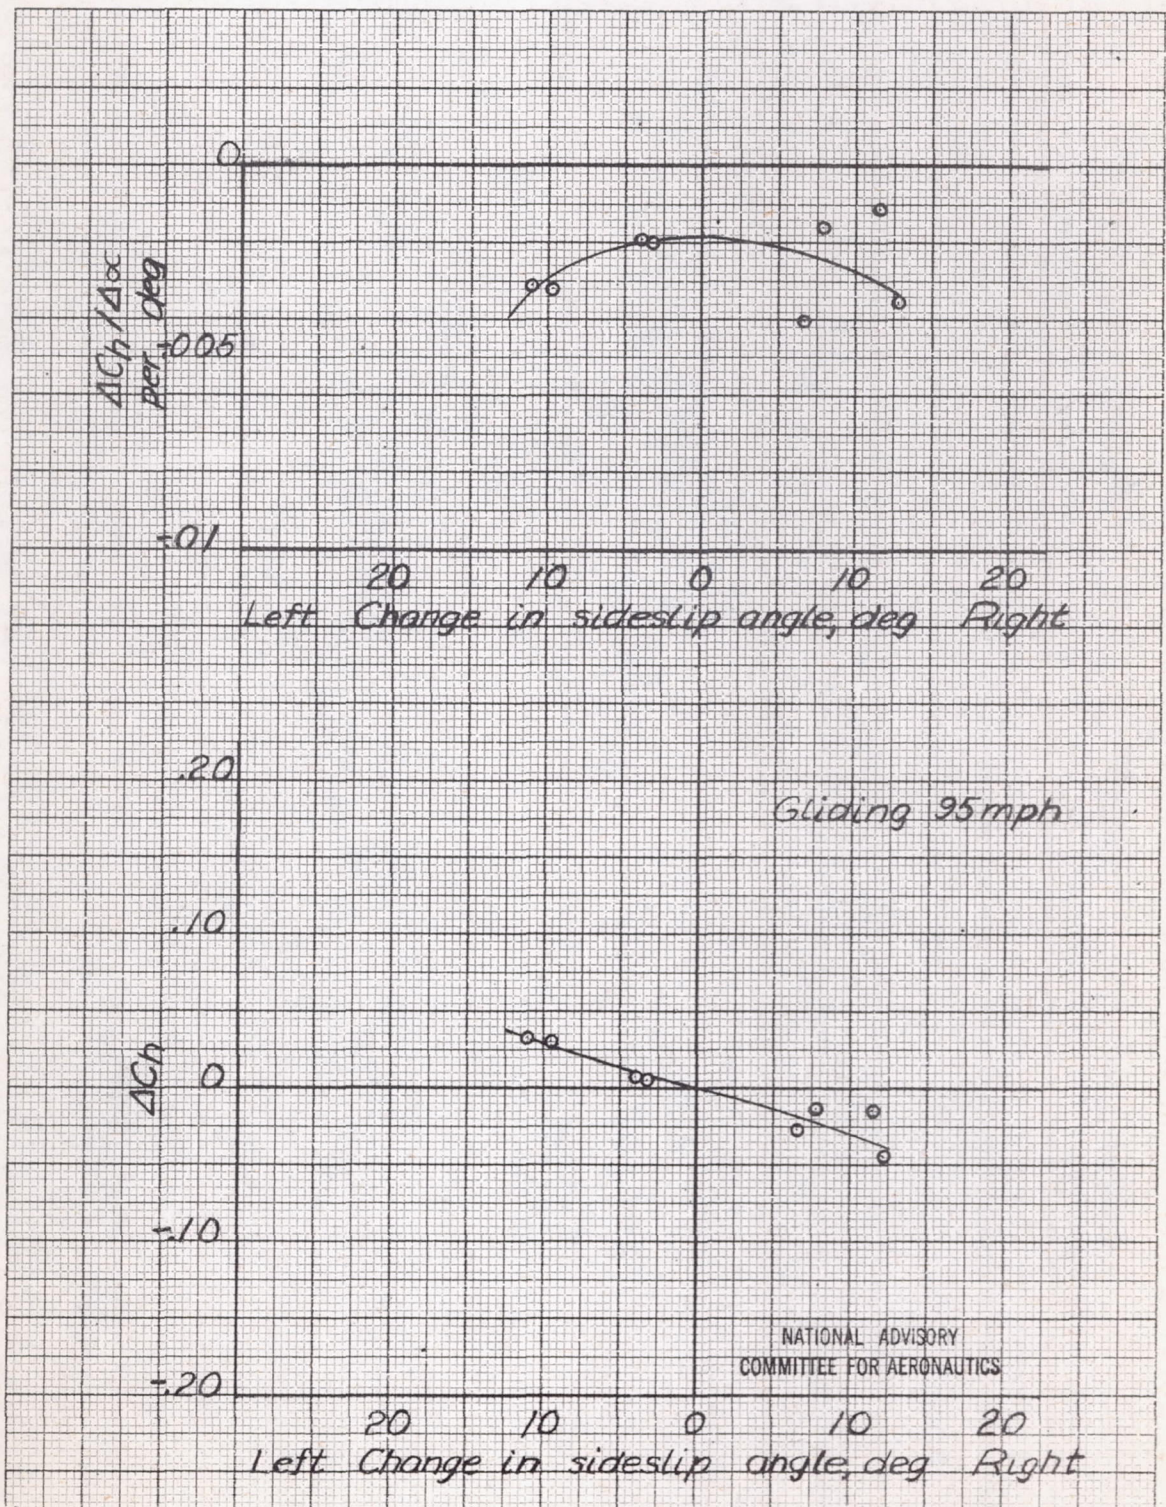
Figure 56.- Plots of $\Delta C_h / \Delta \alpha$ and ΔC_h against change of sideslip angle during rudder kicks; XSBA-1 airplane with tail configuration 3.
