NATIONAL ADVISORY COMMITTEE FOR AERONAUTICS

April 1945 as
Advance Confidential Report L5C24

SUMMARY OF MEASUREMENTS IN LANGLEY FULL-SCALE TUNNEL
OF MAXIMUM LIFT COEFFICIENTS AND
STALLING CHARACTERISTICS OF AIRPLANES

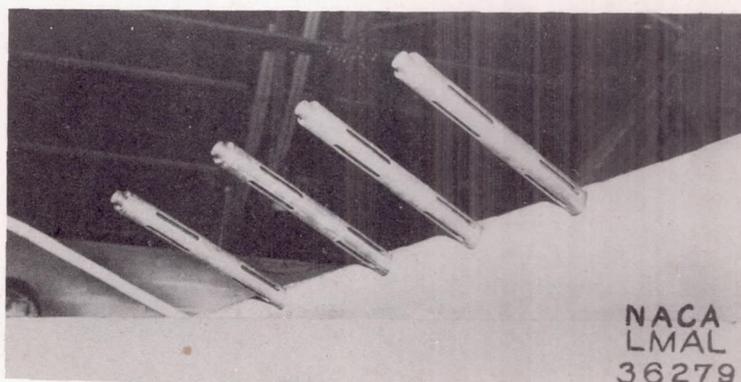
Figure 23.- Eighteen-inch barrel extension in low position on right wing. Airplane 11.
