FLIGHT MEASUREMENTS OF THE RUDDER CONTROL AND SIDESLIP

CHARACTERISTICS OF FOUR VERTICAL TAIL ARRANGEMENTS

ON THE P-40 SERIES AIRPLANES

MEMORANDUM REPORT

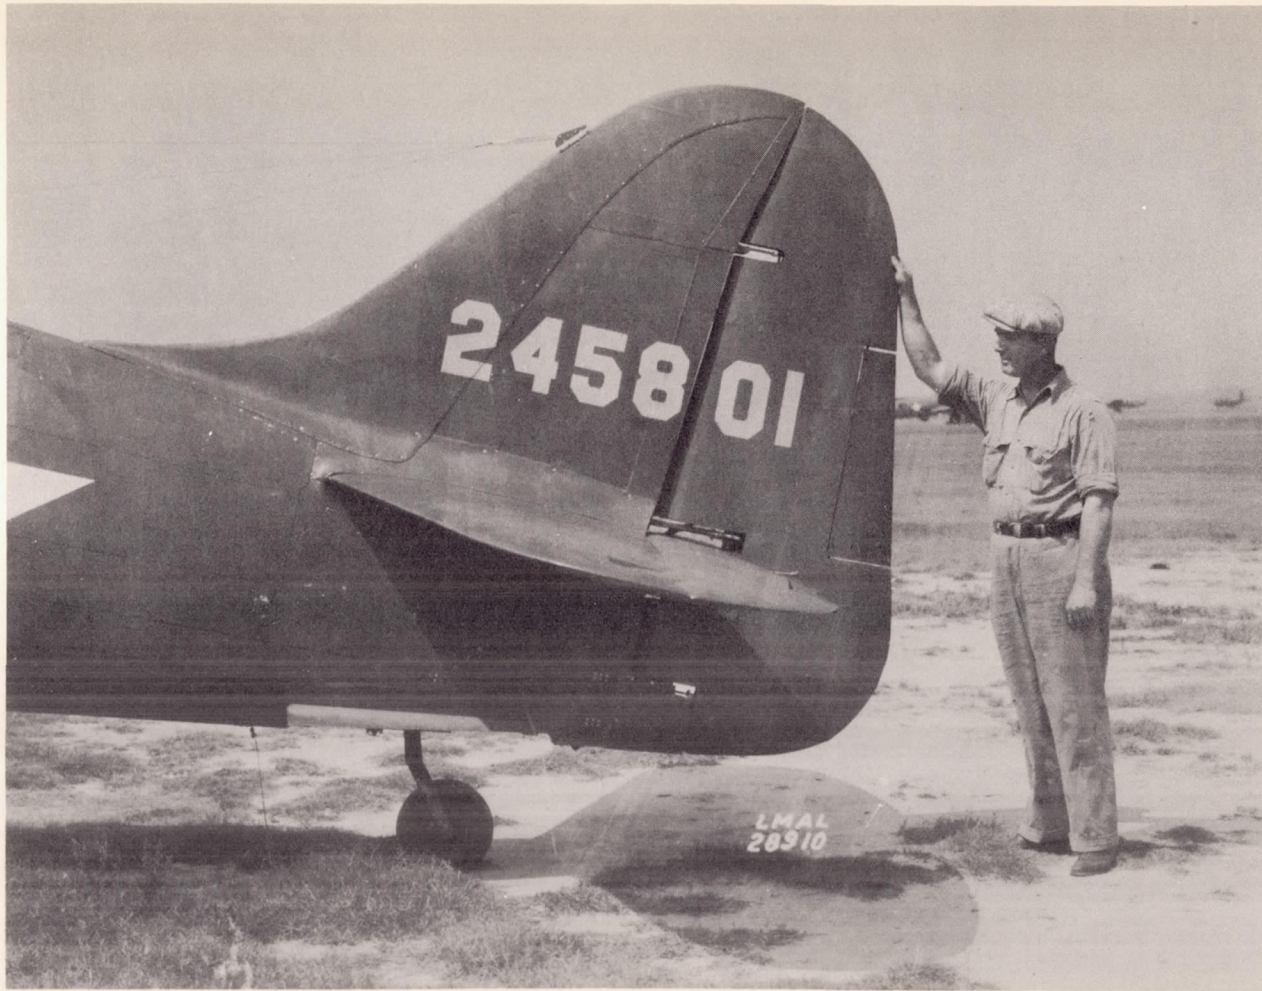
Figure 4.- Side view of Curtiss fin extension No. 6 on a tall fin
(Curtiss DWG. Sk-5524) and rudder (Curtiss DWG. Sk-5676).

Photographs of the four tail arrangements tested are shown in figures 1 through 6. Tests of the original vertical tail, Curtiss fin extension no. 1, and Curtiss fin extension no. 6 on a tall fin (Curtiss dwg. SK-5524) and rudder (Curtiss dwg. SK-5676) were made on a P-40E airplane. Flight measurements with the original vertical tail moved aft 20 inches were conducted on a modified P-40F airplane.

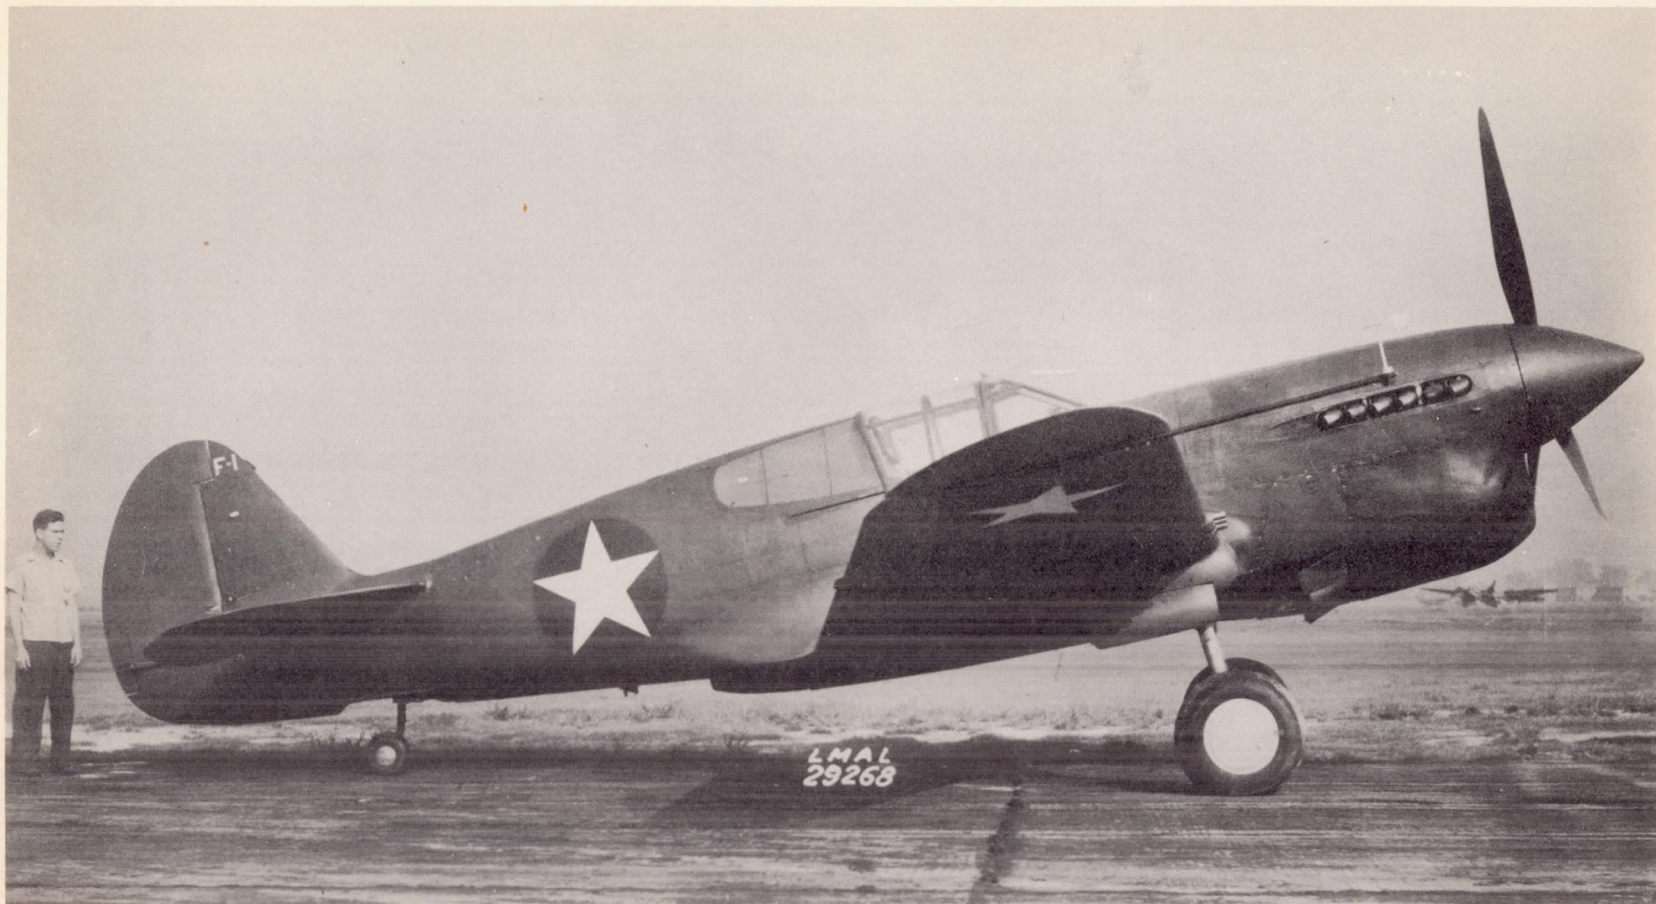
Figure 5.- Side view of Curtiss P-40F airplane with an original vertical tail on a 20-inch fuselage extension.

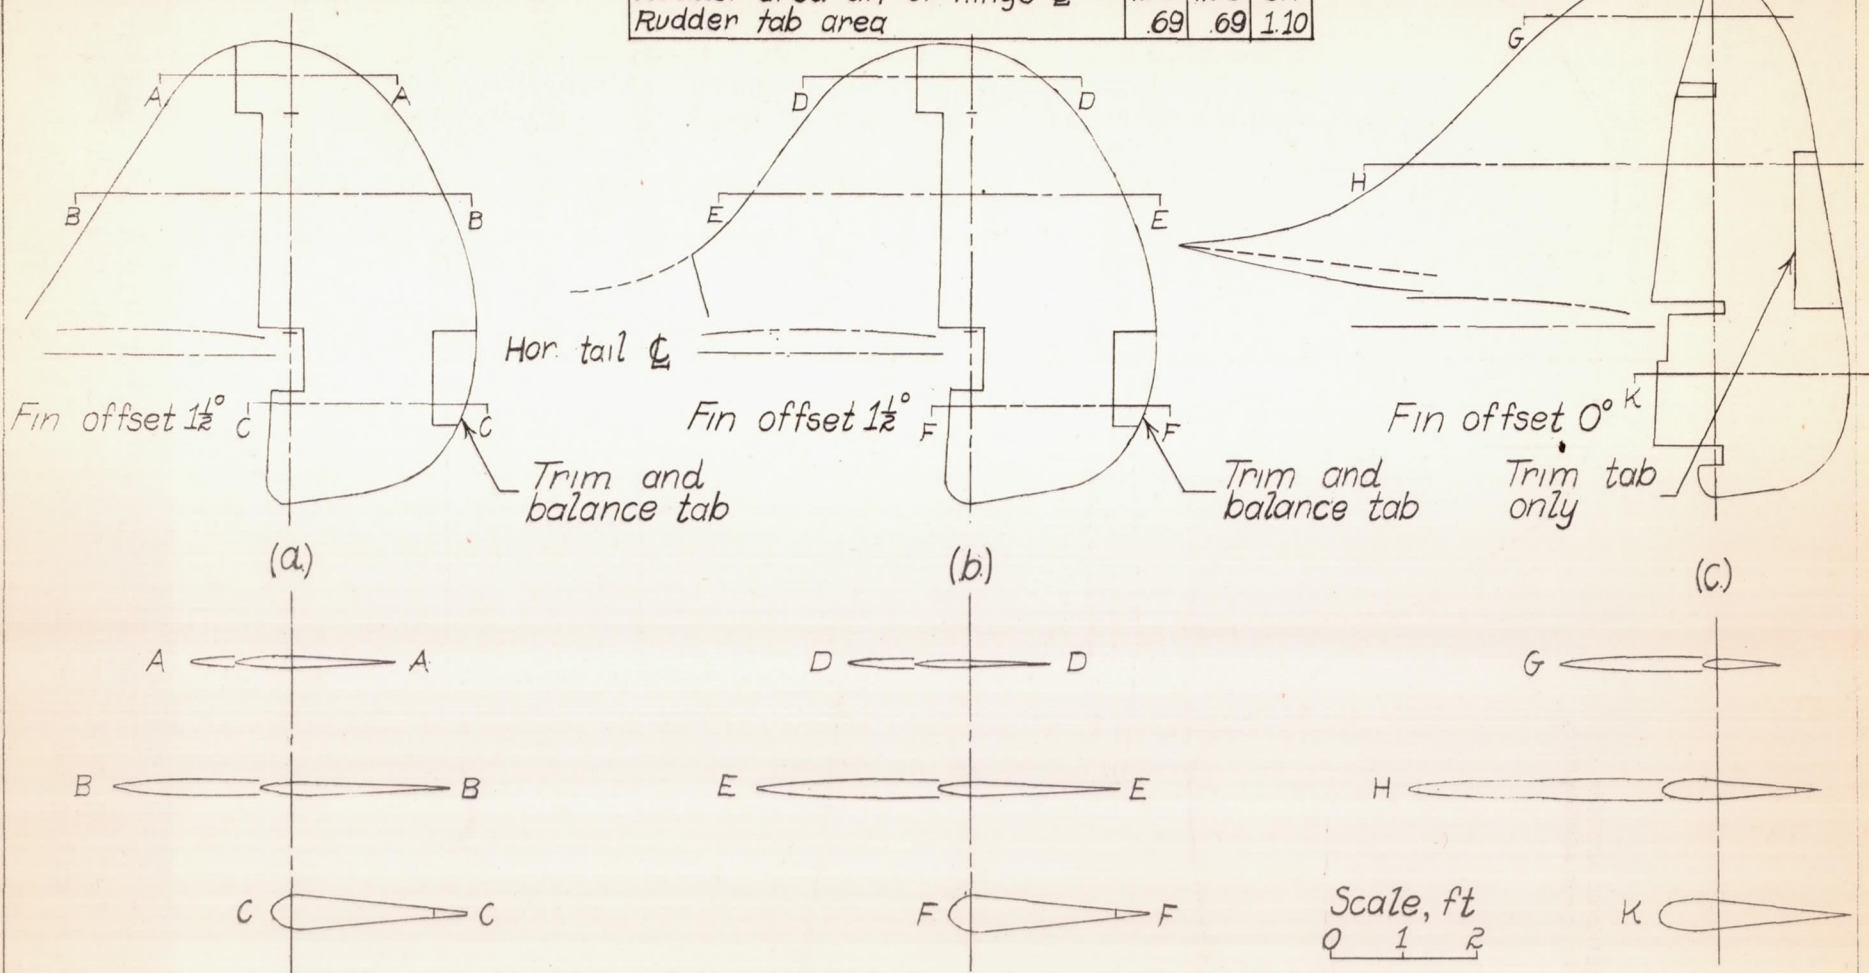
Approximate areas, sq. ft.	(a)	(b)	(c)
Total vertical tail area	22.0	23.4	28.7
Fixed fin area	7.5	8.9	15.2
Total rudder area	14.5	14.5	13.5
Rudder area forward of hinge ζ	2.5	2.5	3.8
Rudder area aft of hinge ζ	12.0	12.0	9.7
Rudder tab area	.69	.69	1.10

Figure 7a. - Vertical tails tested on P-40E airplane: (a) original P-40E vertical tail; (b) fin extension no. 1 on original vertical tail; (c) fin extension no. 6 on tall fin (Curtiss dwg. SK-5524) and rudder (Curtiss dwg. SK-5676).

Line drawings of the vertical tail surfaces, that is, the original vertical tail, Curtiss fin extension no. 1, and Curtiss fin extension no. 6, along with their respective areas, are shown on figure 7. The rudder of the original vertical tail surfaces and of that used with fin extension no. 1 were equipped with balancing trim tabs, while the rudders used with Curtiss fin extension no. 6 and the 20-inch fuselage extension on the P-40F airplane were equipped with trim tabs only. The relations between rudder trim tab position, rudder position, and cockpit tab setting are shown on figures 8 through 11. The fin offset on the original vertical tail and on the tail with fin extension no. 1 was $1-1/2^{\circ}$, while the fin offset for fin extension no. 6 and the 20-inch fuselage extension was 0° .

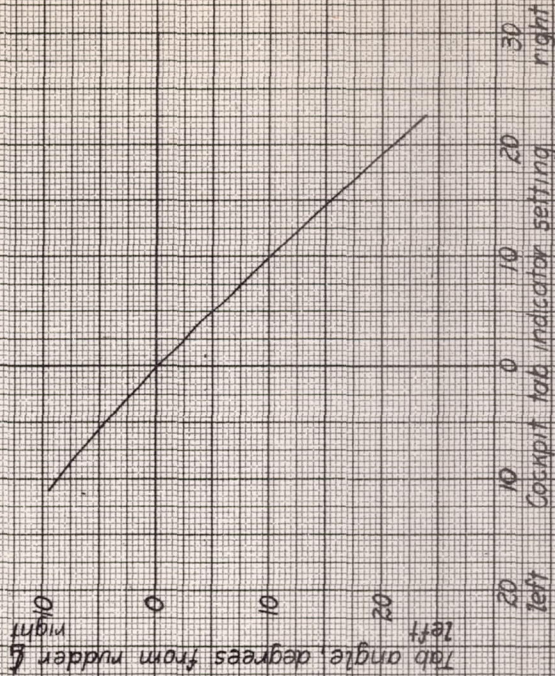
Figure 11. - Relation between rudder trim tab position and cockpit indicator setting, P-40G airplanes, original vertical tail on 20-inch fuselage extension, fin offset 0°.

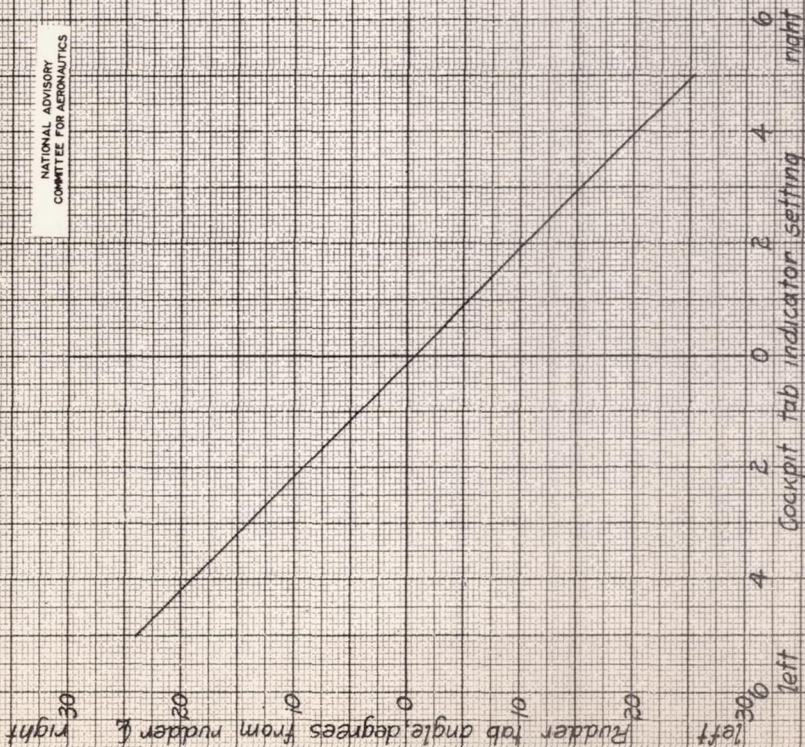
Figure 10. - Relation between rudder trim tab position and cockpit indicator setting, P-40G airplanes, fin extension no. 6 on tall fin and rudder, fin offset 0°.

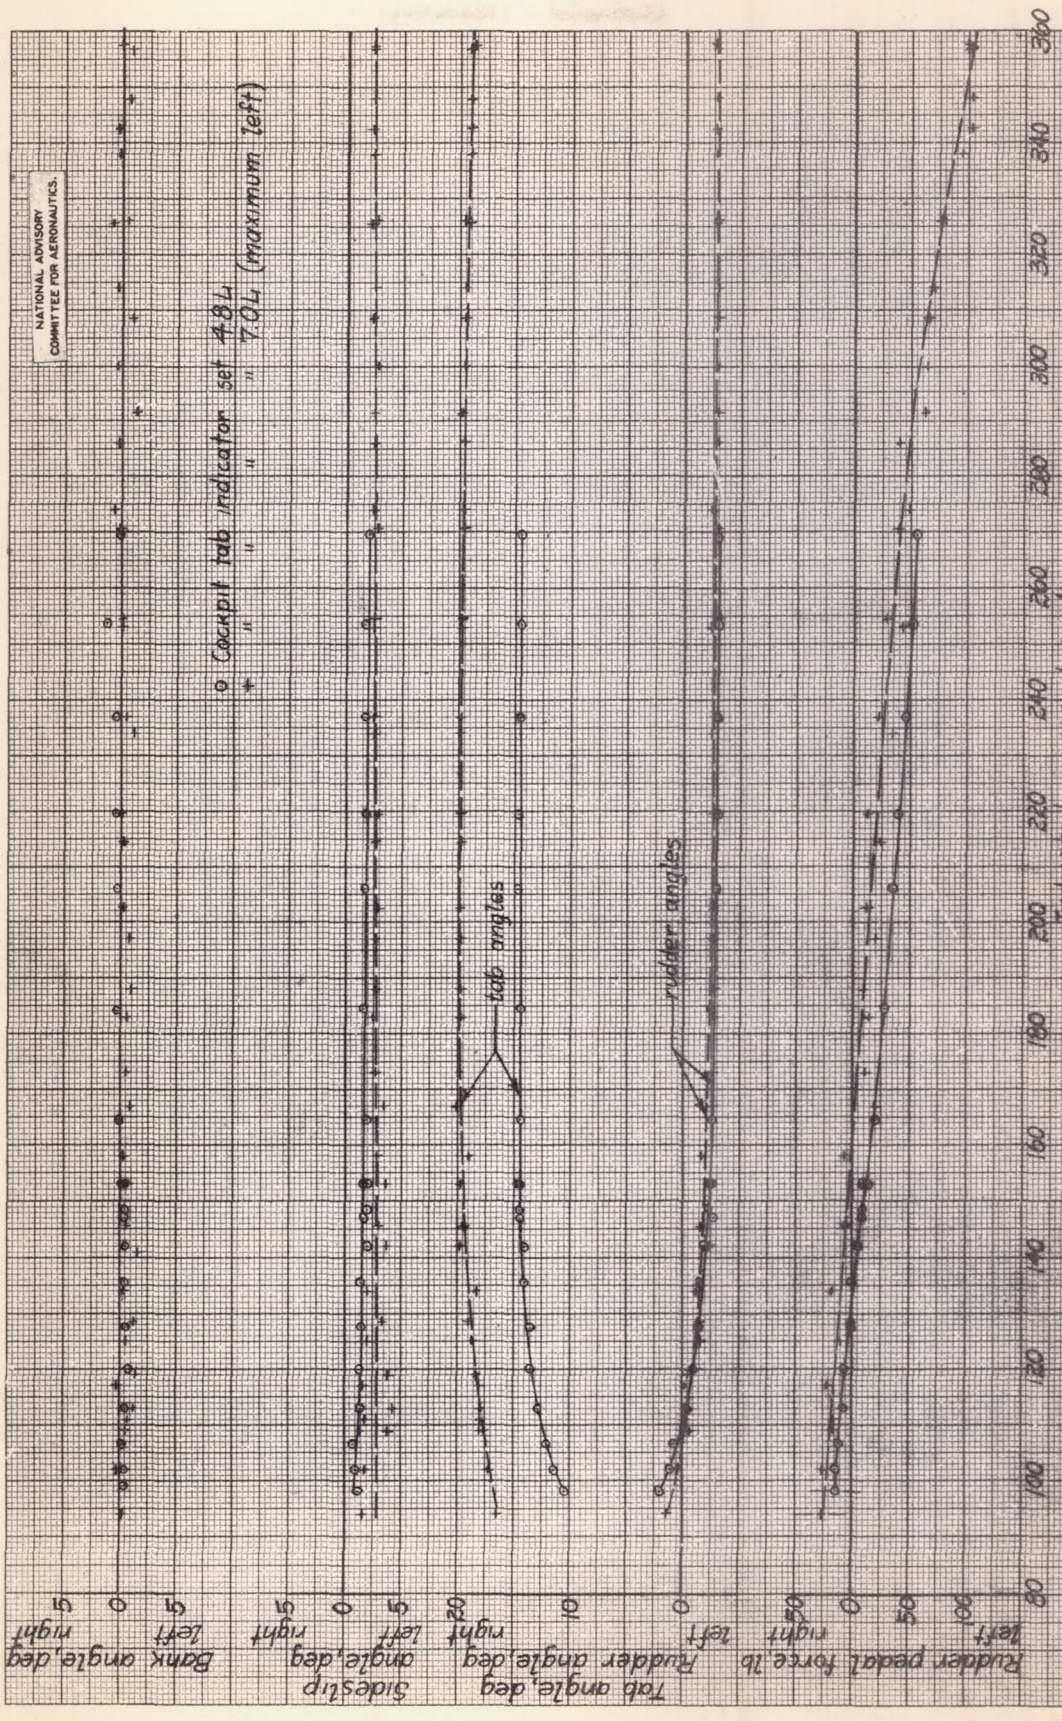
FIGURE 15. - DIRECTIONAL TRIM CHARACTERISTICS, P-30C AIRPLANE, FIN EXTENSION NO. 1 ON ORIGINAL VERTICAL TAIL, FIN OFFSET 1-1/2", POWER OFF, CLEAN CONDITION.

The rudder-control characteristics in straight flight are presented for the four vertical tail arrangements tested in figures 12 through 23. The effectiveness of the rudder trim tabs as a function of indicated airspeed is shown on figure 24.

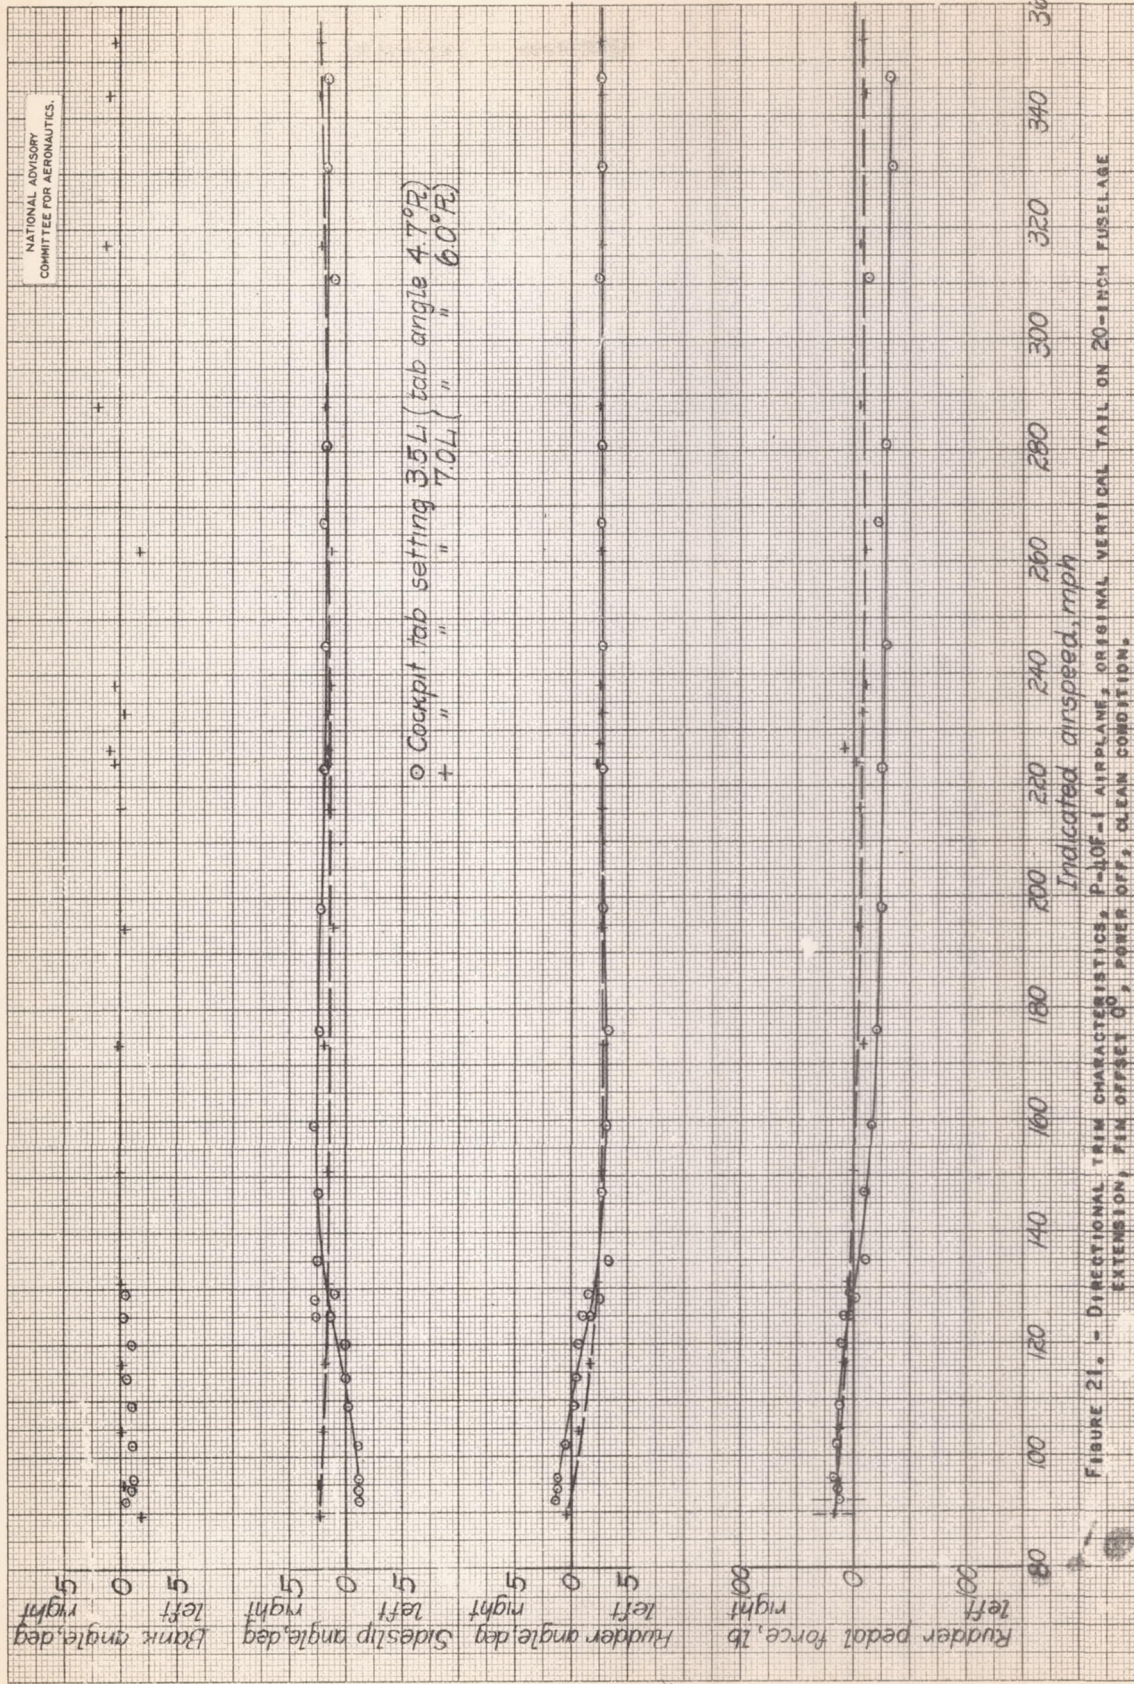
FIGURE 21. - DIRECTIONAL TRIM CHARACTERISTICS, P-40F-1 AIRPLANE, ORIGINAL VERTICAL TAIL ON 20-INCH FUSELAGE EXTENSION, FIN OFFSET 0°, POWER OFF, CLEAN CONDITION.

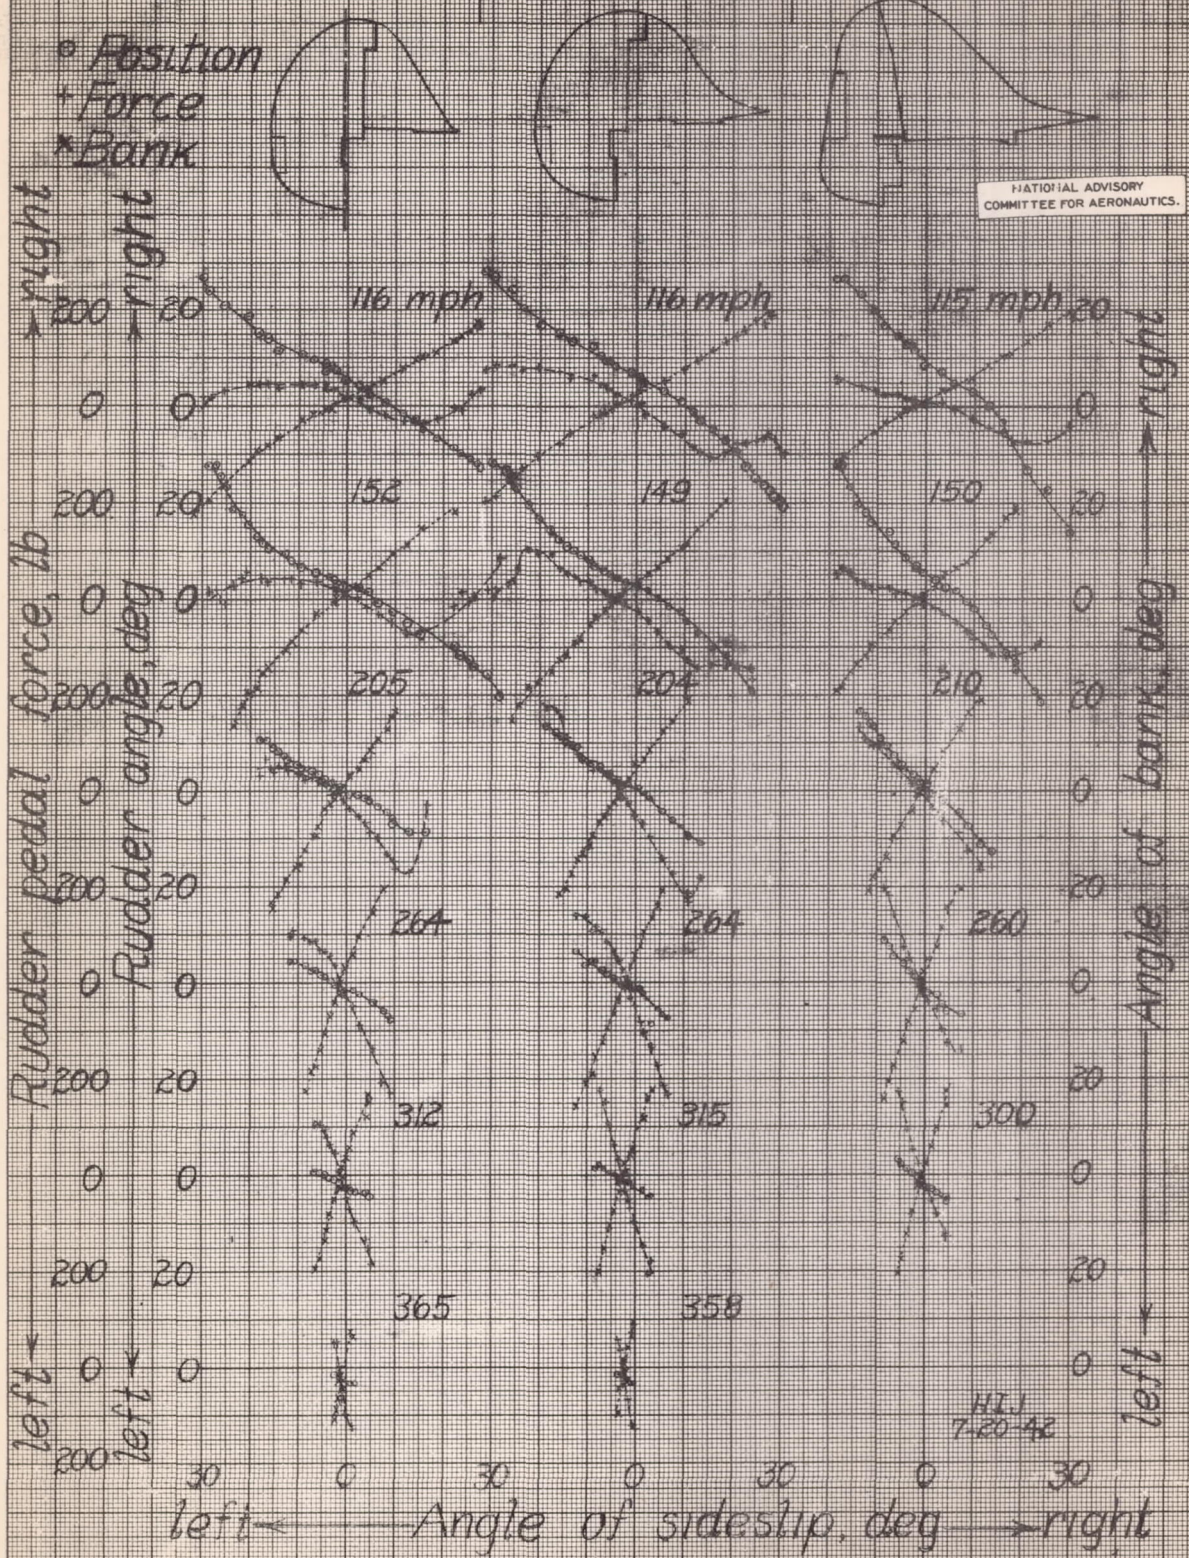
Figure 25 - Sideslip Characteristics of a P-40E Airplane at Various Indicated Airspeeds with Rated Power

The sideslip characteristics of the tail arrangements tested are shown in figures 25 and 26. Attention is

I-547
called to the rudder force reversals encountered in the lower speed range with rated power on with the original P-40E airplane. Sideslip characteristics for small angles of yaw are shown for all the tail configurations in figures 27 and 28.
