MR No. L5B13a

FLIGHT MEASUREMENTS OF THE FLYING QUALITIES
OF AN F6F-3 AIRPLANE (BUAER NO. 04776)
II - LATERAL AND DIRECTIONAL STABILITY AND CONTROL
By Walter C. Williams and John P. Reeder

Bureau of Aeronautics, Navy Department

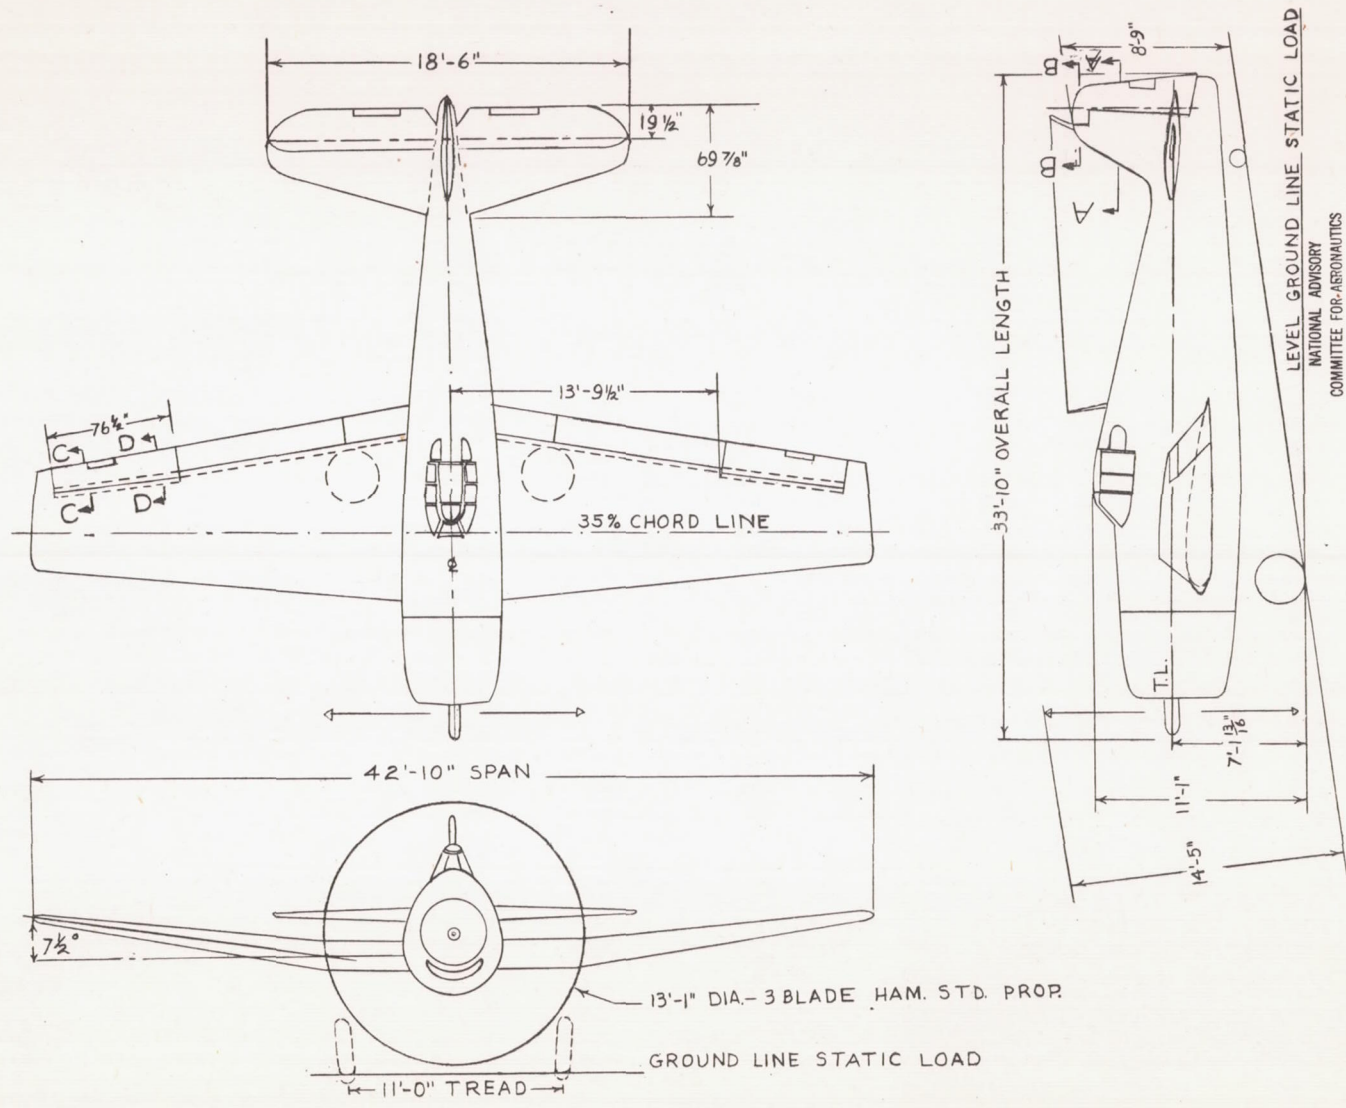
Figure 1. - Three-view layout of the F6F-3 airplane.

A three-view layout of the F6F-3 airplane is shown in figure 1. Pertinent details and dimensions of the F6F-3 airplane are given in reference 1. The relation between control-surface deflection and stick and rudder pedal position is shown in figure 2 for the rudder and aileron controls. Rudder angles are measured in degrees from the fin and aileron angles are referenced to neutral. Trim-tab angles are given in degrees from the control surface. Sections of the rudder are given in figure 3. Figure 4 gives aileron sections. Section letters on figures 3 and 4 correspond to the sections shown on figure 1. The products of the span and chord squared, on

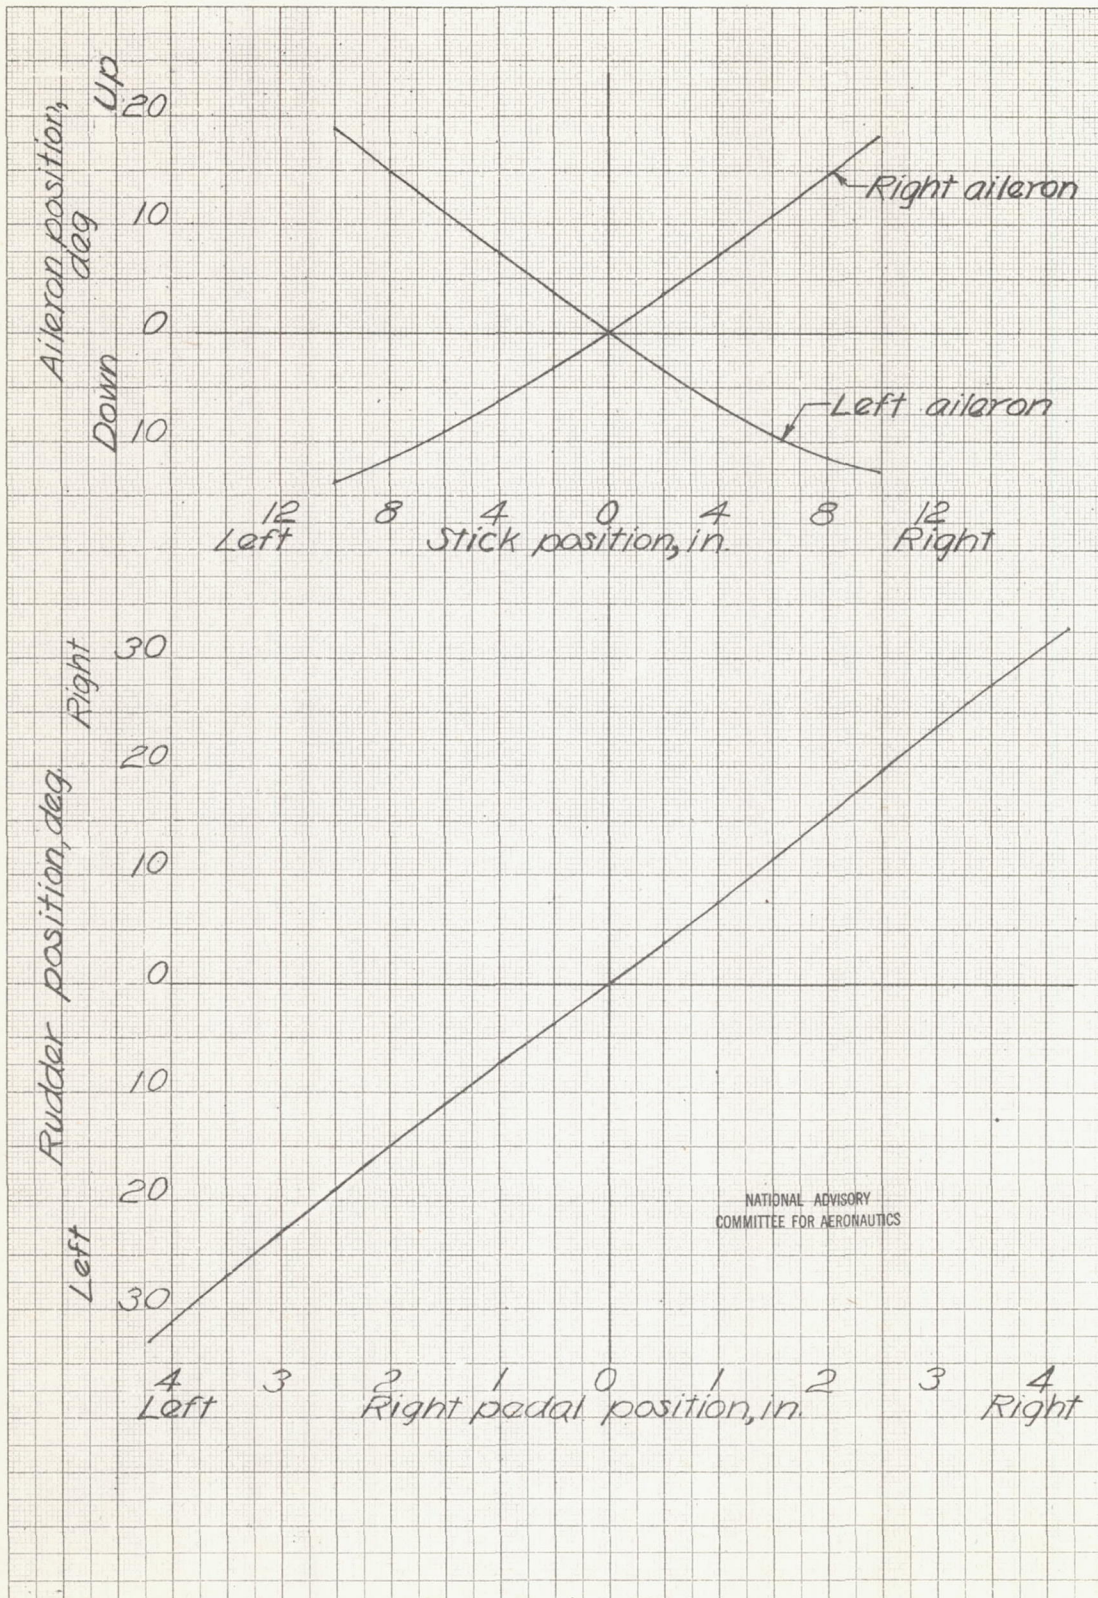
Figure 2. - Variation of control-surface deflection with stick and rudder pedal position. F6F-3 airplane.

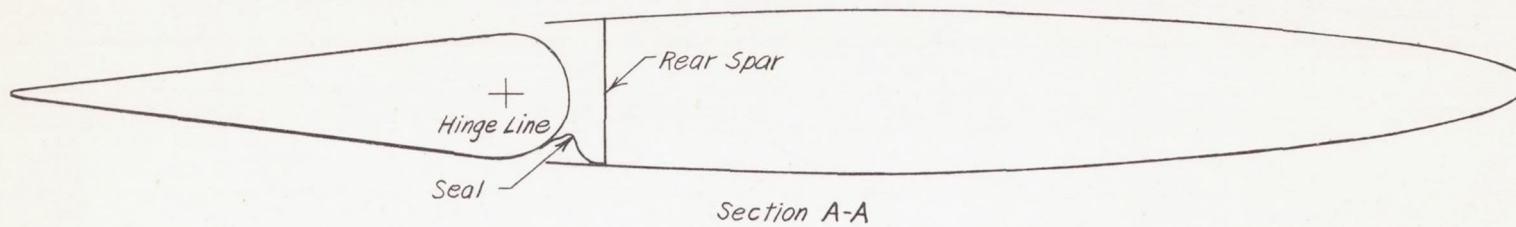
Figure 3. - Section of vertical tail, F6F-3 airplane.

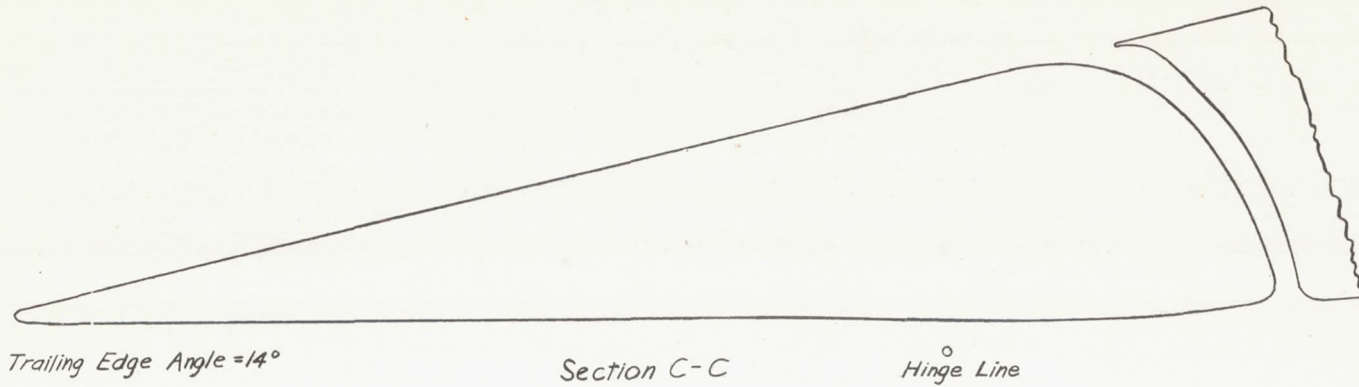
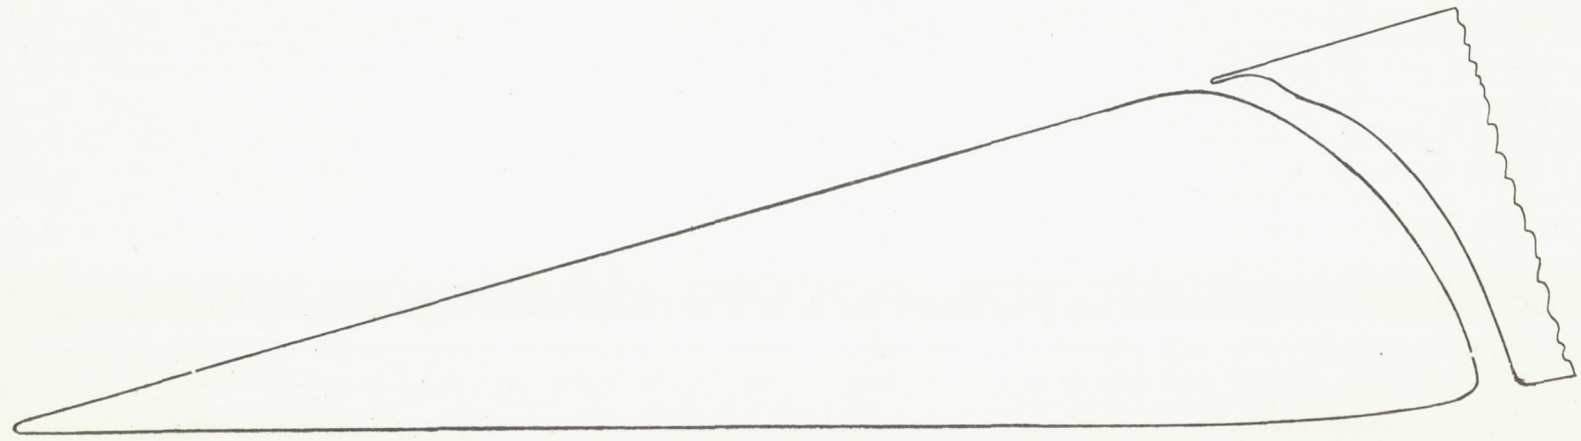
Trailing Edge Angle = 14°

Trailing Edge Angle = 15°

Figure 4. - Section of right aileron, F6F-3 airplane.

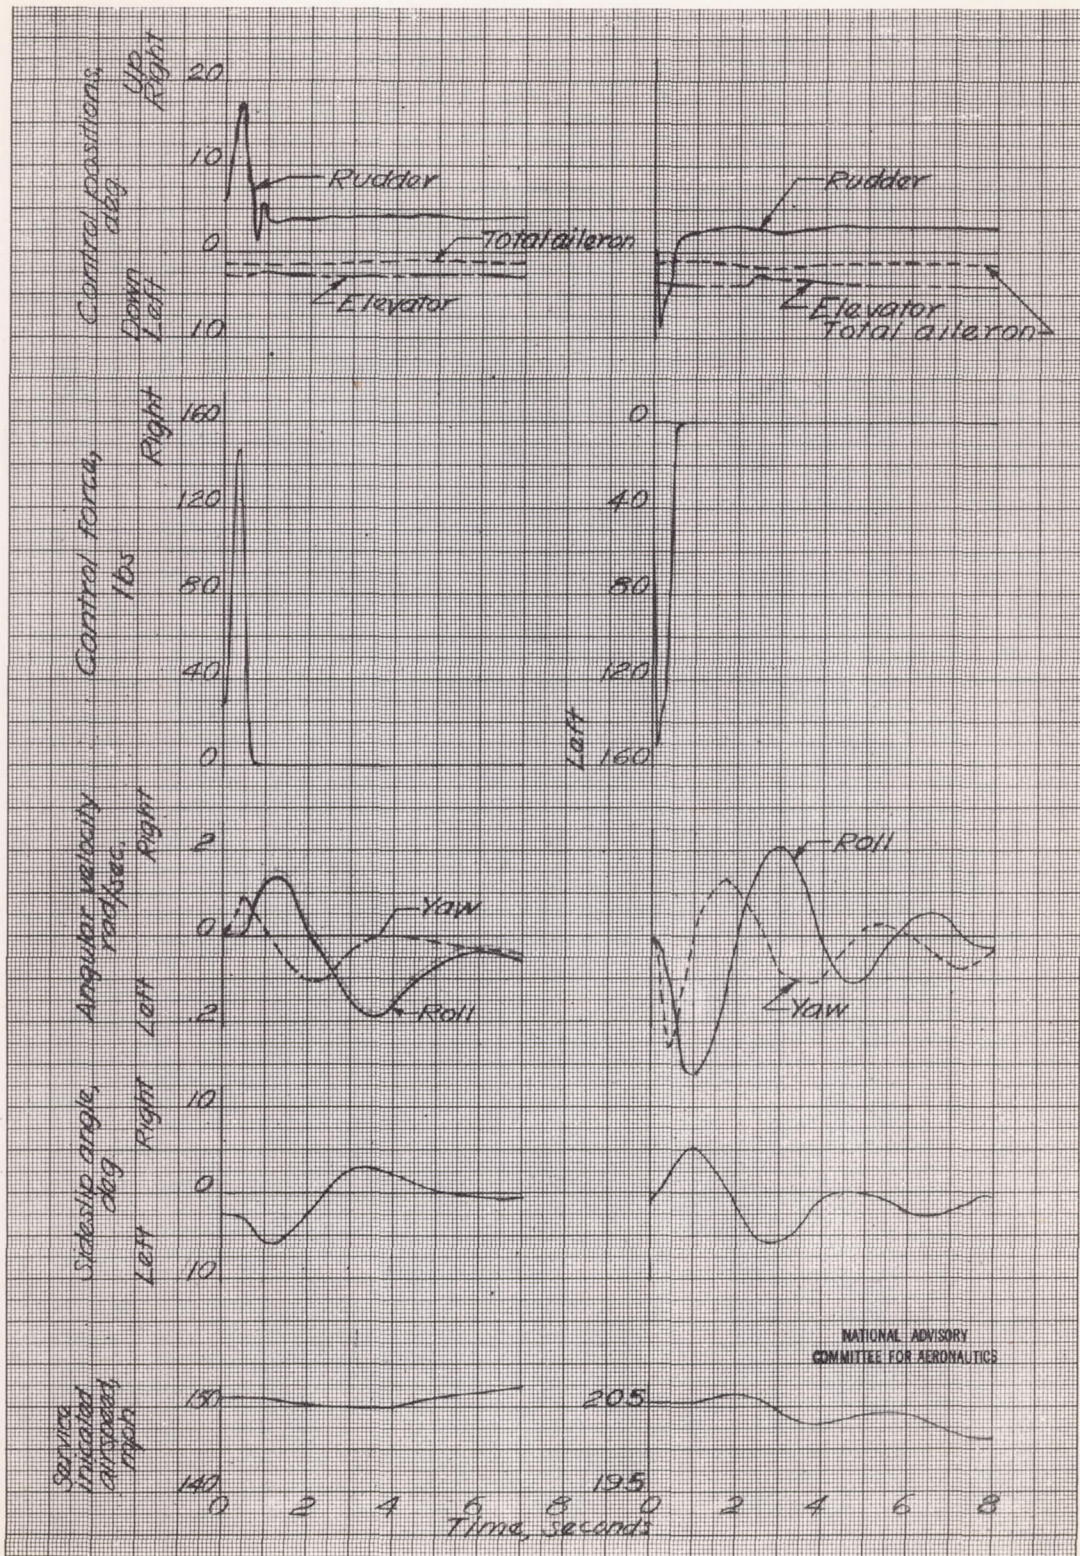
Figure 5. - Time histories of typical lateral oscillations following abrupt rudder deflection, climbing condition, F6F-3 airplane.

The characteristics of the uncontrolled lateral and directional motion were determined in the speed range from 100 to 300 miles per hour for the gliding condition and climbing condition. In these tests the airplane was trimmed for laterally level flight and continuous records were taken while the pilot abruptly deflected the rudder, then released all controls. Typical time histories of this maneuver are shown in figures 5 and 6. The variation of the period of the lateral oscillation with service indicated airspeed is shown in figure 7. It can be seen, on figures 5 and 6, that the short-period lateral oscillations damped to half amplitude within two cycles, satisfying the requirements. Figure 6, however, shows that a lateral oscillation of small amplitude continued and was poorly damped. This oscillation was noticed by the pilots and was considered objectionable.

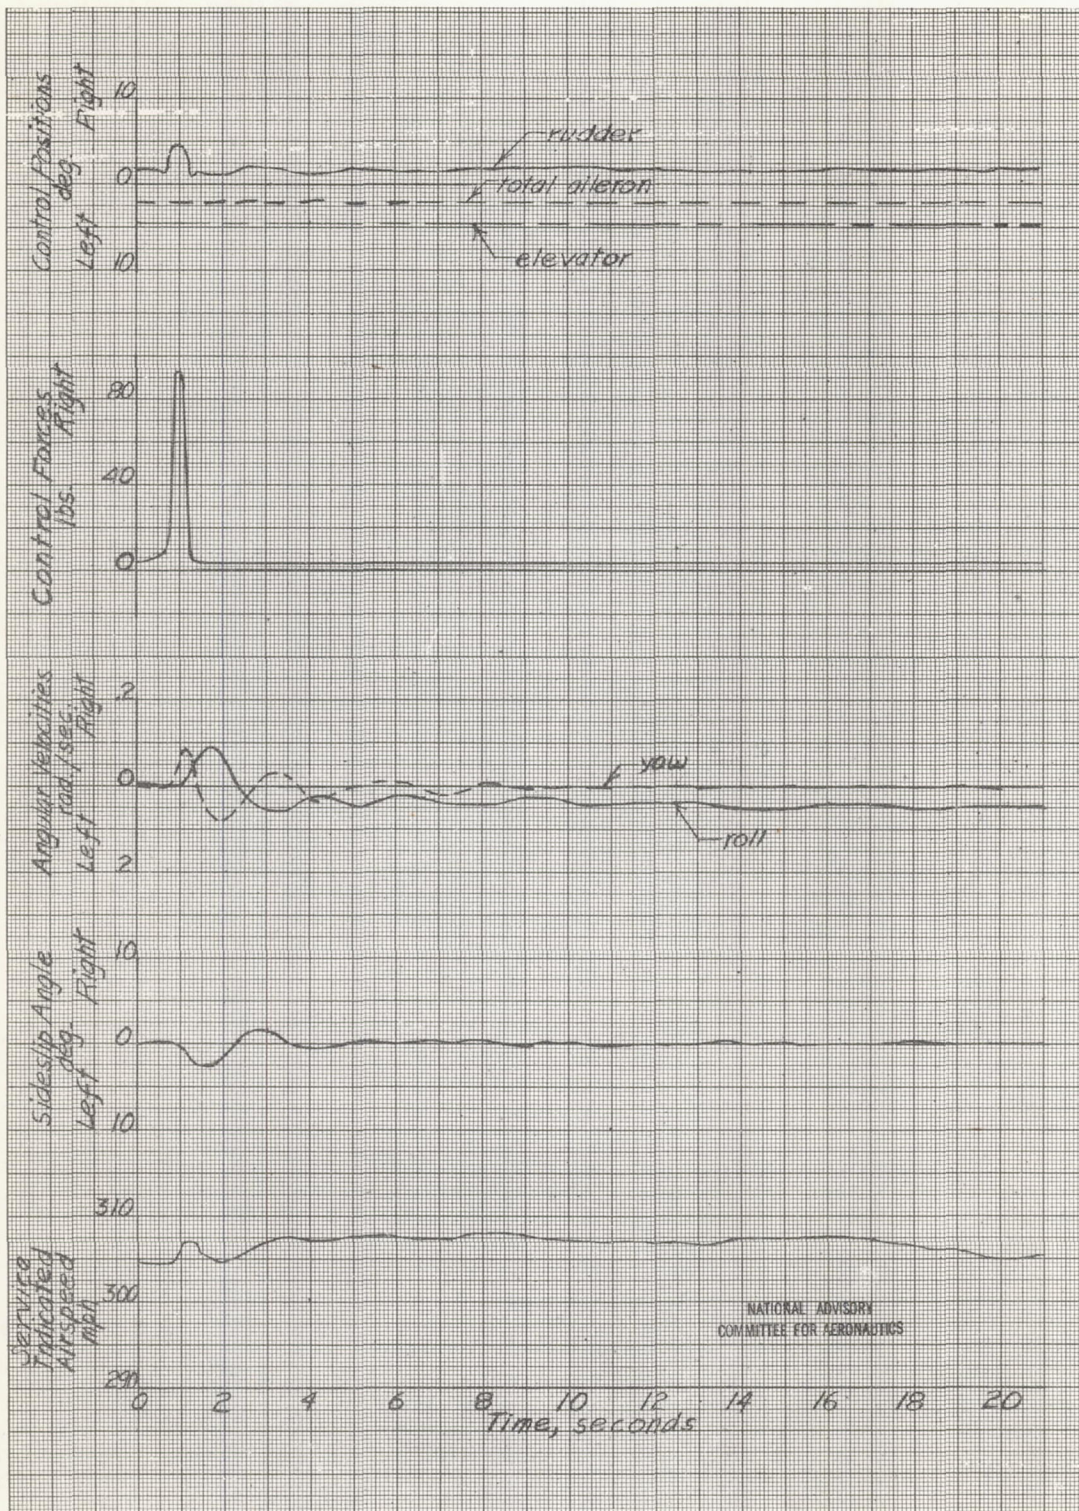
Figure 6. Time history of a typical lateral oscillation following an abrupt rudder deflection at approximately 305 miles per hour, climbing condition, F6F-3 airplane.

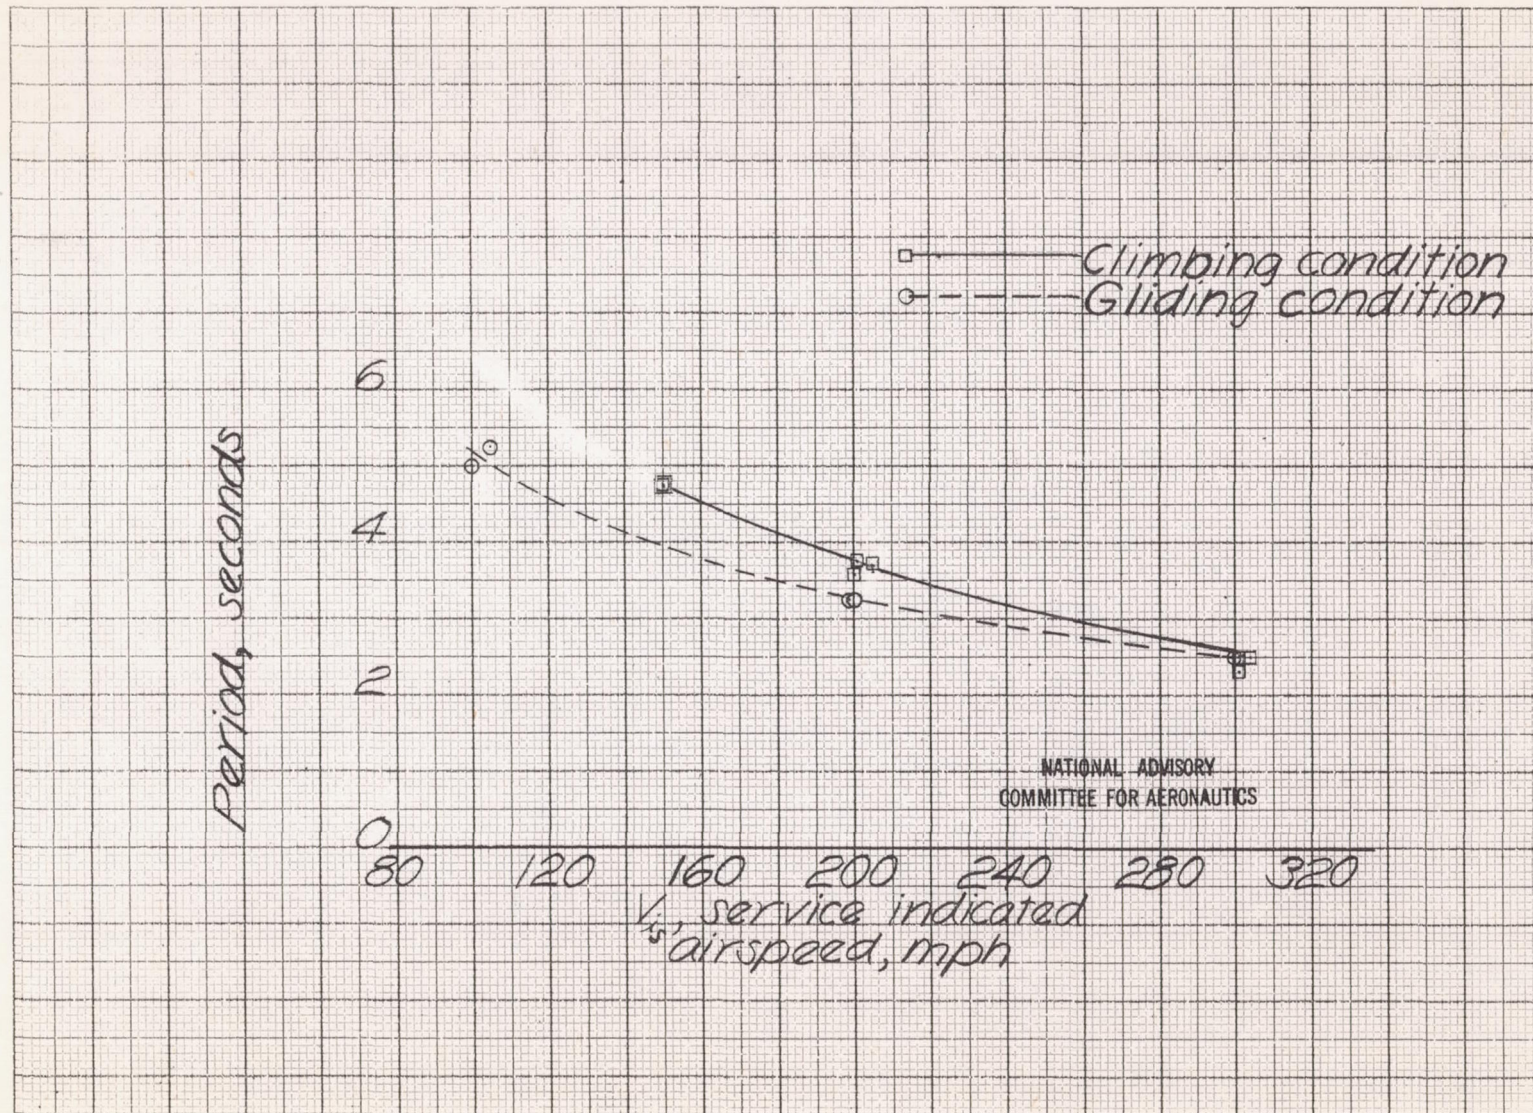
Figure 7. - Variation of the period of lateral oscillations with service indicated airspeed, F6F-3 airplane.

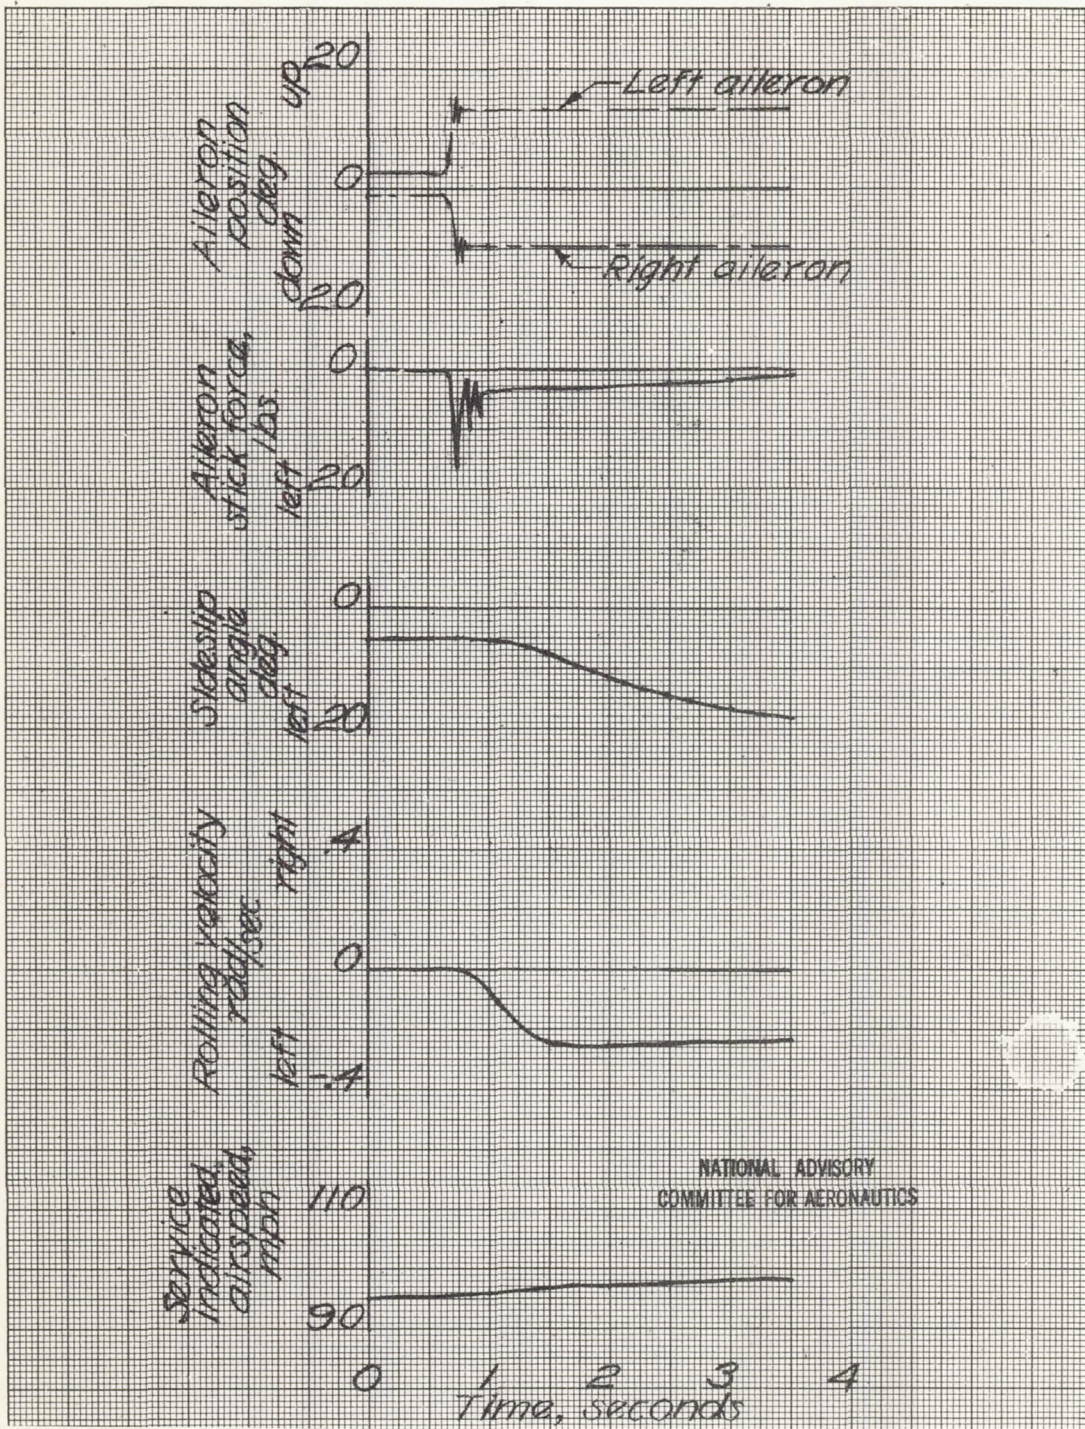
Figure 8. - Typical time history of an abrupt aileron roll made at approximately 95 miles per hour using partial aileron deflection, rudder fixed, clean condition, power for level flight, F6F-3 airplane.

Figures 8 and 9 give time histories of typical aileron rolls made from laterally level flight. It should be noted that where the use of full aileron deflection is indicated, as in figure 9, the aileron stick force shown is not a true measure of the force required to deflect the ailerons as the stick is against the stops. The data obtained from the aileron rolls were evaluated to determine the variation of aileron effectiveness $pb/2V$ and change in aileron stick force with change in total aileron angle. These data are presented on figure 10. From these data, it was possible to determine the helix angle, $pb/2V$, and

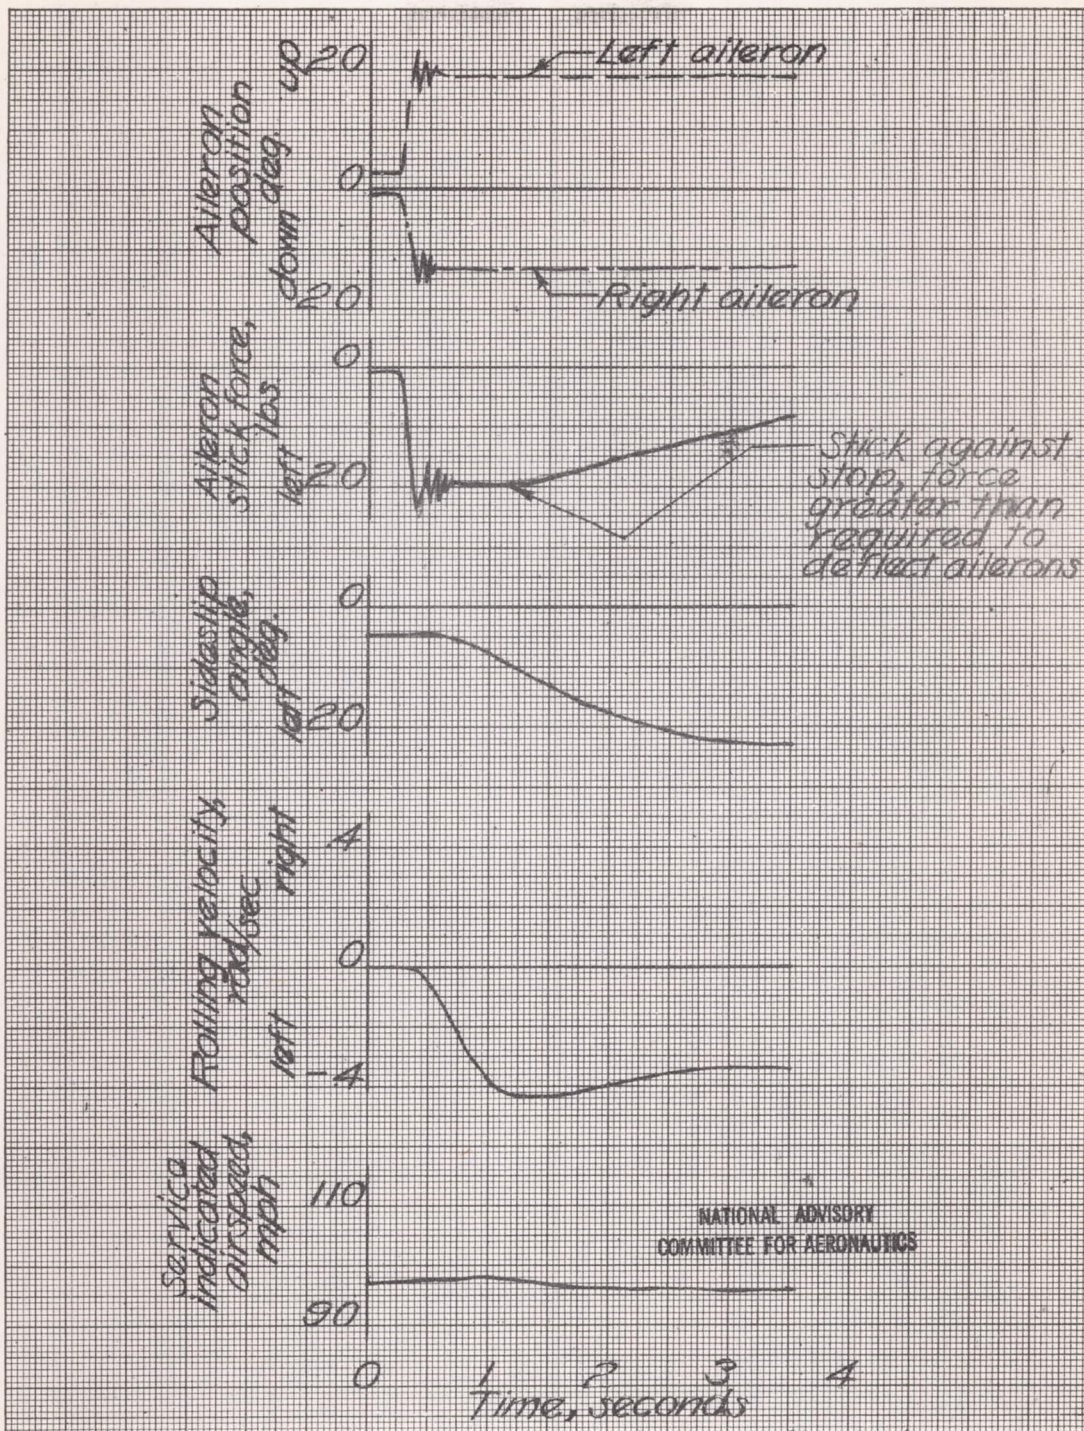
Figure 9. - Typical time history of an abrupt aileron roll made at approximately 97 miles per hour, using full aileron deflection. Clean condition, power for level flight, F6F-3 airplane.

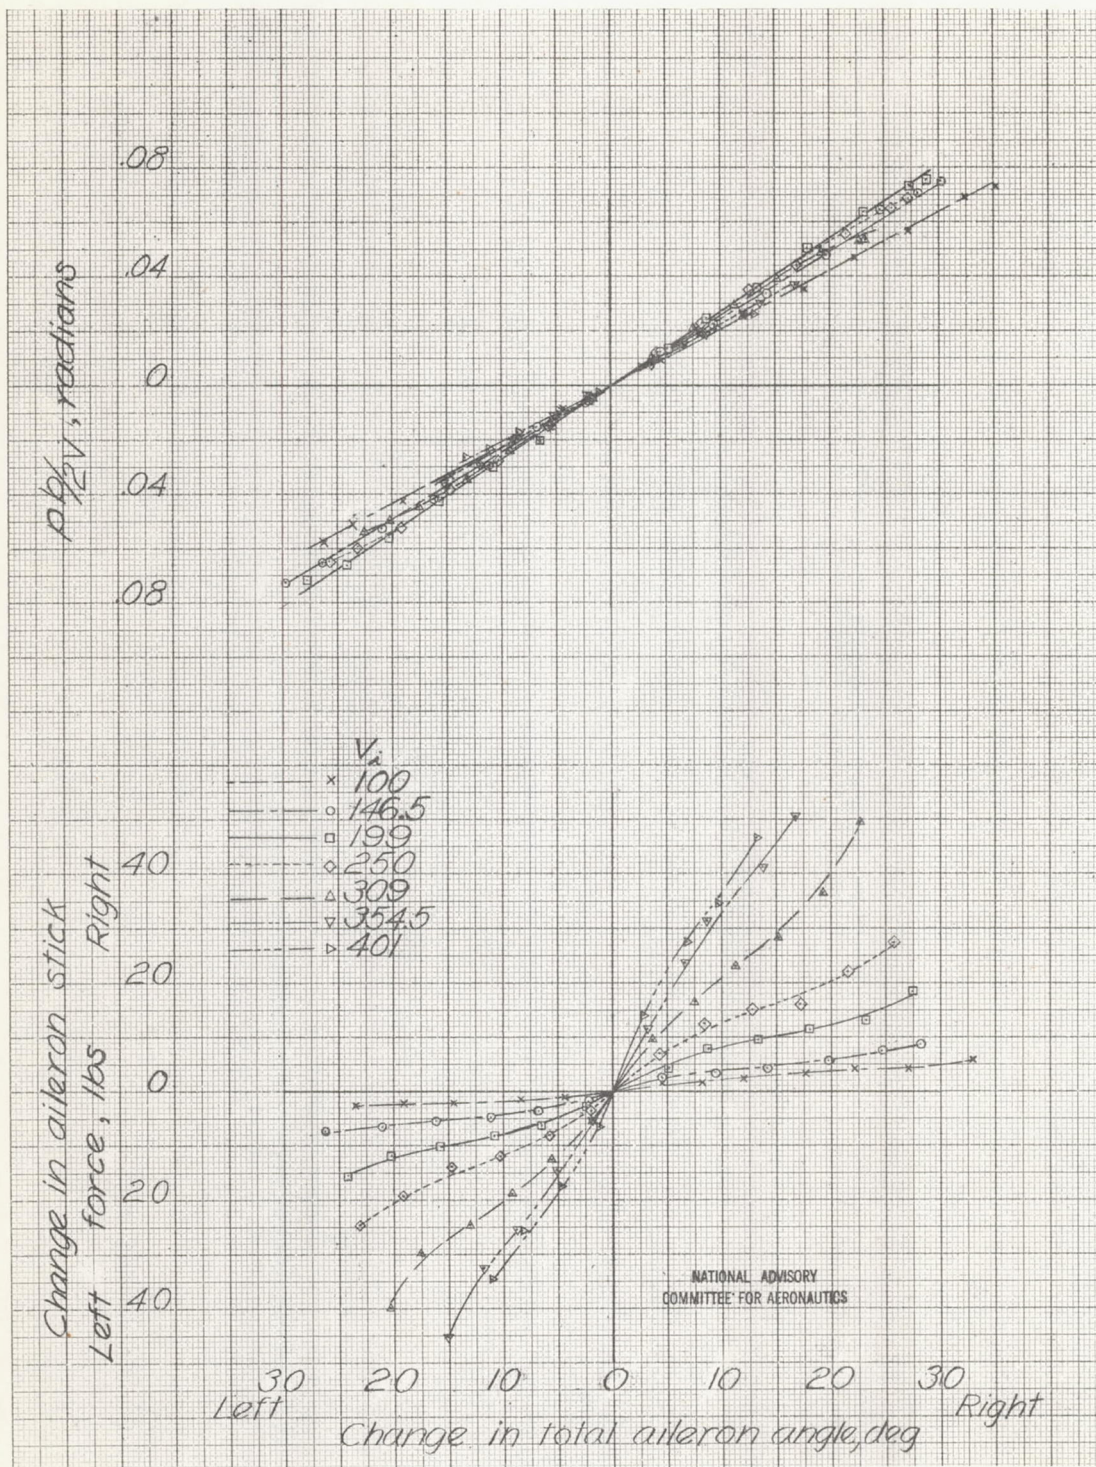
Figure 10. - Variation of the helix angle $pb/2V$ and change in aileron stick force with change in total aileron angle at various speeds, F6F-3 airplane.

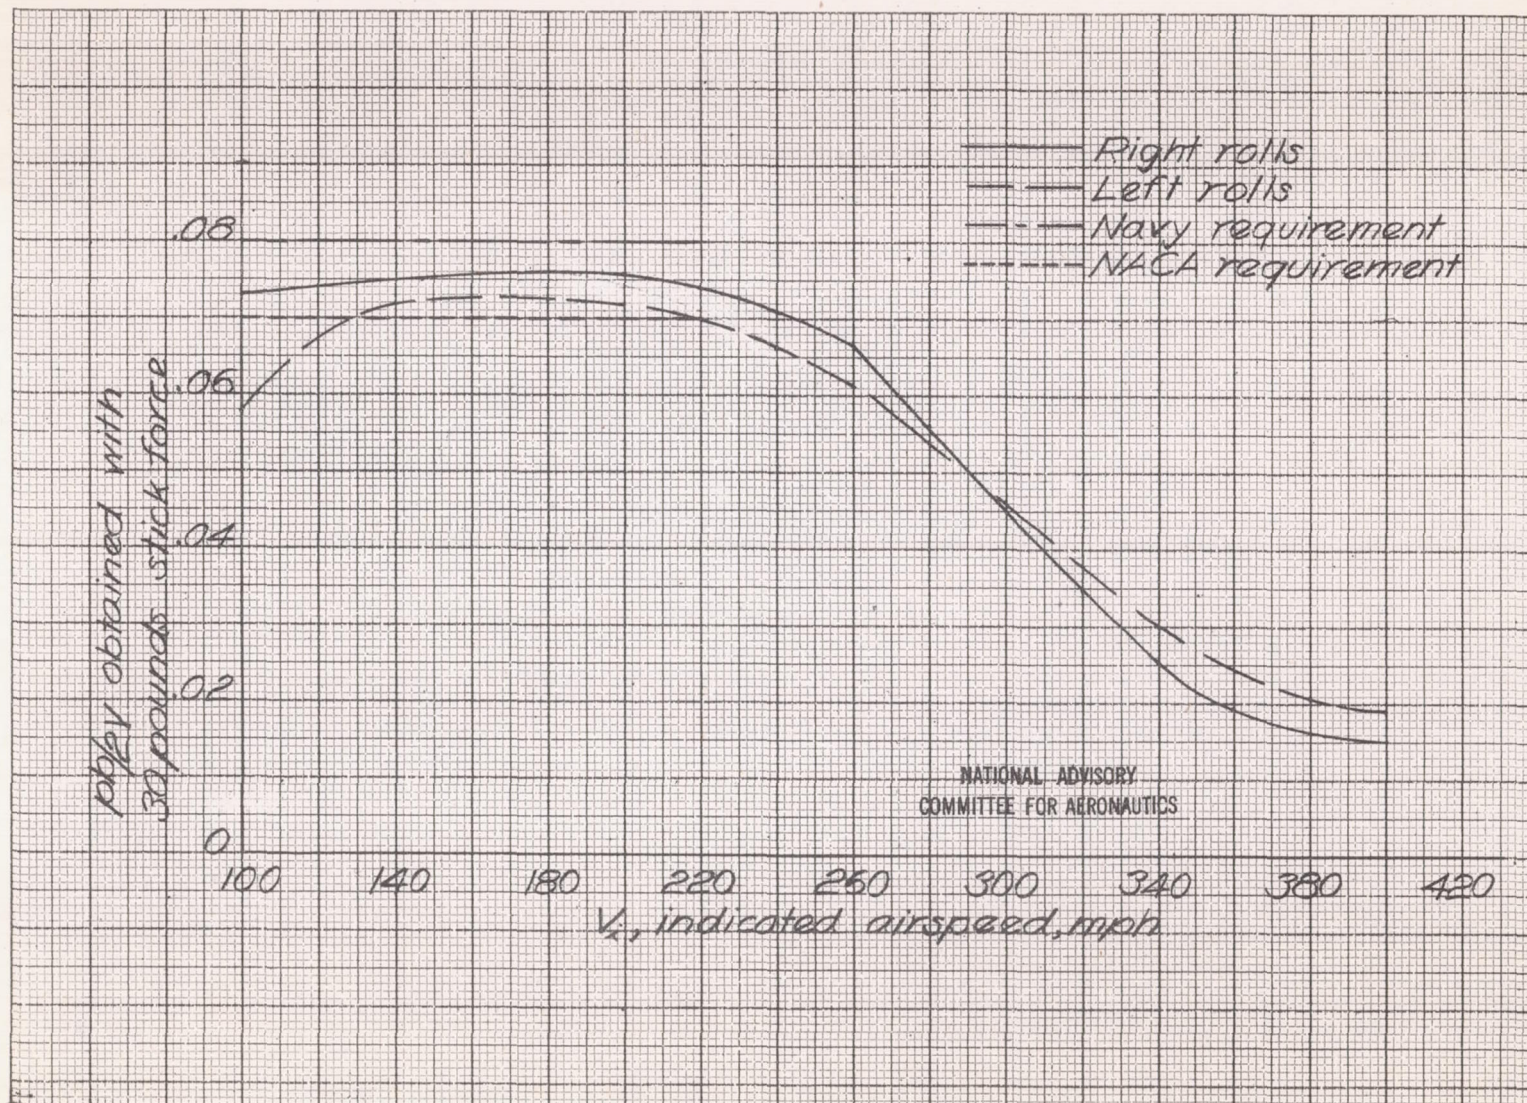
Figure 11. - Variation with indicated airspeed of the $pb/2V$ obtained with a 30-pound stick-force limit F6F-3 airplane.

rolling velocity obtainable with any stick force through the speed range of the tests. Figure 11 gives the values of $pb/2V$ obtainable with a 30-pound stick force as a function of speed. The Navy and NACA requirements of values of $pb/2V$ of 0.08 and 0.07, respectively, up to 80 percent of the maximum level-flight indicated airspeed (reference 2 and 3) are also shown on this figure. Figure 12 shows the rolling velocity obtained at 10,000 feet altitude with a 30-pound stick force through the speed range. The Navy requirement of a rolling velocity of 30° per second at 400 miles per hour indicated airspeed is shown on this figure.

80 percent of the maximum level-flight speed except in rolls to the left below 130 miles per hour. (See fig. 11.)

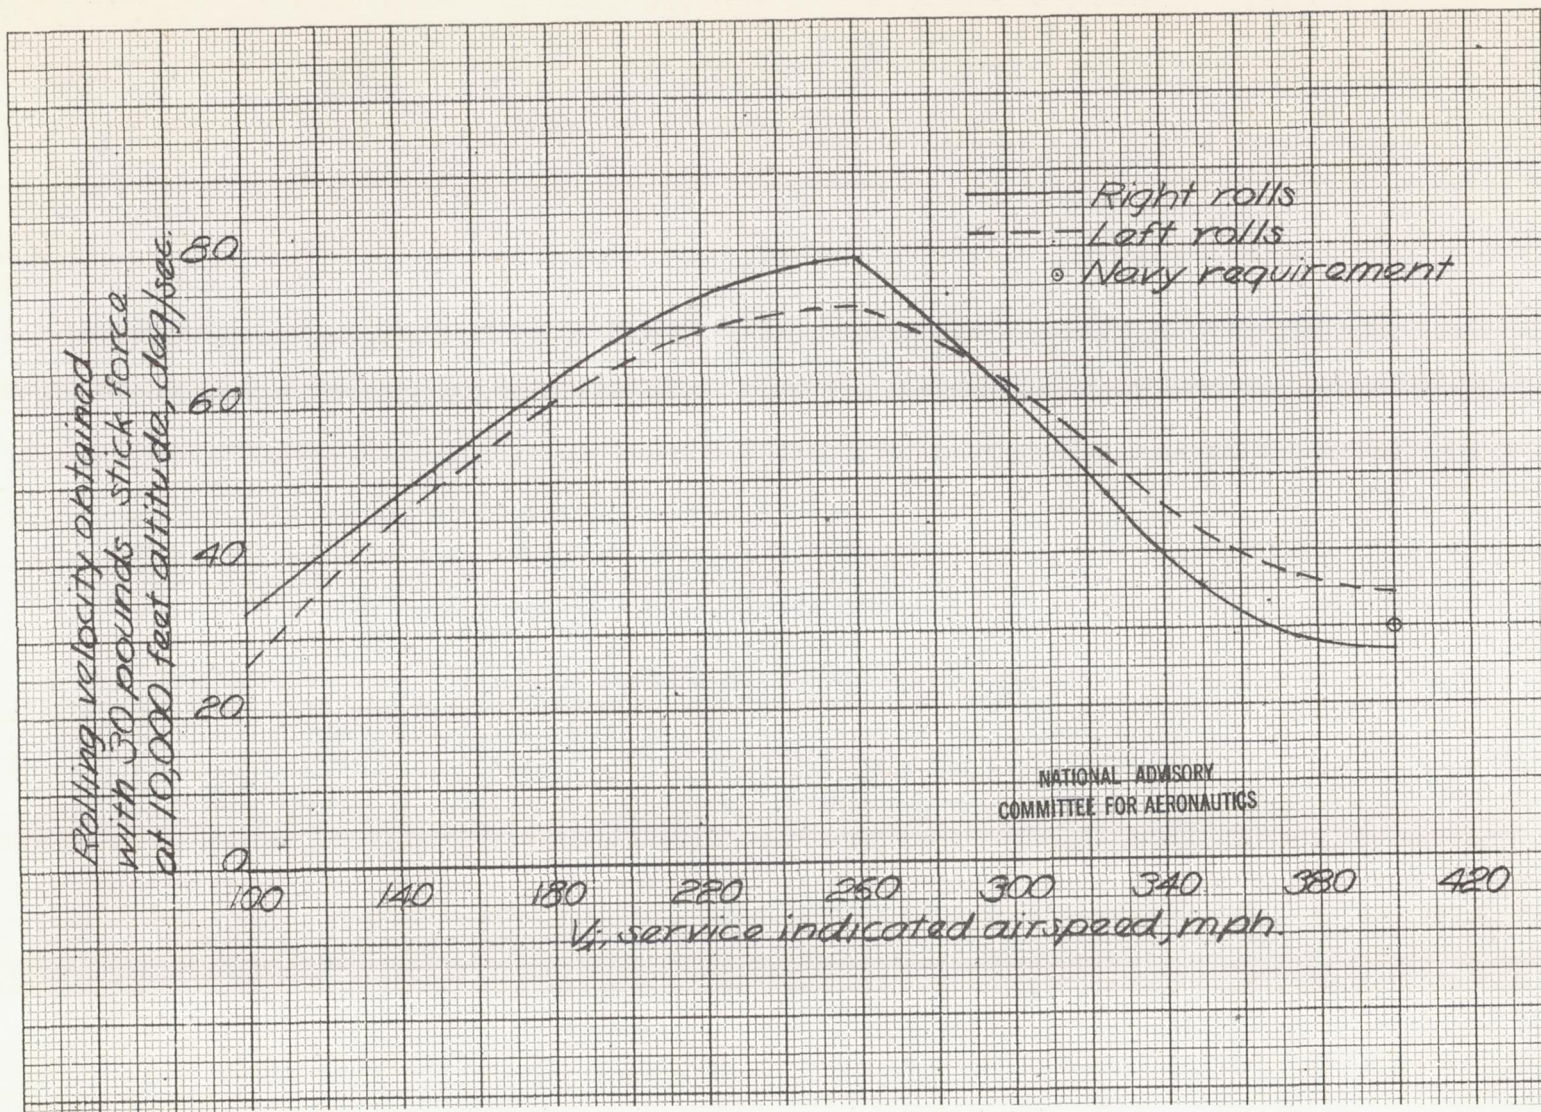
Figure 12. - Variation with indicated airspeed of the rolling velocity obtained at 10,000 feet altitude with a 30-pound stick-force limit, F6F-3 airplane.

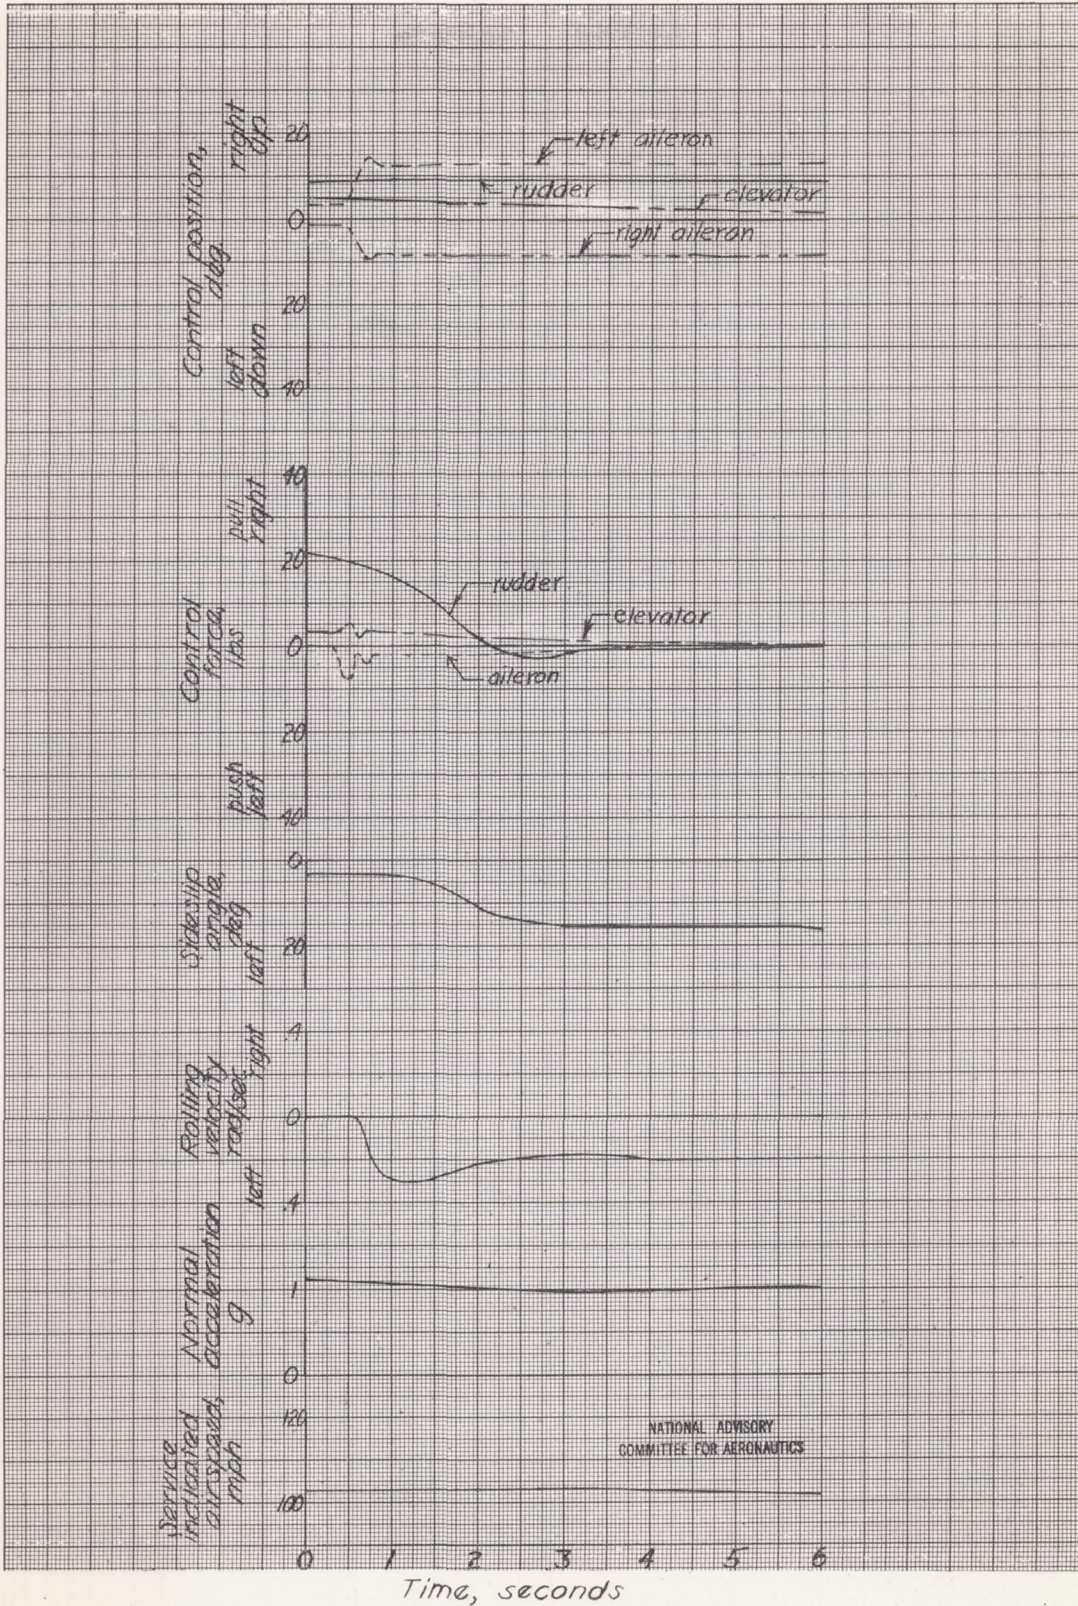
Figure 13.- Time history of rolling out of a right turn using partial aileron deflection with rudder held fixed. Clean condition, power for level flight, F6F-3 airplane.

The sideslip due to ailerons was measured in the abrupt aileron rolls from laterally level flight described above and in abrupt rolls out of turns with the rudder held fixed. The latter maneuver has been adopted as standard practice at Langley for measuring sideslip due to ailerons because it has been found difficult to obtain maximum sideslip angle in a roll from laterally level flight, since the airplane usually reaches an extreme angle of bank before maximum sideslip angle is reached. In the present instance, it was possible to reach maximum sideslip angle in right rolls from laterally level flight. Figures 8 and 9 illustrate rolls from laterally level flight. Rolls out of turns are shown in figures 13, 14, and 15. Figure 16 shows the change in maximum sideslip angle as a function of change in total aileron angle in abrupt rolls made from laterally level flight at 98 miles per hour. Inspection of these figures shows that the use of full aileron deflection at approximately 100 miles per hour will result in approximately 18.5° of sideslip.
