MR No. L5B13a

FLIGHT MEASUREMENTS OF THE FLYING QUALITIES
OF AN F6F-3 AIRPLANE (BUAER NO. 04776)
II - LATERAL AND DIRECTIONAL STABILITY AND CONTROL
By Walter C. Williams and John P. Reeder

Bureau of Aeronautics, Navy Department

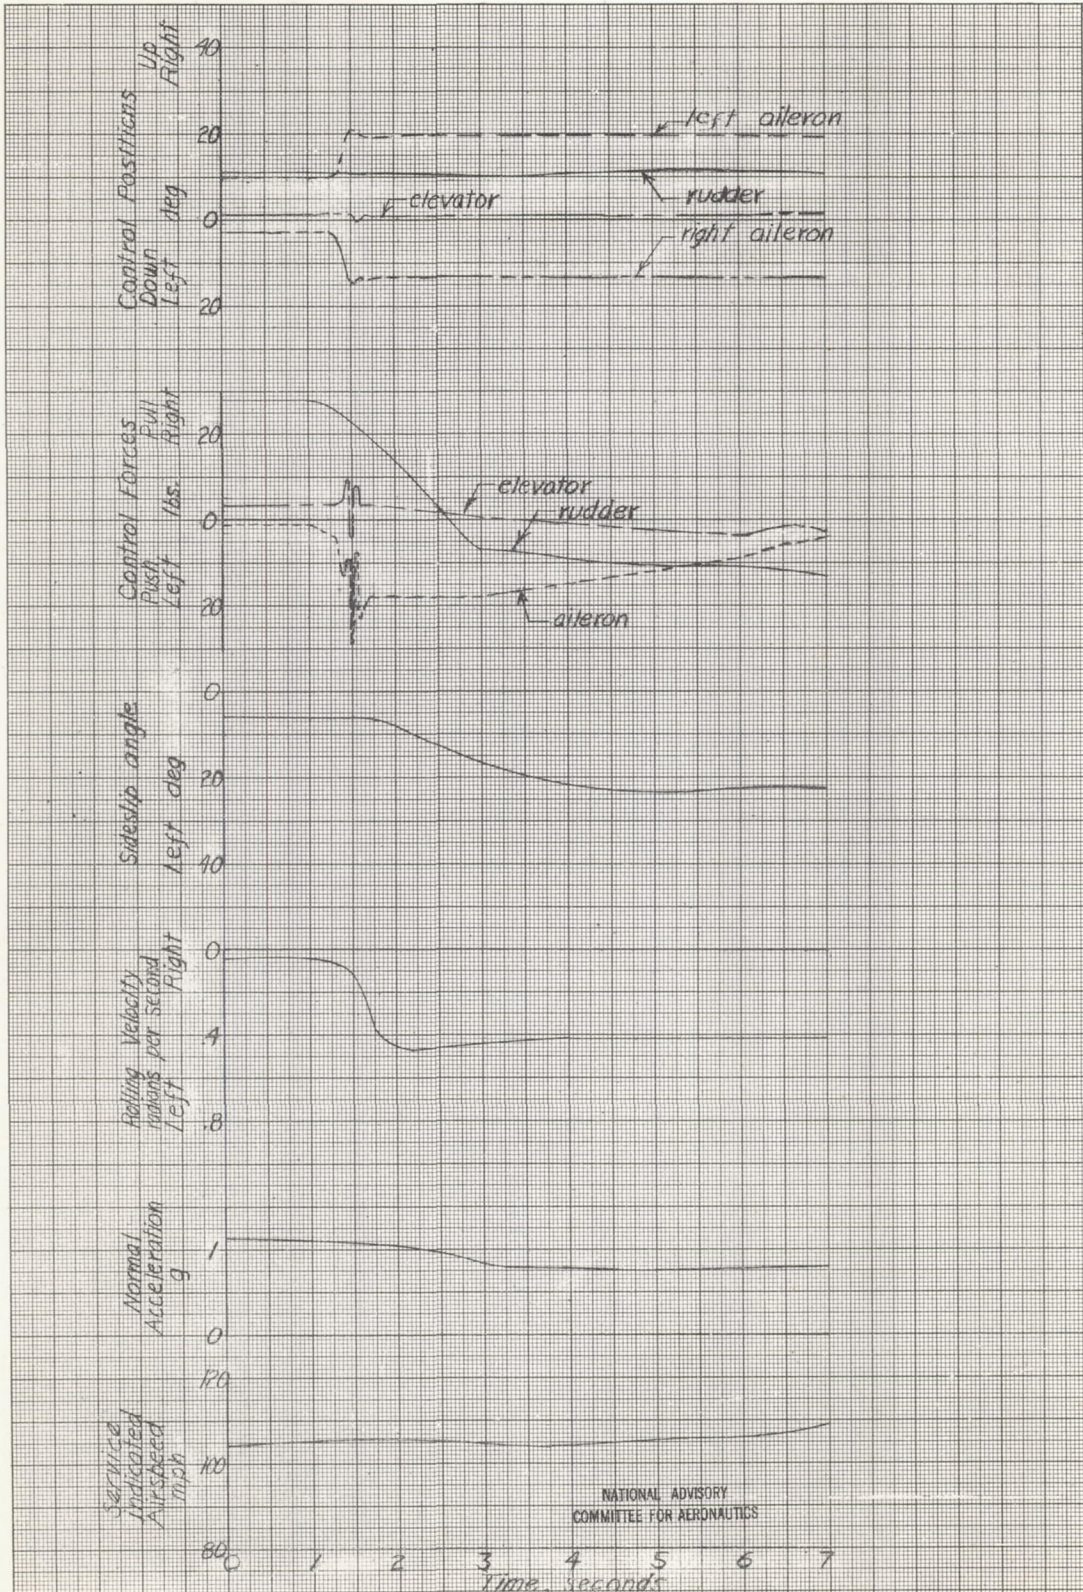
Figure 14. - Time history of rolling out of a right turn using full aileron deflection with rudder held fixed. Clean condition, power for level flight, FoF-3 airplane.

The sideslip due to ailerons was measured in the abrupt aileron rolls from laterally level flight described above and in abrupt rolls out of turns with the rudder held fixed. The latter maneuver has been adopted as standard practice at Langley for measuring sideslip due to ailerons because it has been found difficult to obtain maximum sideslip angle in a roll from laterally level flight, since the airplane usually reaches an extreme angle of bank before maximum sideslip angle is reached. In the present instance, it was possible to reach maximum sideslip angle in right rolls from laterally level flight. Figures 8 and 9 illustrate rolls from laterally level flight. Rolls out of turns are shown in figures 13, 14, and 15. Figure 16 shows the change in maximum sideslip angle as a function of change in total aileron angle in abrupt rolls made from laterally level flight at 98 miles per hour. Inspection of these figures shows that the use of full aileron deflection at approximately 100 miles per hour will result in approximately 18.5° of sideslip.

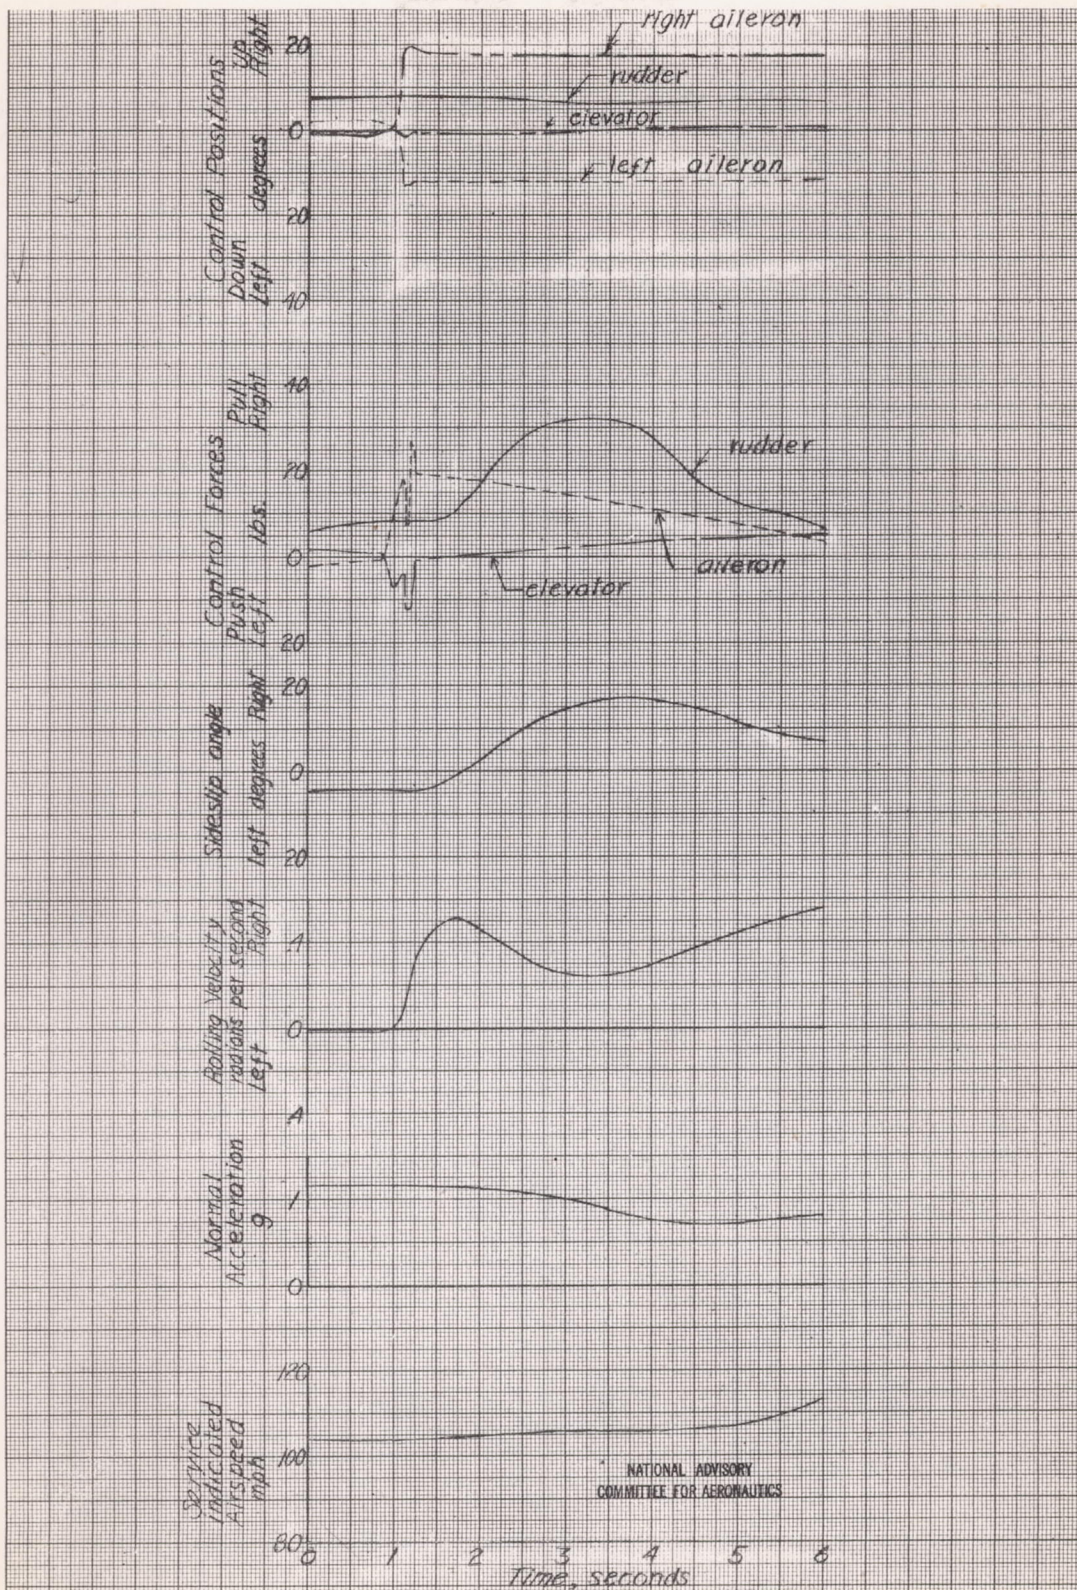
Figure 15. - Time history of rolling out of a left turn using full aileron deflection with rudder held fixed. Clean condition, power for level flight, F6F-3 airplane.

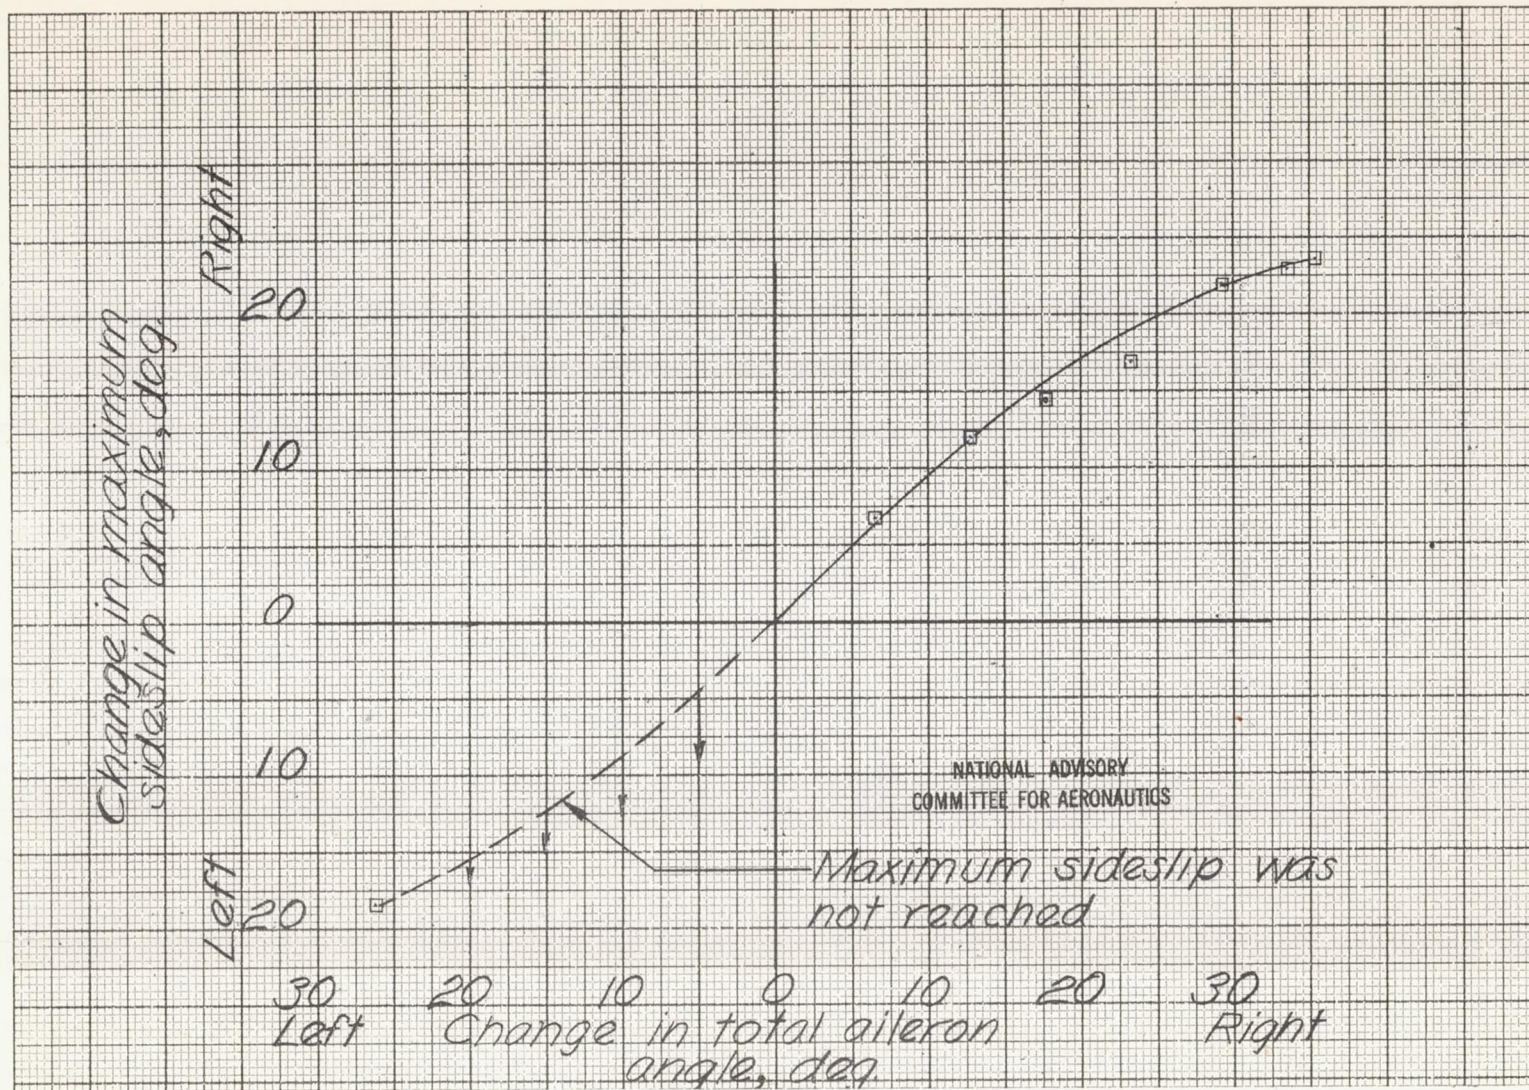
Figure 16. - Change in maximum sideslip angle with change in total aileron angle in abrupt aileron rolls made from laterally level flight at 98 miles per hour. Clean condition, power for level flight, F6F-3 airplane.

in left rolls and 23.5° in right rolls which exceeds the specified maximum of 20° . The sideslip in right rolls is larger because of the greater available change in total aileron angle to the right at low speeds. In figure 16, maximum sideslip in left rolls with partial aileron deflection was not reached and is probably higher than the curve shown because of the decrease in directional stability at small angles of left sideslip which is discussed in section II-F. This decrease in directional stability at small sideslip angles was objectionable to the pilots because of the relatively large sideslip caused by use of partial aileron deflections.

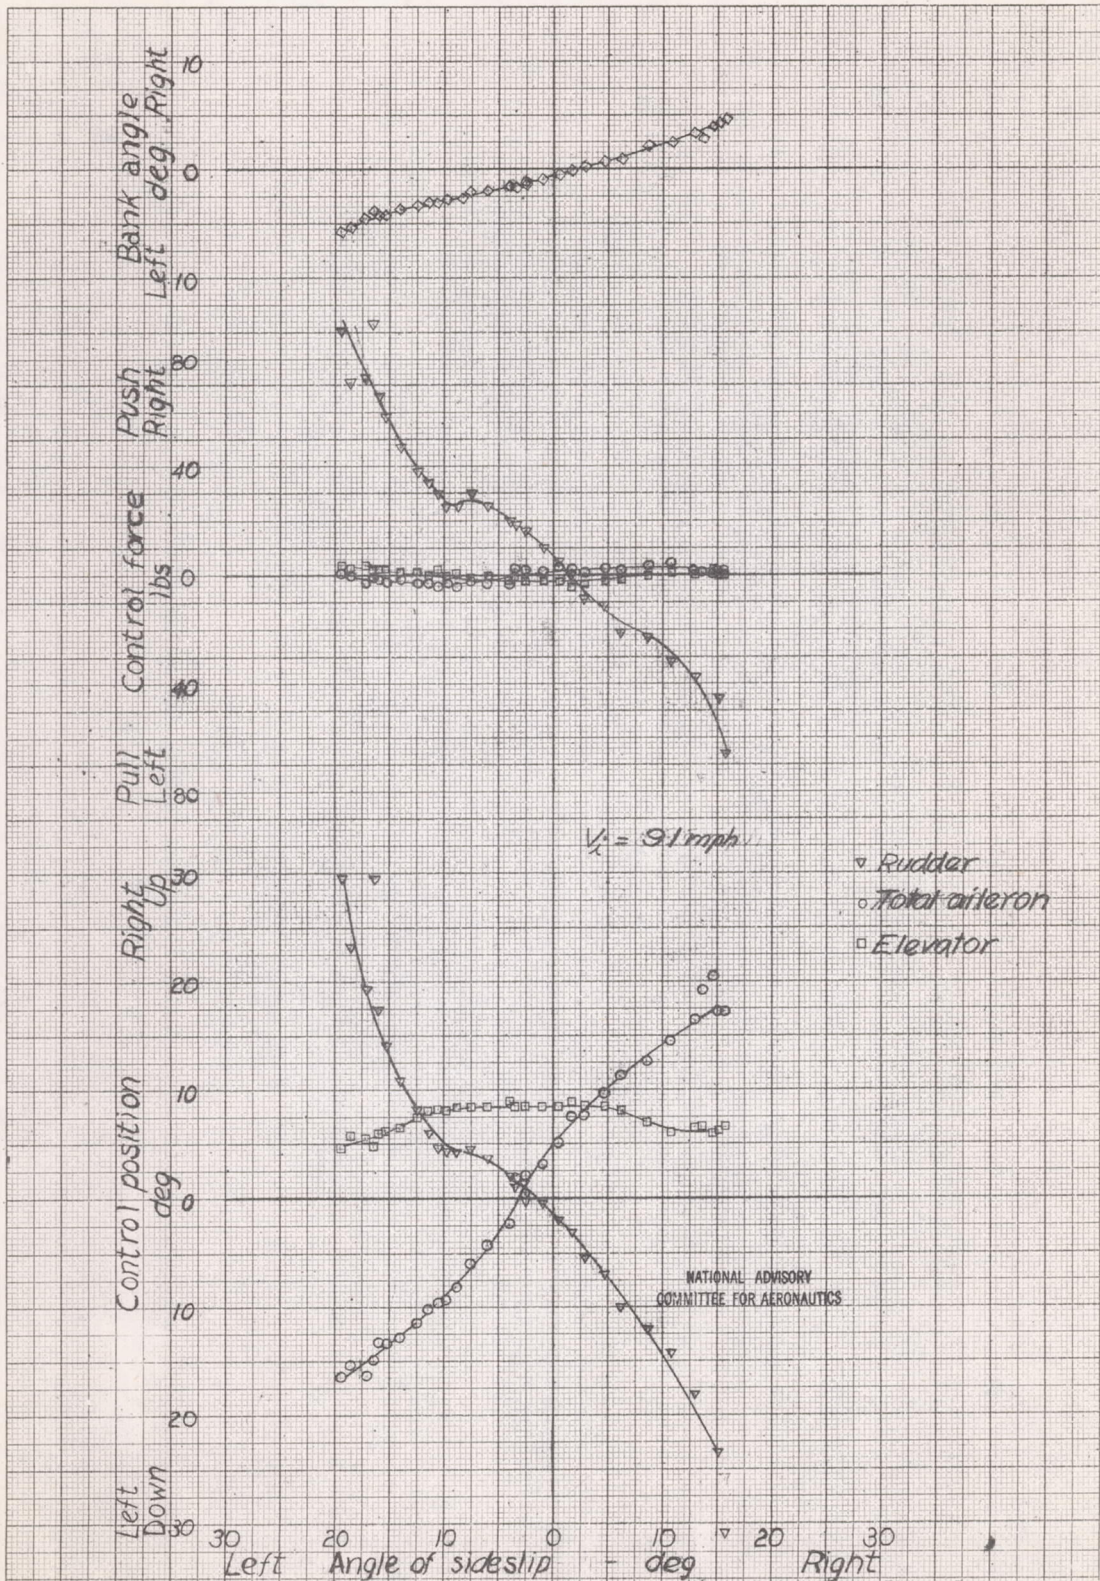
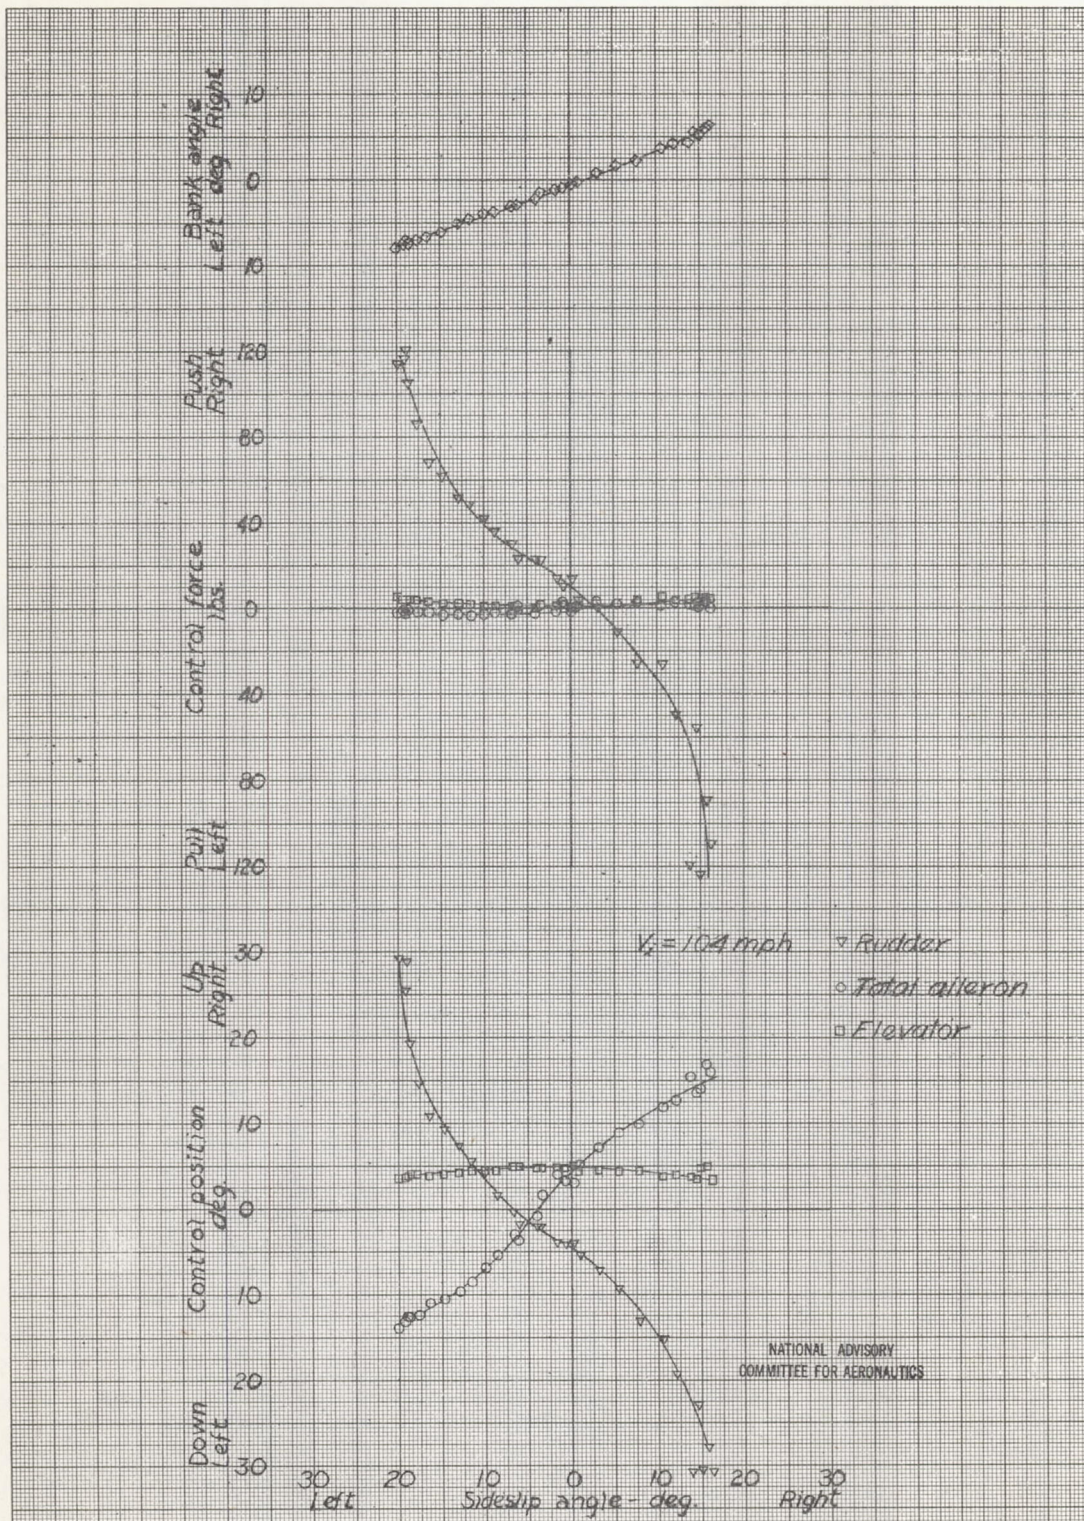
Figure 17. - Steady sideslip characteristics in the landing condition at 91 miles per hour, F6F-3 airplane.

Figure 18. - Steady sideslip characteristics in the landing condition at 104 miles per hour, F6F-3 airplane.

4. As shown by figures 16 to 29 right-rudder force was required to hold right-rudder deflections and left-rudder force was required to hold left-rudder deflections.

The variation of cross-wind force with sideslip angle was in the correct direction; that is, right bank accompanied right sideslip and left bank accompanied left sideslip as shown by figures 17 to 30.

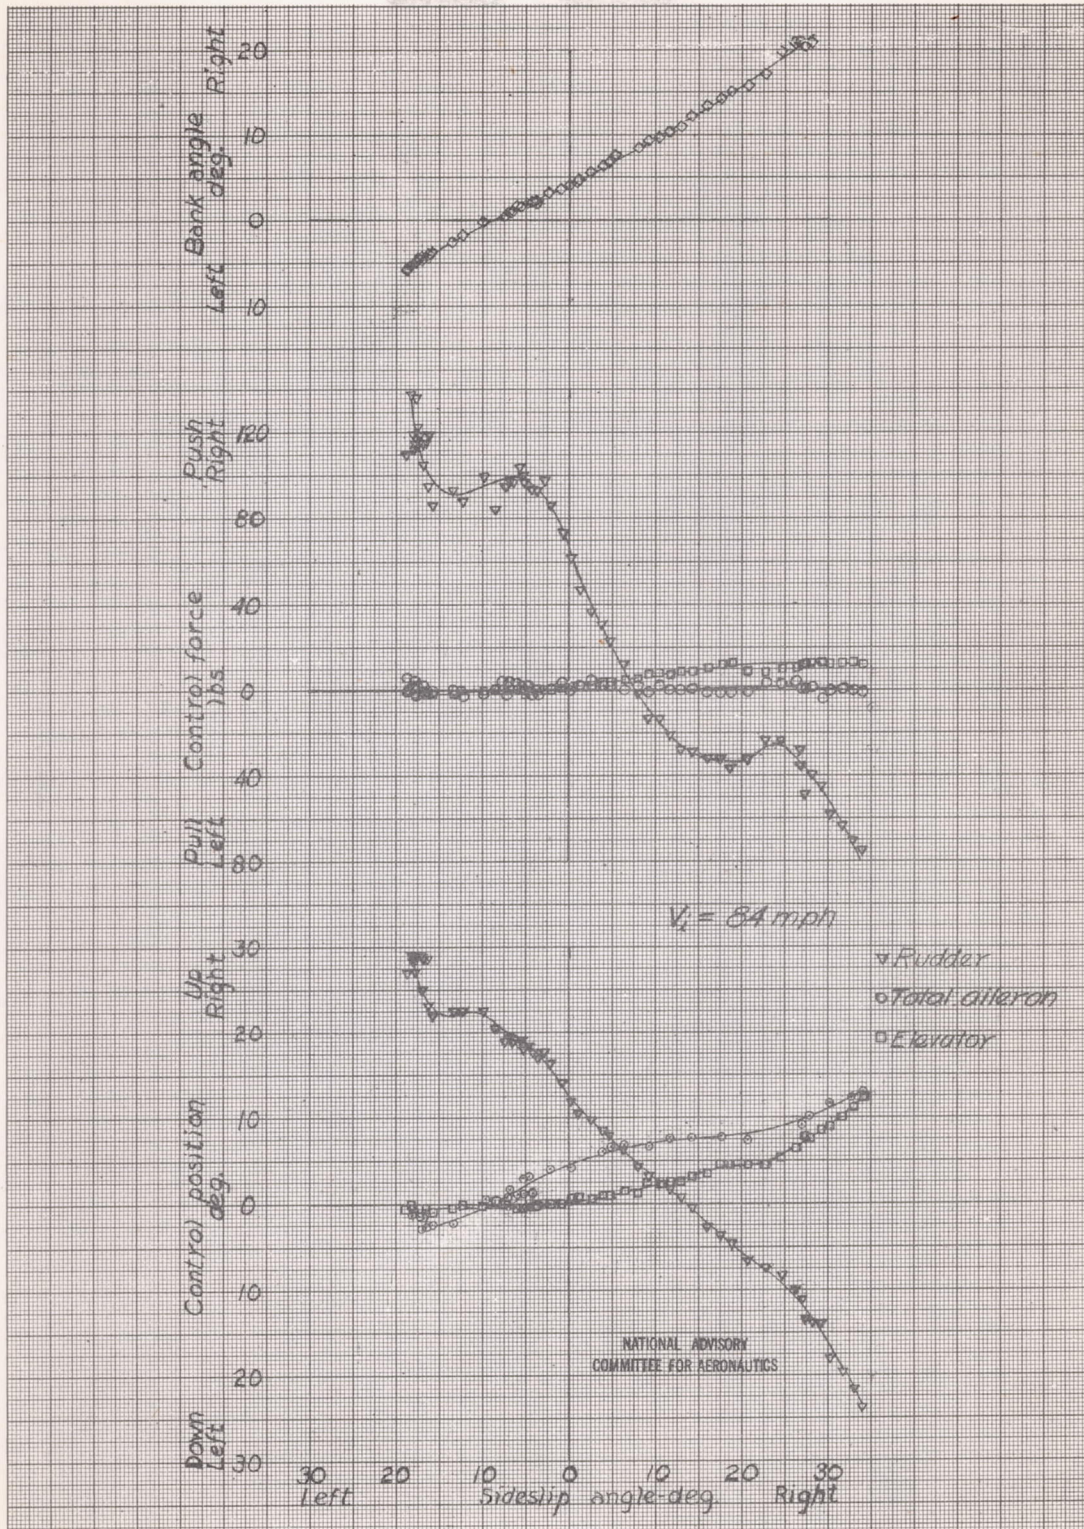
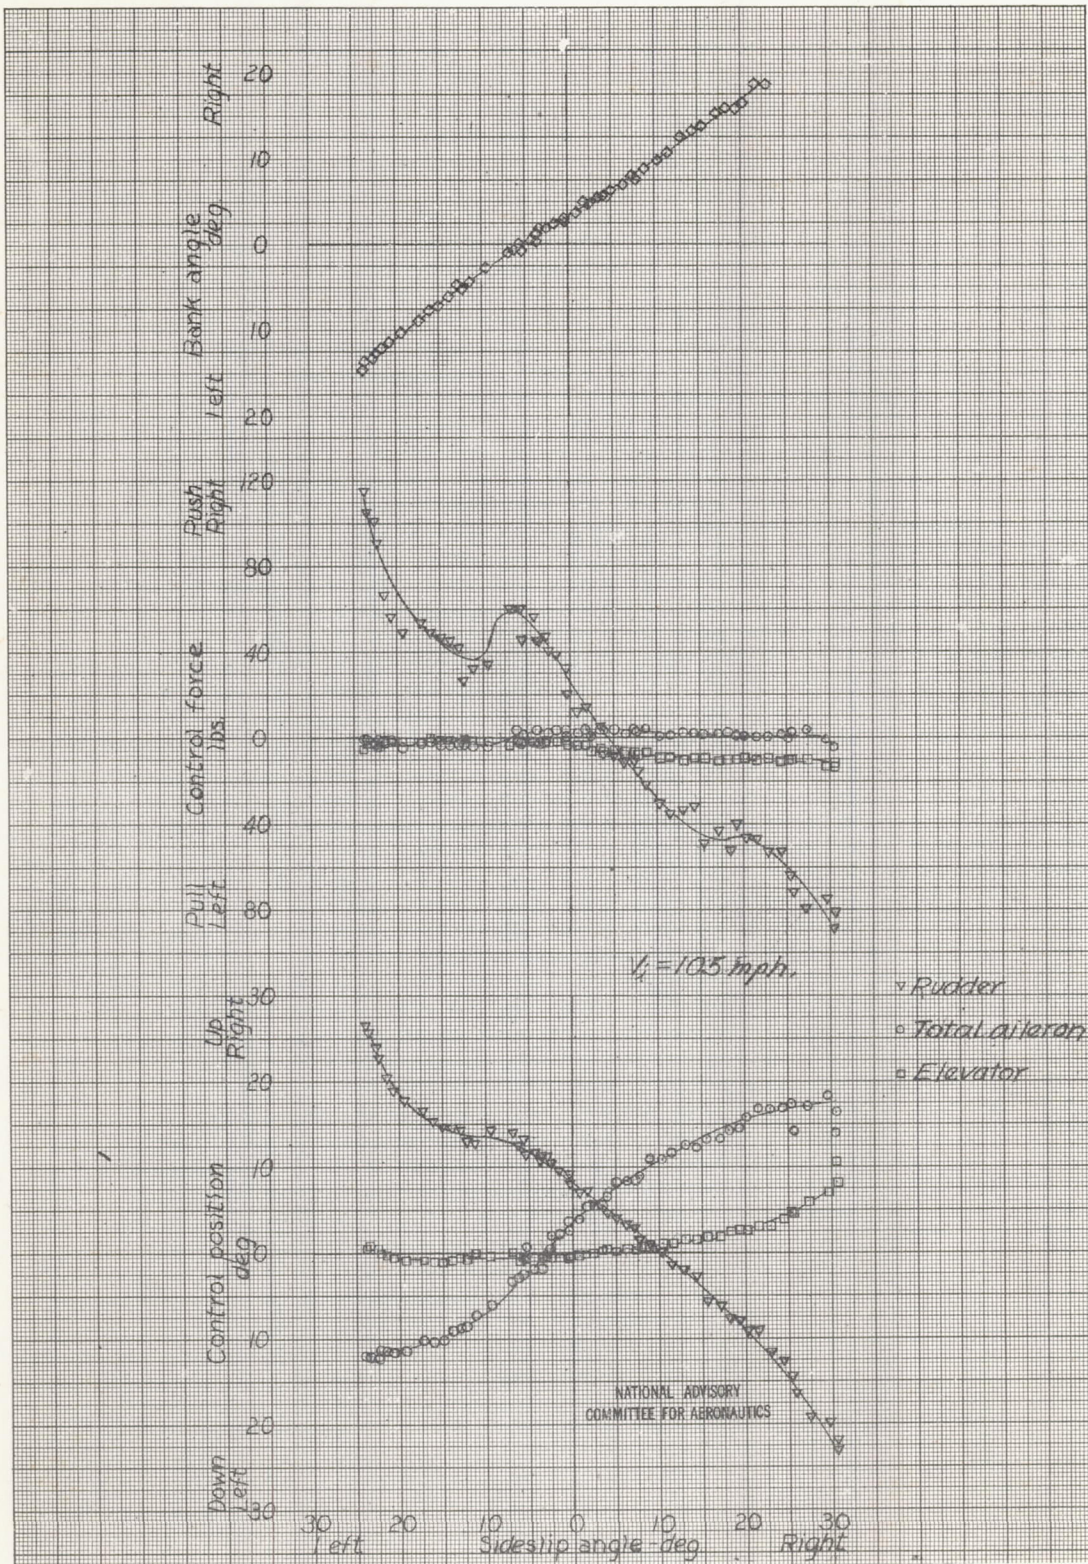
Figure 19. - Steady sideslip characteristics in the wave-off condition at 84 miles per hour, F6F-3 airplane.

Figure 20. - Steady sideslip characteristics in the wave-off condition at 105 miles per hour, F6F-3 airplane.

3. The yawing moment due to sideslip (rudder free) was found to be such that the airplane would always tend to return to zero sideslip, regardless of the angle of sideslip to which it was forced in all conditions of flight tested. In the wave-off condition, however, there was reversal in the slope of the rudder force curves as can be seen by inspection of figures 19 and 20.

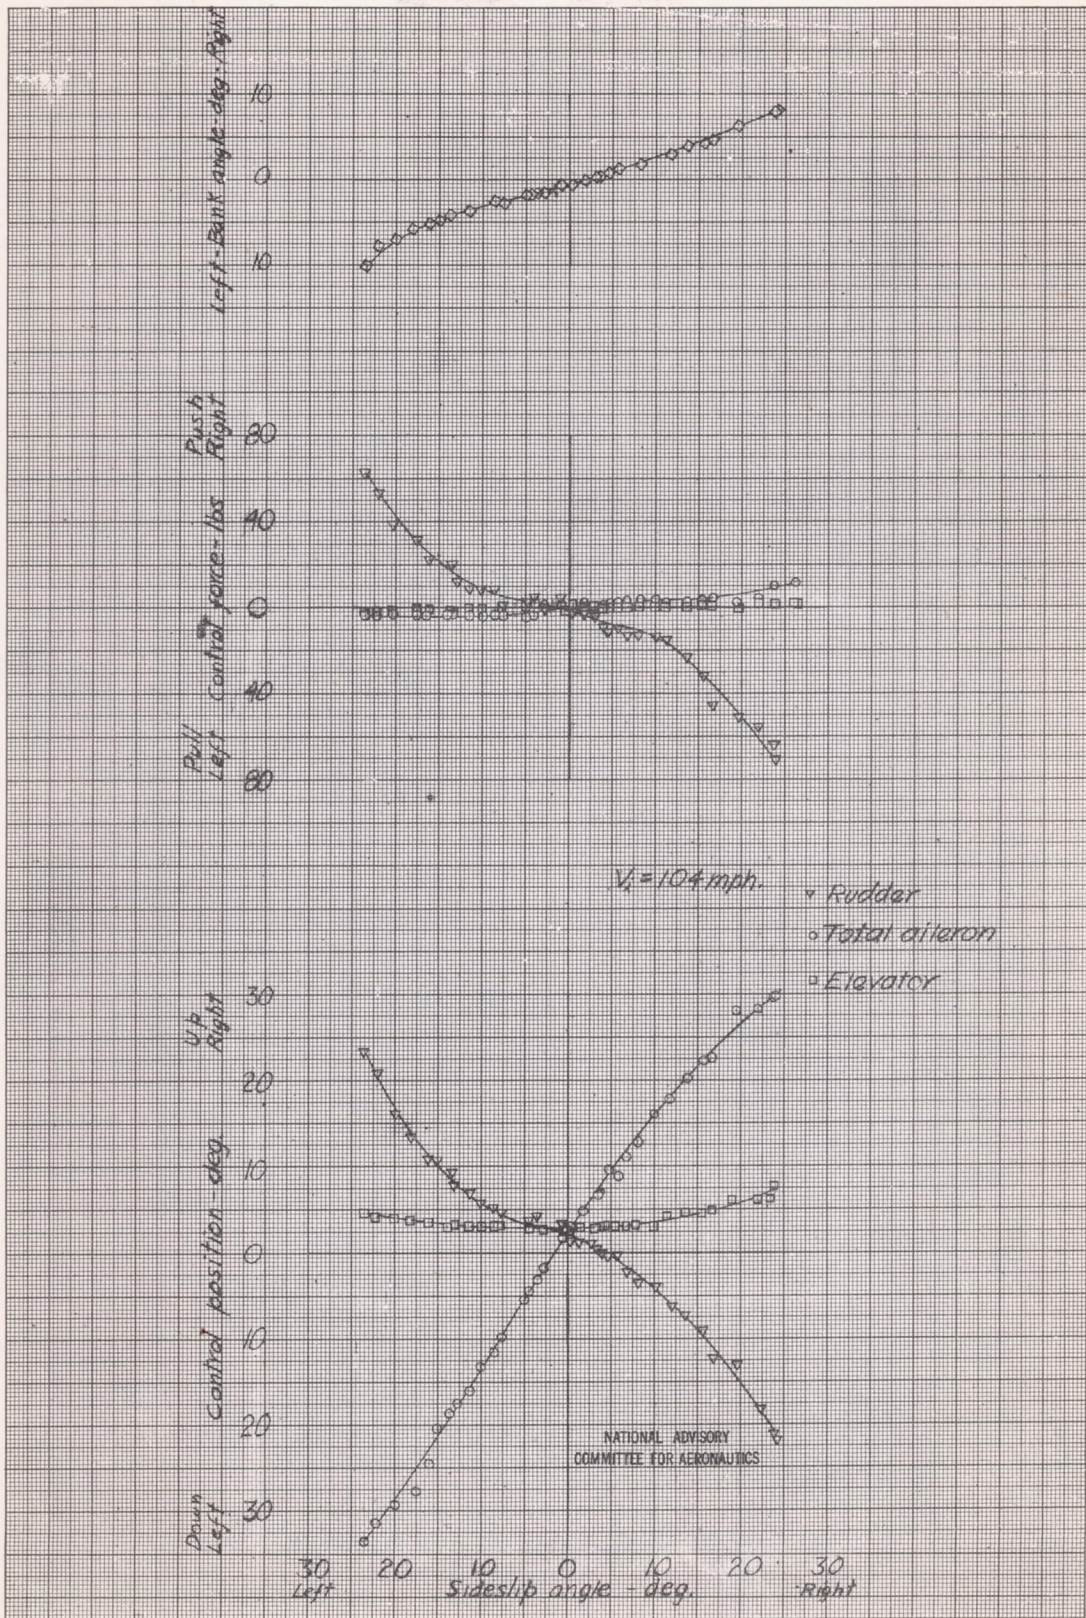
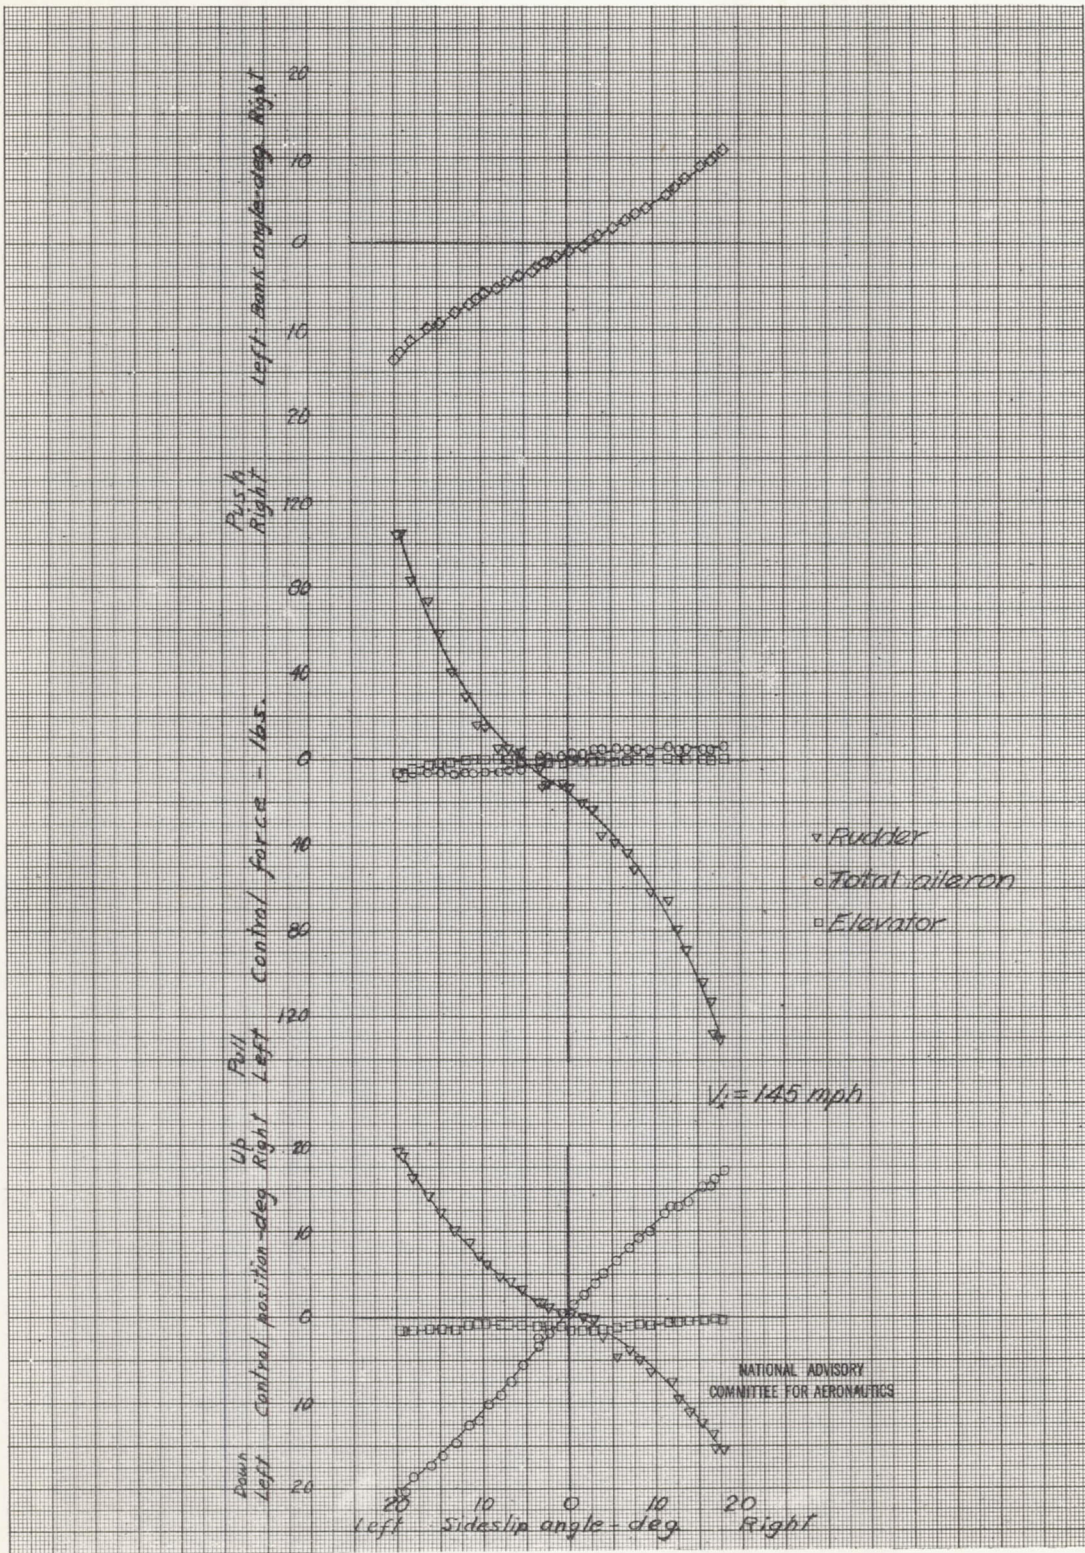
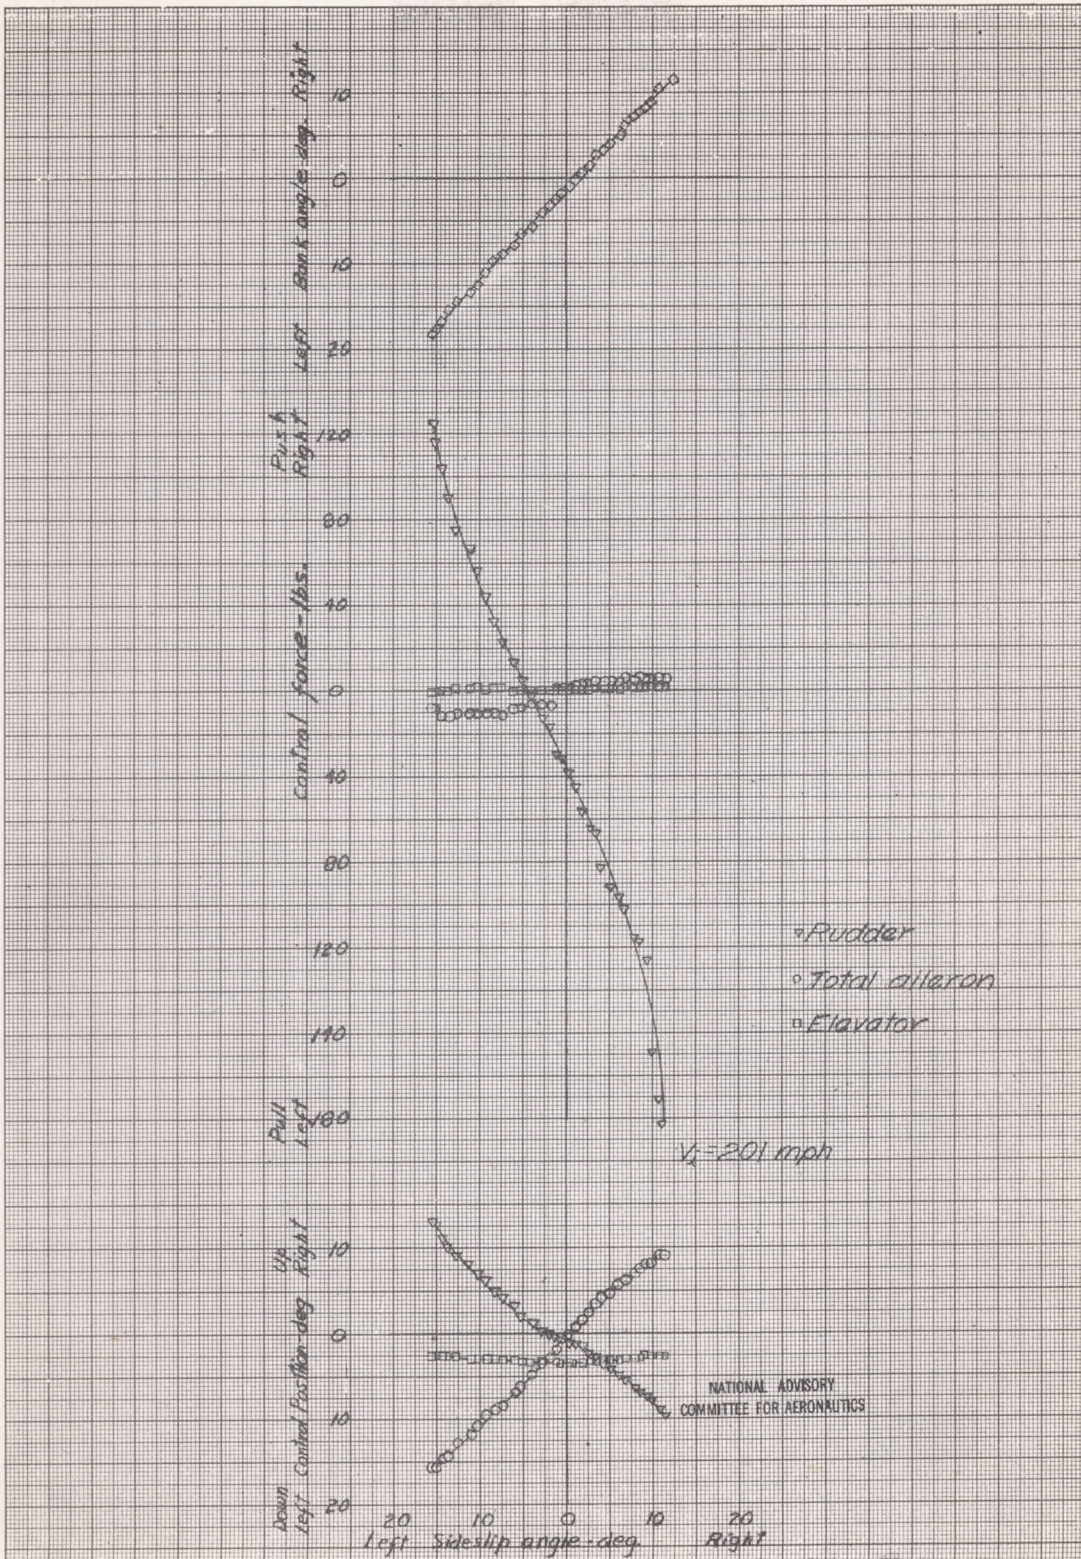
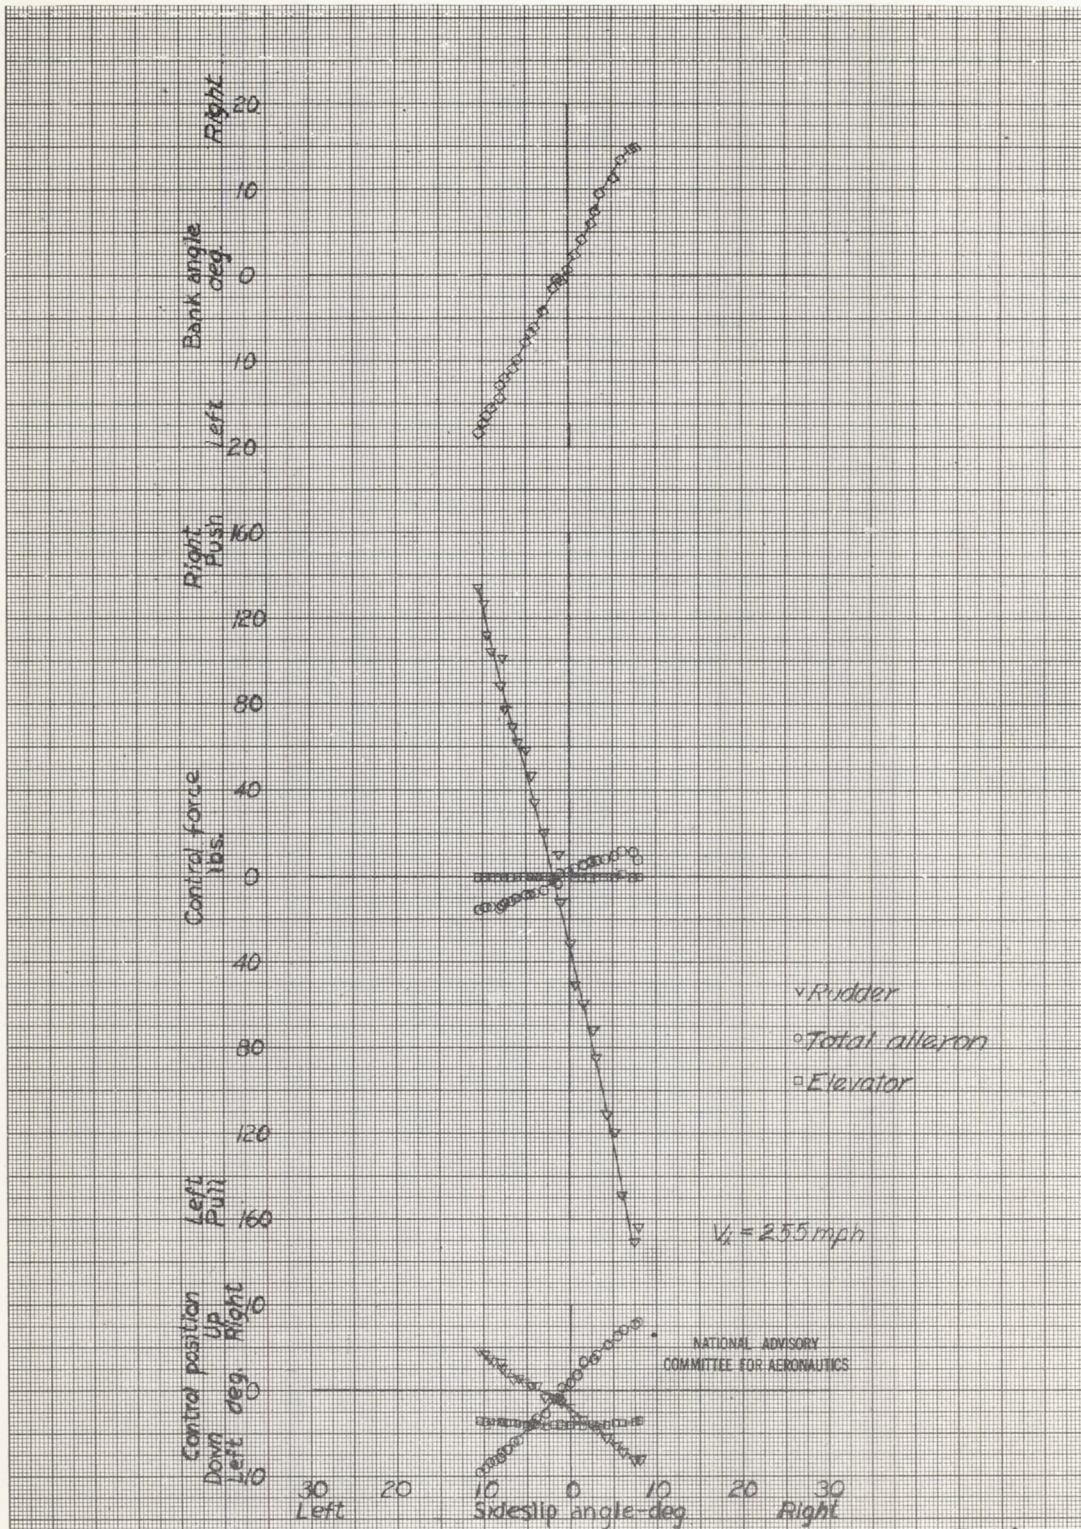
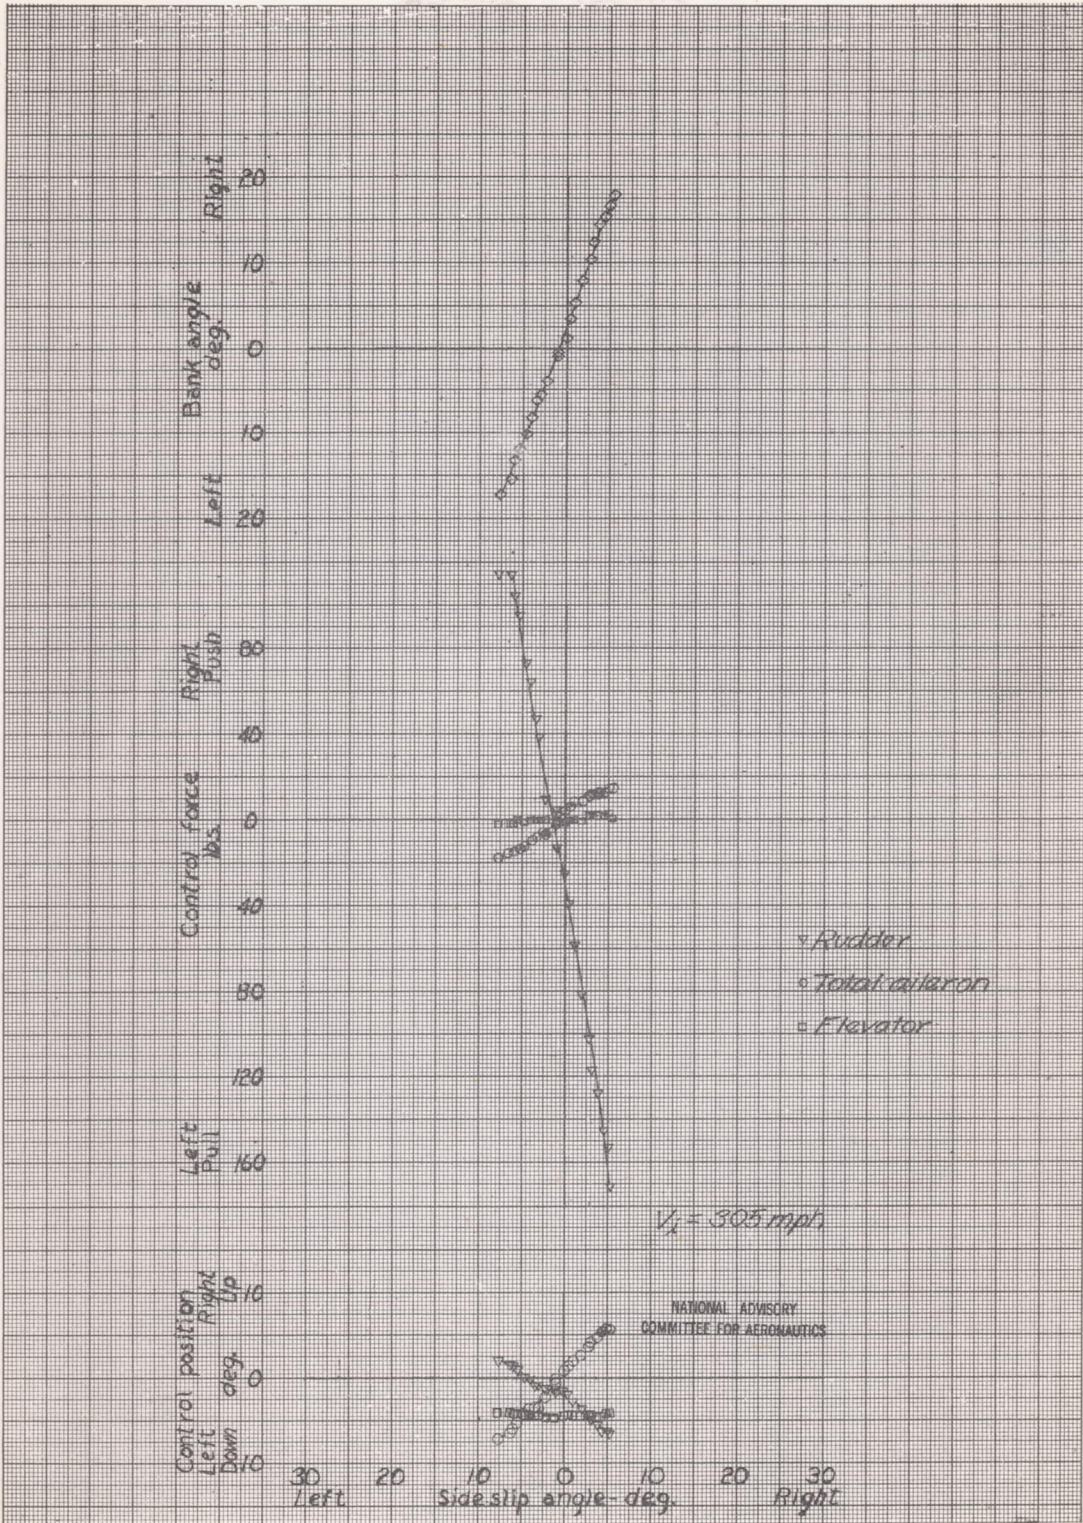
Figure 21. - Steady sideslip characteristics in the gliding condition at 104 miles per hour, F6F-3 airplane.

Figure 22. - Steady sideslip characteristics in the gliding condition at 145 miles per hour, F6F-3 airplane.

Figure 23. - Steady sideslip characteristics in the gliding condition at 201 miles per hour, F6F-3 airplane.

Figure 24. - Steady sideslip characteristics in the gliding condition at 255 miles per hour, F6F-3 airplane.

Figure 25. - Steady sideslip characteristics in the gliding condition at 305 miles per hour, F6F-3 airplane.
