MR No. L5B13a

FLIGHT MEASUREMENTS OF THE FLYING QUALITIES
OF AN F6F-3 AIRPLANE (BUAER NO. 04776)
II - LATERAL AND DIRECTIONAL STABILITY AND CONTROL
By Walter C. Williams and John P. Reeder

Bureau of Aeronautics, Navy Department

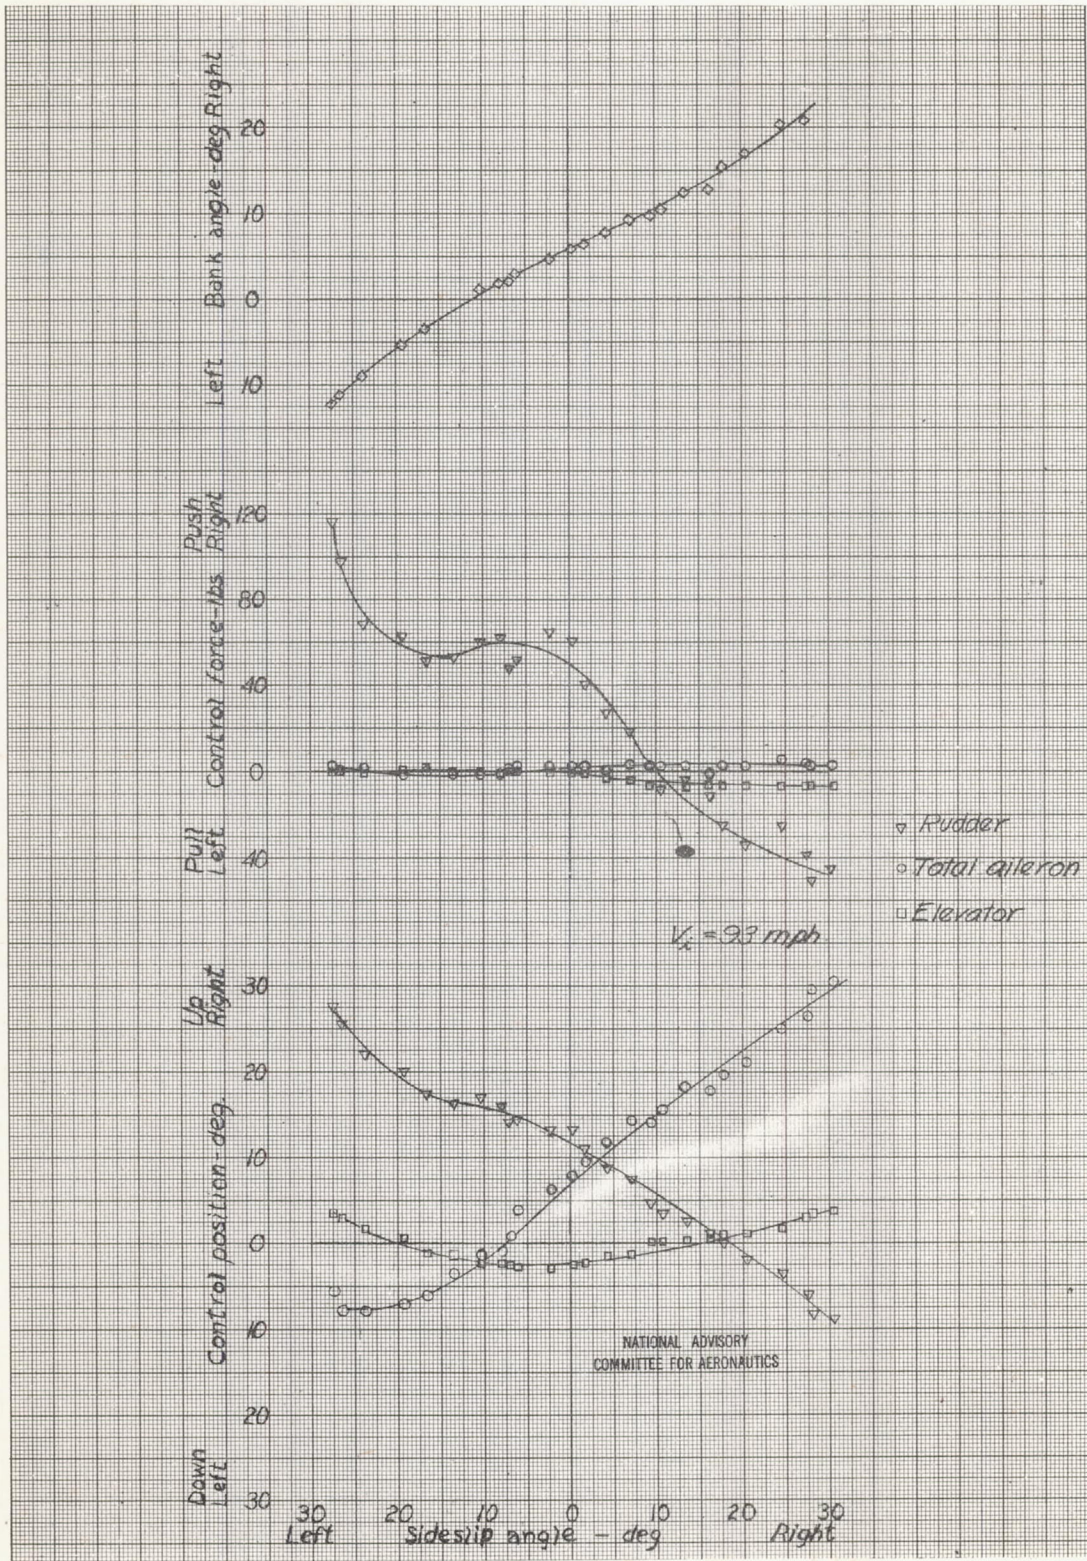
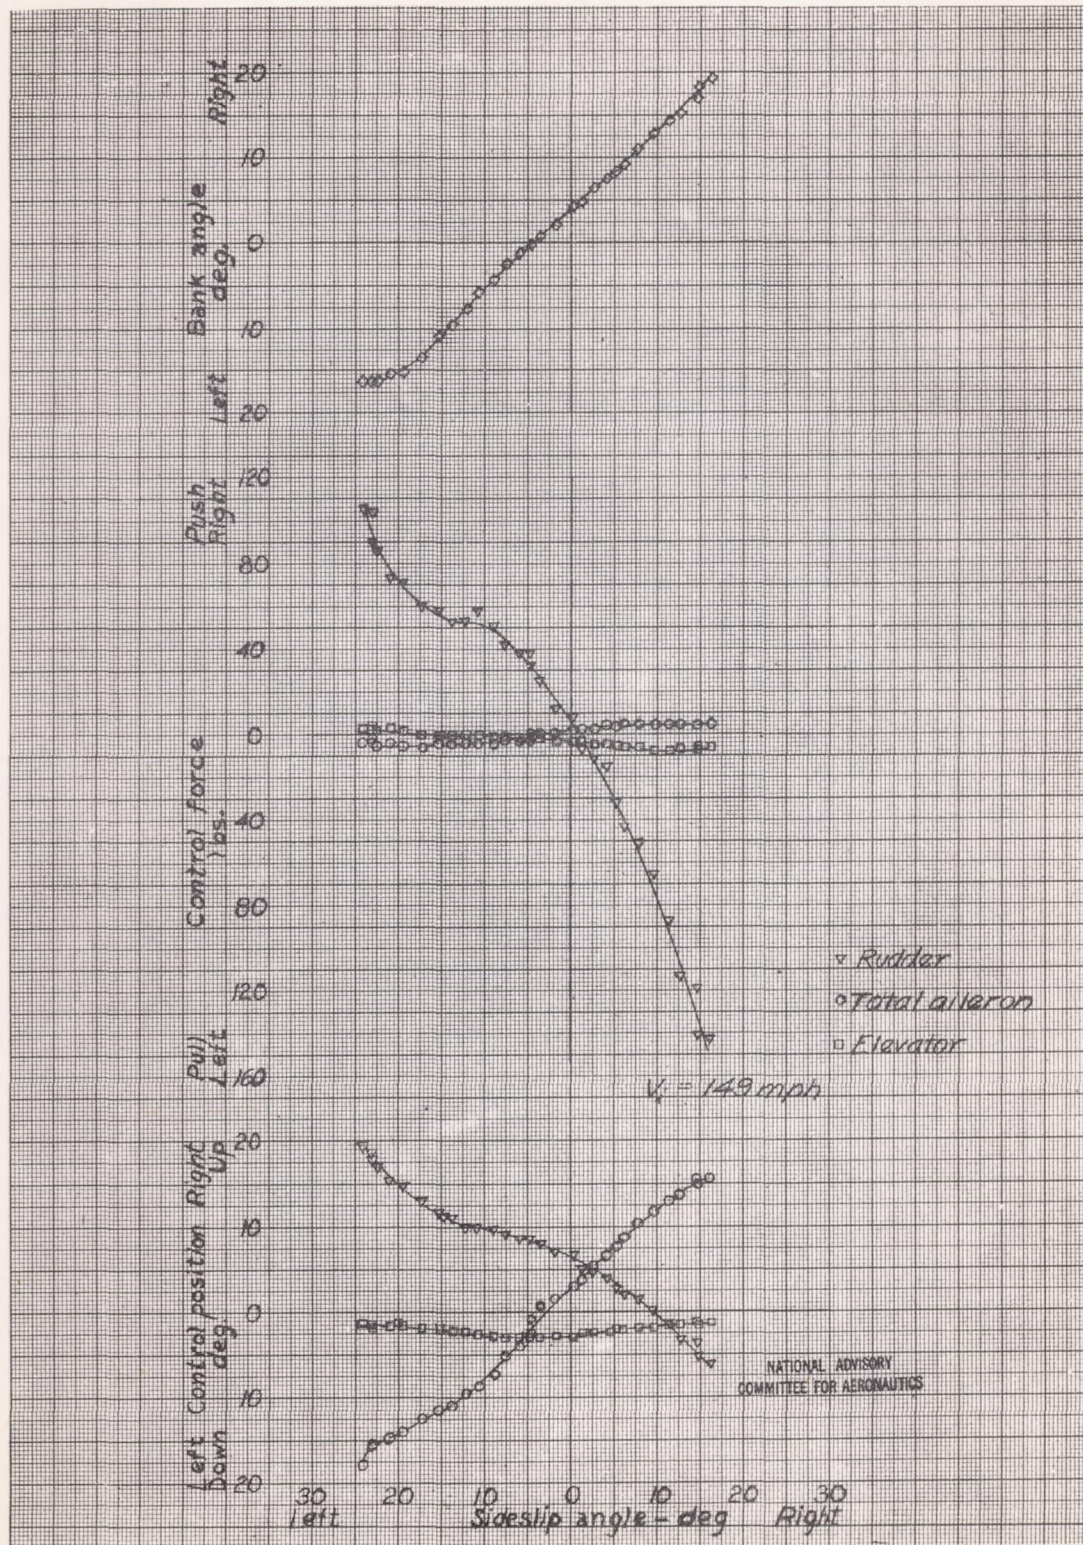
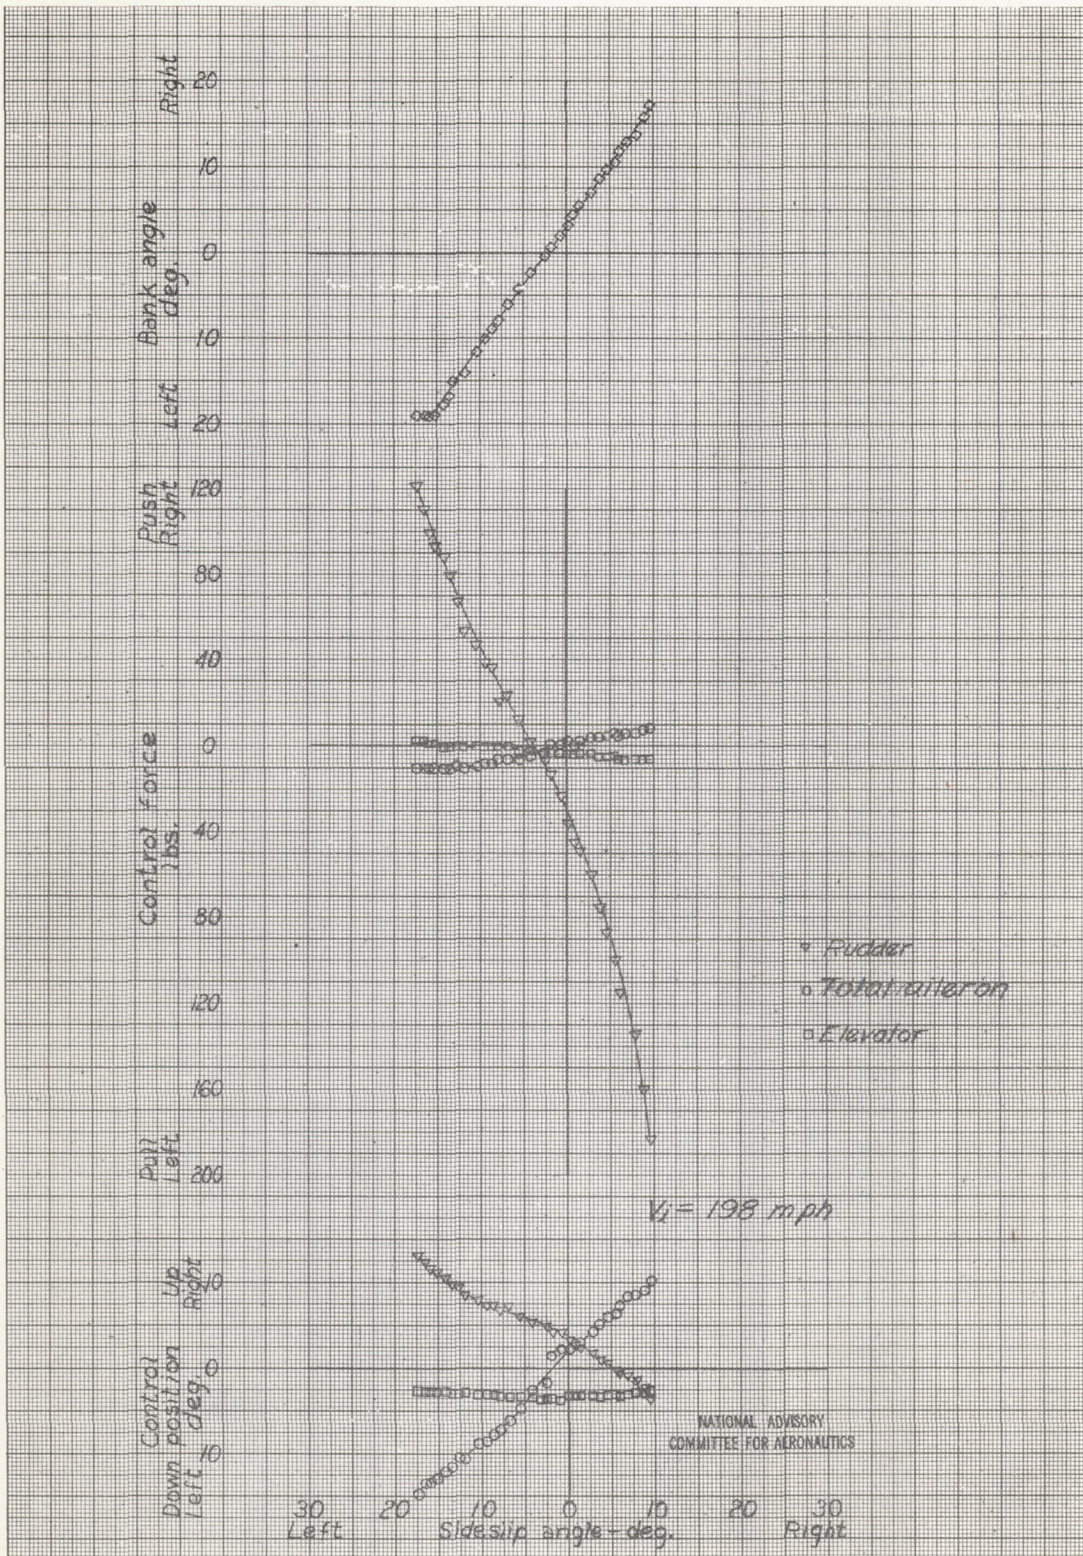
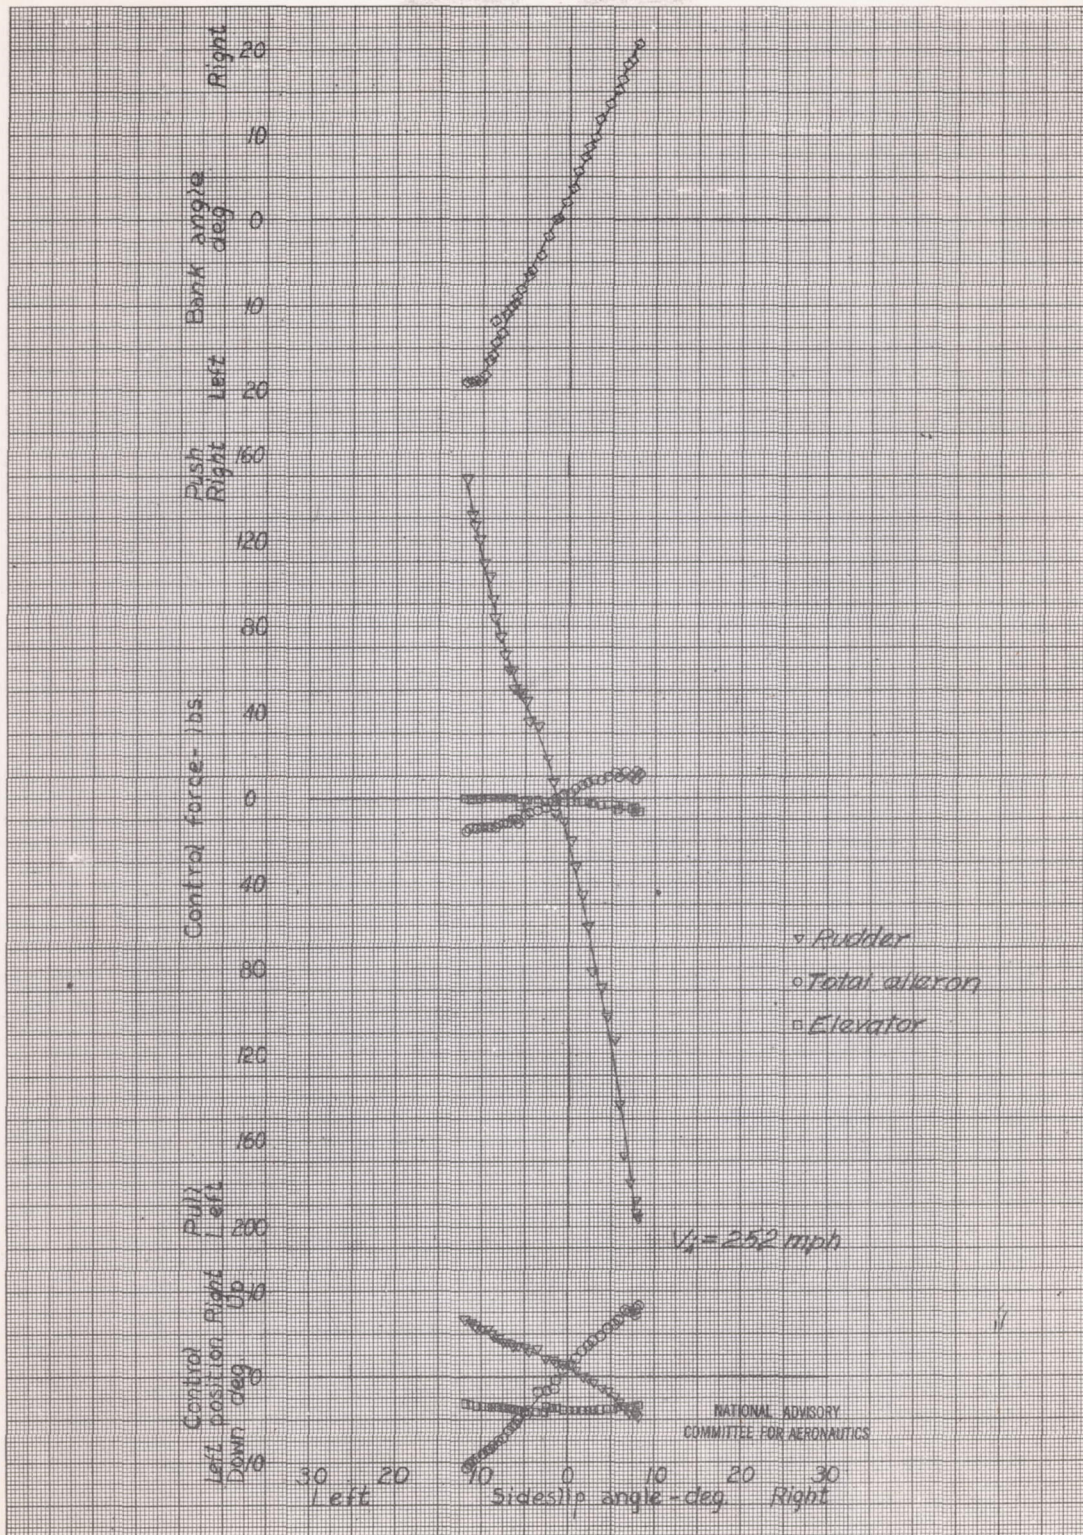
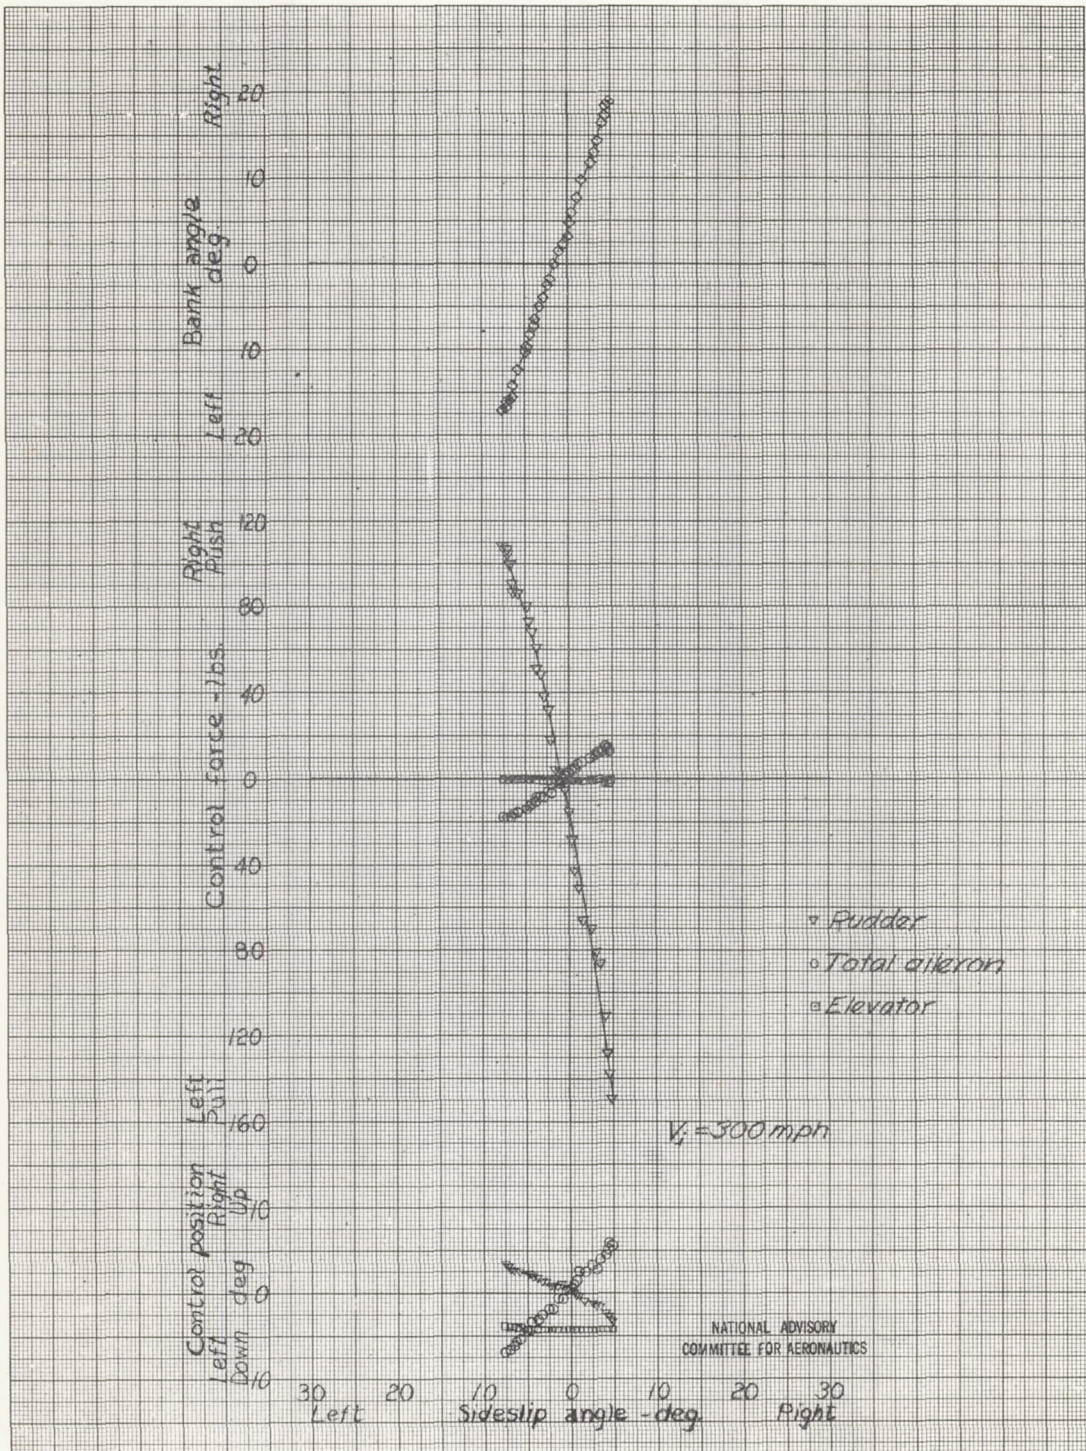
Figure 26. - Steady sideslip characteristics in the climbing condition at 93 miles per hour, F6F-3 airplane.

Figure 27. - Steady sideslip characteristics in the climbing condition at 149 miles per hour, F6F-3 airplane.

Figure 28. - Steady sideslip characteristics in the climbing condition at 198 miles per hour, F6F-3 airplane. -

Figure 29. - Steady sideslip characteristics in the climbing condition at 252 miles per hour, F6F-3 airplane.

Figure 30. - Steady sideslip characteristics in the climbing condition at 300 miles per hour, F6F-3 airplane.

4. As shown by figures 16 to 29 right-rudder force was required to hold right-rudder deflections and left-rudder force was required to hold left-rudder deflections.

The variation of cross-wind force with sideslip angle was in the correct direction; that is, right bank accompanied right sideslip and left bank accompanied left sideslip as shown by figures 17 to 30.

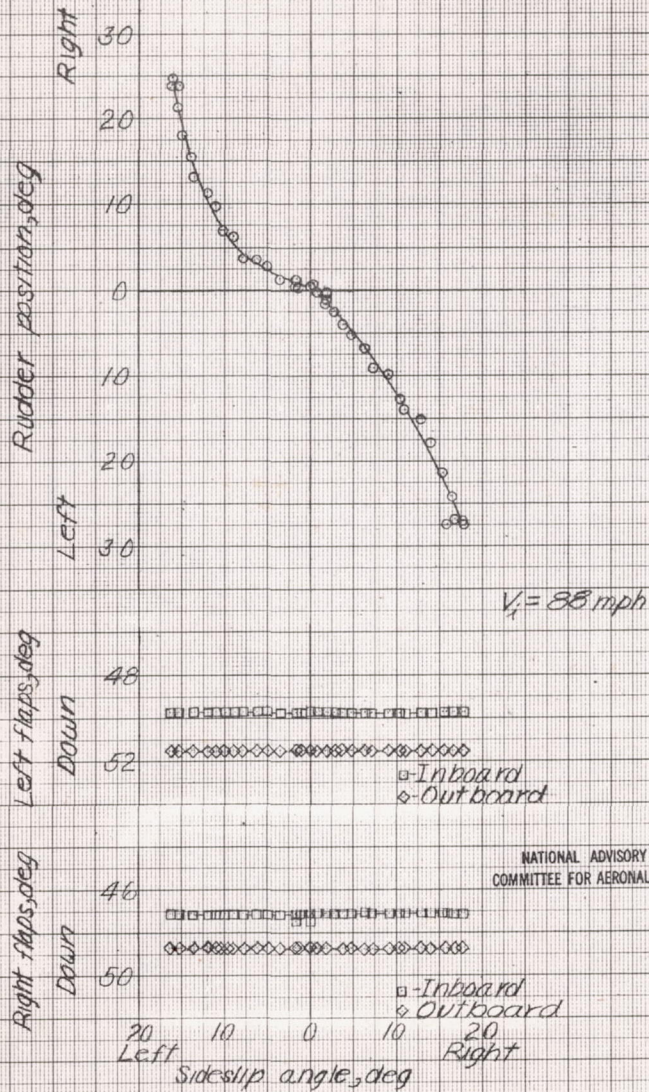
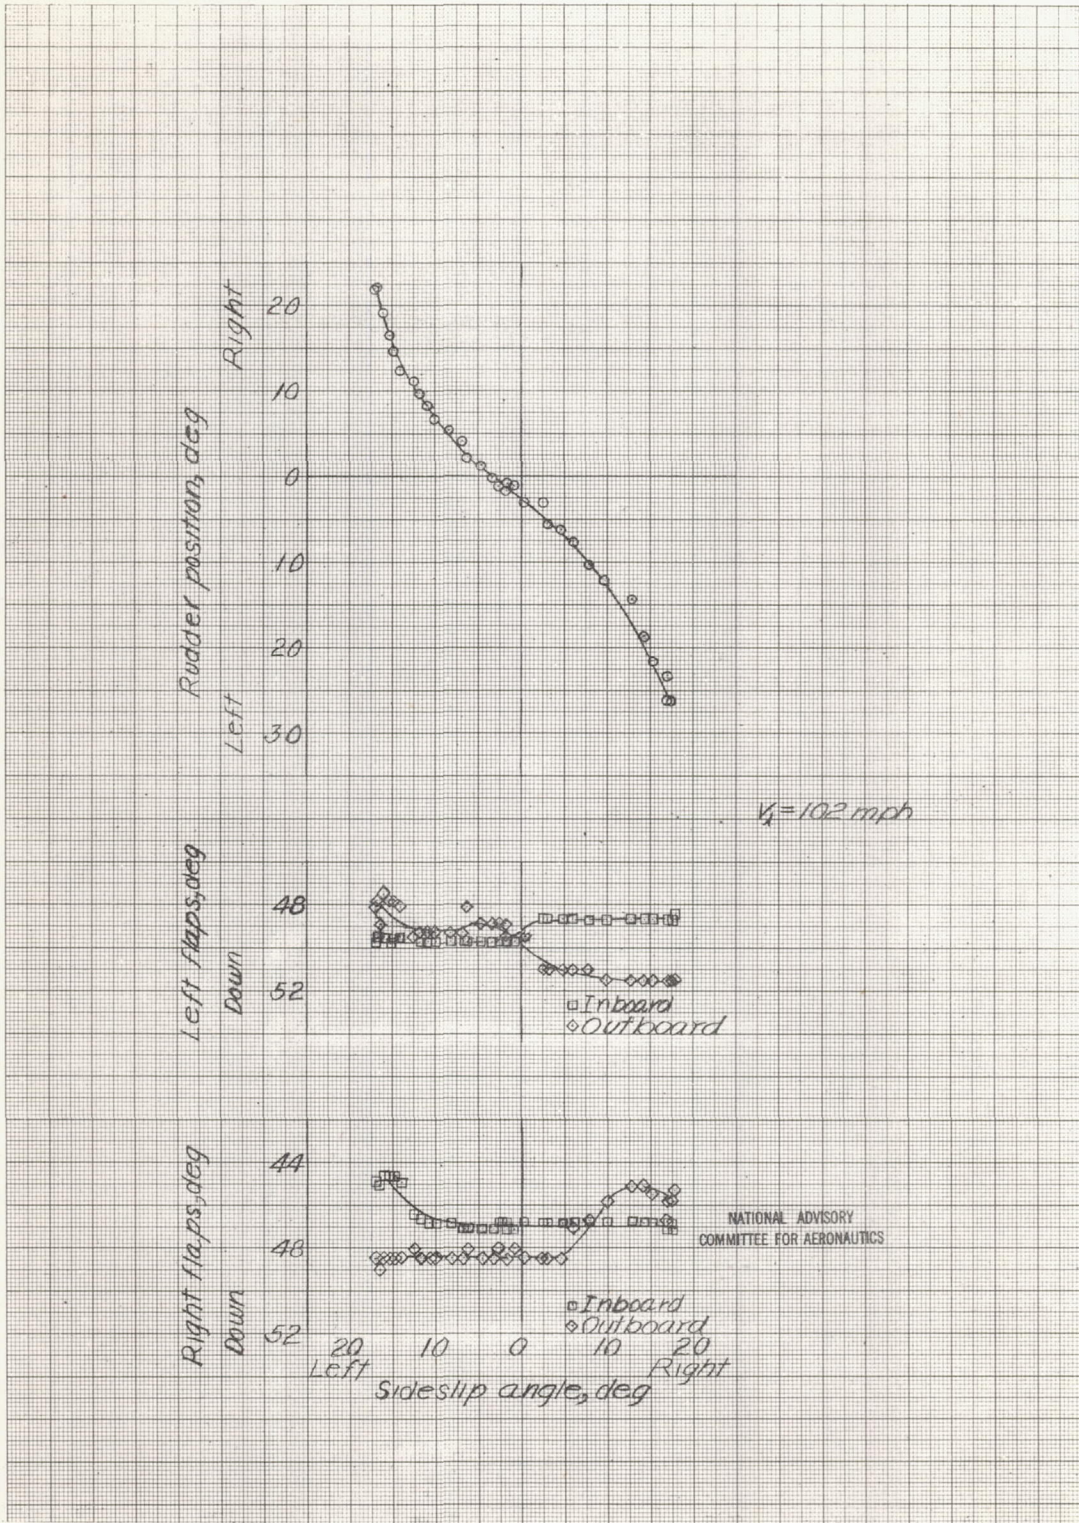
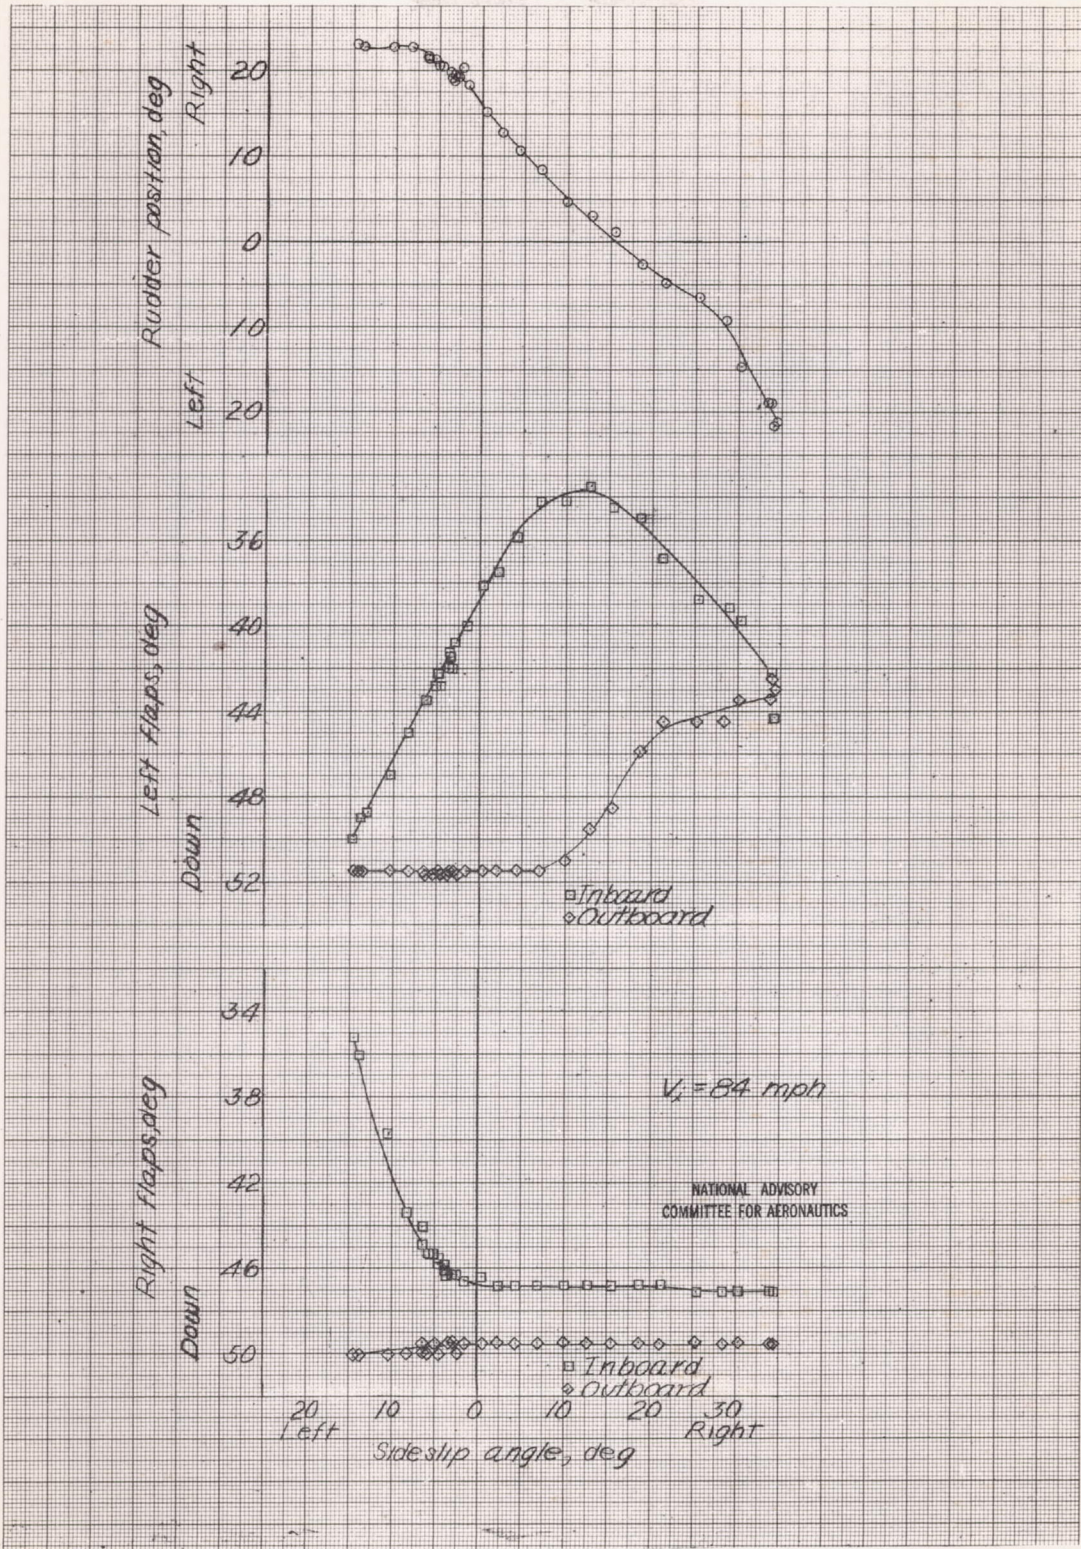
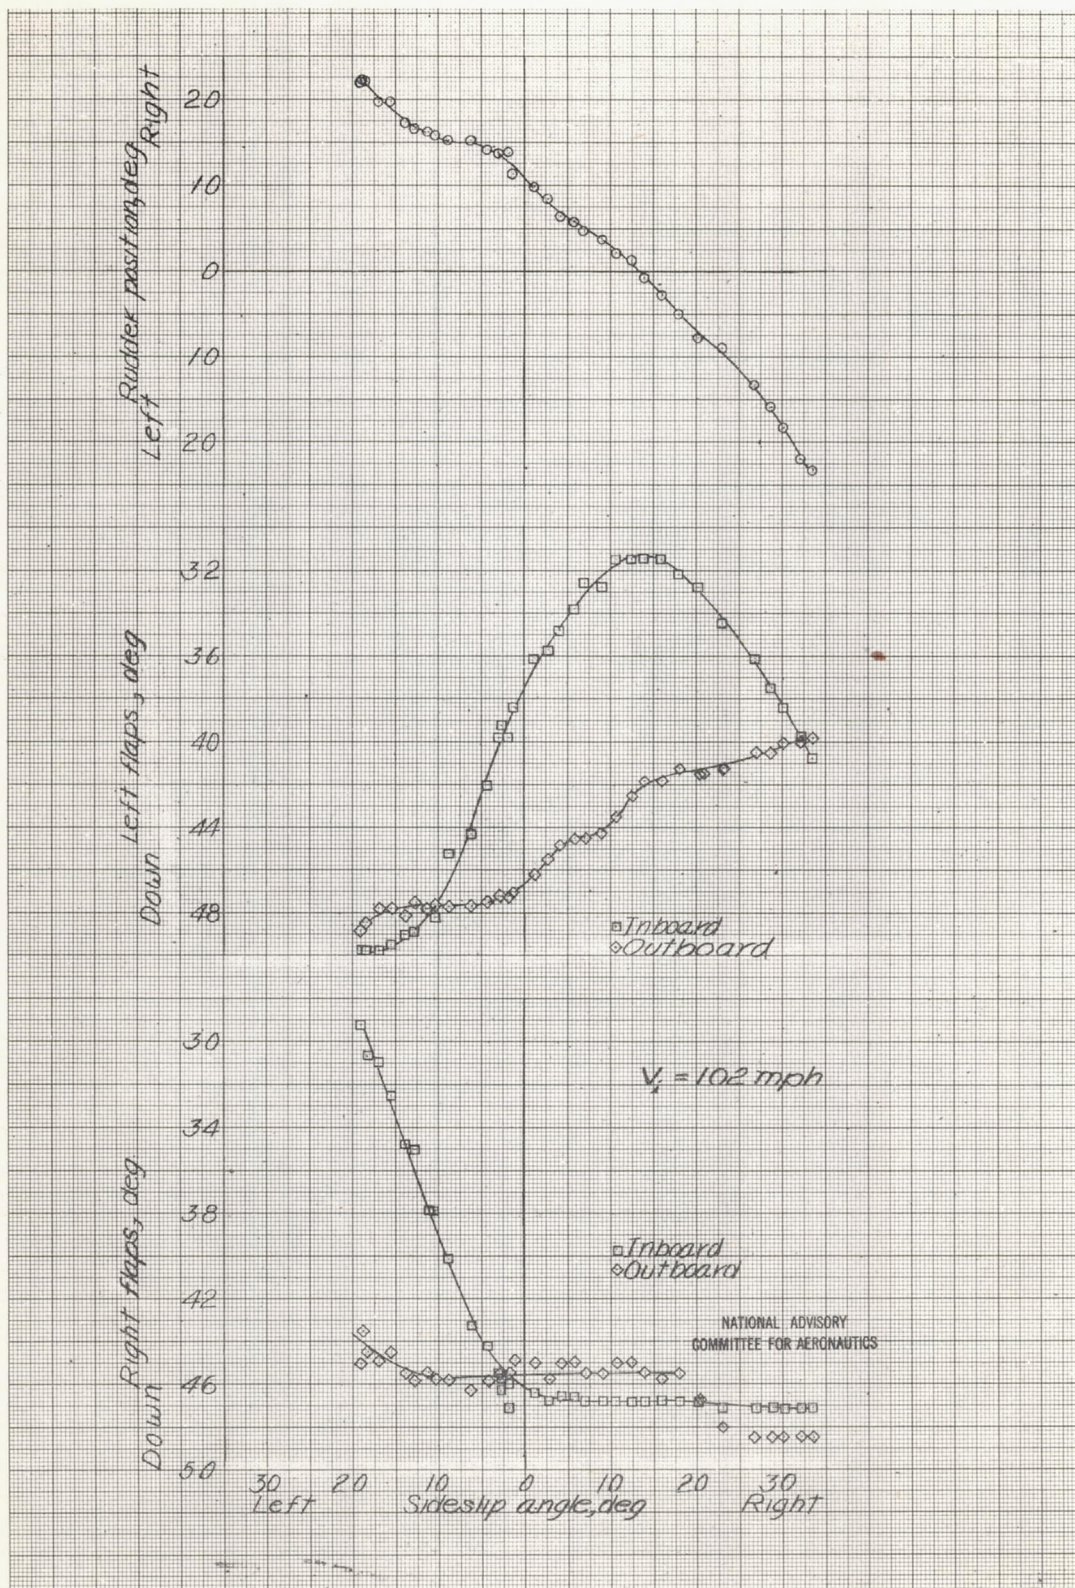
Figure 31. - Flap blow-up characteristics in steady sideslips, $V_1 = 88$ miles per hour, landing condition, F6F-3 airplane.

Figure 32. - Flap blow-up characteristics in steady sideslips
 $V_1 = 102$ miles per hour, landing condition
 F6F-3 airplane.

Figure 33. - Flap blow-up characteristics in steady sideslip $V_1 = 84$ miles per hour, wave-off condition, F6F-3 airplane.

Figure 34. - Flap blow-up characteristics in steady sideslips
 $V_1 = 102$ miles per hour, F6F-3 airplane.

3. The blow-up characteristics of the landing flaps are such as to cause greater dihedral effect in the wave-off condition than would be obtained if the flaps were held in a fixed full-down position. With flaps that are held rigidly in the down position, dihedral effect is greatly reduced in the wave-off condition because of the additional lift on the trailing wing as the slipstream moves out over the wing with increasing sideslip angle. In the present instance, however, the destabilizing effect is decreased because the flap deflection is reduced by the slipstream over the trailing wing, which decreases the lift on that wing and causes more positive dihedral effect. Unpublished wind-tunnel tests of an F6F-3 model showed that in the wave-off condition at a lift coefficient of 1.46, which corresponds to a speed of approximately 90 miles per hour, the effective

dihedral with the flaps held fixed was 2.6° , while with the flap deflection varying with sideslip angle in the same manner as in the flight tests, the effective dihedral was 3.5° .

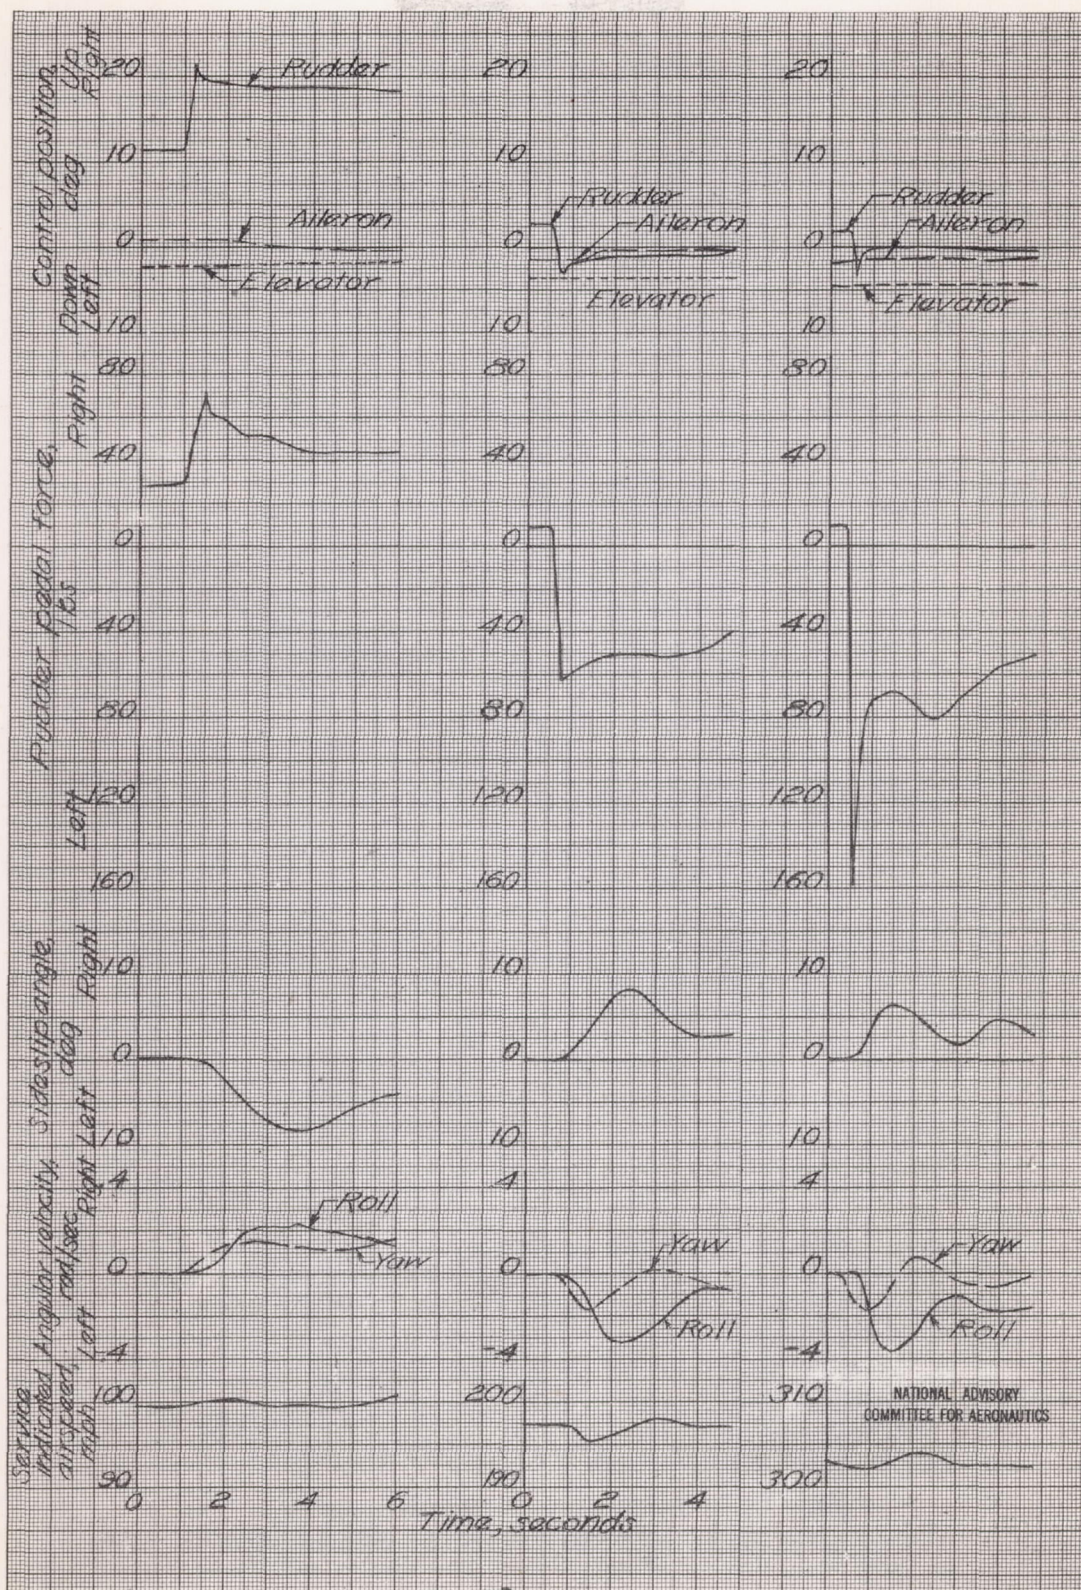
Figure 35. - Typical time histories of abrupt rudder kicks, clean condition, power for level flight, F6F-3 airplane.

The rolling moment due to sideslip was measured in gradually increasing sideslips which were made by slowly deflecting the rudder using the ailerons and elevators to maintain straight flight. A measure of the dihedral effect was obtained from the variation of total aileron angle with sideslip angle. Sideslips were made at various speeds in the landing, wave-off, gliding, and climbing conditions. The data are presented in figures 17 to 30. In these figures rudder, elevator, and aileron forces and deflections and the angle of bank are plotted as functions of sideslip angle. Figures 17 and 18 pertain to the landing condition and data for the wave-off condition are presented in figures 19 and 20. Data for the gliding and climbing condition are shown in figures 21 through 25 and figures 26 through 30, respectively. Additional sideslips were made at a later date in the landing and wave-off condition with control-position recorders installed to measure the landing flap blow-up characteristics. The flaps of the F6F-3 are in four segments which are spring-loaded and blow up independently of each other under aerodynamic loads. A detailed description of this flap arrangement is given in reference 1. During the aforementioned tests the airplane was equipped with an experimental spring tab rudder. The data obtained are shown in figures 31 through 34 where the angle of the four segments of the flaps and the rudder position are plotted as functions of the sideslip angle. Figures 31 and 32 apply to the landing condition and figures 33 and 34 show data for the wave-off condition. Another measure of the dihedral effect was obtained from rudder kicks in which the pilot deflected and held the rudder at a given position, holding the ailerons fixed at trim. Typical time histories of this maneuver are shown

in figure 35. The data obtained were used to determine the variation of maximum yawing and rolling velocity and maximum change in sideslip angle with change in rudder angle. These results are shown in figure 36.
