MR No. L5B13a

FLIGHT MEASUREMENTS OF THE FLYING QUALITIES
OF AN F6F-3 AIRPLANE (BUAER NO. 04776)
II - LATERAL AND DIRECTIONAL STABILITY AND CONTROL
By Walter C. Williams and John P. Reeder

Bureau of Aeronautics, Navy Department

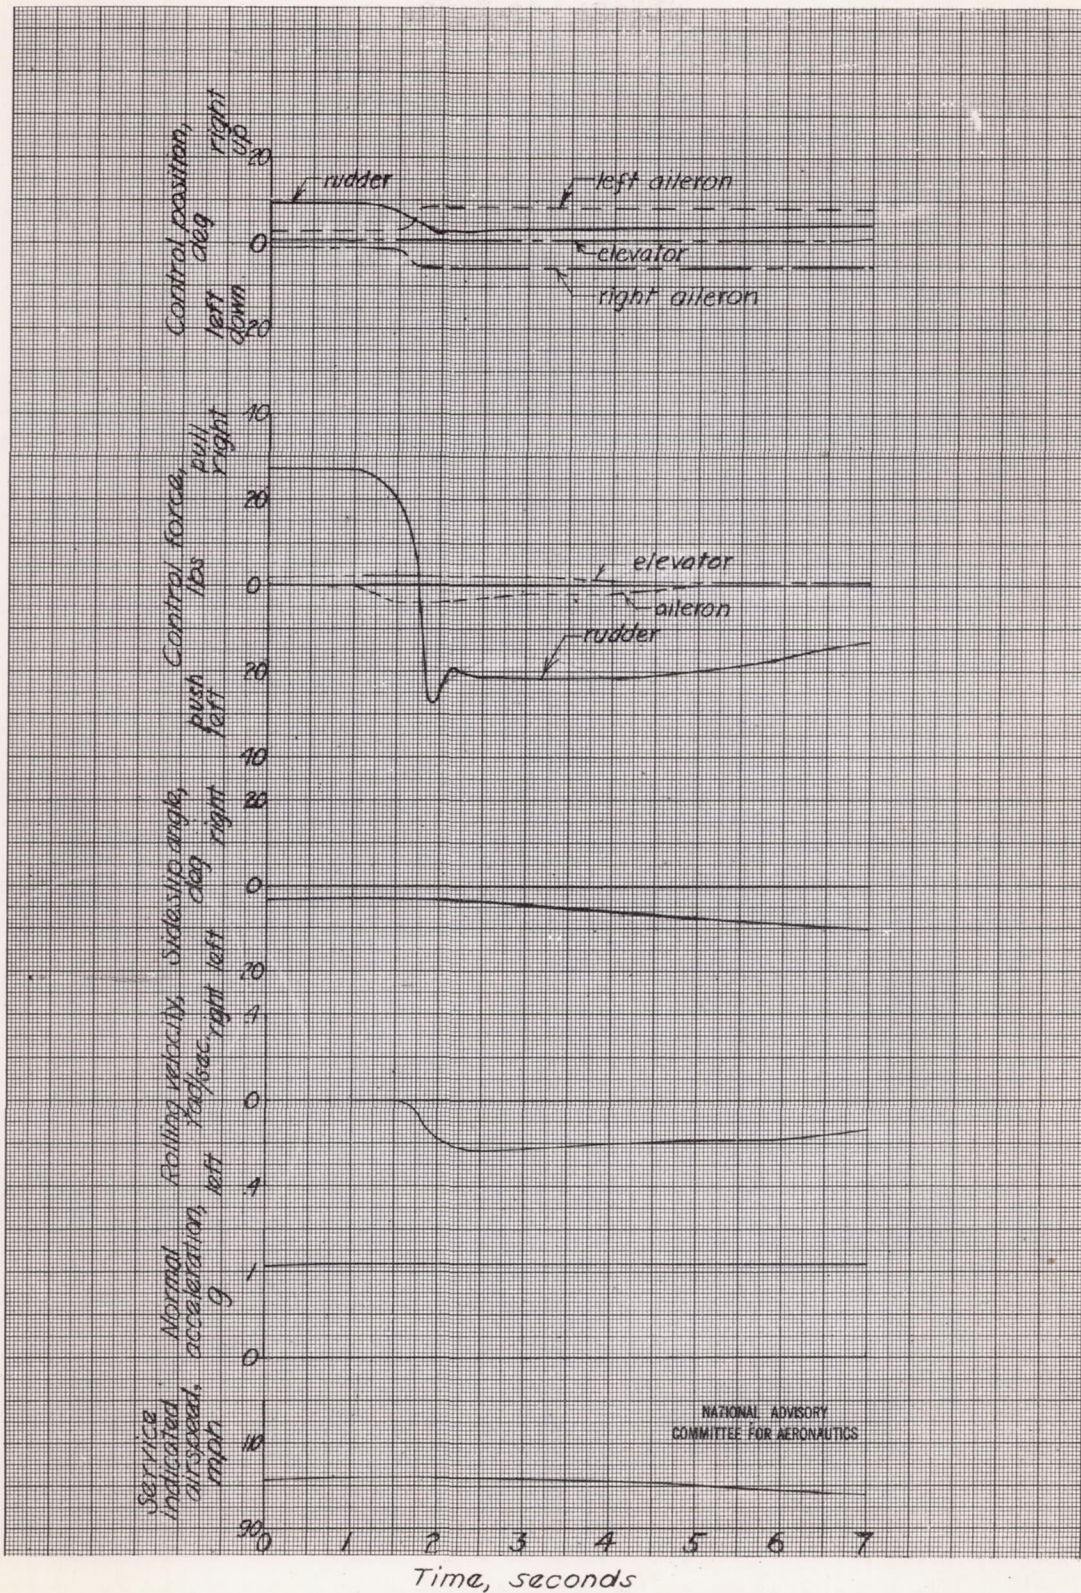
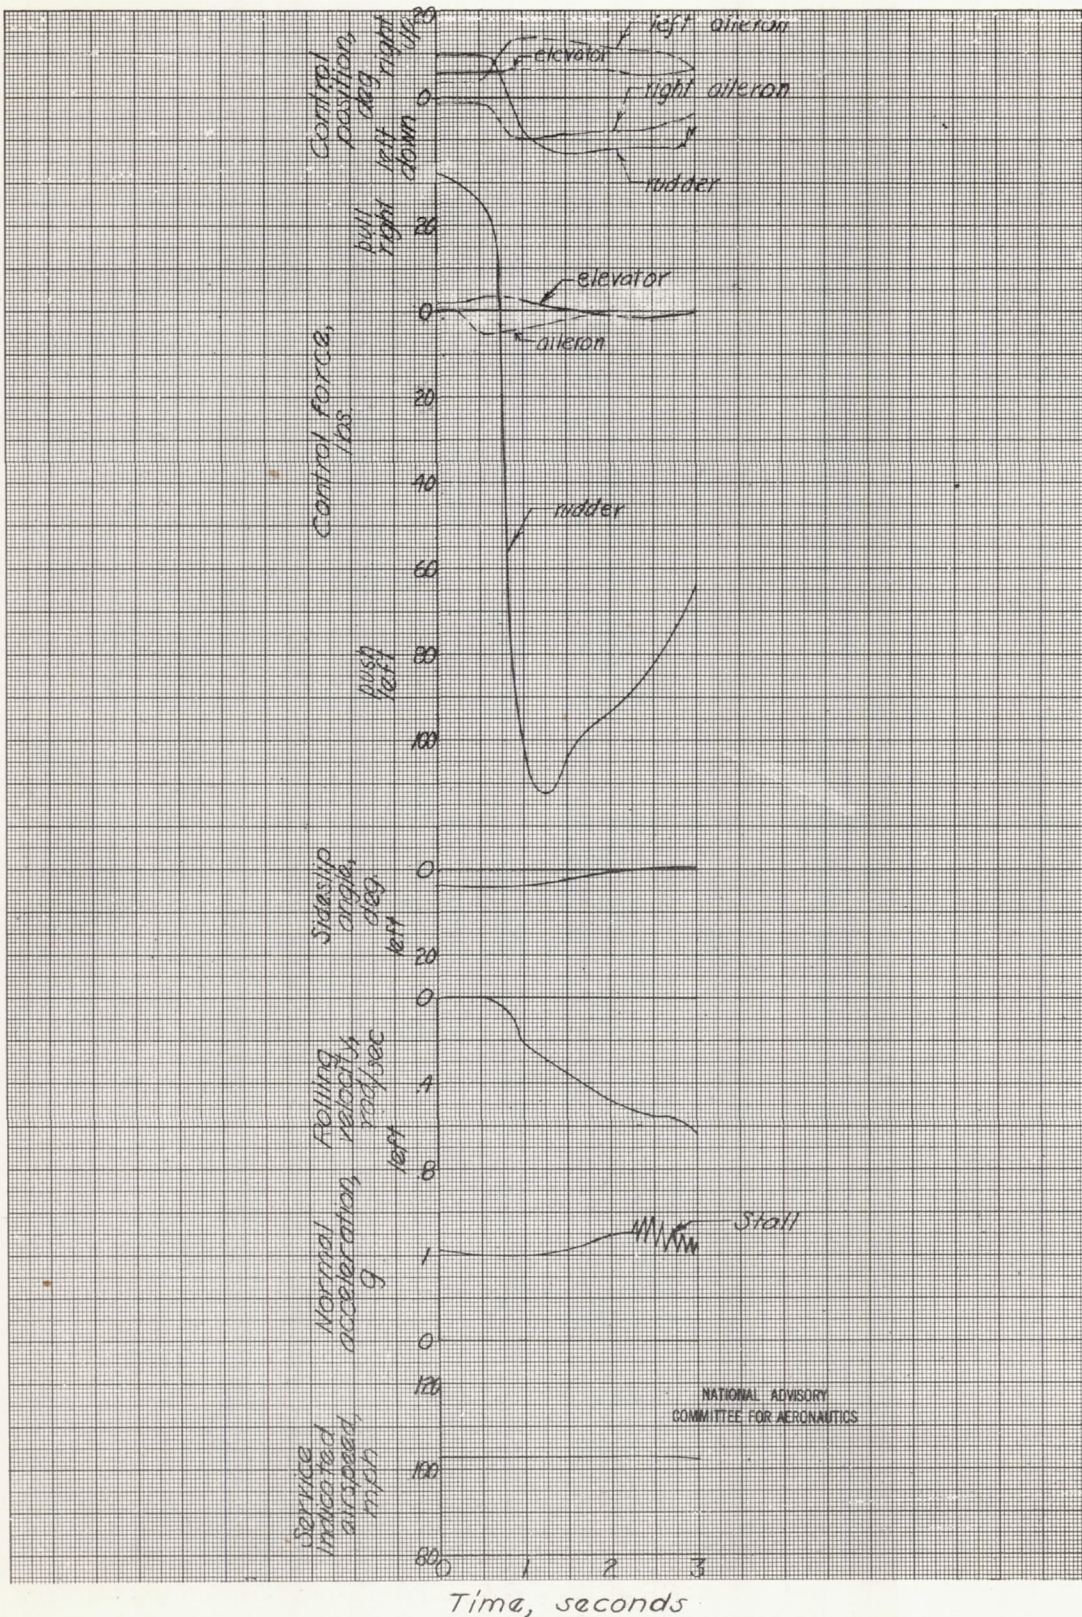
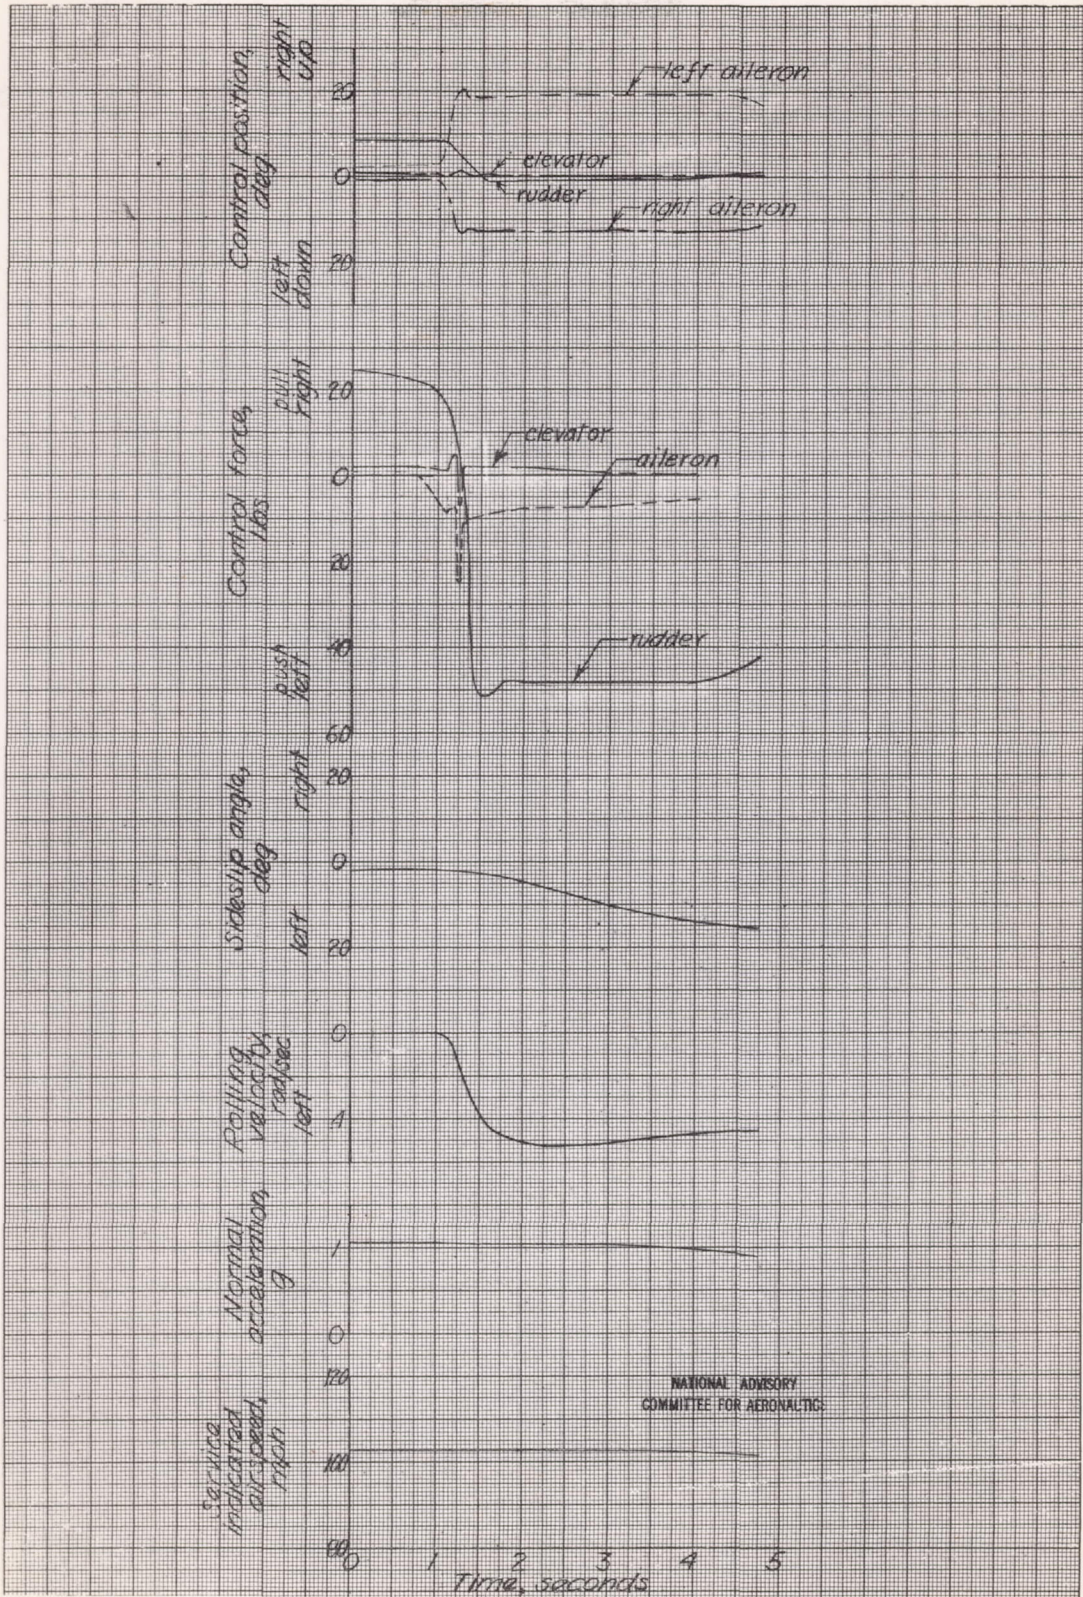
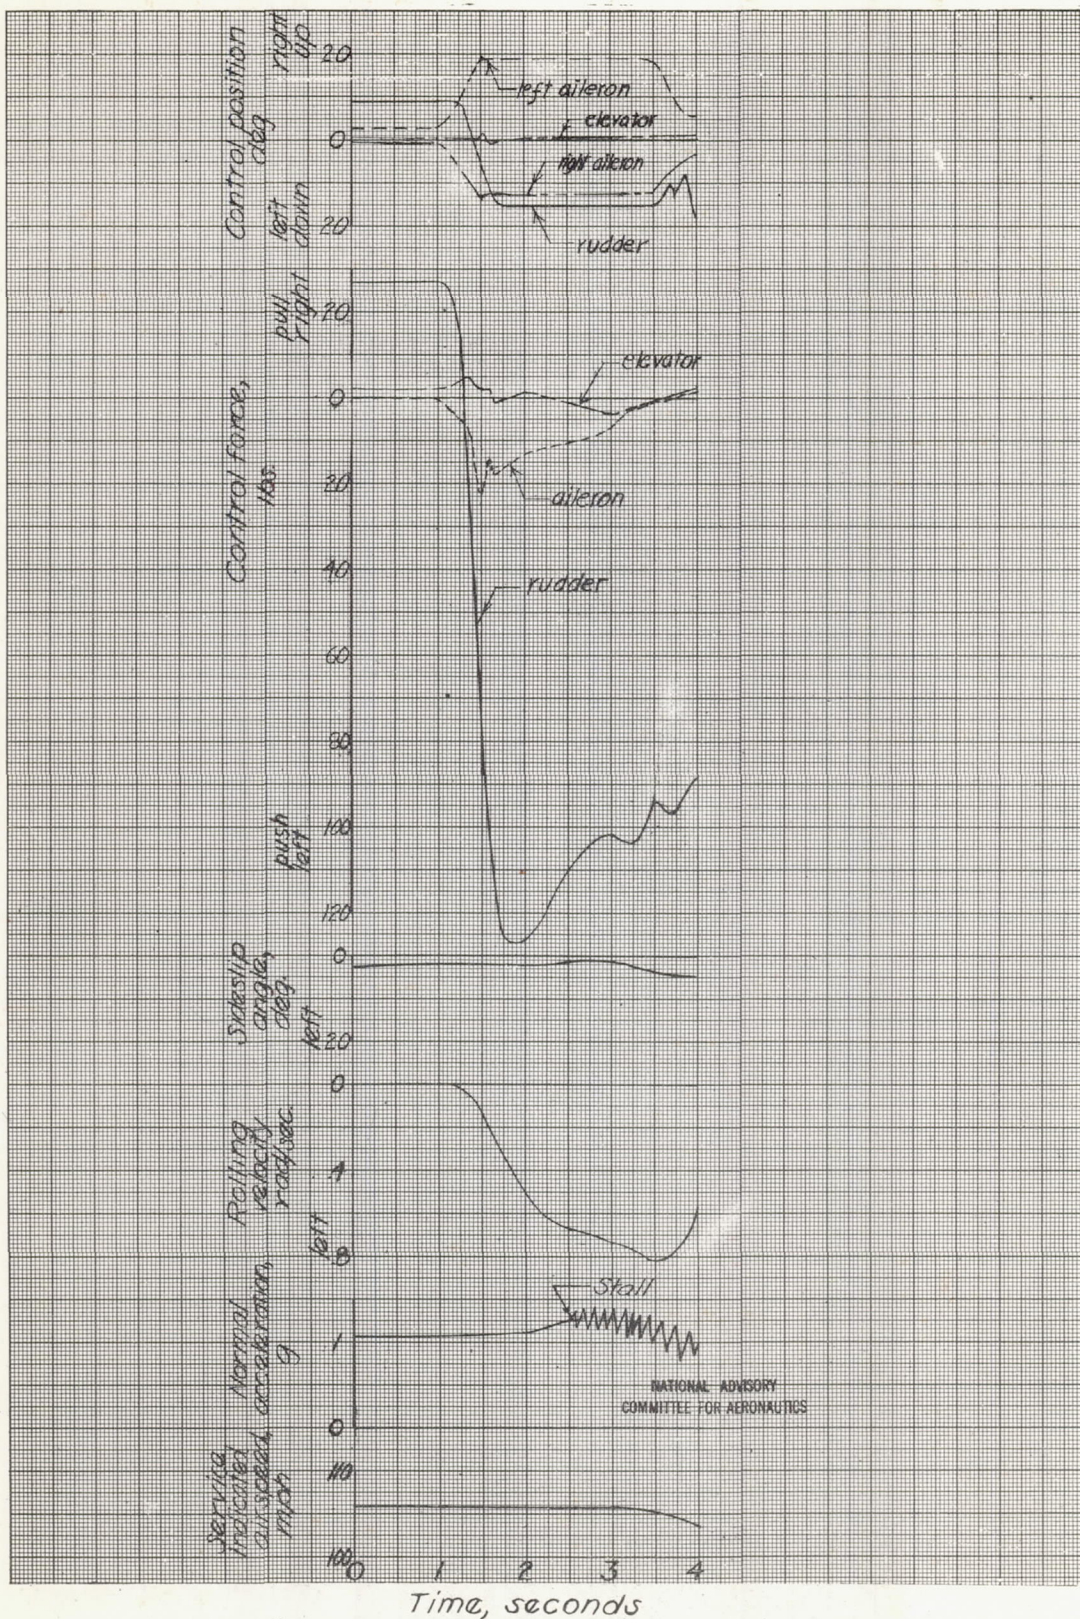
Figure 37.- Time history of rolling out of a right turn using partial aileron control and less rudder than necessary to overcome adverse aileron yaw. Clean condition, power for level flight, F6F-3 airplane.

Figure 38.- Time history of rolling out of a right turn using partial aileron control and more rudder than necessary to overcome adverse aileron yaw. Clean condition, power for level flight, F6F-3 airplane.

Figure 39. - Time history of rolling out of a right turn using full aileron deflection and less rudder than necessary to overcome adverse aileron yaw. Clean condition, power for level flight, F6F-3 airplane.

Figure 40.- Time history of rolling out of a right turn using full aileron and slightly more rudder deflection than necessary to overcome adverse aileron yaw. Clean condition, power for level flight, T-6A-3 airplane.

1. The power of the rudder in overcoming adverse aileron yaw was determined in rolls out of turns. Rolls were made where the pilot used less rudder deflection than he thought necessary to overcome adverse yaw and where the pilot used more rudder than he thought necessary to overcome adverse yaw. These maneuvers were made in the clean condition with power for level flight. Typical maneuvers of this type are shown in figures 37 to 40. It can be seen from inspection of these figures that 15° of rudder deflection is sufficient to maintain zero sideslip while using full aileron deflection at approximately 105 miles per hour. The change in rudder force is considerable (154 pounds) but is within the specified limit of 180 pounds (references 2 and 3).

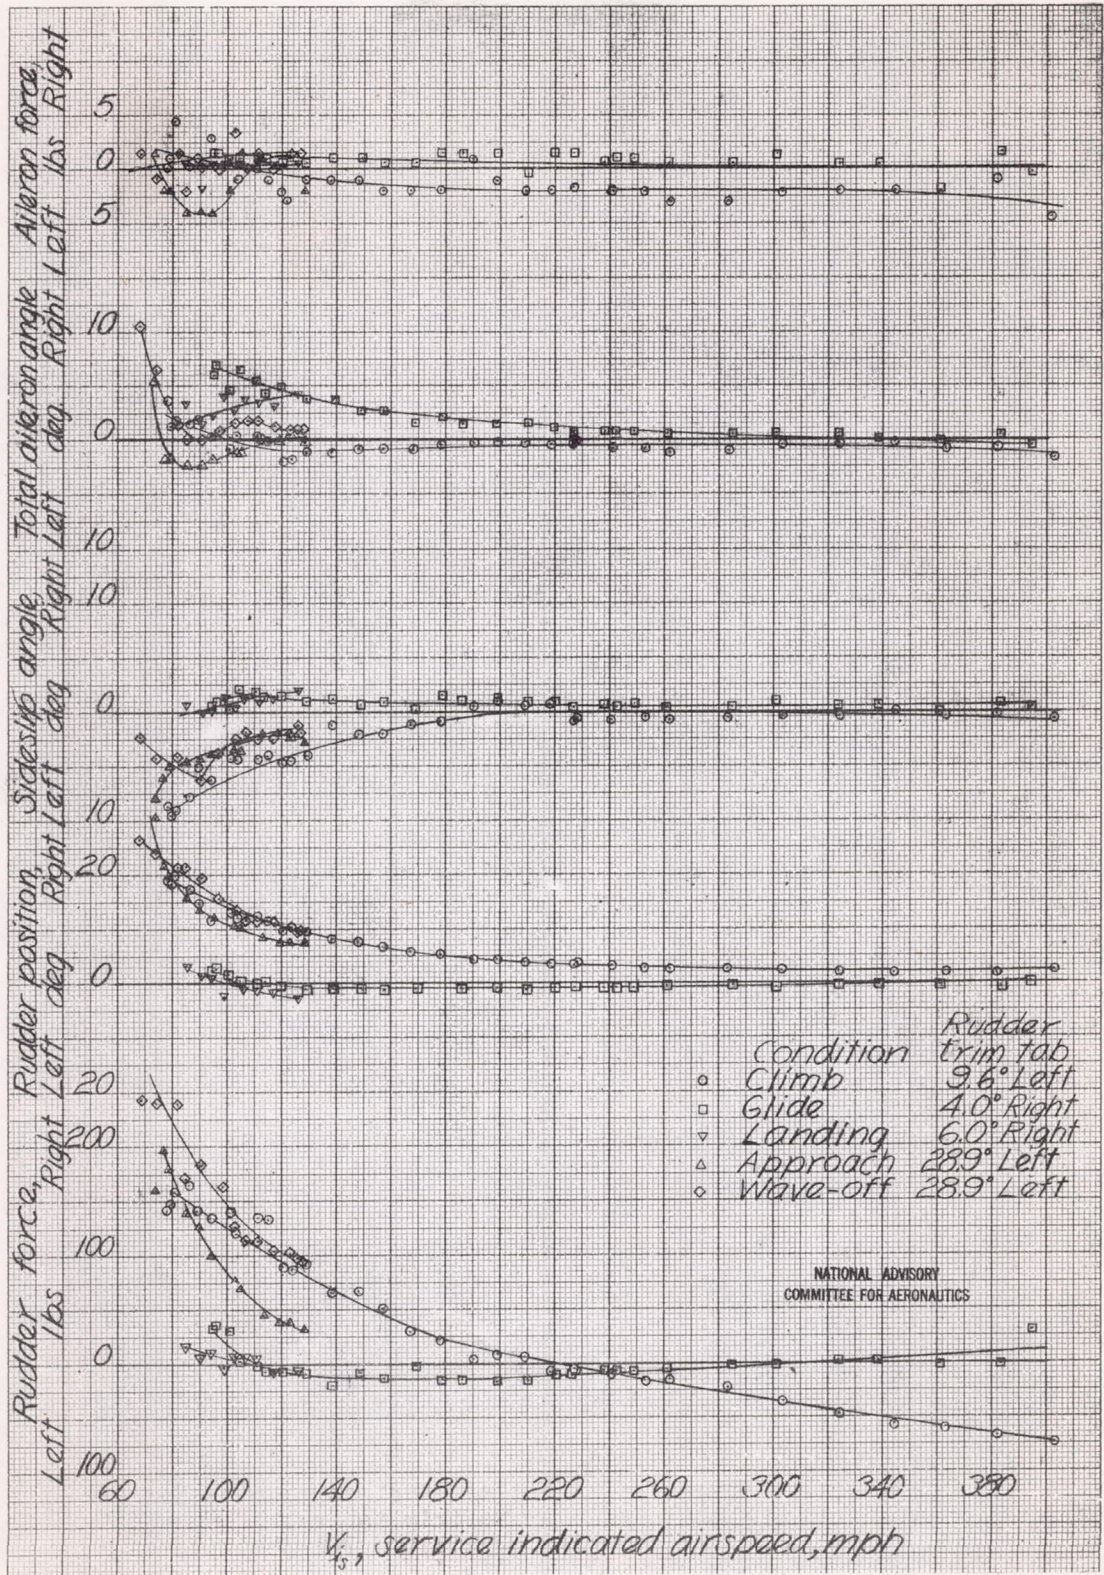
Figure 41. - Directional and lateral trim characteristics, F6F-3 airplane.

4. The directional trim characteristics were determined by measuring the rudder forces and angles required to trim at various speeds. These data are presented in figure 41 as the variation of rudder force and angle with indicated airspeed for various flight conditions. Figure 41 also shows the variation of aileron angle and force, and sideslip angle with indicated airspeed. There is no requirement specified for the change in rudder trim force with speed, but the pilots felt that in the case of the F6R-3 these changes in force were excessive. The pilots also reported a rudder shake which was present throughout the speed range in all flight conditions, which may be caused by a turbulent flow behind the elevator cutout.

The power of the rudder trim tabs was measured in a manner similar to that used to determine the power of the elevator tabs. Measurements were made in the gliding and climbing condition. Figure 41 shows the variation of rudder pedal force with speed for two trim-tab settings in the gliding and climbing condition. The data were used to determine the change in rudder pedal force per degree trim-tab deflection. This factor is plotted as a function of indicated airspeed in figure 42.

No quantitative measurements were made of the power of the aileron trim tab. The aileron trim forces were small as shown by figure 41. The aileron trim tab was reported by the pilot to be adequate for trimming the airplane within the conditions and speed range tested.

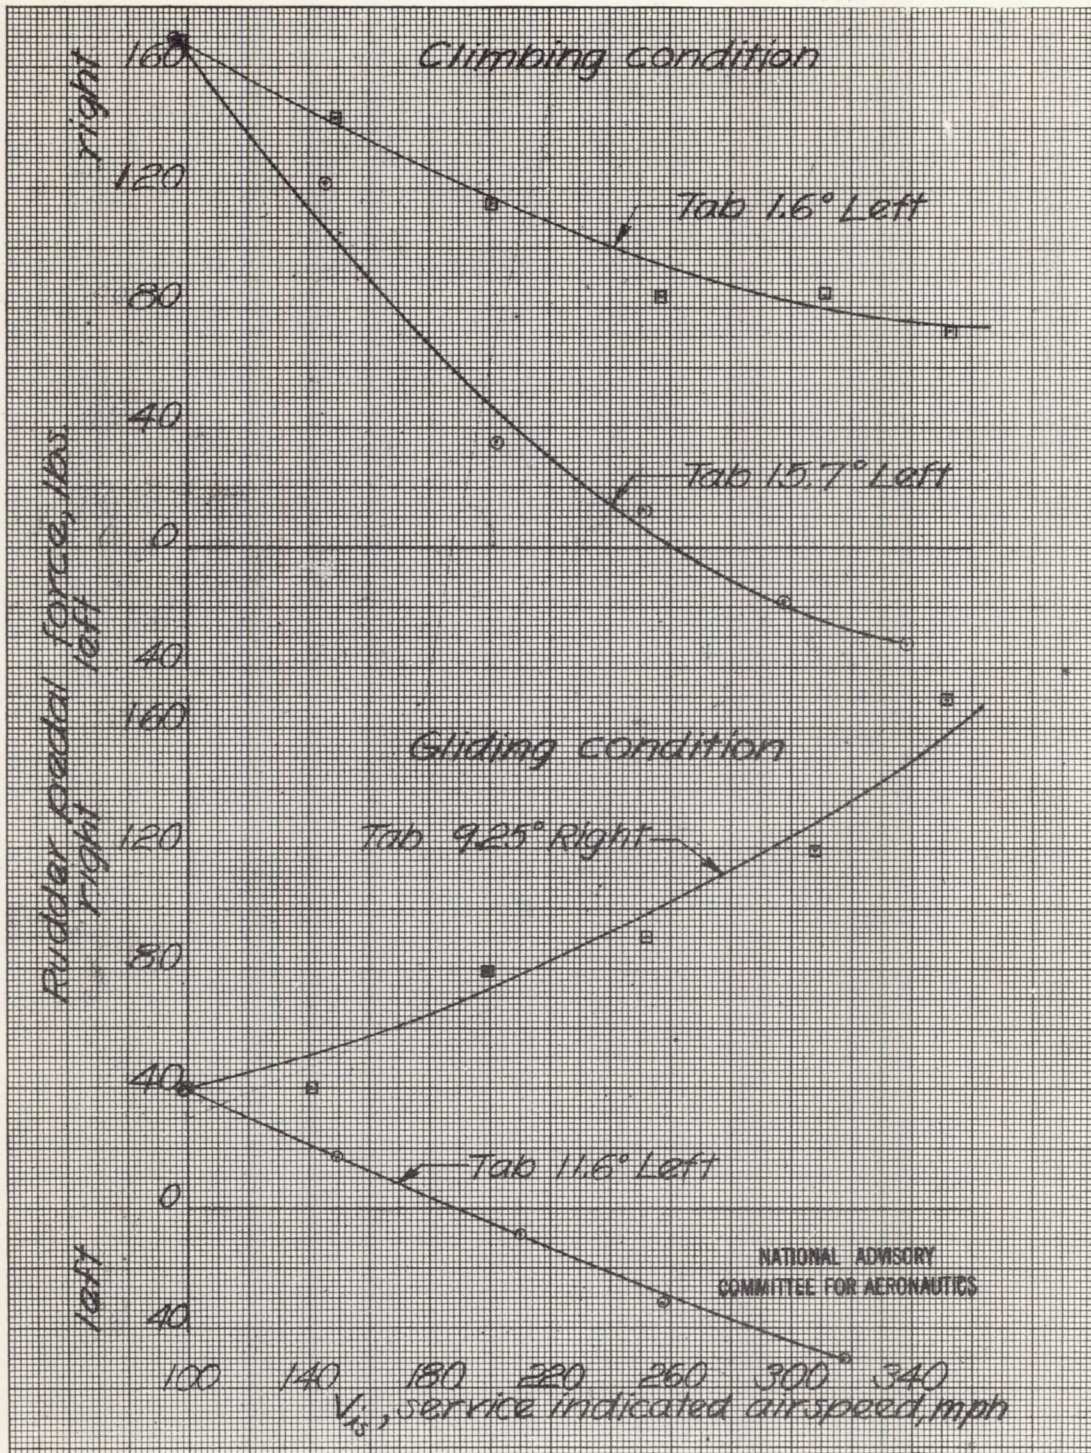
Figure 42. - Variation of rudder pedal force with indicated airspeed for two trim tab settings, gliding and climbing condition, F6F-3 airplane.

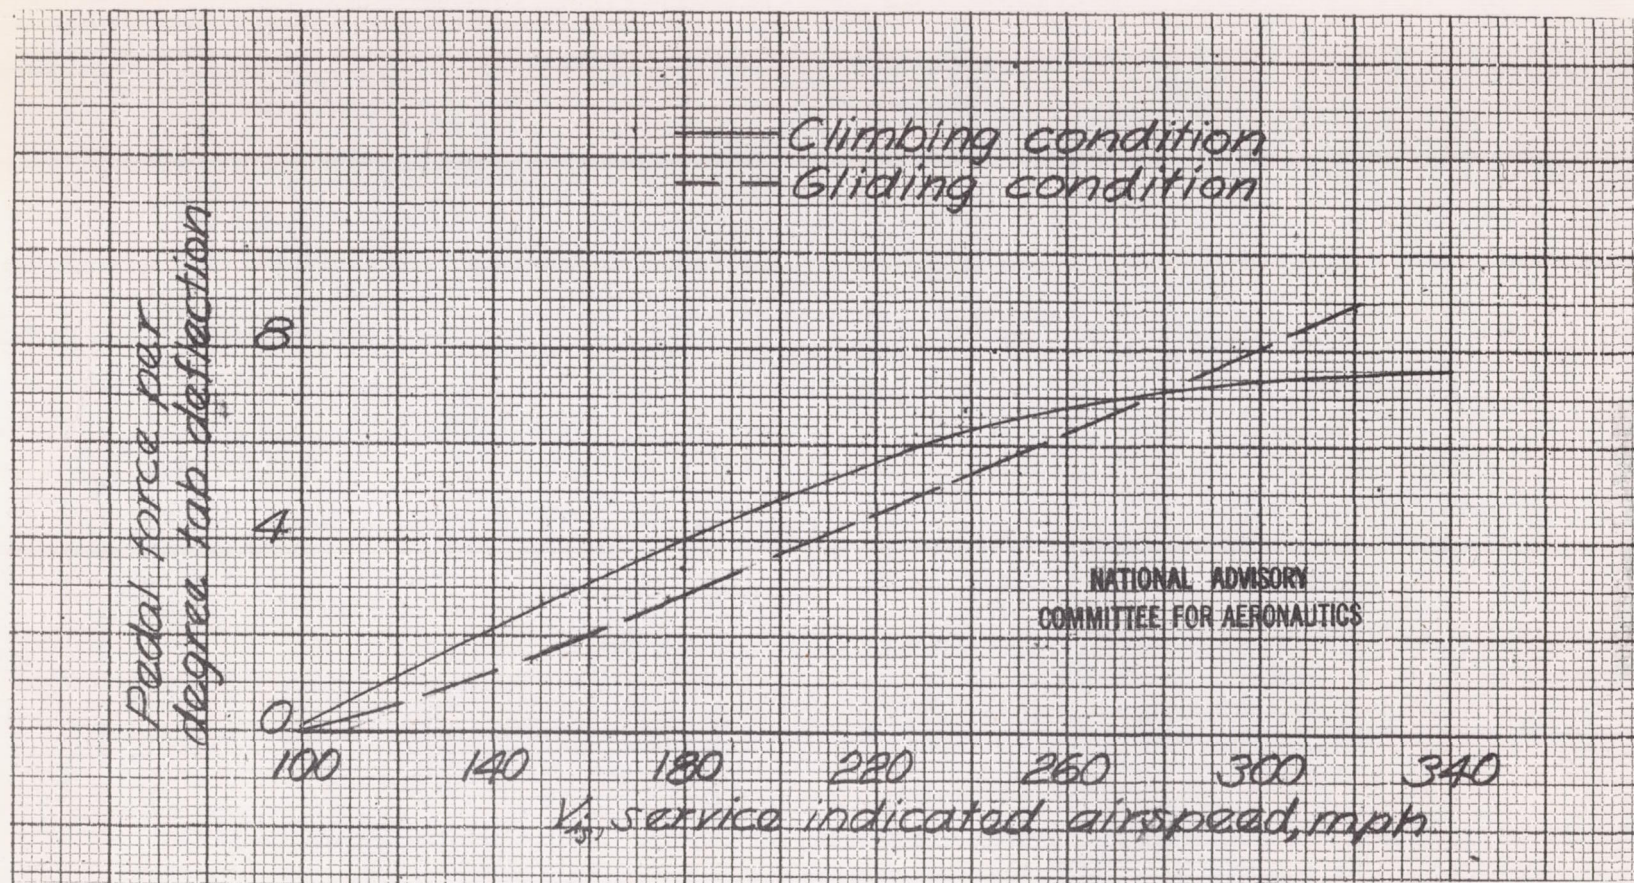
Figure 43. - Variation of rudder pedal force per degree trim tab deflection with indicated airspeed, gliding and climbing condition, F6F-3 airplane.

From the data shown on figures 41 and 43, the following may be concluded regarding the power of the rudder trim tab of the F6F-3 airplane:

1. The rudder pedal force could not be trimmed to zero below approximately 155 miles per hour in the climbing condition.
2. The rudder trim tab was adequate in the gliding condition from approximately 100 miles per hour to the highest speeds tested.
3. The rudder pedal force could not be trimmed to zero with full deflection of the trim tab in either the approach or wave-off condition in the speed range tested.
