RESEARCH MEMORANDUM

TESTS OF AERODYNAMICALLY HEATED MULTIWEB
WING STRUCTURES IN A FREE JET AT MACH NUMBER 2

AN ALUMINUM-ALLOY MODEL OF 40-INCH CHORD
WITH 0.125-INCH-THICK SKIN

By George E. Griffith and Georgene H. Miltonberger

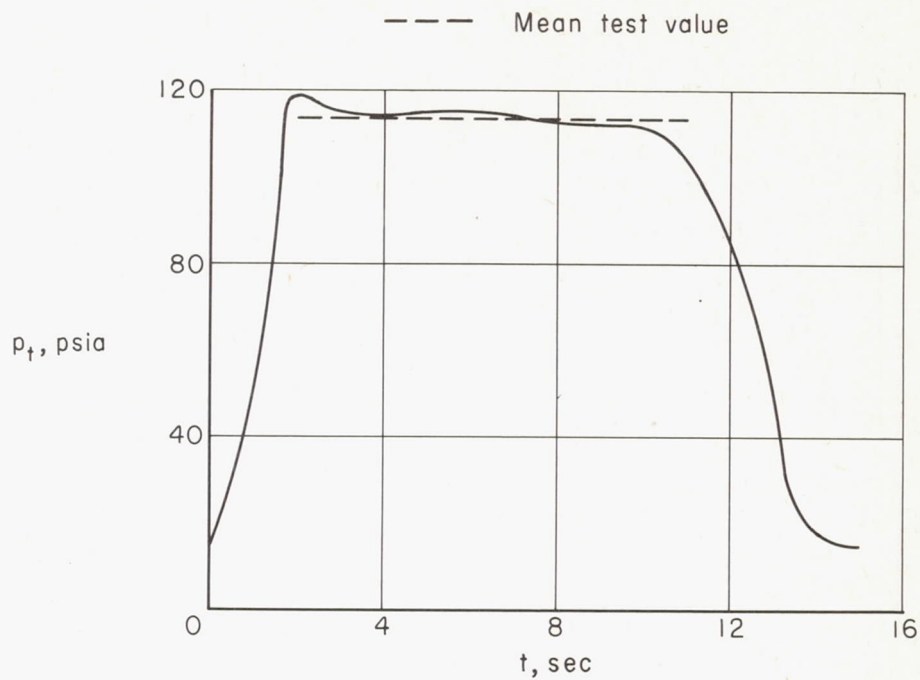
(a) Stagnation pressure.

Figure 5.- Stagnation pressure and temperature.

Tunnel stagnation pressure.- A plot of the variation with time of the stagnation pressure is given in figure 5(a). The curve shown represents an average of two pressures which differed by less than 2.5 psi and which were obtained from total-pressure tubes located just downstream of the heat accumulator. The period of test conditions was determined from this plot and was considered to be the time during which the stagnation pressure equaled or exceeded 100 psia, that is, from 1.6 to 11.3 seconds. Except for an initial peak, the pressure is nearly constant during this period but can be seen to have dropped slightly during the latter portion of the test. The average or mean value of 113 psia was obtained from an integration of the area under the curve during the period of test conditions.

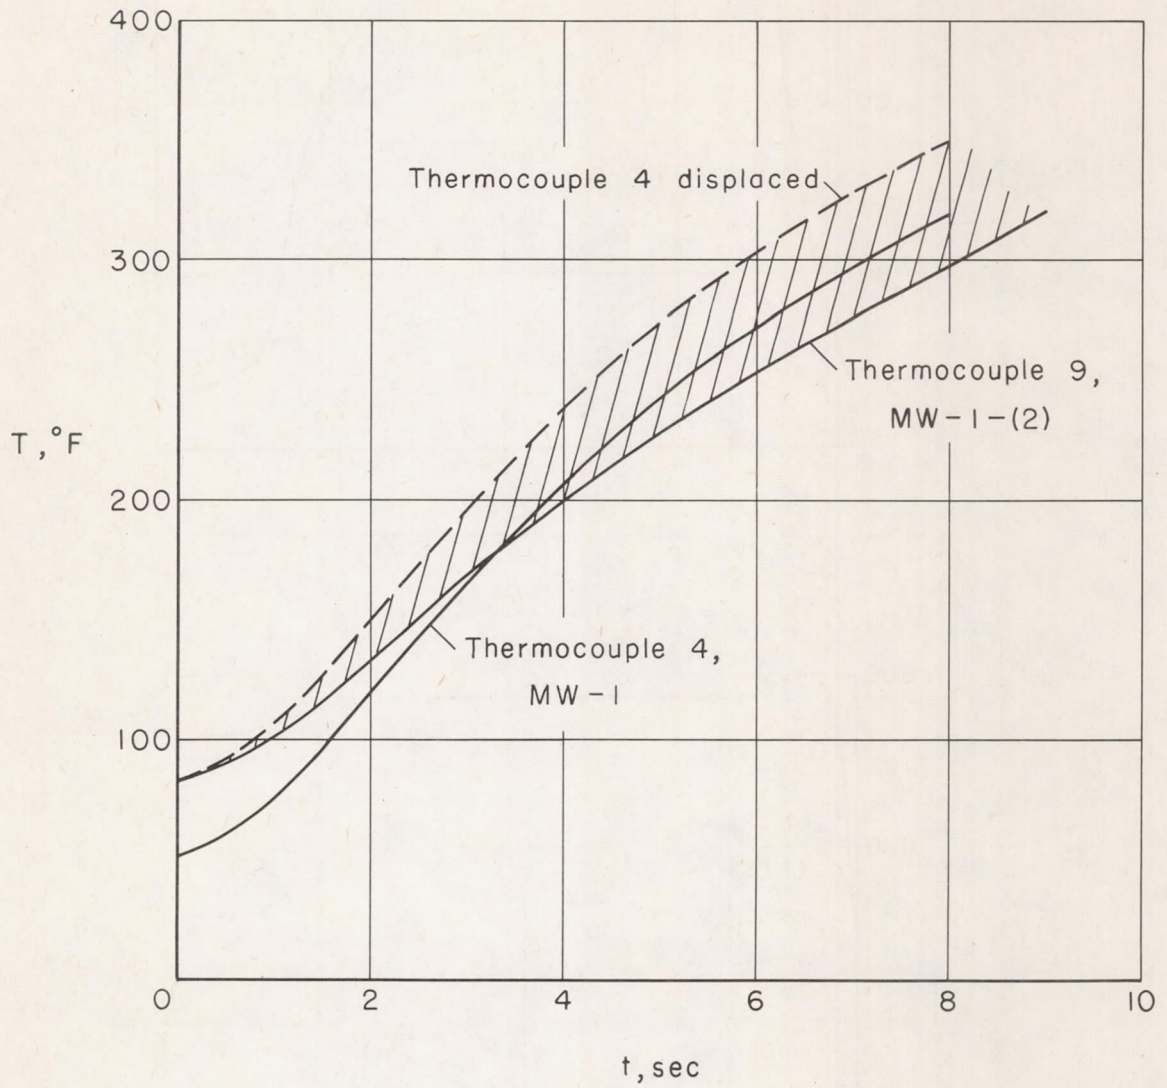
Figure 6.- Typical skin temperature histories.

Plotted in figure 6 are typical skin temperature histories for model MW-1-(2) and for model MW-1 at approximately the corresponding chordwise location. Figure 6 shows that model MW-1 experienced a greater temperature increase with respect to time and therefore more aerodynamic heating than did model MW-1-(2); this fact is evidenced by the difference between the two curves shown by the shaded area after the curves were made to originate at the same point. Since the aerodynamic heat-transfer coefficients for the two tests should have been essentially the same, a

When the typical skin temperatures shown in figure 6 are reduced to nondimensional form and compared with values calculated by using Van Driest's heat-transfer coefficients, the results are as shown in figure 8. Actual rather than nondimensional time is used for the plots since all quantities (including h) contained in the appropriate dimensionless time parameter were considered to be essentially the same for the two wings. The dimensionless temperature data for the two wings appear to be in fairly good agreement but are somewhat higher than the calculated temperature ratios. Since generally good overall agreement between the test data for the two wings was obtained, it would appear that the average values of the indicated adiabatic wall temperatures were fairly indicative of the true test conditions and therefore that use of the indicated adiabatic wall temperatures in evaluating the test data is reasonable.

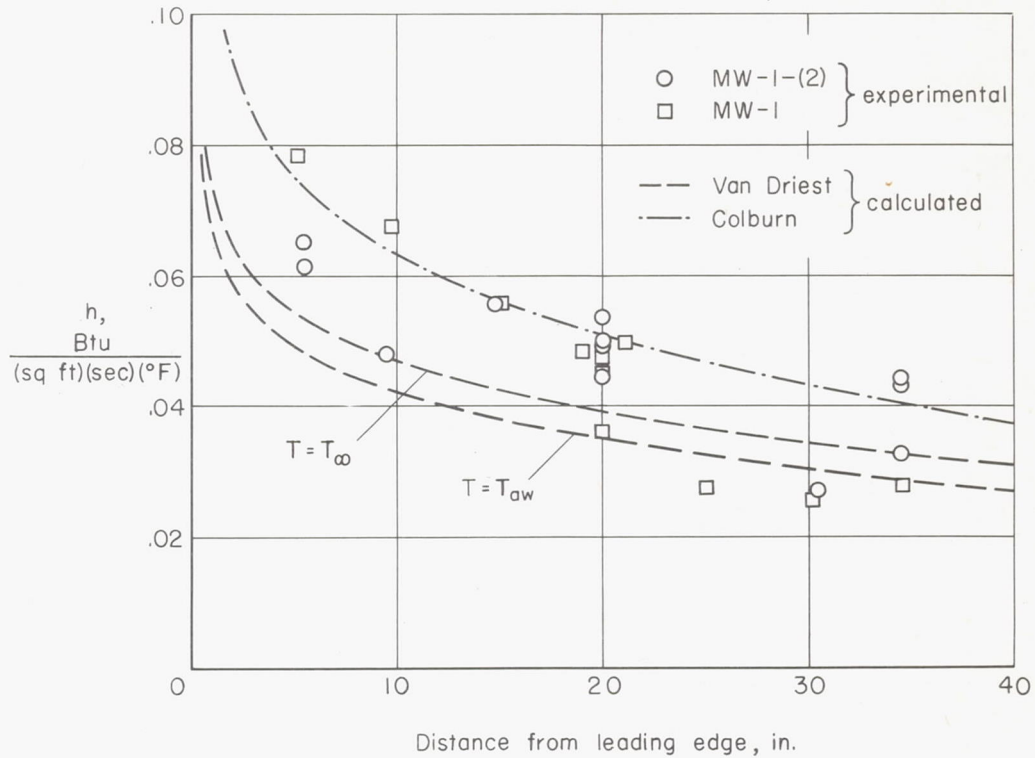
Figure 7.- Chordwise variation of aerodynamic heat-transfer coefficient and adiabatic wall temperature.

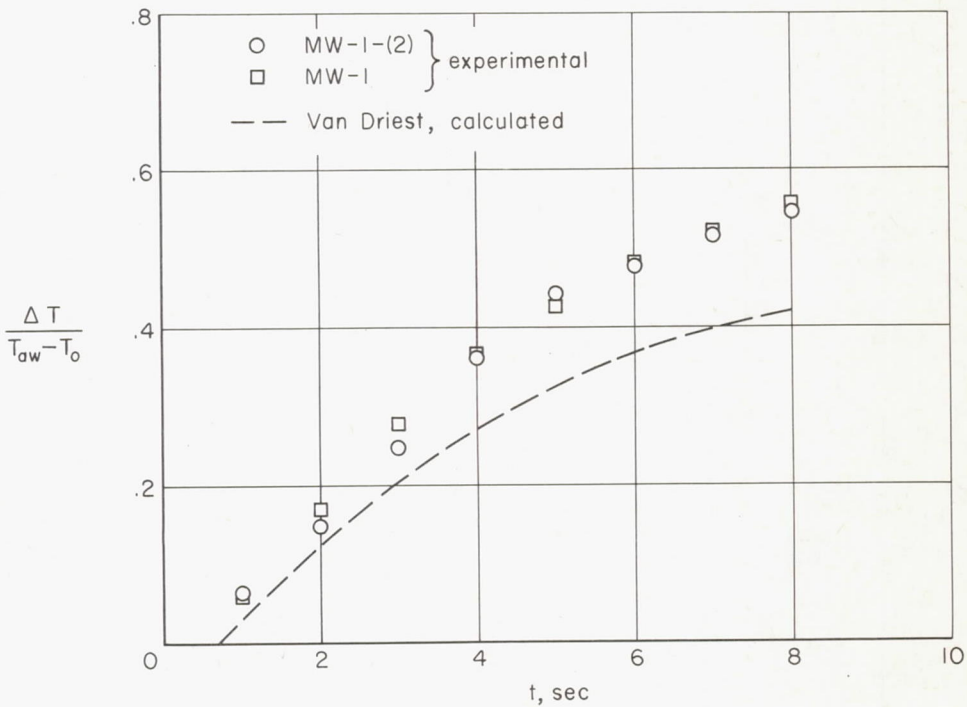
(b) Nondimensional temperature differences for skin and web 3.

Figure 9.- Skin and web temperature differences.

When the results of figure 9(a) for skin and web 3 are replotted as dimensionless temperatures, as in figure 9(b), the experimental data for the two wings, using indicated values of T_{aw} , appear to be in much better agreement. This would imply that the thermal conductance was not significantly different in the joints in the skin-web combinations of the two models, and, therefore, that the higher actual temperature differences experienced by model MW-1 were mainly due to the higher rate of aerodynamic heating. Comparison of the test data with calculated values obtained by using the method given in reference 4 and Van Driest's aerodynamic heat-transfer coefficients shows results similar to those previously obtained for the skin temperatures in that the test data are somewhat higher than the predicted values. Since the Van Driest method underestimates the skin temperatures by approximately this amount, little of the difference between the calculated values and the test data is due to any joint resistance to internal heat flow.
