RESEARCH MEMORANDUM

TURBOJET ENGINE INVESTIGATION OF EFFECT OF THERMAL
SHOCK INDUCED BY EXTERNAL WATER-SPRAY

COOLING ON TURBINE BLADES OF FIVE

HIGH-TEMPERATURE ALLOYS

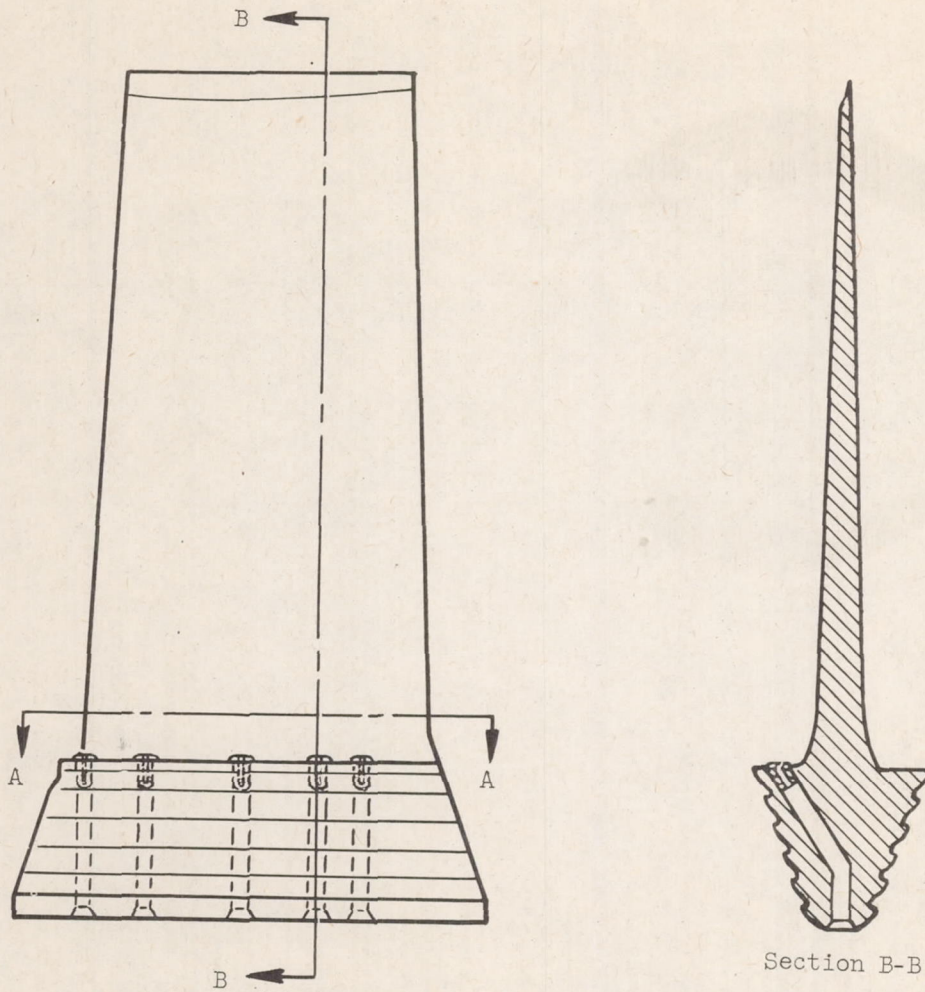
Figure 1. - Turbine rotor blade modified for water injection.

Fifty unmodified production blades of S-816 material and four test blades comprised the complete turbine rotor and blade assembly. The four test blades were of the same profile as the production blades and were modified to include five water-injection orifices in the base as shown in figure 1. The injection orifices were 0.031 inch in diameter and were located along the suction surface. Test blades of two alloys (two of one alloy and two of another) were always installed for any period of cyclic operation. Test blades were made of five high-temperature alloys. The alloys investigated were wrought S-816, Nimonic 80, Inconel X, cast HS-21, and cast Guy alloy. The first four alloys were chosen because they are commonly used in aircraft turbine blades and the thermal-shock effect of spray cooling on such blades should be known in order to evaluate aircraft application of turbine spray cooling. Guy alloy, although not commonly used, shows promise for high-temperature, high-stress applications and was therefore included.

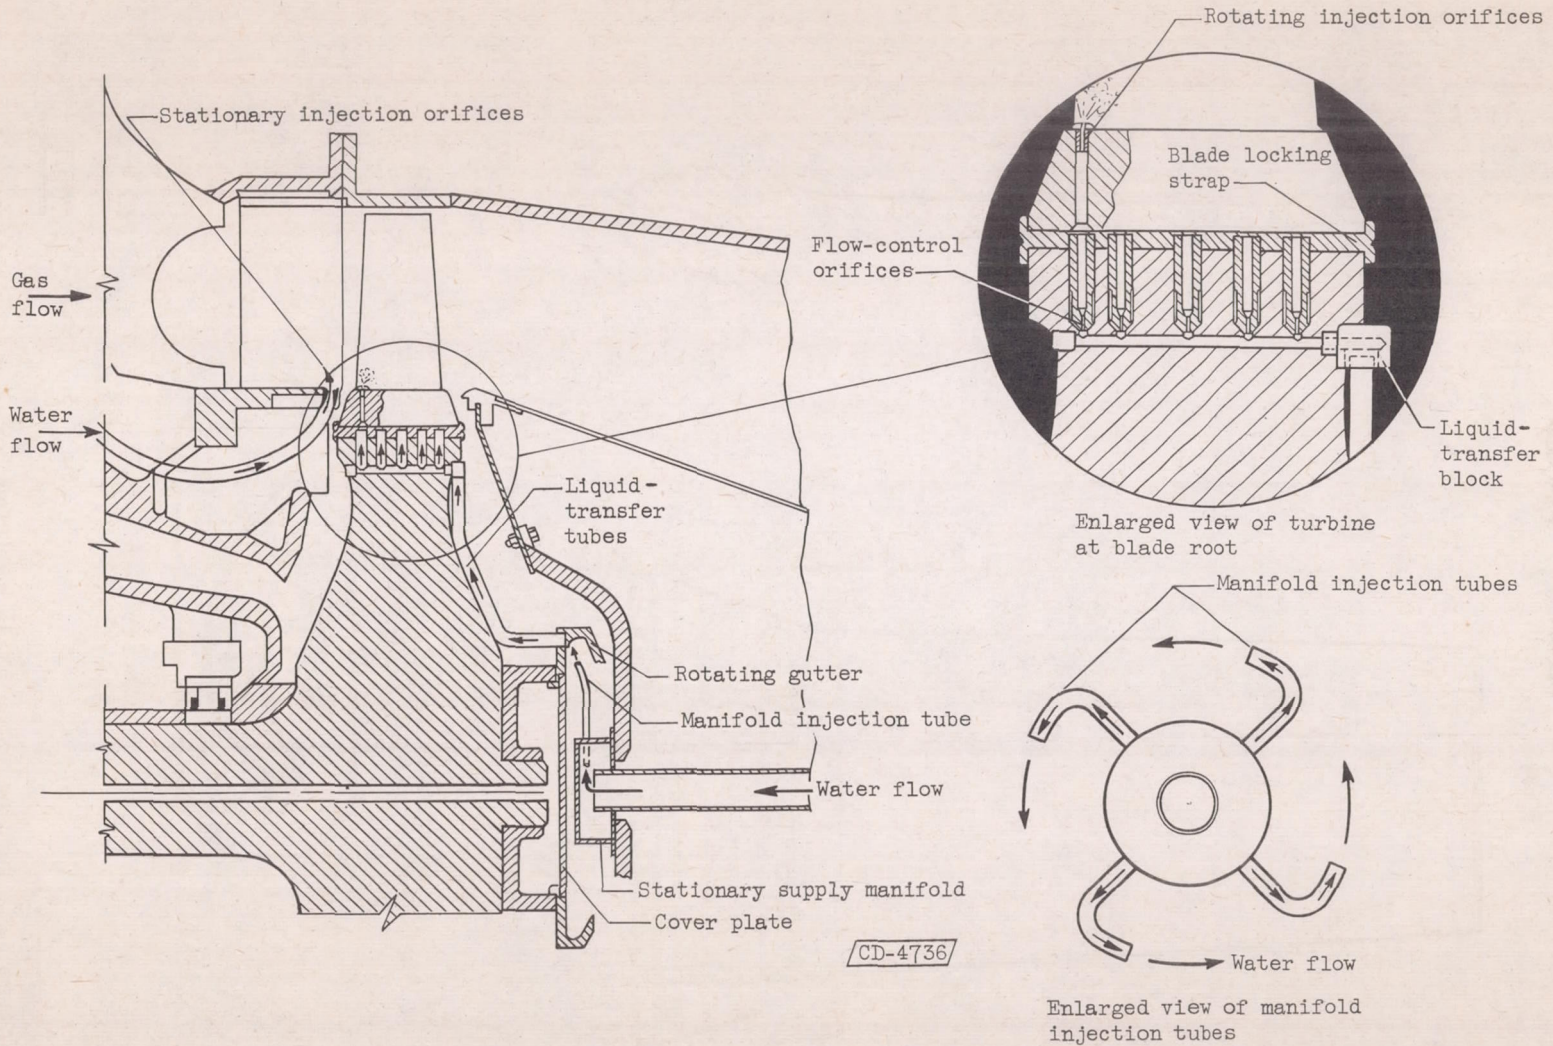
Figure 2. - Sectional view of engine showing ducts for water-spray injection from orifices located in turbine rotor blade bases and from stationary orifices in stator diaphragm.

Rotating injection system. - The rotating injection configuration employed in this investigation was one that provided nearly uniform cooling of the blade when used in conjunction with the proper stationary injection configuration (ref. 4). Various components of the rotating injection system are illustrated in figure 2 and the design details are described in reference 4. The four test blades provided with injection orifices in the blade base were spaced at approximately 90° intervals around the rim of the turbine disk. Water was supplied to a stationary manifold (fig. 2) through stainless steel tubing and discharged to the rotating gutter on the rear face of the rotor. The water then flowed radially through four liquid-transfer tubes, which were fastened to the rotor rear face, and into axial passages in the rotor rim directly beneath each of the test blades. The maximum water flow rate for any rotative speed was established by the metering action of 0.015-inch-diameter flow-control orifices located in plugs force-fitted into the rotor above the rotor axial passages. Centrifugal force on the water permitted it to bridge the slight clearance space between the rotor and blades. Water then flowed through the drilled passages in the rotor blade base and onto the blade surface through the injection orifices. In order to minimize the possibility of clogging the small flow-control orifices, distilled water was used in the rotating injection system.

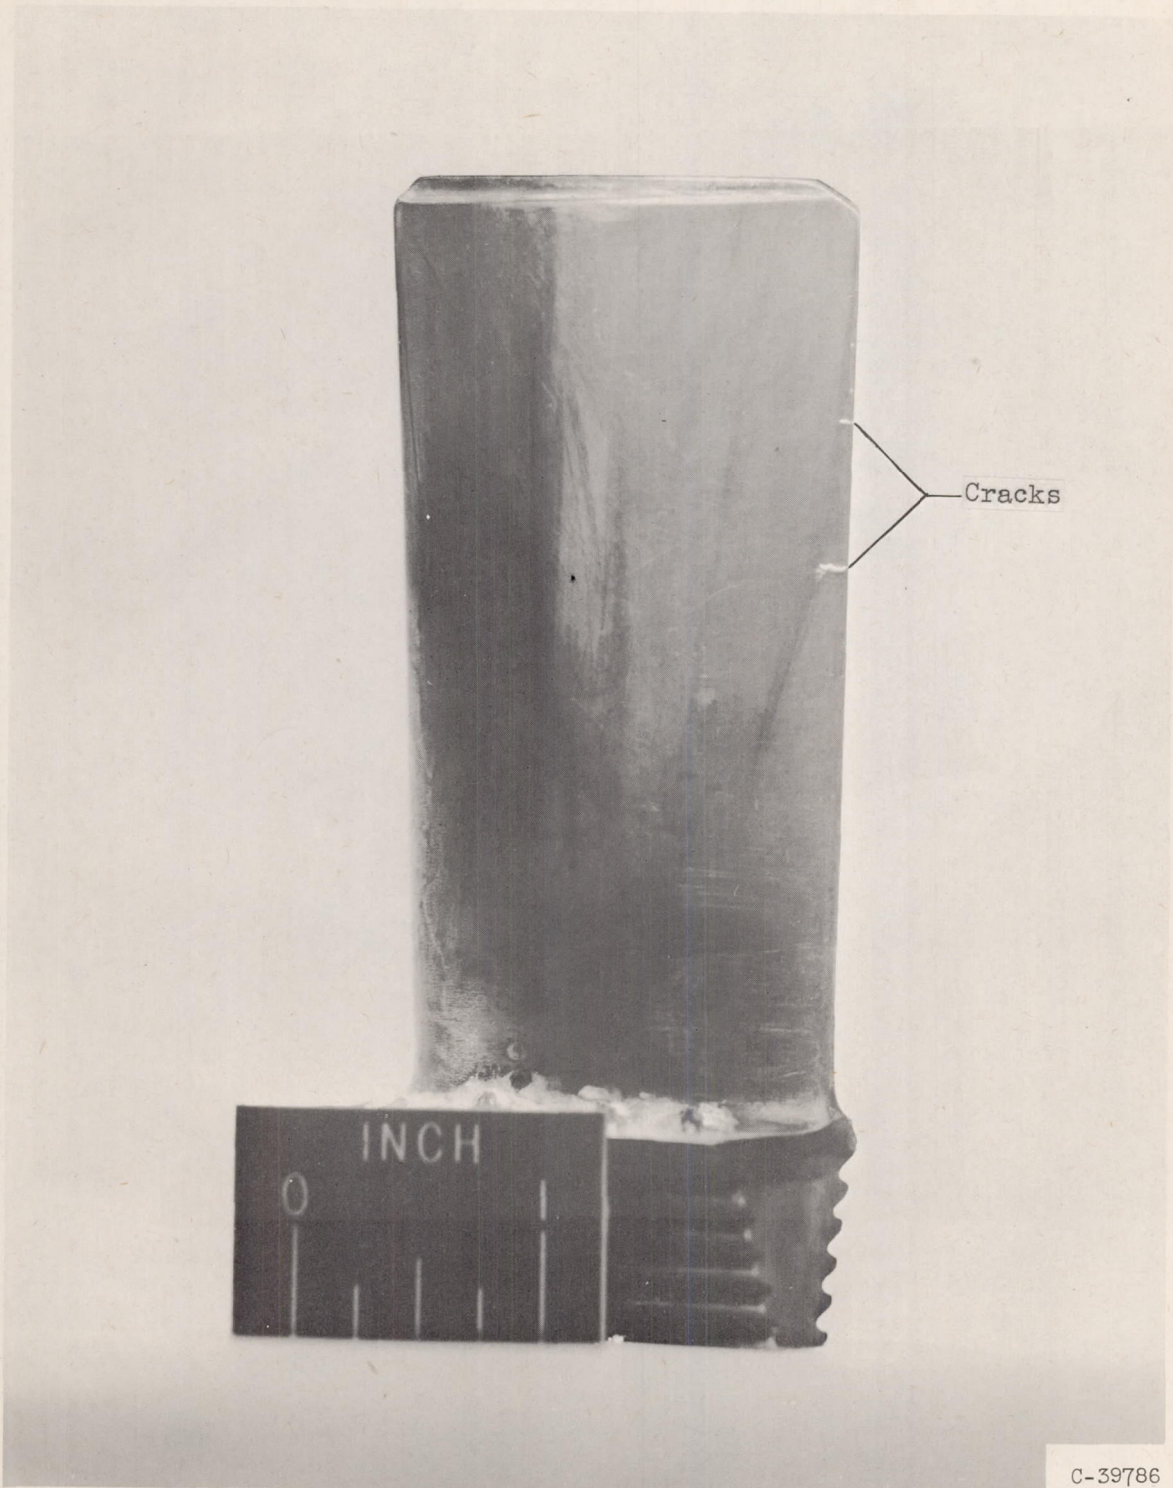
Figure 3. - HS-21 spray-cooled turbine blade with cracks in trailing edges after nine cycles of operation with sudden water injection.

Figure 3 shows an HS-21 blade after 9 cycles. The trailing-edge cracks illustrated in this figure are typical of all those encountered. The fifth blade material, Guy alloy, failed immediately upon introduction of the water during the first cycle. Figure 4 shows the root section of a failed Guy alloy blade. Failure occurred at the blade root section in both Guy alloy test blades. The generally brittle nature of the material probably played a major role in this result. X-ray examination of these Guy alloy blades prior to operation indicated casting imperfections in one blade that may also have contributed to the blade failures.

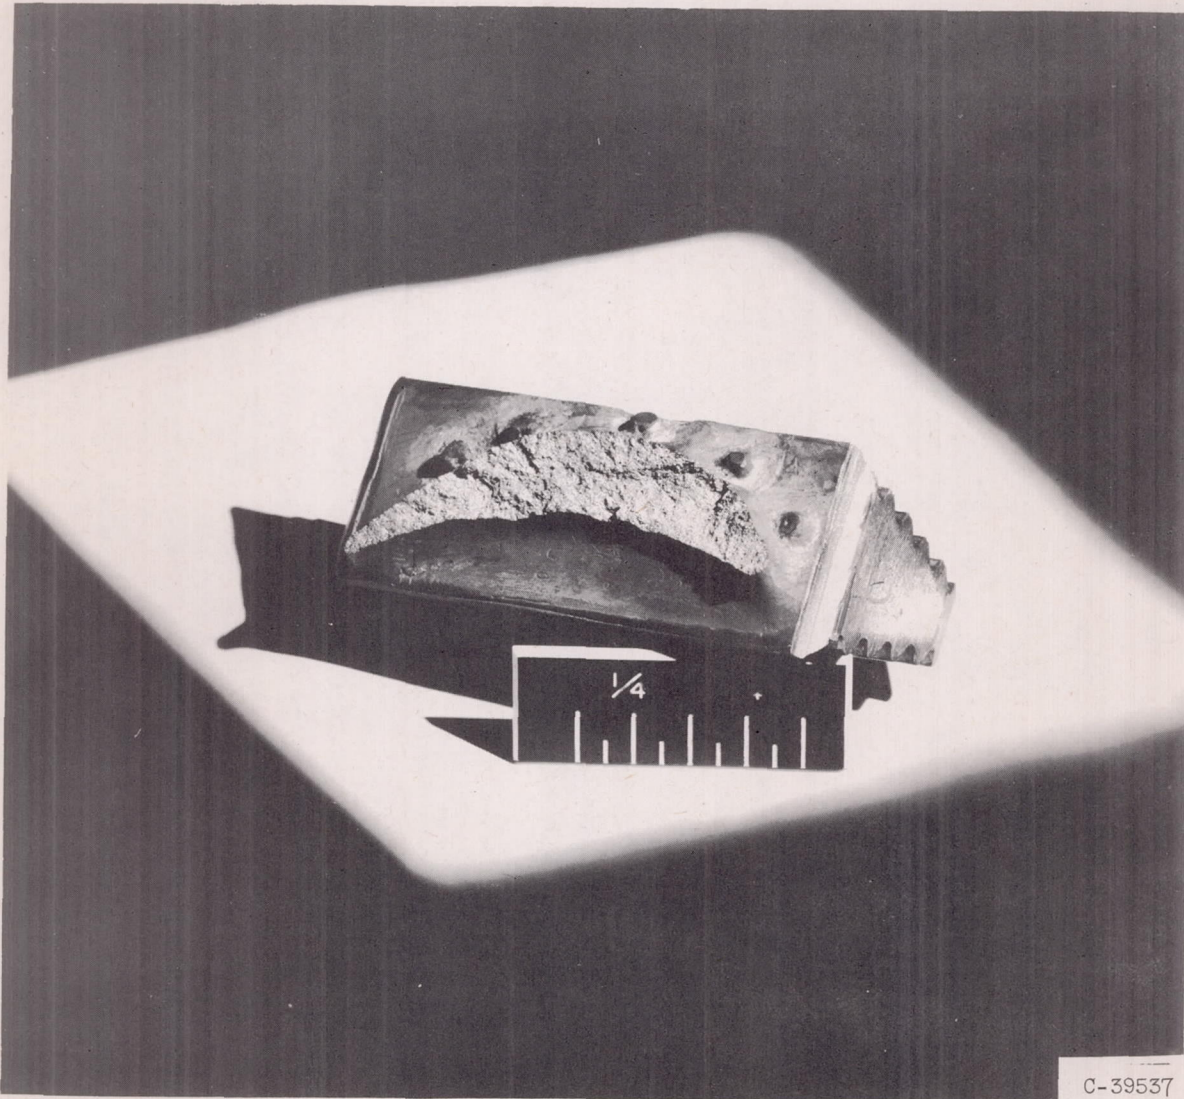
Figure 4. - Root section of Guy alloy spray-cooled turbine blade that failed immediately upon injection of water.

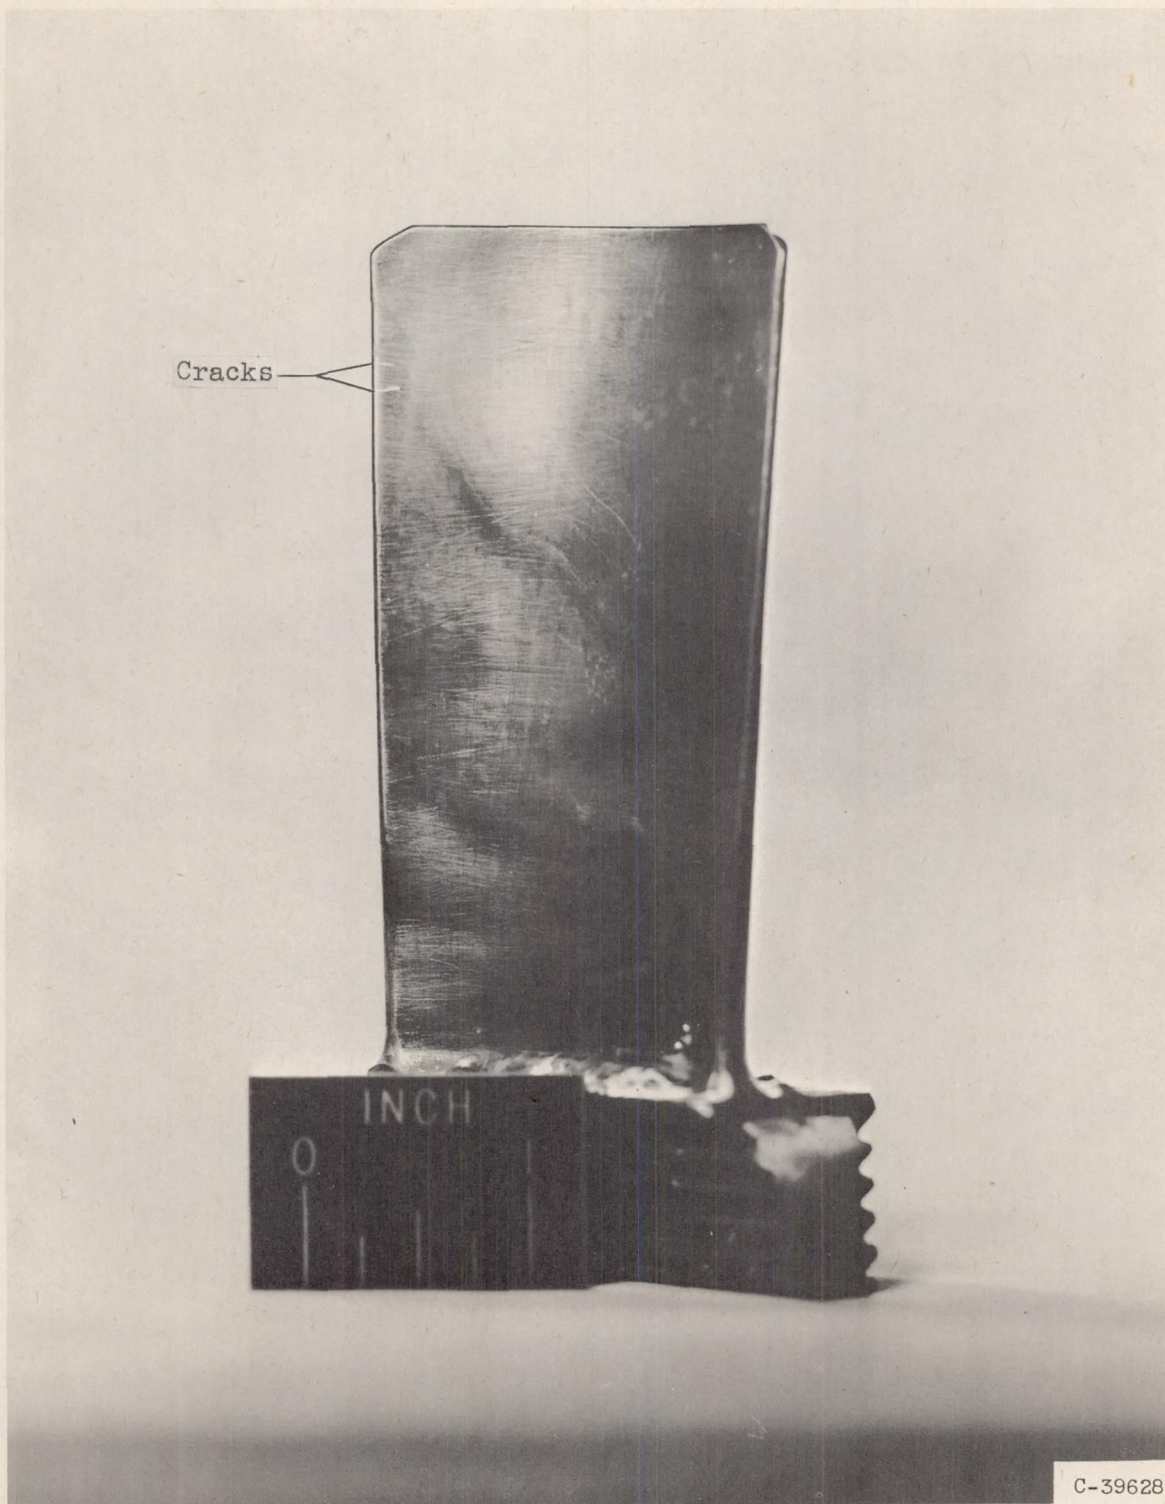
Figure 5. - HS-21 spray-cooled turbine blade with cracks in trailing edge after 10 cycles of operation with gradual water injection.

Tests with gradual water injection. - Two of the blade materials, HS-21 and Inconel X, were investigated under conditions of gradual water injection as a means of reducing the thermal-shock effect. The test blades of these materials had cracks similar to (and in one case even more pronounced than) cracks in the blades investigated under conditions of sudden water injection. Figure 5 shows an HS-21 blade after 10 cycles with gradual water injection. The cracks occurred at about the same spanwise position as on one of the HS-21 blades tested with sudden water injection. The Inconel X blades both showed a pronounced crack at the leading edge as well as smaller cracks at the trailing edge after 10 cycles. Figure 6 shows one of the Inconel X blades after 10 cycles utilizing gradual water injection. A large crack at the leading edge, approximately at the 2/3-span position is clearly visible. A similar crack was observed on the other Inconel X test blade. Slight trailing-edge cracks were observed but are not apparent in this figure. Comparison of these results with those for sudden water injection indicates that no improvement in blade life resulted for HS-21 and Inconel X blades, and further tests with gradual water injection were abandoned.

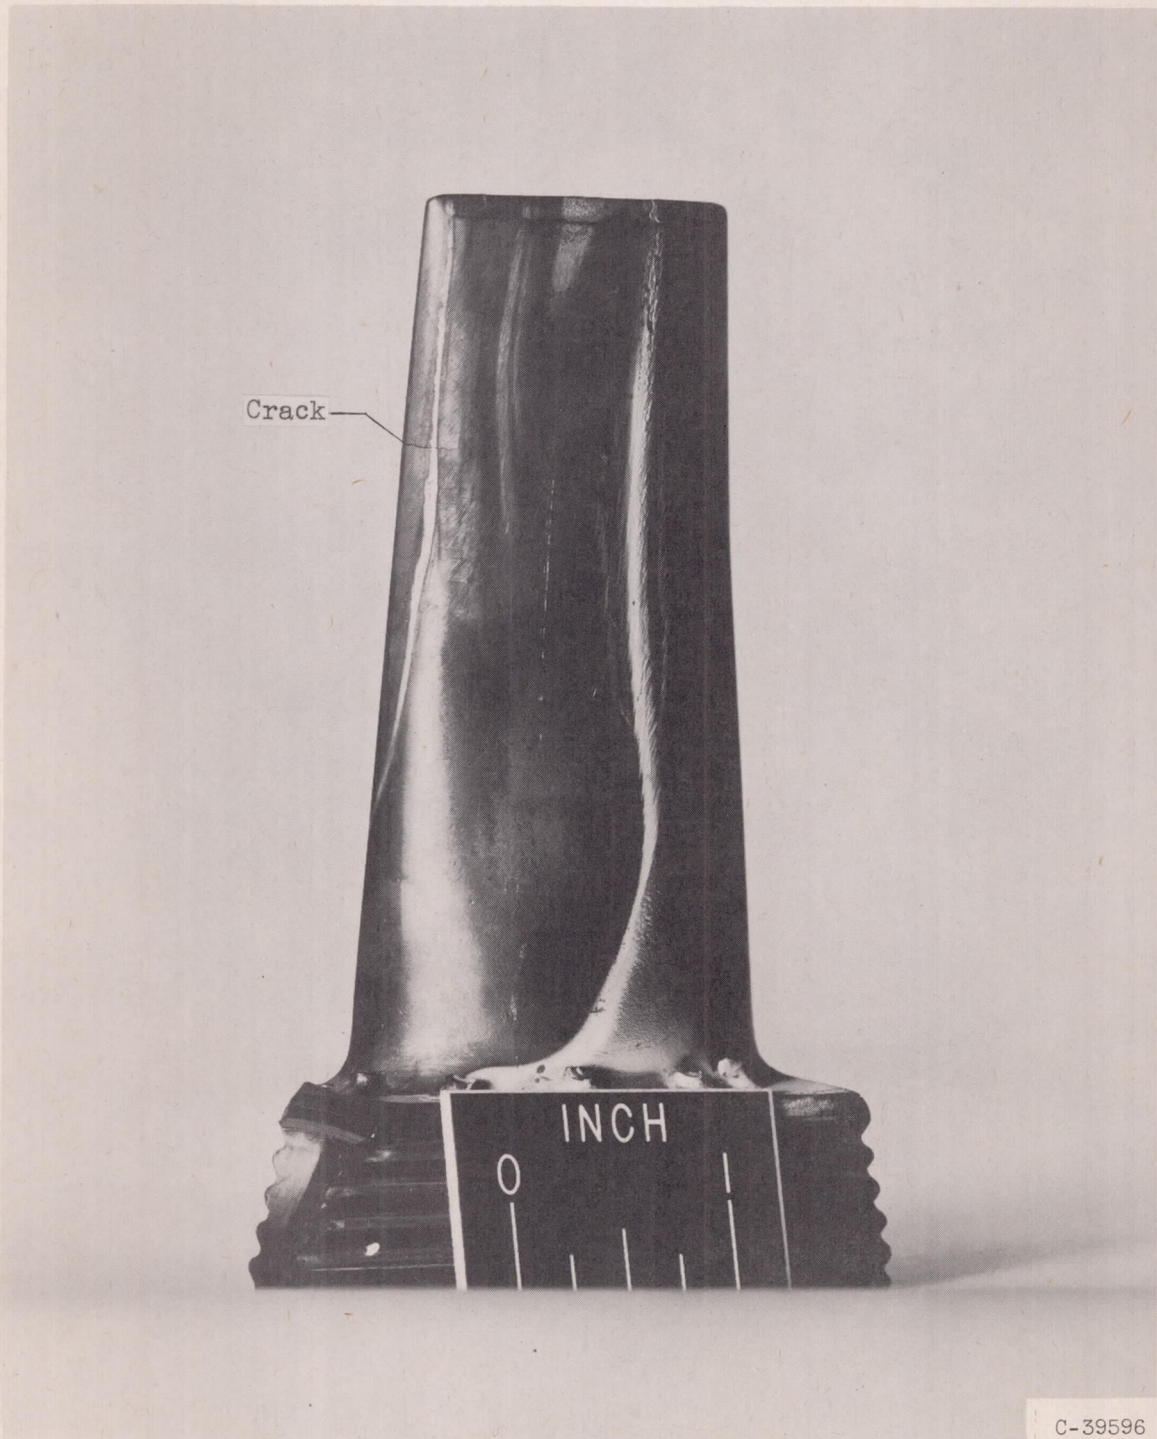
Figure 6. - Inconel X spray-cooled blade with crack in leading edge after 10 cycles of operation with gradual water injection.
