RESEARCH MEMORANDUM

EFFECT OF SEVERAL WING MODIFICATIONS ON THE
LOW-SPEED STALLING CHARACTERISTICS OF THE
DOUGLAS D-558-II RESEARCH AIRPLANE

By Jack Fischel and Donald Reisert

July 18, 1955

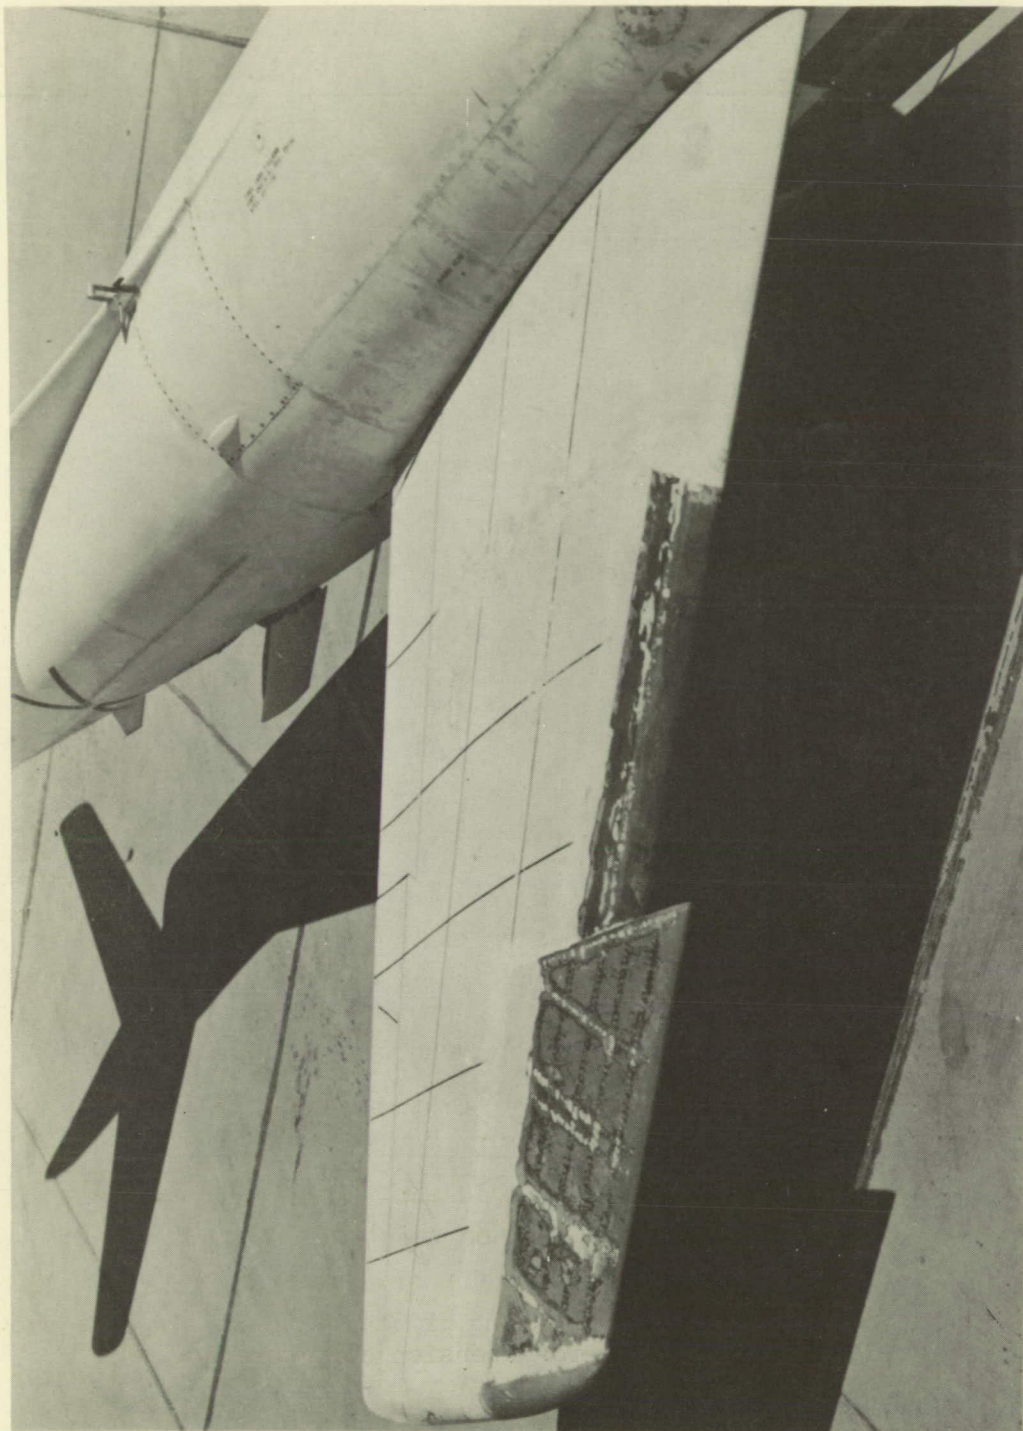
L-87976
Figure 8.- Photograph of the wing of the D-558-II airplane showing the wing leading-edge chord-extension configuration.

The wing leading-edge chord-extensions shown in figures 7 and 8 were similar to those tested in the wind tunnel and found to provide an improvement in static longitudinal stability at moderate angles of attack (refs. 5, 6, and unpublished data). These chord-extensions were approximately the NACA 63-008 airfoil profile in the streamwise direction and were faired into the wing profile over the span of the chord-extensions. In addition, the chord-extensions were faired into the wing tips and the inboard ends were flat-sided in the vertical streamwise plane. For this configuration the wing slats were locked closed and all fences were removed. Addition of the wing chord-extensions increased the wing area from 175 square feet to 181.2 square feet and the wing mean aerodynamic chord from 87.3 inches to 90.0 inches. For convenience in comparison of the data with data for the unmodified airplane, however, all data presented are based on the dimensions of the unmodified airplane.
