NACA RM E55B09

INFLUENCE OF BORIC OXIDE DEPOSITION ON TURBOJET-  
ENGINE OPERATION

By James W. Useller, Richard R. Burley, and  
Wallace W. Velie

Lewis Flight Propulsion Laboratory  
Cleveland, Ohio

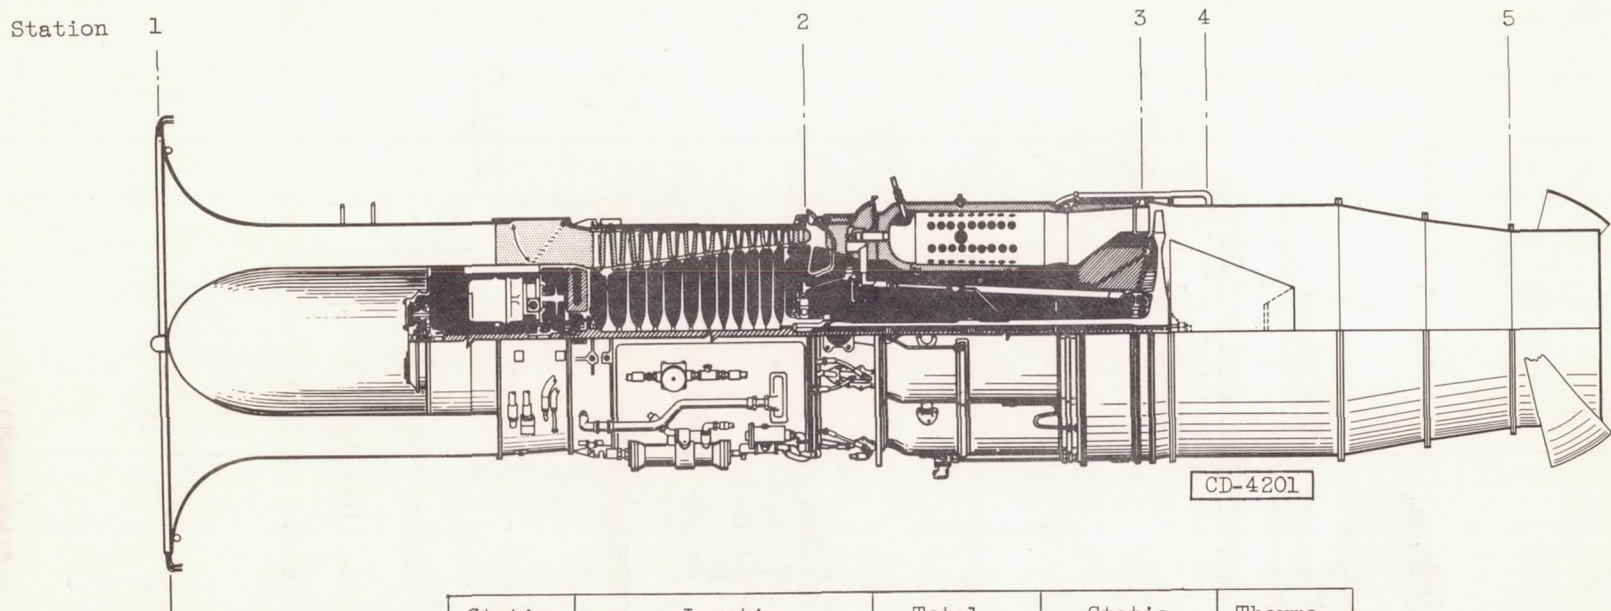
Figure 1. - Schematic diagram of turbojet engine showing location of pressure and temperature instrumentation used throughout engine.

Engine and installation. - The turbojet engine used in this investigation was a standard production model with a nominal thrust rating of 5920 pounds at a rotational speed of 7950 rpm and a turbine-discharge gas temperature of  $1275^\circ$  F. A schematic diagram of the engine is shown in figure 1. The following modifications were made to the engine for operation with the trimethyl borate fuel:

Instrumentation. - The number and location of the total- and static-pressure and temperature instrumentation used in this investigation are tabulated in figure 1. Pressure instrumentation used downstream of the combustor outlet was of the air-purging type to exclude collection of boric oxide and subsequent blockage. A sketch of a typical purging-type pressure probe is shown in figure 3.

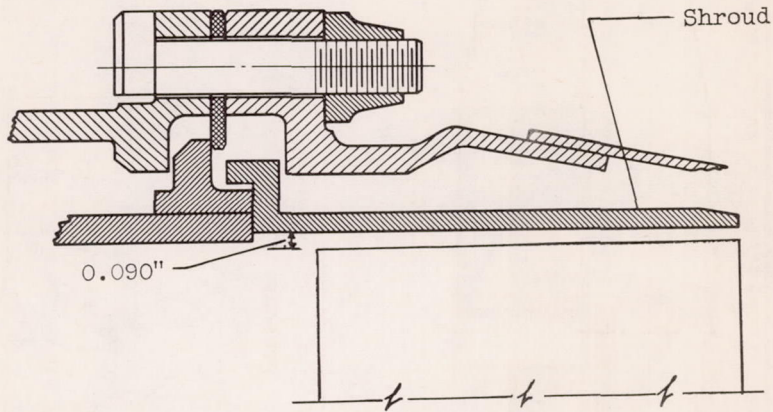
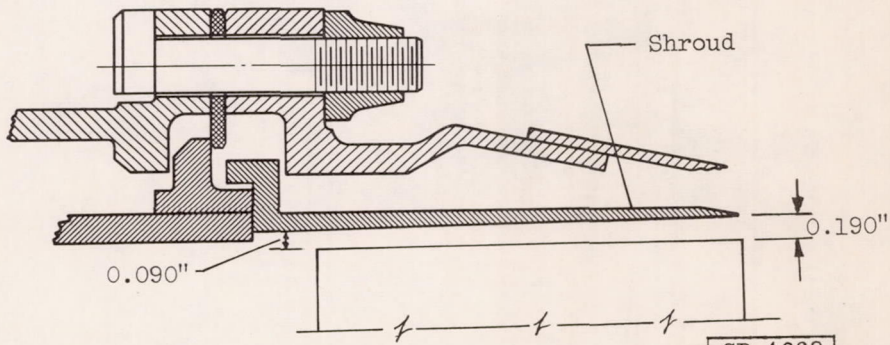
(a) Turbine-clearance increase.

Standard turbine shroud

Modified turbine shroud

Figure 2. - Modifications to standard turbojet-engine components for operation with trimethyl borate fuel.

<sup>a</sup>See fig. 2(a).

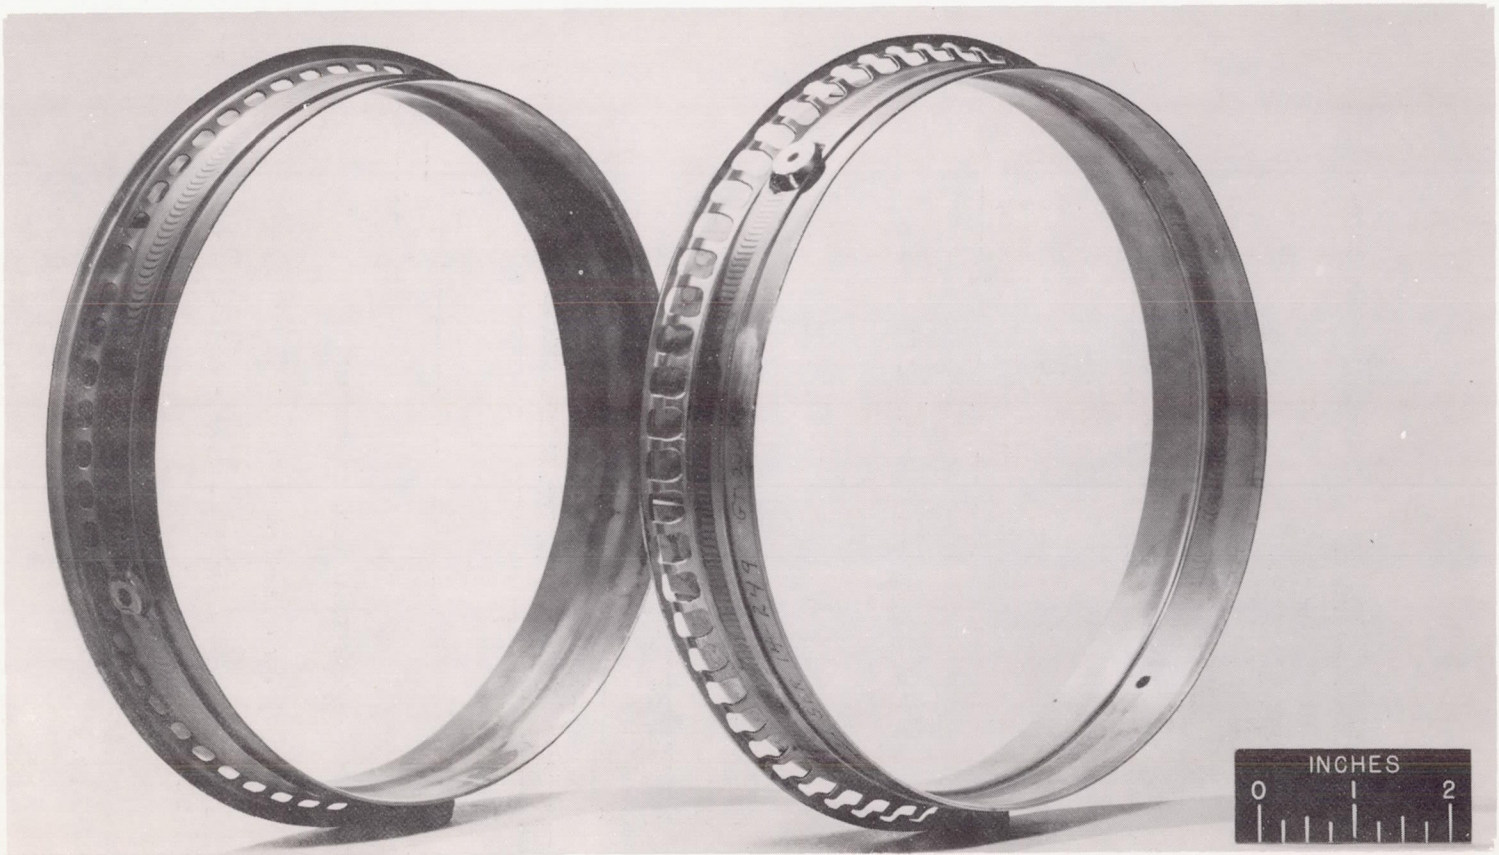
(b) Combustor-outlet retainer-ring modification.

Original

Modified

Figure 2. - Concluded. Modifications to standard turbojet-engine components for operation with trimethyl borate fuel.

<sup>b</sup>See fig. 2(b).

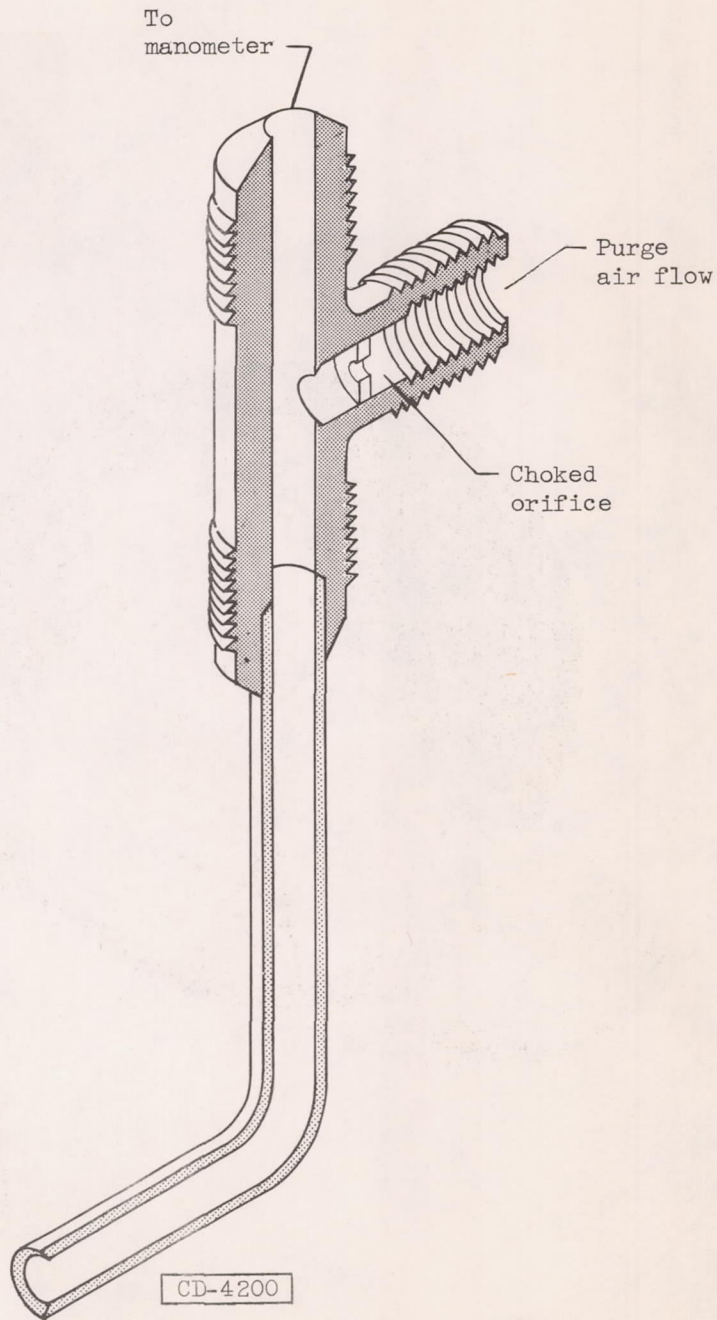
Figure 3. - Purge-type pressure instrumentation used downstream of combustor to prevent boric oxide interference.

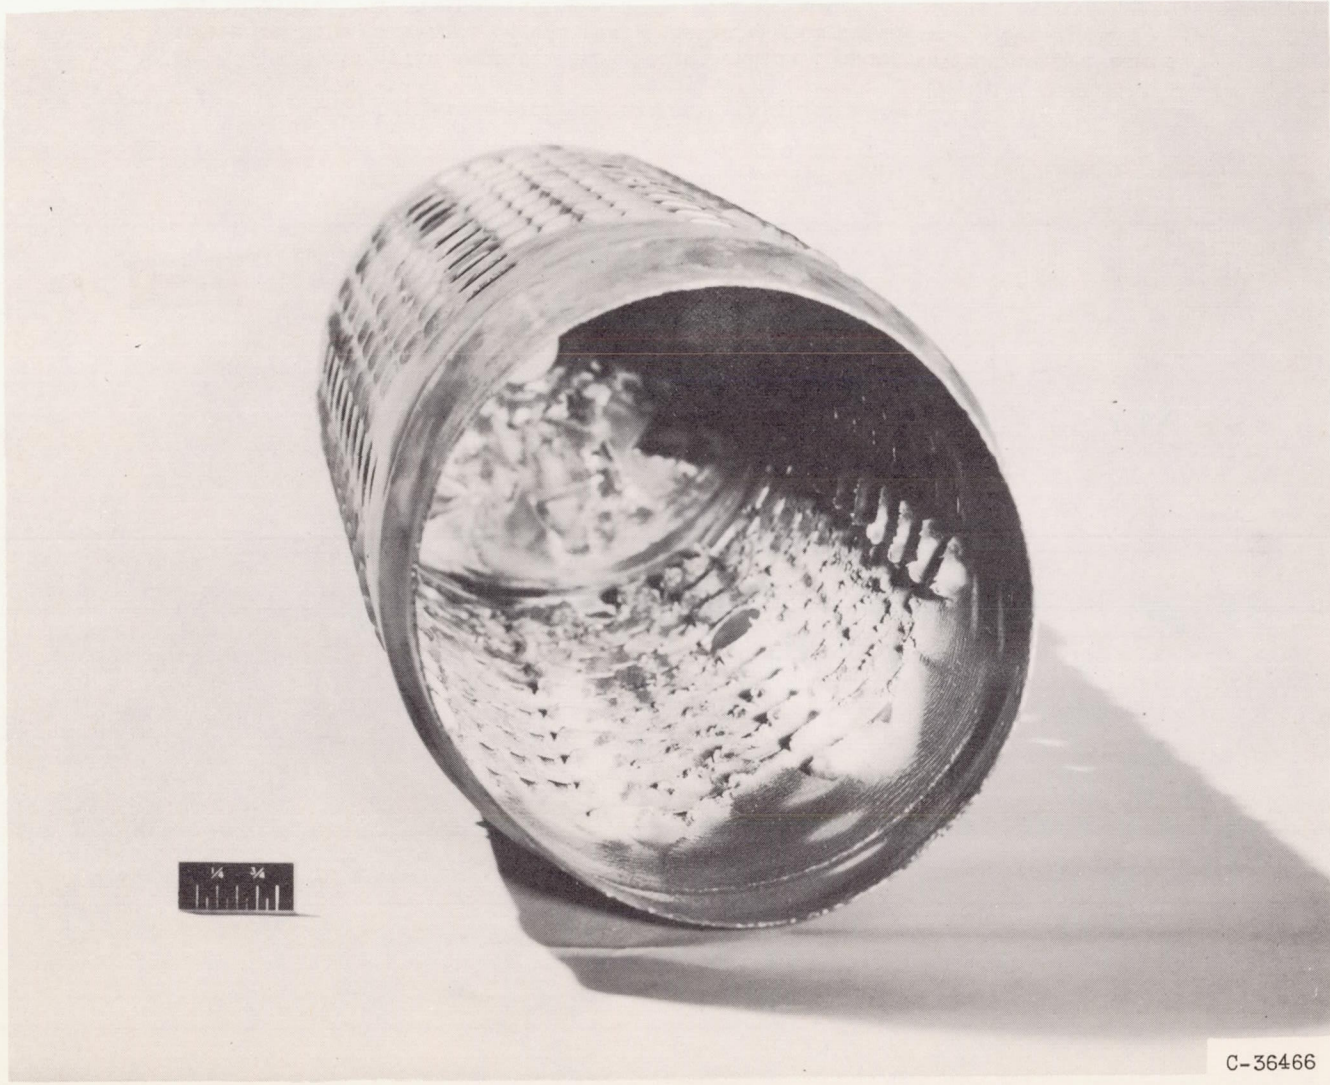
Figure 4. - Boric oxide deposits in combustion chamber following engine start and 7 minutes operation. Configuration A.

Boric oxide deposition. - The engine was successfully started with trimethyl borate fuel, and only moderate immediate deposits were formed on the relatively cold metal components during starting. The deposits

in a typical combustion chamber are shown in figure 4 following the engine start and approximately 7 minutes of operation.

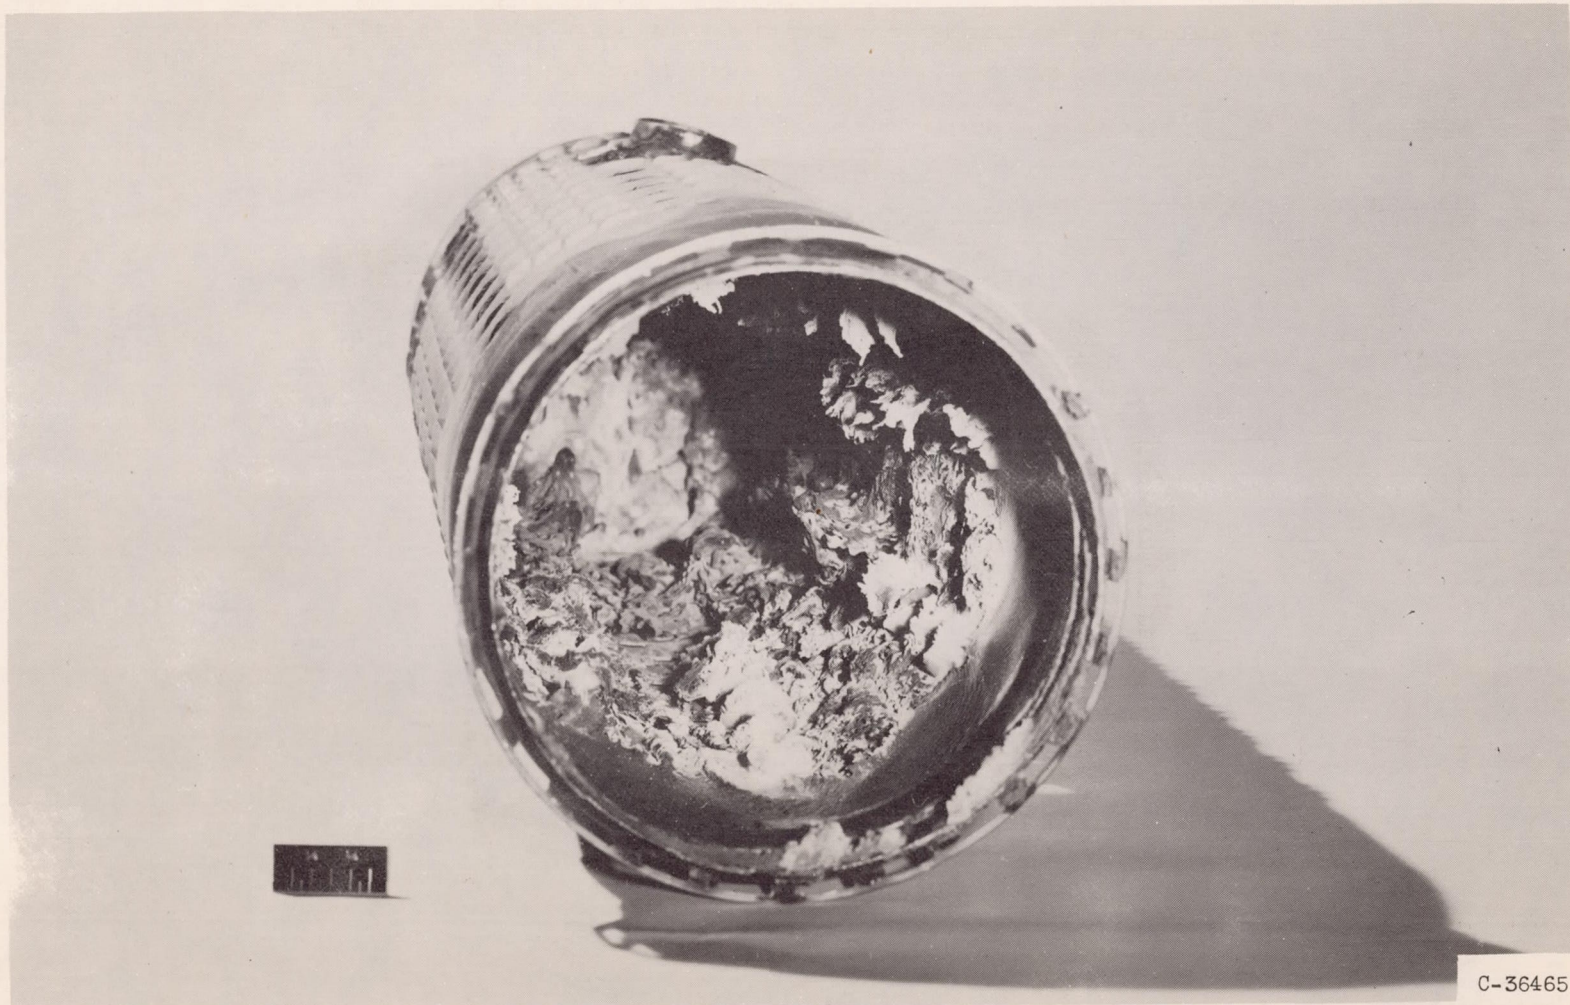
(a) Combustion chamber with thimbled liner.

Figure 5. - Boric oxide deposits in turbojet-engine components following 2 hours operation with trimethyl borate fuel. Rated engine conditions. Sea-level static operation. Configuration A.

After 2 hours of operation with trimethyl borate fuel, the boric oxide deposits reached the state shown in figure 5. Figure 5(a) shows the deposits in the combustion-chamber liner that was equipped with thimbles that protruded into the combustion chamber to provide additional turbulence in the combustion zone. The liner of figure 5(b) was without thimbles. Both types of combustor liner are in use in current turbojet engines. In general, these deposits were vitreous with only minor crystalline formations. Figure 5(c) compares a clean liner with the plugging obtained longitudinally in a combustion-chamber liner after 2 hours of operation with trimethyl borate. The oxide deposits in the tail pipe following the same period of operation are shown in figure 5(d). Although some crystalline deposits are visible, the majority of the oxide in the tail pipe is in a vitreous form and appears to have been plastic while still molten.

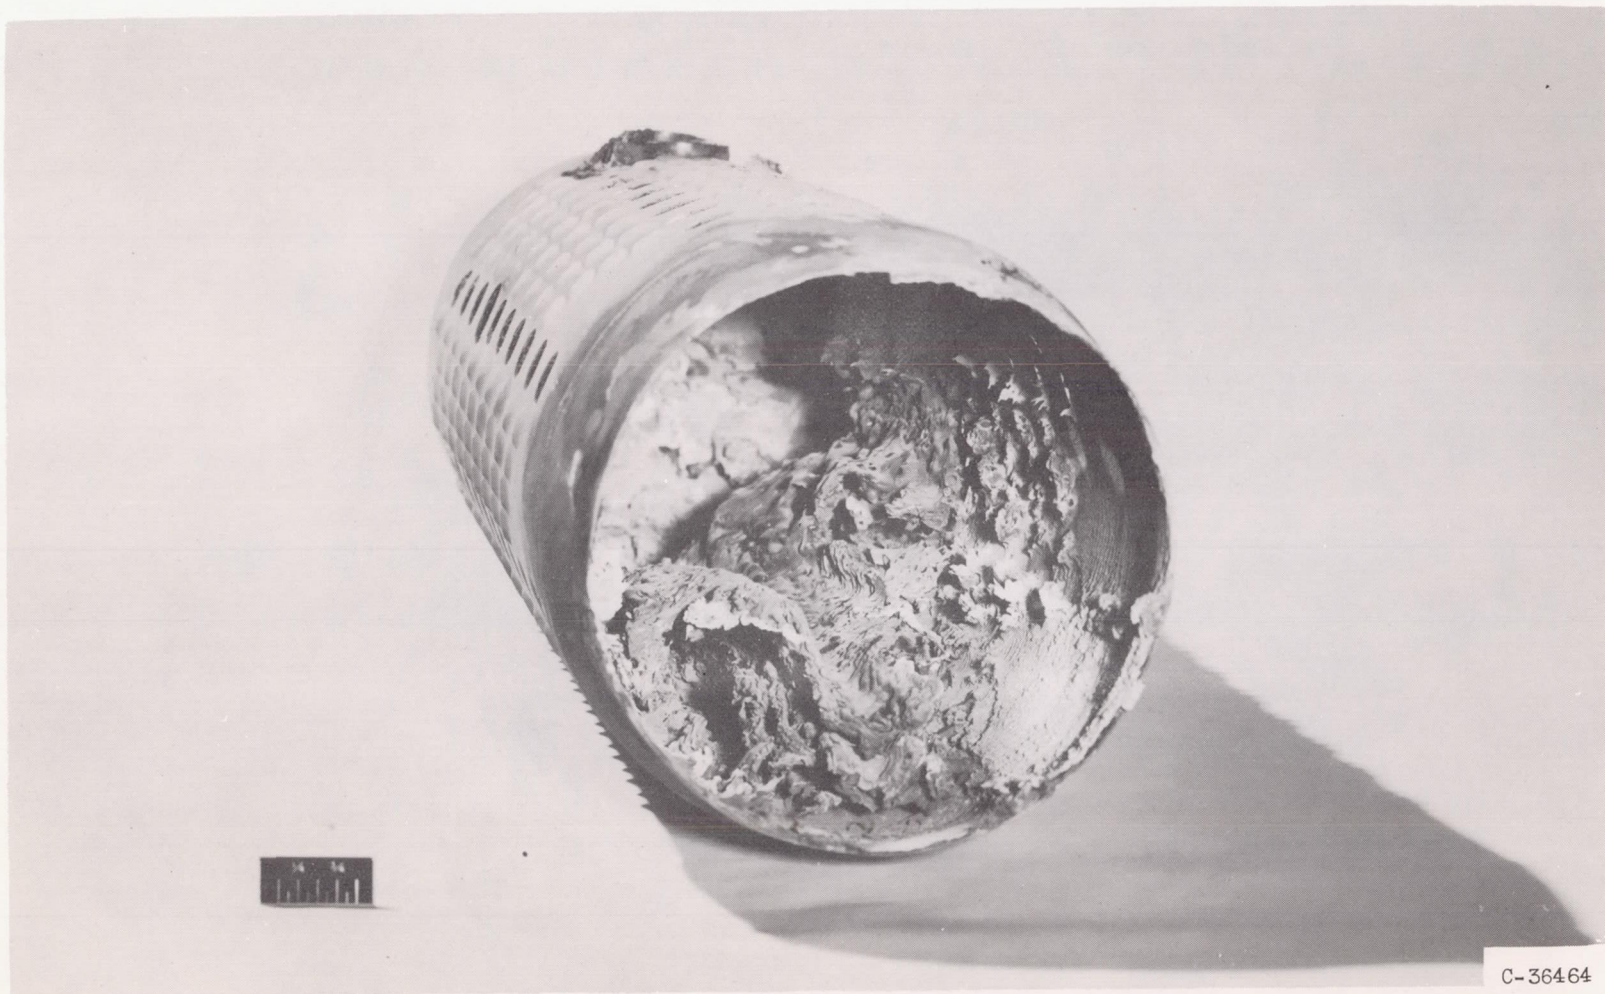
(b) Combustion chamber with thimbleless liner.

Figure 5. - Continued. Boric oxide deposits in turbojet-engine components following 2 hours operation with trimethyl borate fuel. Rated engine conditions. Sea-level static operation. Configuration A.

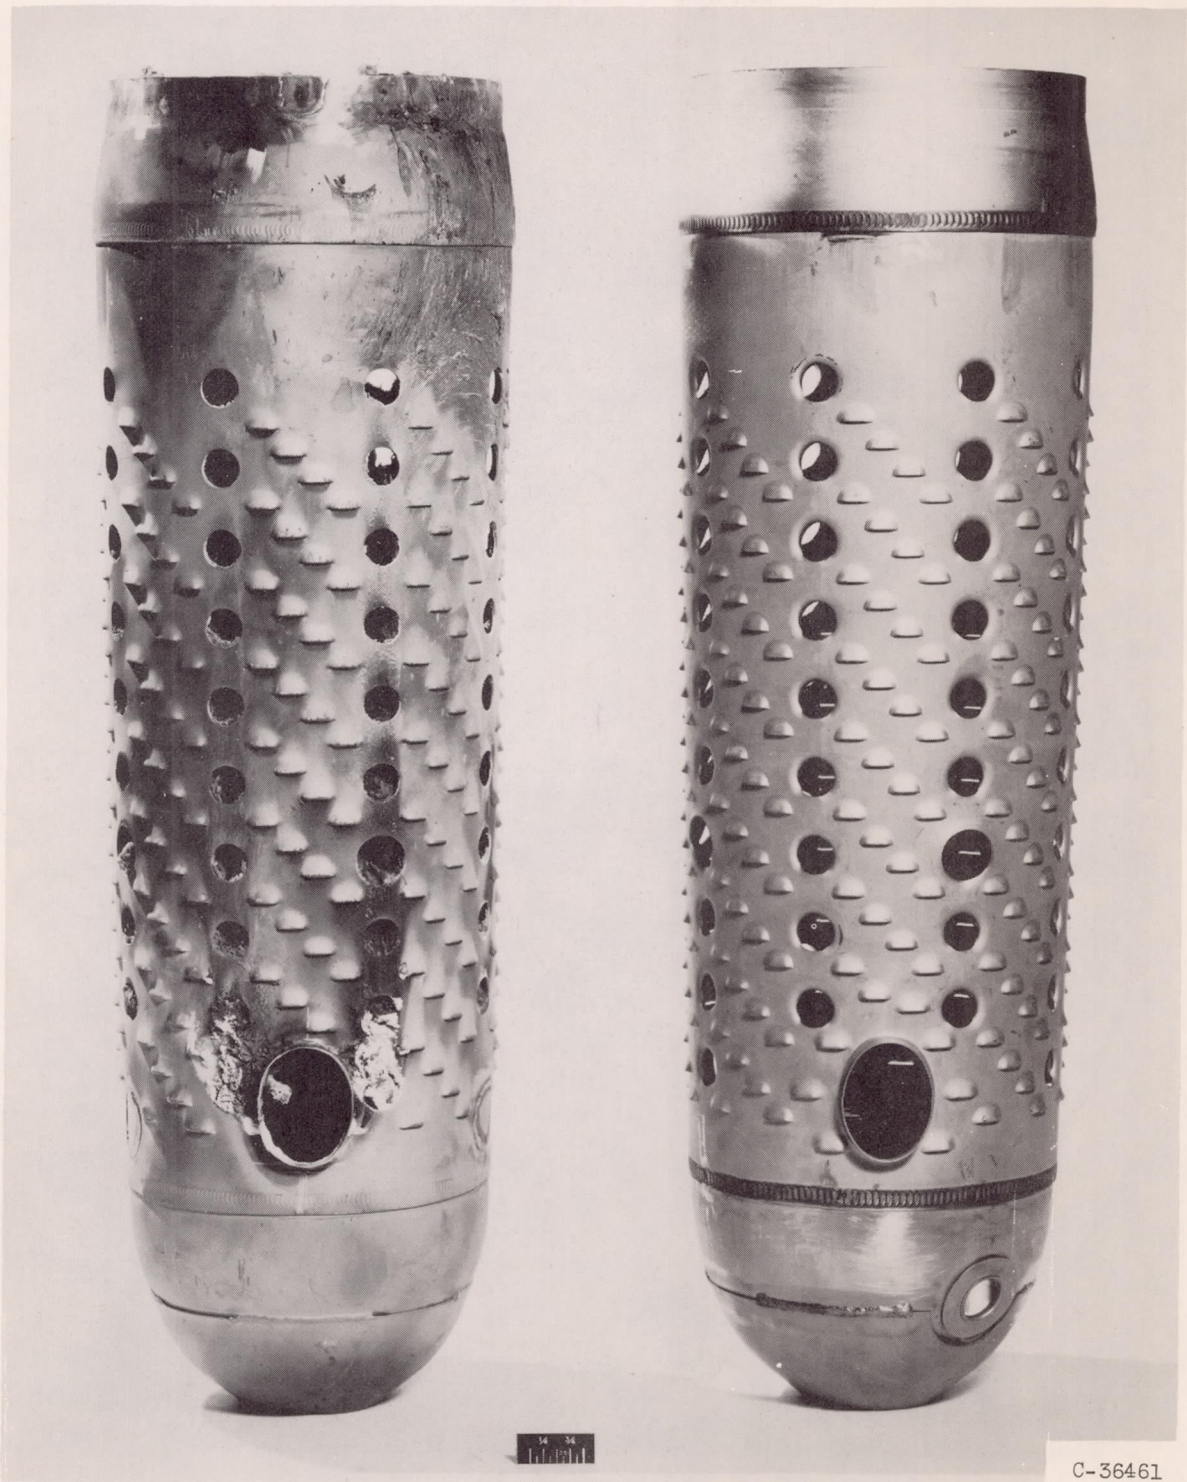
(c) Longitudinal boric oxide deposition compared with clean combustion-chamber liner.

Figure 5. - Continued. Boric oxide deposits in turbojet-engine components following 2 hours operation with trimethyl borate fuel. Rated engine conditions. Sea-level static operation. Configuration A.

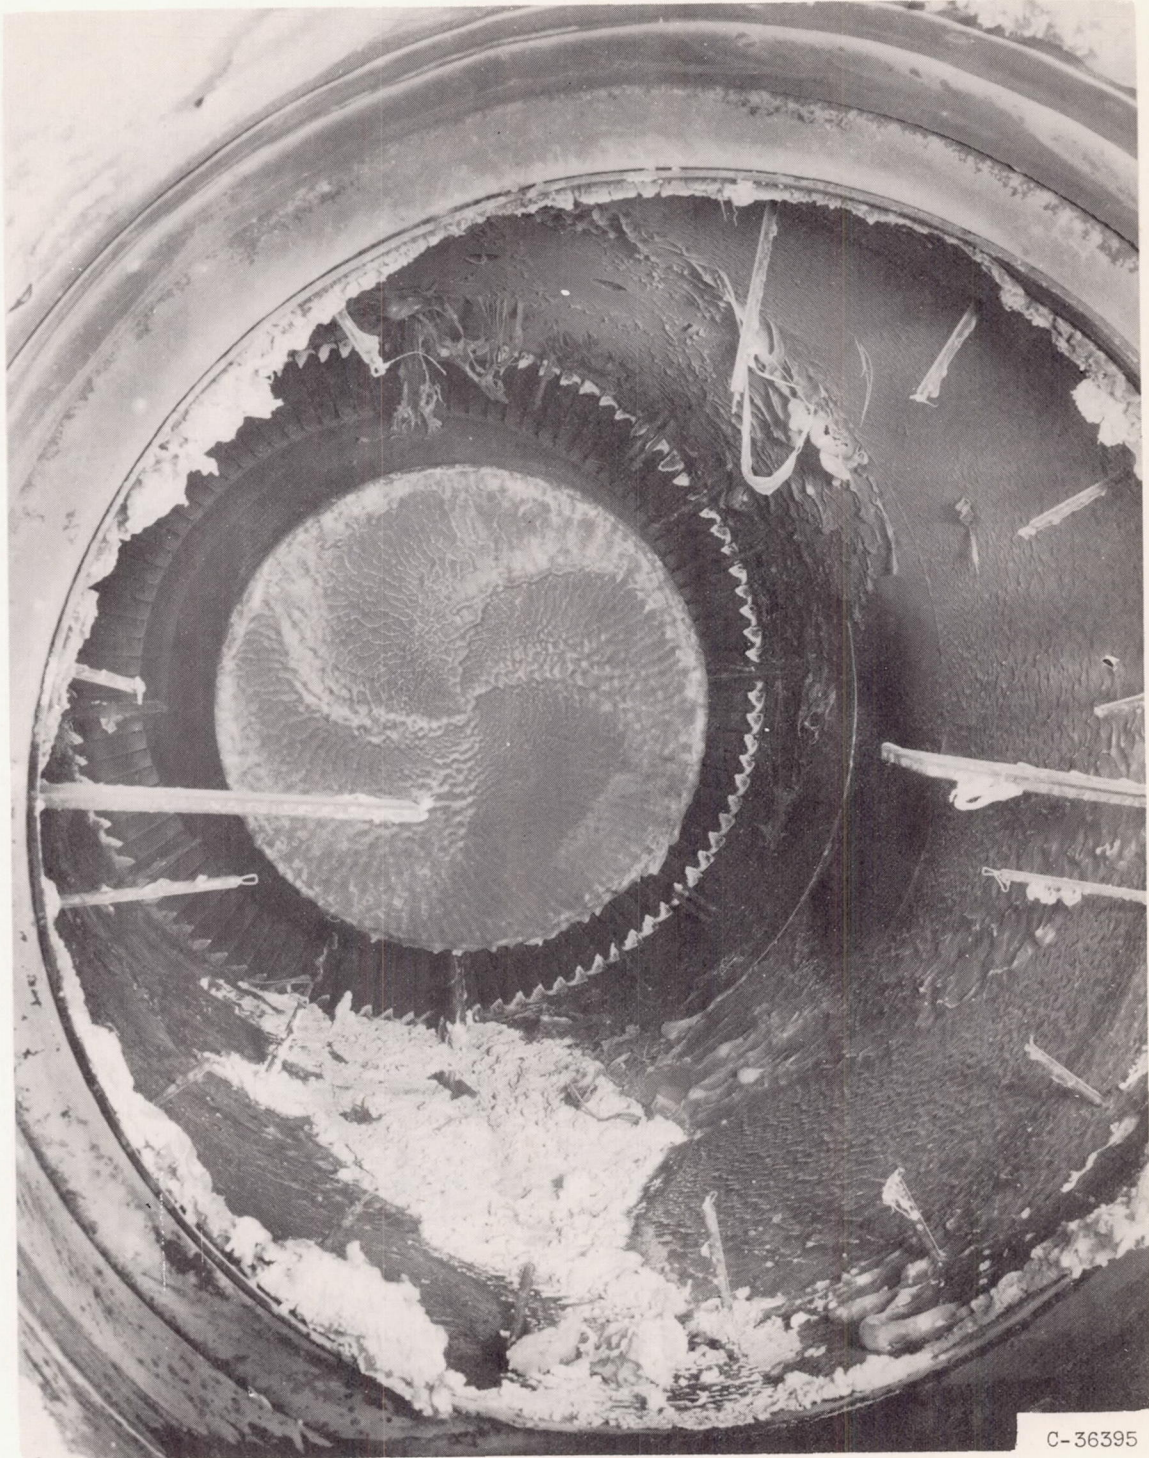
(d) Engine tail pipe, looking upstream.

Figure 5. - Concluded. Boric oxide deposits in turbojet-engine components following 2 hours operation with trimethyl borate fuel. Rated engine conditions. Sea-level static operation. Configuration A.

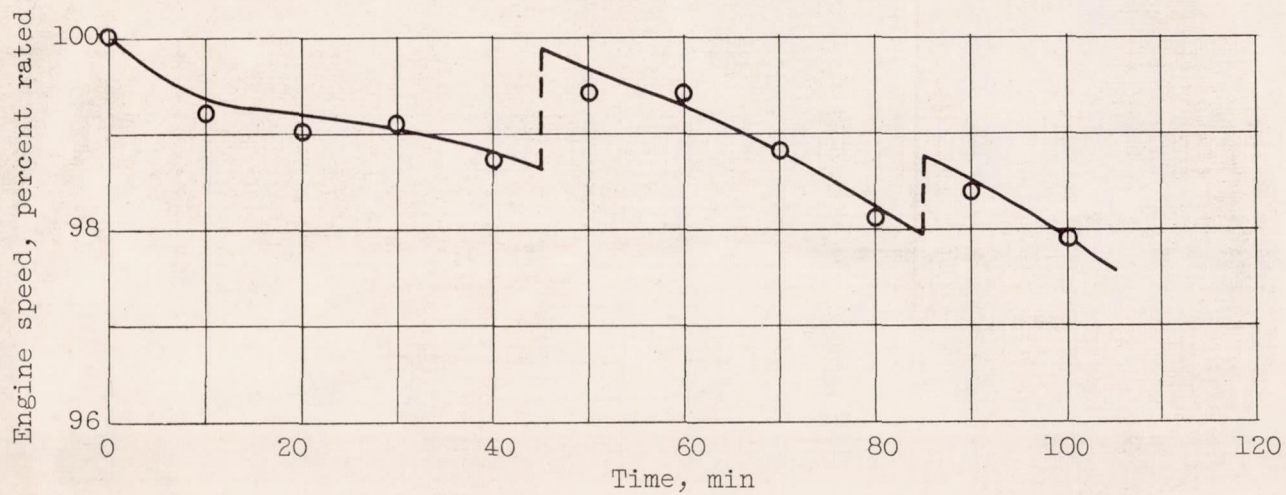
Figure 6. - Effect of boric oxide deposition on turbojet-engine speed.  
Configuration A. Tail-pipe temperature,  $1700^{\circ}$  R.

Engine operation and performance. - The engine fuel flow and exhaust-nozzle area were maintained constant and the engine speed was permitted to decrease so as to maintain a tail-pipe temperature of  $1700^{\circ}$  R. A maximum engine speed decrease of 2 percent was measured using configuration A as is shown in figure 6. The decrease in engine speed resulted from the increased combustor pressure drop and the burning of some of the fuel downstream of the turbine as may be seen from figure 7. Operation was for 100 minutes with trimethyl borate fuel. The irregular changes in engine speed that occurred at 45 and 85 minutes are believed to have resulted from the dislodgment of sizeable quantities of the accumulated deposits of the combustor.

It should again be noted that for these data the cooling air to the nozzle diaphragm was blocked and that they are therefore not comparable to the data of figure 6.

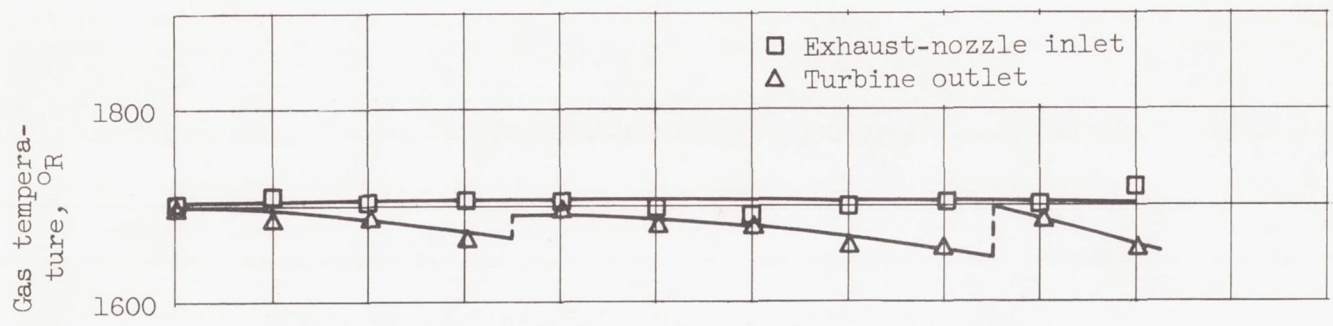
(a) Turbine-outlet and exhaust-gas temperatures.

Figure 7. - Effect of boric oxide deposition on turbojet-engine temperatures and pressures. Configuration A. Tail-pipe temperature, 1700° R.

It may be seen in figure 7(a) that the turbine-discharge gas temperature decreased with time (increasing deposition) while the gas temperature measured downstream (at the exhaust-nozzle inlet) remained constant.

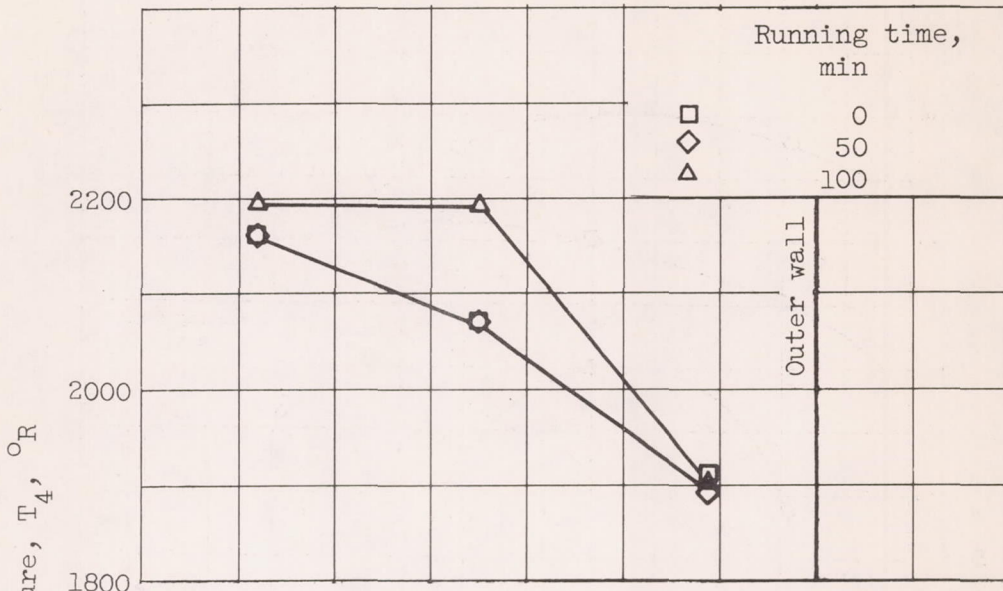
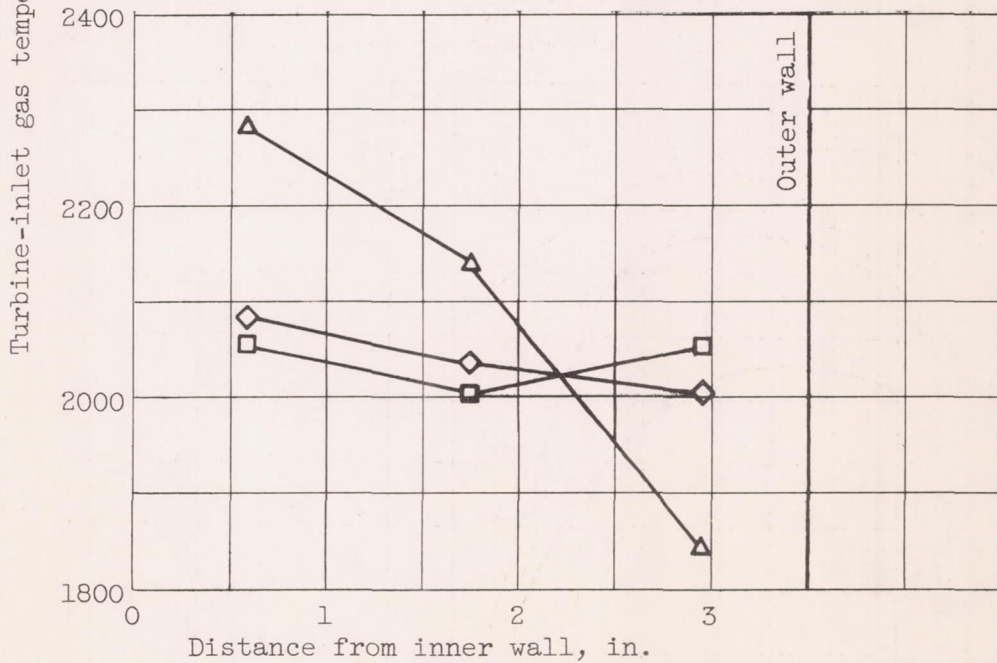
(a) Downstream of combustor 1.

(b) Between combustors 1 and 2.

Figure 8. - Change in turbine-inlet gas-temperature profiles with operation of engine with trimethyl borate fuel.

at the turbine. Figure 8 shows the variation of the turbine-inlet gas-temperature profile at several time intervals during operation with trimethyl borate. Radial profiles are shown for positions at the turbine inlet both behind a combustor and between two combustors. In general, a somewhat steeper temperature gradient from the inner portion of the annulus to the outer wall was experienced with prolonged use of the trimethyl borate. The change in turbine-inlet total-pressure profile is shown in figure 9. Both the circumferential pressure distribution (fig. 9(a)) and the radial pressure profile (fig. 9(b)) were slightly altered because of the accumulated boric oxide deposits in the combustor.

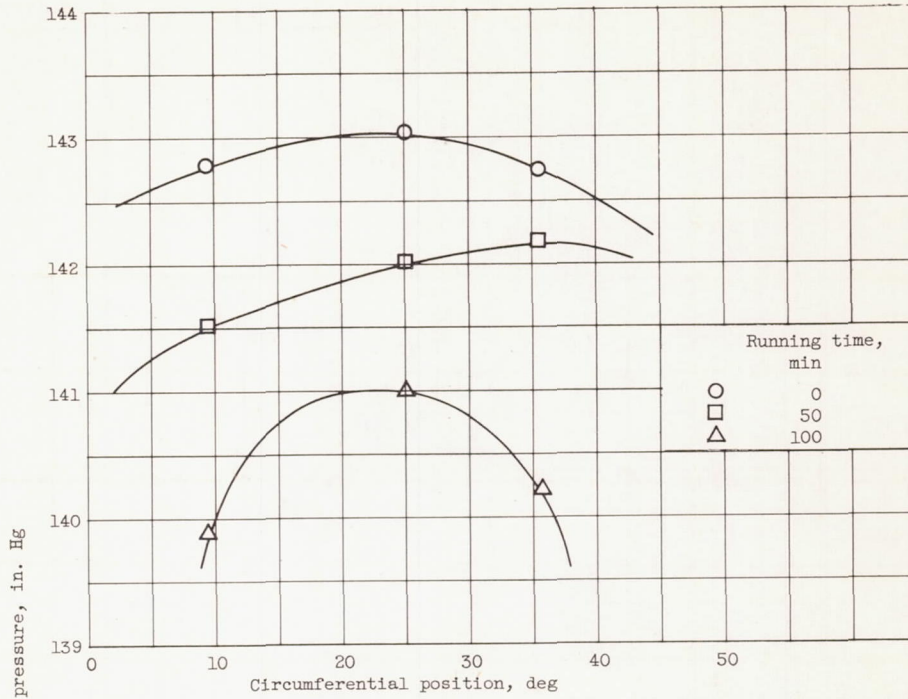
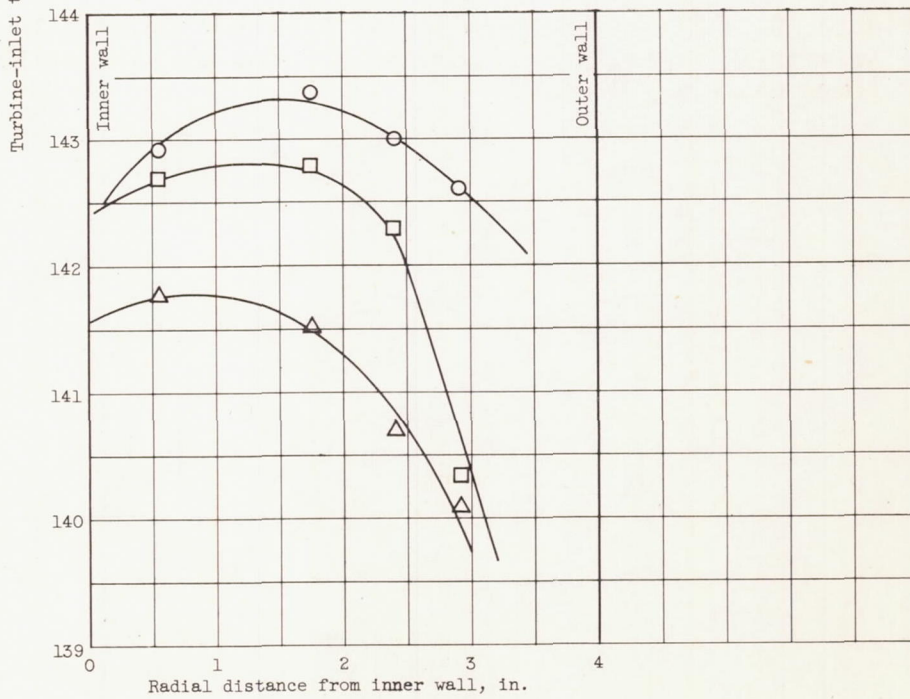
(a) Circumferential pressure distribution.

(b) Radial pressure profile.

Figure 9. - Change in turbine-inlet total-pressure profiles with operation of engine with trimethyl borate fuel.

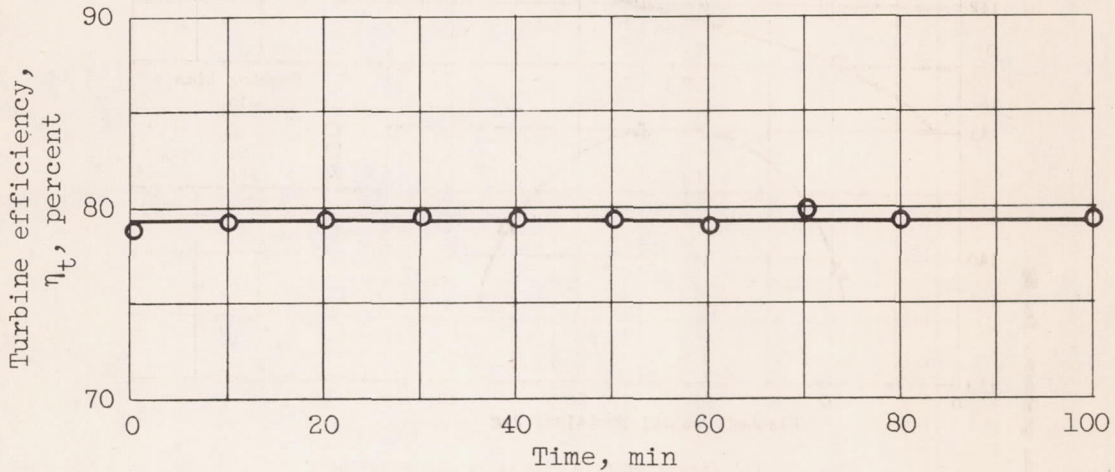
Figure 10. - Effect of operation of turbojet engine with trimethyl borate fuel on turbine efficiency. Tail-pipe temperature, 1700° R.

Although the combustor deposits altered the temperature and pressure distributions entering the turbine nozzle diaphragm, these relatively small changes were insufficient to produce a measurable change in the performance of the turbine. The turbine efficiency (fig. 10) remained constant throughout the investigation even with prolonged use of the trimethyl borate fuel.

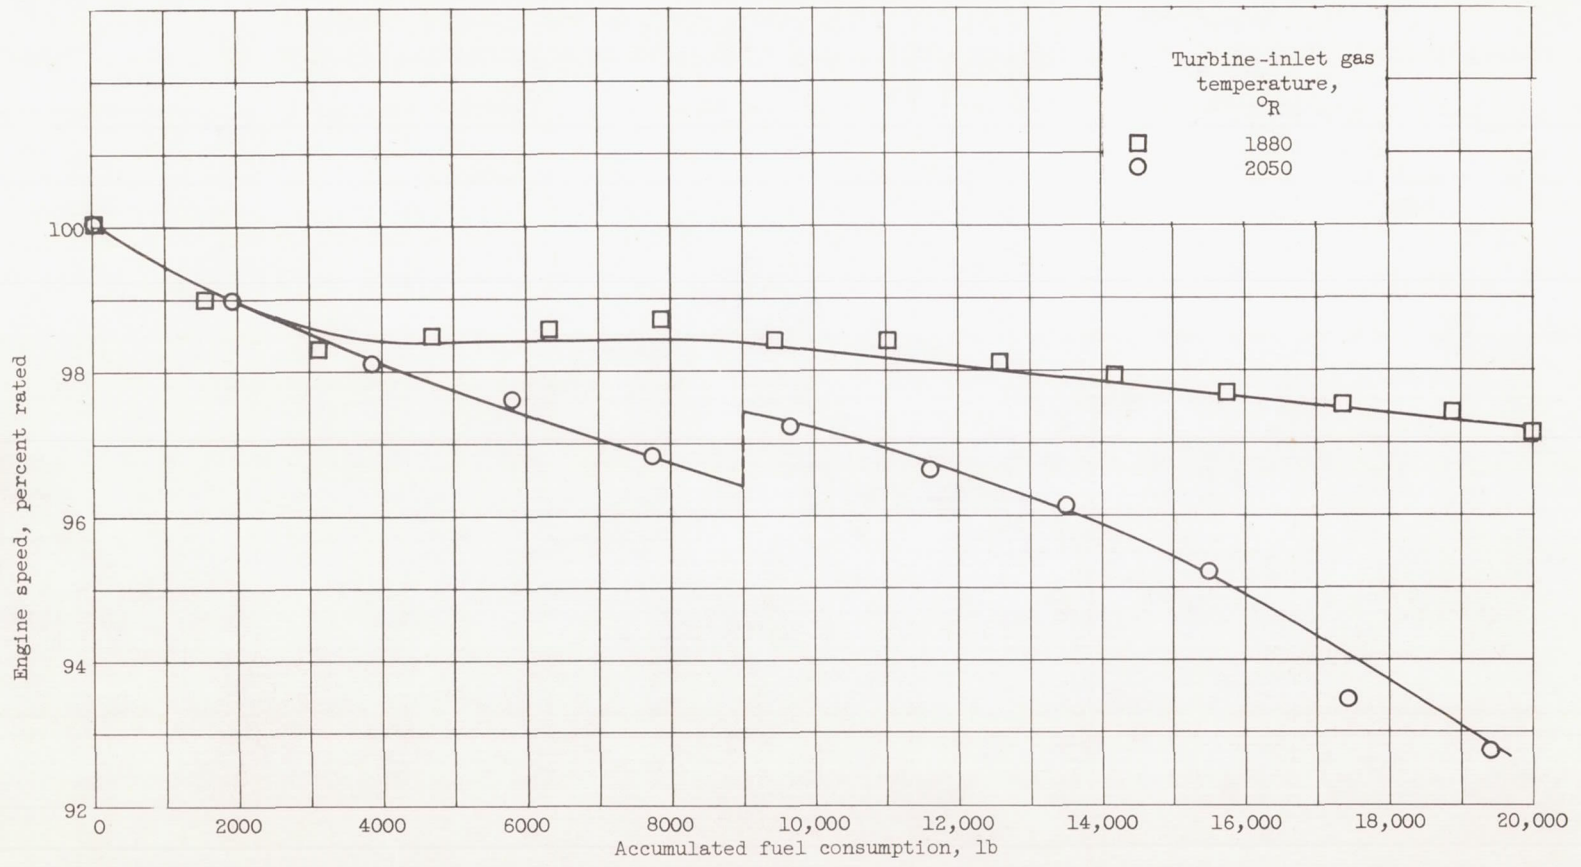
Figure 11. - Effect of turbine-inlet temperature on engine speed deterioration during operation with trimethyl borate fuel. Configuration B.

With a turbine-inlet gas temperature of 1880° R, the oxide deposits caused a 2.8-percent reduction in engine speed. Increasing the turbine-inlet temperature from 1880° to 2050° R caused an engine speed deterioration of approximately 7.3 percent for a similar quantity of fuel consumption. The comparison of engine speed deterioration is presented in figure 11 as a function of the accumulated fuel consumption because the oxide formation is a direct function of the fuel-consumption rate. The tendency to increase the oxide deposition and consequently cause a further speed deterioration with increased turbine-inlet temperature is contrary to expectation. It was anticipated that the erosion would increase with the reduced viscosity of the deposits at higher temperatures. The increased oxide-deposition trend, however, has been substantiated with unpublished data obtained on a single combustor rig. It is believed that this incongruity can be explained by the fact that the

The irregularity of the data shown in figure 11 for 2050° R turbine-inlet temperature for fuel consumption between 8000 and 10,000 pounds is again believed due to a sudden change in the deposits such as would occur with the dislodgment of large pieces.

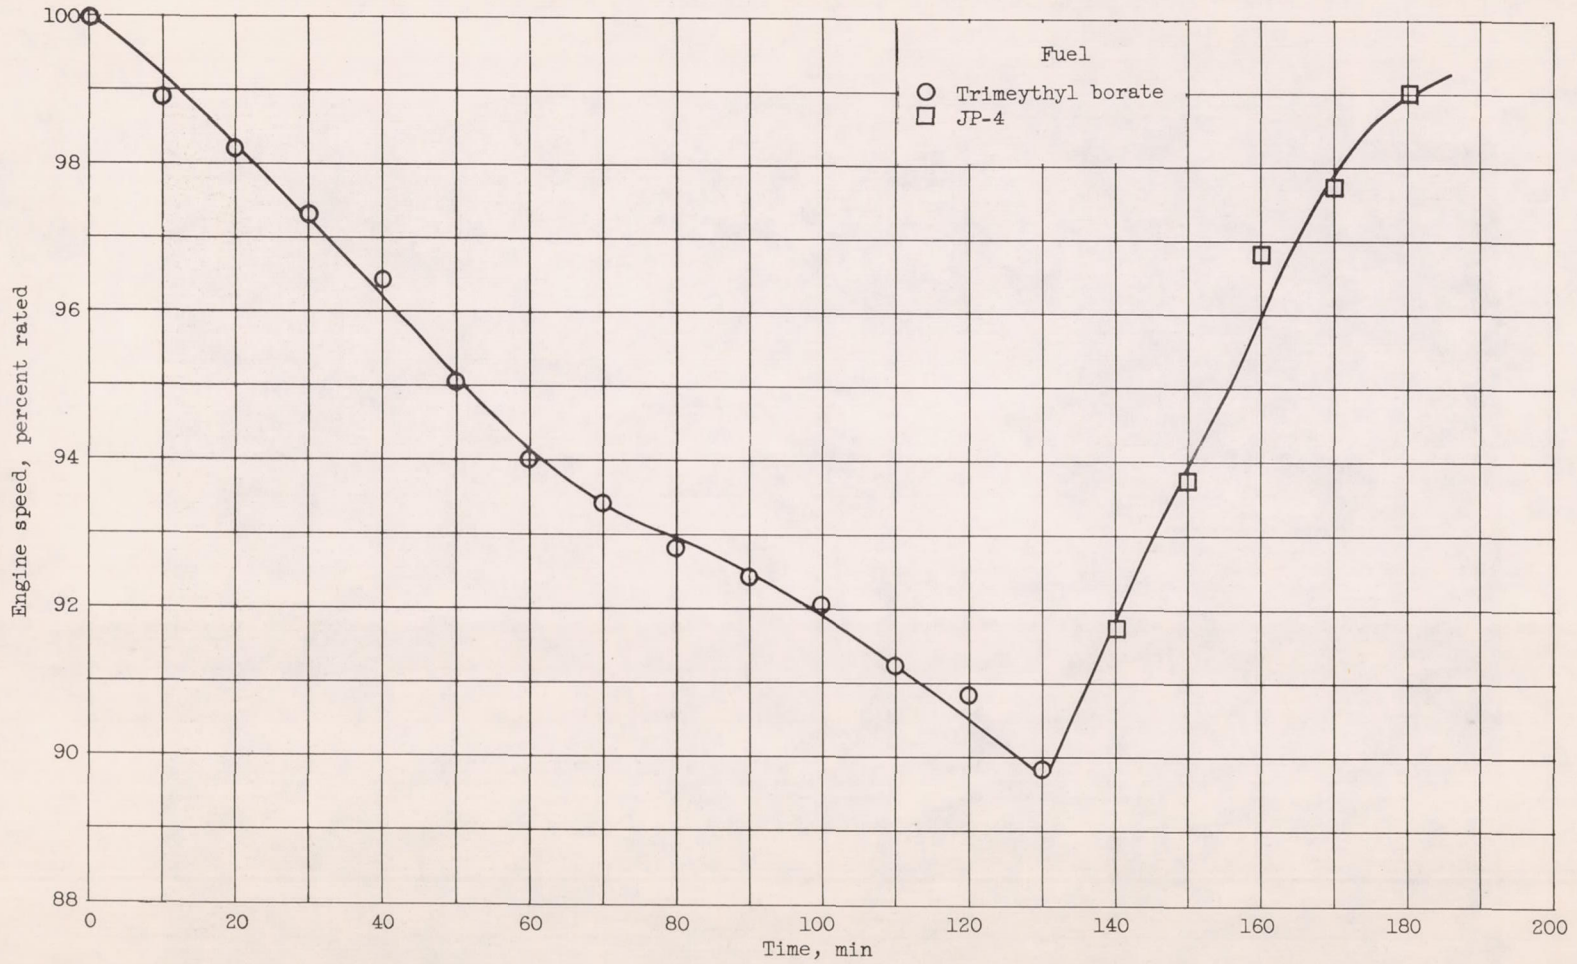
Figure 12. - Dissipation of effect of boric oxide deposits in engine components by operation with JP-4 fuel. Rated engine conditions. Static sea-level operation. Tail-pipe temperature, 1700° R. Configuration C.

Subsequent to the operation with trimethyl borate, the engine was operated with hydrocarbon fuel, JP-4. After about 50 minutes of operation with JP-4, the engine speed approached normal operation, as is shown in figure 12, indicating substantial removal of the deposits. Visual inspection showed that the deposits throughout the engine were dissipated by the JP-4 operation. Figure 13(a) shows the deposits in a typical combustor following operation with JP-4 fuel, and figure 13(b) shows the relatively minor deposits remaining in the engine tail pipe.

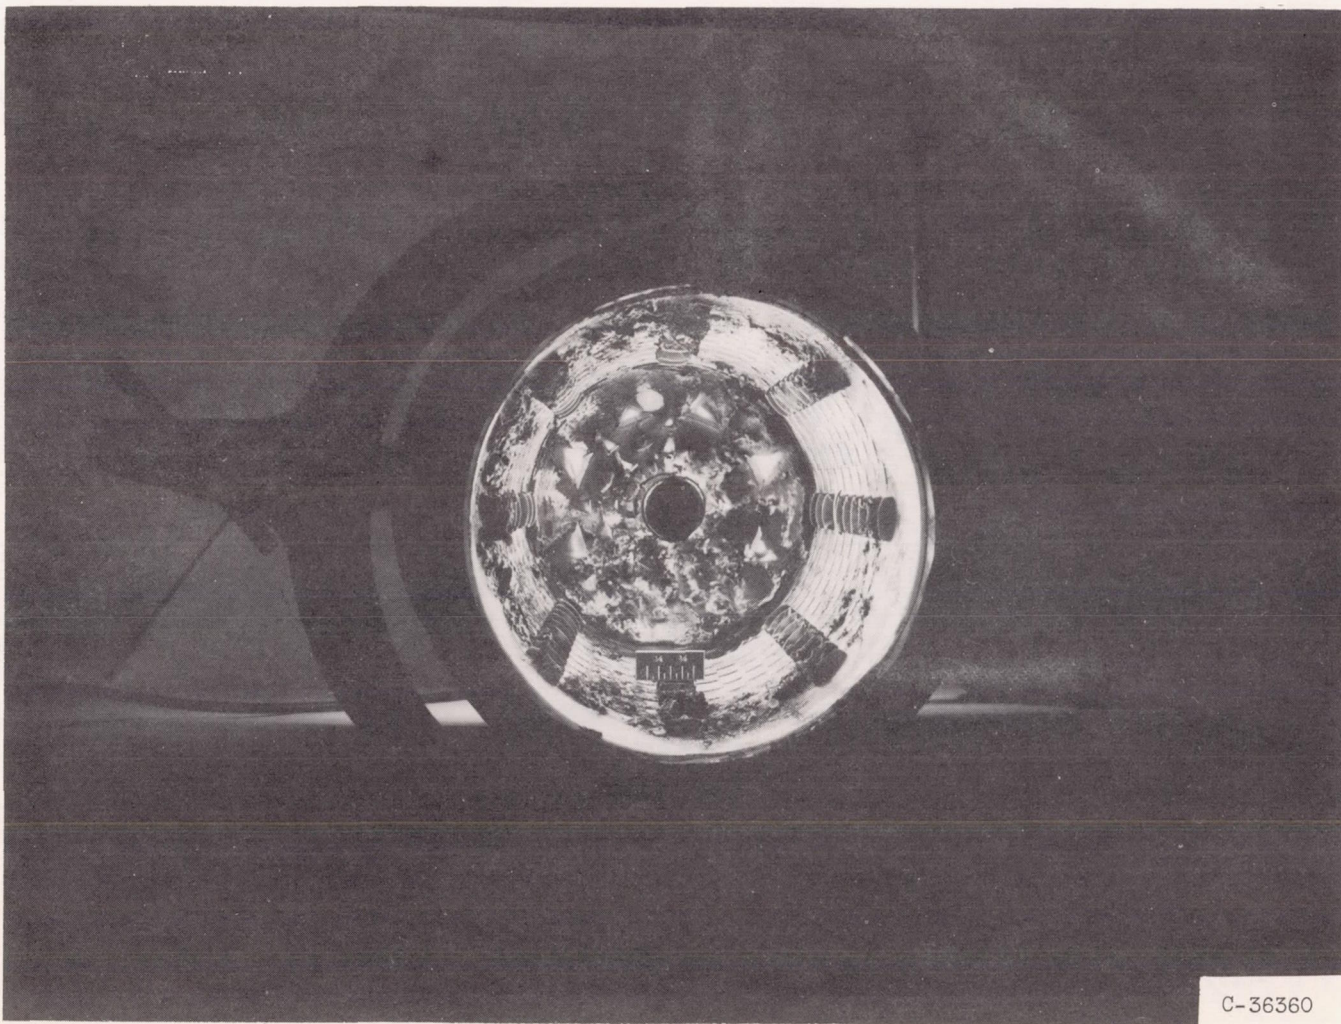
(a) Combustion chamber.

Figure 13. - Boric oxide deposits in engine components following operation with JP-4 fuel for 50 minutes. Previous trimethyl borate operation for 130 minutes. Configuration C.
