NACA RM E55B09

INFLUENCE OF BORIC OXIDE DEPOSITION ON TURBOJET-  
ENGINE OPERATION

By James W. Useller, Richard R. Burley, and  
Wallace W. Velie

Lewis Flight Propulsion Laboratory  
Cleveland, Ohio

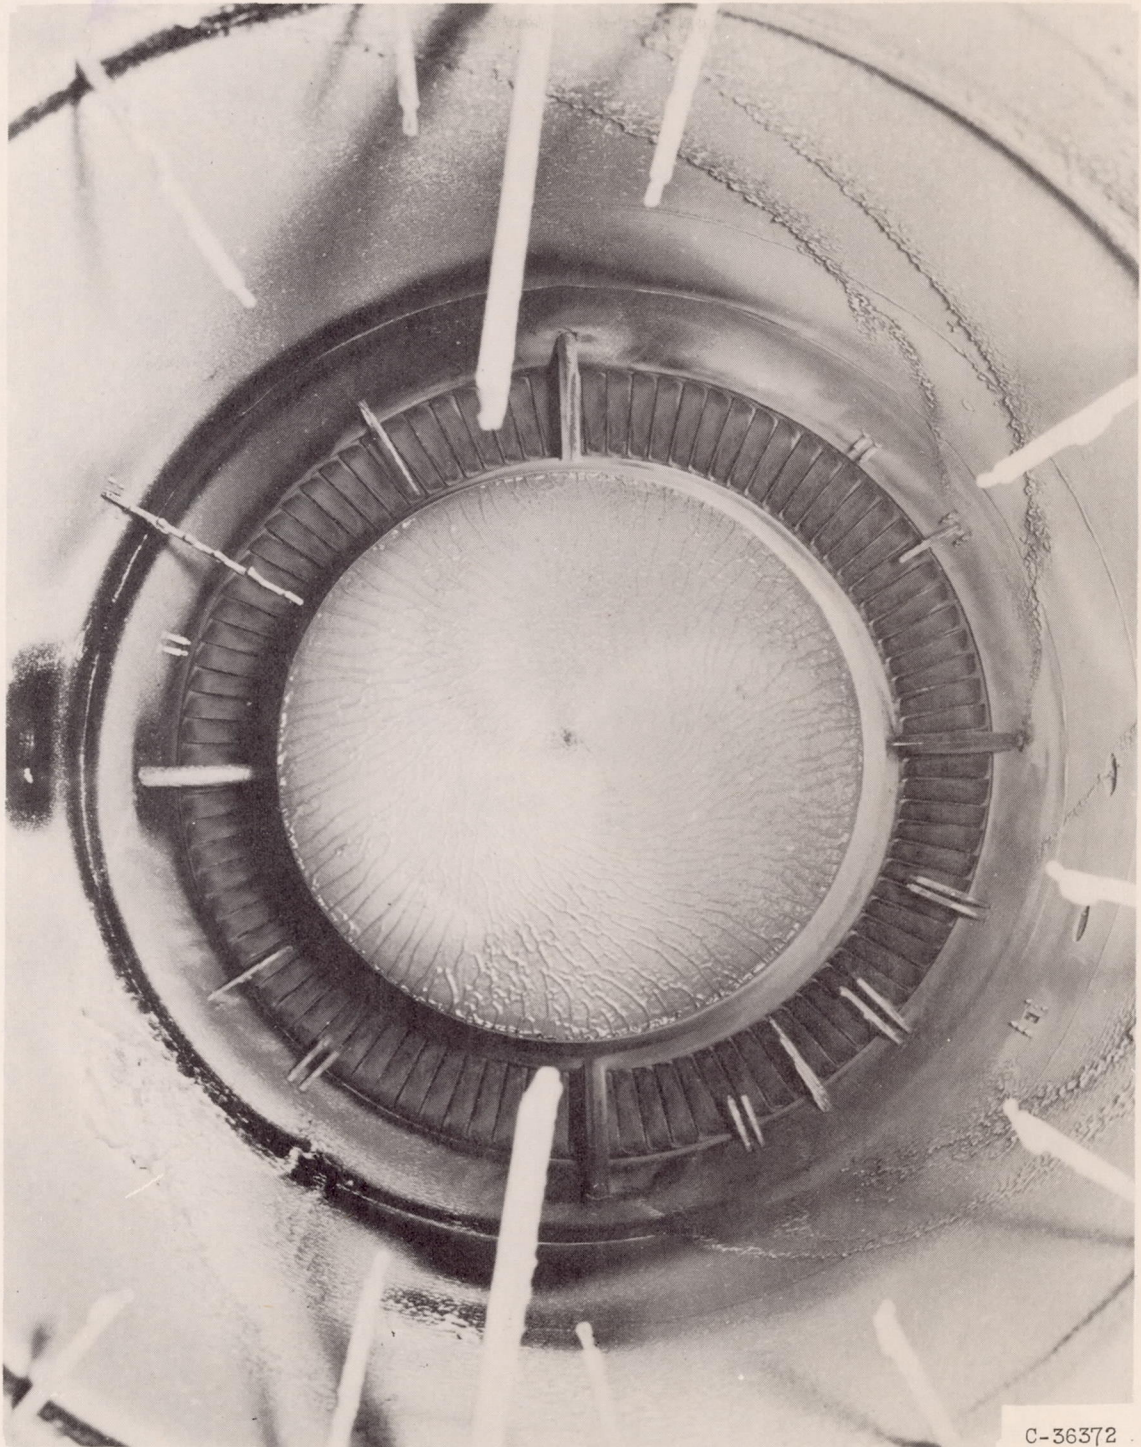
(b) Engine tail pipe, looking upstream.

Figure 13. - Concluded. Boric oxide deposits in engine components following operation with JP-4 fuel for 50 minutes. Previous trimethyl borate operation for 130 minutes. Configuration C.

Subsequent to the operation with trimethyl borate, the engine was operated with hydrocarbon fuel, JP-4. After about 50 minutes of operation with JP-4, the engine speed approached normal operation, as is shown in figure 12, indicating substantial removal of the deposits. Visual inspection showed that the deposits throughout the engine were dissipated by the JP-4 operation. Figure 13(a) shows the deposits in a typical combustor following operation with JP-4 fuel, and figure 13(b) shows the relatively minor deposits remaining in the engine tail pipe.
