FLIGHT AND WIND-TUNNEL INVESTIGATION TO DETERMINE THE
AILERON-VIBRATION CHARACTERISTICS OF $\frac{1}{4}$ -SCALE WING
PANELS OF THE DOUGLAS D-558-2 RESEARCH AIRPLANE

NATIONAL ADVISORY COMMITTEE
FOR AERONAUTICS

November 30, 1948
Declassified May 8, 1957

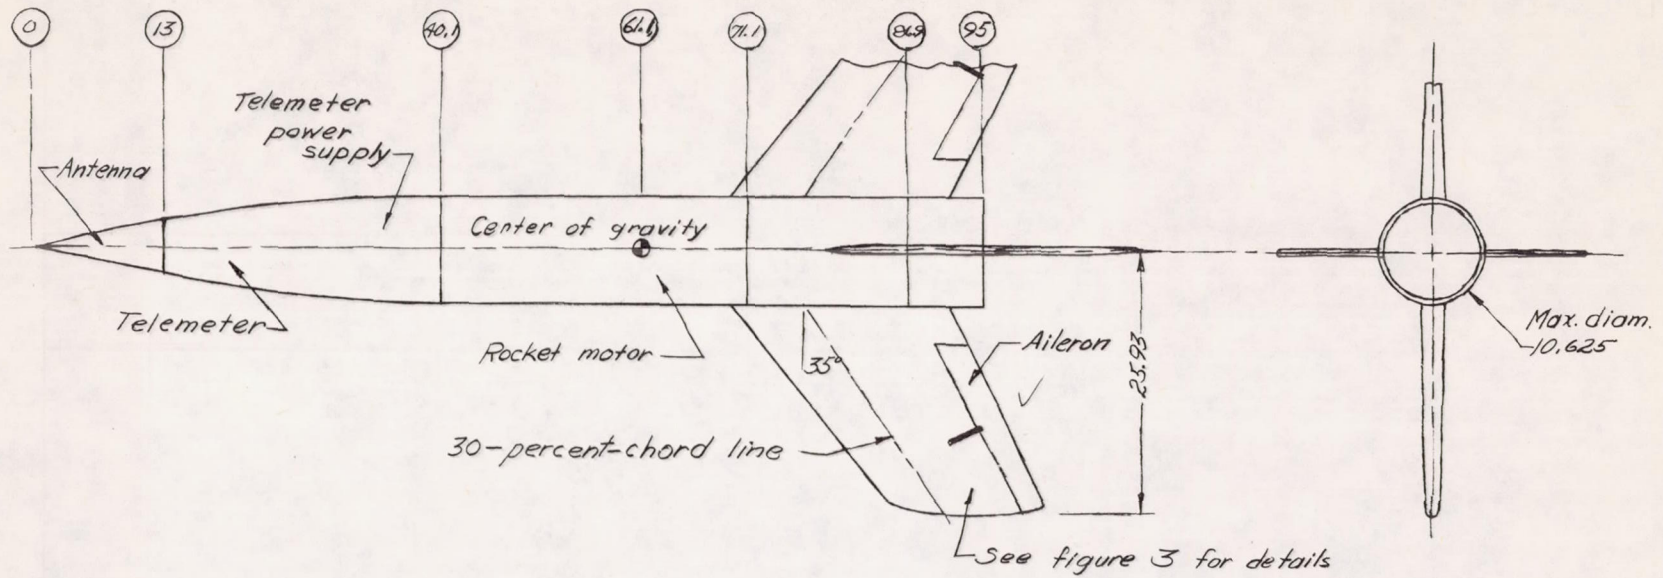
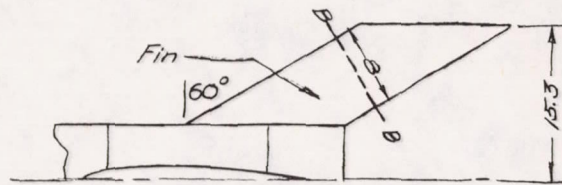
Figure 1.- Flutter test vehicle and test wing panels.

The test vehicle was of the FR-1 type configuration (reference 1) with minor modifications to facilitate a satisfactory mounting of wing aileron panels. Figure 1 shows the physical dimensions of the test vehicle and its physical characteristics are listed in table I. Two views of the test vehicle on its launching rack are shown in figure 2. The wing-aileron panels were mounted as the stabilizing surfaces in pitch.

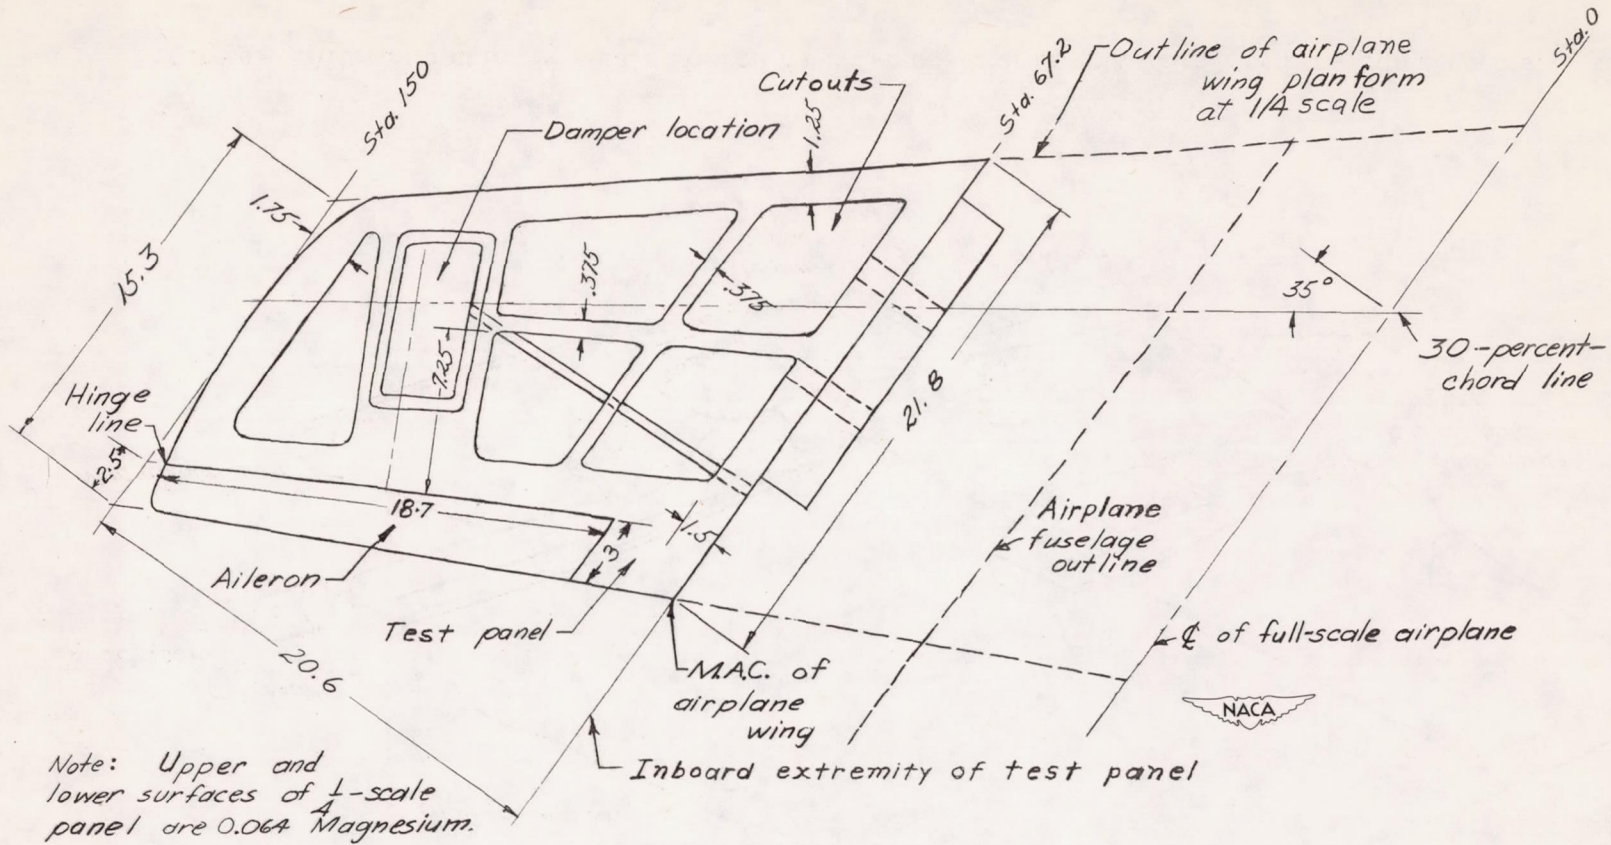
Figure 3.- Comparison of $\frac{1}{4}$ -scale test panel with complete wing plan form D-558-2; all dimensions in inches.

The original test wing panels sent by Douglas Aircraft Company were of solid cast magnesium. It was necessary to reduce the weight of these panels to move the center of gravity of the test vehicle forward and to increase the maximum speed. These wing panels were $\frac{1}{4}$ -scale models of the outer 55 percent semispan, station 67 to station 150 of the full-scale wing. A sketch of one modified test model showing comparison with complete wing plan form is shown in figure 3 and some of its physical characteristics, static and dynamic, are listed in table II, together with some of the vibration parameters of the airplane wing. Figure 4 shows a three-dimensional cutaway of part of wing and aileron.

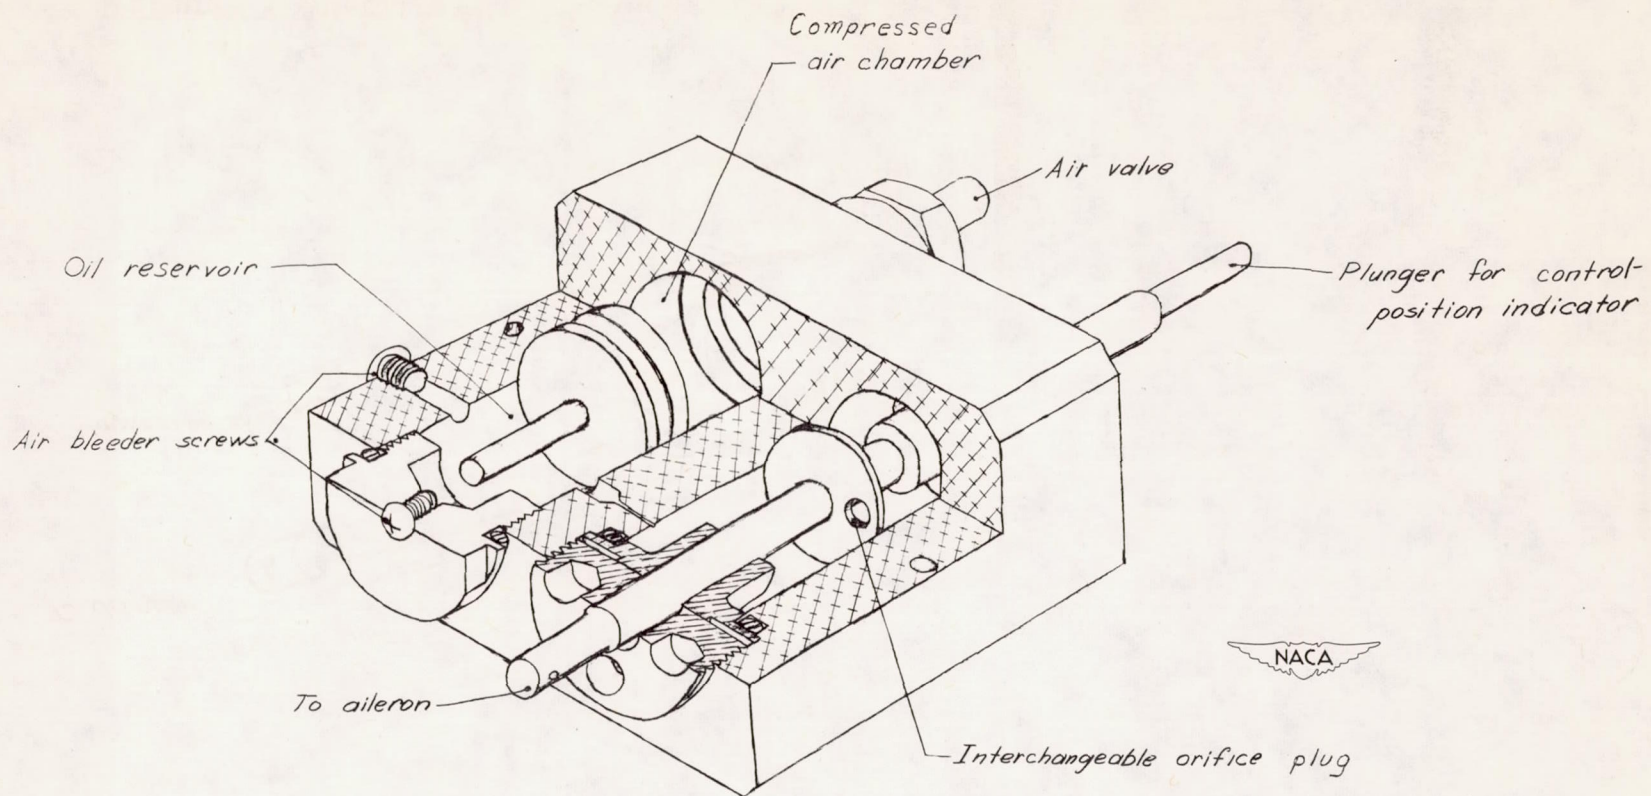
Figure 5.- Hydraulic damper, $\frac{1}{4}$ -scale aileron "buzz" models of Douglas D-558-2 research airplane.

Knowing the distance from the aileron hinge to the pivot to be 0.75 inch, the coefficient C' may be converted to the coefficient C . The internal construction of the damper is shown in figure 5 and its installation in the wing panel is shown in figure 6(a). In tests where no external damping was desired, a dummy damper was used which was merely a piece of steel rod rigidly attached to the aileron rod and free to move in a brass guide. Installation of the dummy damper is shown in figure 6(b).

The hydraulic dampers used in these tests were designed, constructed, and calibrated by the Douglas Aircraft Company. The orifice used in these

dampers was made in a removable plug so that the amount of damping desired could be chosen by inserting a plug with an orifice size corresponding to the desired value of damping. The dampers were calibrated on a test setup which could oscillate the damper piston at various frequencies and amplitudes. The force required to move the piston was measured by a strain-gage link and was presented on the Y-axis of a cathode-ray oscilloscope. The displacement was measured with a slide-wire pickup and presented on the X-axis of the oscilloscope. The resulting pattern on the oscilloscope screen was an approximate ellipse whose area was a measure of the work absorbed per cycle by the damper. Knowing the work absorbed per cycle and the frequency and amplitude at which the damper piston is driven, it was possible to calculate the damping coefficient from the formula $C' = \frac{\text{Work}}{2\pi^2 f A^2}$

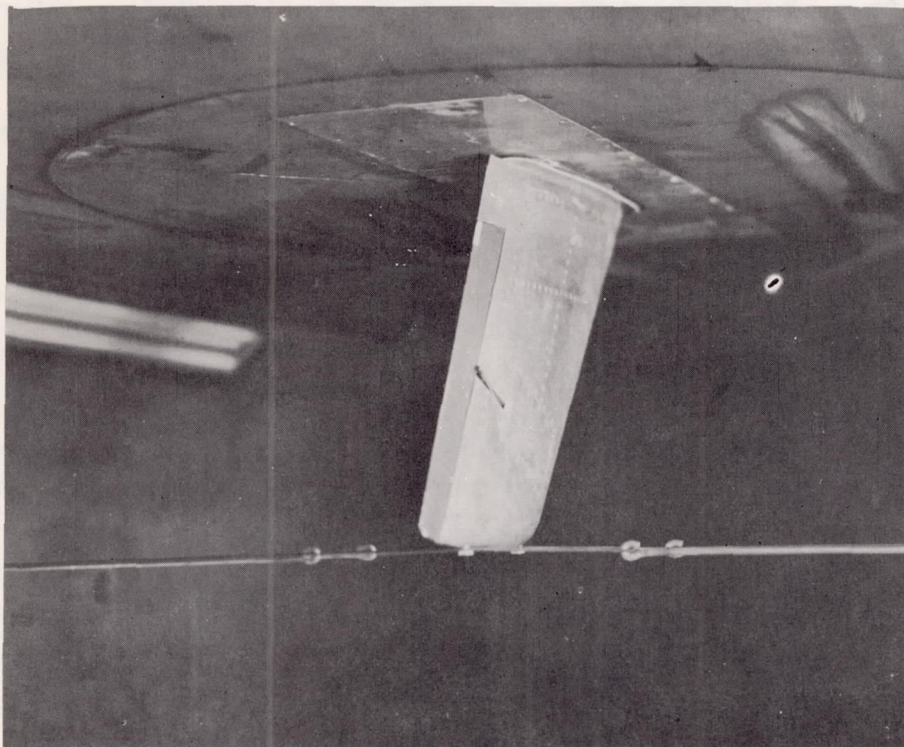
Figure 7.- Test wing-aileron panel with tip restraints mounted on tunnel wall.

The values of damping and method of recording aileron deflections were similar to those used in the free-flight tests. Figure 7 shows the wing mounted from the tunnel ceiling and shows the fore and aft wing-tip restraints that were used on some of the tests largely to eliminate wing twist and flexure. Strain gages mounted inside the wing structure were used to give an indication of the magnitude of the wing

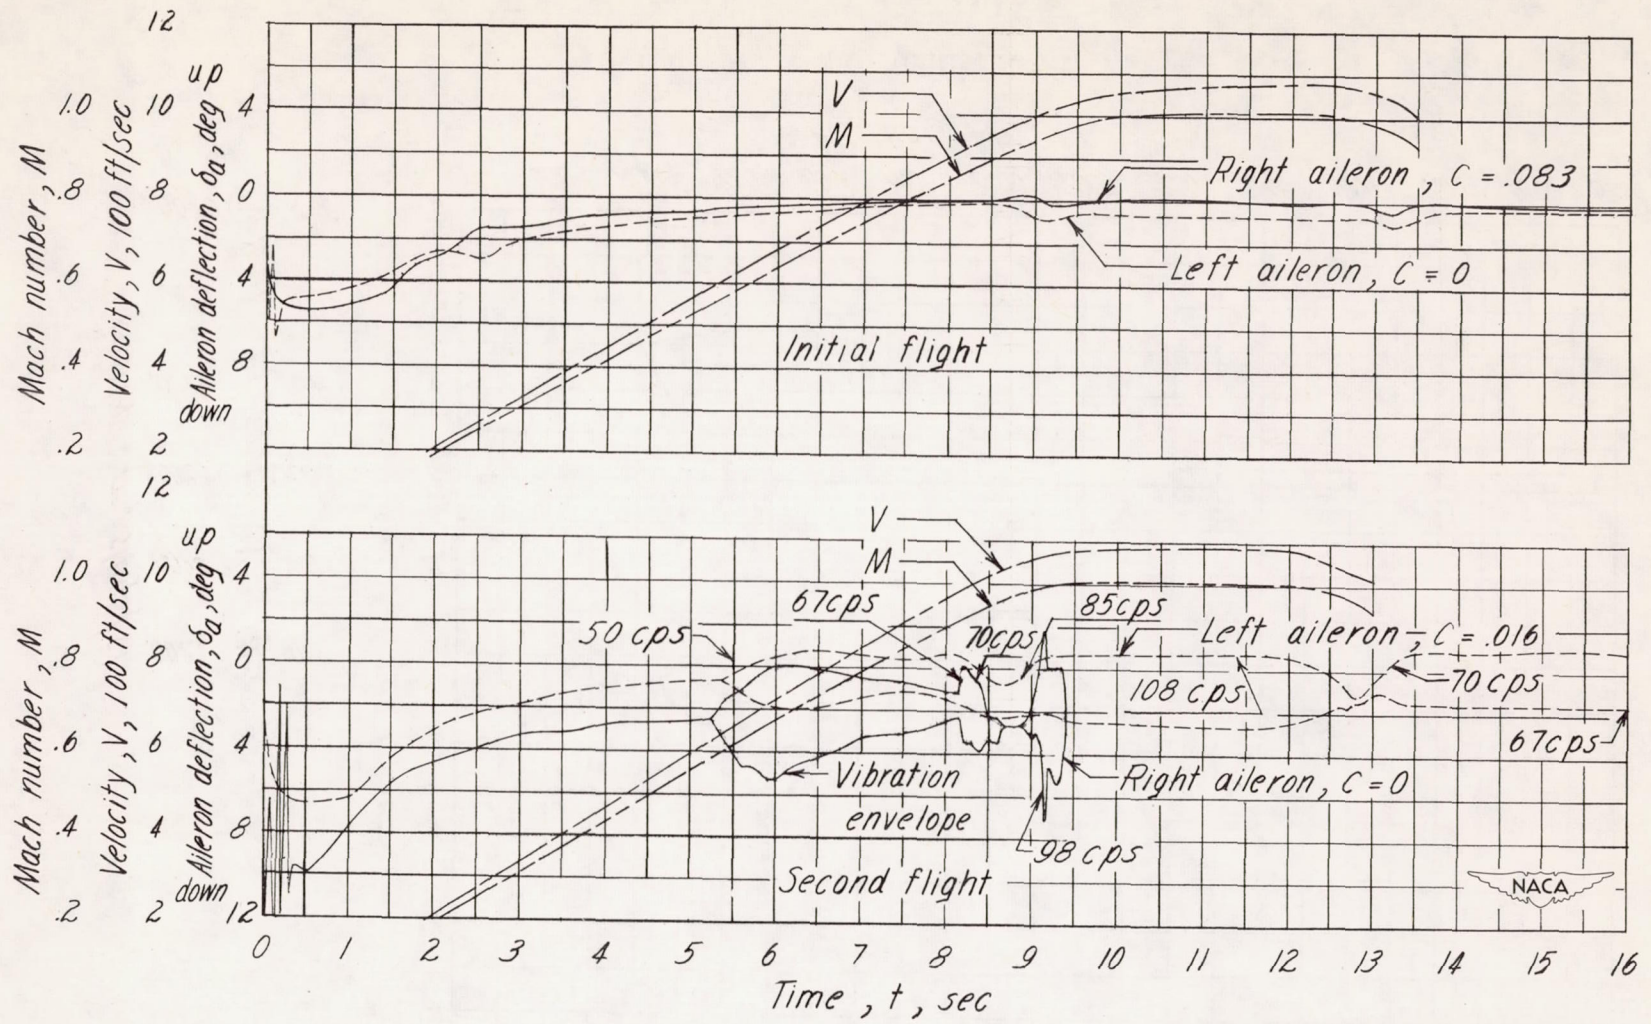
Figure 8.- Results of flight test of $\frac{1}{4}$ -scale aileron "buzz" models.

The aileron of the left wing in the initial free-flight test was undamped except for the friction of the dummy damper, and the damper of the right aileron was equipped with the proper orifice plug to give $C = 0.083$ foot-pounds per radian per second. It can be seen from the upper set of curves in figure 8 that no vibration of the aileron occurred up to a Mach number of 1.03, which was the maximum attained in the test.

Since no aileron buzz developed, the test was repeated to confirm the results of the first test. The second test was conducted with a dummy damper attached to the right aileron and a damper adjusted to give 0.016 foot-pounds per radian per second on the left aileron. During the flight a vibration of 50 cycles per second developed on the right aileron at a Mach number of 0.58 and continued to a Mach number of 0.73. Between a Mach number of 0.73 and a Mach number of 0.9 a 67-cycle-per-second vibration gradually became superimposed upon this 50-cycle-per-second vibration, becoming a pure 67-cycle-per-second vibration at a Mach number of 0.9. This gradually increased in frequency to 70 cycles per second at a Mach number of 0.96. Between 9.1 seconds ($M = 0.99$) and 9.4 seconds ($M = 1.00$) the right aileron trace shows a violent oscillation that ends abruptly at 9.4 seconds as shown in the lower curves of figure 8. Inspection of the deflection signal on the telemeter record after 9.4 seconds indicates the possibility of either a structural failure of the aileron or a failure of the control-position indicator. The left aileron developed a vibration at $M = 0.59$ having the same frequency variation as the right aileron with increase in speed. After the floating angle changed ($M = 0.96$), the frequency changed to 85 cycles per second and gradually increased to 108 cycles per second at a Mach number of 1.01 (Reynolds number is 10,500,000). During the decelerated flight the frequency again gradually decreased to 85 cycles per second until the floating angle again changed at a Mach number of 0.96. The vibration momentarily ceased as the floating angle changed and started again at 70 cycles per second, gradually decreasing to 67 cycles per second. At a Mach number of approximately 0.73, this vibration momentarily ceased and a 50-cycle-per-second vibration started and continued for the remainder of the flight.

As may be seen in figure 8, the amplitude of the aileron vibrations during the low-speed phase ($M = 0.58$ to $M = 0.73$) and the high-speed phase ($M = 0.96$ to $M = 1.01$) increased with increasing Mach number. The amplitude of the second-phase vibration during decelerating flight was approximately constant, but during accelerated flight this phase was of such short duration and so near the floating-angle change that no amplitude variation could be determined.

Figure 8 also gives an indication of the effect of damping on the amplitude of the vibration. During the low-speed phase, which wind-tunnel tests showed to be flexure aileron flutter, the vibration amplitude of the undamped aileron was about twice that of the damped aileron. The data that were obtained from the undamped aileron during the high-speed phase ($M = 0.96$ to $M = 1.01$) indicate that the amplitude was approximately twice that of the damped aileron.

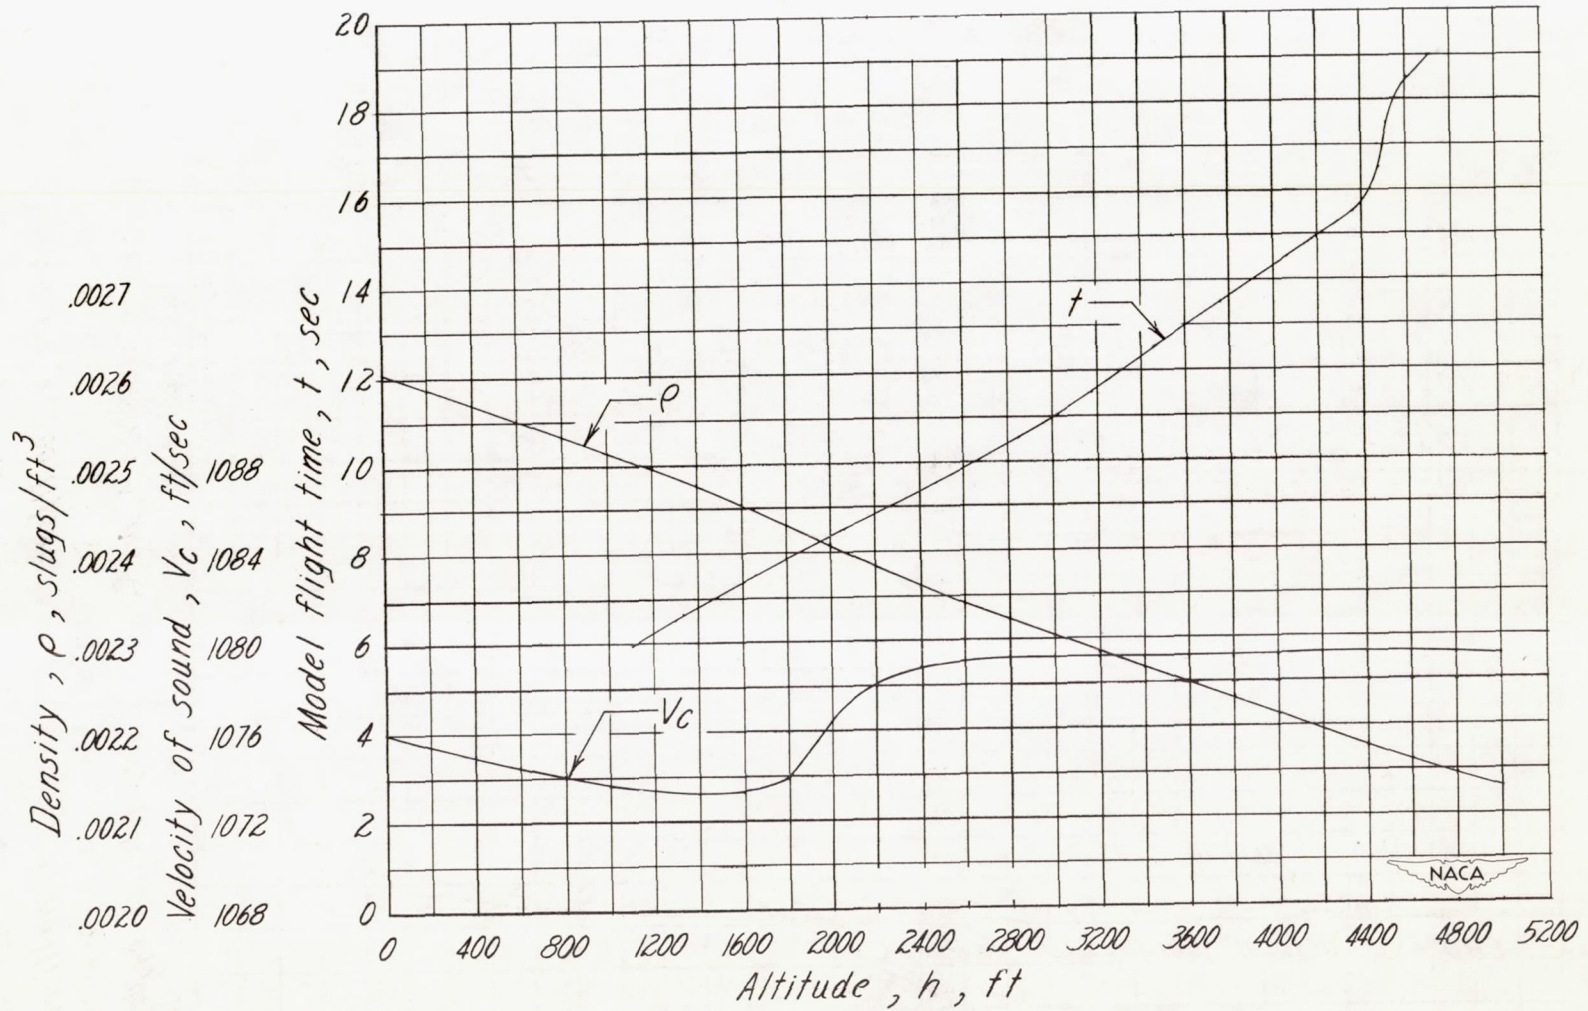
(a) Initial flight.

Altitude of the missile as obtained from the tracking radar is shown in figure 9. Air density and velocity of sound as obtained from the radiosonde are also shown in figure 9.
