NACA TN 4158

ACCELERATIONS IN TRANSPORT -AIRPLANE CRASHES

By G. Merritt Preston and Gerard J. Pesman

Lewis Flight Propulsion Laboratory
Cleveland, Ohio

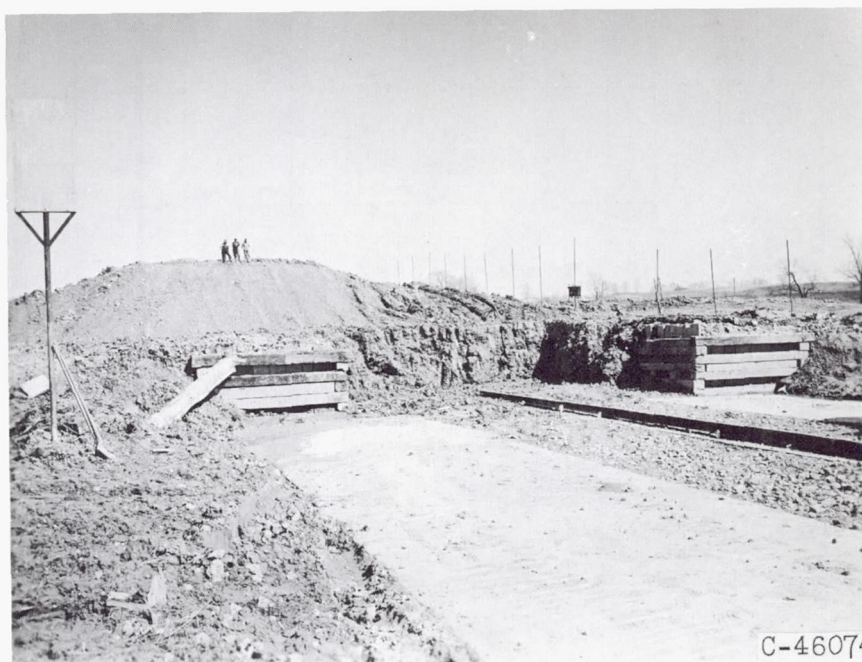
C-46074

(a) Earth and timber abutments that ripped landing gear from airplane upon crash.

The crash site was arranged so that the desired sequence of events would result. For example, if an unflared landing was desired, the landing wheels were first torn off by earth and timber abutments (fig. 1(a)). The airplane then flew across a pit and onto the inclined face of an earthen mound (fig. 1(b)). Various angles of impact (angle between the airplane trajectory and ground) could be obtained by changing the angle of the mound's face.

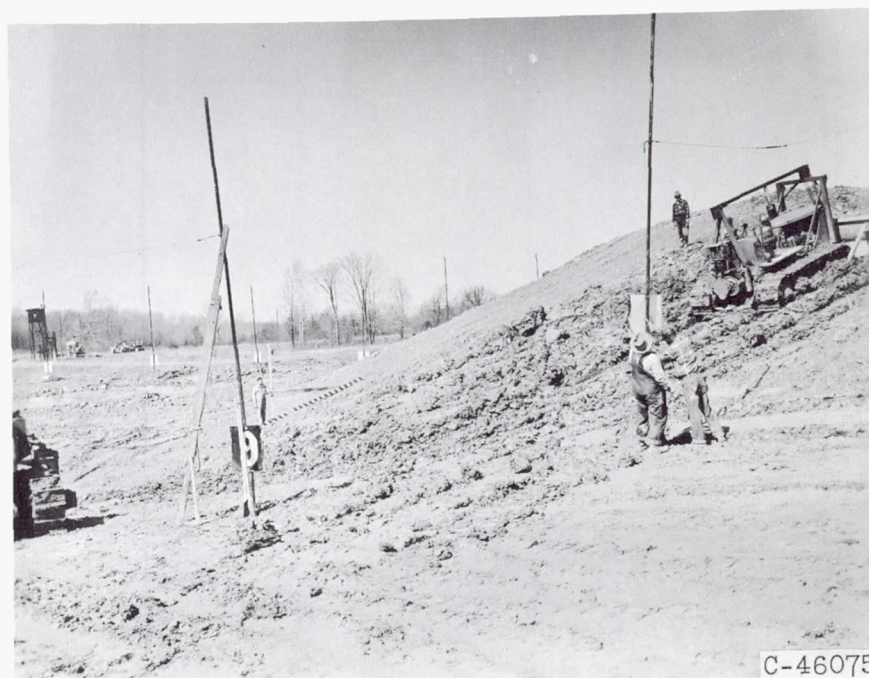
C-46075

(b) Earthen mound that airplane struck after landing gear was removed.

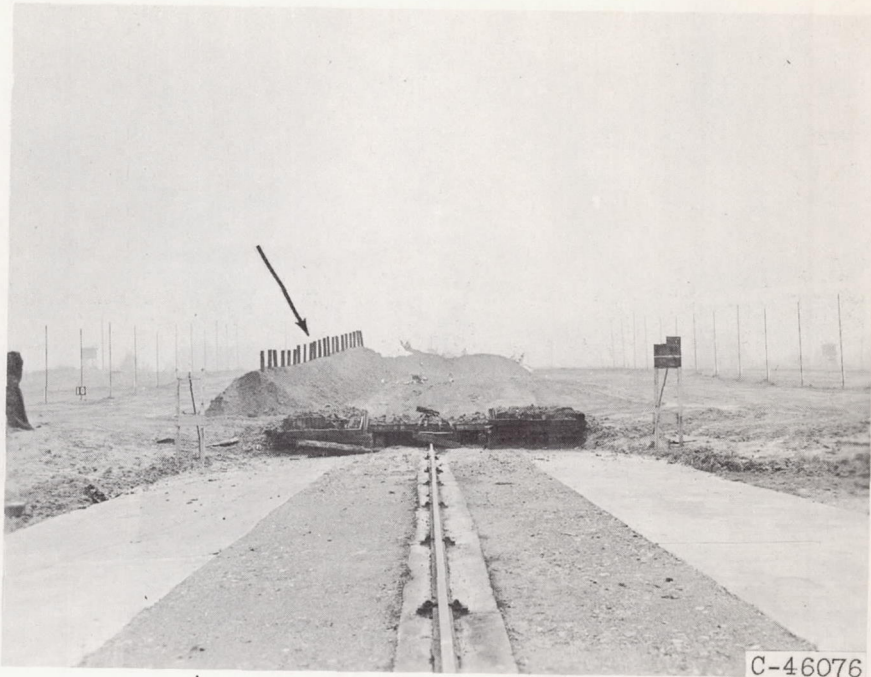
(c) Wing barrier used to produce groundloop crash.

If a groundloop crash was desired, only one of the main landing wheels was torn off. The wing tip on the same side would then fall and drag on the ground. This off-center drag would gradually turn the airplane around. If it was thought the wing-tip drag would not turn the airplane rapidly enough, additional obstacles were placed in the wing's path (fig. 1(c)). By similar means, a variety of landing or takeoff crashes could be simulated.

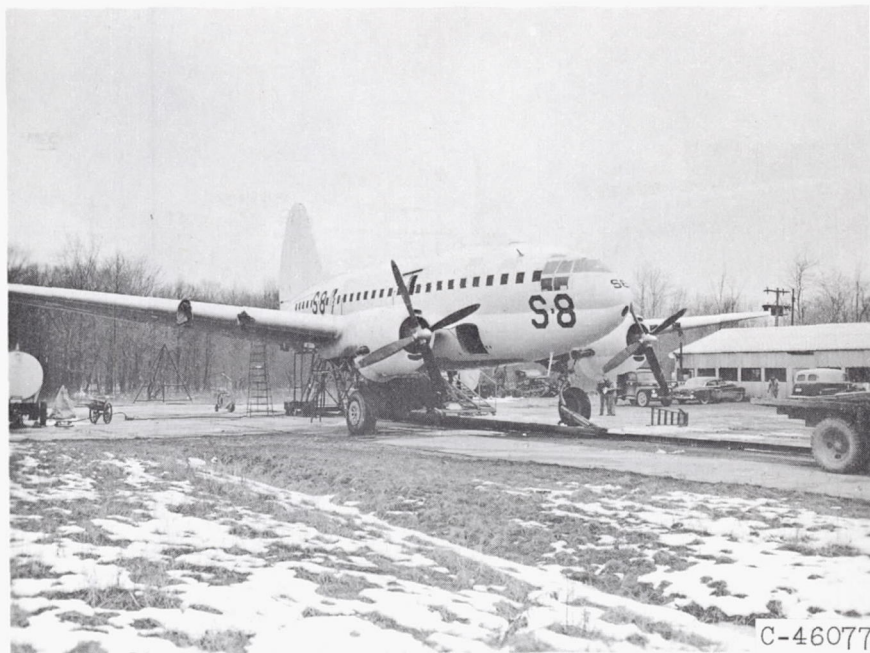
(a) Pressurized low-wing transport.

representing a pressurized low-wing transport is shown in figure 2(a). This airplane was designed for high-altitude pressurized flight and has the gross structure characteristic of this airplane class. The airplane shown in figure 2(b) is representative of low-wing unpressurized transports. The fuselage belly and undersides of the nacelles are approximately on the same level, so that in crashes in which the airplane strikes the ground while moving in its original direction, such as in an unflared landing, the impact forces will be taken simultaneously by the three surfaces. Since this airplane was not designed for pressurized loads, its structure was quite different from that of the pressurized transport.

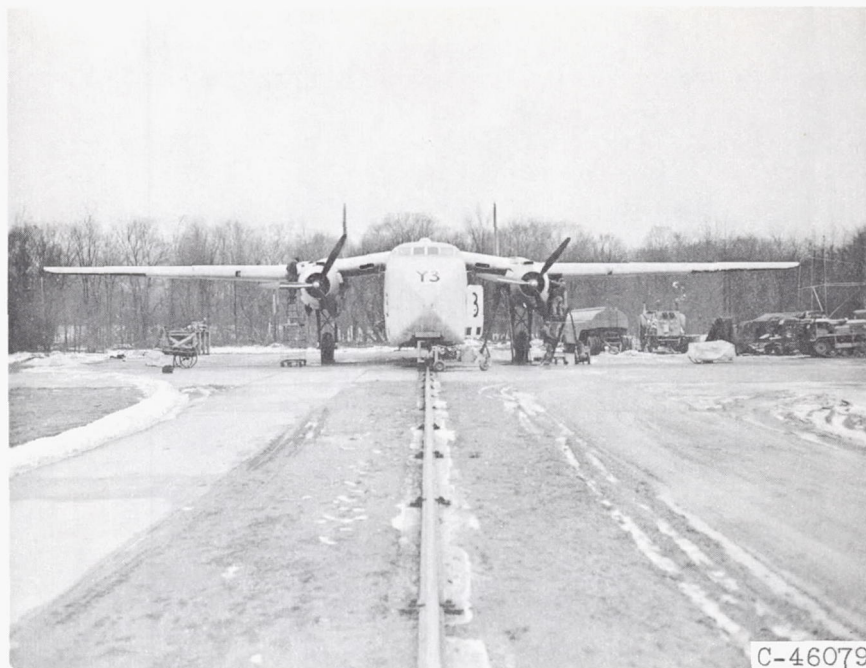
(c) Unpressurized high-wing transport.

The unpressurized high-wing airplane (fig. 2(c)) is a cargo-carrying airplane having an integral floor and belly structure throughout the main fuselage. The nose section of the fuselage, however, is a weaker structure covering the front wheel and strut and also serving as an aerodynamic fairing. The main fuselage structure is suspended from the wing. If the main landing gear fails, however, the fuselage structure must support the entire wing, nacelle, and fuel-tank load.

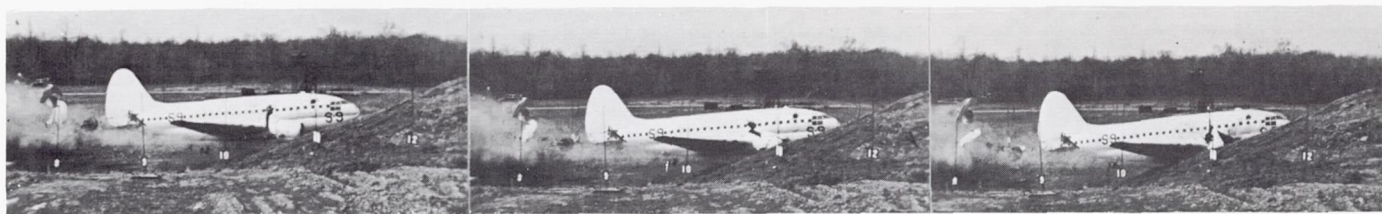
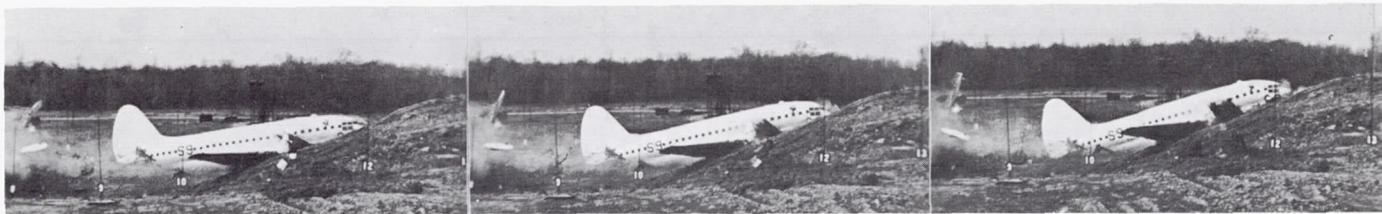
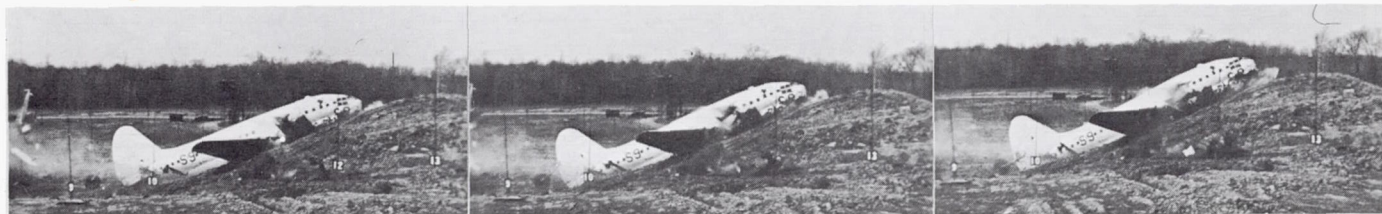
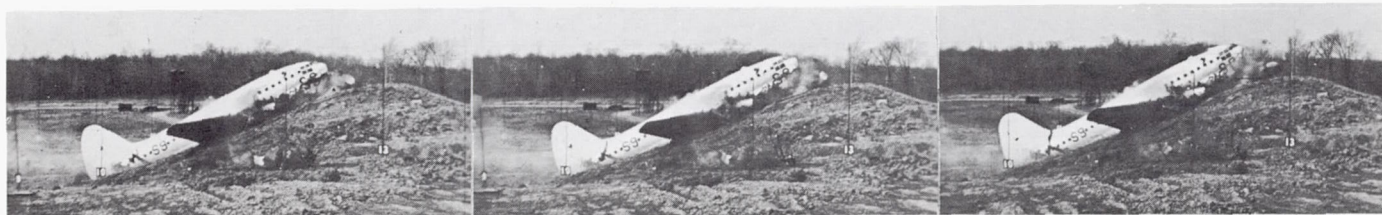
(b) Concluded. Angle of impact, 15°; impact speed, 93 mph.

Figure 3. - Continued. Sequence pictures and accelerations of crashes of pressurized transports. (Zero time is fuselage nose impact with ground.)

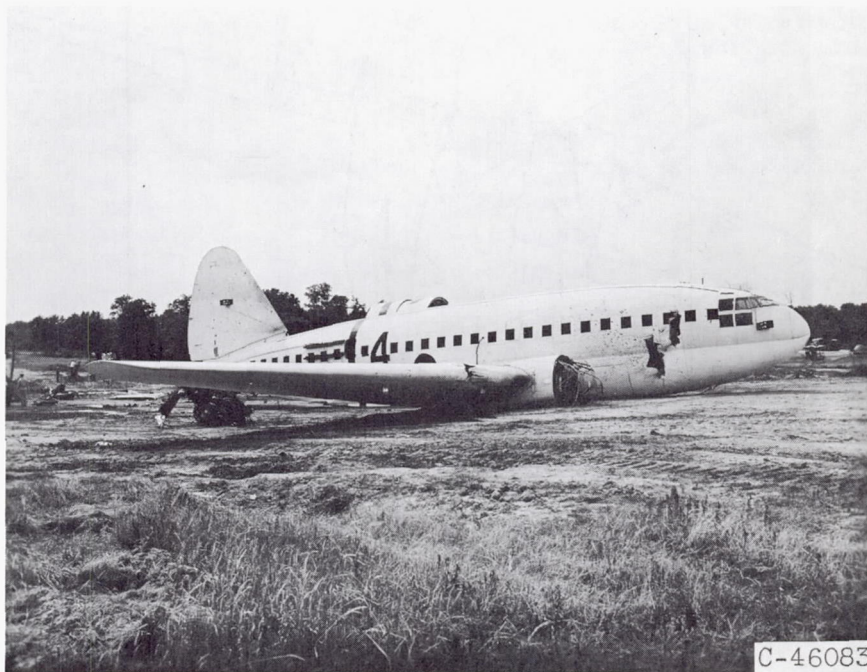
(a) Angle of impact, 5° ; impact speed, 81 mph.

Figure 8. - Extent of fuselage crushing resulting from three crashes of pressurized transport airplanes.

The fuselage distortion that resulted from the experimental crashes of this investigation was relatively minor. During the 5° crash the fuselage received practically no damage (fig. 8(a)). The major damage was the ripping off of the engines. The holes in the side of the fuselage were caused by flying propeller blades. Likewise, the damage inflicted on the airplane in the 15° and 29° crashes was minor (figs. 8(b) and (c)). The large holes in the fuselage fore section of the 15° crash (fig. 8(b)) were caused by flying propeller blades. The maximum acceleration of 20 g's in the 29° crash resulted in damage that would not jeopardize the safety of the occupants of the airplane. Even the cockpit was completely

The fuselage distortion that resulted from the experimental crashes of this investigation was relatively minor. During the 5° crash the fuselage received practically no damage (fig. 8(a)). The major damage was the ripping off of the engines. The holes in the side of the fuselage were caused by flying propeller blades.

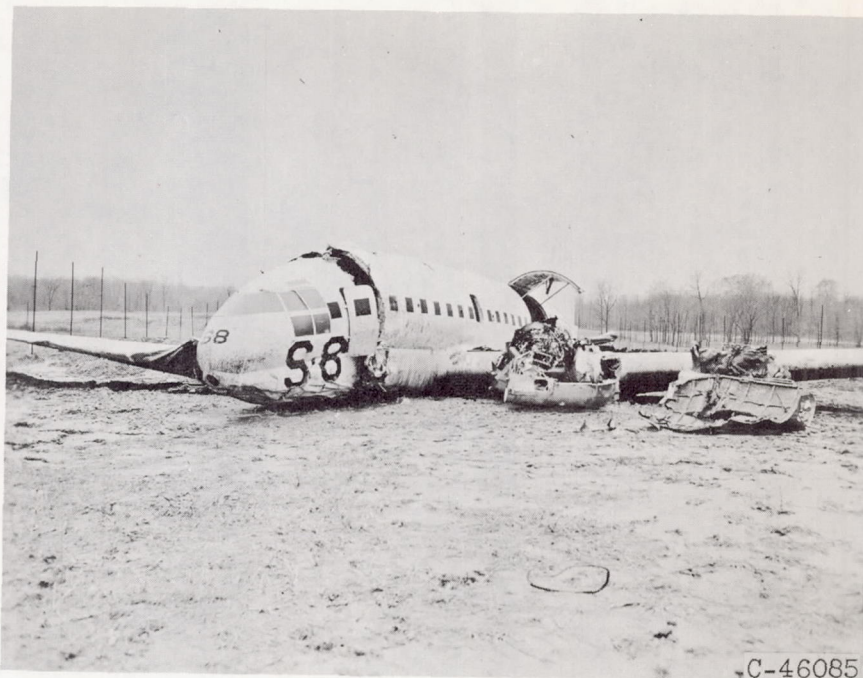
(b) Angle of impact, 15° ; impact speed, 93 mph.

Likewise, the damage inflicted on the airplane in the 15° and 29° crashes was minor (figs. 8(b) and (c)). The large holes in the fuselage fore section of the 15° crash figure 8(b) were caused by flying propeller blades. The maximum acceleration of 20 g's in the 29° crash resulted in damage that would not jeopardize the safety of the occupants of the airplane. Even the cockpit was completely intact.

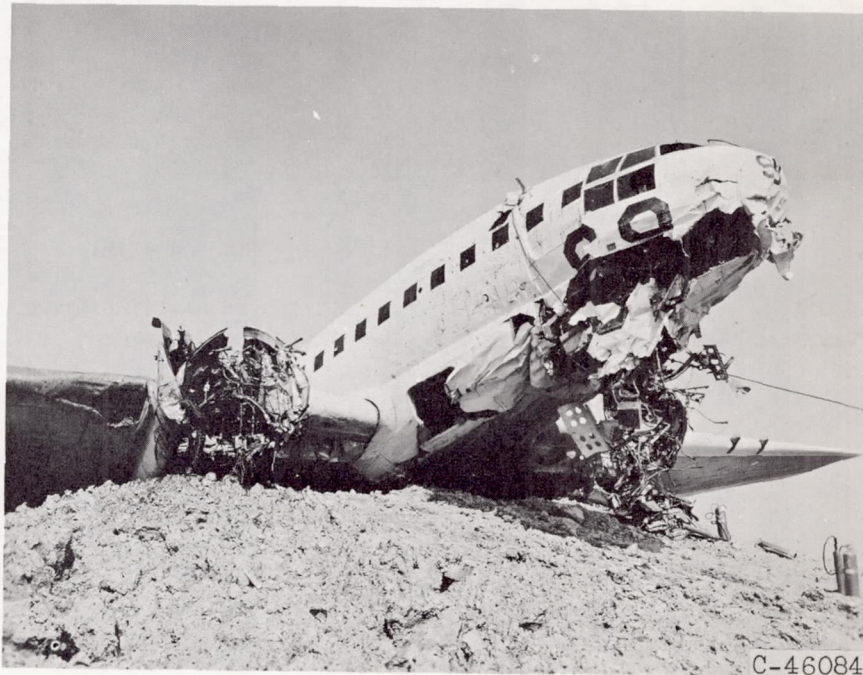
(c) Angle of impact, 29° ; impact speed, 97 mph.

Figure 8. - Concluded. Extent of fuselage crushing resulting from three crashes of pressurized transport airplanes.

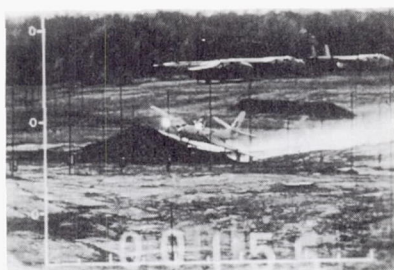
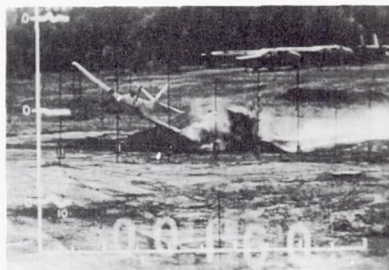
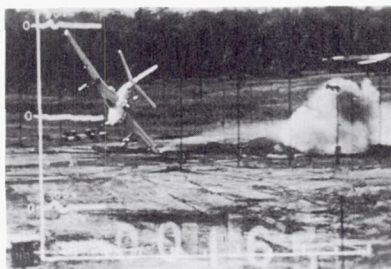
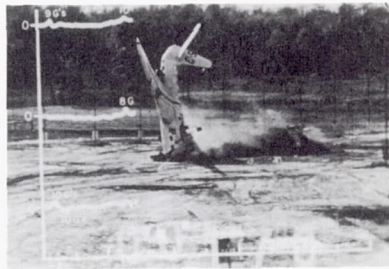
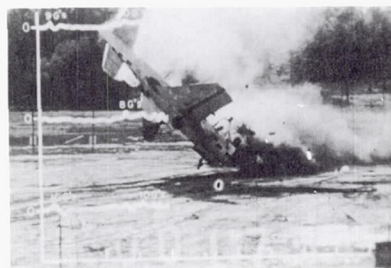
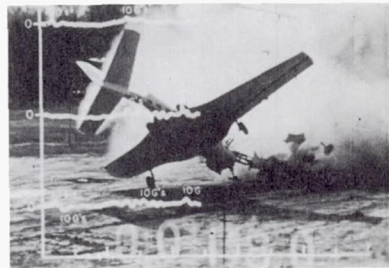
Figure 13. - Sequence pictures of cartwheel crash of FH-1 fighter airplane with superimposed acceleration graphs. Top curve, longitudinal; middle curve, normal; bottom curve, lateral.

were made at angles of impact 4° , 18° , 22° , and 27° . The impact speed in all cases was approximately 110 miles per hour. The data for the fighter crashes fall well above the data for both low-wing transports. The data for the fighter crashes however show almost the same relation as that obtained with the high-wing transport. Extremely severe plowing of the fuselage occurred in these fighter crashes. The airplane had a nose fairing in front of the cockpit section. This nose fairing broke off in the three higher impact crashes and was deformed in the groundloop crash, in which the initial angle of impact was 4° . This exposed a very sharp plowing edge that was supported by the strong cockpit structure. Sequence pictures of one of these crashes are shown in figure 13.

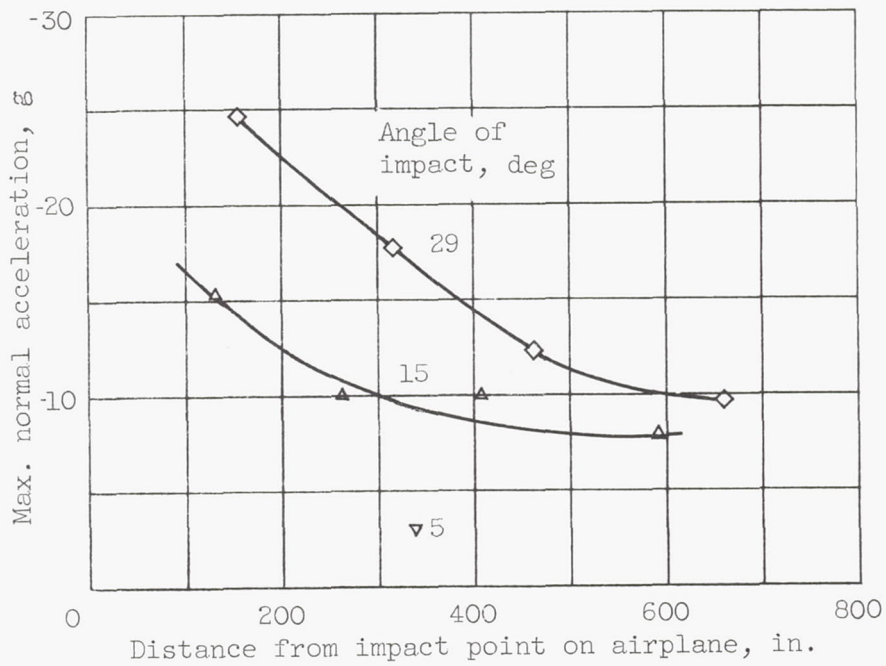
Figure 21. - Variation of maximum normal acceleration with distance from impact point for 5°, 15°, and 29° crashes of pressurized transports (impact speed corrected to 95 mph).

The same decrease in normal acceleration with distance from the impact point was noted in the 15° crash of the pressurized transport. The data for this crash are also shown in figure 21. However, the general slope of the line is less than for the 29° crash.

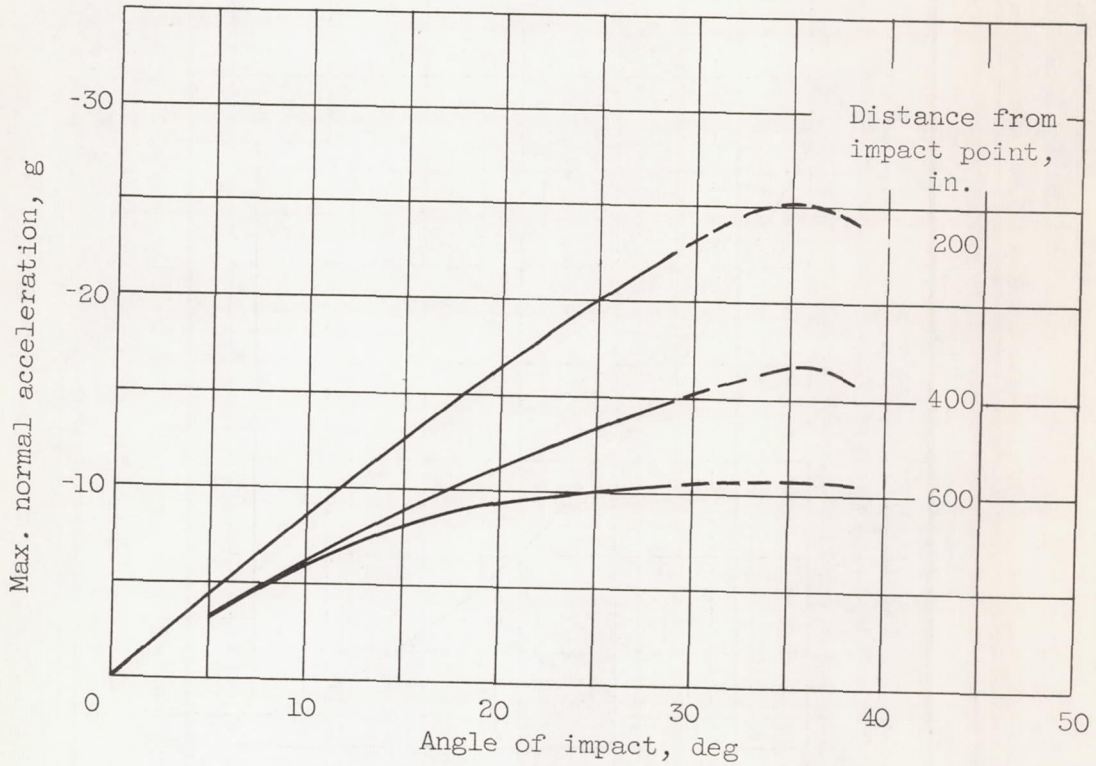
Figure 22. - Variation of maximum normal acceleration with impact angle during crashes of pressurized transports.

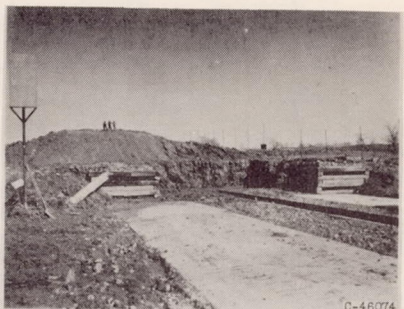
(a) Earth and timber abutments that ripped landing gear from airplane upon crash.

Figure 1. - Site of crash investigation.

The crash site was arranged so that the desired sequence of events would result. For example, if an unflared landing was desired, the landing wheels were first torn off by earth and timber abutments (fig. 1(a)). The airplane then flew across a pit and onto the inclined face of an earthen mound (fig. 1(b)). Various angles of impact (angle between the airplane trajectory and ground) could be obtained by changing the angle of the mound's face.

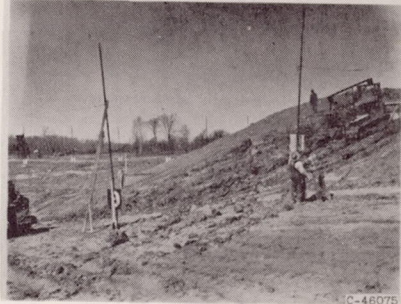
(b) Earthen mound that airplane struck after landing gear was removed.

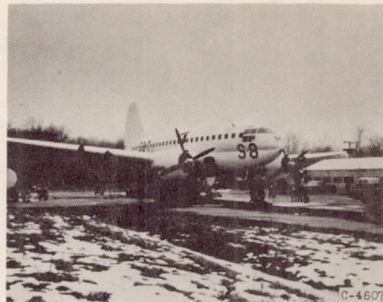
(a) Pressurized low-wing transport.

Figure 2. - Photographs and diagrams of fuselage structures of transport airplanes crashed in impact-survival investigation.

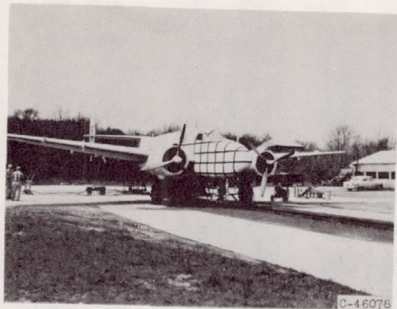
(b) Unpressurized low-wing transport.

Figure 2. - Continued. Photographs and diagrams of fuselage structures of transport airplanes crashed in impact-survival investigation.

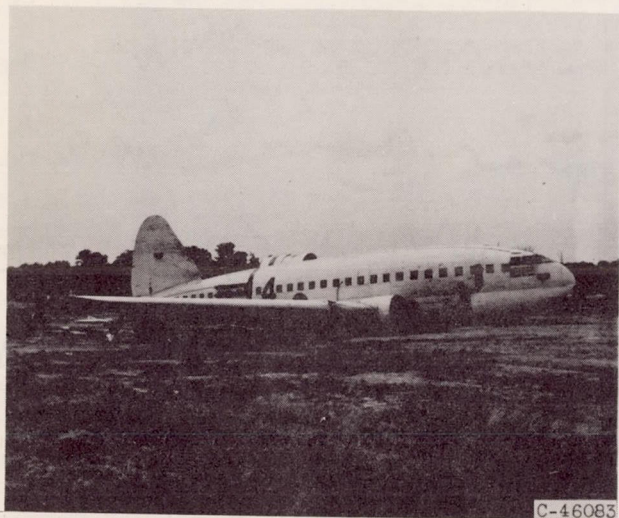
(a) Angle of impact, 5°; impact speed, 81 mph.

Figure 8. - Extent of fuselage crushing resulting from three crashes of pressurized transport airplanes.

The pressurized airplane with its strong fuselage structure in relation to the airplane weight, on the otherhand, retained an essentially smooth planing undersurface when subjected to a 15° crash (fig. 8(b)). When the nose of the airplane hit the ground, it did not crush appreciably. Instead, the airplane pitched up and slid on its belly up the hill. Since there were few sharp edges plowing the ground, the maximum accelerations obtained at four locations on the floor averaged only 9 g's (fig. 4(a)),

compared with 15 for the unpressurized low-wing airplane. Even when the pressurized transport was crashed at an angle of impact of 29° , the destruction of the fuselage nose was minor, so that there was a relatively smooth planing surface (fig. 8(c)). The accelerations in this crash were low considering the angle of impact of the crash; peak acceleration averaged only 20 g's (fig. 4(b)).

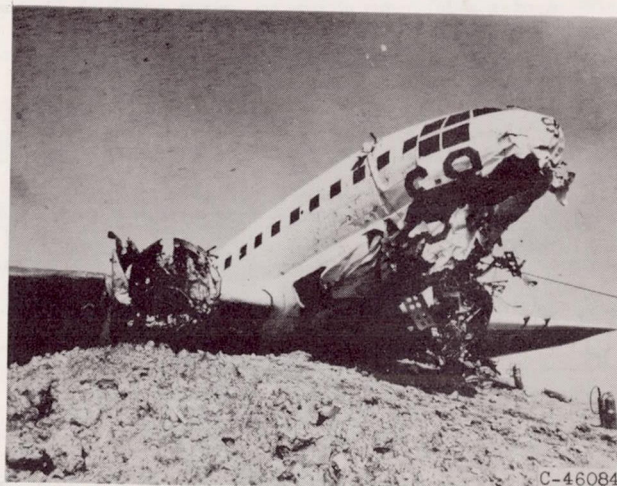
(c) Angle of impact, 29°; impact speed, 97 mph.

Figure 8. - Concluded. Extent of fuselage crushing resulting from three crashes of pressurized transport airplanes.

1. Pressurized transport airplanes can withstand high-impact-angle crashes and still maintain survivable areas within the fuselage. During the 29° unflared-landing crash, of this investigation, a maximum of 20 g's longitudinal acceleration was recorded on the fuselage floor, and only minor damage to the fuselage resulted.

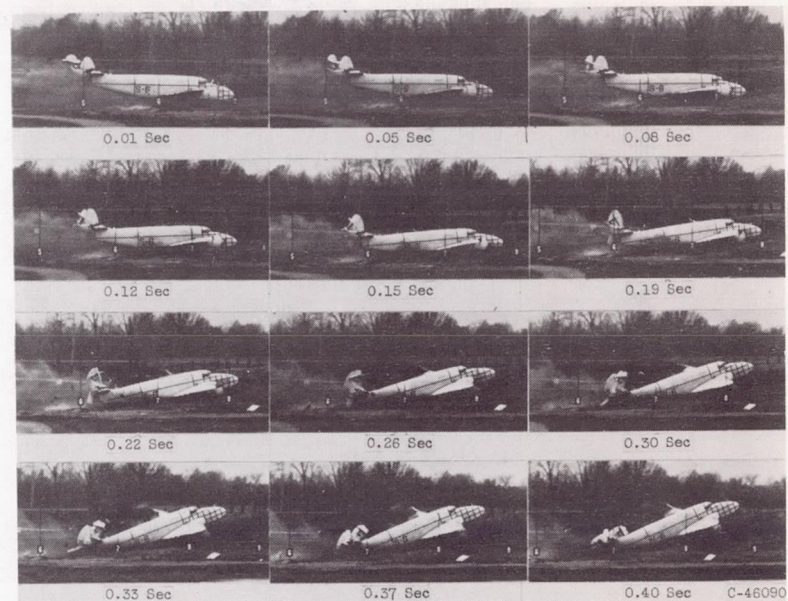
(b) Sequence pictures and accelerations of 16° crash of low-wing unpressurized transport. Impact speed, 109 mph.

Figure 9. - Continued. Comparison of 16° crashes of high- and low-wing unpressurized transports. (Zero time corresponds to fuselage impact with ground.)
