NACA TN 3159

FLIGHT INVESTIGATION AT LARGE ANGLES OF ATTACK
OF THE STATIC-PRESSURE ERRORS OF A SERVICE
PITOT-STATIC TUBE HAVING A MODIFIED
ORIFICE CONFIGURATION

By William Gracey and Elwood F. Scheithauer

Langley Aeronautical Laboratory
Langley Field, Va.

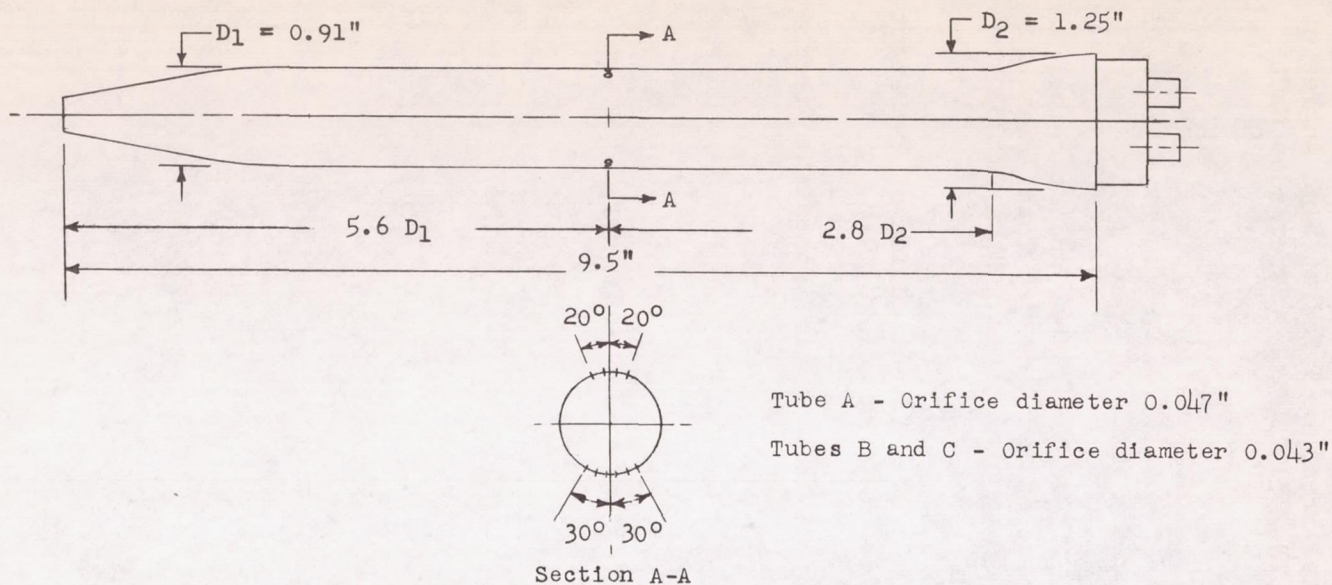
(a) Side view and orifice arrangement of service pitot-static tubes.

Figure 1.- Diagram of service pitot-static tubes showing original and modified orifice arrangements.

A sketch of the service pitot-static tubes which were tested during this investigation is presented in figure 1(a); the arrangement of the static-pressure orifices around the tubes is also shown.

Tubes A and B are the same except for the size of the static-pressure orifices. Although the tubes were built to the same Military specification (ref. 5), they were constructed by different manufacturers, a fact which accounts for the difference in orifice size. The Military specification calls for an orifice diameter of 0.040 ± 0.005 inch. The orifices of tube B (0.043 inch) are, therefore, within the specified tolerance; those of tube A (0.047 inch), which are just one drill size larger, are slightly over the limit.

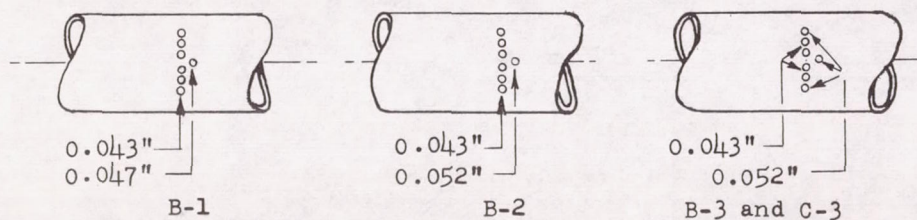
Bottom views (orifices on top same as for original arrangement)

(b) Modified orifice arrangements of tubes B and C.

The three modifications which were made to the orifice configuration of tube B are shown in figure 1(b). The tube was modified in three steps by (1) the addition of one orifice with a diameter of 0.047 inch to the bottom of the tube along its center line and to the rear of the plane of the original orifices (tube B-1), (2) the enlargement of this orifice to 0.052 inch in diameter (tube B-2), and (3) the enlargement of the two orifices at a radial position of 30° from the bottom to 0.052 inch in diameter (tube B-3).

Modified orifice arrangements of tube B.- For the initial modification to tube B (designated B-1), one orifice, 0.047 inch in diameter, was added to the bottom of the tube along its center line and to the rear of the plane of the original orifice (fig. 1(b)). As shown in figure 7(a), the static-pressure error at positive angles of attack was reduced to a maximum of about $1\frac{1}{2}$ percent of q_c for angles of attack up to 45° . In an attempt to reduce the error at positive angles still further, the orifice along the bottom center line was enlarged to a diameter of 0.052 inch (tube B-2). The calibration of this orifice arrangement (fig. 7(b)) showed that the error was reduced at angles of attack between 20° and 40° but was increased slightly at angles of attack in the region of 15° . From an examination of the trends of the calibrations of tubes B, B-1, and B-2, it appeared that any additional enlargement of the orifice along the bottom center line would result in a still greater increase in the error at $\alpha = 15^\circ$ and, quite probably, in the vicinity of 40° . Additional orifice area was therefore provided by enlarging the two orifices at the 30° radial position to a diameter of 0.052 inch (tube B-3). A calibration of this arrangement (fig. 7(c)) showed the error to be reduced at $\alpha = 15^\circ$ and to remain within 1 percent up to $\alpha = 40^\circ$. This arrangement is, therefore, the best of those tested in this Mach number range.

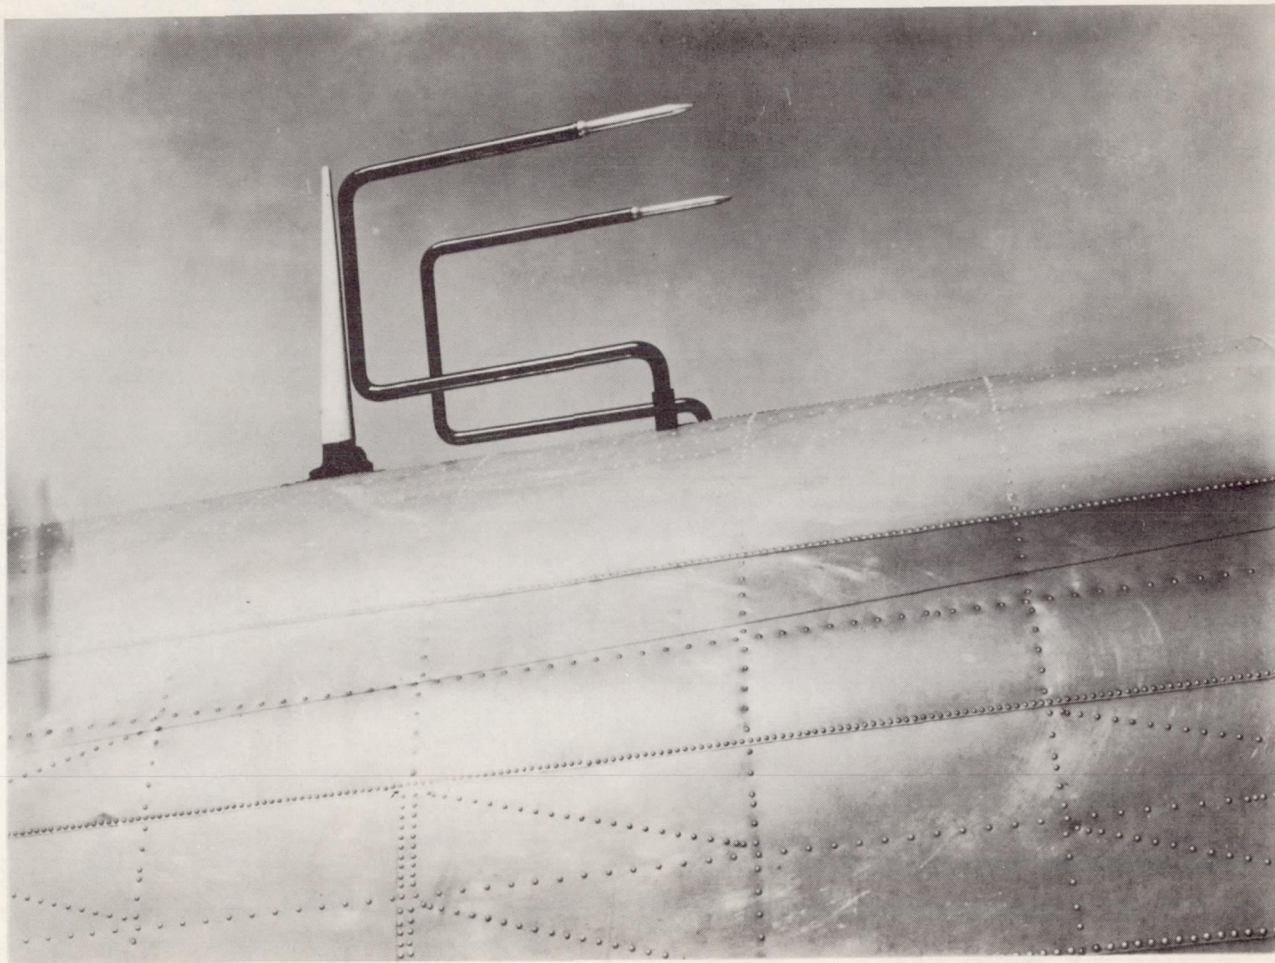
L-82102

(a) Installation of service pitot-static tubes.

Figure 2.- Support booms located above fuselage of transport airplane.

For the initial tests of tubes A and B and the modified orifice arrangements of tube B, two U-shaped support booms were installed about 2 feet apart on the top of the fuselage of a transport airplane (fig. 2(a)).

One of these booms was aligned parallel to the center line of the fuselage and clamped in place. The other was designed so that it could be rotated parallel to the XY-plane through an angular range of $\pm 45^\circ$ from the fuselage center line. The test pitot-static tube was mounted on the rotary boom, and a similar pitot-static tube which was used as a static-pressure reference and for the measurement of impact pressure, was installed on the fixed boom. The rotary boom was designed so that the static-pressure orifices of the test tube were on the axis of rotation and, thus, would remain at the same point in the airstream for all angular settings of the boom. The boom for the reference tube was made the same as the rotary boom in order that the blocking effects of the two supports would be the same and a more sensitive differential-pressure recorder could be used. On the inside of the fuselage, the rotary boom was equipped with an angular scale and a means for manually setting the boom to any desired angle within a range of $\pm 45^\circ$.

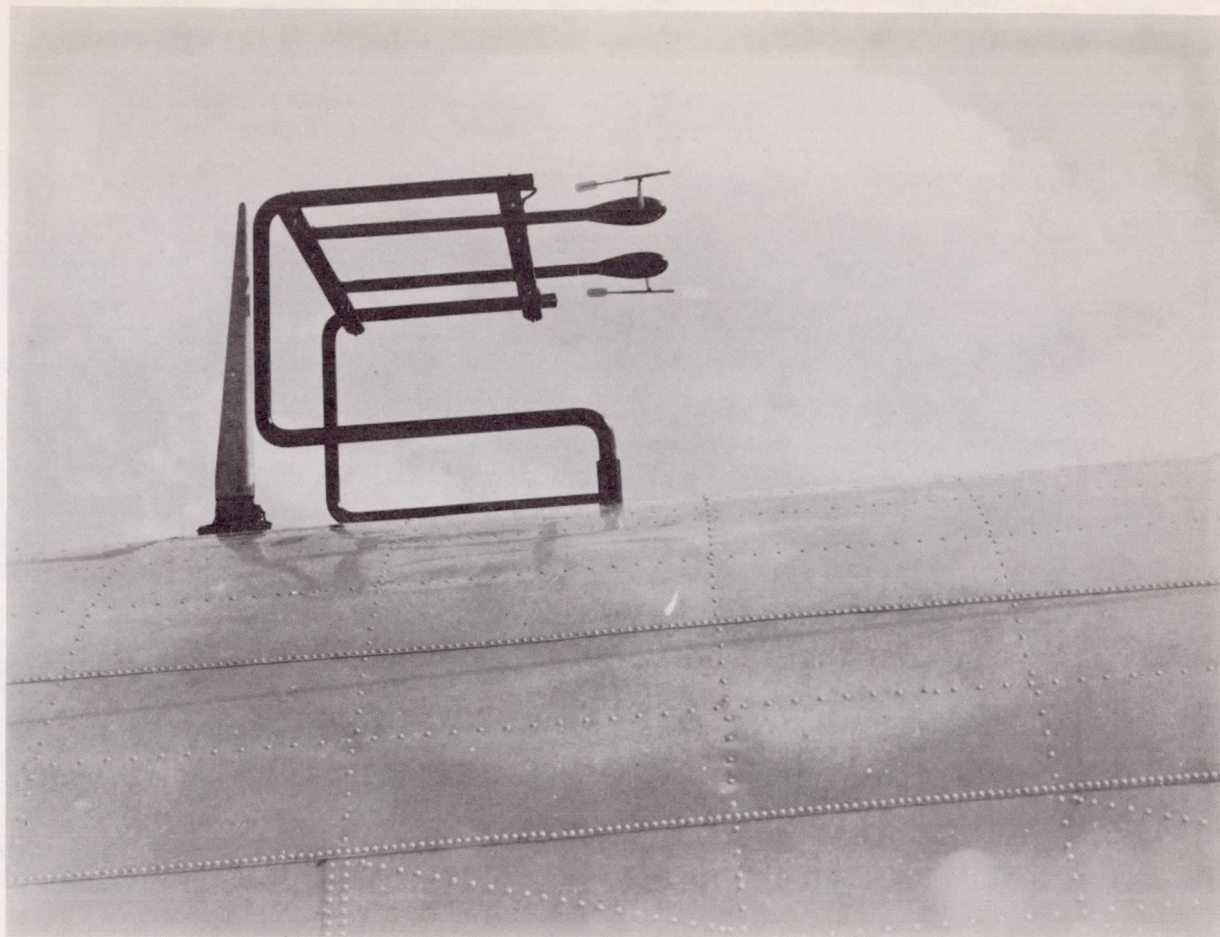
L-82103.1

(b) Flow-direction vanes used to check angle of flow over service tubes.

On succeeding flights, tests were conducted to determine the air-flow direction at the two tube locations. The direction of the airflow ahead of the two booms was investigated by installing air-flow-direction vanes in the region occupied by the two tubes (fig. 2(b)). The results of the tests of flow alignment in the XY-plane of the airplane showed that the air-flow direction at the two stations was very nearly parallel and within 2° of the center line of the fuselage. Tests in the XZ-plane showed the flow to be aligned with the longitudinal axis of the tube to within 1° .

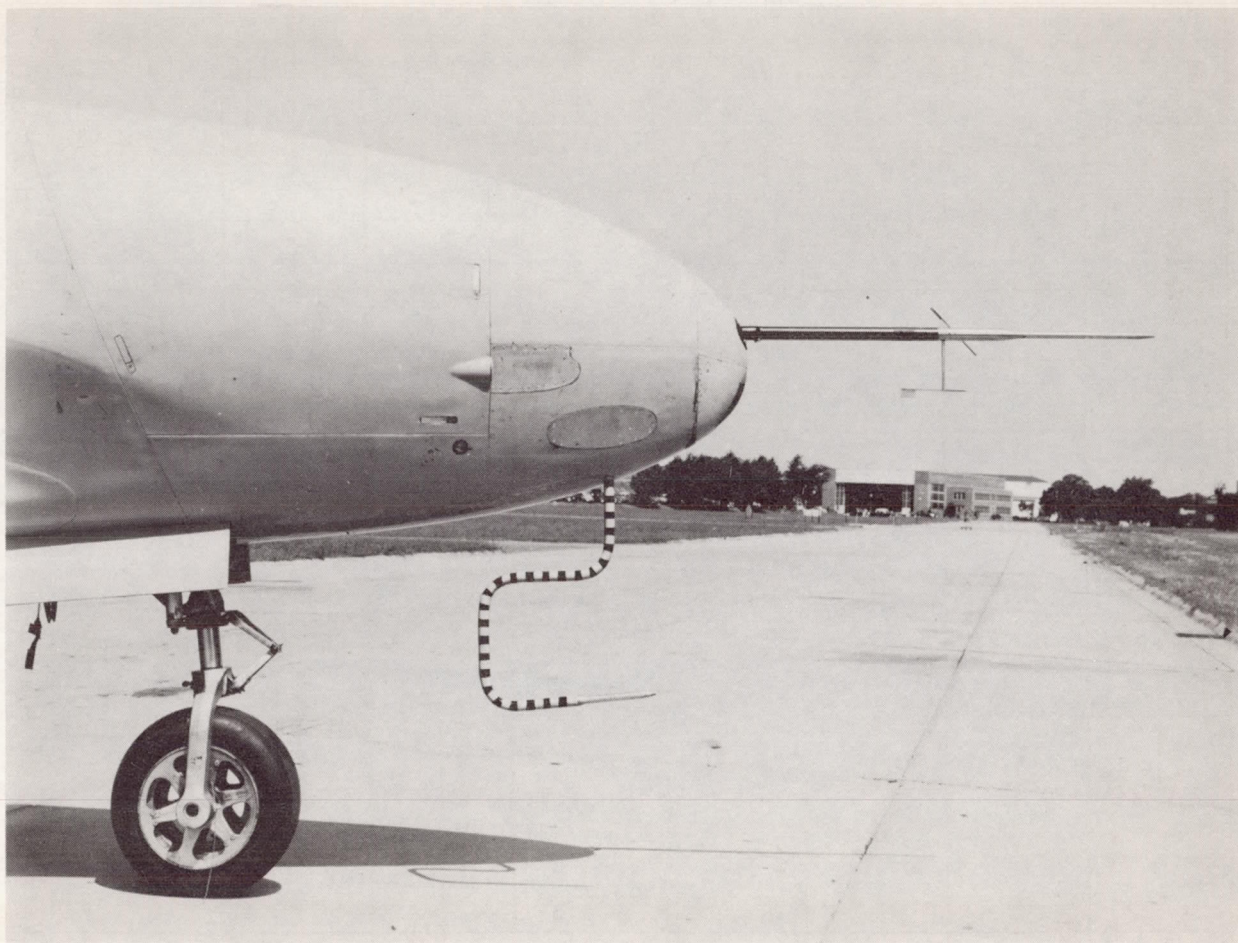
L-75890

Figure 3.- View of fighter airplane showing modified service tube installed underneath nose and combination pitot-static—flow-direction boom located ahead of the nose of the airplane.

After the completion of the tests on the transport airplane, a rotary boom was installed below the nose section of a fighter airplane (fig. 3) for tests of tube B-3 at higher speeds. Tube B-3, however, was damaged after its removal from the transport airplane, so another tube, designated C-3 which had the same orifice size and arrangement was used for the rest of the tests.

The tube was installed on the rotary boom so that the vertical axis of the tube was alined with the Y-axis of the airplane. As in the tests on the transport airplane, the boom was built to allow the orifices to remain at the same location in the air stream as the boom rotated. Rotation was accomplished by a motor and gear system which, when actuated, caused the boom to oscillate continuously through an angular range of -20° to 45° at a rate of about 4° per second. Errors due to pressure lag determined by stopping the boom at various angles of attack and comparing the pressure measurements with those obtained when the boom was rotating were found to be negligible. The angular position of the boom was measured by a mechanical-optical-type position recorder connected to the upper end of the boom shaft.

The variation of static-pressure error with angle of attack of the test tube was determined by measuring the difference between the pressure registered by the test tube and that registered by a pitot-static tube mounted ahead of the fuselage nose (fig. 3). The differential-pressure recorder for these tests had a range of 10 inches of water and a highly probable precision of ± 0.025 inch of water. The fuselage nose boom also provided measurements of impact and ambient pressures.

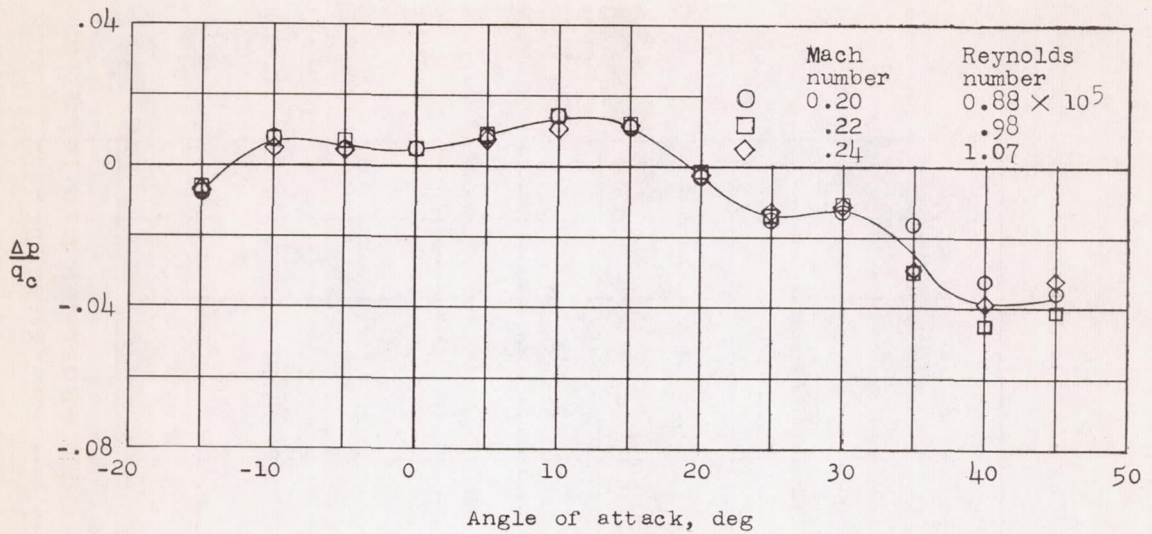
Figure 4.- Variation of static-pressure error of tube A with angle of attack.

Tubes A and B.— The variation of static-pressure error with angle of attack of tubes A and B is shown in figures 4 and 5. Each point shown on these curves is the average of two readings taken a few minutes apart during the same test. For this series of tests the precision of the data at $\alpha < 25^\circ$ was about ± 0.05 percent of q_c ; at $\alpha = 30^\circ$ to 45° the precision was of the order of ± 0.4 percent of q_c .

The Military specification (ref. 5) to which these tubes were built specifies that, for indicated airspeeds up to 250 mph, the static-pressure error at angles of attack between -10° and 16° shall differ from the error at zero angle by no more than 0.15 inch of water. For the indicated speeds covered by the present tests, this pressure difference corresponds to a static-pressure error between 1.2 and 1.8 percent of q_c . Figures 4 and 5 show that both of the tubes meet this Military specification and that, within the specified angle-of-attack range, the effect of the difference in orifice size is small. At angles of attack above 16° , however, the calibrations differ appreciably; thus, it is indicated that differences in orifice diameter as small as 0.004 inch have a pronounced effect on the sensitivity of this type of tube at the higher angles.

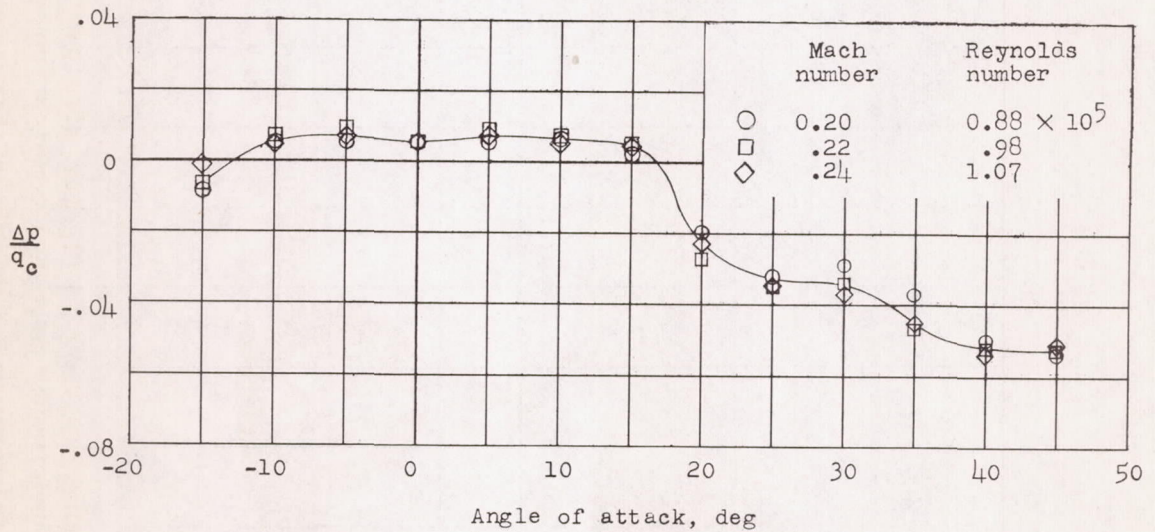
Figure 5.- Variation of static-pressure error of tube B with angle of attack.

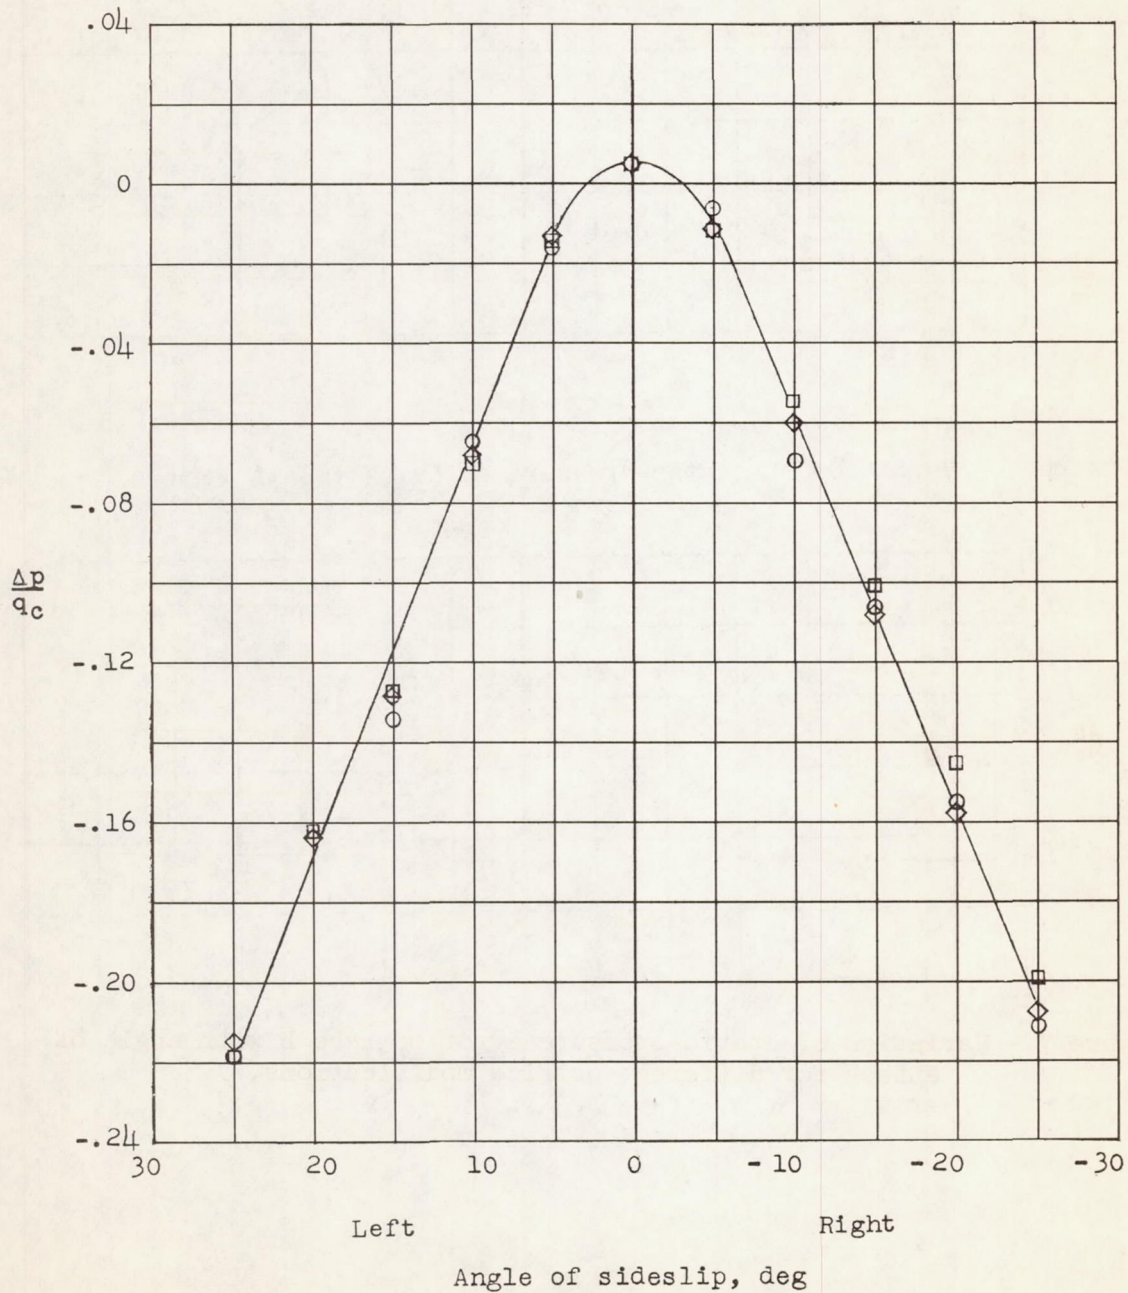
Figure 6.- Variation of static-pressure error of tube B with angle of sideslip.

The calibration of tube B at angles of sideslip is given in figure 6. Because of the unsymmetric orifice arrangement, there is, as expected, a wide difference in the sensitivity of the tube to angles of attack and sideslip. At angles of attack, for example, the static-pressure error remains within 1 percent of q_c from -15° to 18° , whereas, at angles of sideslip, the error is within 1 percent over a range of only about $\pm 5^\circ$.

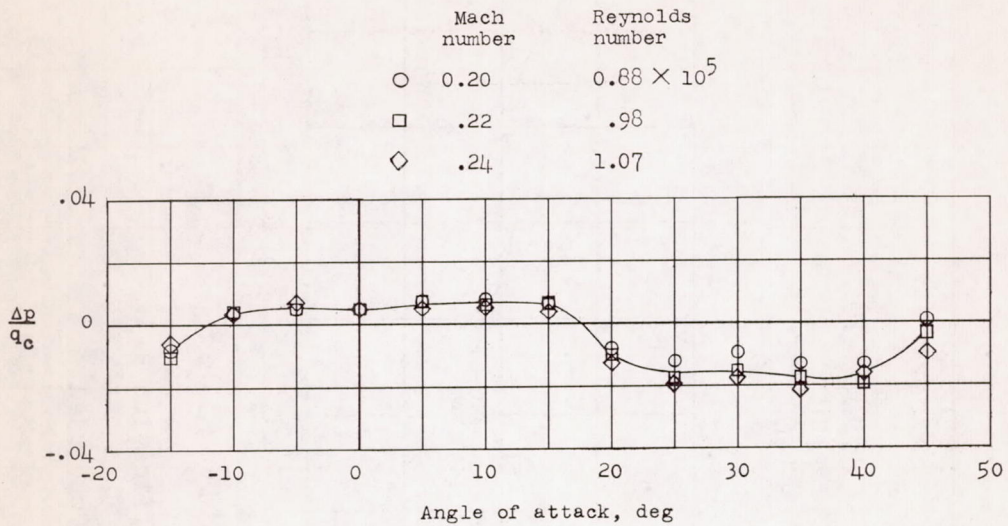
(a) Orifice modification B-1.

Figure 7.- Variation of static-pressure error of tube B with angle of attack for different orifice modifications.

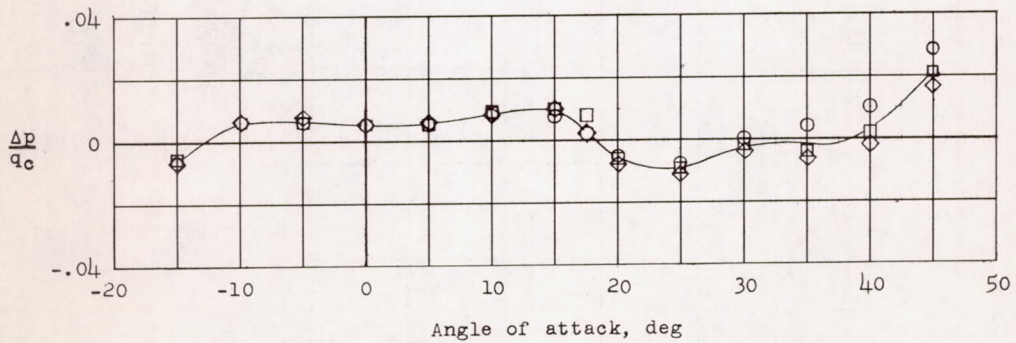
(b) Orifice modification B-2.

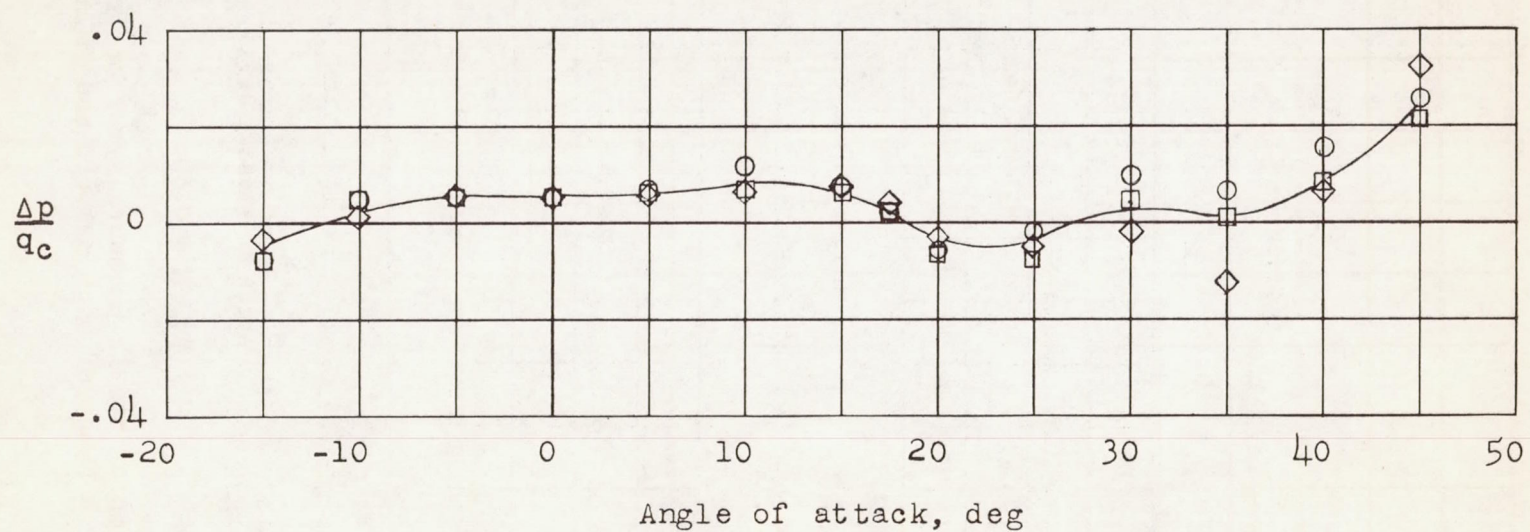
(c) Orifice modification B-3.

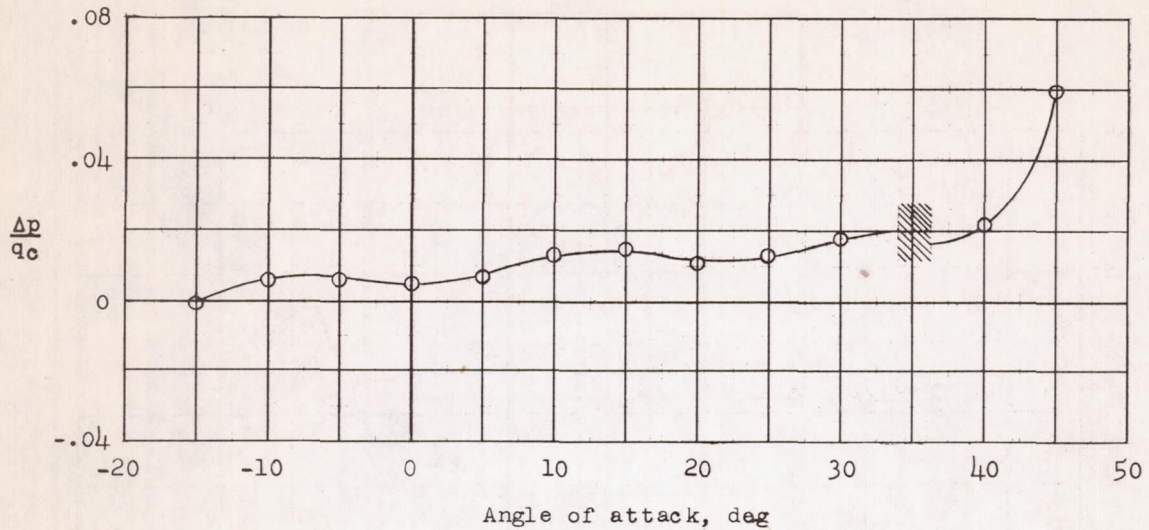
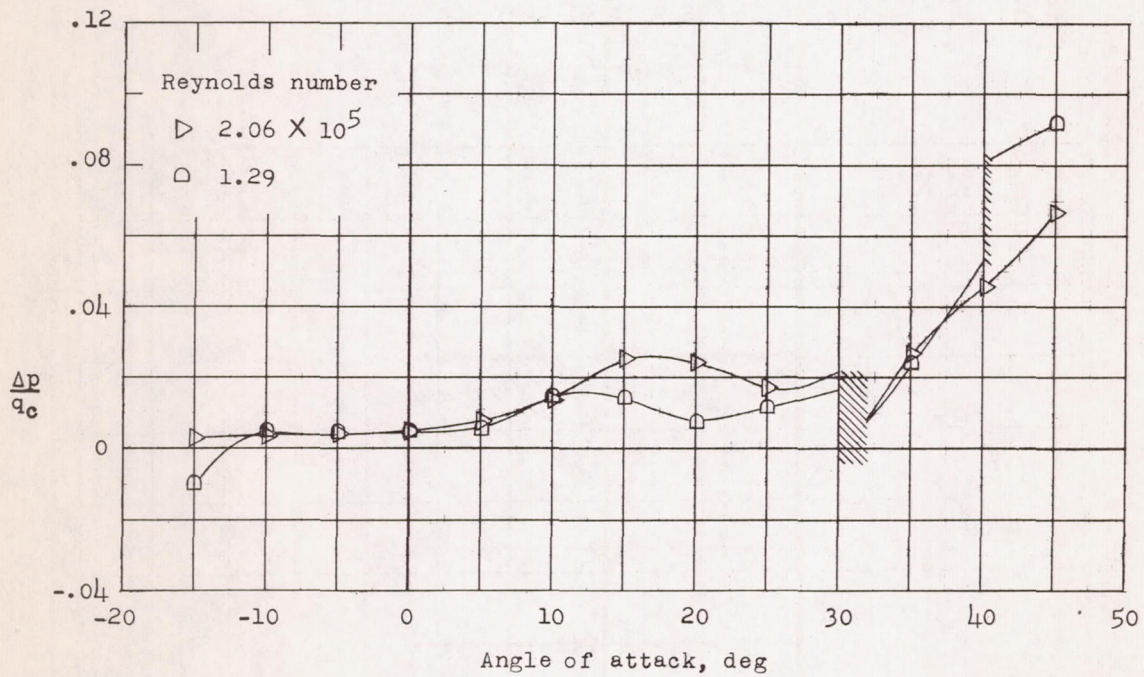
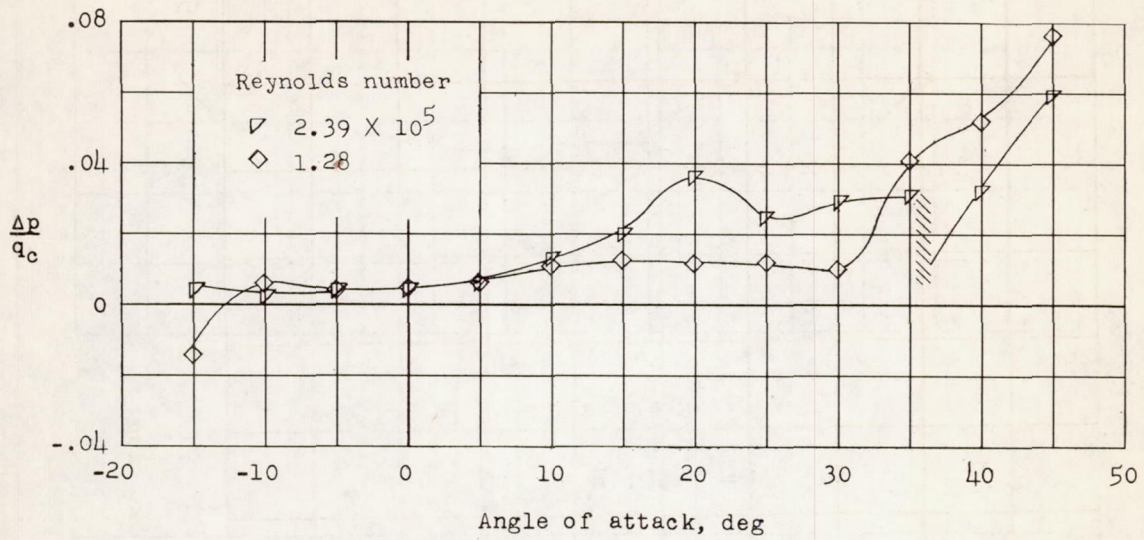
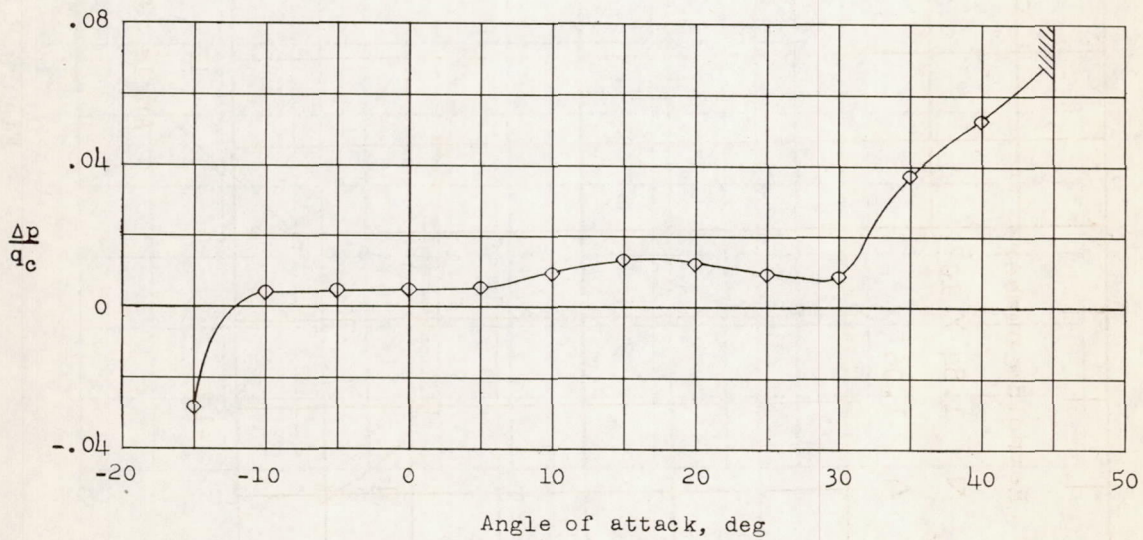
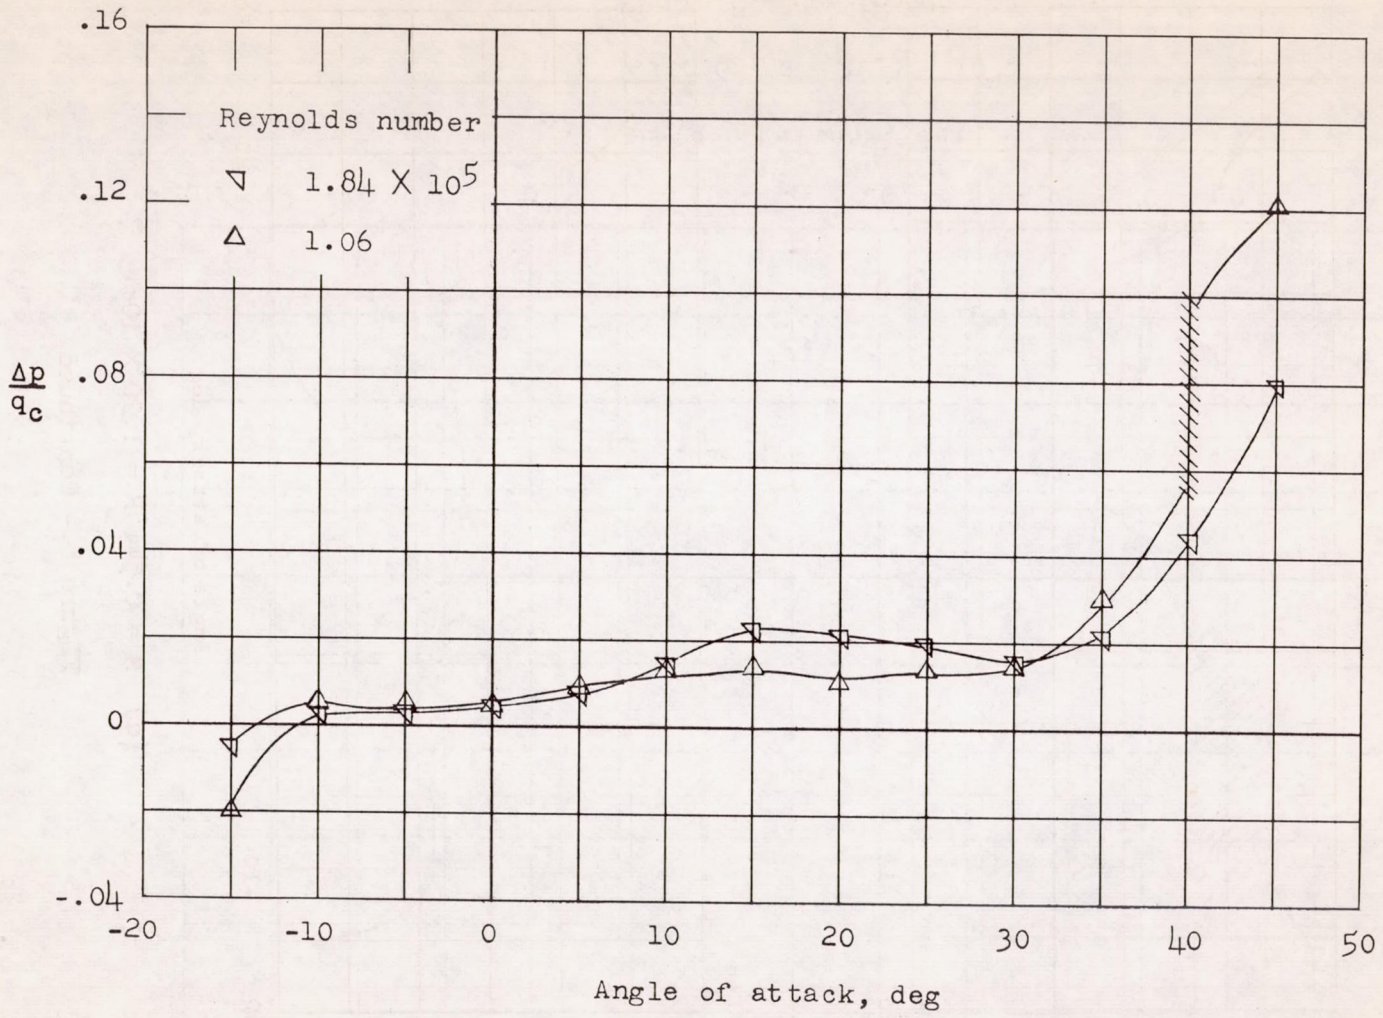
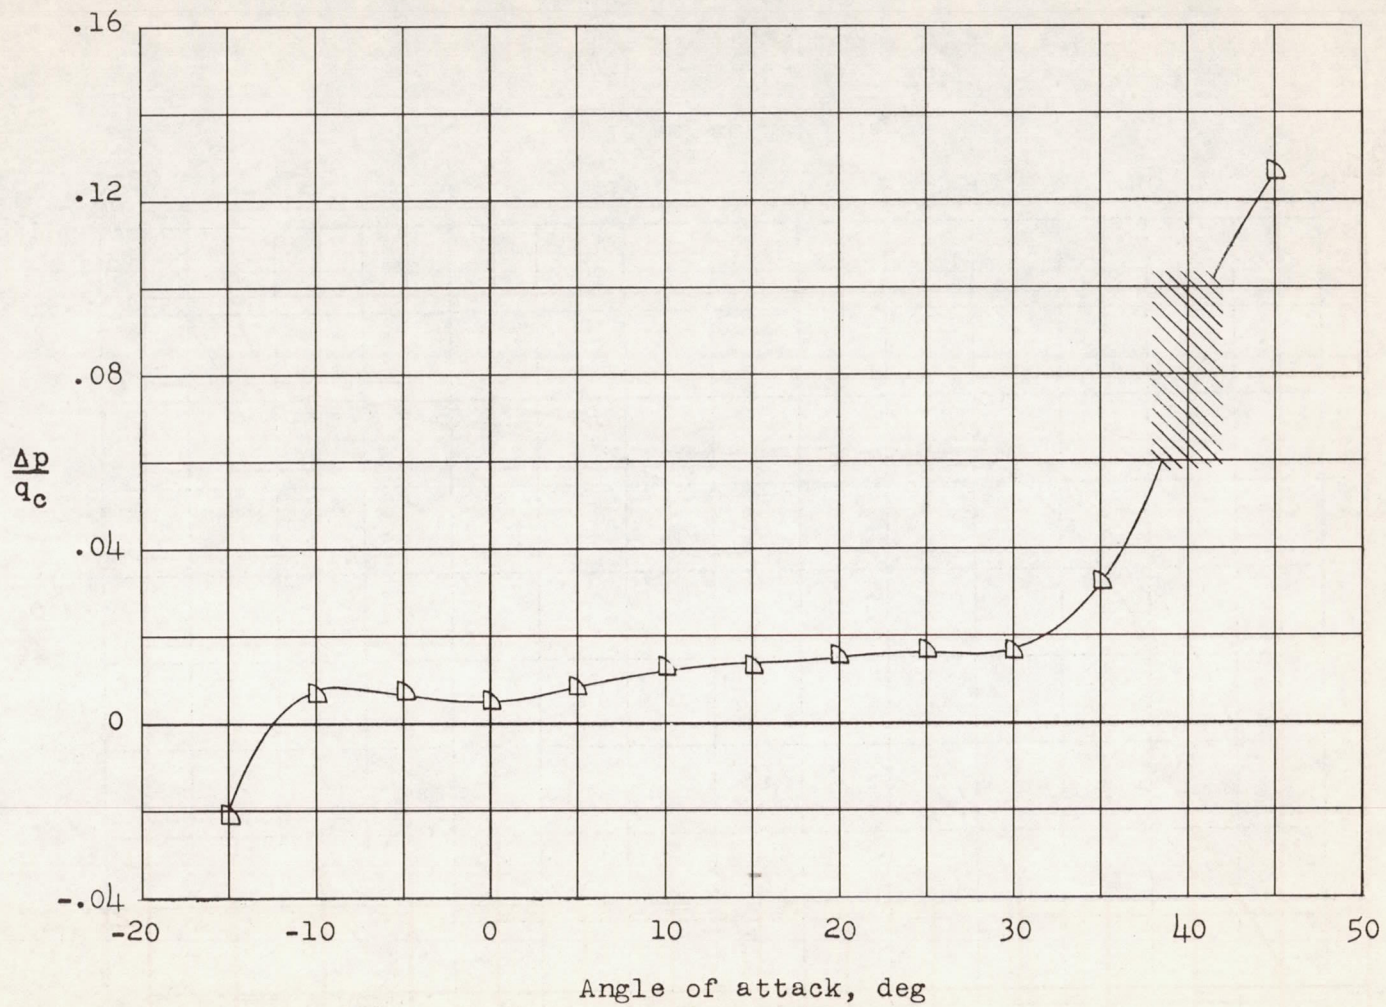
(a) $M = 0.30$; $R = 1.65 \times 10^5$.

(b) $M = 0.39$.

Figure 8.- Variation of static-pressure error of tube C-3 with angle of attack over a range of Mach numbers and Reynolds numbers.

(c) $M = 0.50$.

(d) $M = 0.54; R = 1.20 \times 10^5$.

(e) M = 0.57.

(f) $M = 0.60$; $R = 1.11 \times 10^5$.

Calibration at Mach numbers from 0.30 to 0.68.- Calibrations of tube C-3 at Mach numbers from 0.30 to 0.68 and at Reynolds numbers

from 1.1×10^5 to 2.4×10^5 are given in figure 8. Each of the test points shown on the curves represents the average of two readings taken from different cycles of the boom traverse, with the tube approaching a given angle from different directions. The precision of the data for this series of tests was ± 0.05 percent of q_c for α below 30° and ± 0.4 percent of q_c for α above 30° . Comparison of the calibrations shows that between $\alpha = -10^\circ$ and 30° the variation of static-pressure error with angle of attack is relatively small and the magnitude of the errors is less than about 3.5 percent of q_c . For $\alpha > 30^\circ$, however, the variation of static-pressure error with angle of attack became erratic in addition, the magnitude of the errors increased rapidly and reached values as high as 15 percent of q_c at $\alpha = 45^\circ$. The erratic behavior of the pressure registered by the test tube at angles of attack above 30° consisted of oscillations with an amplitude of ± 0.25 percent of q_c . As the angle of attack increased, the amplitude of the oscillations steadily increased to about ± 1 percent of q_c at $\alpha = 45^\circ$. In most of the tests there was superimposed on these oscillations a pressure discontinuity accompanied by fluctuations which had amplitudes as large as the discontinuity. The magnitude of the pressure discontinuities and the angle-of-attack range over which the large-amplitude fluctuations persisted are shown on the calibrations as a hatched area. Because of the magnitude of the errors and the erratic pressure fluctuations in this angle-of-attack range, the usefulness of the tube is limited to angles of attack below 30° .

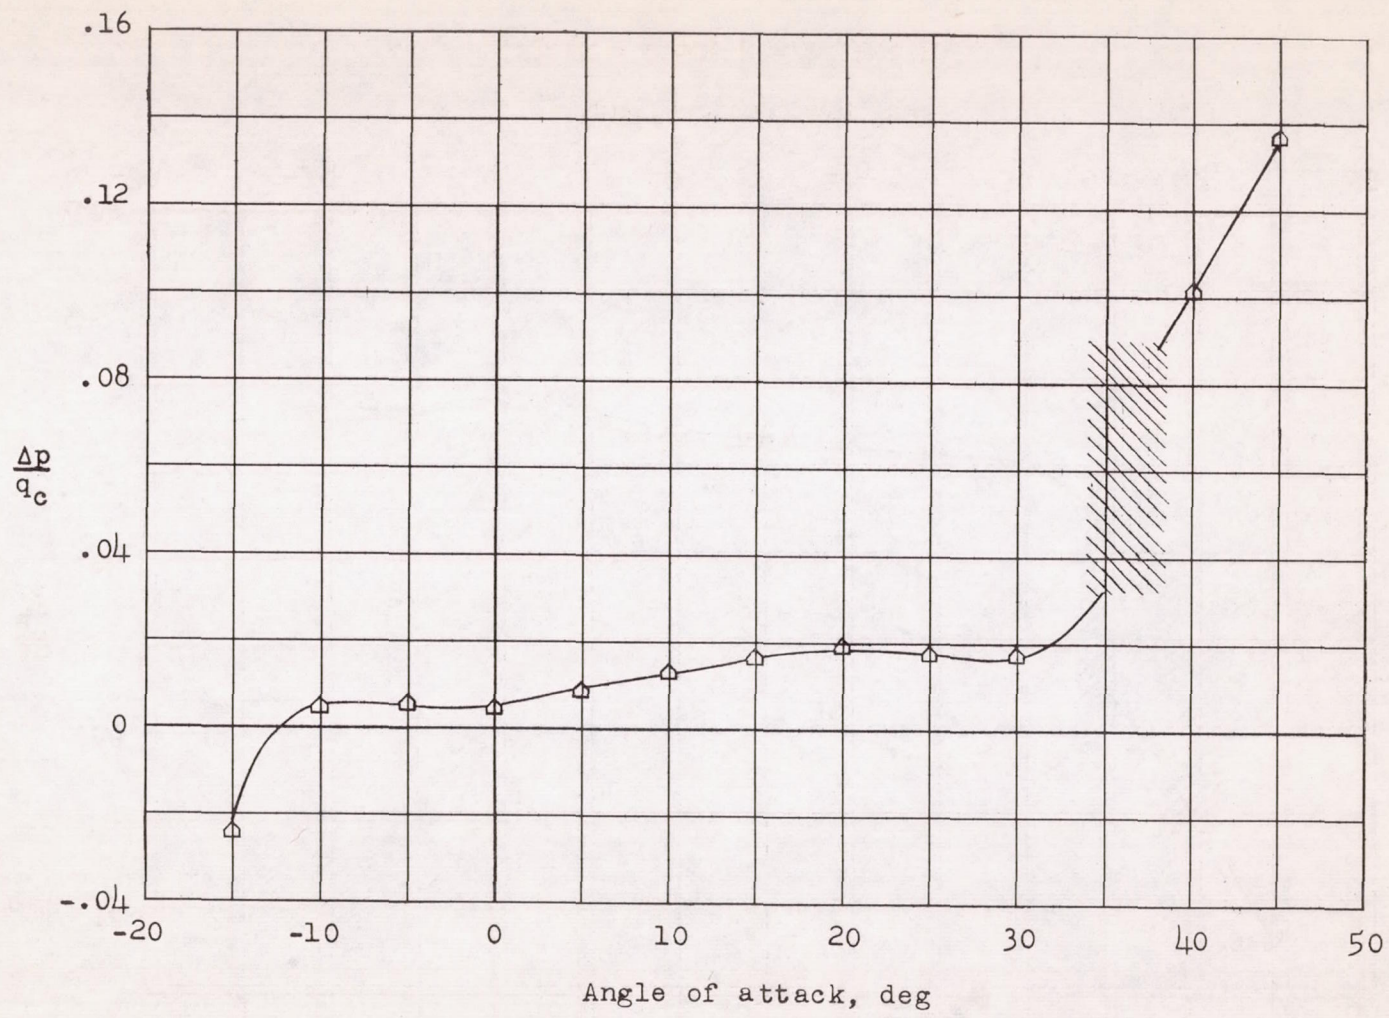
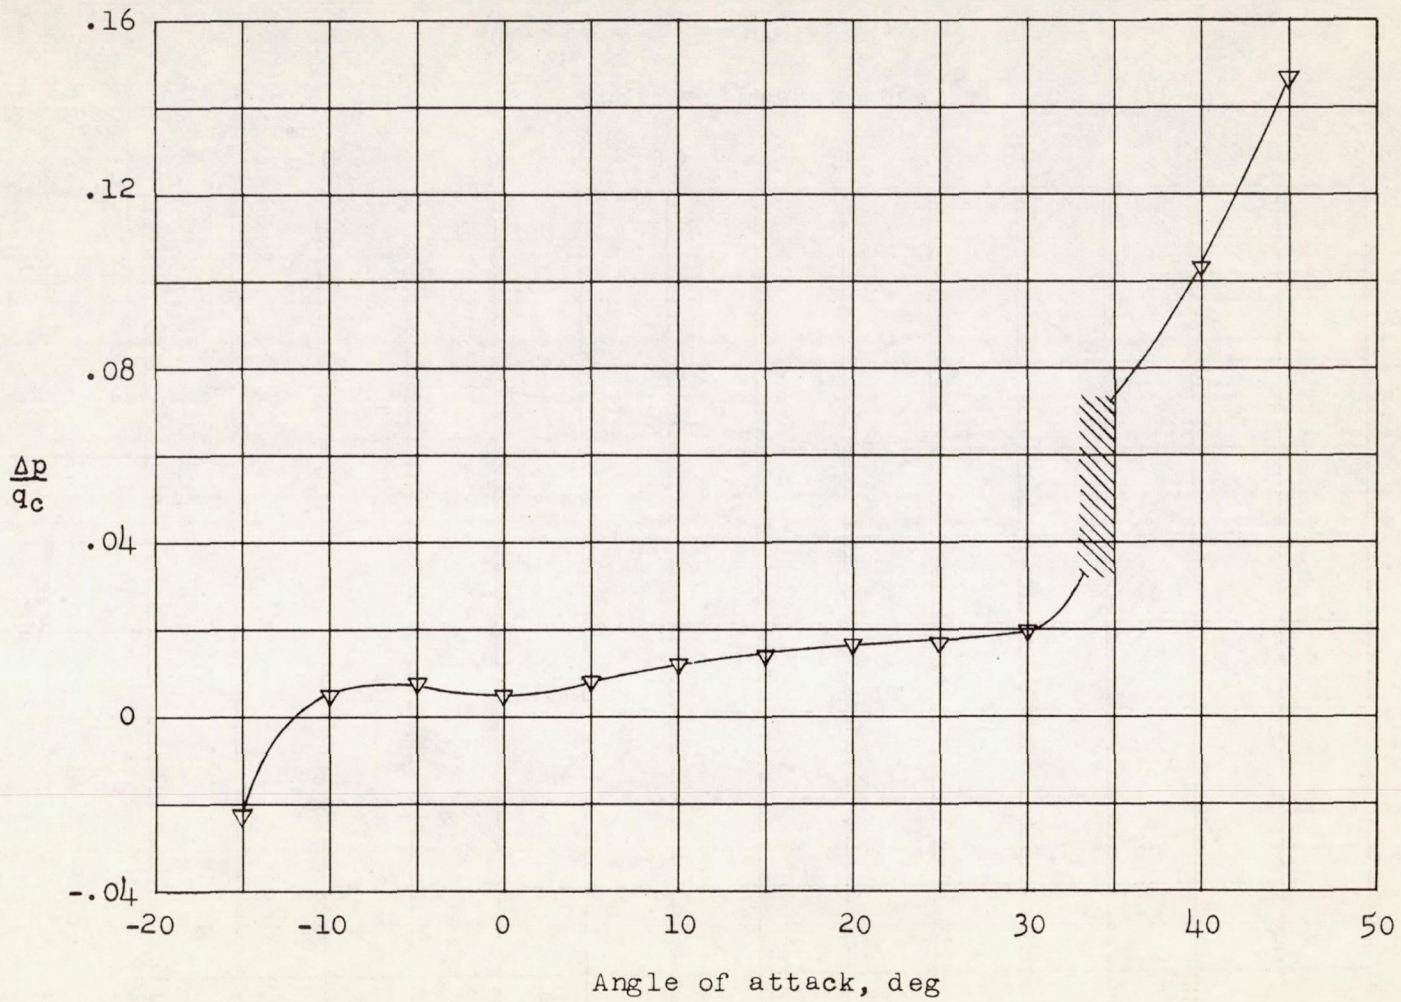
(g) $M = 0.64$; $R = 1.18 \times 10^5$.

(h) $M = 0.68$; $R = 1.26 \times 10^5$.

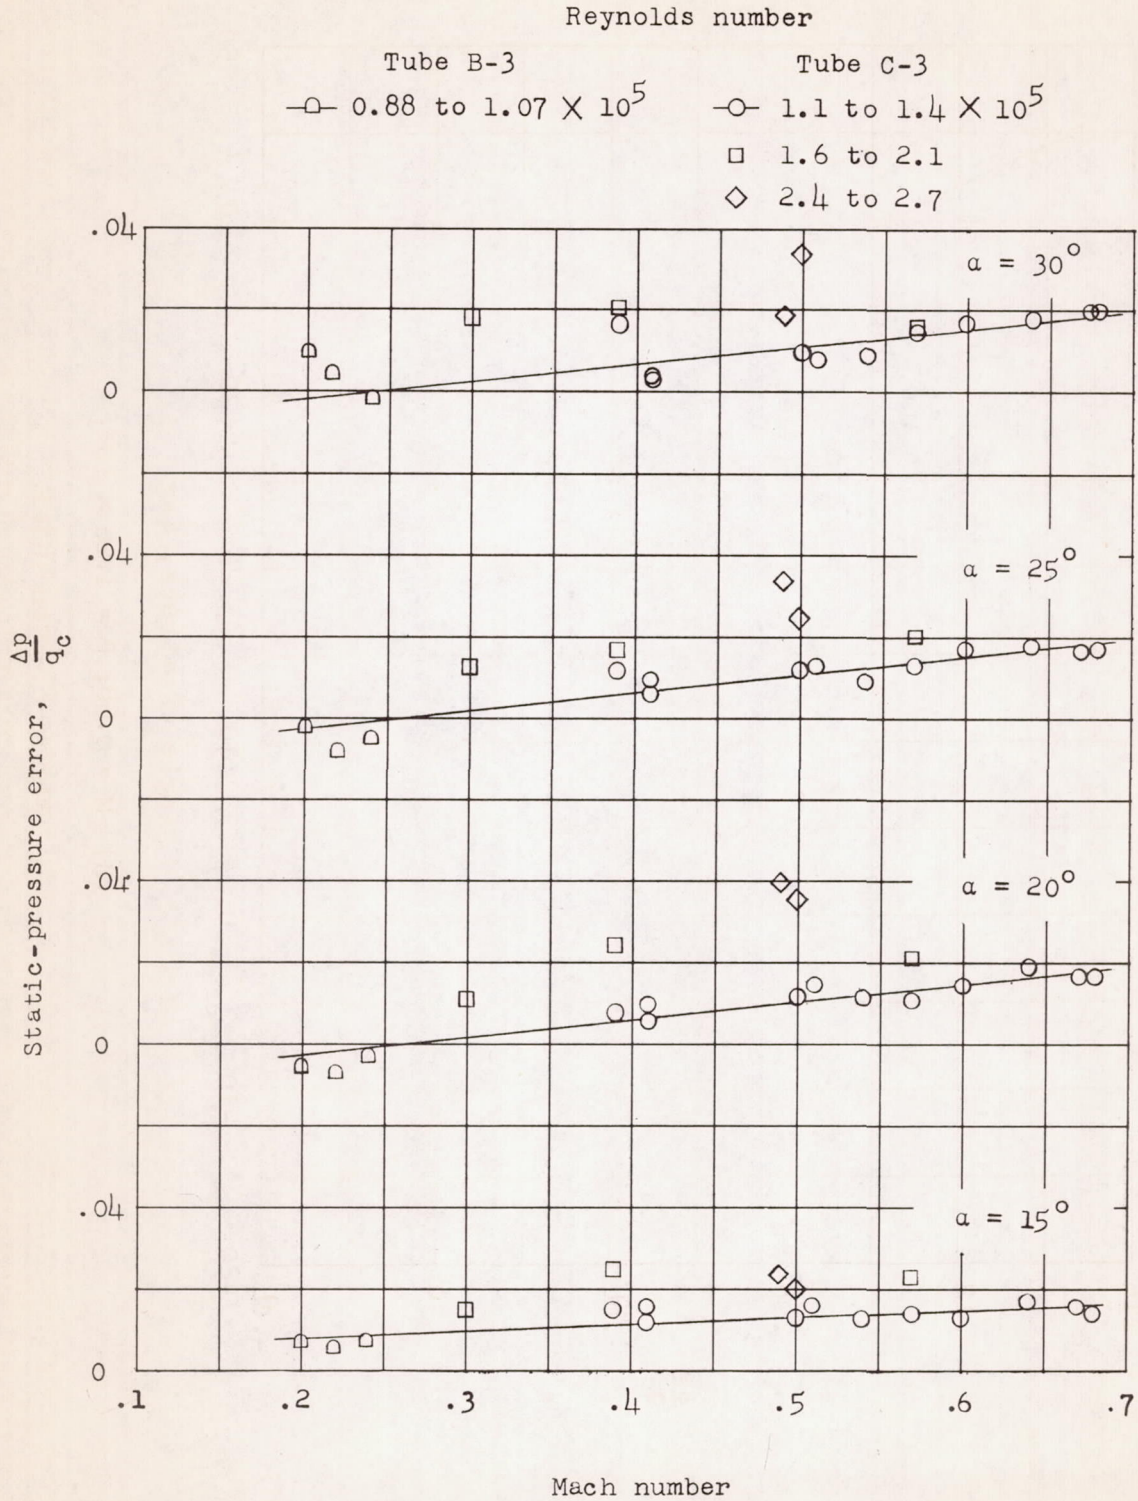
Figure 9.- Variation in static-pressure error of tubes B-3 and C-3 with Mach number and Reynolds number.

Effect of Mach and Reynolds numbers on static-pressure errors.- In order to show the manner in which the static-pressure error at the higher angles of attack varies with Mach number and Reynolds number, the errors at $\alpha = 15^\circ, 20^\circ, 25^\circ,$ and 30° have been replotted as a function of Mach and Reynolds numbers in figure 9. The data shown in this figure were obtained with tubes B-3 and C-3 and were derived from figures 7(c) and 8 and from other tests conducted during the investigation. Figure 9 shows that the error at a given angle of attack increases with both Mach and Reynolds numbers and that for the Reynolds number range at which most of the data were obtained (0.9×10^5 to 1.4×10^5), the increase in error is generally of the order of 1 to 2 percent of q_c for the Mach number range investigated. On the basis of the results of the tests of tubes B-3 and C-3, it is concluded that for Reynolds numbers between 0.9×10^5 and 1.4×10^5 , and for Mach numbers between 0.20 and 0.68, the static-pressure error for a tube with this orifice arrangement will remain within 2 percent of q_c over an angle-of-attack range of -10° to 30° .
