NACA TN 2996

APPRAISAL OF HAZARDS TO HUMAN SURVIVAL
IN AIRPLANE CRASH FIRES

By Gerard J. Pesman

Lewis Flight Propulsion Laboratory
Cleveland, Ohio

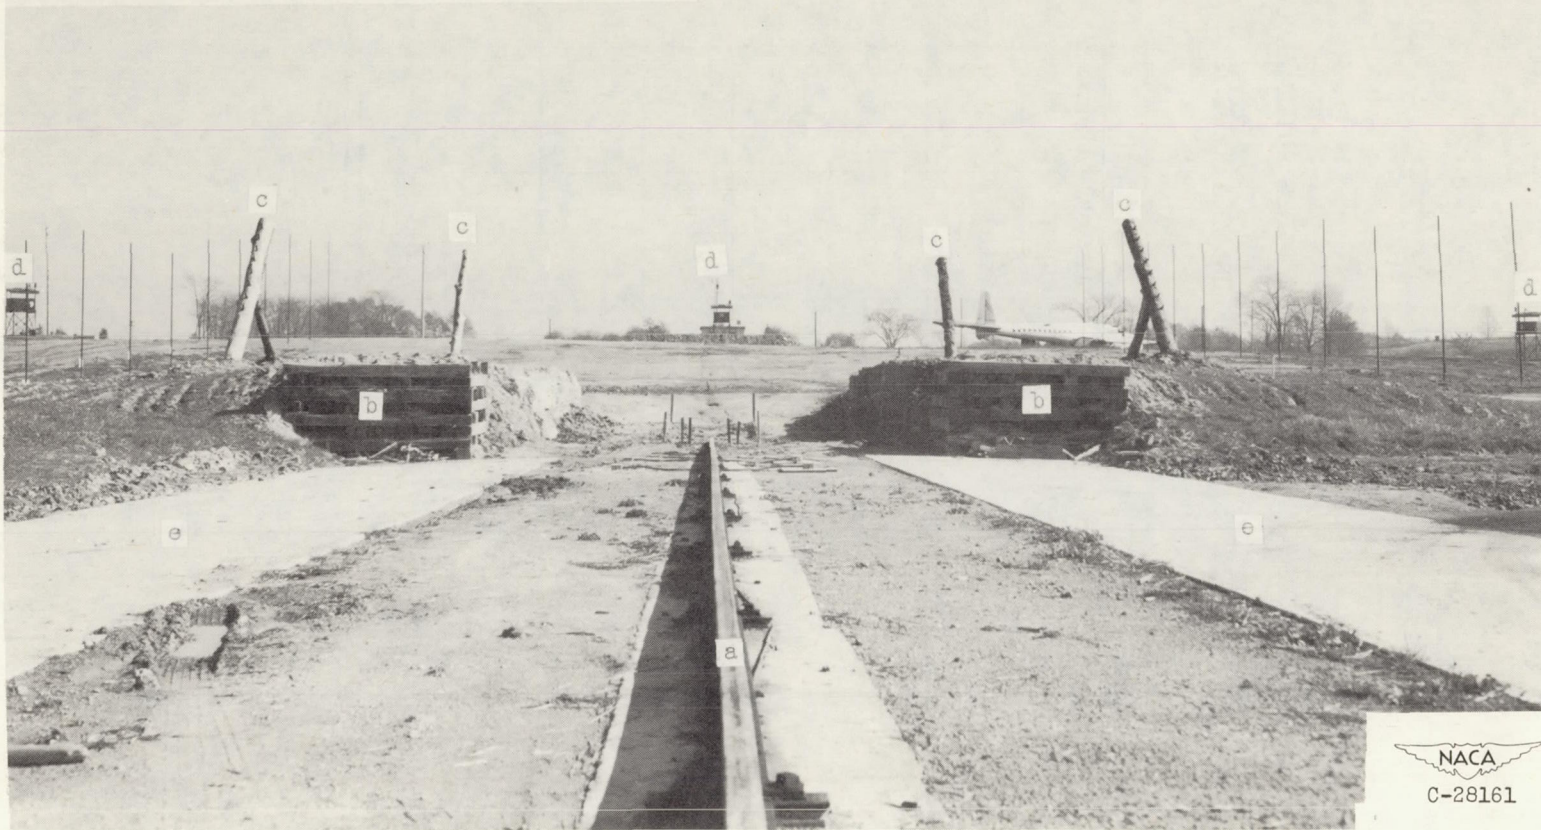
- a Guide rail
- b Timber-and-dirt barrier to damage propellers and landing gear
- c Spike-studded poles to tear open fuel tanks
- d Stands for motion-picture cameras
- e Paved runways for main landing gear wheels

Figure 1. - Crash site showing end of guide rail, propeller and wheel barriers, fuel-tank pole barriers, and camera stations.

The studies were conducted by guiding an unmanned airplane along a fixed path under its own power and allowing it to strike preconstructed barriers that damaged the propellers, engines, landing gear, and fuel tanks. The airplane was guided by slaving the front landing wheel or wheels to a steel monorail placed in the center of a paved runway. This runway was long enough to allow the airplane to reach a speed of 85 to 95 miles per hour, approximately take-off speed. Removal of the main landing wheels by the barriers caused the airplane to slide along the ground on its belly while the additional damage to propellers, engines, and fuel tanks created the conditions conducive to fire. The crashes therefore simulated a take-off accident in which the likelihood of serious fire was high but the structural damage was moderate. The out-board fuel tanks were approximately three-fourths filled so that about 1000 gallons of fuel were involved in each crash. The fuel used was either standard 100/130 grade aviation gasoline or a low volatility fuel having a Reid vapor pressure of 0.1 pound per square inch. Figures 1 to 5 show various features of the crash site, crash operation, and damage inflicted on the airplane.

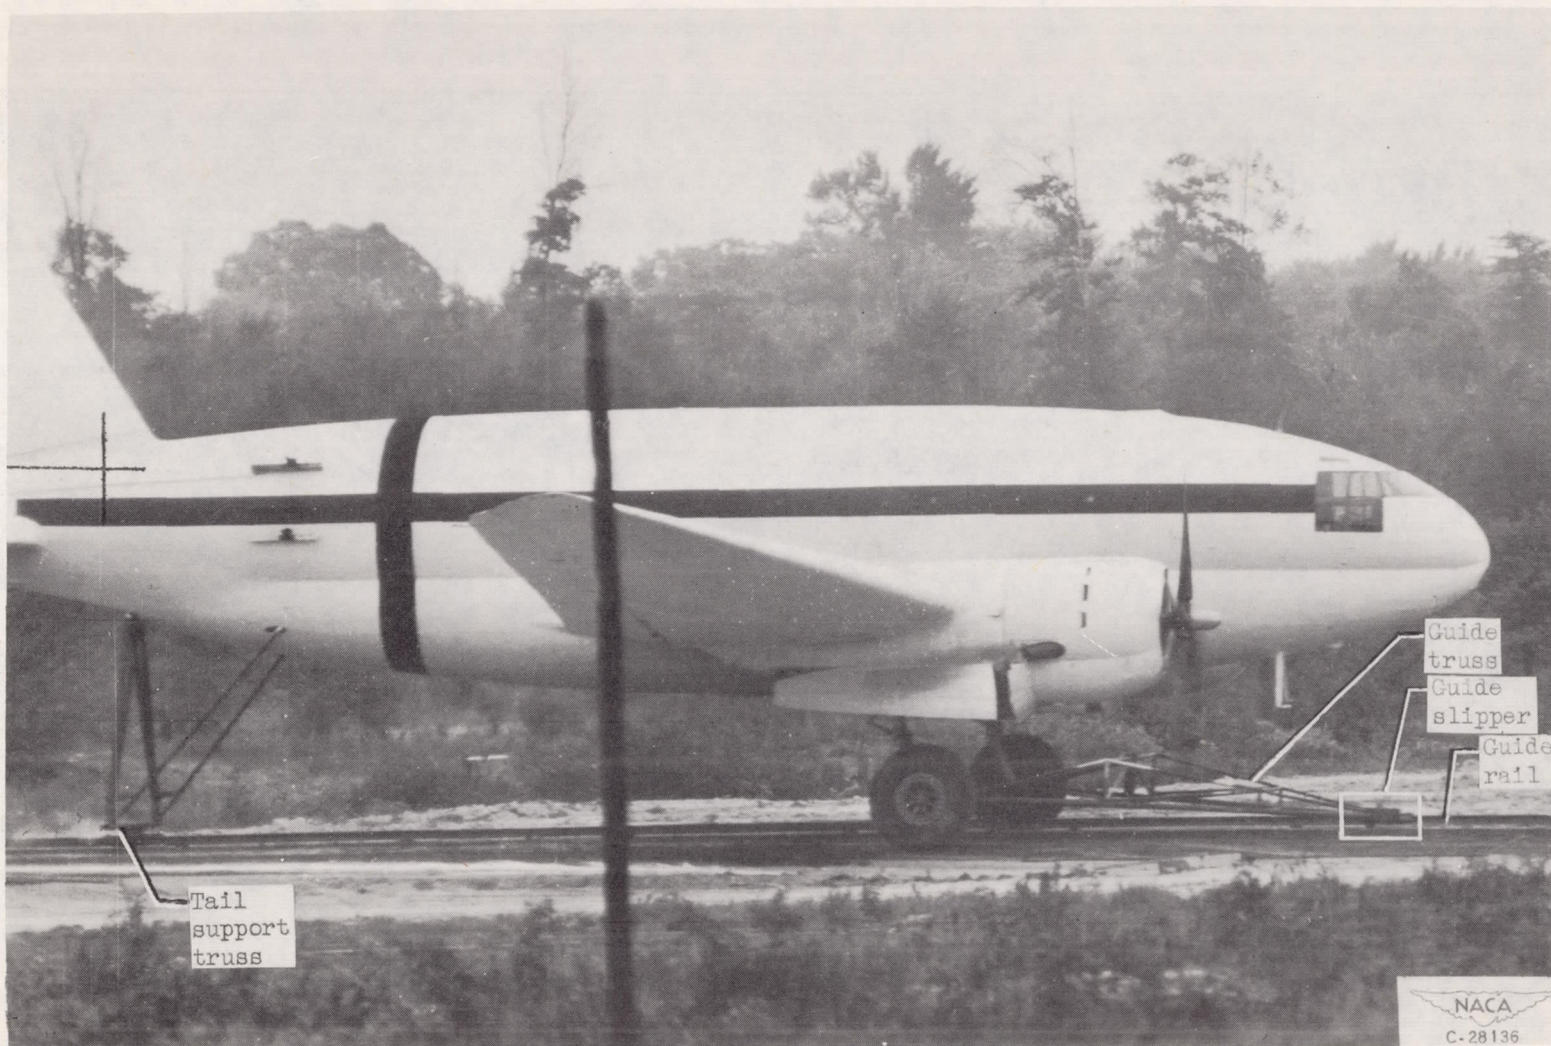
Figure 2. - Airplane with conventional landing gear traveling along guide rail showing guide slipper, guide truss attached to main landing gear, and tail support truss that slides along top of guide rail.

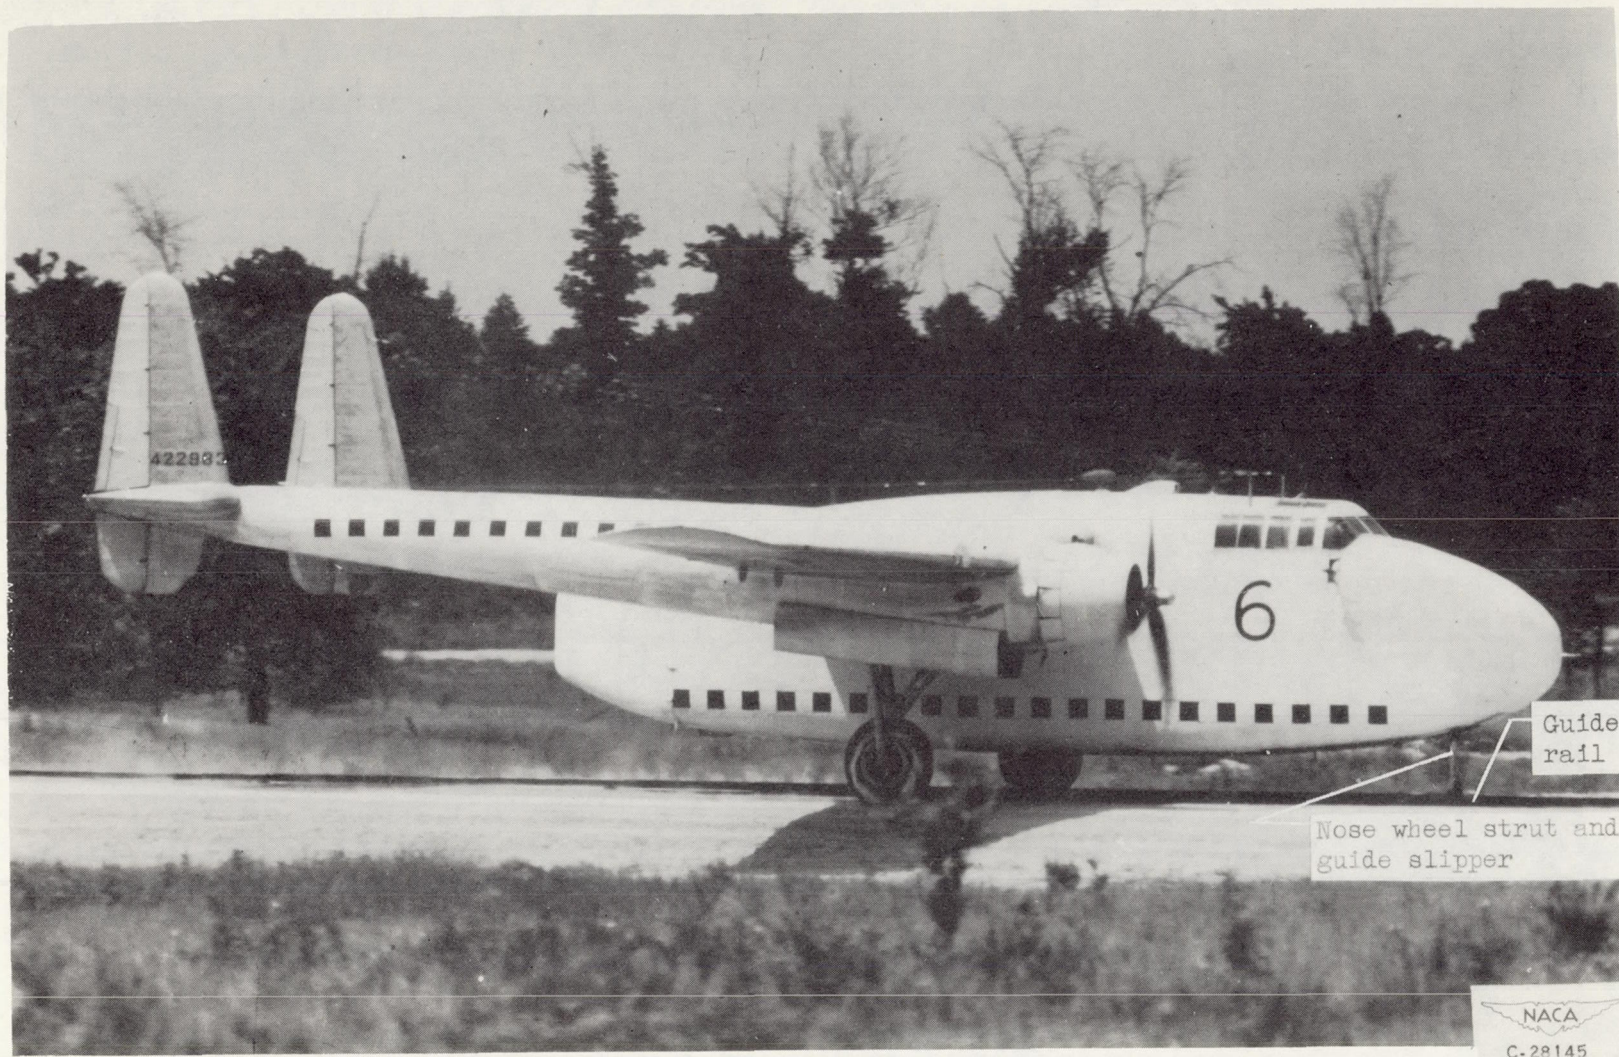
Figure 3. - Airplane with tricycle landing gear traveling along crash strip showing guide slipper attached to strut and replacing nose wheel.

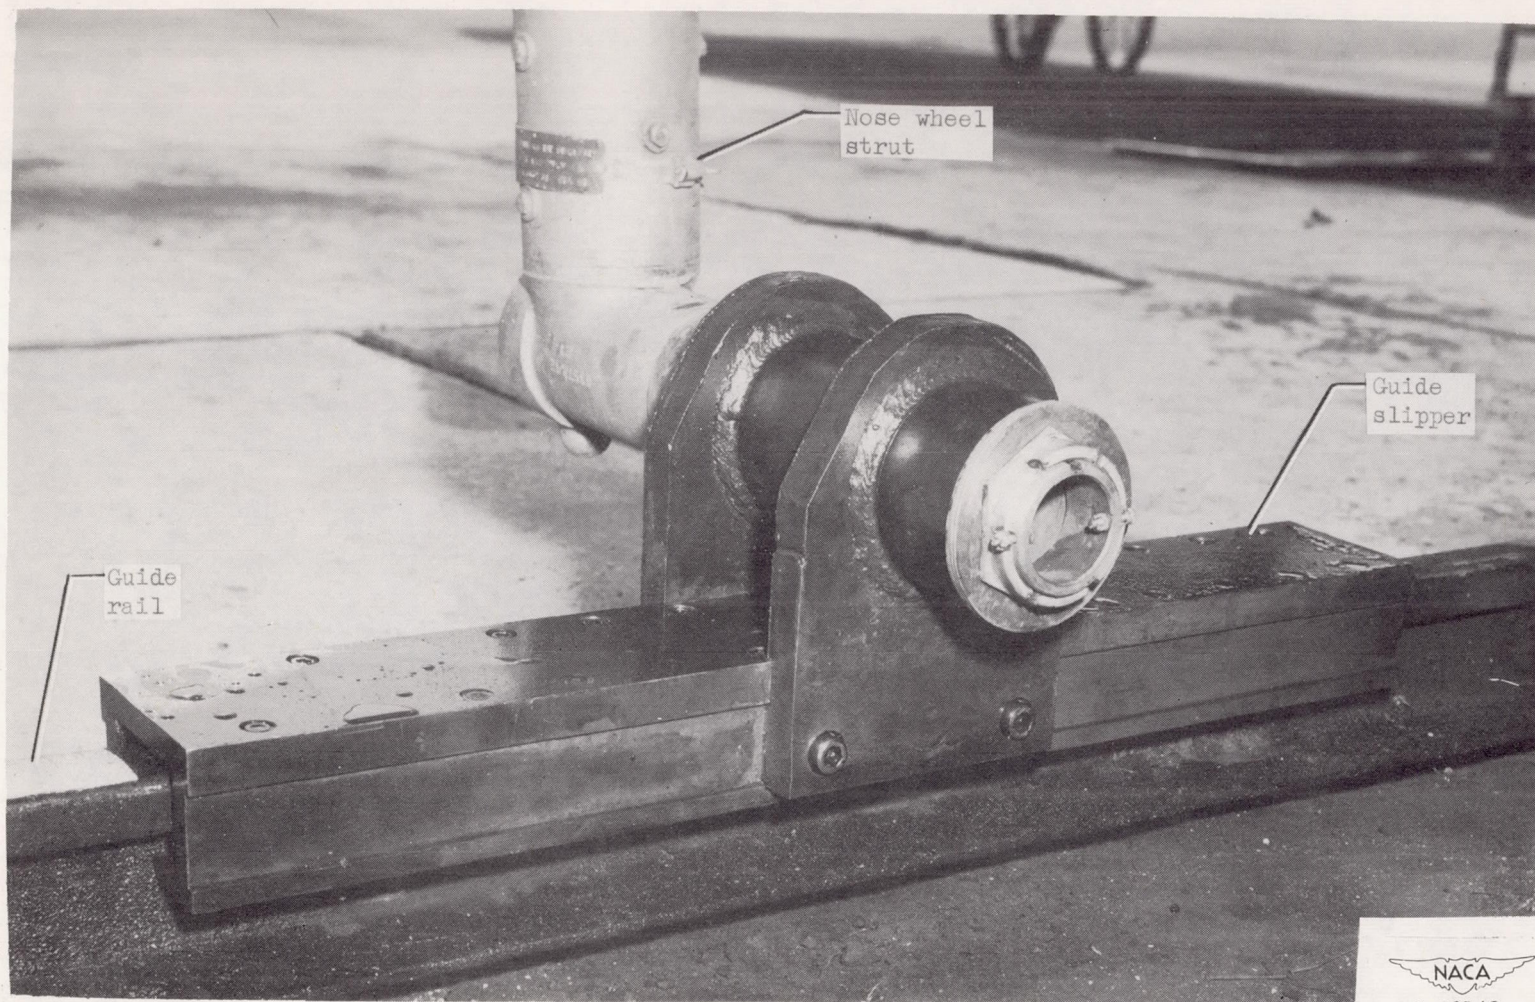
Figure 4. - Close-up view of guide slipper attached to strut in place of nose wheel. Guide slipper grips over top bead of rail to prevent airplane nose from lifting.

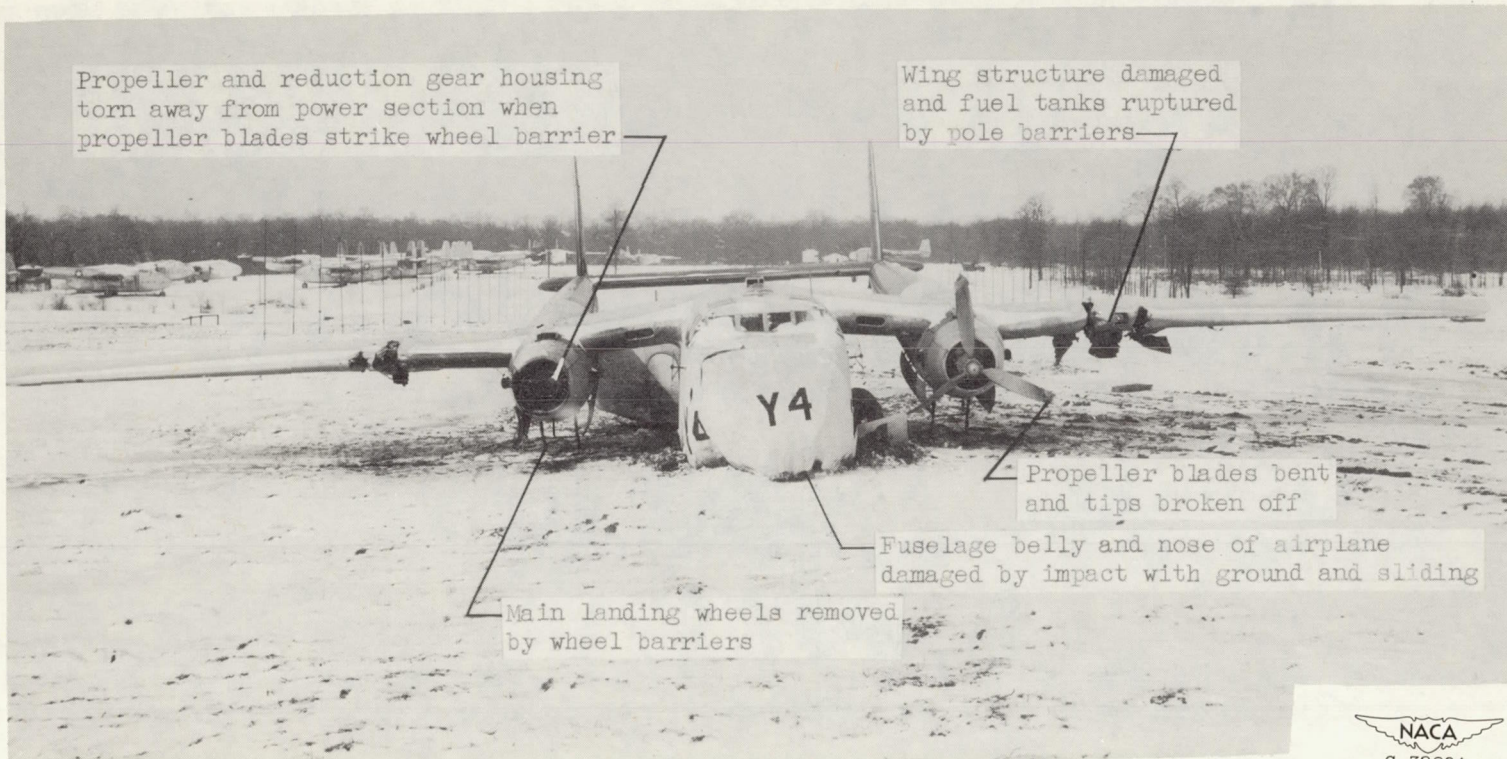
Figure 5. - Damage inflicted to airplane and engines by wheel barriers, fuel tank barriers, and contact with ground.

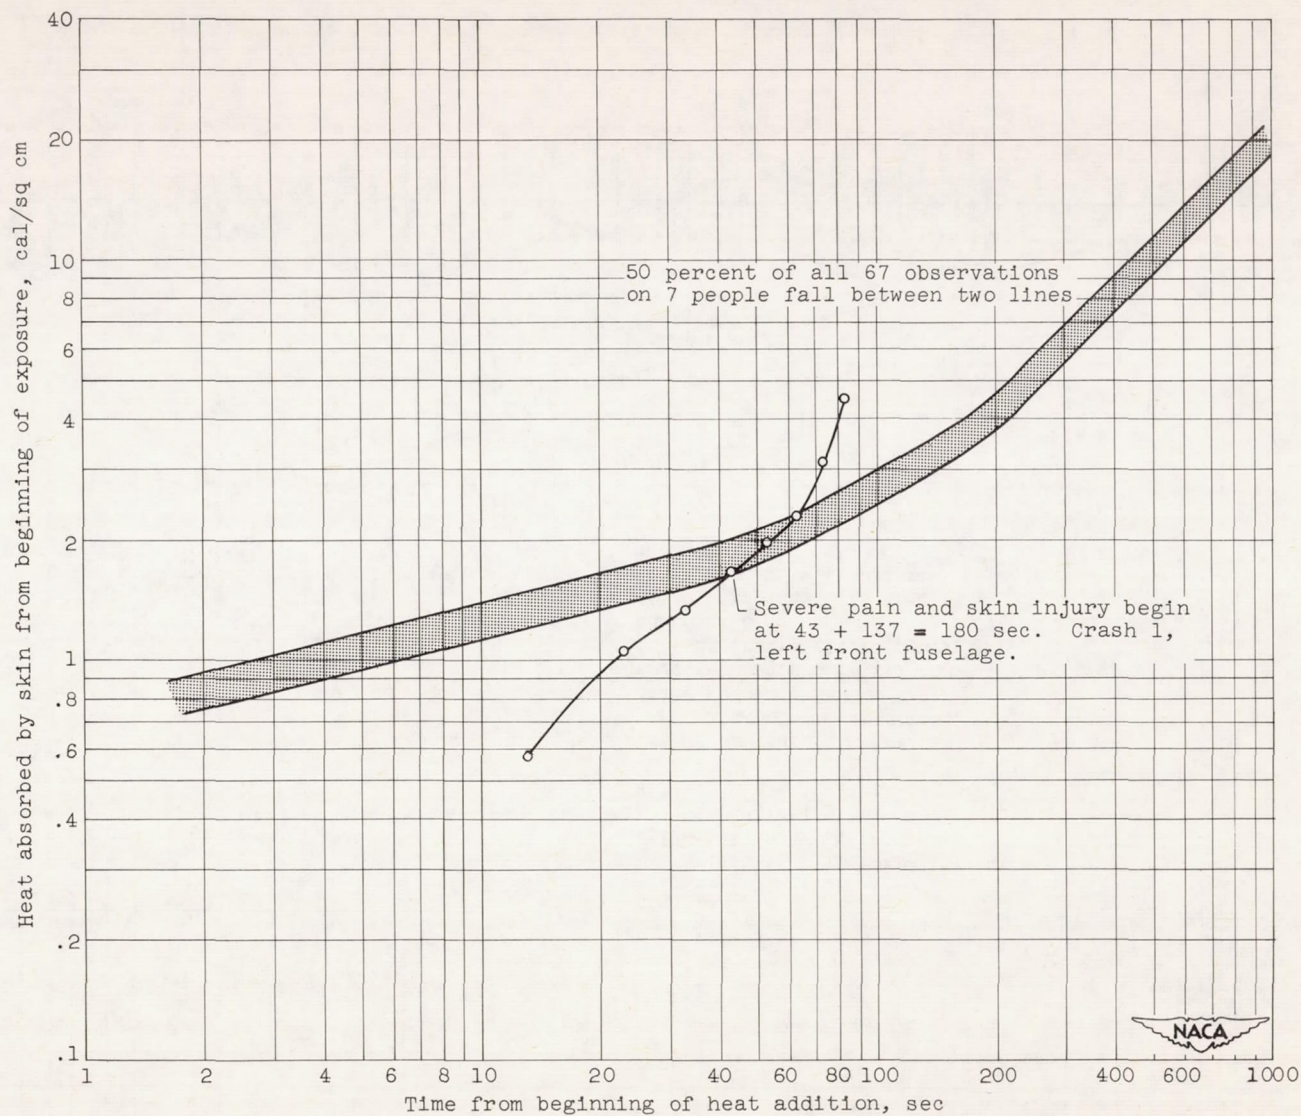
Figure 6. - Time until unbearable pain occurs if dorsal side of forearm is exposed to infrared radiation and absorbs indicated amount of heat. (Converted from fig. 3 of ref. 4.)

The relation between heat absorbed by the skin and the time during which absorption occurs that causes unbearable pain is shown in figure 6. This figure is a modification of figure 3 presented in reference 4.

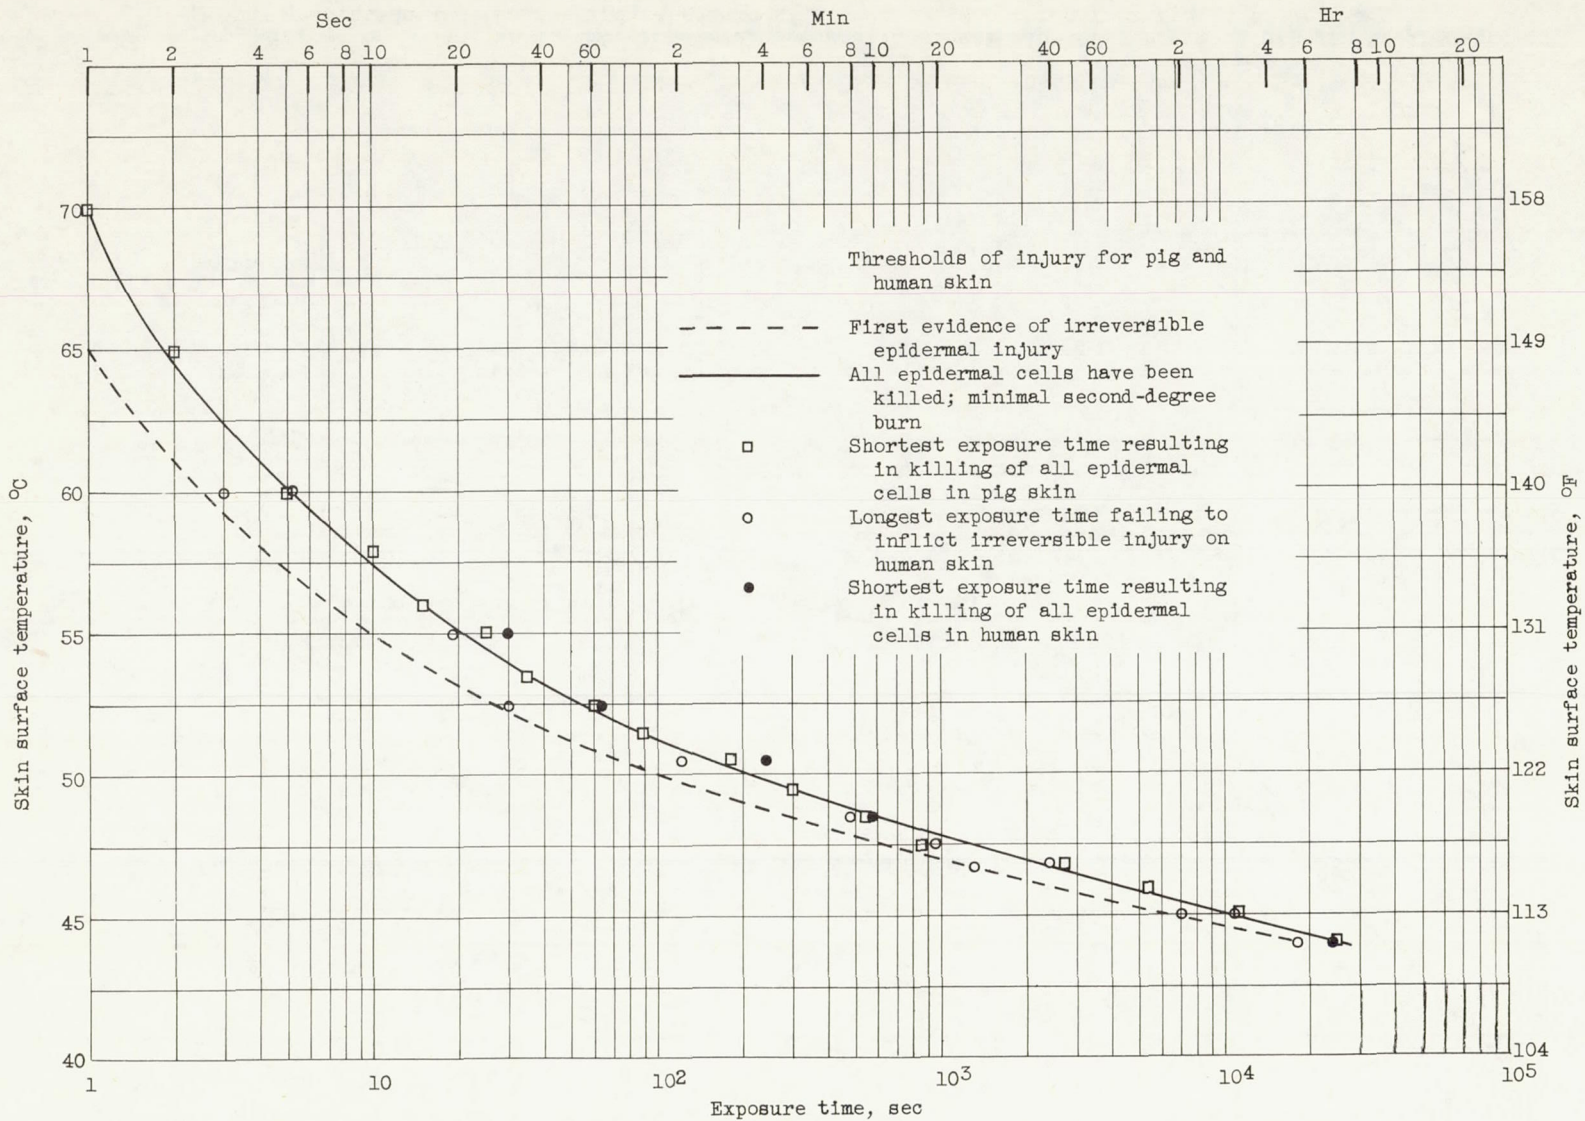
Figure 7. - Time-surface temperature thresholds for skin burning. (Reproduced from ref. 5.)

An investigation of thermal skin injury reported in reference 5 showed that skin burning, injury to the skin tissue, begins when the skin surface temperature is raised to 44° C (fig. 7). If this minimum skin surface temperature is maintained, progressively more severe injury occurs, the extent of the injury depending upon the duration of the exposure. Below 44° C the rate of cellular repair is equal to the rate of injury and no cumulative injury occurs. Because of the similar temperature values for pain and the beginning of skin injury, pain is a good indication that skin injury will occur if the application of heat continues. A skin surface temperature of 42° to 45° C (107.6° to 113° F) can then be used as one criterion limiting the escape time. The method of determining this escape time is described in appendix A.

epidermal layer have been killed by heat. The relation between skin surface temperature and exposure time causing a second-degree burn is shown by the solid line on figure 7. This figure shows that if the skin surface temperature is 44°C (111°F), an exposure of about 6 hours is required to produce a second-degree burn. If the skin surface is maintained at 55°C (131°F), an exposure of only 20 seconds is required for a second-degree burn; while at a skin surface temperature of 70°C (158°F), a second-degree burn will be inflicted in 1 second. The information presented in this figure makes possible the calculation of escape time as limited by a second-degree burn. With possible complicating factors neglected, a second-degree burn of face, head, and neck is considered survivable by medical authorities. The escape times based upon this criterion will be presented for comparison with the escape times as limited by pain and the beginning of skin injury. The method of calculating the second-degree burn escape time from a time history of calorimeter bulb temperature is also shown in appendix A.

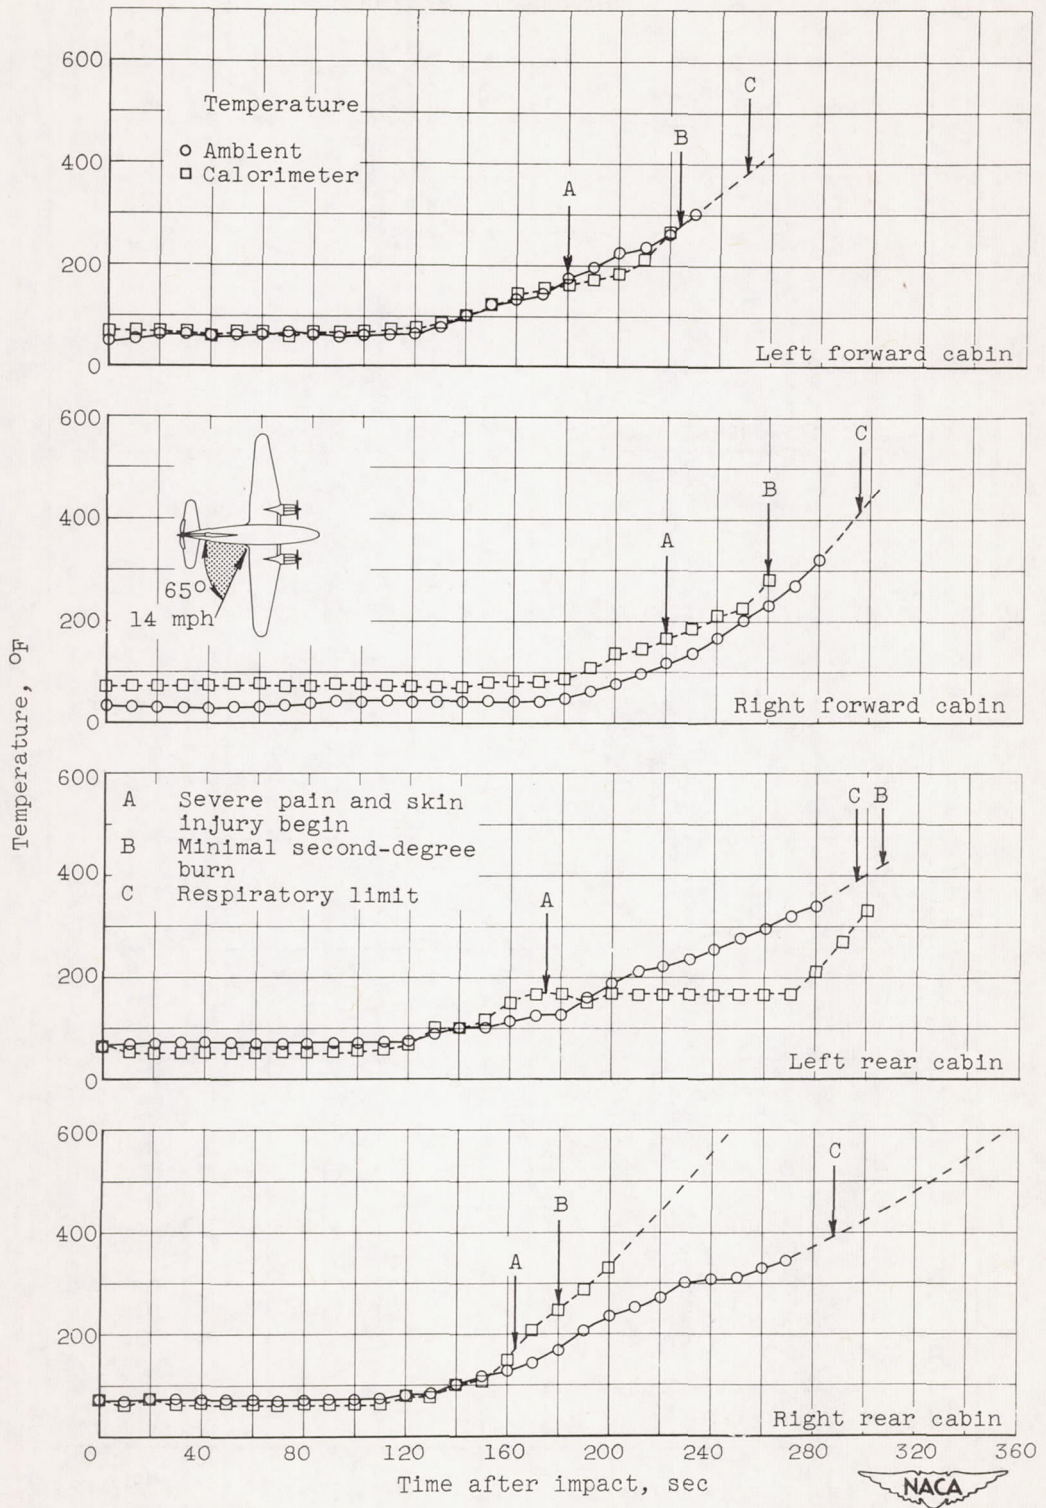
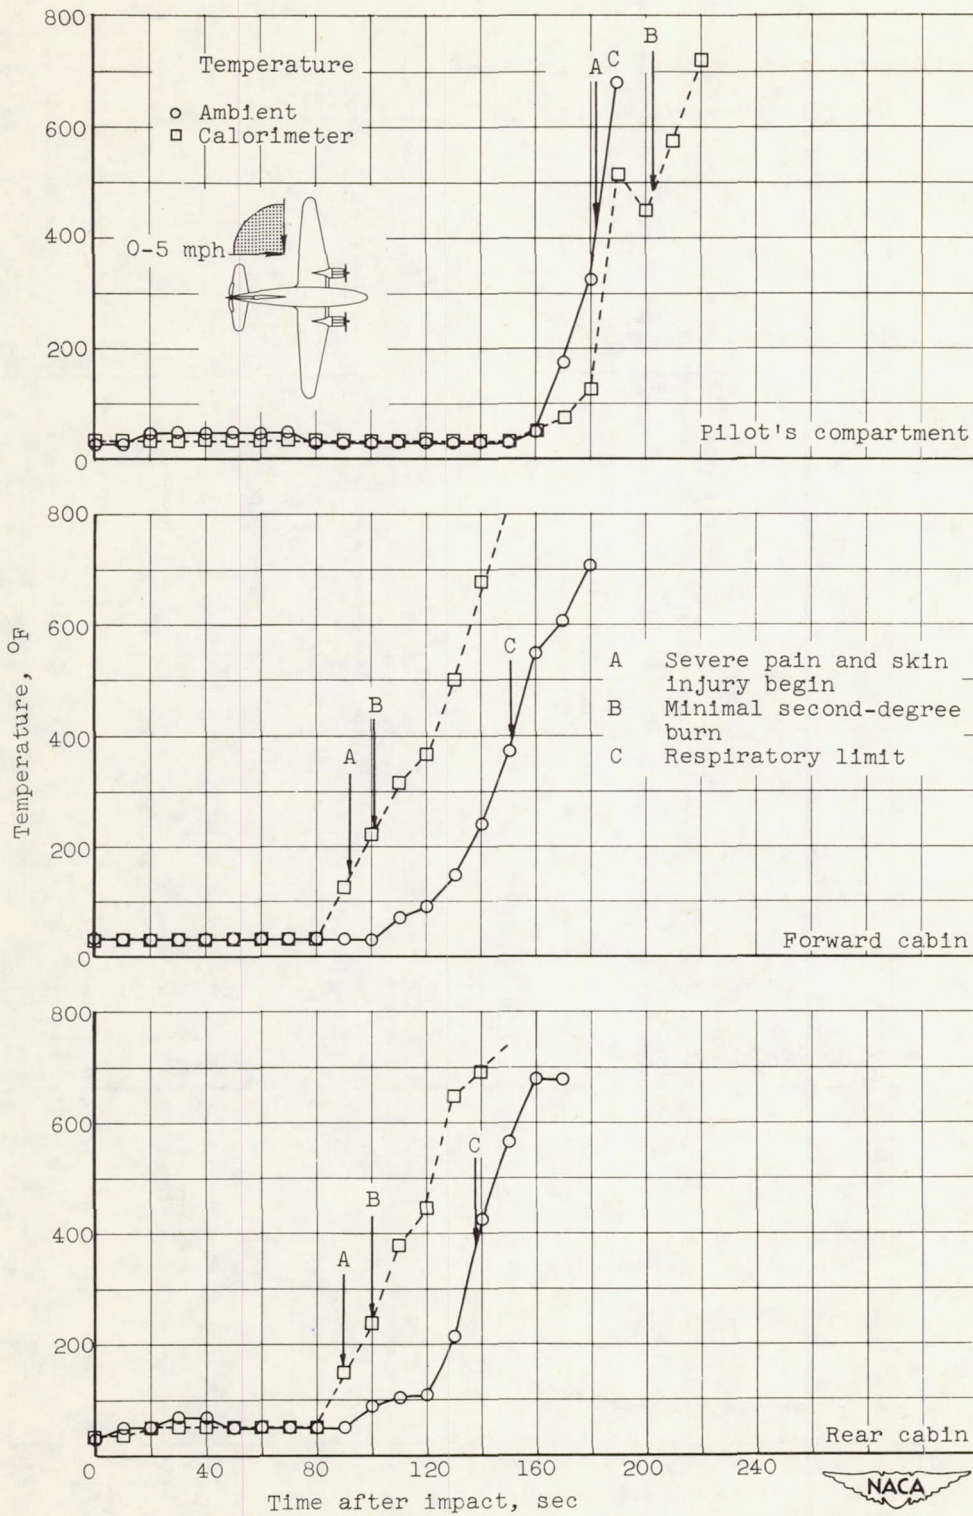
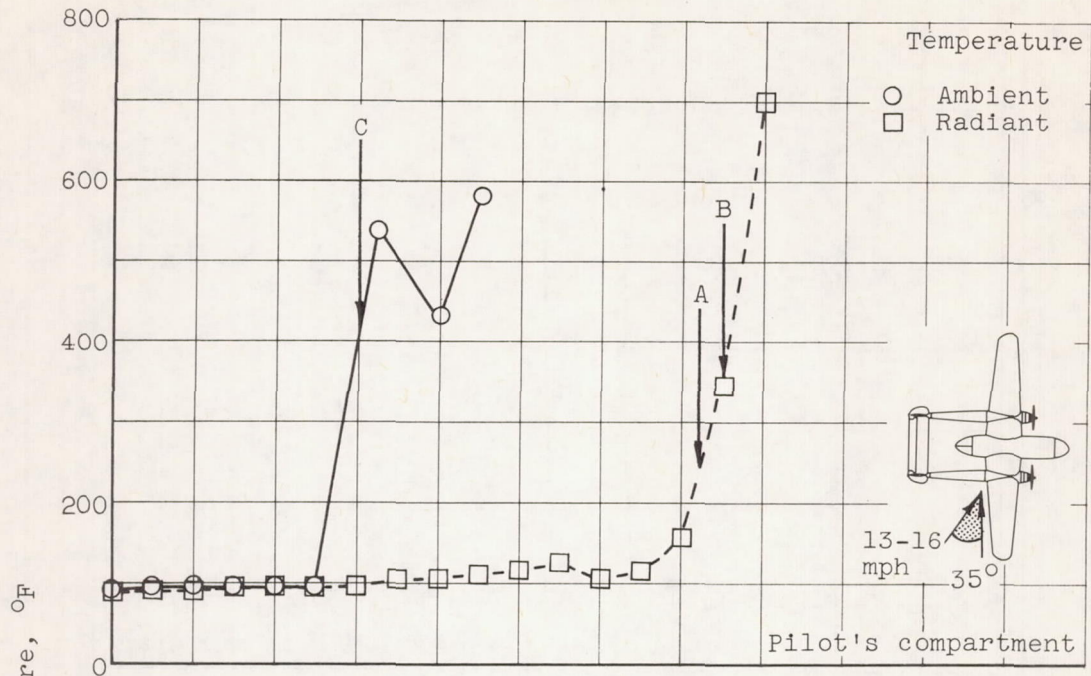
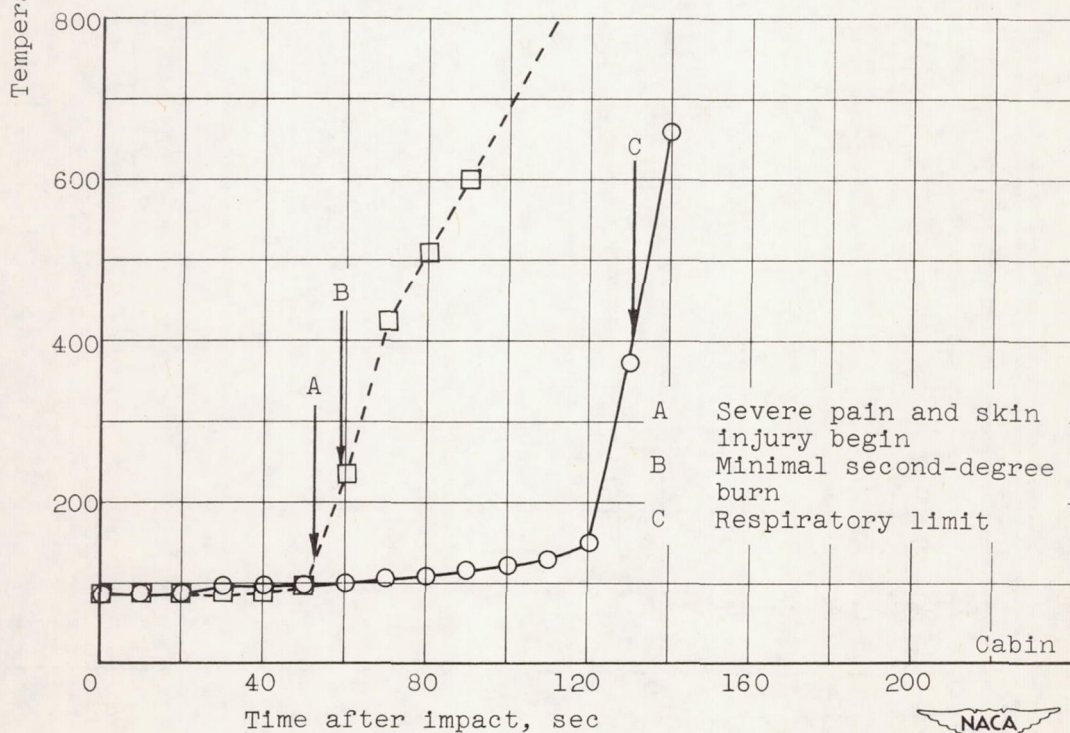
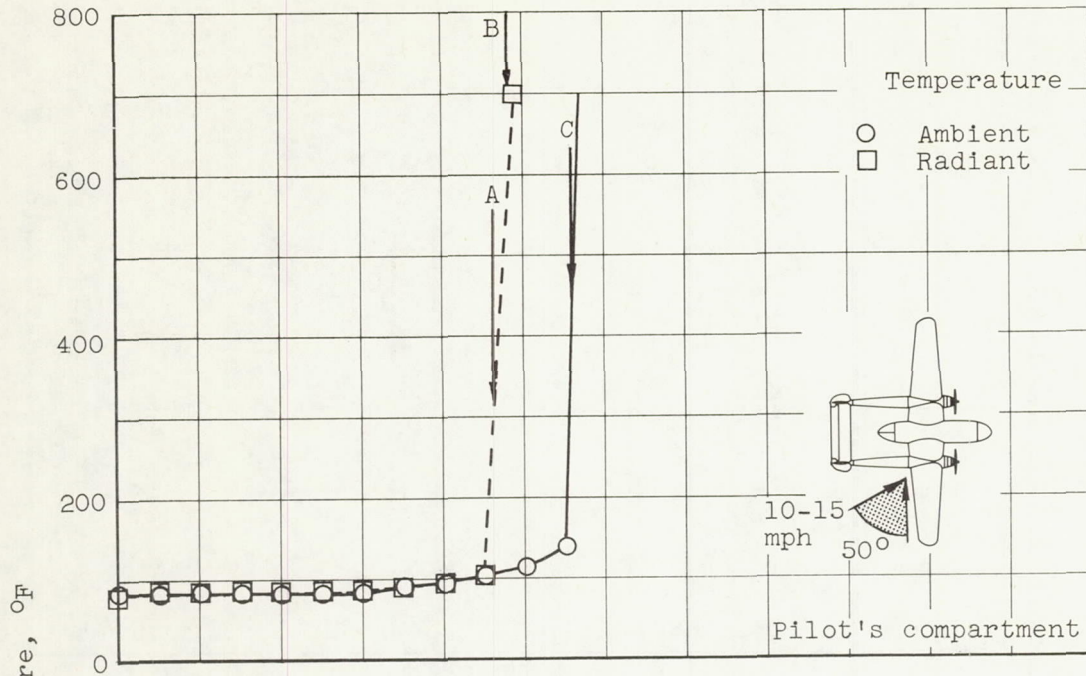
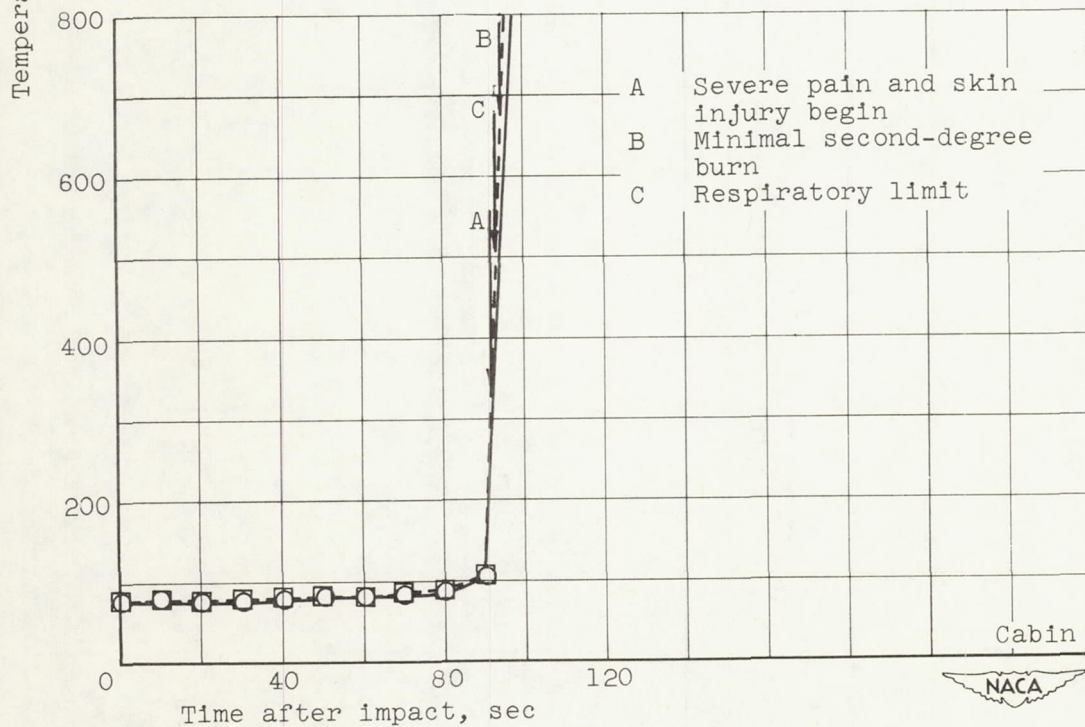
(a) Crash 1; low midwing transport-type airplane; fuel, gasoline.

Figure 8. - Time histories of ambient and calorimeter temperatures in various compartments during several crashes.

(b) Crash 3; low midwing transport-type airplane; fuel, gasoline.

(c) Crash 6; High wing cargo-type airplane; fuel, gasoline.

(d) Crash 7; high wing cargo-type airplane; fuel of low volatility.

Temperature histories and associated escape times. - Histories of the ambient and calorimeter temperatures in passenger and crew compartments during the various crashes together with the escape times as determined by the criteria described in the previous paragraphs are shown on figure 8. The pain and second-degree-burn escape times are indicated by appropriate labels. Pertinent data concerning type of airplane, type of

Because the mist fires rise away from the airplane and also burn out in a few seconds, the air and calorimeter temperatures inside the fuselage do not increase. This effect is shown by inspection of the first 20 seconds of each temperature history (fig. 8). These cabin environment temperatures are not increased because the aluminum fuselage skin reflects most of the heat radiated by the fire; consequently, mist fires that touch the fuselage walls only momentarily while the airplane is sliding are not hazardous to the occupants.

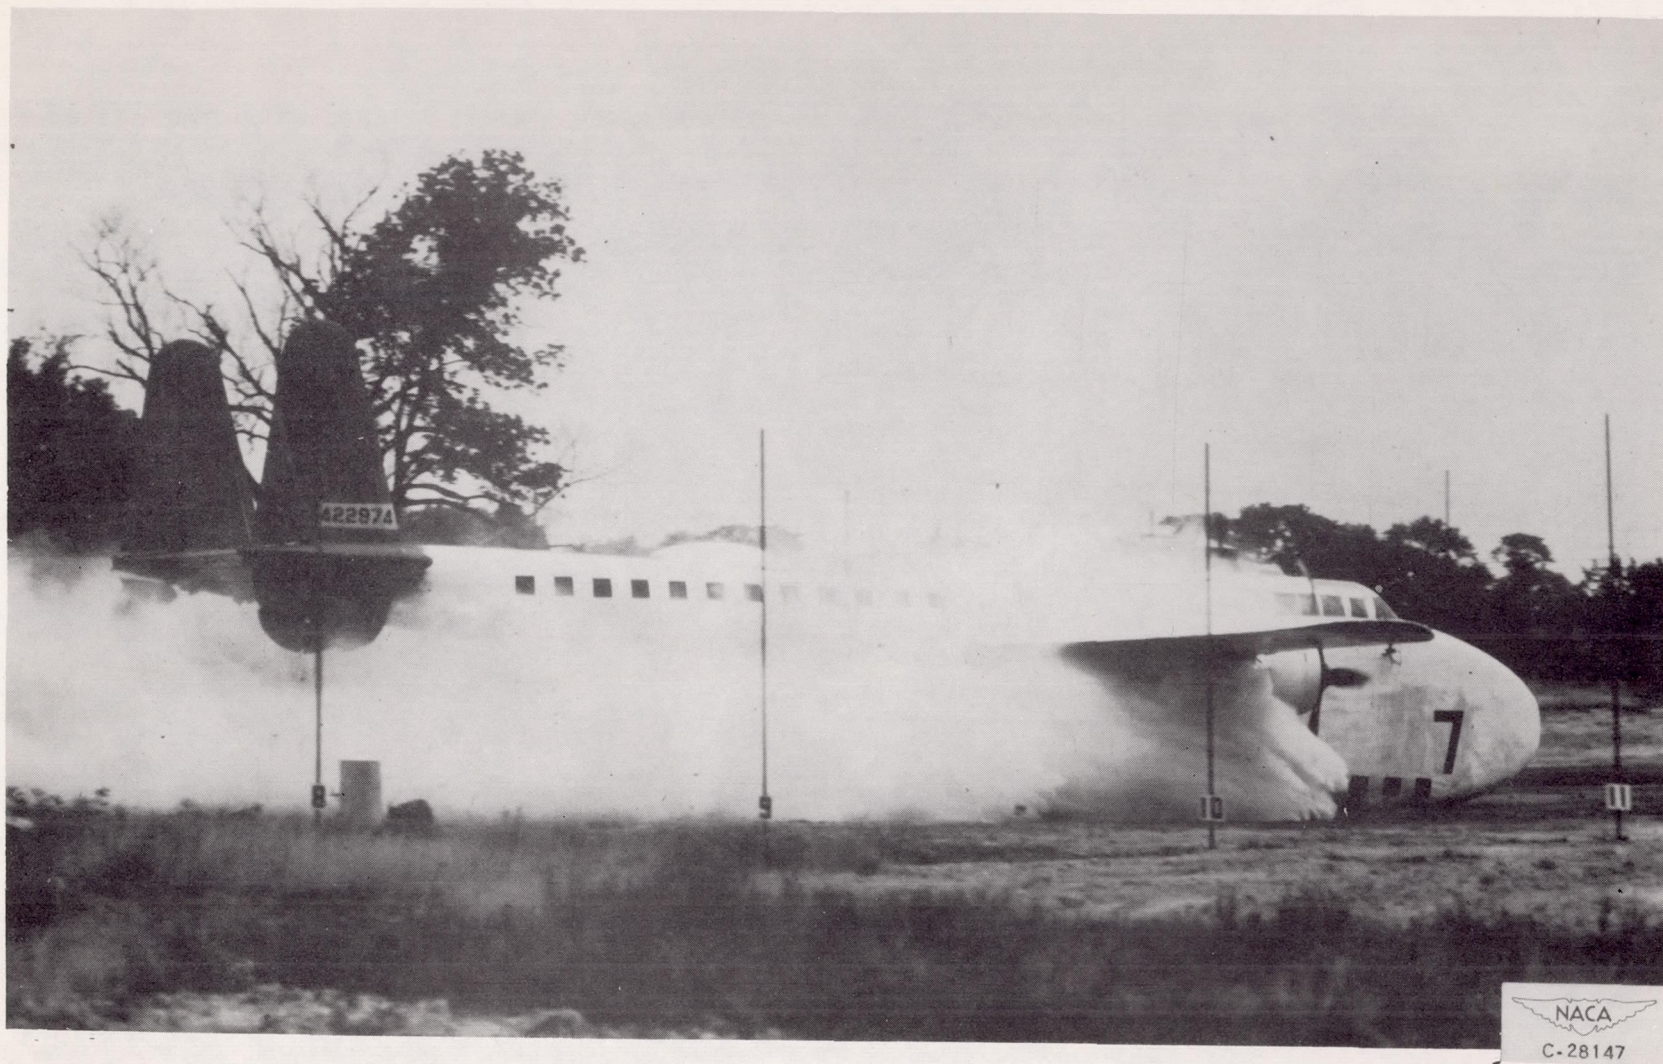
Figure 9. - Typical fuel mist formed when either gasoline or low volatility fuel tanks are ruptured while airplane is in motion. Fuel mist appears as white cloud around and behind wing surfaces. No fire existed at time this photograph was taken.

These temperature histories represent the thermal conditions that resulted from crashes in which fire occurred on both sides of the airplane. In three of the four crashes large volumes of fuel mist formed when fuel tanks were ruptured while the airplane was moving rapidly (fig. 9). When this fuel mist was ignited while the airplane was sliding, large mist fires developed. Figure 10 shows the extent of such a mist fire. These mist fires burn away in 15 to 20 seconds, leaving fires burning from fuel on the ground, on the wetted airplane structure, and pouring from the tanks. The size and extent of these fires are shown by the upper photographs of figure 11. In from 2 to 5 minutes these fires subsequently develop to the size shown by the lower photographs on this same figure.

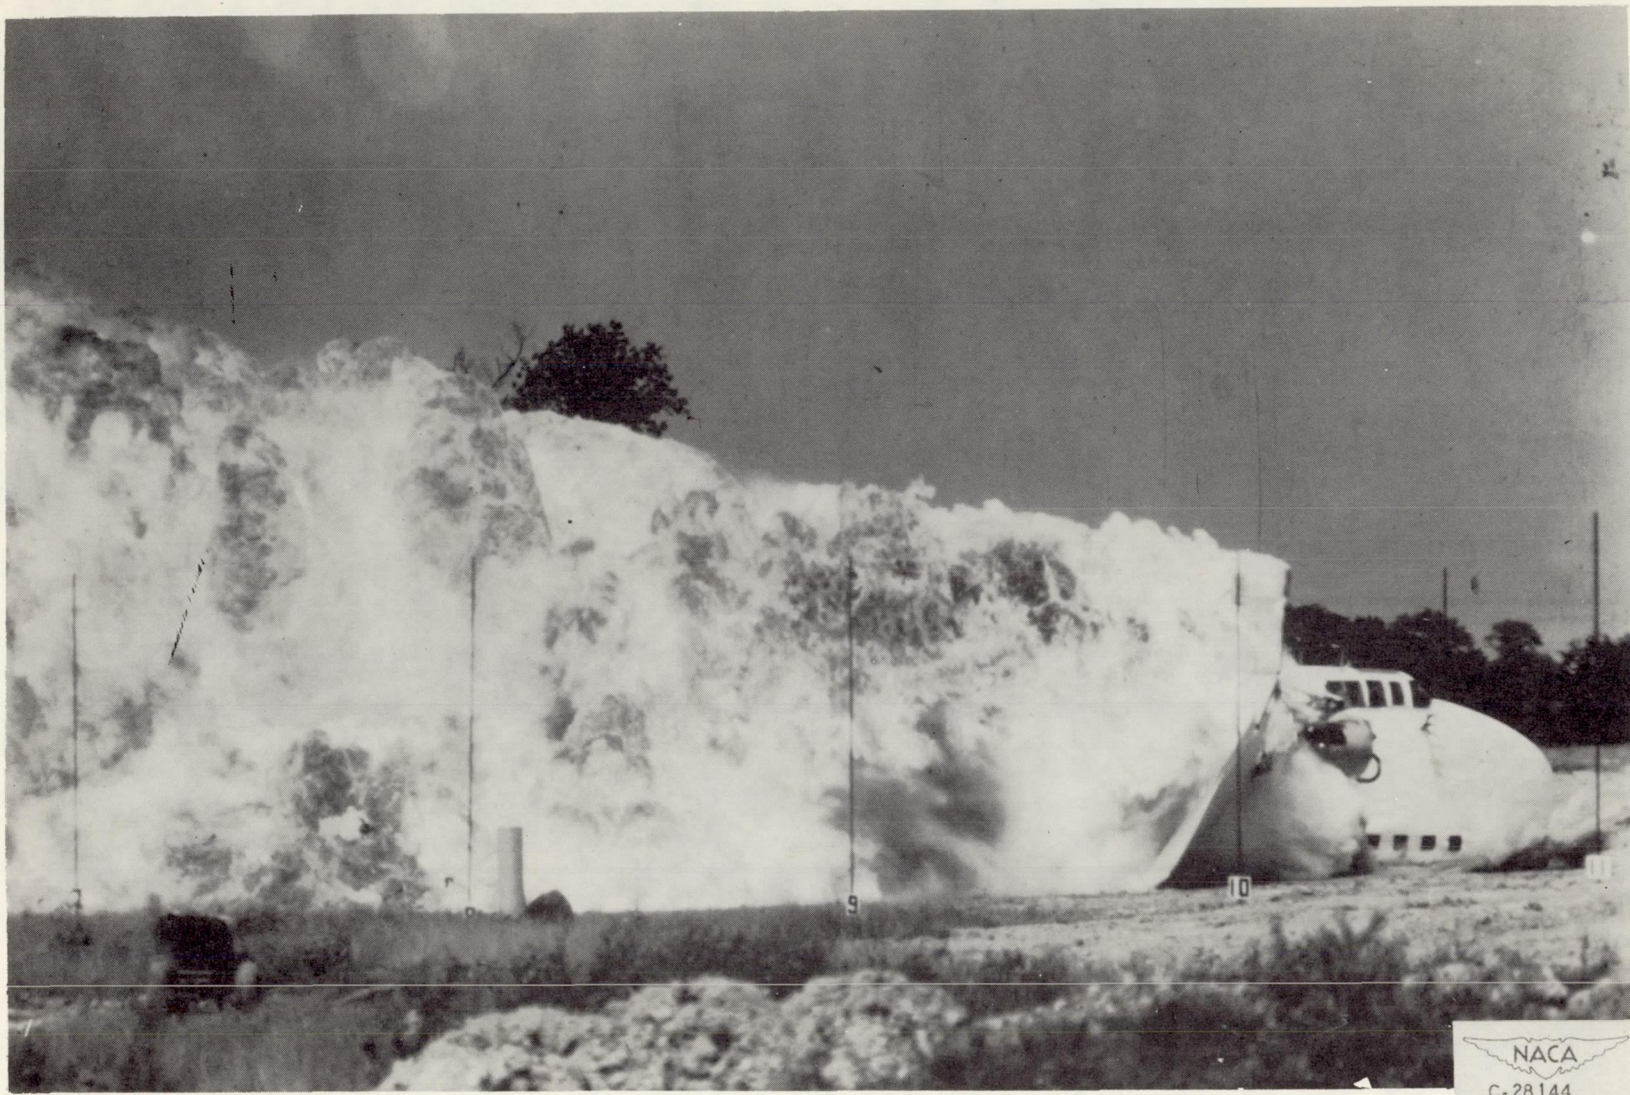
Figure 10. - Fire resulting from ignition of cloud of gasoline mist.
